**State of Louisiana
Office of Coastal Protection and
Restoration**

2011 Annual Inspection Report

**TERREBONNE BAY SHORE
PROTECTION
DEMONSTRATION**

State Project Number TE-45
Priority Project List 10

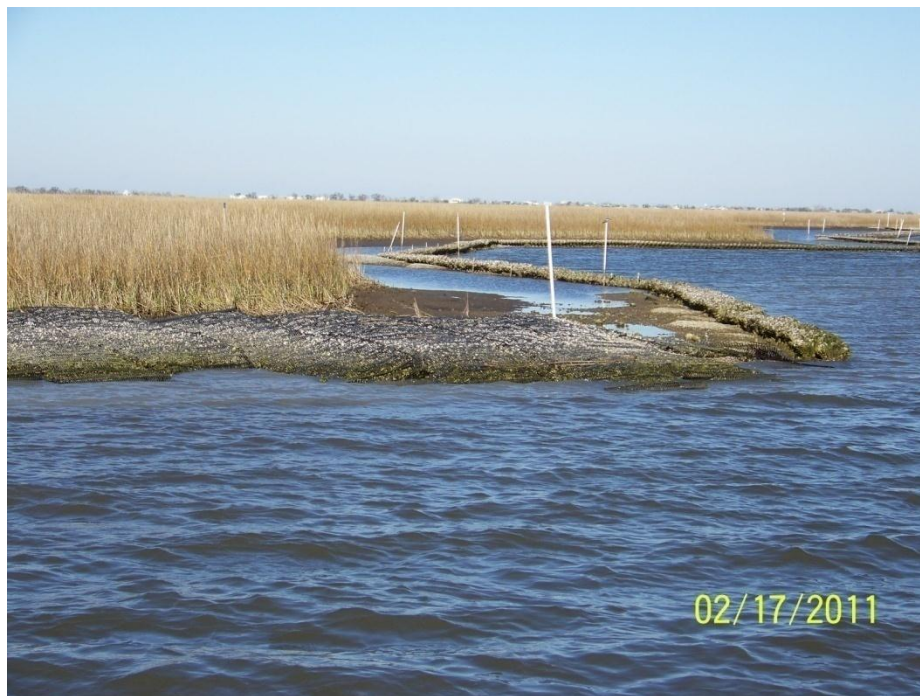
Reach A: Gabion Mats and A-Jacks tie-in

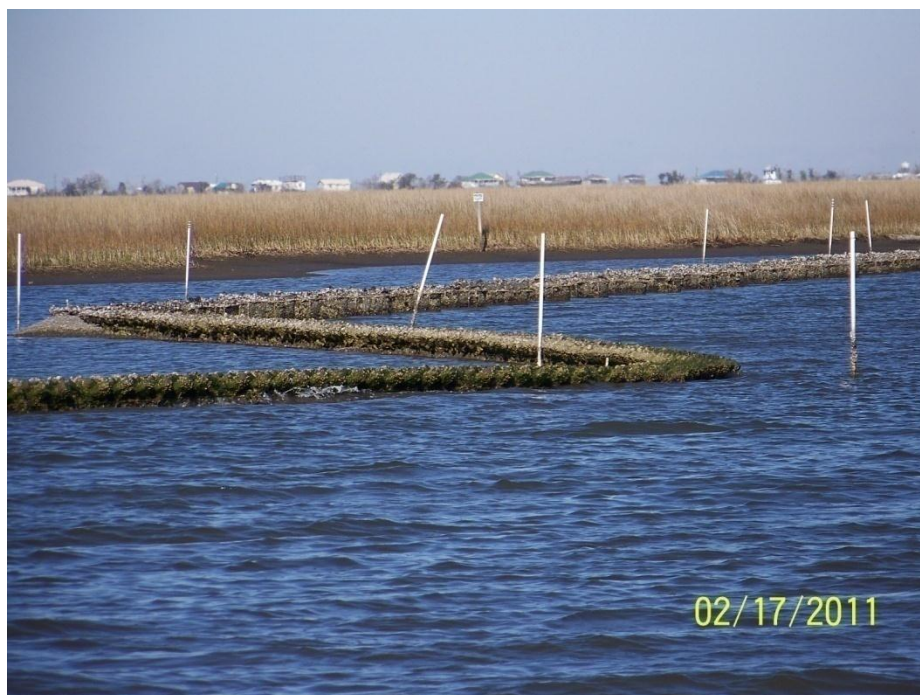
Reach A: A-Jacks tie-in to ReefBlks

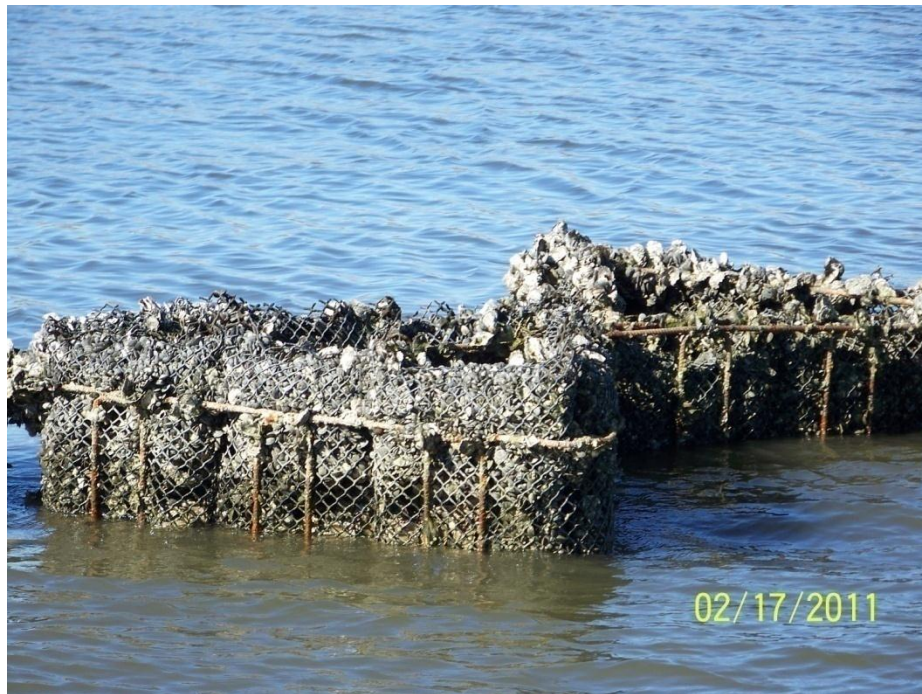
Reach A: Close-up view of ReefBlks

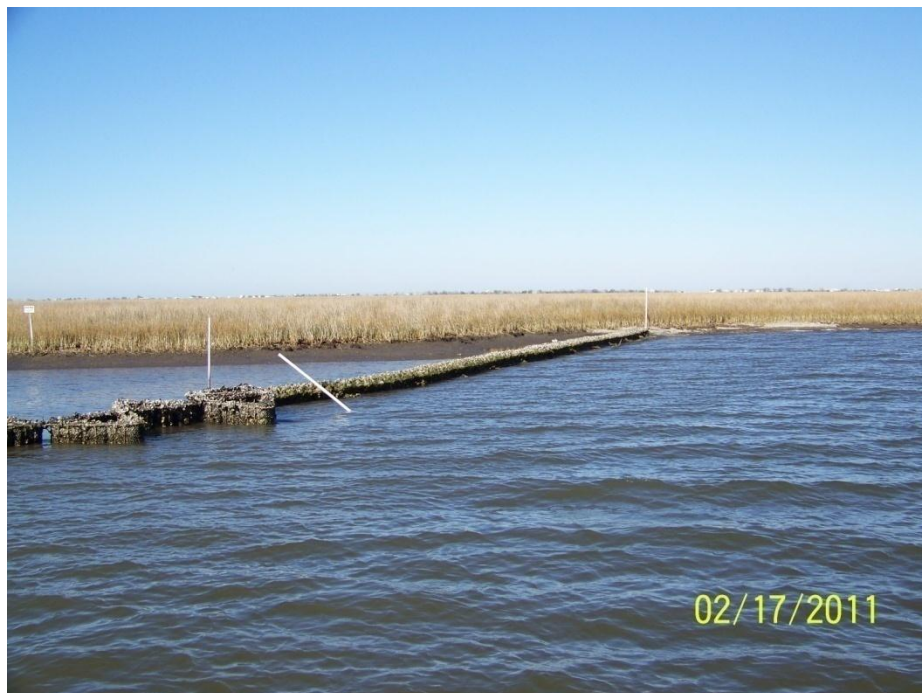
Reach A: A-Jacks tie-in to shoreline

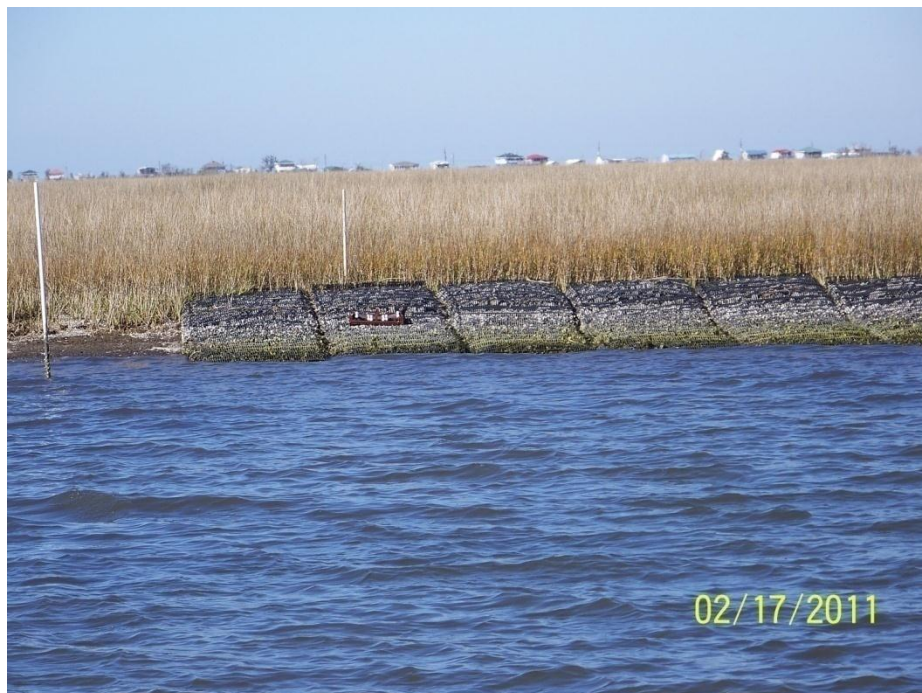
Reach B: Gabion Mats

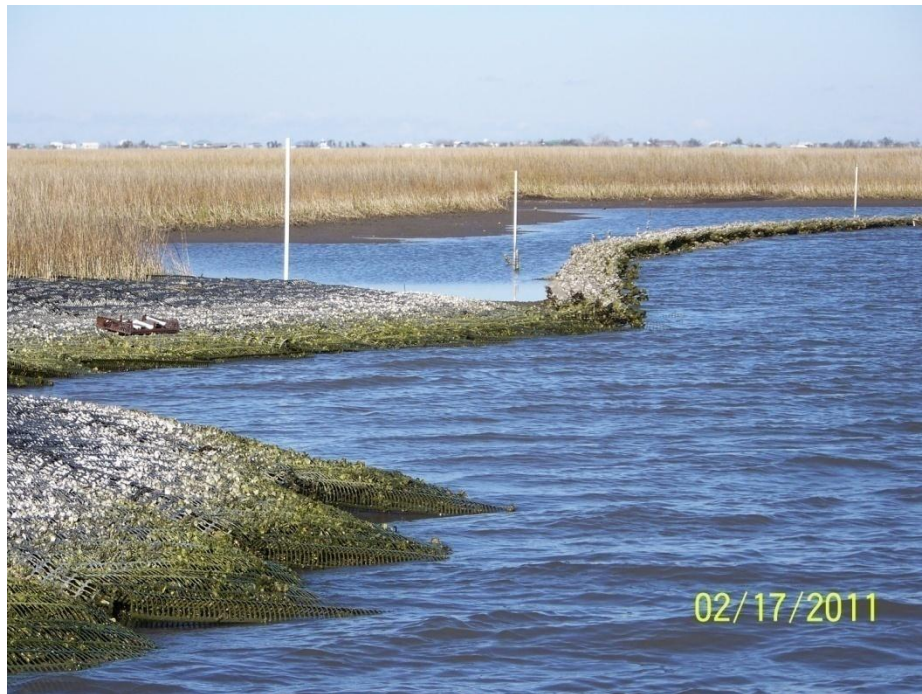
Reach B: Gabion Mats and A-Jacks tie-in

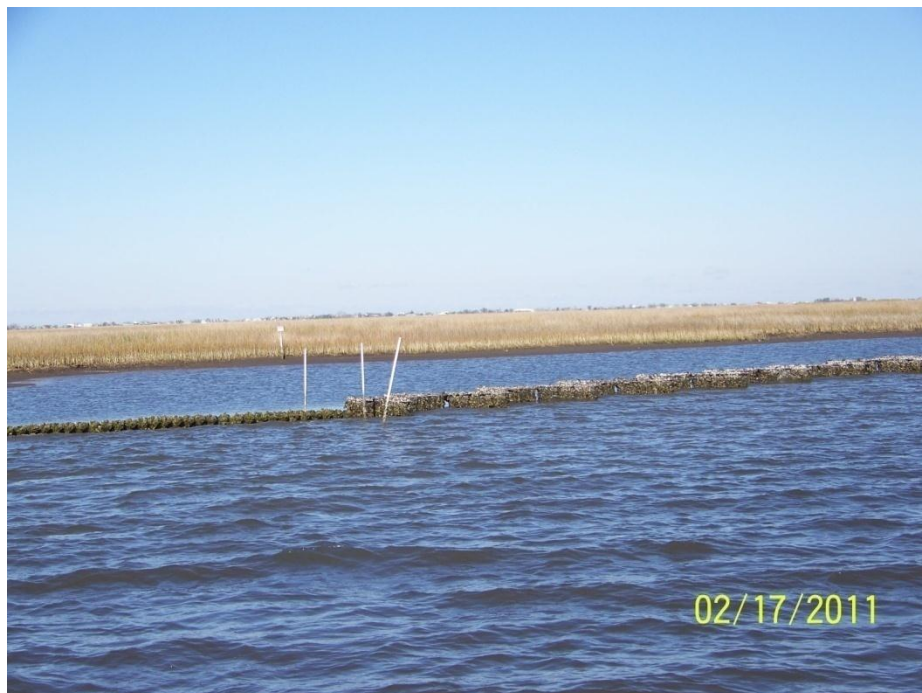
Reach B: A-Jacks tie-in to ReefBlks

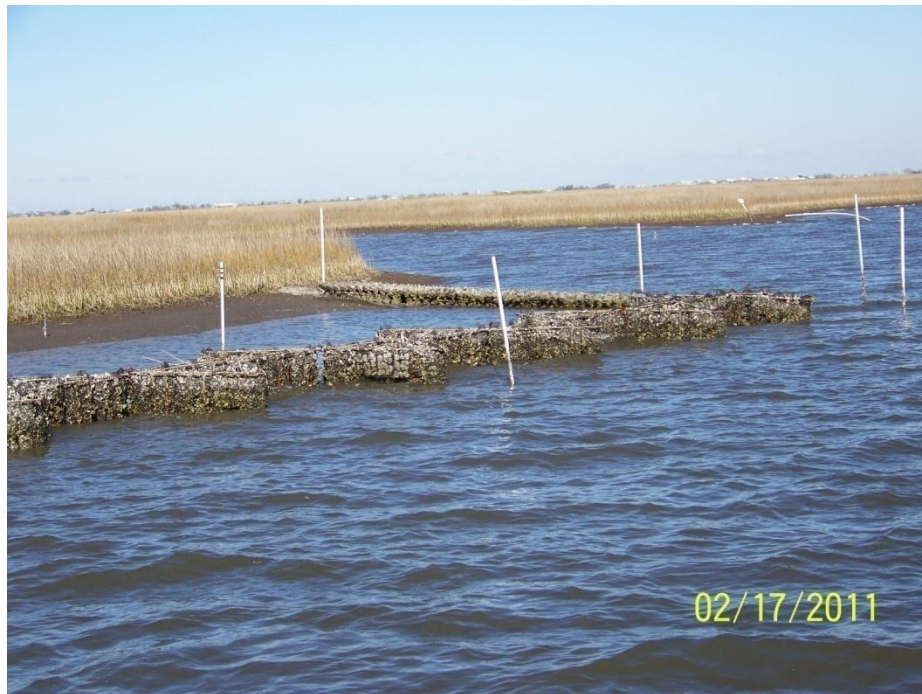
Reach B: ReefBlks and A-Jacks Tie-in to shoreline

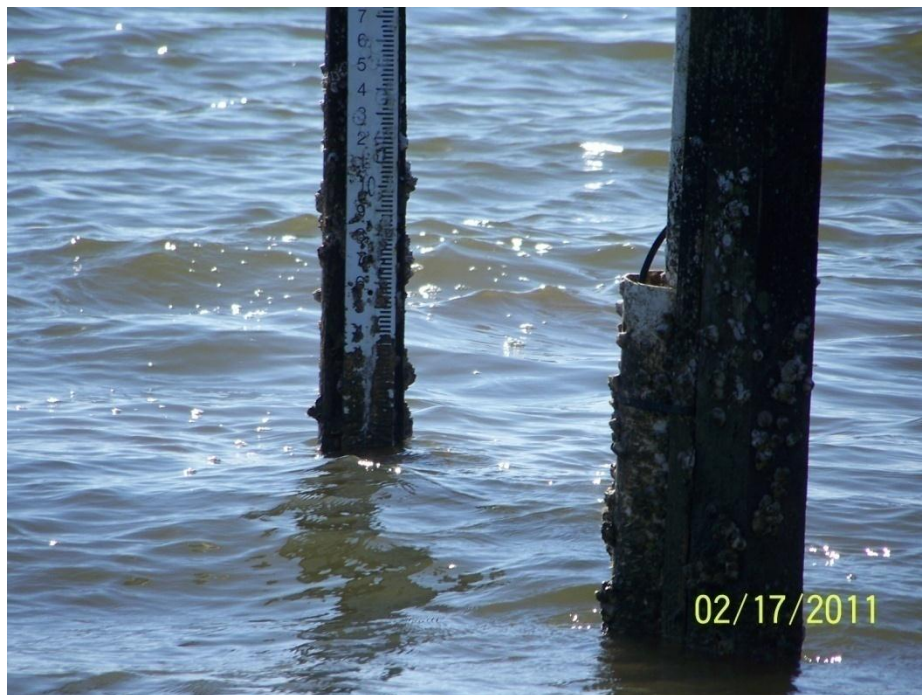
Water level was low during the time of the inspection. A staff gage reading of 0.0' NAVD88 at 10:00 a.m. was taken from staff gage TE45-SG-01 near Reaches A and B. A second reading of -0.2' NAVD88 at 10:30 a.m. was taken from staff gage TE45-SG-02 near Reach E.

Water level at TE45-SG-02

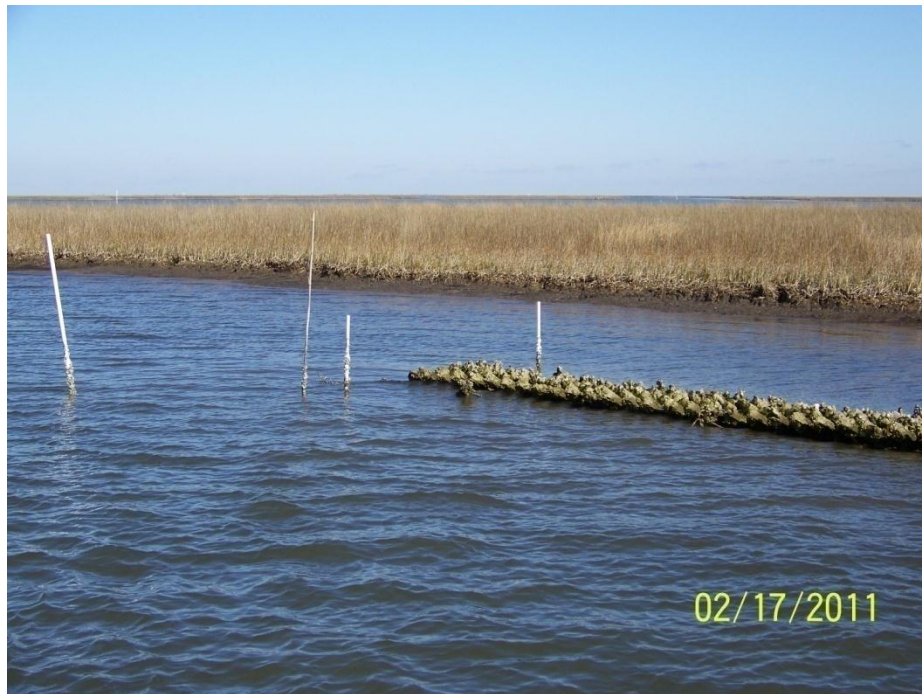
Reach E: A-Jacks tie-in to shoreline

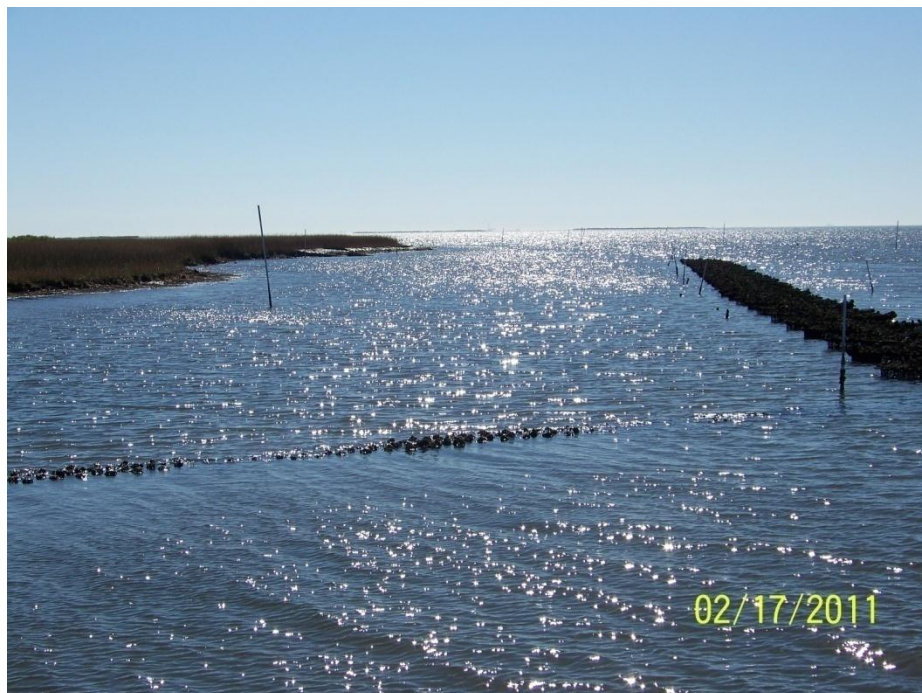
Reach E: Partially submerged A-Jacks tie-in to ReefBlks

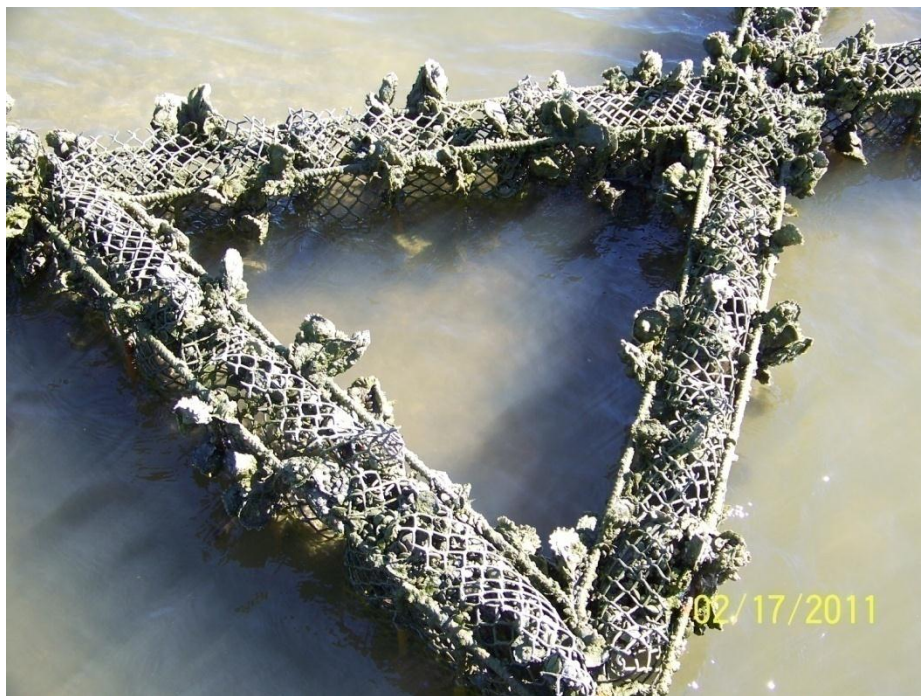
Reach E: Close-up view of ReefBlks

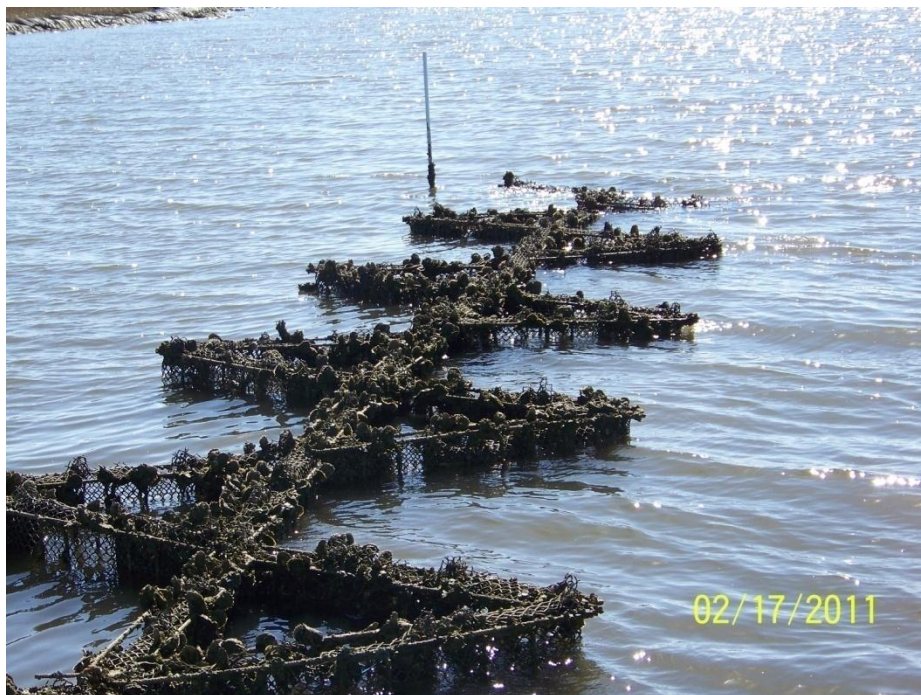
Reach E: Close-up view of ReefBlks

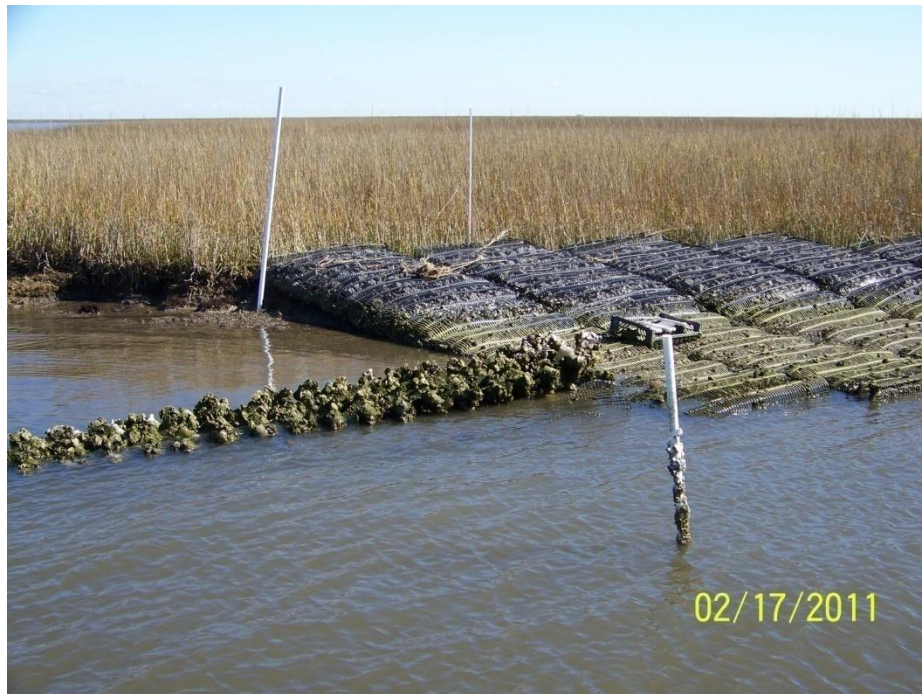
Reach E: A-Jacks tie-in to Gabion Mats

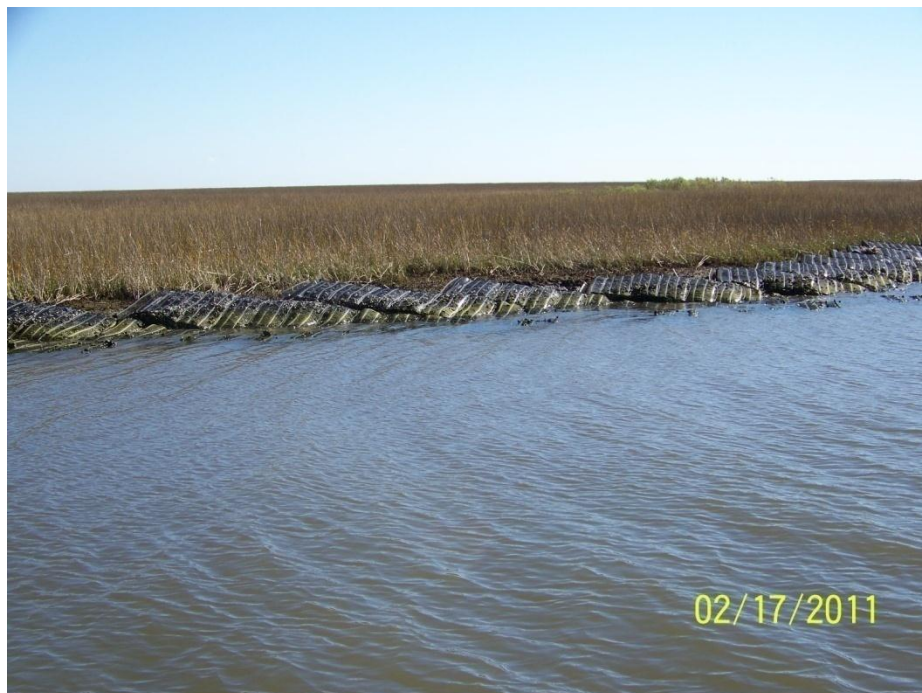
Reach E: Gabion Mats

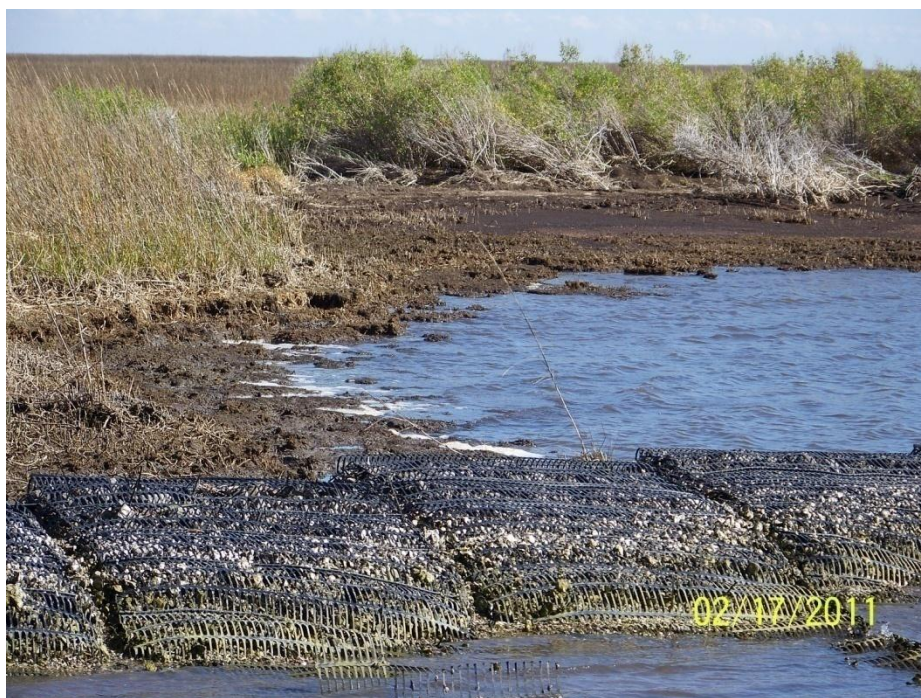
There is no apparent damage to the shoreline protection project features, therefore no rehabilitation of existing structures are necessary. There was some discoloration and burnt marsh along the shoreline at the southern end of Reach E, believed to be damage from the recent oil spill and not a result of salinity spikes or other natural occurrences.

Reach E: Apparent damage to shoreline vegetation due to oil spill

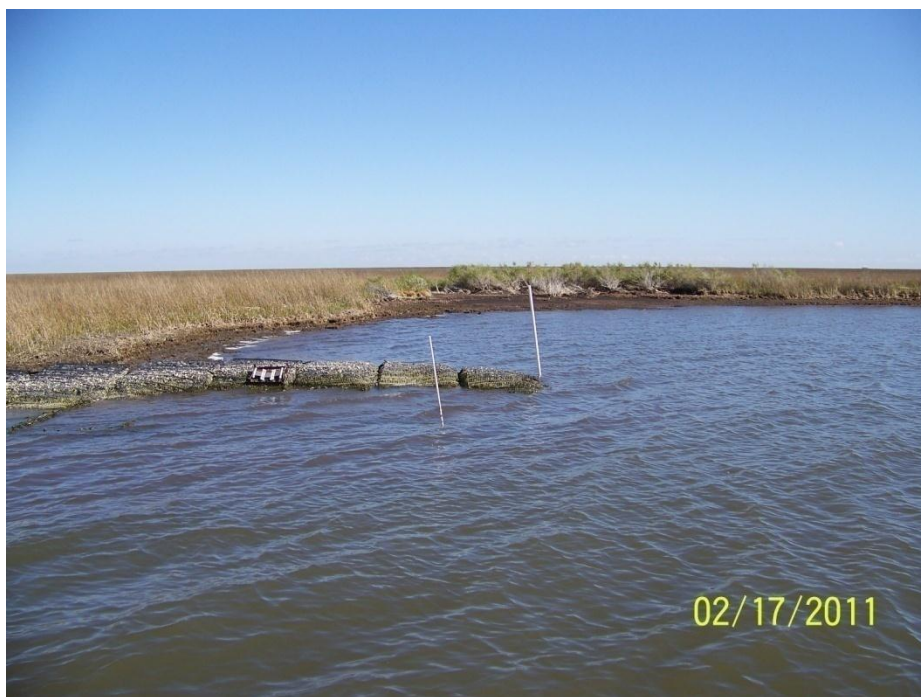
Reach E: Oil damage behind Gabion Mats on South end of section

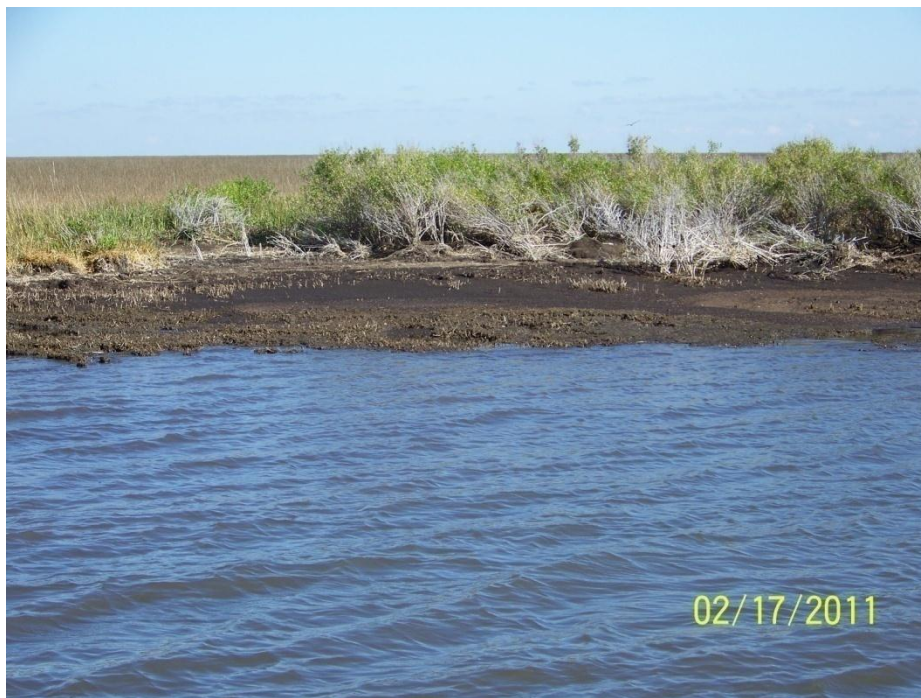
Close-up view of oil spill damage

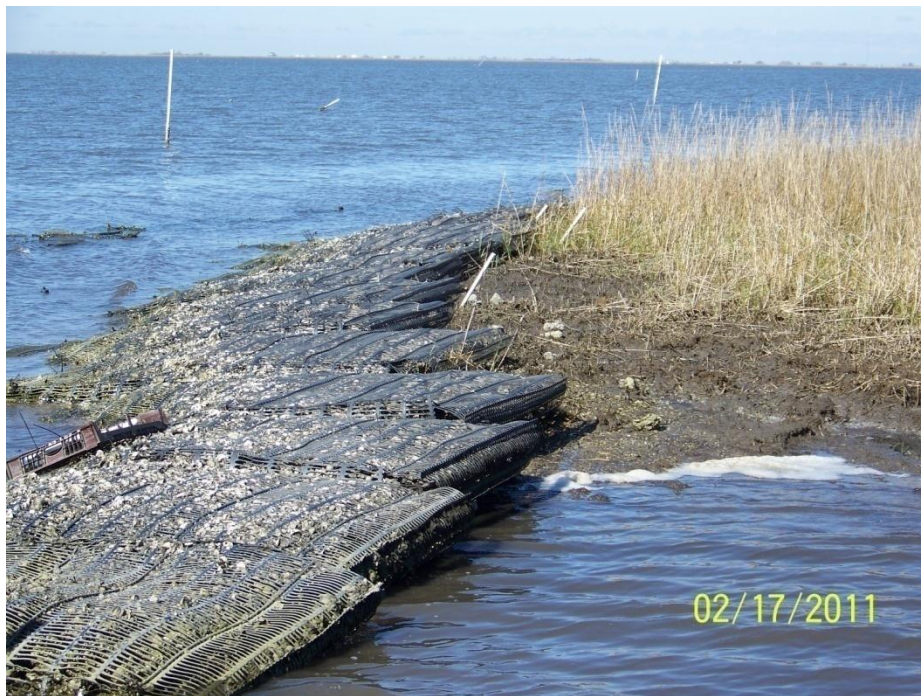
All of the shoreline structures at the three sites appear to be in good condition. All gabion mats were intact. The A-Jacks and ReefBlks were upright with no rollover observed. Oyster growth was noted on all structures. No tie-units (A-Jacks) appeared to have any damage. The two monitoring stations also appeared to be intact with no apparent damage. There was some apparent damage to the shoreline vegetation at the south end of Reach E, but it is believed to be a result of the recent oil spill in the area and should not affect the performance of the structure.

Reach E: Due to oil damage, Gabion mats no longer follow shoreline
