**State of Louisiana
Department of Coastal Protection and
Restoration
Operations Division**

2011 Annual Inspection Report

DELTA WIDE CREVASSES (MR-09)

January 12, 2012
Plaquemines Parish

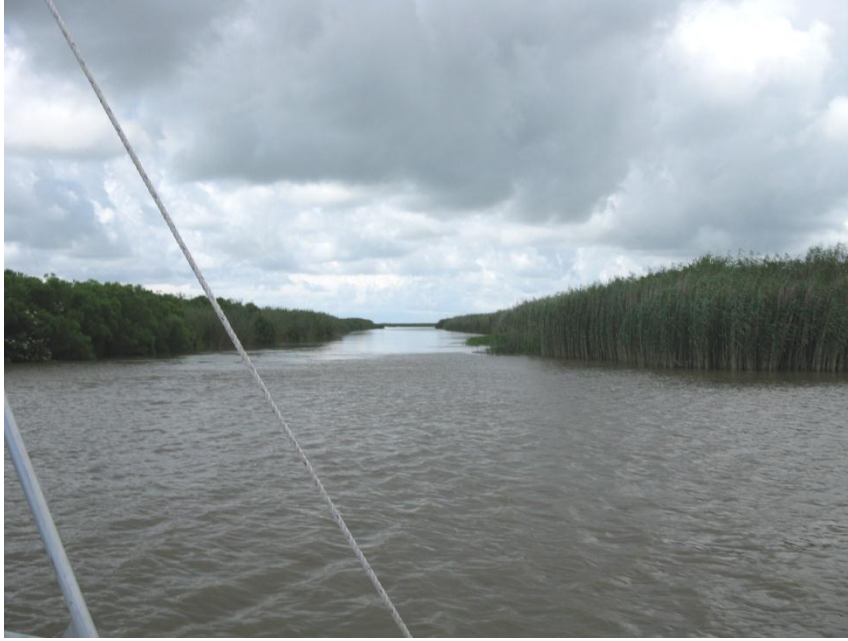
- E. Crevasse No. 12 (1999): (2,000 ft. X 75 ft. X -8.0 ft. NAVD 88) Despite being located off of the main channel, this crevasse appears to be functioning very well. There is sufficient current to carry sediments to the inner section of the bays and lagoons despite maintaining only slightly more than half its original depth. This crevasse had been originally dredged in (1999).

Crevasse No. 12 (View 1) Looking into crevasse from South East Pass.

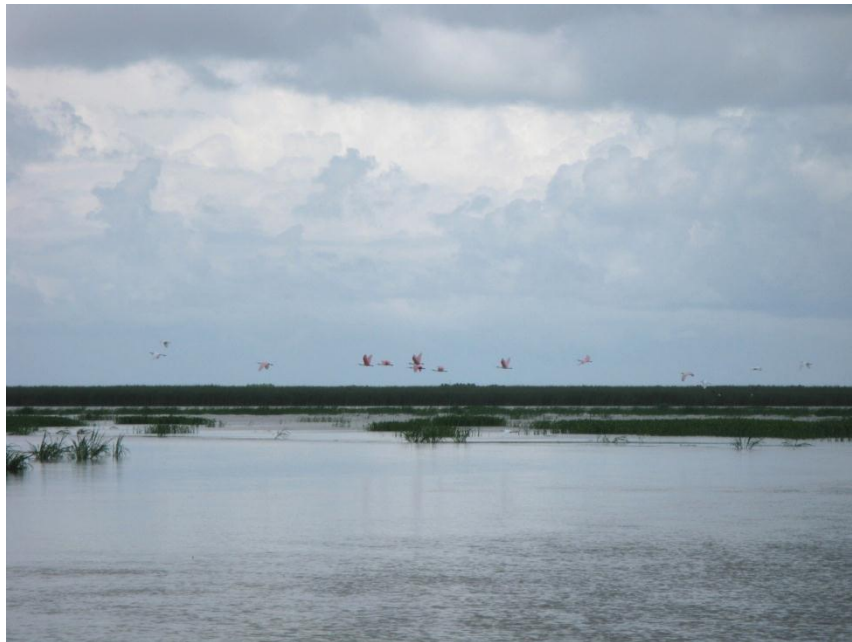
Crevasse No. 12 (View 2) Looking west. Vegetated spoil area in center of view.

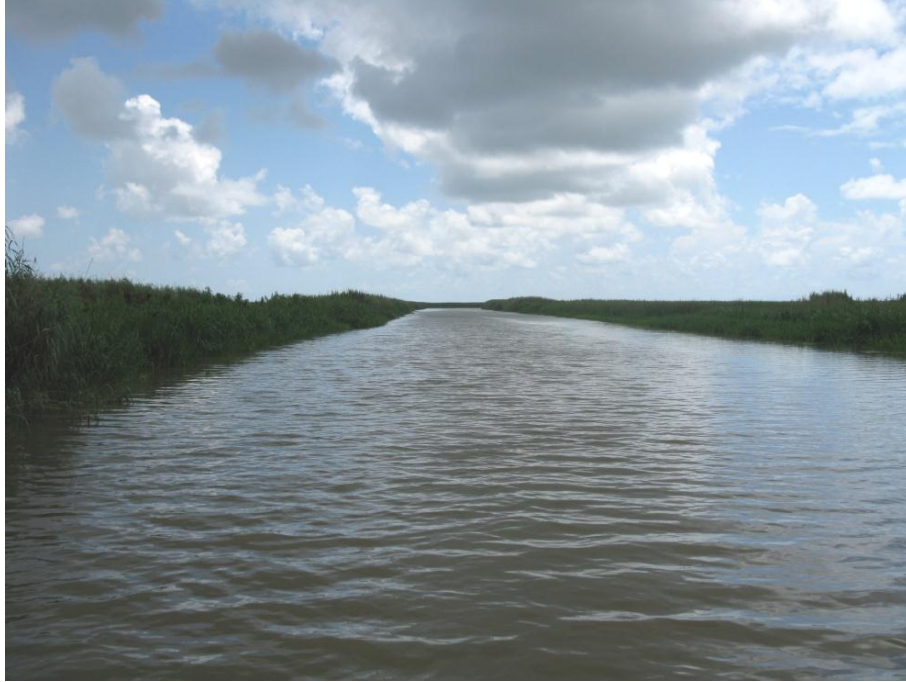
- D. Crevasse No. 11 (1999): (2,600 ft. X 100 ft. X -8.0 ft. NAVD 88) This re-dredged crevasse (1999) is maintaining a good flow throughout its length. Soundings indicate that it has maintained over 80% of its original depth throughout, which is partly due to the swift current. The spoil deposited in the inner lagoon area has vegetated very heavily and appears to be in excellent condition. Wild rice is now growing in the interior receiving bay.

Crevasse No. 11. (View 1) Looking back to Pass a Loutre. Crevasse has maintained its constructed width throughout.

Crevasse # 11	Very Good	None	2,600 ft X 100 ft by -8.0' NAVD 88	Appendix B	This re-dredged, very wide crevasse maintains a good flow throughout its length and appears to be carrying much needed river sediments into the interior marsh areas. Soundings read approximately 7' throughout, shoaling to only 3' at the terminus. Spoil has heavily vegetated (some wild rice) throughout the interior bays.
Crevasse # 12	Very Good	None	2,000 ft X 75 ft by -8.0' NAVD 88	Appendix B	Currents are moderate to swift through this crevasse, despite it being located off of the main channel. Soundings read 10' at the inlet, 5'-6' halfway through, and 4' at the terminus. The spoil from the crevasse excavation has vegetated very heavily with roso cane. New vegetation has grown along the banks..
Crevasse # 81	Poor	None	1,200 ft X 100 ft by -8.0' NAVD 88	Appendix B	This crevasse is located on the south bank of Baptiste Collette just off of the Miss. River. Due to its location, it is receiving strong current and heavy sediment loads. The dredge spoil has vegetated very nicely; however, it's location causes it to shoal at the inlet (3'-4' depth) during the first high river and renders it inefficient for the long term.

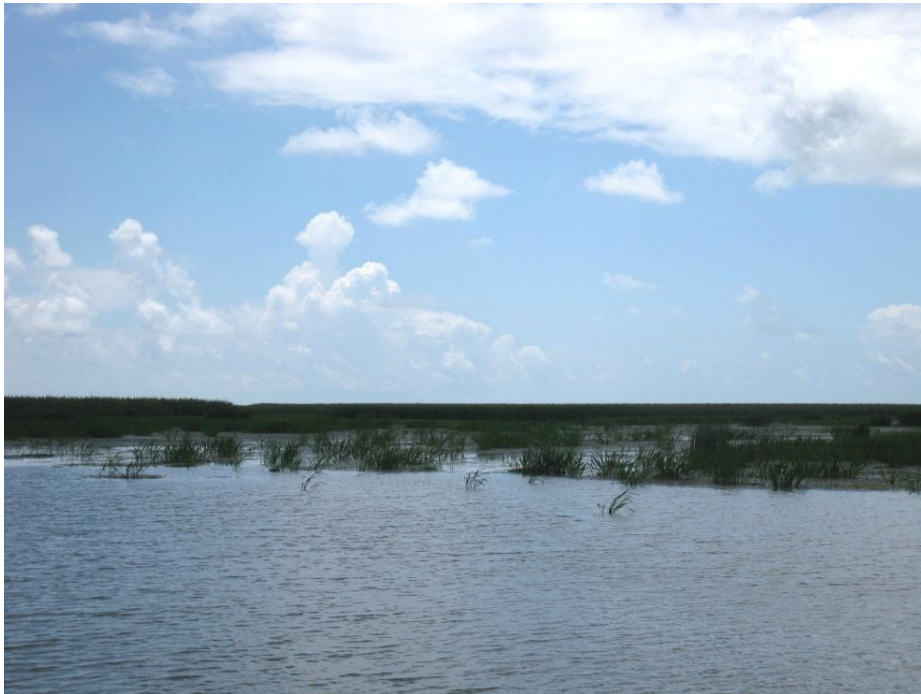
Crevasse No. 11. (View 2) Heavily vegetated crevasse dredging spoil in bay area, foreground.

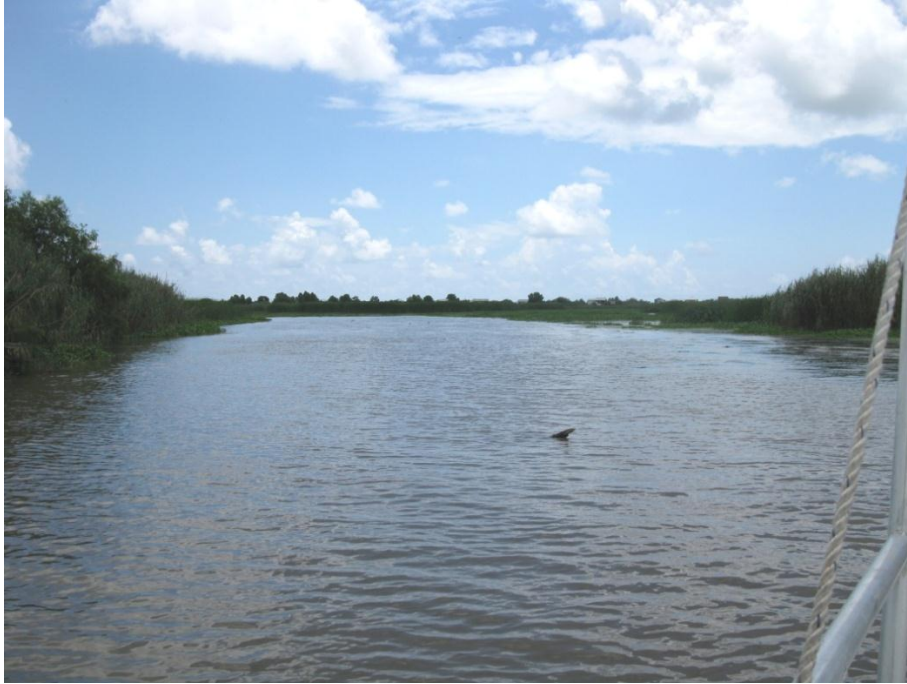
- A. Crevasse No. NC-1 (2005): (1,000 ft. X 100 ft. X -8.0 ft. NAVD 88) This crevasse appears to be in good condition. Soundings indicate that it has retained slightly more than half of its originally constructed depth. The interior indicates that river water is flowing very well through the channel carrying large amounts of sediment, and the spoil from the dredging of the crevasse is heavily vegetated throughout the deposited bay area.

Crevasse No. NC-1. (View 1) Looking south. Notice heavily vegetated construction easement from crevasse dredging.

Item	Condition	Physical Damage	Dimensions	Photo	Observations and Remarks
Crevasse # NC-1	Good	None	1,000 ft X 100 ft by -8.0' NAVD 88	Appendix B	This new crevasse (2005) appears to be in good condition. Soundings read 4.5'-5' at the inlet, ~7' halfway through, and 4' at the terminus. The interior indicates that river water is slowing very well through the channel carrying large amounts of sediment. The spoil from the dredging of the crevasse is heavily vegetated throughout the deposited bay area.
Crevasse # NC-3	Excellent	None	1,400 ft X 100 ft by -8.0' NAVD 88	Appendix B	This new crevasse (2005) off of South Pass is functioning very well, seems to be flowing swiftly. This crevasse maintains a -10'+ throughout the channel. Soundings read 9' at the inlet, 12' halfway through, and 13.5' at the terminus. The interior bay is heavily silted and full of vegetation.
Crevasse # 9	Very Good	None	2,200 ft X 75 ft by -8.0' NAVD 88	Appendix B	Good flow is being maintained by this dog-leg shaped crevasse. From the flow velocity, that good water depth (average -7') is being maintained throughout its length. Dredge spoil from the crevasse has vegetated (alligator grass) very well throughout.

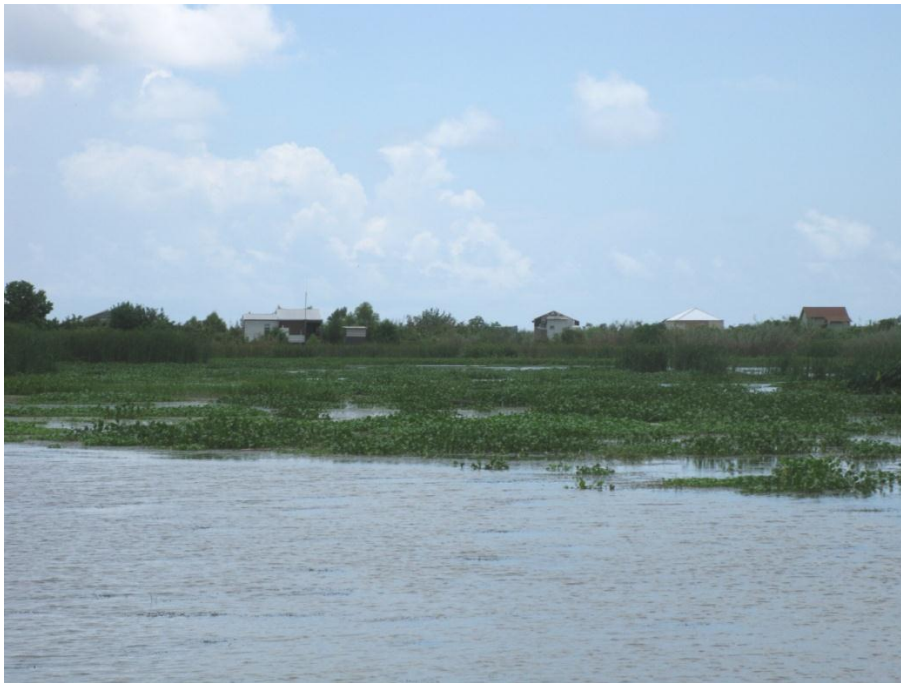
Crevasse No. NC-1. (View 2) Vegetated spoil deposition in inside bay area.

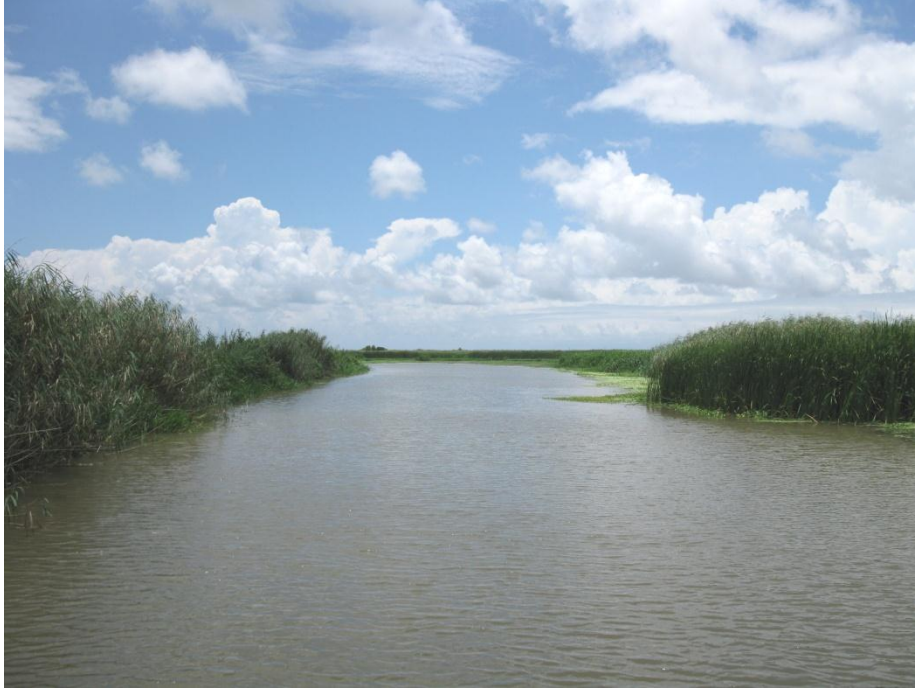
- C. Crevasse No. 9 (1999): (2,200 ft. X 75 ft. X -8.0 ft. NAVD 88) Good flow is being maintained in this dog-leg shaped crevasse. Its location allows for swift currents during the present high river stages. Soundings indicate that this crevasse has maintained 80% of its original depth throughout its length. The spoil deposition from this cut is very heavily vegetated and seems to have increased in size.

Crevasse No. 9. (View 1) From Pass-a-Loutre looking south into the crevasse. Original width has been maintained.

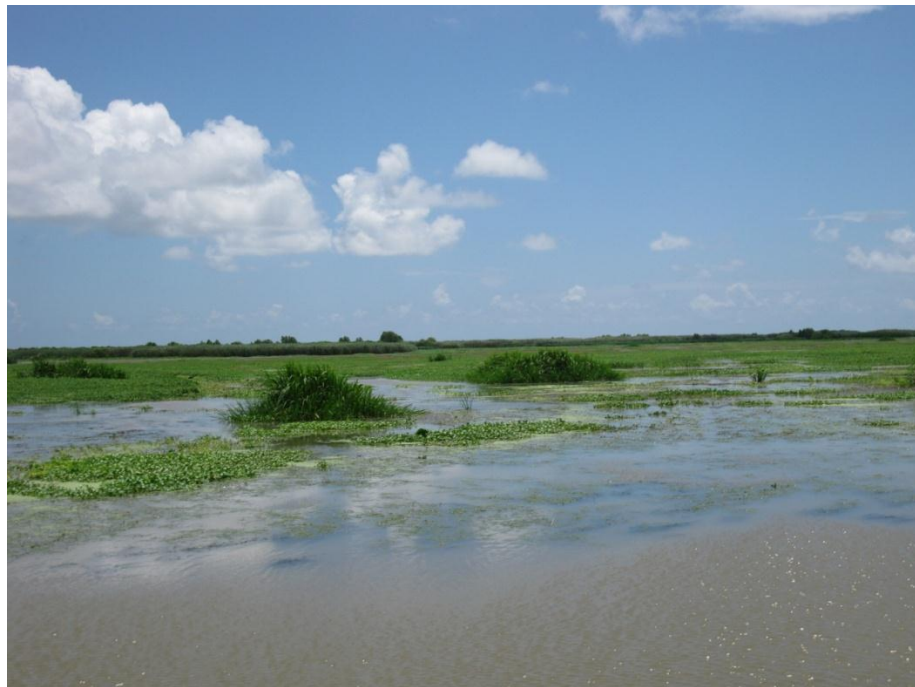
Crevasse No. 9. (View 2) Crevasse end looking at spoil area vegetation sediment deposits from the recent high river.

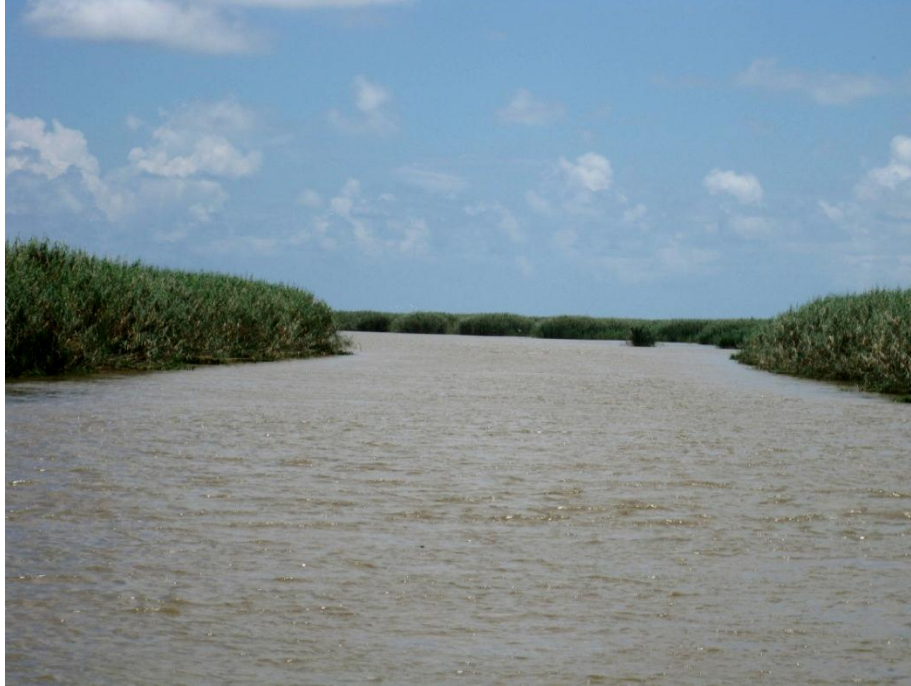
- B. Crevasse No. NC-3 (2005): (1,400 ft. X 100 ft. X -8.0 ft. NAVD 88) This is the second of the two new crevasses and the only one on South Pass. It is functioning very well, and flowing with a very swift current bringing much needed sediments into the interior bays. Our soundings show that the crevasse is maintaining its original depth throughout its channel length and the spoil from the crevasse dredging has completely vegetated. New spoil deposits from this high water season can also be seen in the inner bay.

Crevasse No. NC-3. (View 1) Looking into crevasse from South Pass showing heavy vegetation on both banks.

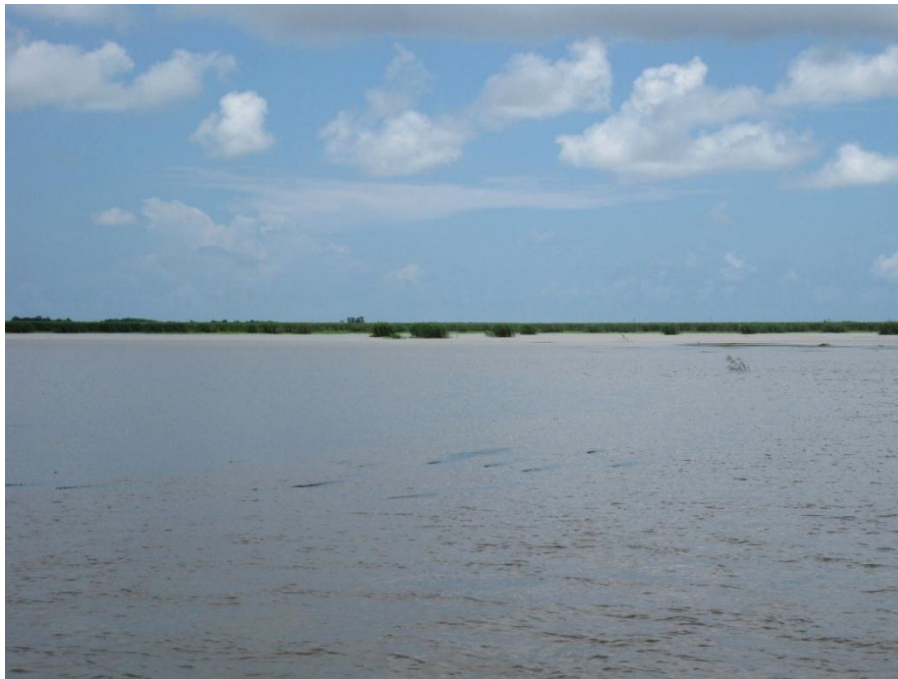
Crevasse No. NC-3. (View 2) Crevasse terminus looking east into open pond area. Notice shallow depth of water in center. This crevasse has maintained all of its original dimensions.

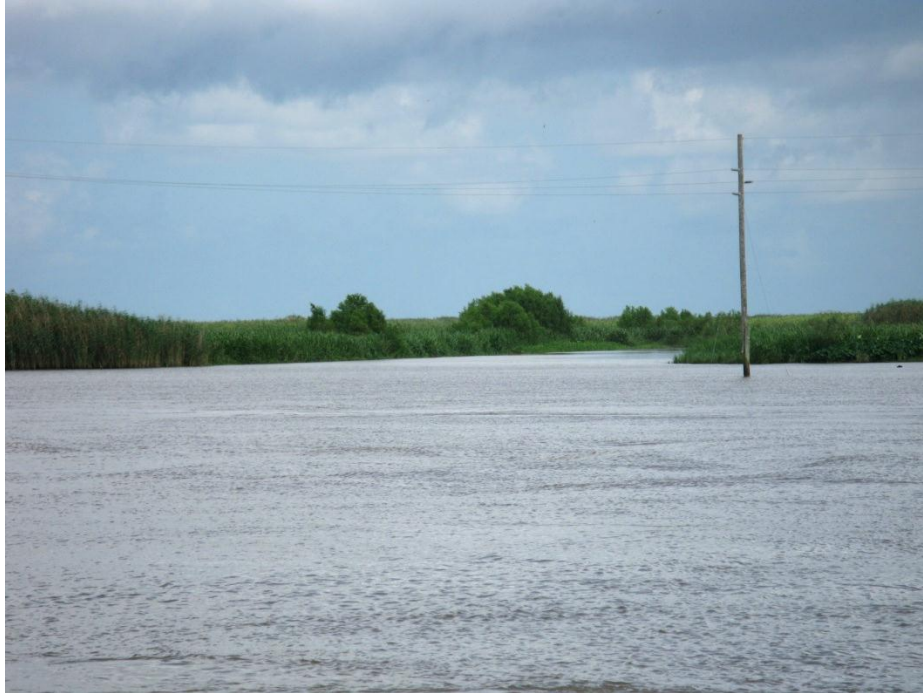
- F. Crevasse No. 81 (2005): (1,200 ft. X 100 ft. X -8.0 ft. NAVD 88) This crevasse is located off of Baptiste Collette in the Delta Wildlife Management Area. The close proximity of this crevasse to the Mississippi River allows for a strong current flow. Despite soundings indicating that the mouth of this crevasse has silted up from the large amounts of sediments moving into the cut, there is still some sediments being carried into the interior marsh area. The 3.5' draft of the boat was too deep to travel into the crevasse.

Crevasse No. 81. (View 1) Looking south from Baptiste Collette channel. Material build-up at channel edge prevented the inspection team from entering the channel.

At this time no immediate action will be taken for maintenance of the existing crevasses. CPRA, NOAA, LDWF, and USFWS will initiate a feasibility study of the identified additional areas to be potentially dredged in 2012/13. It is also recommended that we not return to Baptiste Collette to either maintain or dredge new crevasses at this time – more alternate sites can be found in the Pass-a-Loutre area. The strong current and high sediment load funneled through Baptiste Collette shoaled up these crevasses within the first high water period after dredging rendering them inefficient for the long term (5-years plus).
