**State of Louisiana  
Office of Coastal Protection and  
Restoration  
Operations Division**

## **2011 Annual Inspection Report**

### **DELTA MANAGEMENT AT FORT ST. PHILIP (BS-11)**

January 12, 2012  
Plaquemines Parish

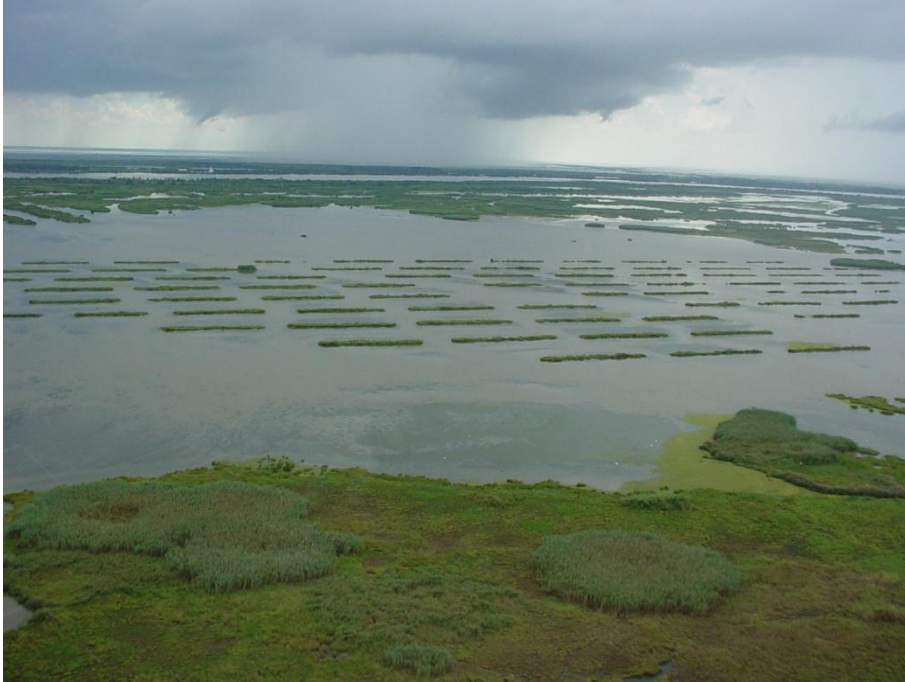
- A. Terraces: Terraces built on the north side with soft, unsuitable material have developed some washout areas in their perimeter. Their original constructed elevations remain unchanged. Vegetation densely covers each terrace. Flow is evident through the terrace field.

**Terrace Field in Bay Denesse Looking South (2010 Stock Photo)**

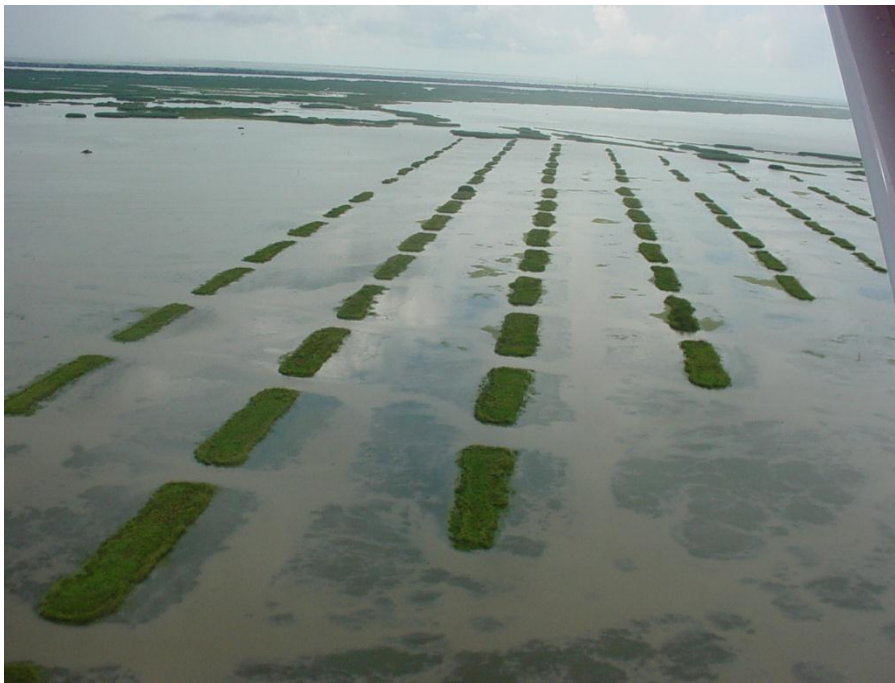
**Terrace Field in Bay Denesse Looking West (2010 Stock Photo)**

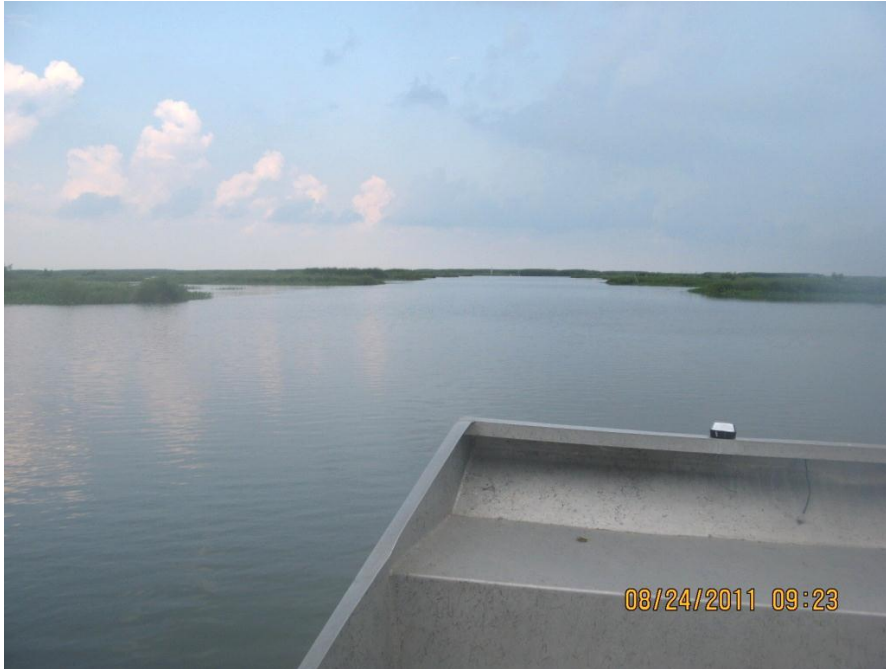
- B. Crevasse No. 1A: This crevasse is the longest of all, and funnels river water directly into Bay Denesse/terrace field. Currents through this crevasse were swift and appeared to be carrying plenty of river sediment. Soundings showed that depth is maintained throughout the length of the crevasse. The crevasse spoil was well vegetated.

**Channel 1-A exiting into the Terrace Field in Bay Denesse**

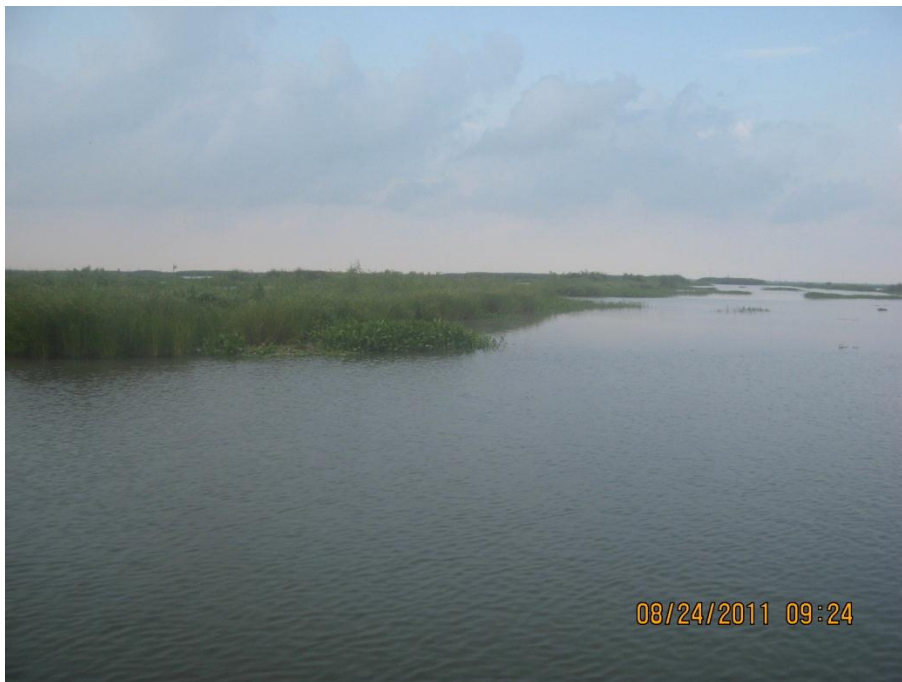
**Terrace Field in Bay Denesse**

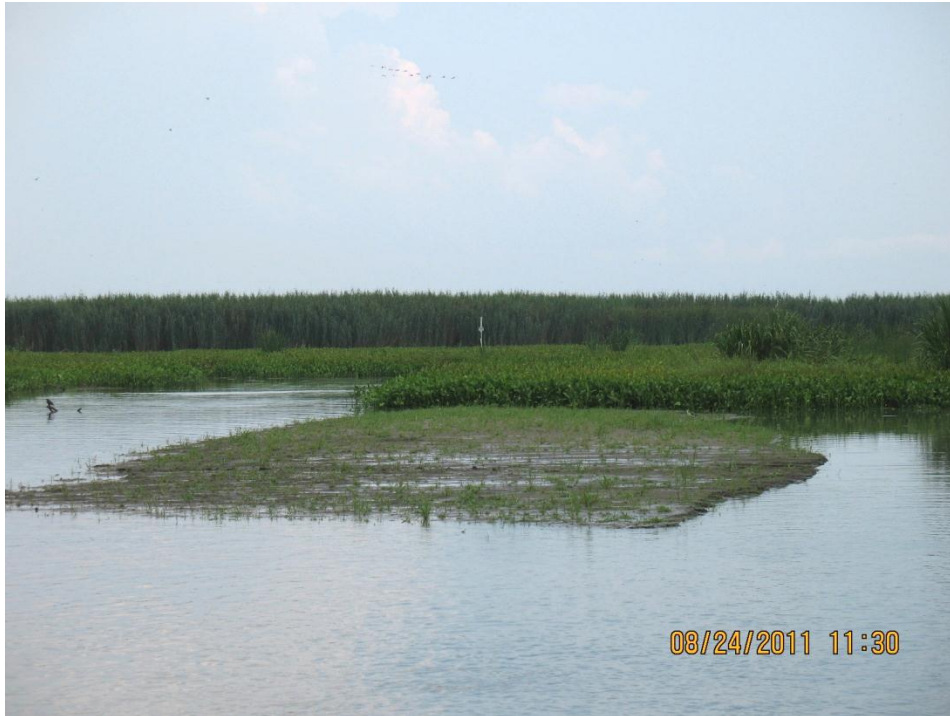
- C. Crevasse No. 1B: This crevasse, which is the shortest of all, feeds a small area of marsh. Alluvial deposits from the most recent river floods are visible above the water line in three quarters of this channel. The channel outfall is heavily vegetated.

**Crevasses 1-B Channel shoaling**

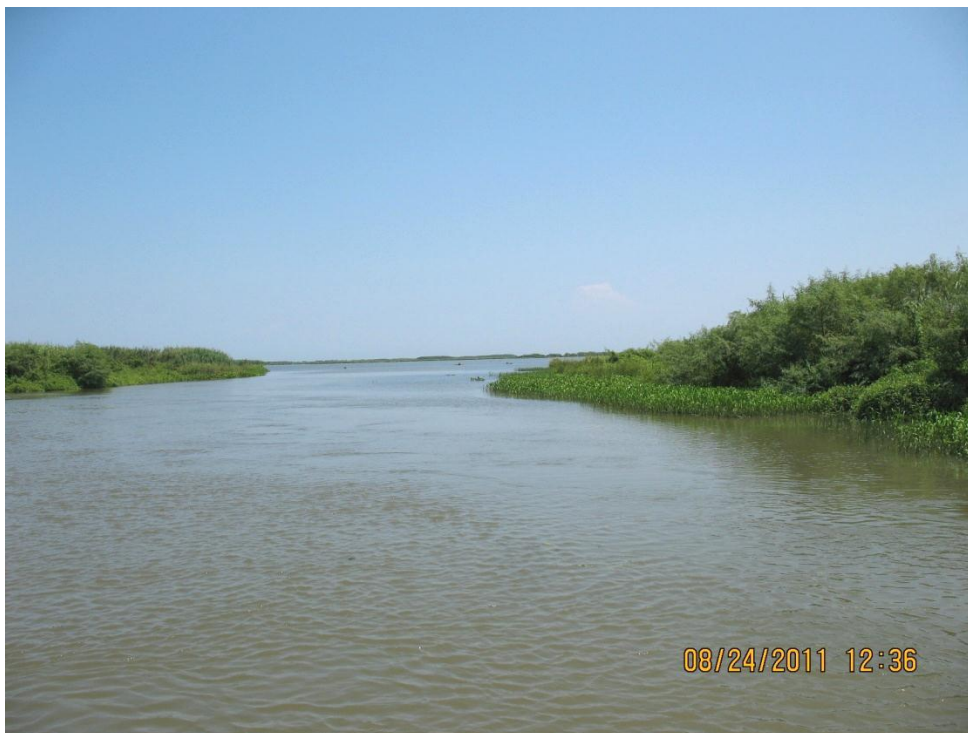
- E. Crevasse No. Alt. 2A: Flow is maintained within the channel. The channel is wide open and has poorly defined banks. Grass growth along the right bank is evidence of some sediment deposition. The channel maintains its designed depth.

**Crevasse 2-A Channel with vegetated spoil bank**

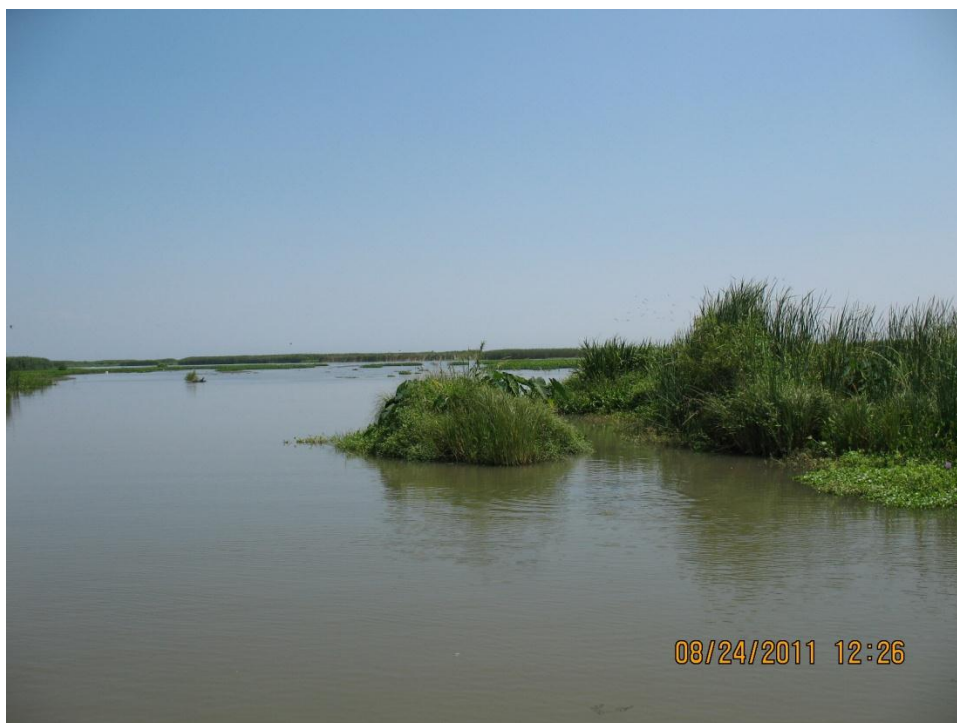
- F. Crevasse No. 2B: Flow is maintained within the channel. Sporadic vegetated islands are emerging within the receiving bay. The channel maintains its designed depth.

**Crevasse 2-B Channel outlet, interior marsh growth.**

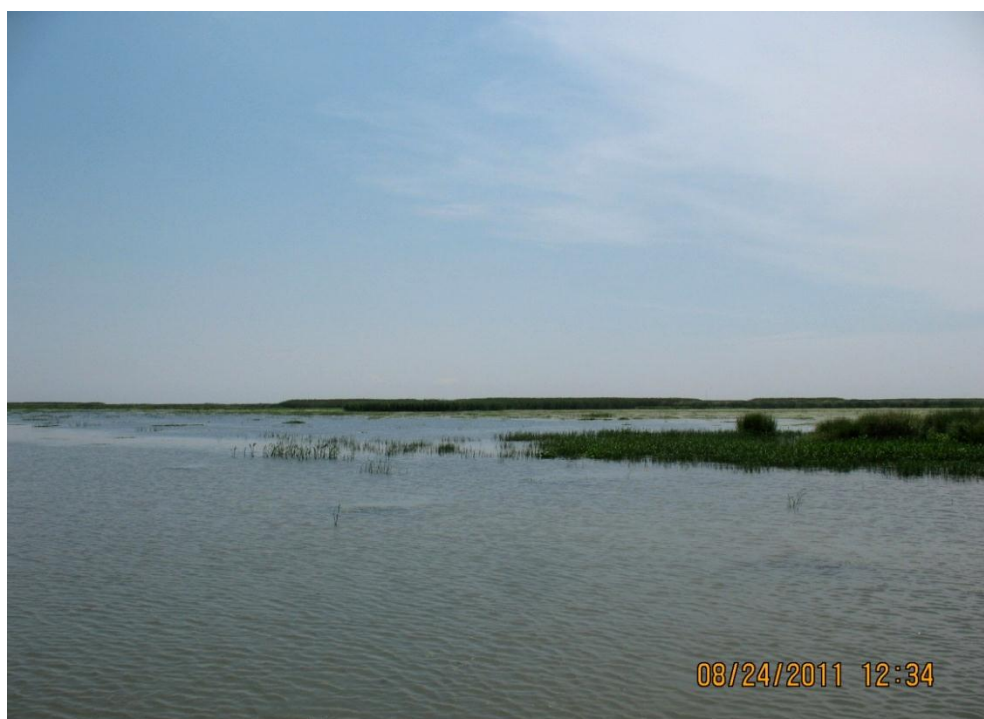
- G. Crevasse No. 2C: Flow is maintained within the channel. The channel is wide open and has poorly defined banks. Grass growth along the right bank is evidence of some sediment deposition. The channel maintains its designed depth.

**Crevasse 2-C Interior marsh growth**
