**2010 Operations, Maintenance, and Monitoring Report**

# Freshwater Bayou Canal Bank Stabilization

State Project Number ME-13 Priority Project List 5

December 2011 Vermilion Parish

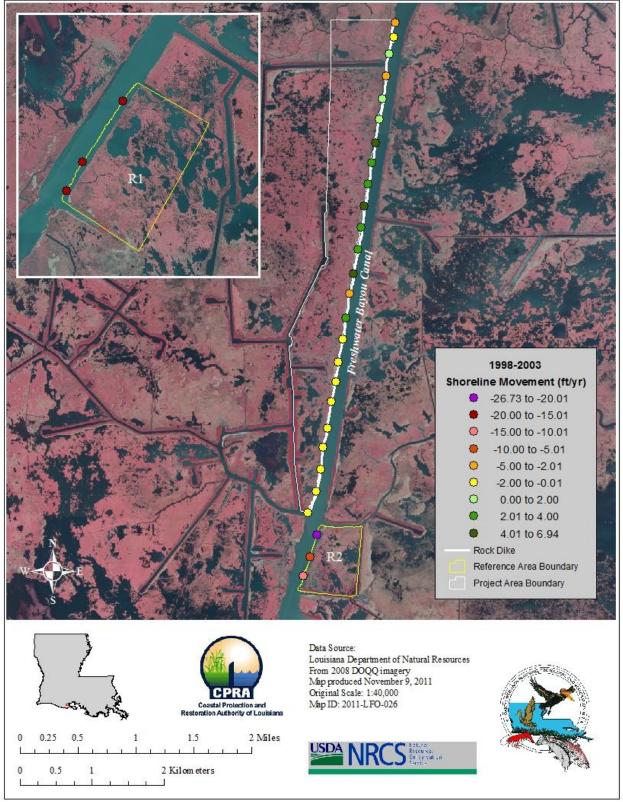
For the period 1998-2003, erosion occurred at some project stations on the south end of the project (0 to -2 ft/yr) and at all reference stations (-5 to -26 ft/yr) (figure 3). On average for the 1998 to 2003 period the project shoreline slightly prograded while the reference shoreline eroded (table 1). An O&M maintenance event occurred in 2005 when the rock dike was lifted back to constructed elevation. Over the 2003 to 2009 period erosion occurred at most project (mostly 0 to -2 ft/yr) and reference stations (> -5 ft/yr) (table 1, figure 4). The reference stations eroded

**Figure 3.** Shoreline change rate (ft/yr) along Freshwater Bayou Canal at the ME-13 project and reference area monitoring stations for the 23 July 1998 - 21 July 2003 time period.

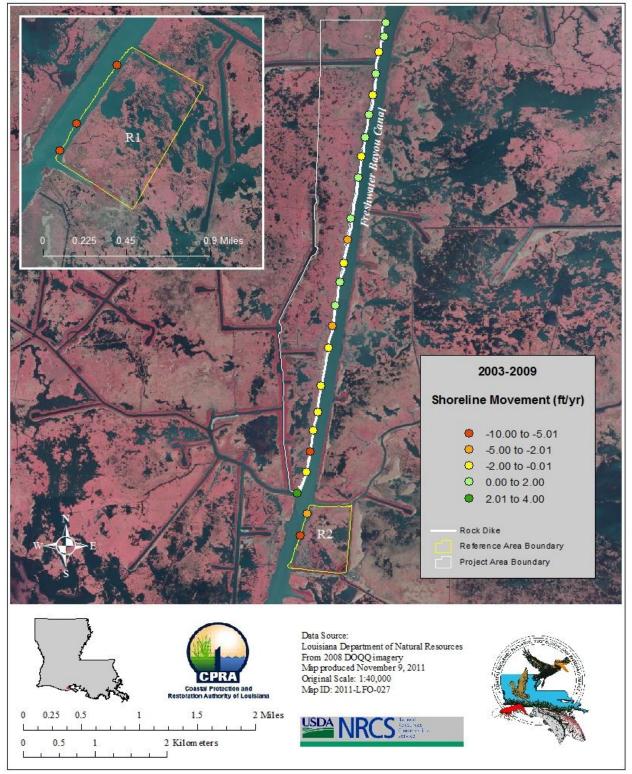
**Figure 4.** Shoreline change rate (ft/yr) along Freshwater Bayou Canal at the ME-13 project and reference area monitoring stations for the 21 July 2003 – 30 July 2009 time period. Small symbol indicates that the station could not be located.

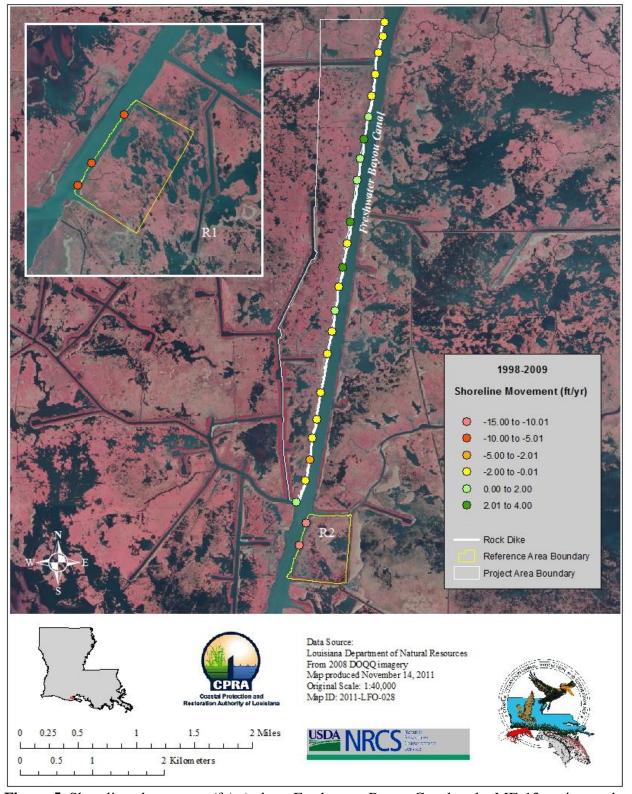
Over the entire period monitored, 1998 to 2009, the project area shoreline eroded much more slowly than the reference shoreline (table 1, figure 5). Portions of the shoreline behind the rocks prograded (42% of stations) while others eroded (58% of stations). The erosion was dispersed through the project length but appeared to be due to rock settling to below constructed height. The highest rate of shoreline erosion in the project area occurred in the southern portion where the shoreline retreated at a rate of almost -4 ft/yr during the period 1998-2009. The highest rate of shoreline erosion occurred at the north end of reference areas R2 (north unit) where the shoreline retreated -158.8 ft or -14.4 ft/yr during the period 1998-2009.

**Figure 5.** Shoreline change rate (ft/yr) along Freshwater Bayou Canal at the ME-13 project and reference area monitoring stations for the 23 July 1998 – 30 July 2009 time period. Small symbol indicates that the station could not be located.

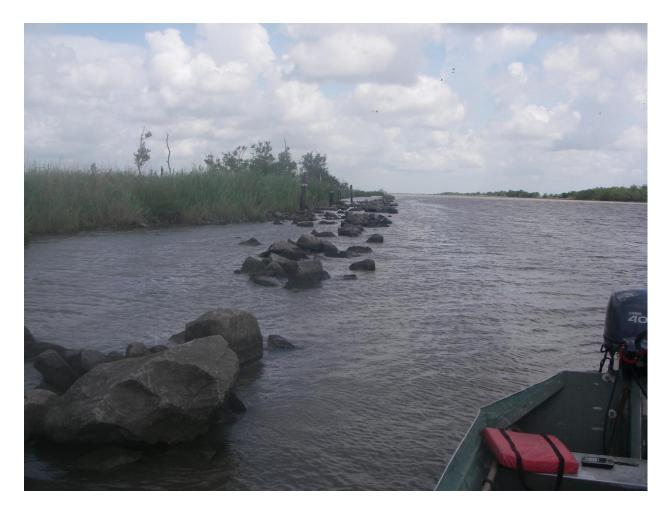
moer than 4x faster than the project area over the 2003 to 2009 period. The rock dike had once again settled by 2009 and erosion was again occurring at most project stations.

Variation in the shoreline retreat rate along the project and reference area shorelines may be related to the erodibility of the substrate. Marsh soils erode more rapidly than spoil bank soils, which erode more rapidly than shell ridges. Additionally, increases in erosion in some parts of the project area may be related to crown height of the rock dike, which has settled in some areas (figures 6-8).

**Figure 6.** Looking north at settled rock along Freshwater Bayou Canal in the ME-13 project area on 30 July 2009.

The ME-13 project appears to be meeting its specific goal of reducing shoreline erosion along the west bank of Freshwater Bayou Canal behind the project rock dike when rock crown elevation is maintained at the as-built level. For the period 1998-2009, the shoreline was being maintained behind the protection of the rock dike where erosion was -0.03 ft/yr compared to the unprotected reference areas which were eroding at -7.92 ft/yr. Some portions of the project area accreted over 3 ft/yr. Project area erosion is occurring where the rock has settled to below the as-built elevation of 2.5 ft NAVD88. The highest rate of shoreline erosion of these sites occurred south of the project area where the shoreline retreated at a rate of almost -4 ft/yr during the period 1998-2009. The rock dike requires periodic additions of rock to be maintained. It appears as though any benefits derived from the 2005 rock lift O&M event had been reduced by 2009 and another event is warranted. Shoreline measurements in 2015 will provide further indications of project effectiveness.

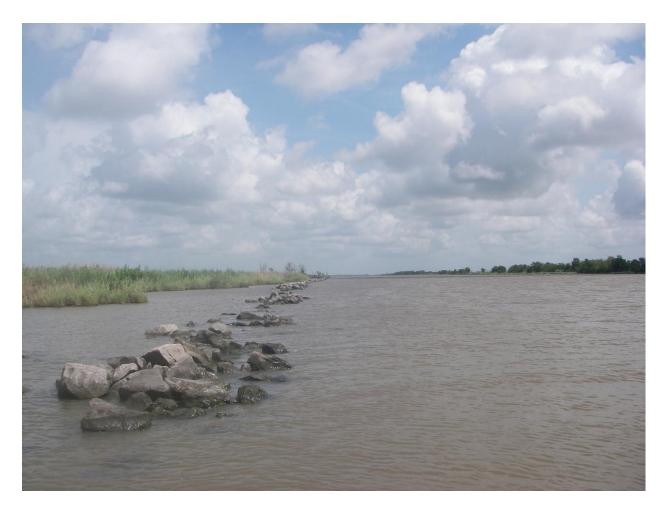
**Figure 7.** Another view looking north at settled rock along Freshwater Bayou Canal in the ME-13 project area on 30 July 2009.

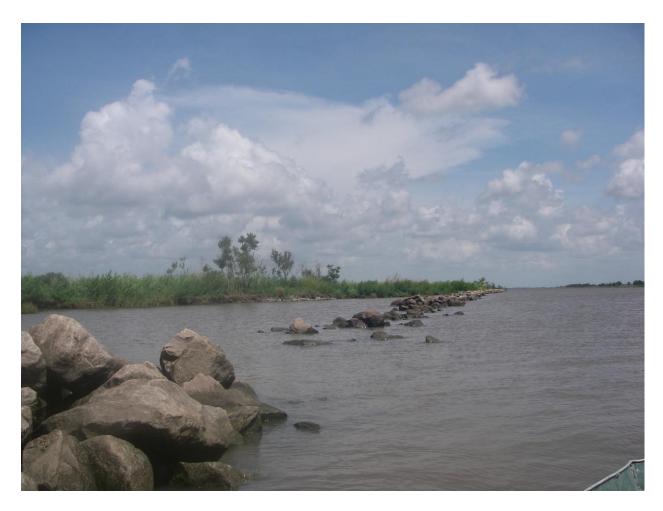
**Figure 8.** A breach in the settled rock along Freshwater Bayou Canal in the ME-13 project area on 30 July 2009.
