Coastal Protection and Restoration Authority of Louisiana

2010/2011 Annual Inspection Report

GIWW BANK STABILIZATION PROJECT (PERRY RIDGE TO TEXAS (CS-30)

State Project Number CS-30
Priority Project List 9

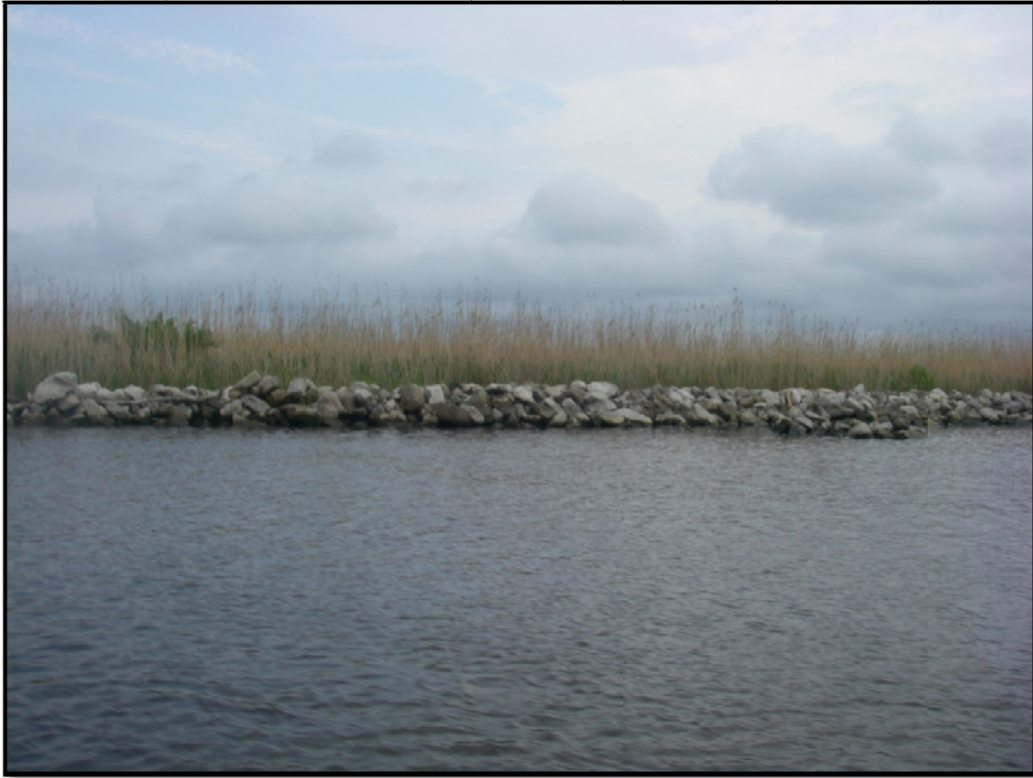
The dike is in very good condition with one small area apparently displaced by a barge noted as being below the constructed height (coordinates N30 03 33, W93 40 29) and one other area where it appears hunters may have moved some rock (coordinates N30 03 33, W93 41 16). These two areas will be monitored during future annual inspection trips. No maintenance is recommended at this time. (Photos: Appendix B, Photo 1, 2)

Photo No. 1, Typical rock dike

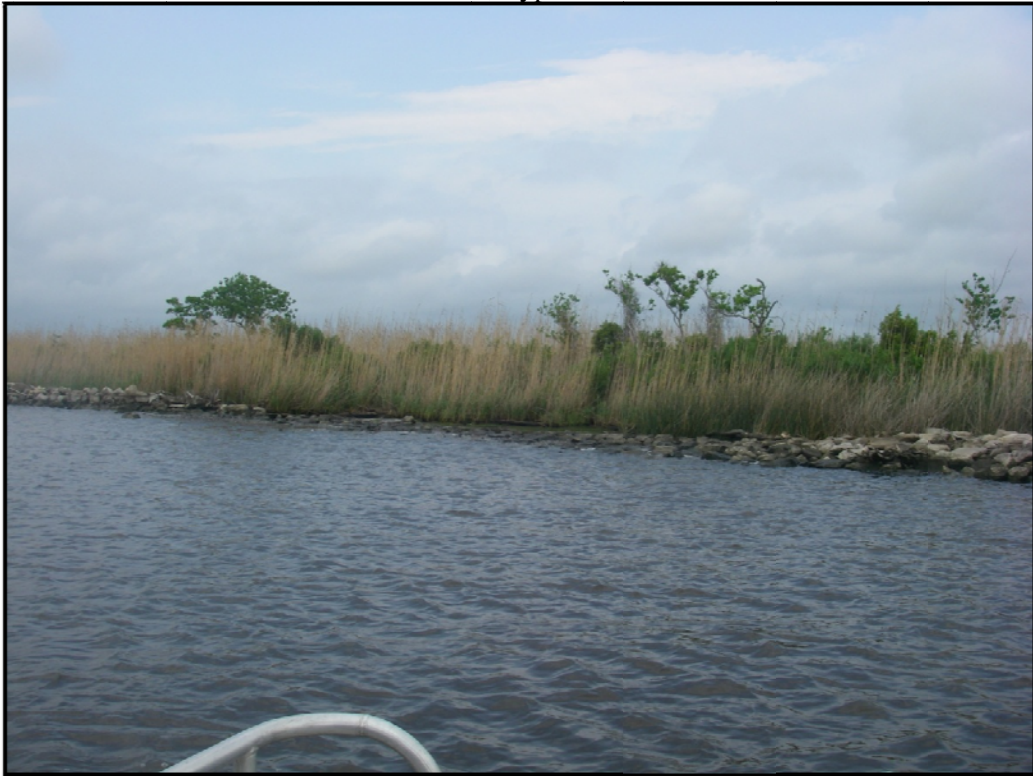
Photo No. 2, Low area of rock dike

Item	Condition	Physical Damage	Corrosion	Photo #	Observations and Remarks
Steel Bulkhead / Caps	N/A				
Steel Grating	N/A				
Stop Logs	N/A				
Hardware	N/A				
Timber Piles	N/A				
Timber Wales	N/A				
Galv. Pile Caps	N/A				
Cables	N/A				
Signage / Supports	N/A				
Rip Rap (fill) (foreshore dike)	Good			1, 2	Low area where it appears a barge has pushed the rock dike down is located at N 30 03' 33.0" W 093 41' 16.2"
Earthen Terraces					Not inspected on this trip.
Vegetative Plantings
