**State of Louisiana
Coastal Protection and Restoration Authority
Office of Coastal Protection and Restoration**

2011 Operations, Maintenance, and Monitoring Report

Timbalier Island Dune/Marsh Restoration (TE-40) Project

State Project Number TE-40
Priority Project List 10

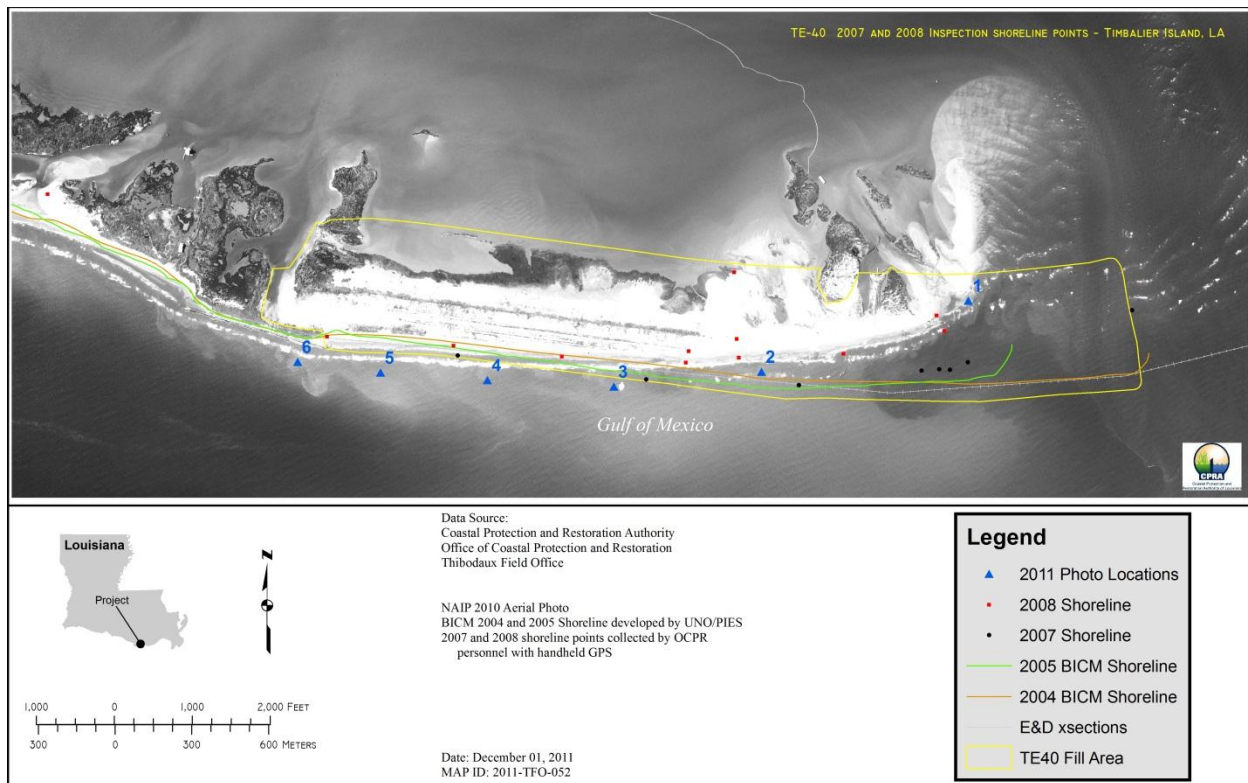
The most severe shoreline erosion in 2008 occurred on the eastern end of the area from station 167+00 to station 178+00, with less erosion as one proceeds westerly (figure 5). The average erosion measured since the 2007 inspection was approximately -99.7 ft. BICM data shows an average erosion rate of -25.0 ft for this portion of the coast in the last decade (1990's to 2005) and +29.0 ft of shoreline gain between 2004 and 2005, even with Hurricanes Katrina and Rita. Removing the short-term erosion rate from that measured gives us an erosion rate of -74.7 ft. This confirms that these storms caused erosion that exceeded the 2005 Hurricanes (Katrina and Rita).

Figure 5. 2011 Inspection photo locations and 2008 Shoreline positions obtained during the post-Ike Assessment, along with 2007 inspection data and the BICM 2004 and 2005 shorelines at the Timbalier Island Dune/Marsh Restoration CWPRRA Project (TE-40).

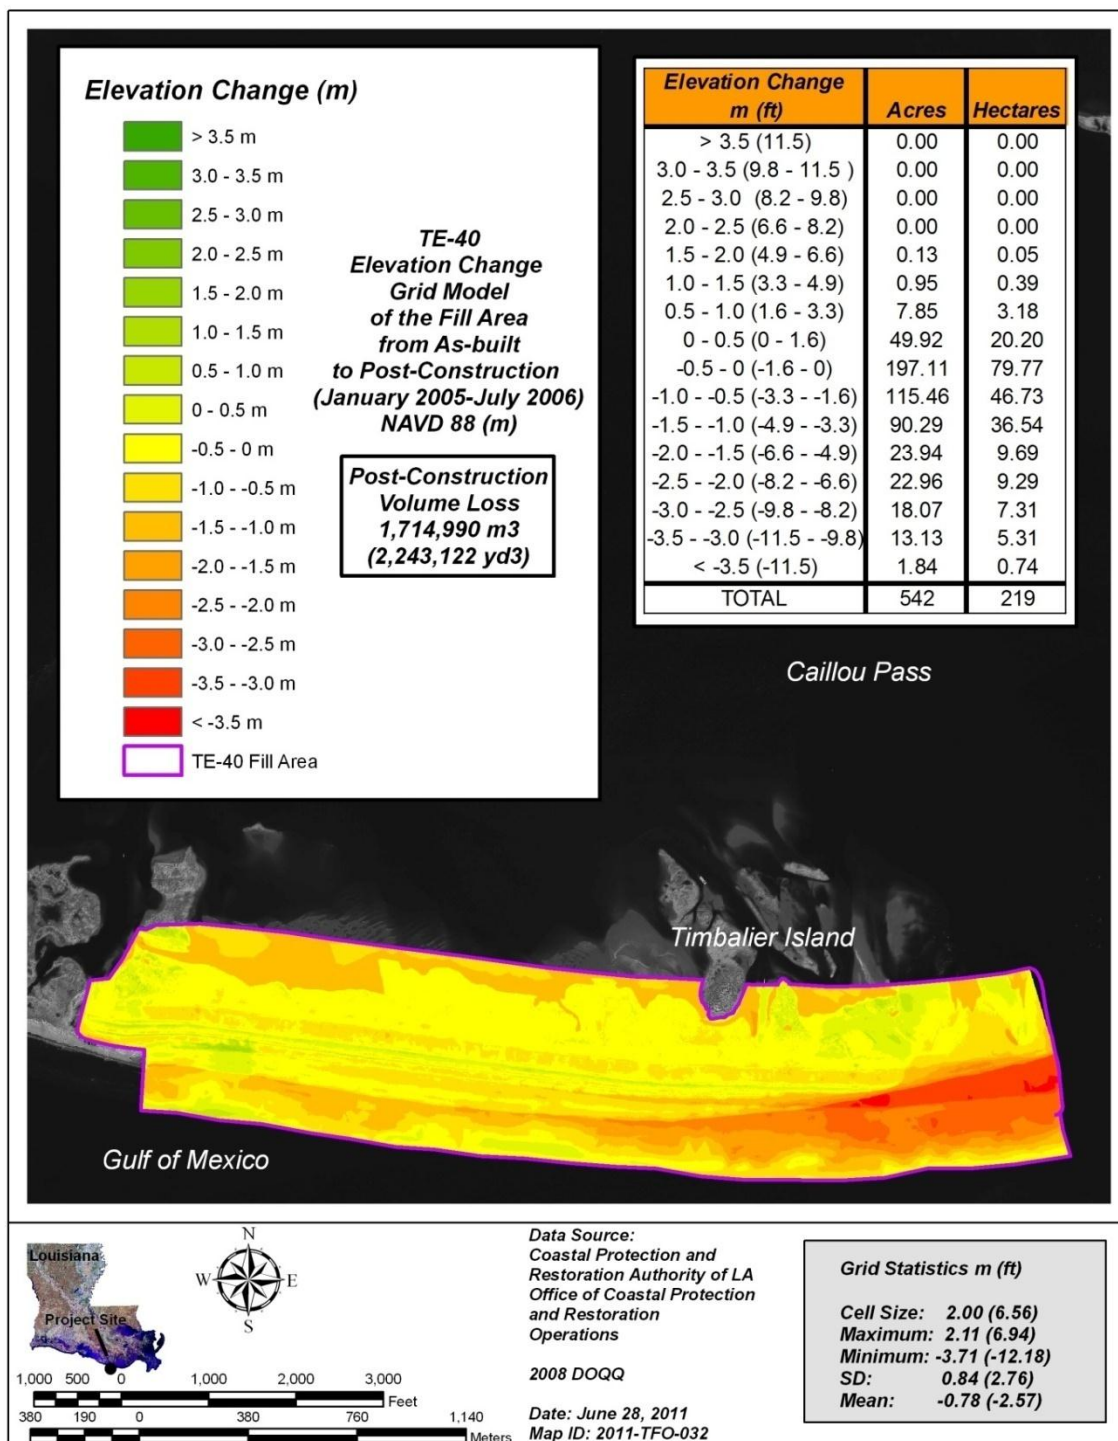
Figure 7. Elevation and volume change grid model inside the Timbalier Island Dune/Marsh Restoration (TE-40) fill area from as-built (January 2005) to post-construction (July 2006).

In addition to the cross-shore and longshore transport of sediments along the TE-40 fill area Gulf of Mexico shoreline, figure 7 provides evidence showing a modest quantity of bay erosion inside the TE-40 fill area. Bay shoreline erosion along barrier islands in Louisiana's deltaic plain has been postulated as being mainly caused by extra-tropical cold fronts (Boyd and Penland 1981; Dingler and Reiss 1990; Georgiou et al. 2005). The narrow width and small marsh platform make Timbalier Island particularly susceptible to bay side erosion. As a result, it seems that other weather events besides the 2005 and 2008 hurricanes events affected the geomorphology of the TE-40 fill area.

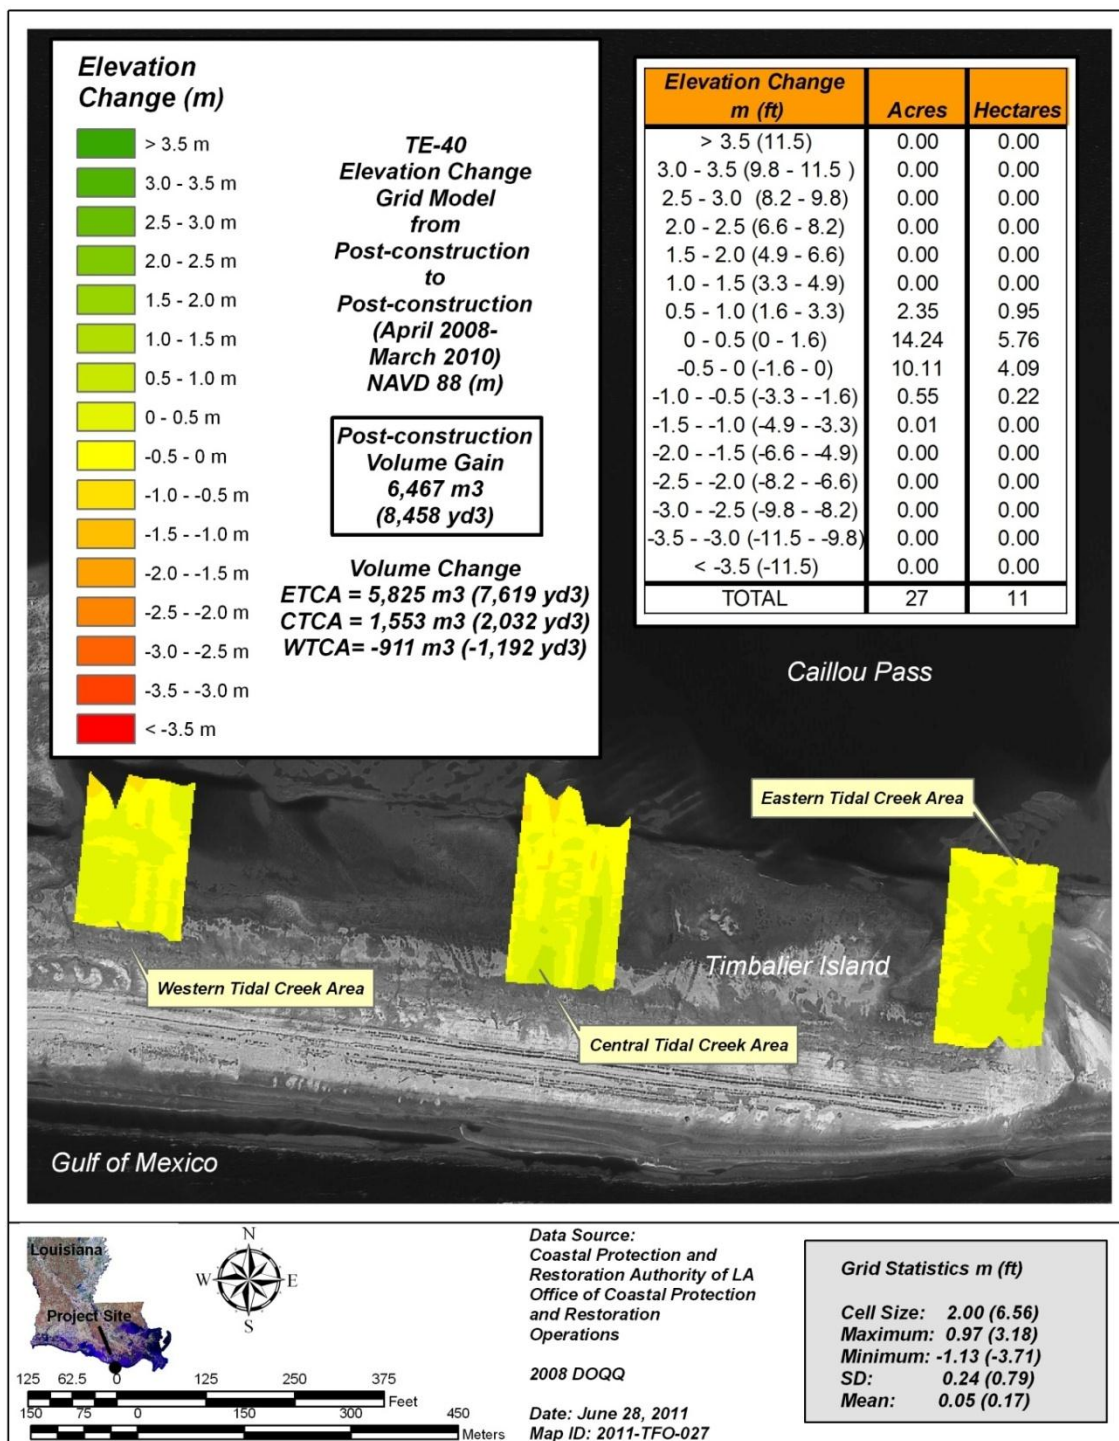
Figure 9. Post-construction elevation and volume change grid model from April 2008 to March 2010 at the Timbalier Island Dune/Marsh Restoration (TE-40) tidal creek areas.

Preliminary results do not confirm tidal creek formation inside the Timbalier Island Dune/Marsh Restoration (TE-40) fill area. No depressions fitting the sinusoidal pattern of tidal creeks were found within the three tidal creek areas (figure 9). Two of the three tidal creek areas gained sediment volume for the study period signifying that cross-shore transport is taking place and sediments are being conserved within the fill area. However, this cross-shore transport may be infilling embryonic tidal creeks and curtailing their evolution. Therefore, the tidal creek development monitoring goal is not currently being attained.

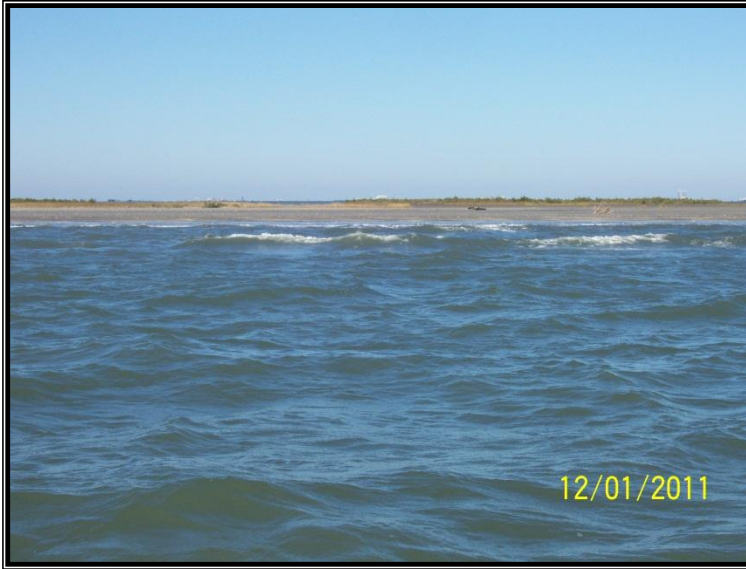
Digital Photo (3535)

Photo 1. Site #1 looking north east near station 185+00. Note complete removal of the dune.

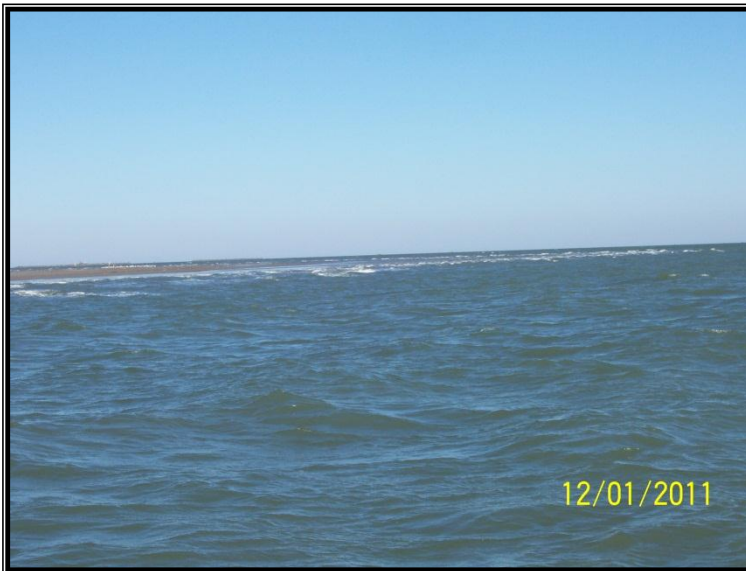
Digital Photo (3536)

Photo 2. Site #1 looking north near station 185+00. Note east end of island now located here with complete removal of the dune and marsh to the east.

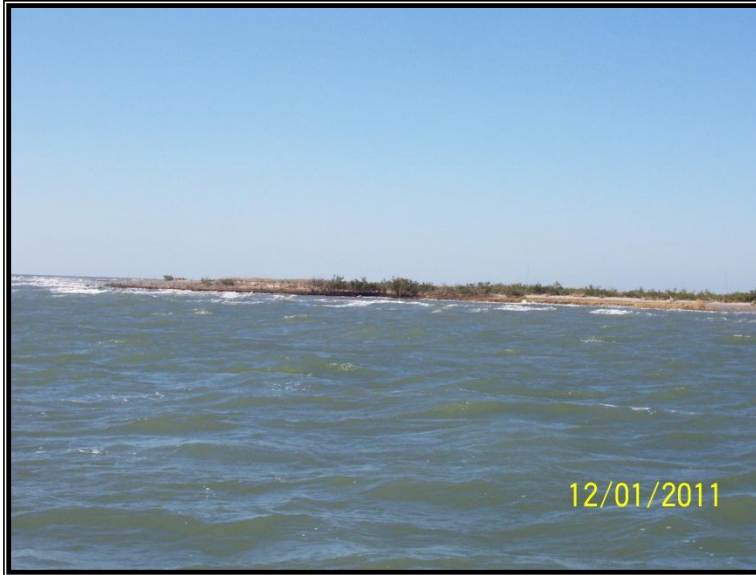
Digital Photo (3537)

Photo 3. Site #1 near station 185+00 looking west. Note remnant marsh platform at gulf shoreline. This is the marsh area immediately east of the project dock.

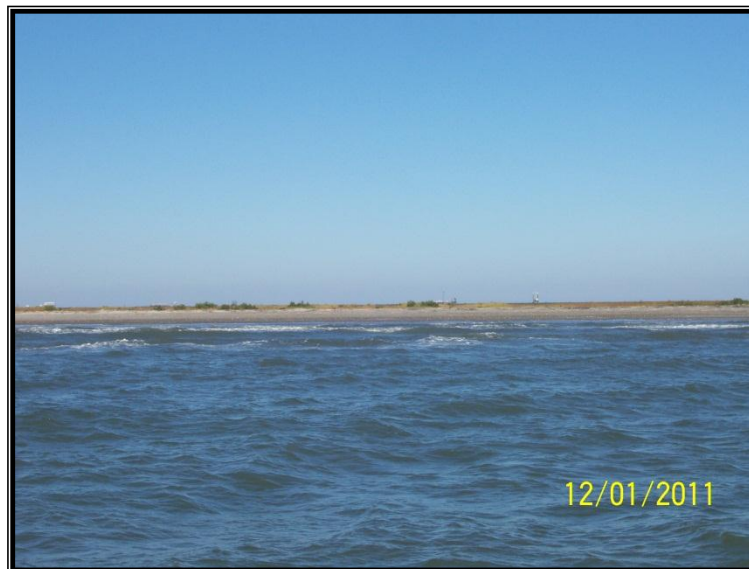
Digital Photo (3538)

Photo 4. Site #2 near station 155+00 looking North. Note narrow beach and east end of dune feature. Remnant dune is narrow and back marsh visible with good vegetative cover.

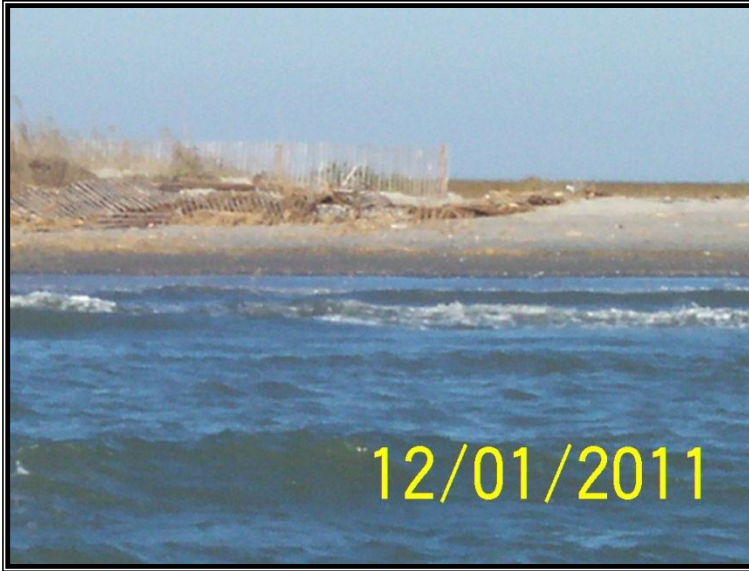
Digital Photo (3539)

Photo 5. Site #2 near station 155+00 looking North. Note narrow beach and east end of dune feature with end of third row of sand fencing (northern most row of fence).

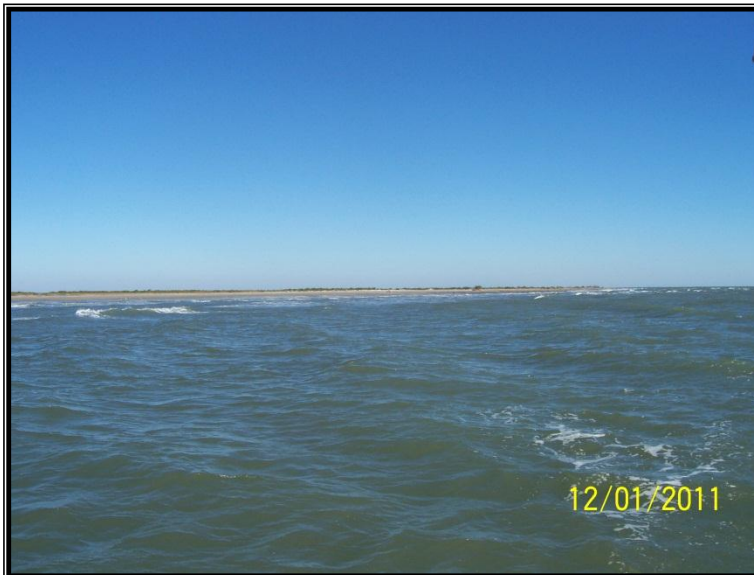
Digital Photo (3540)

Photo 6. Site #2 near station 155+00 looking east northeast. Note narrow beach and low overwash areas remain in eastern fill area.

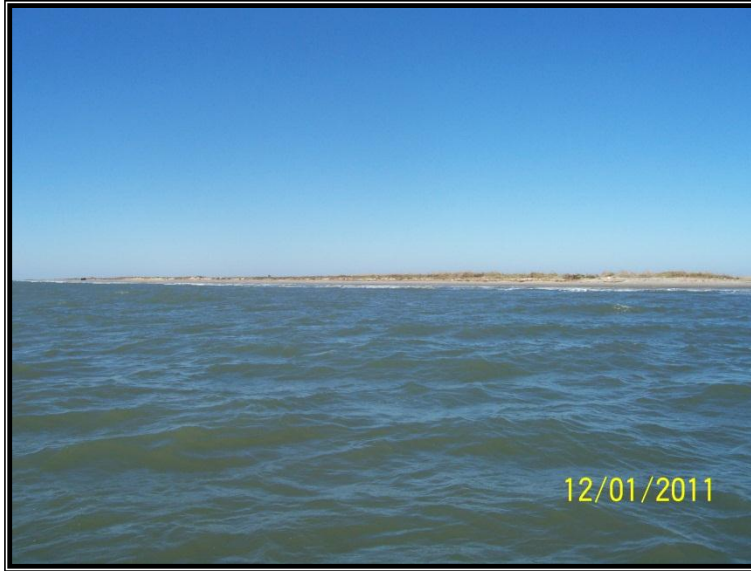
Digital Photo (3541)

Photo 7 Site #2 near station 155+00 looking northwest. Note narrow beach and scarping at the toe of the dune feature. Both remnant dune and back marsh exhibit good vegetative cover..

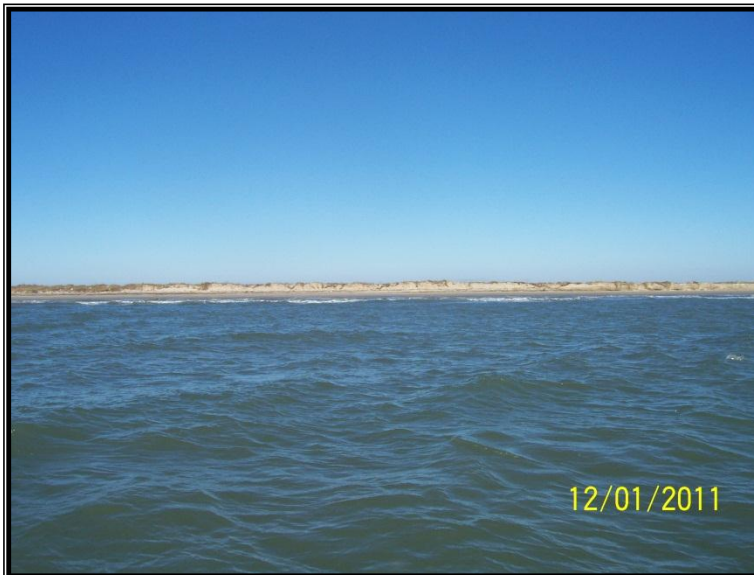
Digital Photo (3542)

Photo 8. Site #3 near station 138+00 looking north. Note slightly wider beach at this location, but still scarping at the dune toe. Dune feature is wider in this area.

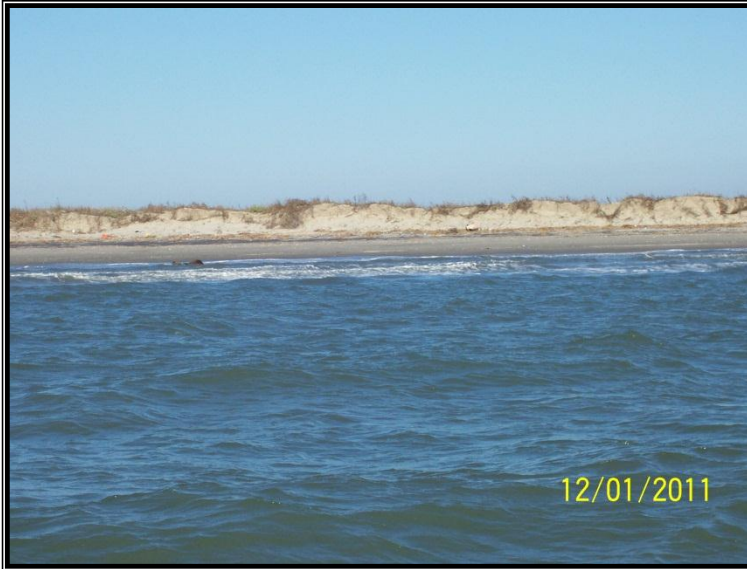
Digital Photo (3543)

Photo 9. Site #3 near station 138+00 looking north. Note slightly wider beach at this location, but still scarping at the dune toe. Dune feature is wider in this area.

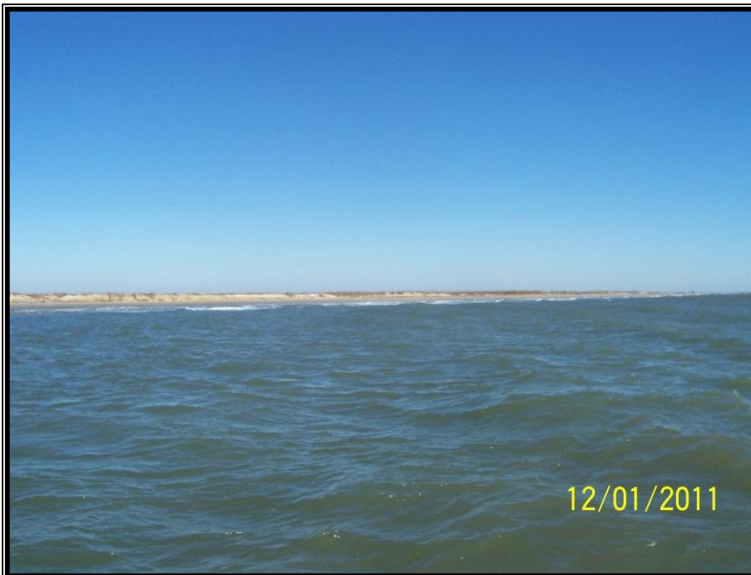
Digital Photo (3544)

Photo 10. Site #3 near station 138+00 looking northeast. Note slightly wider beach at this location, but still scarping at the dune toe. Dune feature diminishes as you proceed east along the beach.

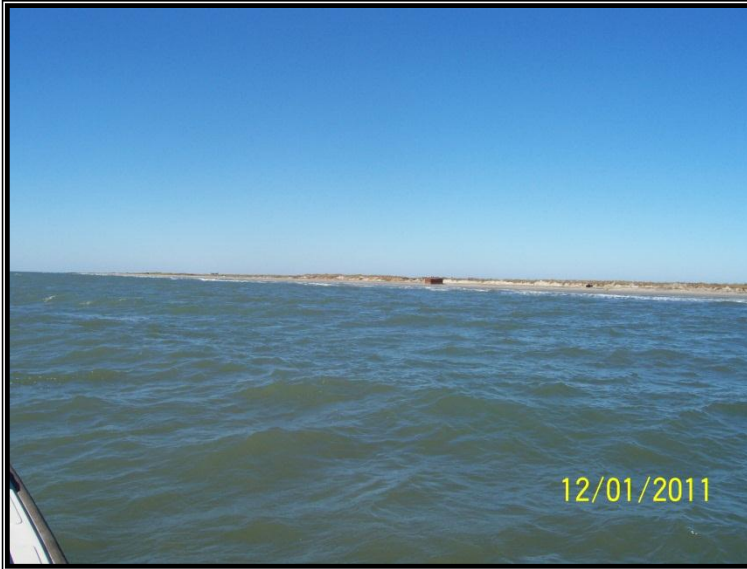
Digital Photo (3545)

Photo 11. Site #3 near station 138+00 looking northwest. Note slightly wider beach at this location, but still scarping at the dune toe. Dune feature becomes less scarped as you proceed west along the beach.

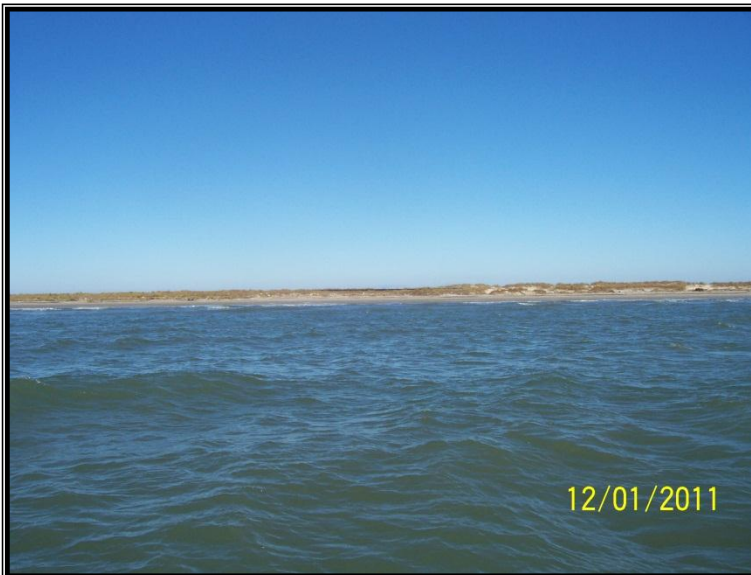
Digital Photo (3546)

Photo 12. Site #4 near station 122+00 looking north. Note wider beach with less scarping of the dune. Dune feature is wider with good vegetative cover.

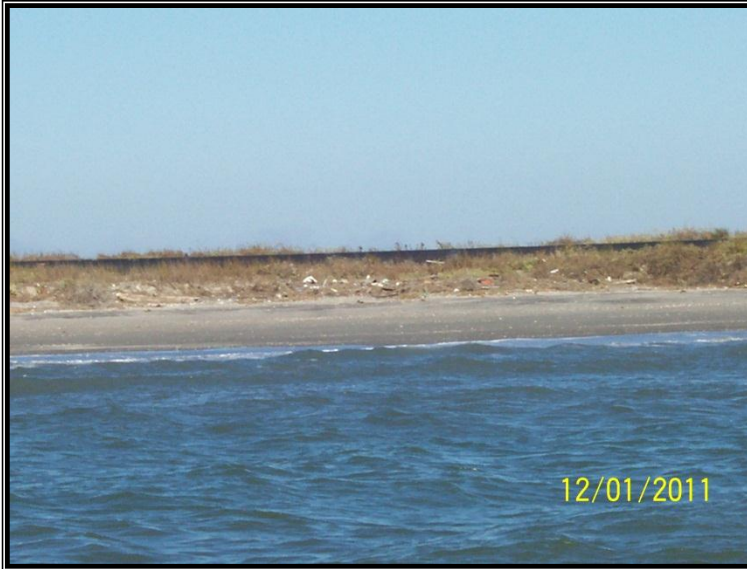
Digital Photo (3547)

Photo 13. Site #4 near station 122+00 looking north. Note wider beach with less scarping of the dune. Dune feature is wider with good vegetative cover.

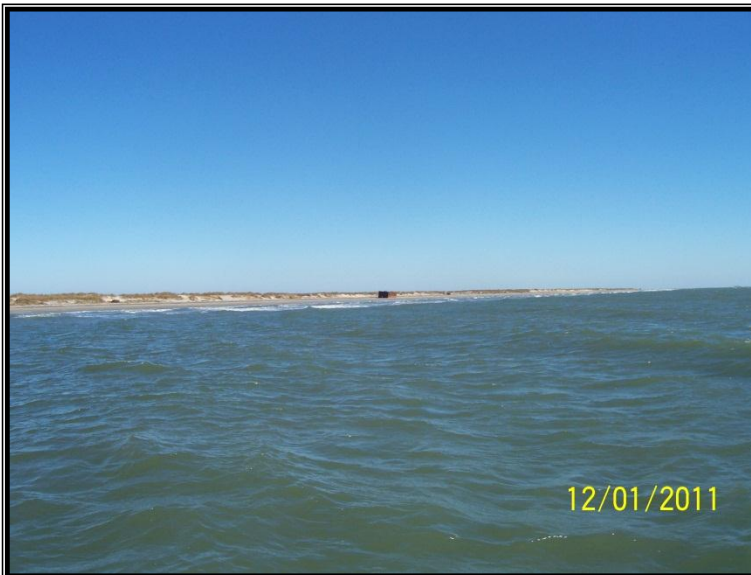
Digital Photo (3548)

Photo 14. Site #4 near station 122+00 looking northeast. Note wider beach with less scarping of the dune. Dune feature is wider with good vegetative cover.

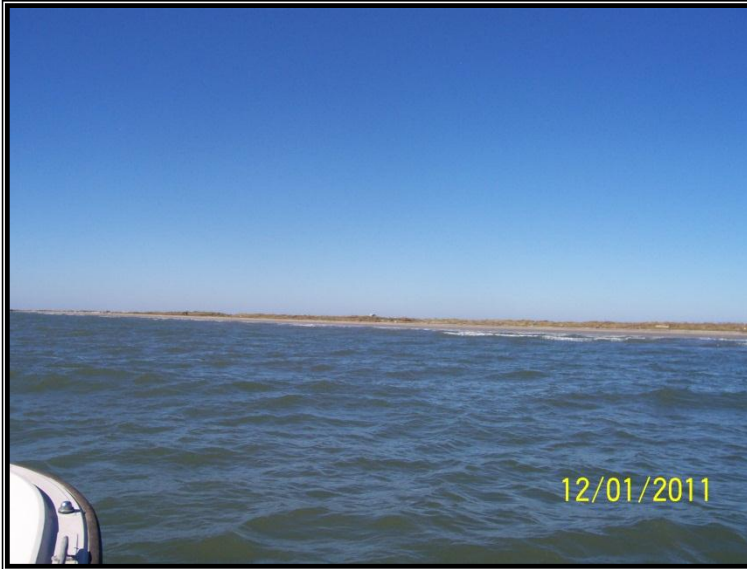
Digital Photo (3549)

Photo 15. Site #4 near station 122+00 looking northwest. Note wider beach with less scarping of the dune. Dune feature is wider with good vegetative cover.

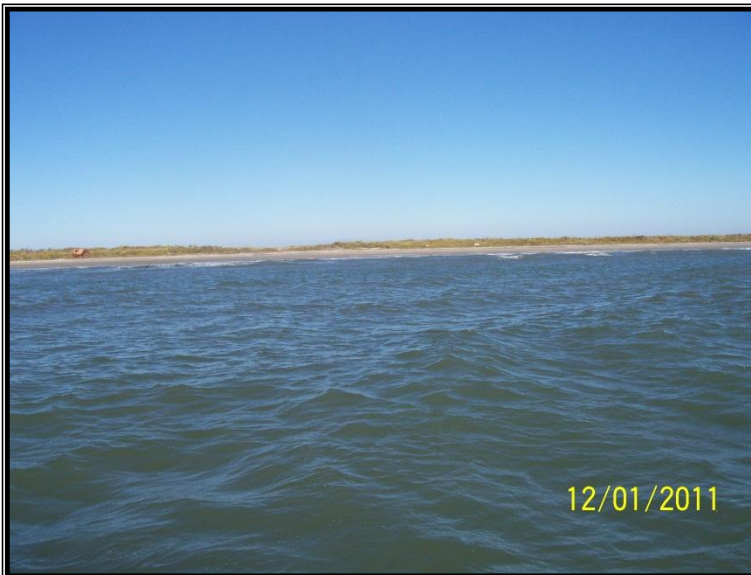
Digital Photo (3550)

Photo 16. Site #5 near station 107+00 looking north. Note wide beach with no scarping of the dune. Dune well vegetated and wide.

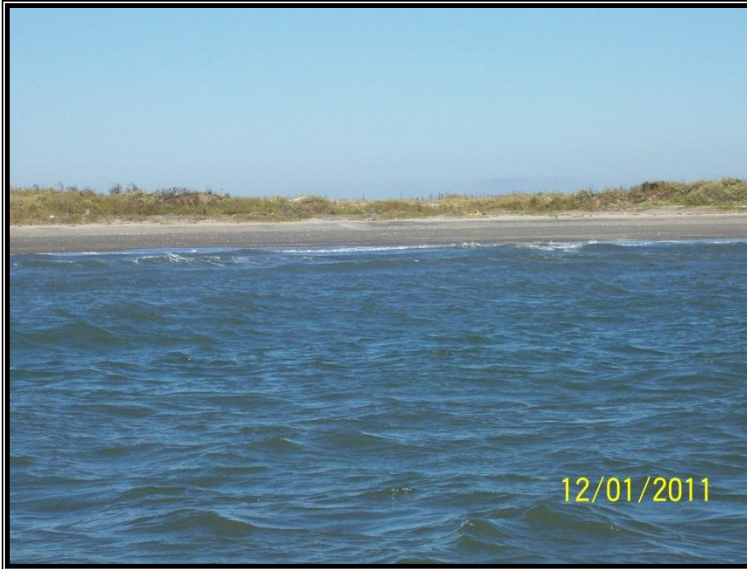
Digital Photo (3551)

Photo 17. Site #5 near station 107+00 looking north. Note wide beach with no scarping of the dune. Dune well vegetated and wide. Second and third rows of fencing visible with some deterioration.

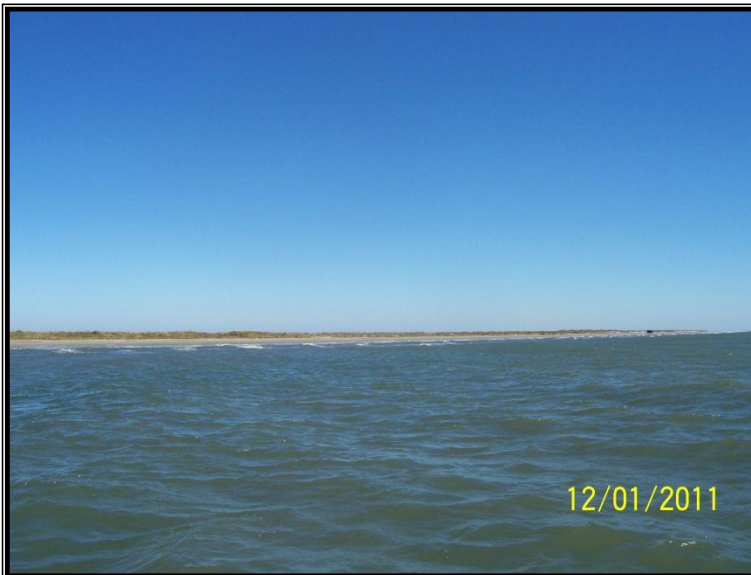
Digital Photo (3552)

Photo 18. Site #5 near station 107+00 looking northeast. Note wide beach with no scarping of the dune. Dune well vegetated and wide.

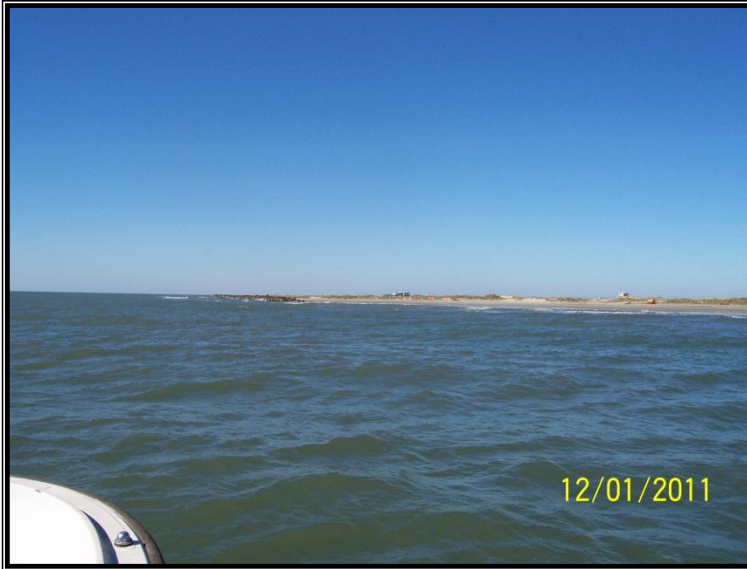
Digital Photo (3553)

Photo 19. Site #5 near station 107+00 looking northwest at Canal 19 rocks. Note wide beach with little scarping of the dune. Typical erosional pocket behind east end of rocks, but little beach erosion on this west end of project.

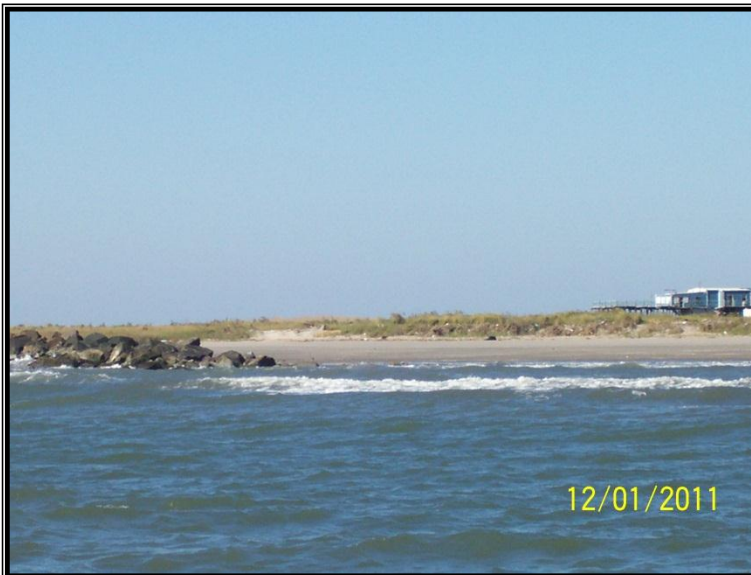
Digital Photo (3554)

Photo 20. Site #5 near station 107+00 looking northwest at east end of Canal 19 rocks. Note typical erosional shadow behind end of rocks, but overall little erosion on the west end of the project.

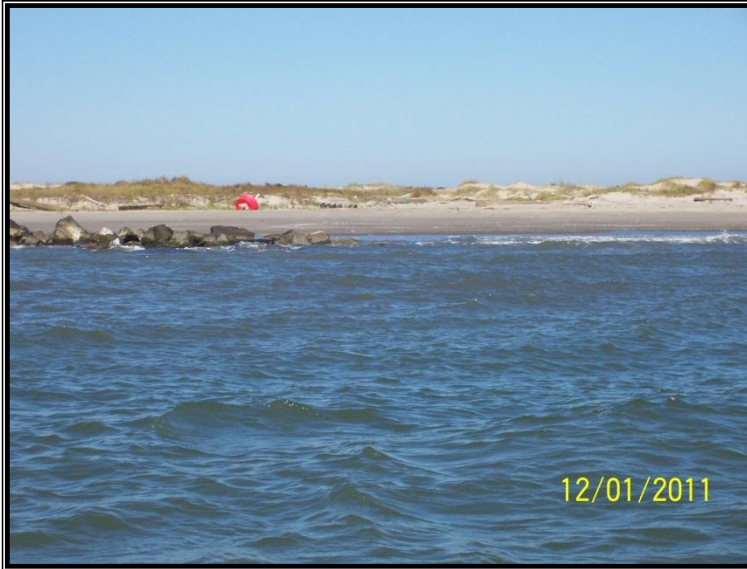
Digital Photo (3555)

Photo 21 Site #6 near station 97+00 looking north at east end of Canal 19 rocks. Note typical erosion pocket at end of rocks, but very little erosion noted at east end of project. Large dunes remain with evidence of newly deposited sand.

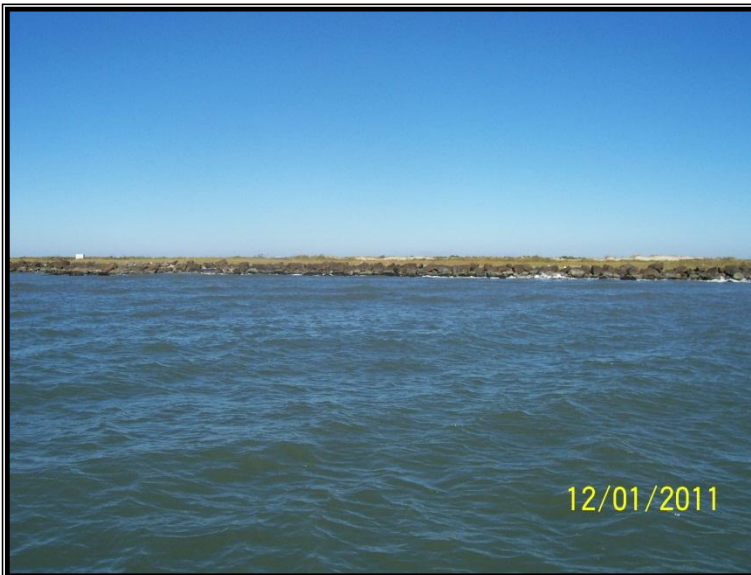
Digital Photo (3556)

Photo 22. Site #6 near station 97+00 looking north at east end of Canal 19 rocks. Large dunes remain with evidence of newly deposited sand.

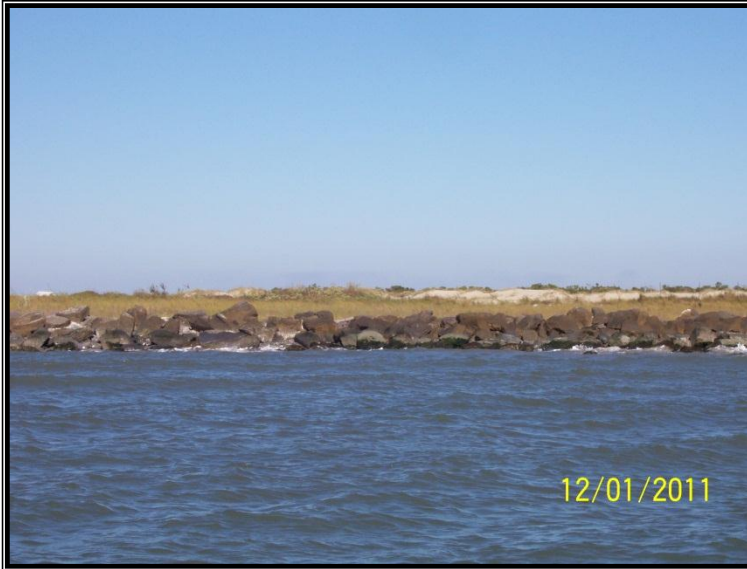
Digital Photo (3557)

Photo 23. Site #6 near station 97+00 looking north at east end of Canal 19 rocks. Large dunes remain with evidence of newly deposited sand.

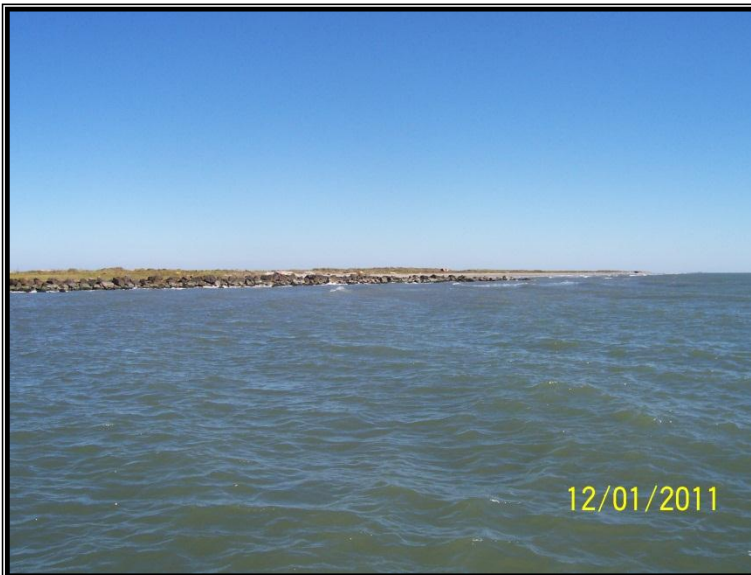
Digital Photo (3558)

Photo 24. . Site #6 near station 97+00 looking northeast at east end of Canal 19 rocks. Note wide beach on western end of fill area and large dunes.

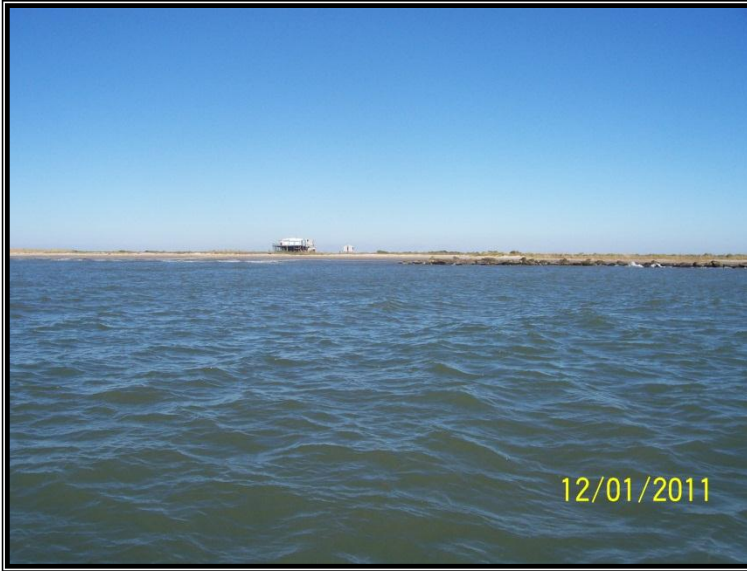
Digital Photo (3561)

Photo 27. *Looking north at Canal 19 rocks west end. Note typical erosional shadow downdrift of structure.*
