COMPLETION REPORT
FOR
LA 82 FRESHWATER INTRODUCTION PROJECT (ME-16)
IN
CAMERON AND VERMILLION PARISHES, LOUISIANA

PREPARED FOR
STATE OF LOUISIANA
OFFICE OF COASTAL PROTECTION AND RESTORATION

PREPARED BY:
EJES, INC
201 WILKINSON STREET
SHREVEPORT, LOUISIANA 71104
318-670-7275

DATED: DECEMBER 2011

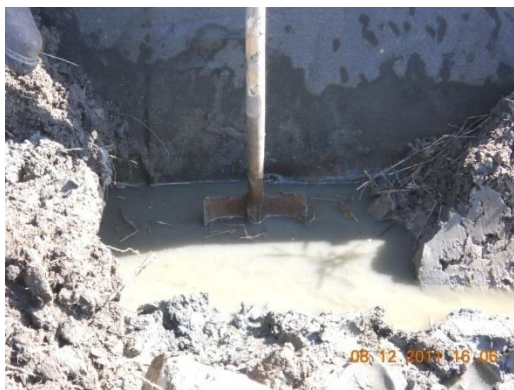
Justification - During the construction of the proposed improvements, field crews noted sinkholes above the existing pipes at Sites 1 and 4. The sinkholes were in the area where the pipes meet the headwalls. The contractor has proposed to excavate the pipes where they meet the headwall. He will seal the area using Wet Dry 700, an epoxy product, and redi-mix concrete. After sealing, the area will be backfilled and the geotextile fabric and riprap will be installed as originally planned.

Photo 5 – Sink hole

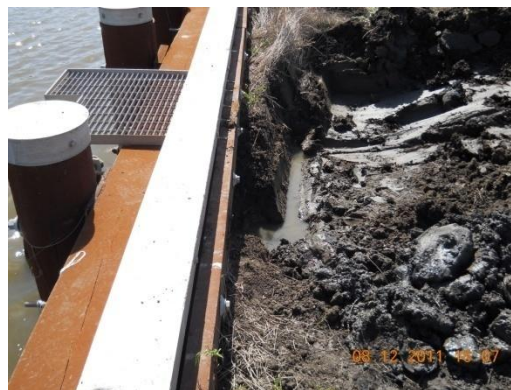
Photo 6 – Sink hole

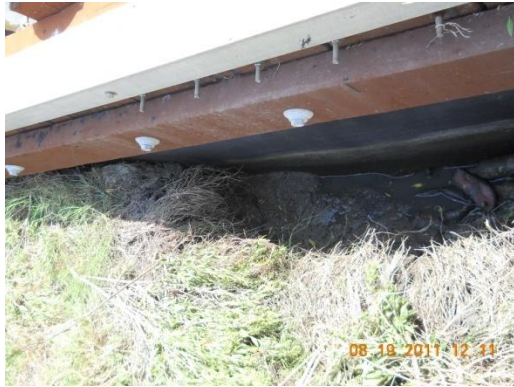
Photo 31 – Sink hole

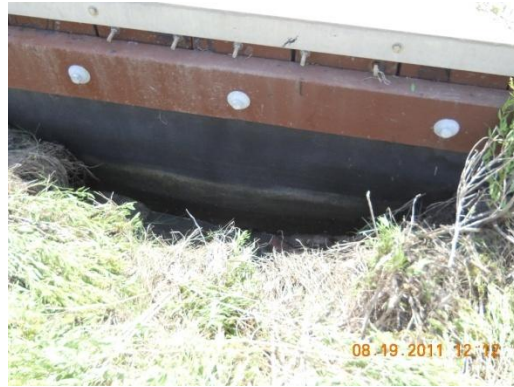
Photo 32 – Sink hole

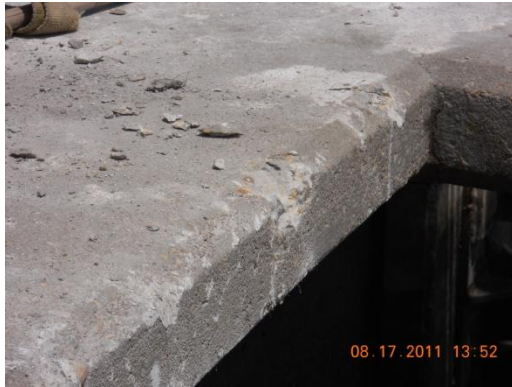
Photo 37 – Existing damage at site

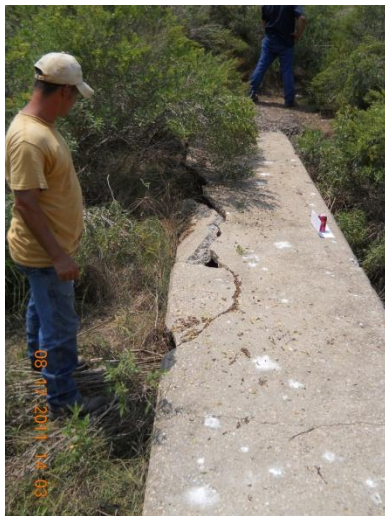
Photo 39 – Existing damage

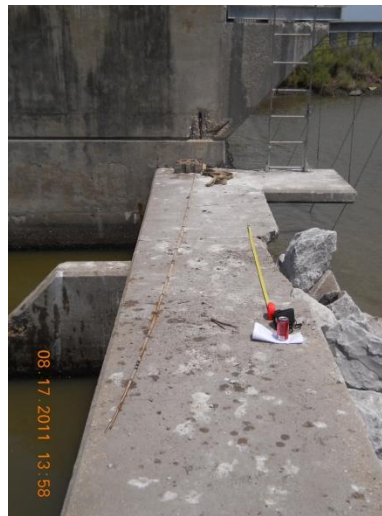
Photo 40 – Damage by contractor

- The contractor shall provide lifting chains for sites 1, 3, and 4.
- Site 3 – the rip rap on the north and south side shall be moved closer to the structure.
- Site 5 – Finalize repair of structure. Concrete broken by rip rap that fell from equipment during construction.

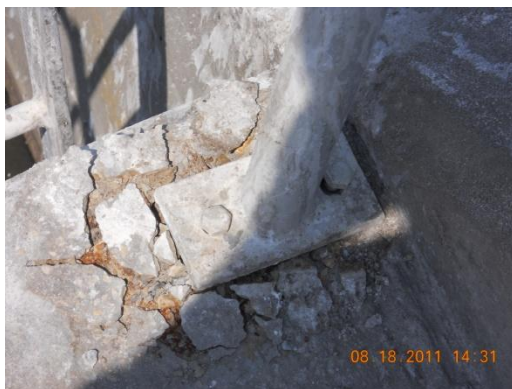
Photo 41 – Ladder damage

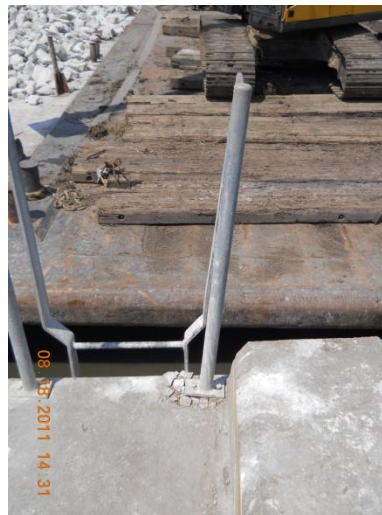
Photo 42 – Ladder damage
