2012 Annual Inspection Report

**GIWW/ CLOVELLY HYDROLOGIC
RESTORATION**

State Project Number BA-02
Priority Project List 1

May 14, 2012
Lafourche Parish

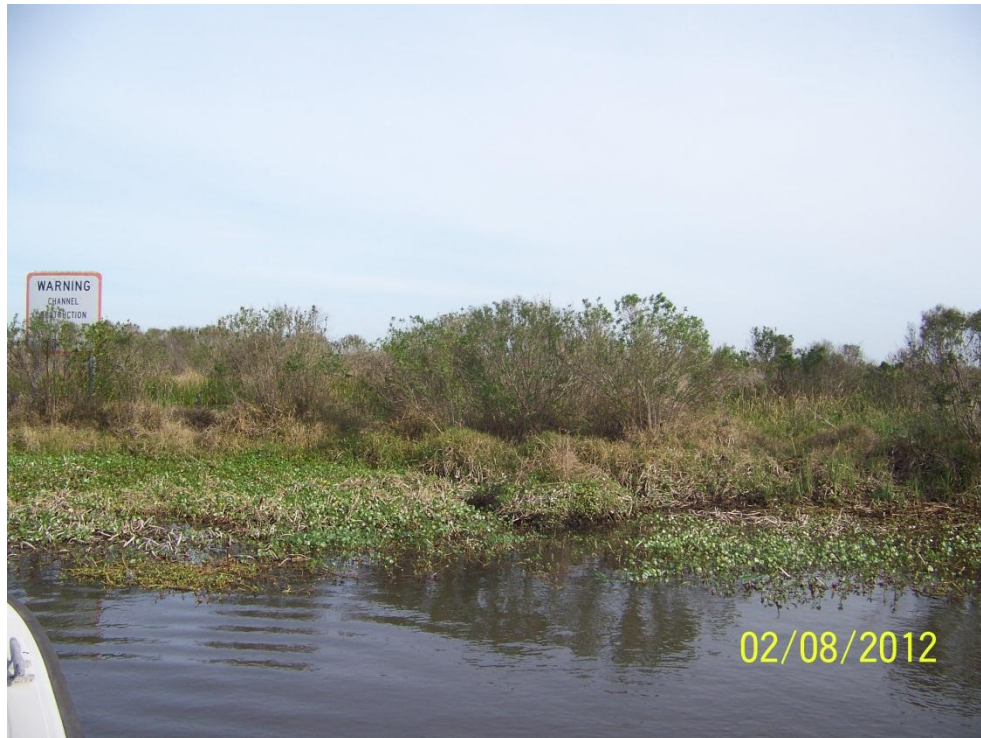
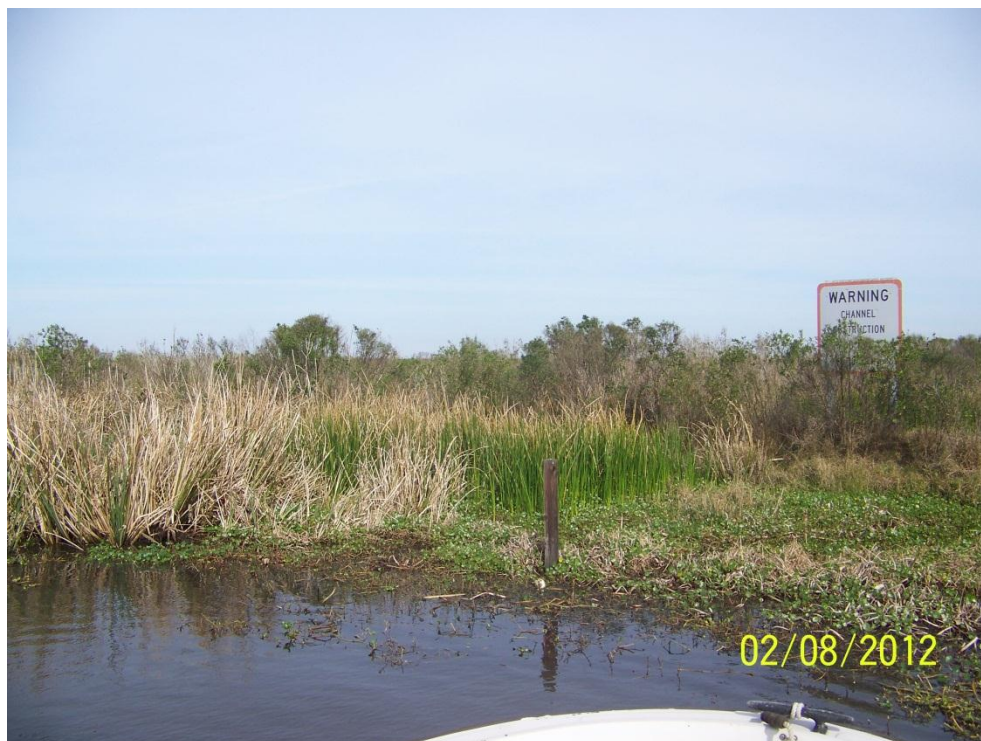
We were unable to visually inspect Structure 43 due to vegetation blocking the visibility of the structure. There is a small breach that has formed around the eastern end of the rock plug allowing water to flow around the structure. This breach has been identified and will be monitored during future visits to determine the magnitude of its effects to the structure. All warning signs and support structures appear to be in good condition, and at this time, there are no recommendations for maintenance. (See Appendix B, Photos 1 through 4)

Photo #1: View of Structure 43 looking north. The rock riprap plug is not visible through the vegetation.

Photo #2: View of Structure 43 looking northwest. The rock riprap plug is not visible through the vegetation.

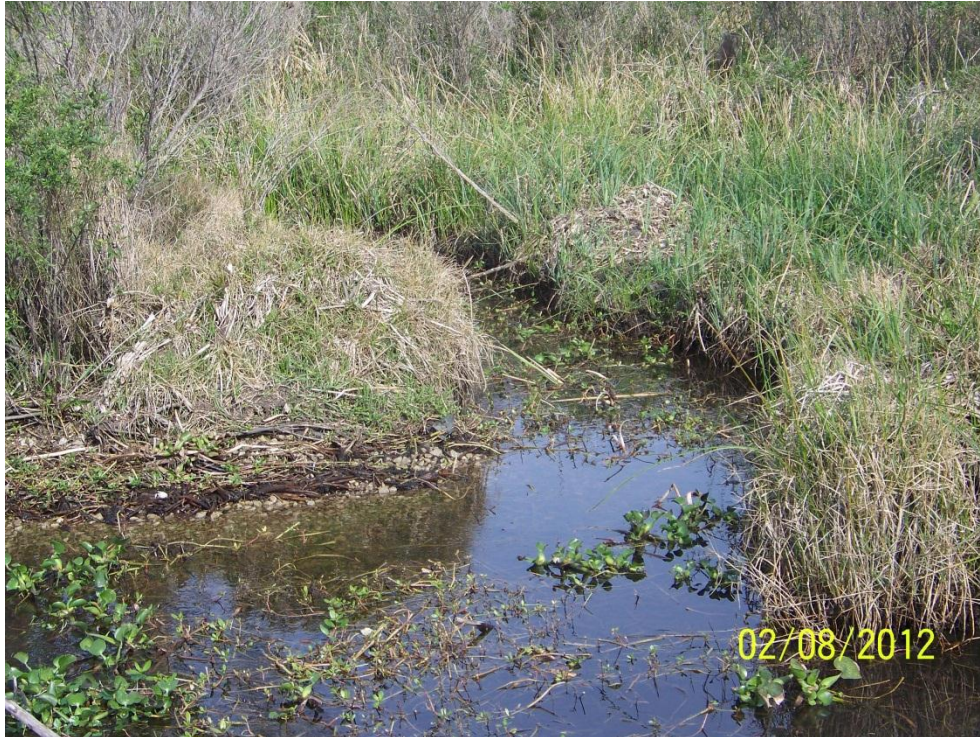
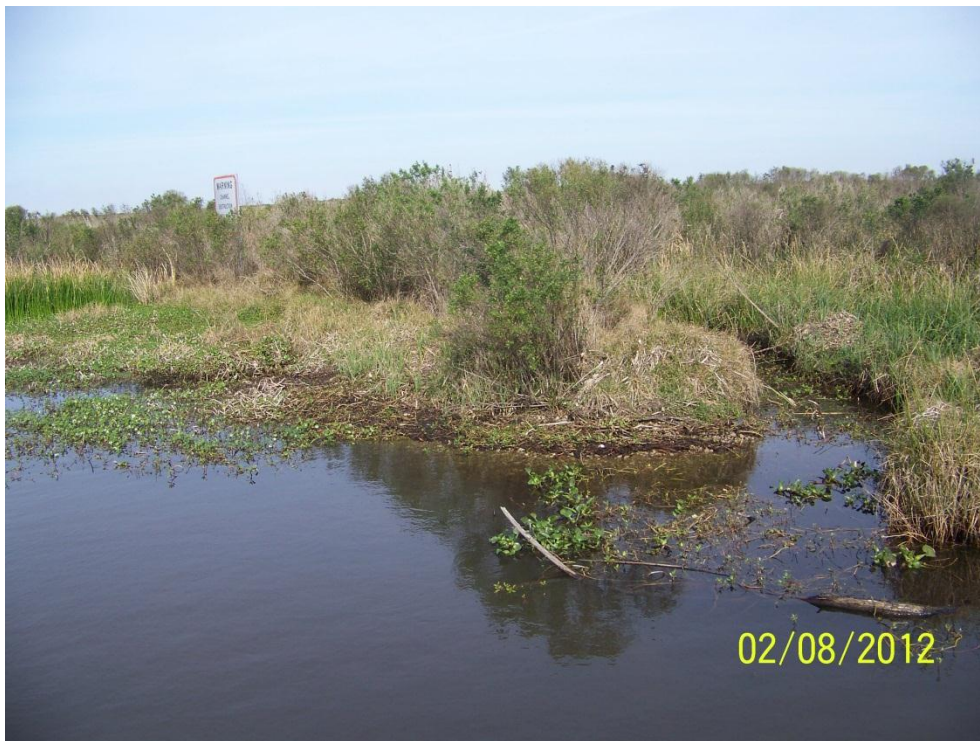
Photo #3: Close up view of breach around the east side of Structure 43, looking northwest.

Photo #4: View of the breach in relation to Structure 43, looking northwest.

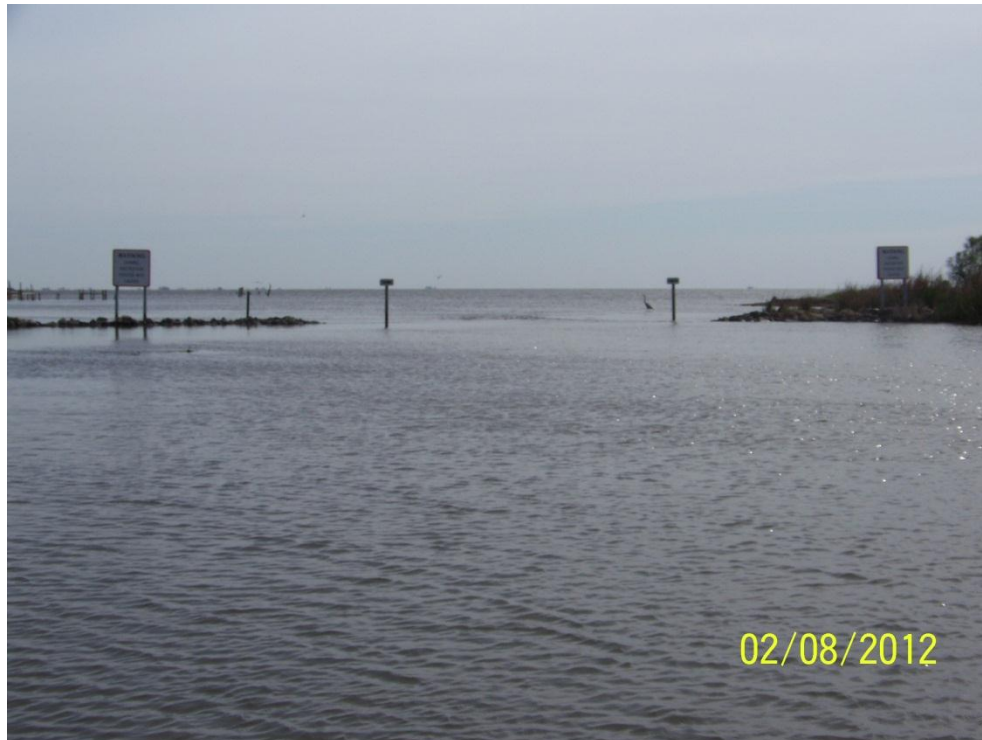
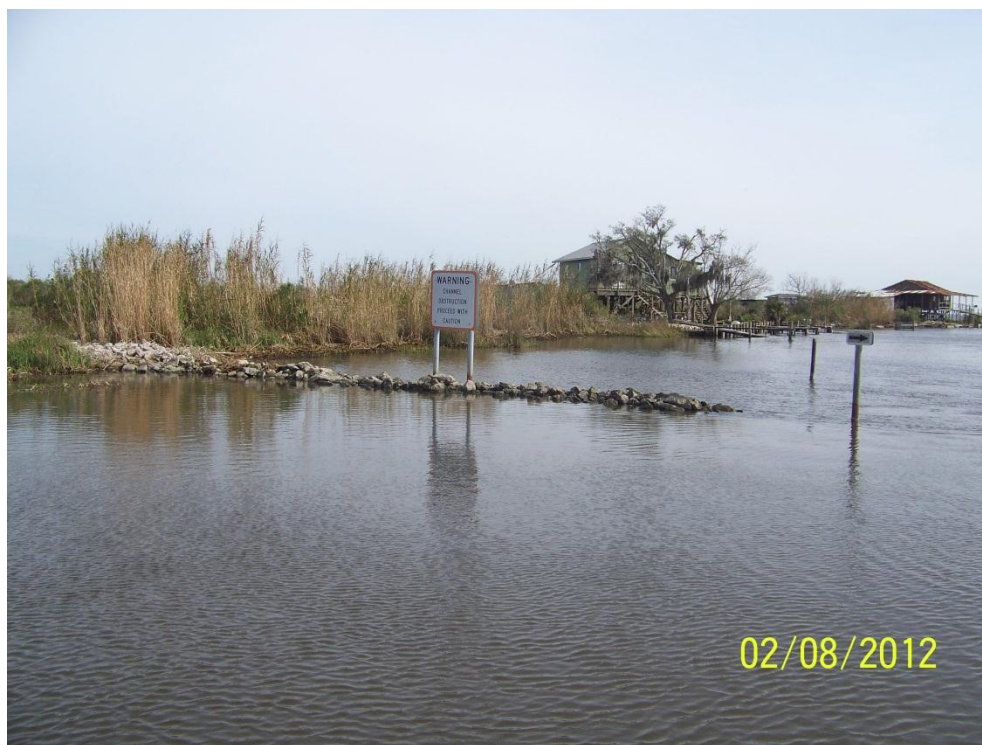
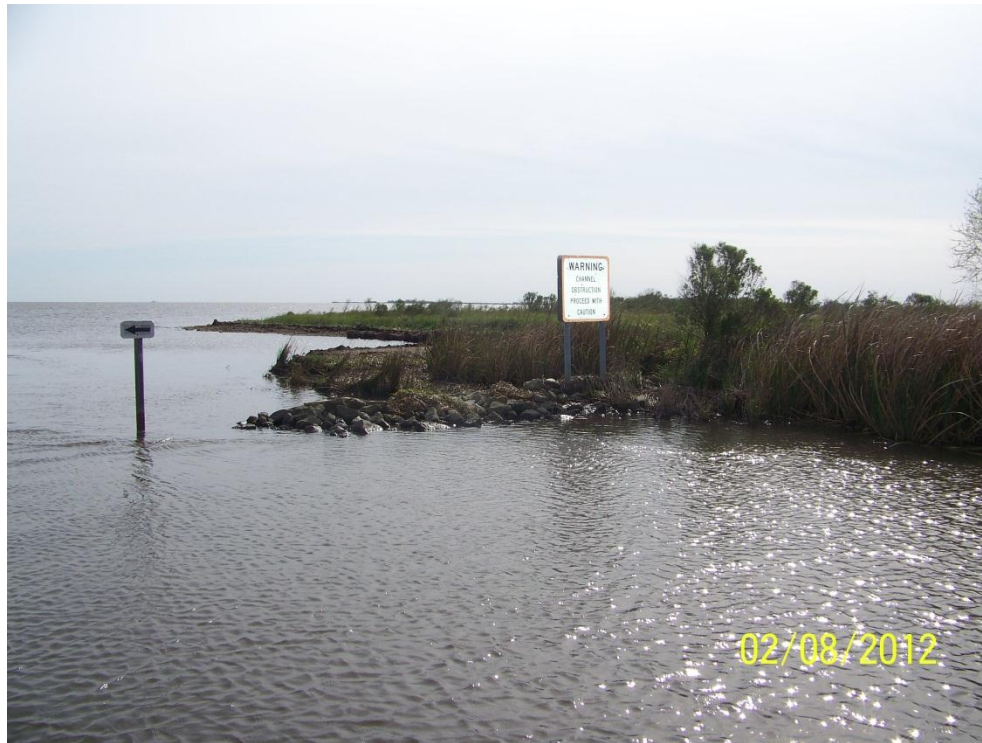
Structure 7 looked to be in fair condition with some settlement of the rock riprap material but no visual damage to the weir or erosion around the bank tie-ins. The as-built drawings show the weir was constructed to a height of -4.4 NAVD in the boat bay and +2.4' NAVD on the north and south sides between the bank and boat bay. The water depth in the boat bay was recorded as 6.4' at the time of the inspection. These observations and supporting data from previous surveys show this structure has settled uniformly along the entire length of the structure approximately 1.0' to 1.5'. Since the settlement of Structure 7 is uniform and relatively minor, we are not recommending corrective actions at this time, but the structure will continue to be monitored during future inspections. All other signs and supports appear to be in good condition. (See Appendix B, Photos 5 through 7)

Photo #5: Overall view of Structure 7 from the canal, looking east

Photo #6: View of the embankment tie-in on the north side of Structure 7, looking northeast

Photo #7: View of the embankment tie-in on the south side of Structure 7, looking southeast

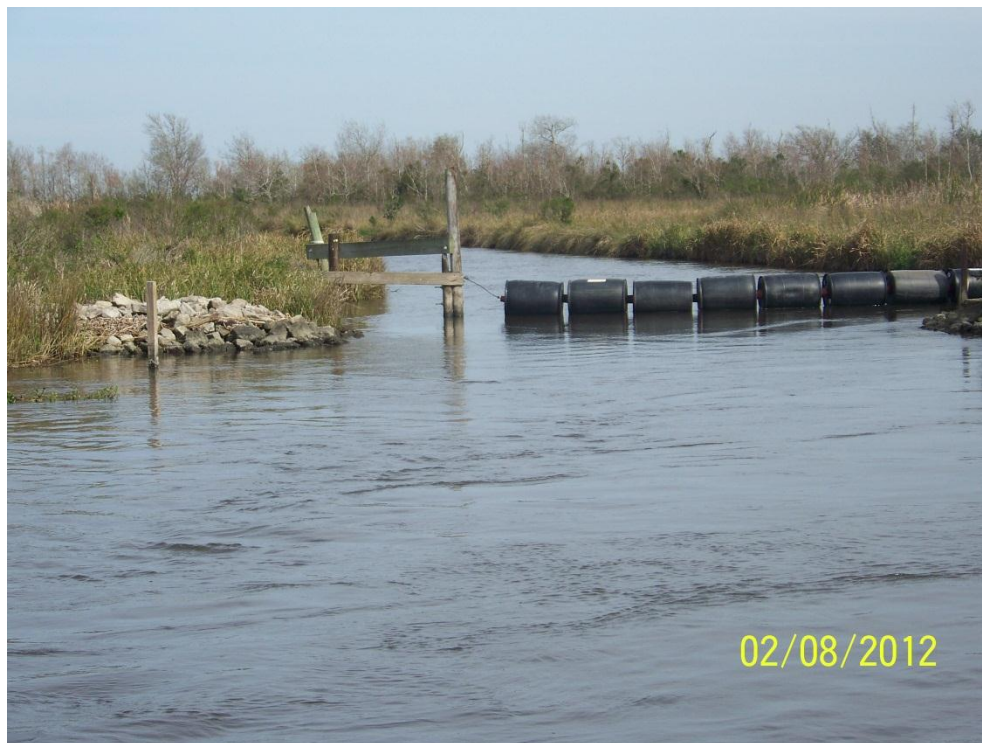
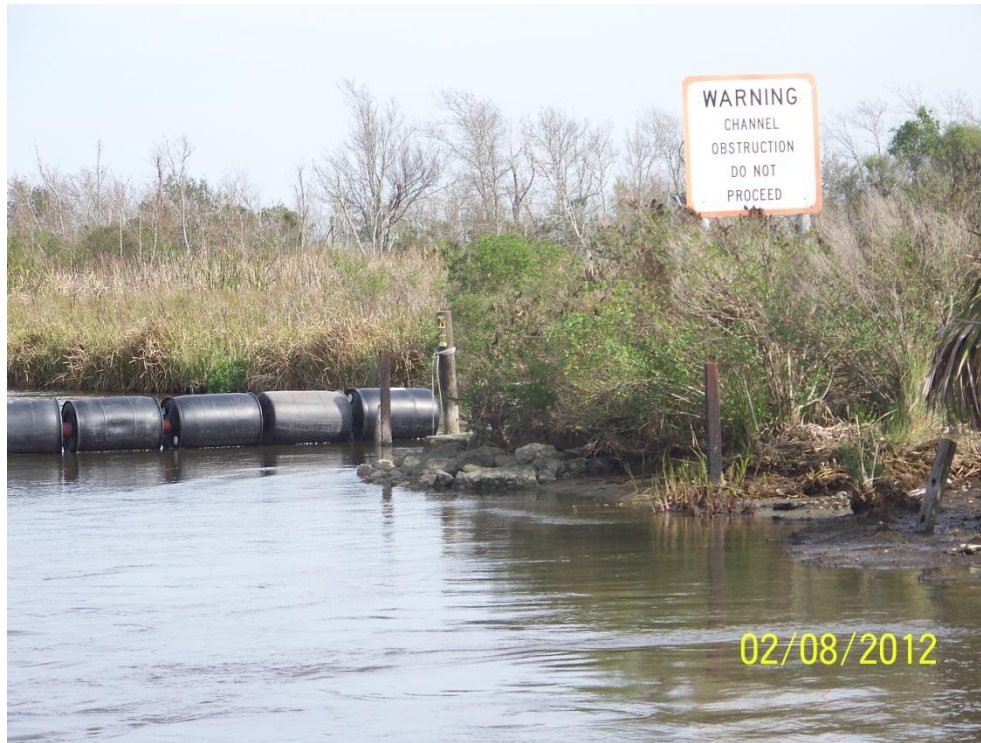
Structure 8 is a small rock weir with a boat bay located just north of Structure 7. This structure appears to be in fair condition with minimal settlement of the riprap material and no erosion or washouts around the bank tie-ins. This structure was originally constructed with a steel gate to prevent access into the interior marsh, but this gate was destroyed during Hurricanes Gustav and Ike. Since the gate was destroyed, the landowner has installed a series of floating barrels to restrict access, thus there is no need to replace the gate at this time. (See Appendix B, Photos 8 through 9)

Photo #8: View of the embankment tie-in on the west side of Structure 8, looking north.

Photo #9: View of the embankment tie-in on the east side of Structure 8, looking north.

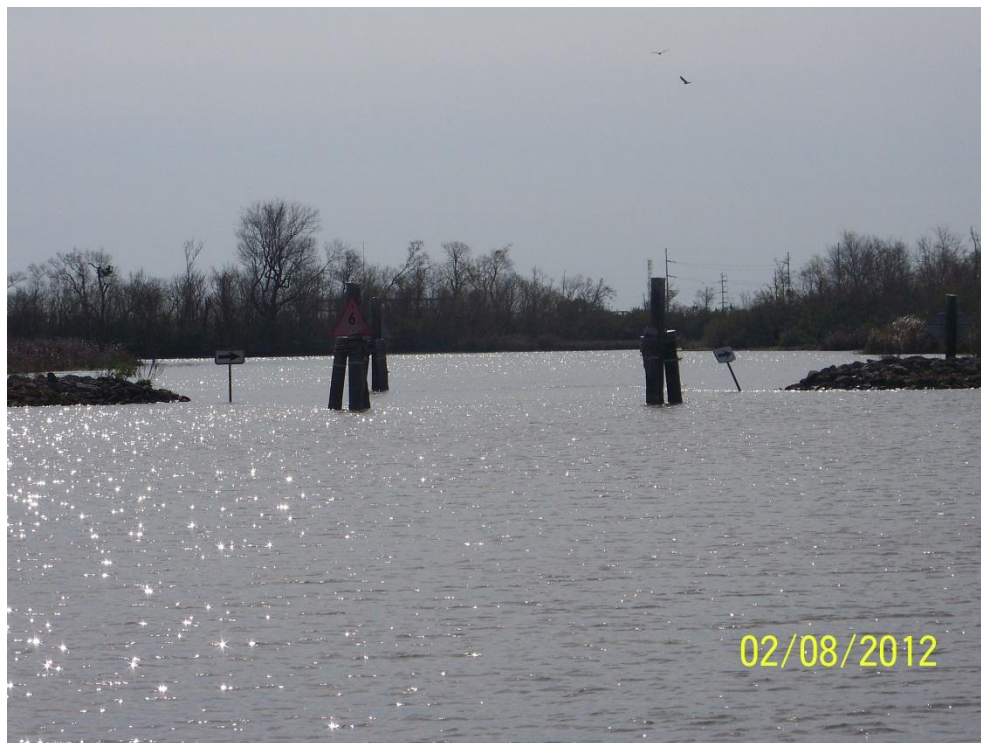
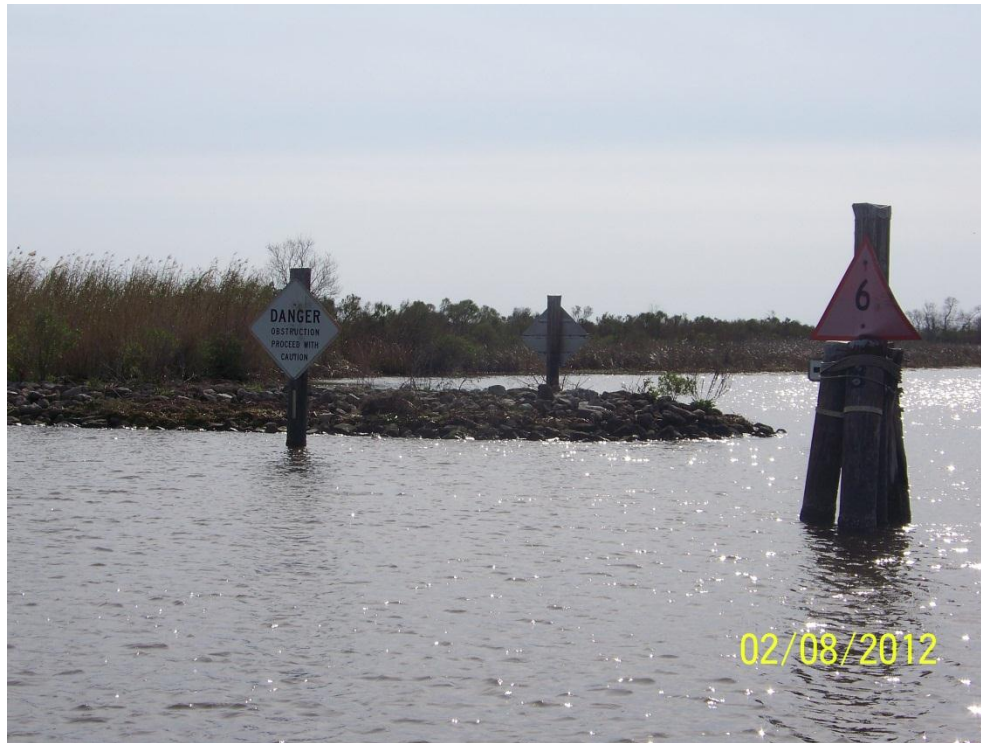
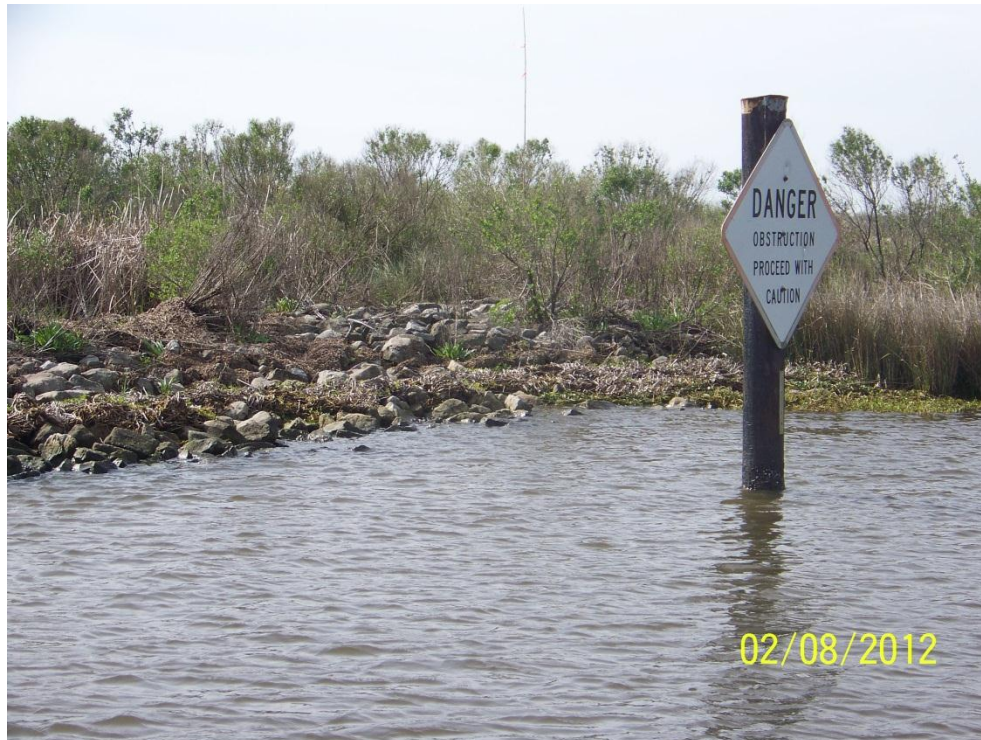
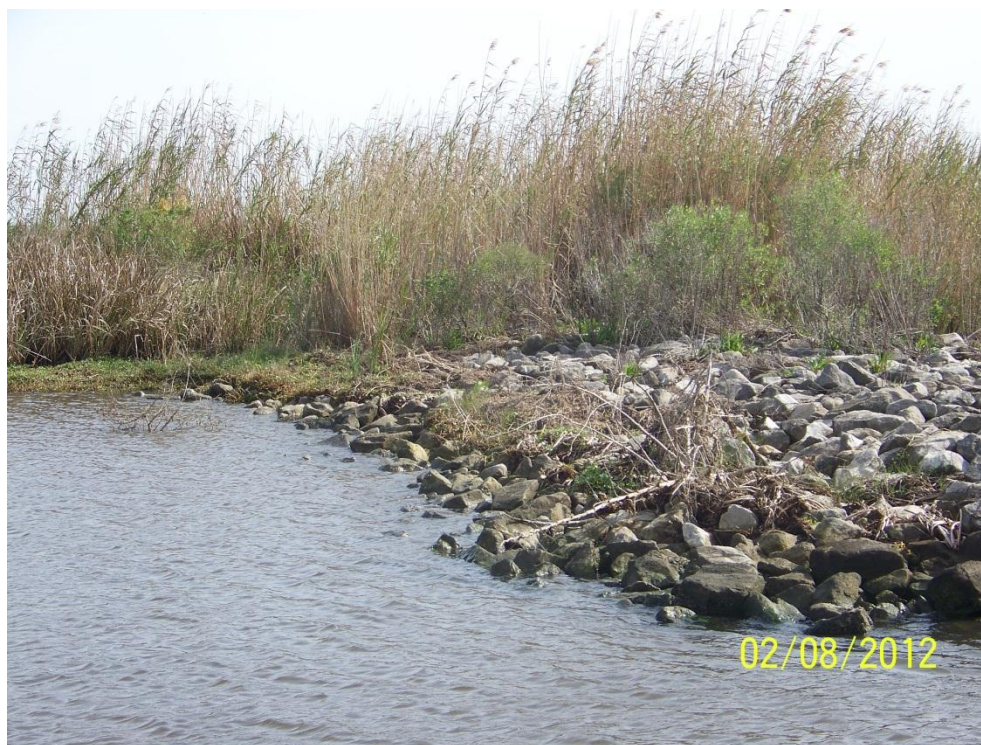
Structure 1 appeared to be in good overall condition with no observable settlement or displacement of the rock riprap material. According to the as-built drawings, the weir was constructed to a height of -6.4' NAVD at the barge bay and +4.0' NAVD along the crest on both sides of the weir between the barge bay and bank line. At the time of the inspection the water depth in the barge bay was recorded as 7.6' from the surface. As previously reported, there is considerable damage to the four (4) timber pile dolphins at the entrance of the barge bay. This damage is believed to be caused by oilfield service barges accessing the opening. The damage includes the vertical piles splitting, piles displaced from original position, scarring on the surface of the piles, and the complete destruction of one of the four dolphin structures. Due to the poor condition of the timber dolphins, we have included provisions in the 2012 Maintenance Project to replace all four (4) dolphin structures. Also, as a preventative measure, we are recommending the structures be relocated approximately 6' further apart towards the bank to allow barges to move more freely through the barge bay without damaging the timber pile dolphins. (See Appendix B, Photos 10 through 14)

Photo #10: Overall view of Structure 1 rock riprap weir, looking southeast.

Photo #11: View of warning signs and navigational aids on the east side of structure 1, looking southeast

Photo #13: Close up view of the embankment tie-ins on the west side of Structure 1, looking southwest

Photo #14: Close up view of the embankment tie-ins on the east side of Structure 1, looking southeast

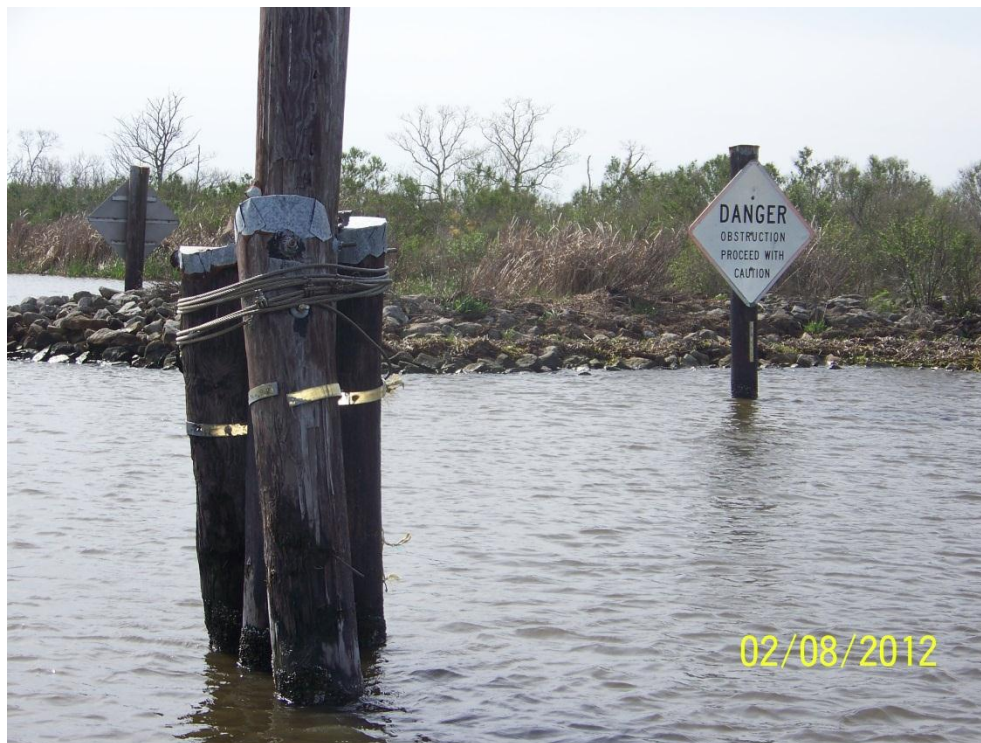
The deficiencies at Structure No.1 were limited to the four (4) timber cluster piles near the entrance of the barge bay. The timber structure on the southwest side of the barge bay was completely destroyed and no longer exists, the remaining three (3) cluster piles were severely damaged with large splits down the middle of the piles, the batter piles were off center and the surface of all the timbers were worn or scarred from marine vessels rubbing the timbers while accessing the barge bay. Under the 2012 Maintenance Project, all four (4) timber pile clusters will be removed and replaced with new material including hardware, cables and signage. With concurrence from NRCS, we are also recommending that the new structures be relocated slightly outwards (6" to 1'), towards the bank, to allow for additional clearance for barge vessels to move through the barge opening without interference.

Photo #12: Close up view of damaged timber dolphin at Structure 1 to be replaced in the 2012 Maintenance Project

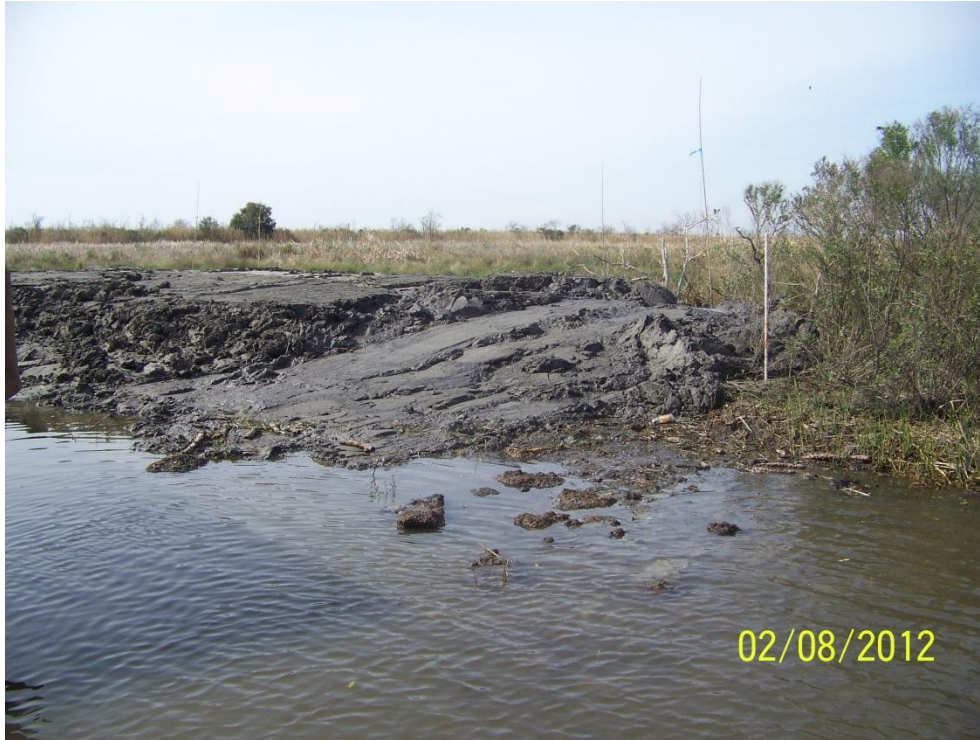
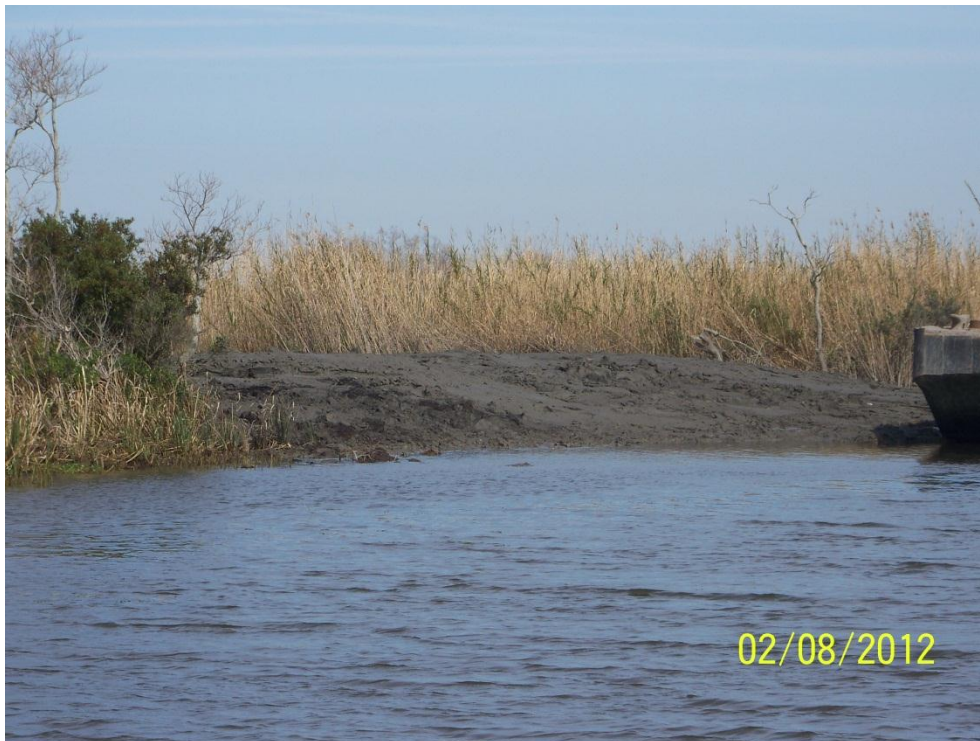
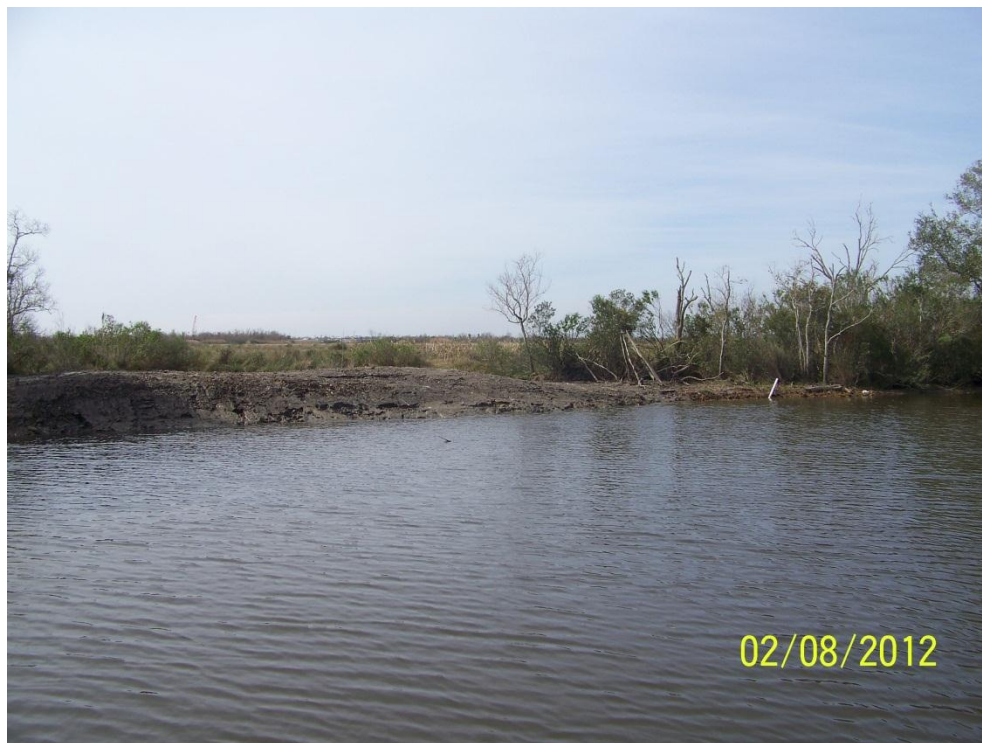
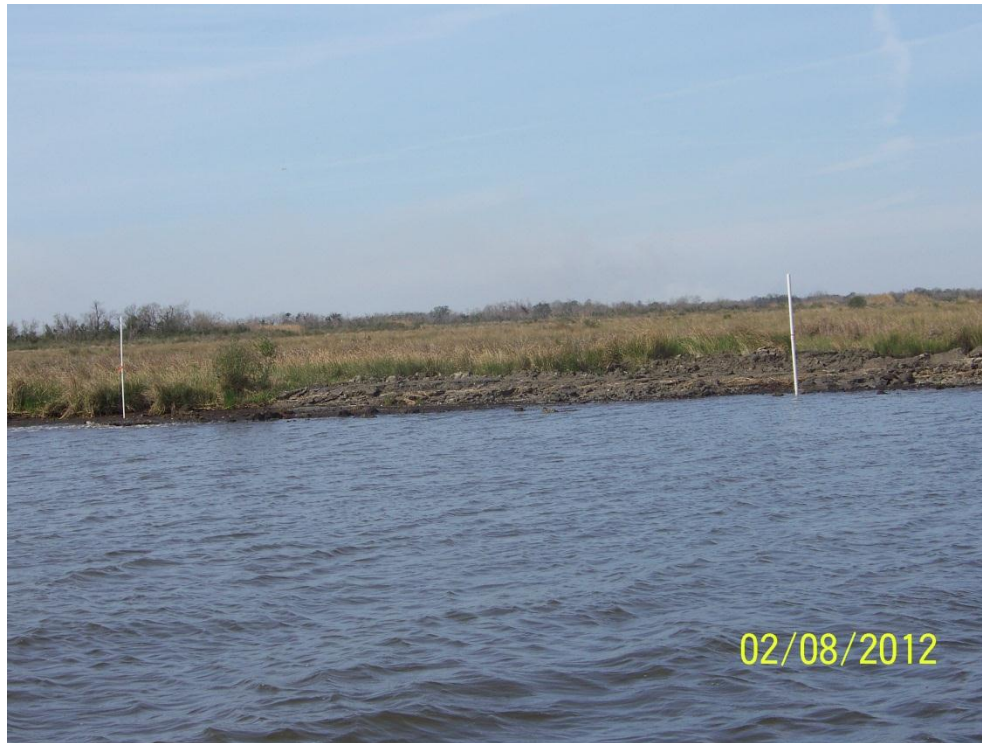
There are five (5) breaches included in the 2012 Maintenance Project that were in the process of being repaired at the time of the inspection. Breach 1 is located along the north bank of Breton Canal just southwest of the first location canal from Bay L' Ours and is approximately 20' wide. Breach 2 is located along the northeast bank of the second location canal north of Breton Canal and is approximately 10' wide. Breach 3 is located on the south bank of the same location canal as Breach 2 and is approximately 25' wide. Breach 4 is located on the west bank of a location canal that intersects Superior Canal east of Structure No. 1 and is approximately 30' wide. Another breach, designated as Breach 5, was discovered at the end of a dead end oil field slip south of Breach 4. The recommended method of repair for these breaches is included in the conclusion of this report. (See Appendix B, Photos 15 through 16 & 24 through 25)

Photo #15: View of progress being made on Breach 5 in the 2012 Maintenance Project

Photo #16: View of progress being made on Breach 4 in the 2012 Maintenance Project

Photo #24: View of progress being made on Breach 3 in the 2012 Maintenance Project

Photo #25: View of progress being made on Breach 1 in the 2012 Maintenance Project

In all, a total of five (5) breaches ranging from 10' to 30' wide were identified within the southern portion of the project area which will be included in the 2012 Maintenance Project. Breach locations are shown in the Work Plan Map of Appendix D. The method of repair for breach closures consist of utilizing in situ material from adjacent channel bottoms to reconstruct the earthen dike. Upon completion of the earthen embankment construction, the surface of the earthen dikes will be seeded to protect against erosion.

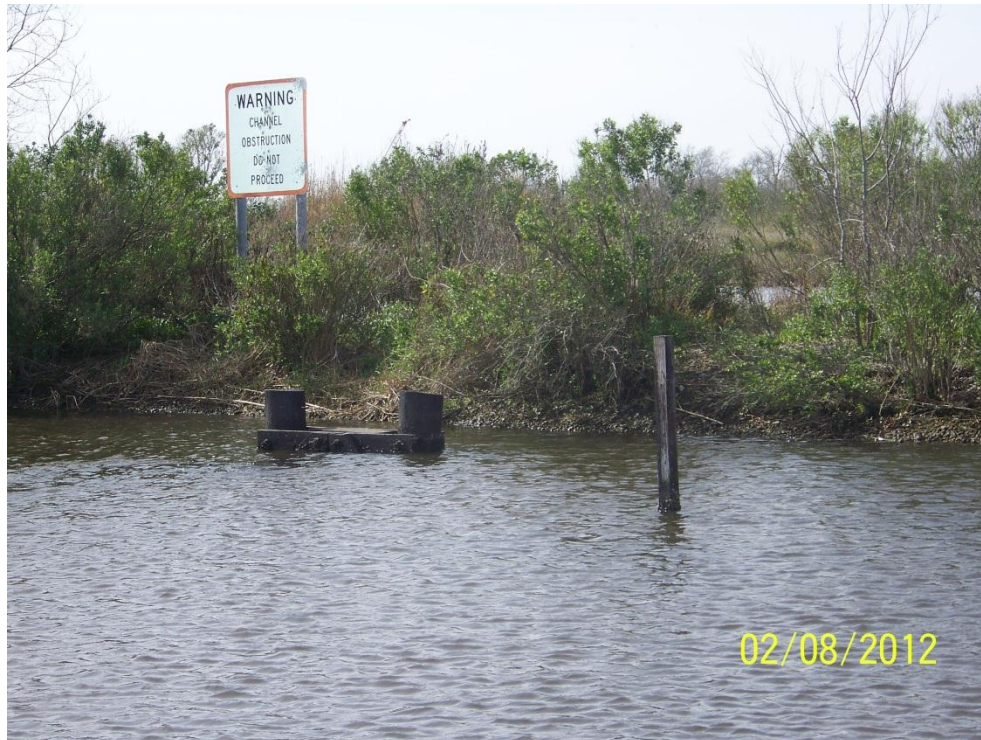
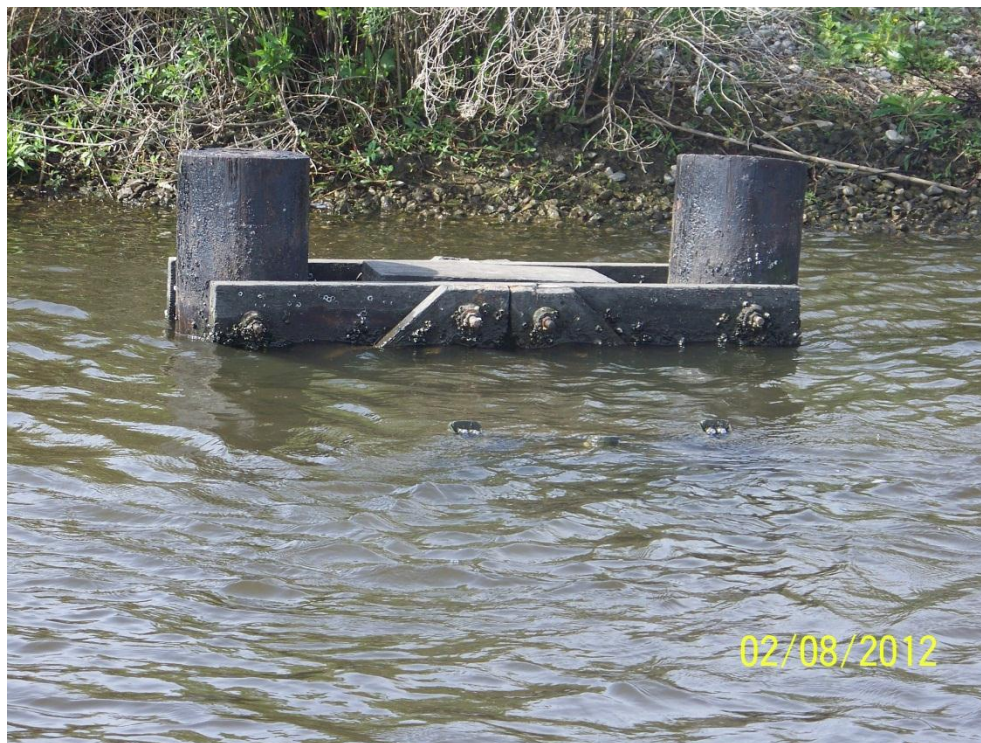
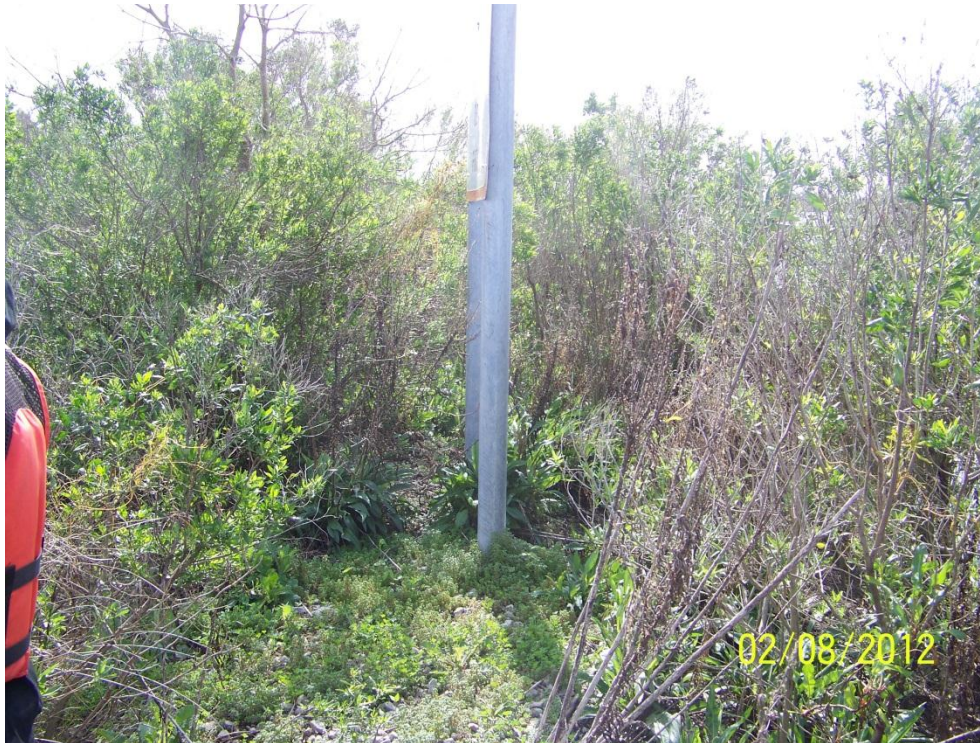
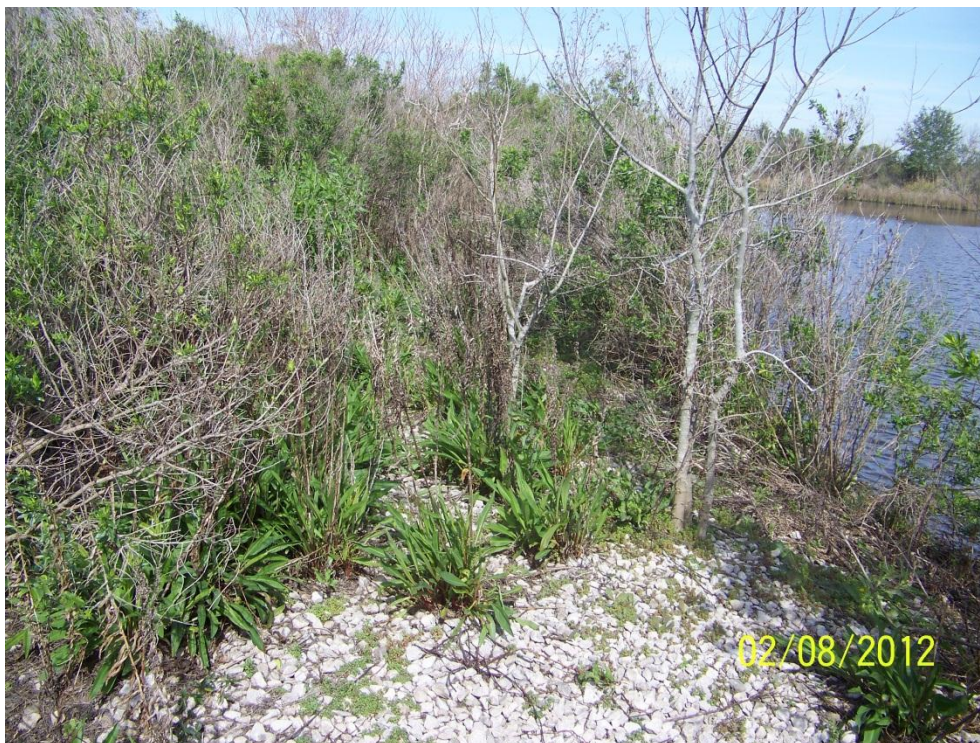
Structure 91 rock plug structure appeared to be in good condition without any signs of rock settlement or erosion around embankment tie-ins. The warning signs and timber supports were also in good overall condition. As previously noted, the sheet metal covering the timber piles supporting the corrugated metal pipe are rusted and corroded. To prevent these timbers from rotting, the replacement of the sheet metal caps are included in the 2012 Maintenance Project. (See Appendix B, Photos 17 through 20)

The rock plug was in good condition with no obvious settlement or erosion around the bank tie-ins. However, we did identify minor maintenance which included severe corrosion of the metal caps covering the butts of the timber piles supporting the culvert and flap gate. To prevent rotting of the heads of the timber piles the metal sheeting on the top the timber piles will be replaced.

Photo #17: Overall view of Structure 91 flap gate culvert, looking south

Photo #18: Close up view of Structure 91 culvert protruding above the waterline

Photo #19: View from standing on top of Structure 91, looking east

Photo #20: View from standing on top of Structure 91, looking west

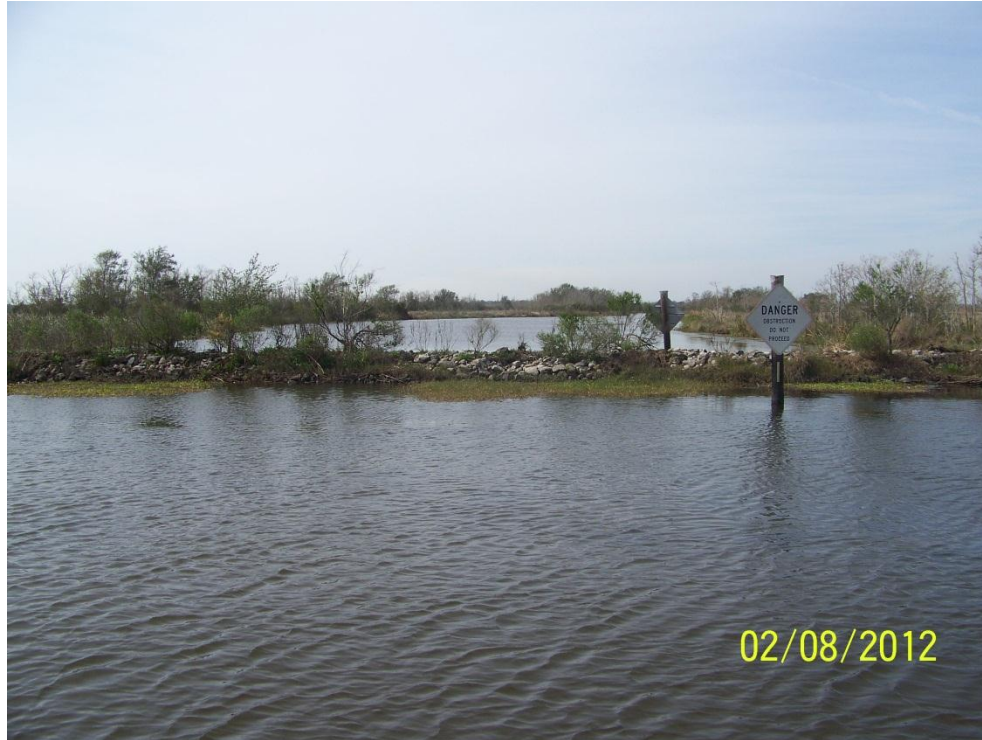
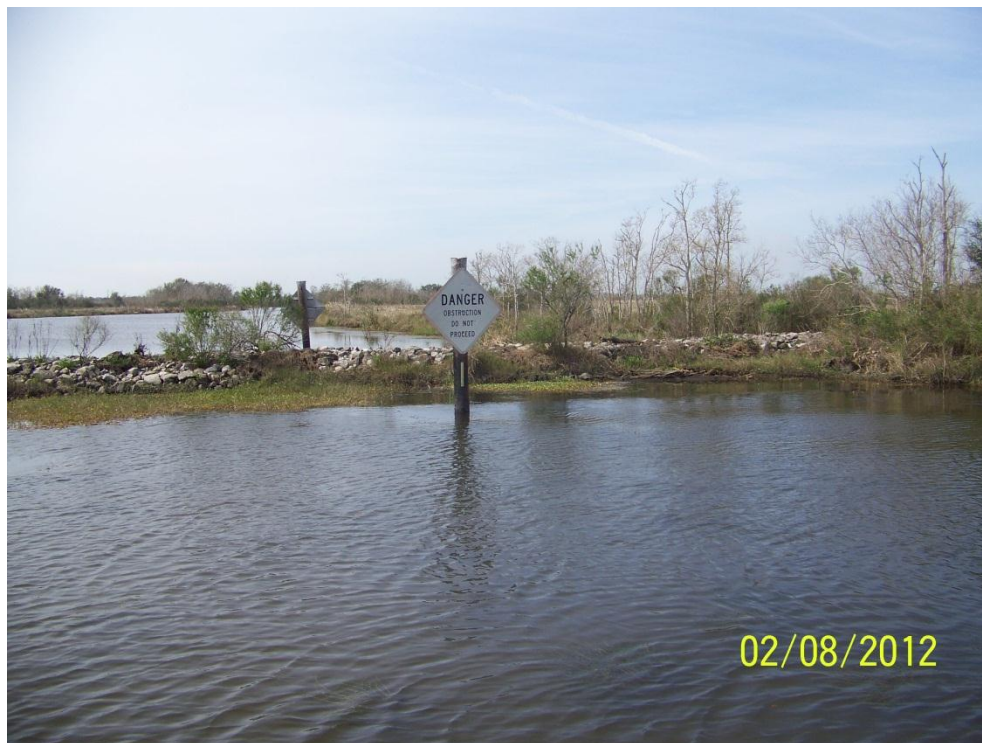
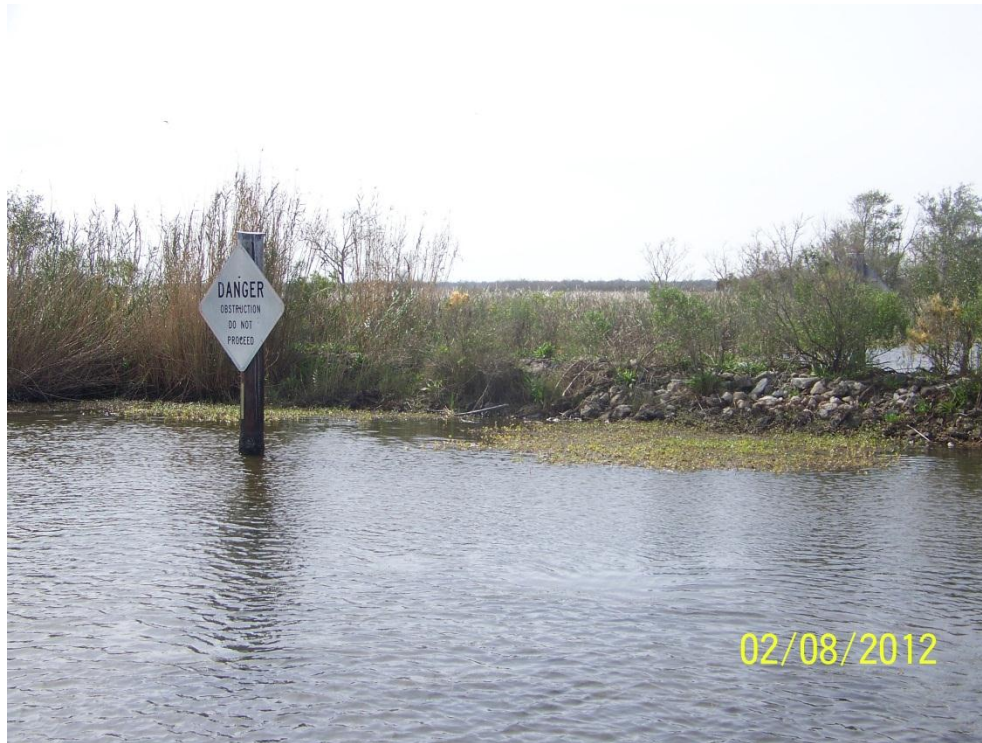
Structure 90 appears to be in overall good condition with no rock settlement/ displacement or erosion around the embankment tie-ins. All warning signs and supports are in good condition also. There are no recommended corrective actions at this time. (See Appendix B, Photos 21 through 23)

Photo #21: Overall view of Structure 90 rock riprap plug, looking southwest

Photo #22: View of warning signs and embankment tie-in on the northwest side of Structure 90

Photo #23: View of warning signs and embankment tie-in on the southeast side of Structure 90
