2012 Annual Inspection Report

**GIWW/ CLOVELLY HYDROLOGIC
RESTORATION**

State Project Number BA-02
Priority Project List 1

May 14, 2012
Lafourche Parish

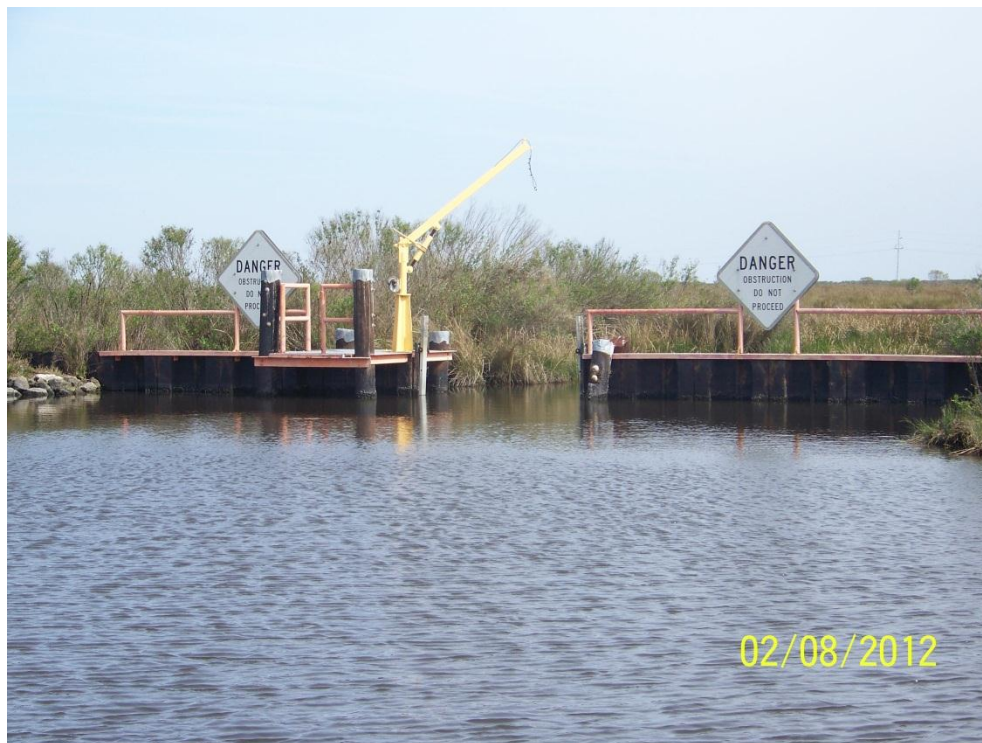
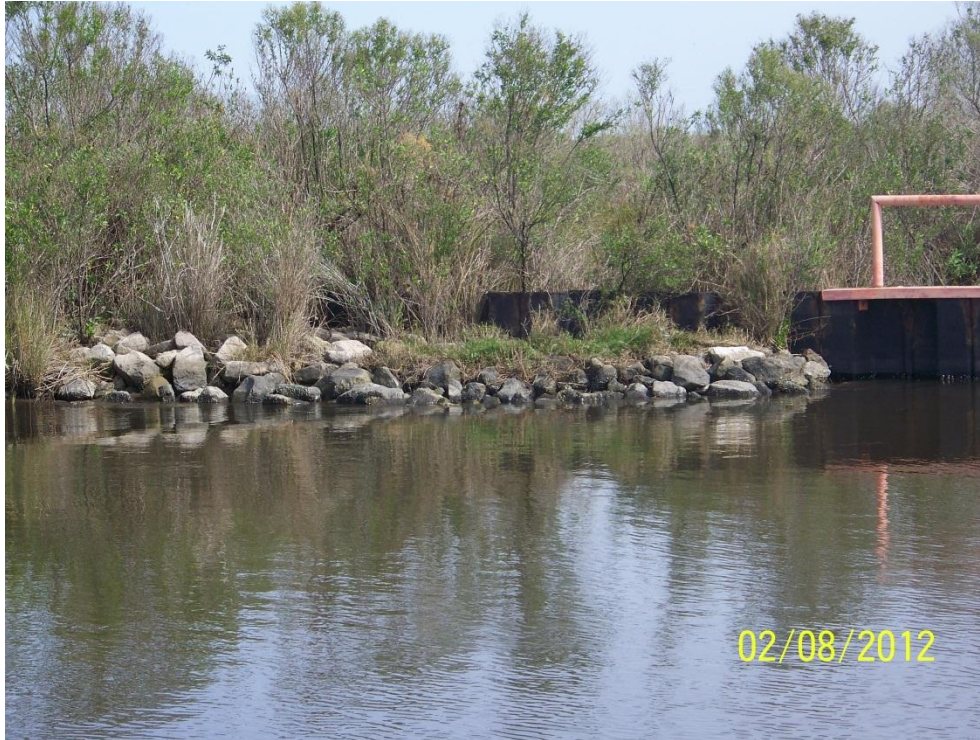
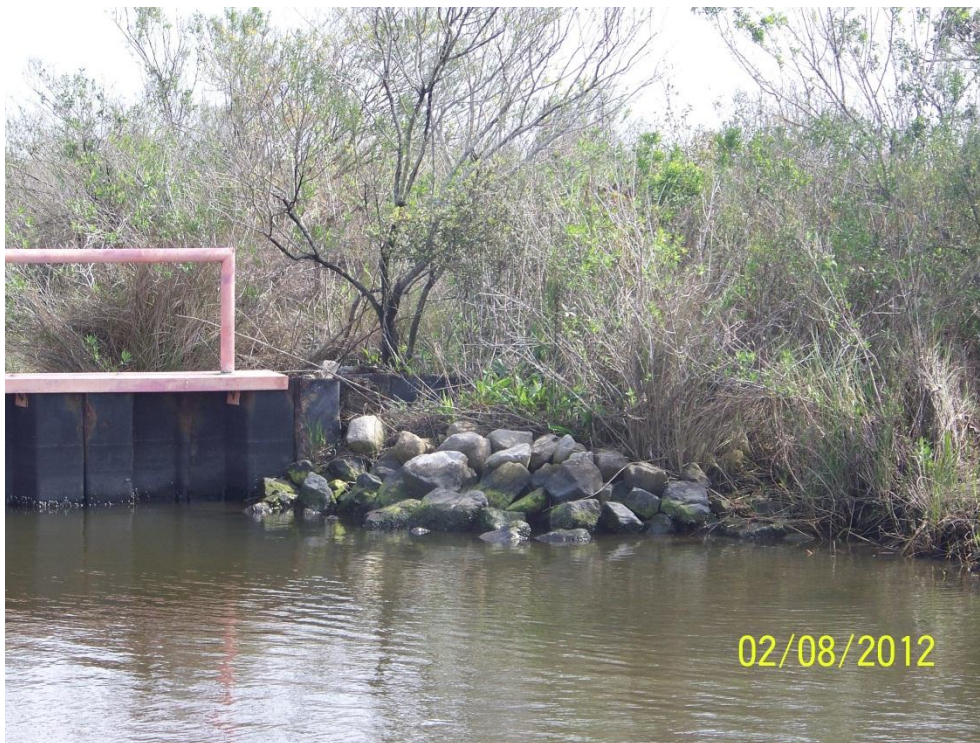
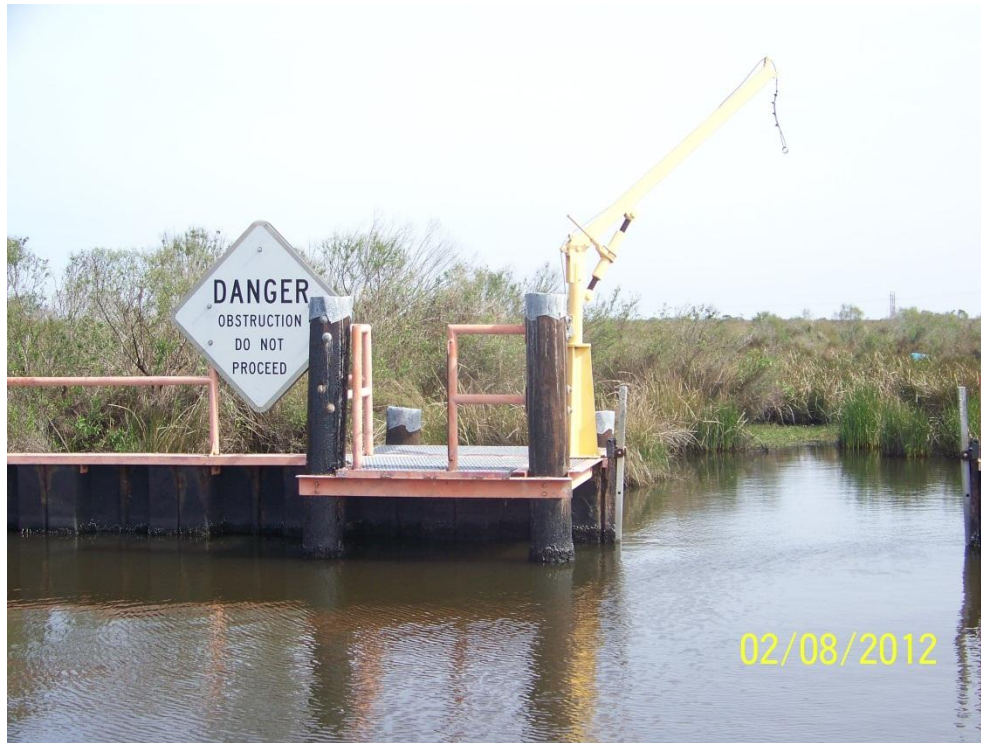
Structure 35 is in overall good condition with some signs of minor corrosion on the bulkhead cap, handrails and deck. The stop logs, cables, signs and supports appear to be in good condition and operable. At the time of inspection the channel from the weir to the interior marsh was open and there appeared to be adequate flow through the interior marsh and structure. The embankment tie-ins also appear to be in good condition with no erosion or washouts. We are not recommending any repairs or corrective actions at this time. (See Appendix B, Photos 27 through 29)

Photo #26: Overall view of Structure 35 variable crest weir, looking northeast

Photo #27: View of embankment tie-in on the northwest end of Structure 35

Photo #28: View of embankment tie-in on the southeast end of Structure 35

Photo #29: Close up view of pilings, decking and hoist of Structure 35, looking northeast

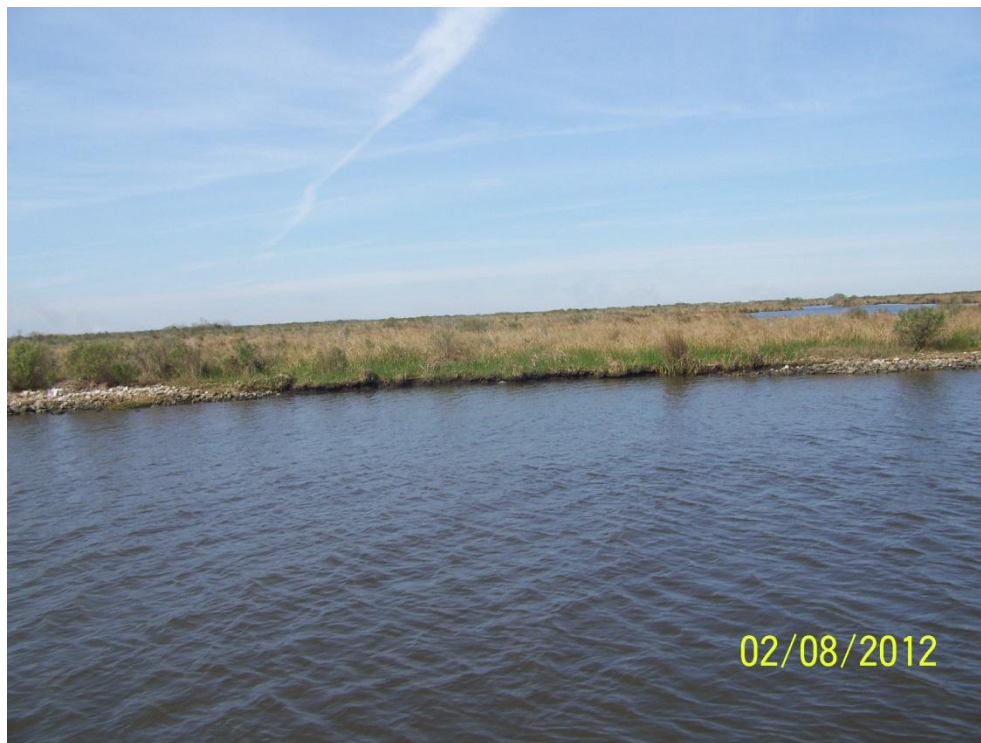
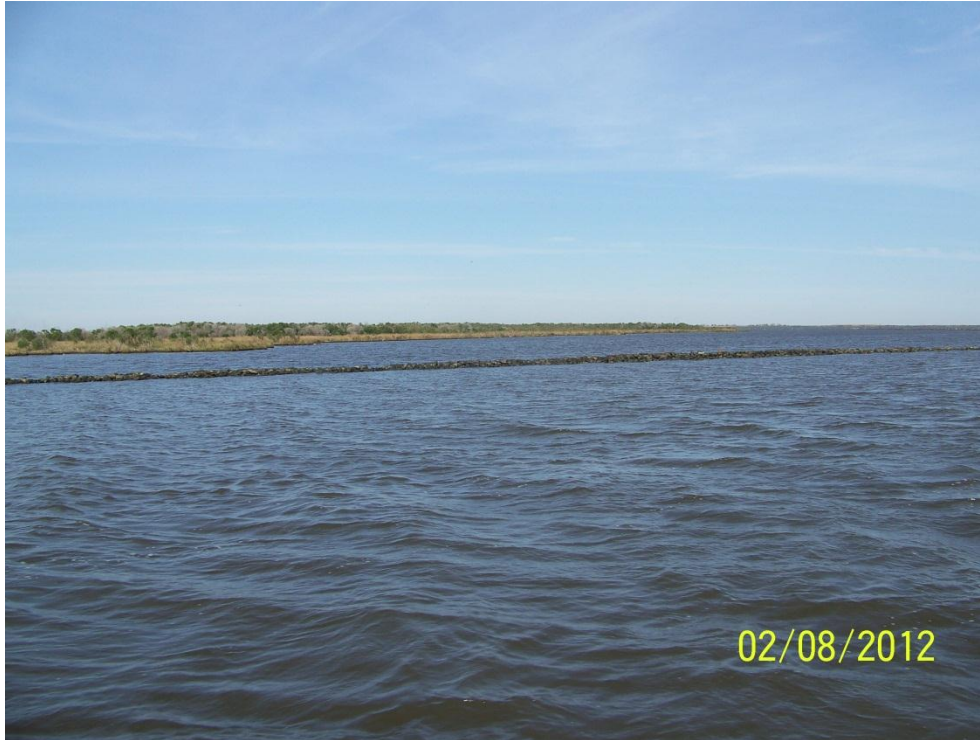
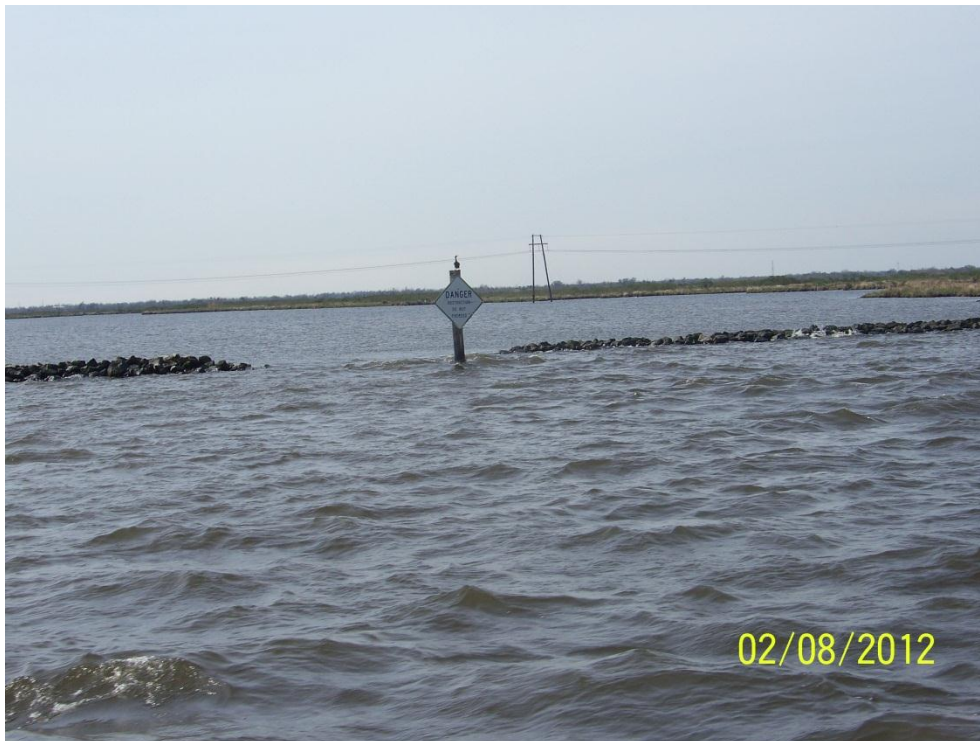
The lake rim structure was constructed between a +2.0' and +3.0' NAVD with six (6) fish dips at various locations along the structure. As indicated on previous inspections and surveys, the rock dike has displayed minor to moderate settlement along the entire length of the structure. The most notable segments include segments between Stations 7+00 and 13+00, 36+00 and 41+00, and the intersection near the mouth of Breton Canal. Due to the current condition of the rock dike, the entire length of the lake rim including the reach along Breton Canal has been included in the 2012 Maintenance Project. Its repairs include recapping the structure with rock riprap to its original design elevation. (See Appendix B, Photos 30 through 32)

Photo #30: View of low area in rock dike along Brenton Canal, looking northwest

Photo #31: View of rock dike when entering Little Lake from Brenton Canal, looking northwest

Photo #32: View of warning signs and fish dip in rock dike along the lake rim, looking west

As indicated in the inspection results and on previous inspections, a large portion of the rock dike along the lake rim has settled below the constructed crest elevation. To rehabilitate the structure, we will be recapping the entire lake rim with rock riprap under the 2012 Maintenance Project from Structure 2 to the termination point along the north bank of Breton Canal. Based on the water depths obtained during the design surveys, we do not anticipate that access dredging will be required.

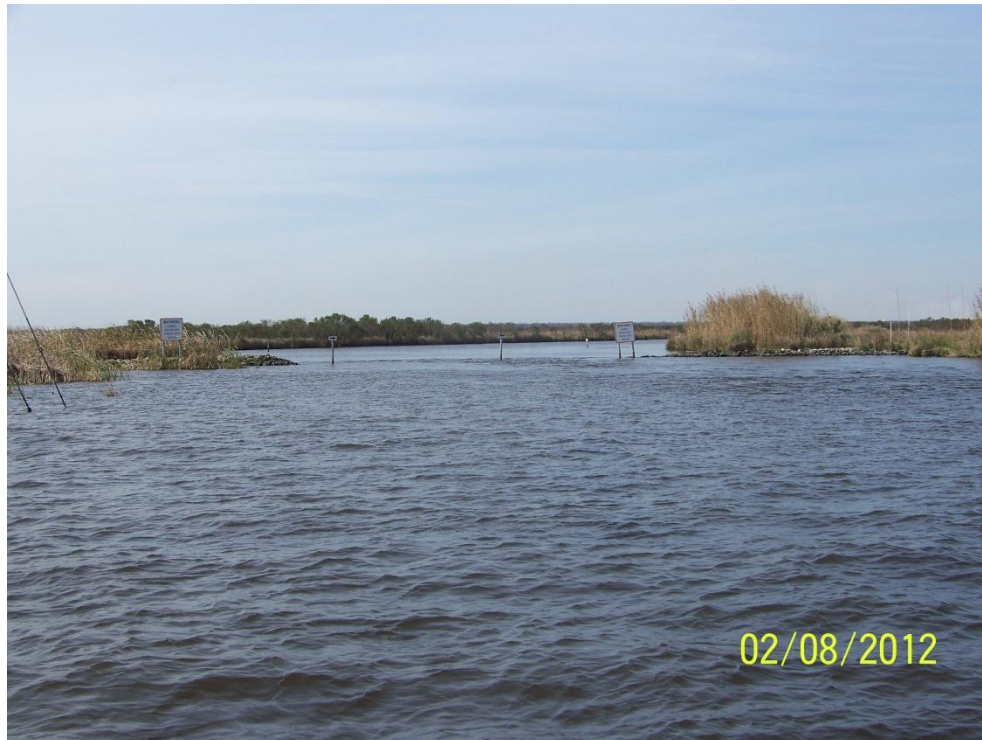
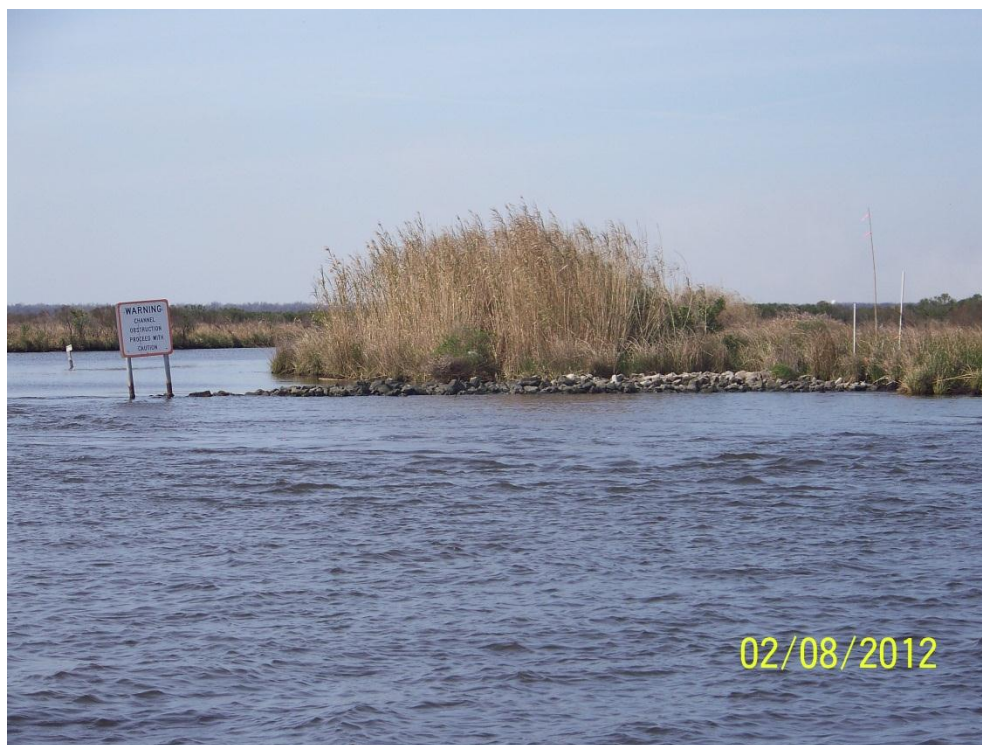
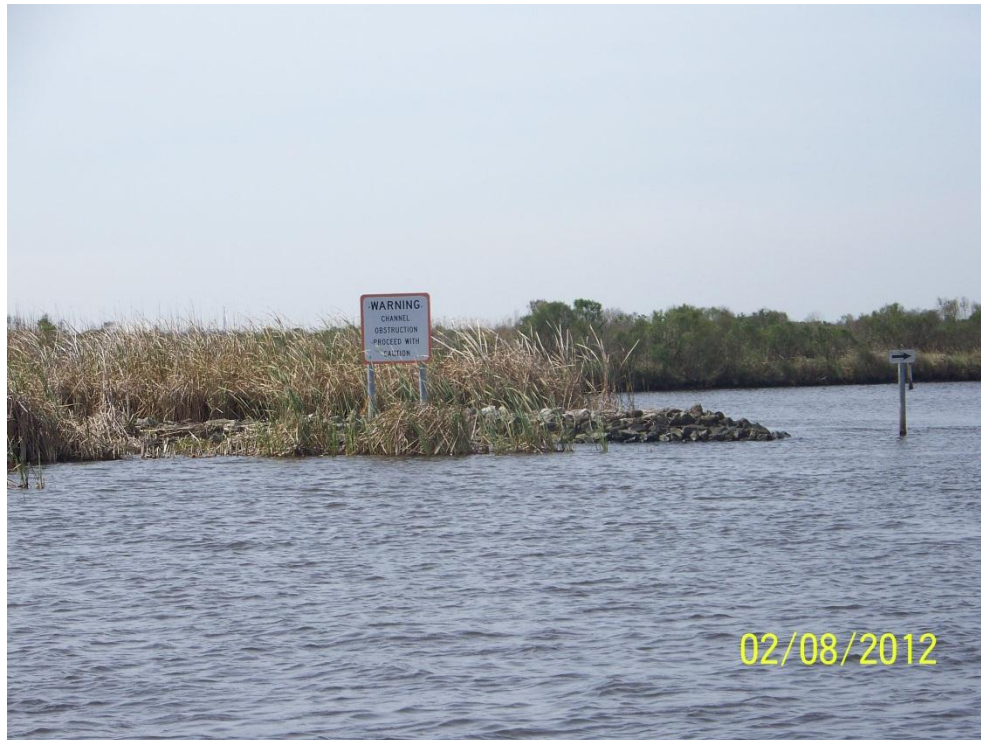
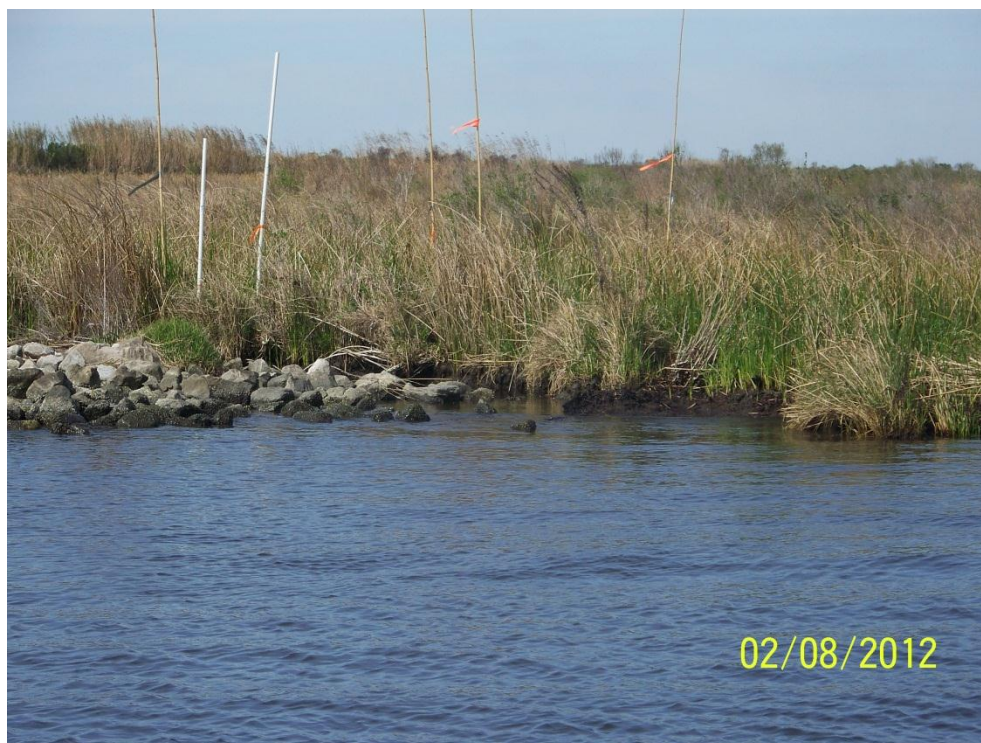
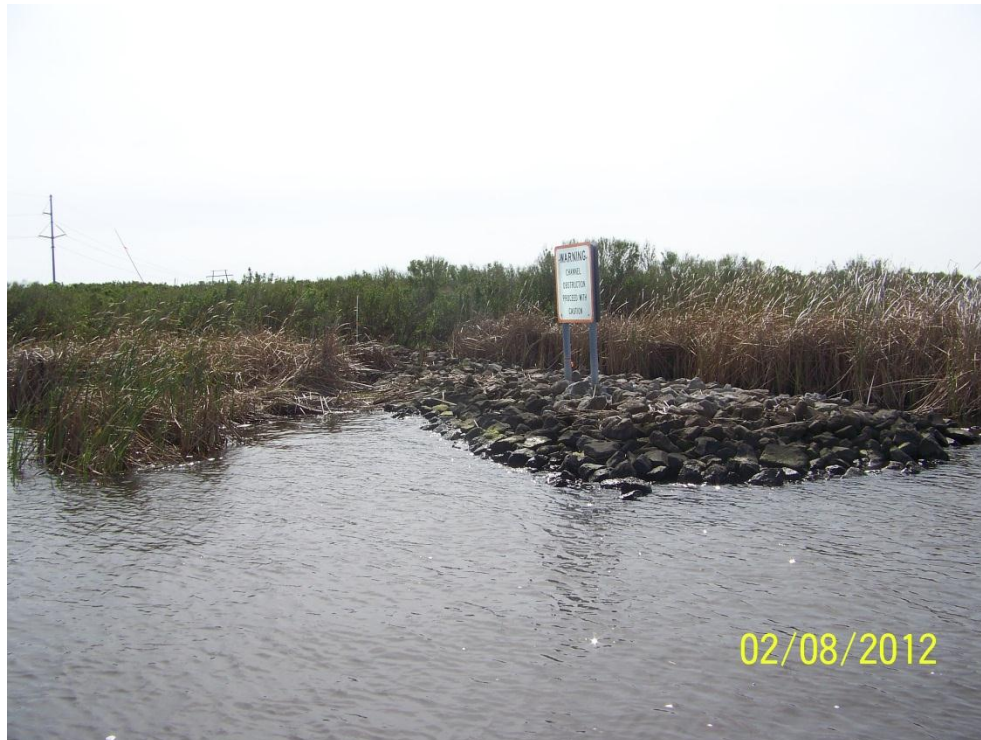
Structure 2 is a three (3) level fixed crest weir constructed of rock riprap material. According to the as-built drawings, the sill elevation closest to the bank was constructed to an elevation of +3.9' NAVD, the section between the bank and the boat bay was constructed to +2.3' NAVD, and the boat bay was constructed to -5.1' NAVD. At the time of the inspection, the water depth in the boat bay was recorded to be 9.1' from the surface. As previously reported, there was some moderate settlement observed between the bank and boat bay (approximately 1.3' to 1.5') and severe settlement observed in the boat bay (approximately 4'). The refurbishment of the rock weir has been included in the 2012 Maintenance Project. All warning signs and supports are in good condition and do not require maintenance. (See Appendix B, Photos 33 through 37)

Photo #33: Overall view of Structure 2 rock weir from Little Lake, looking west

Photo #34: View of warning signs and embankment tie-in on the north end of Structure 2, looking west

Photo #35: View of warning signs and embankment tie-in on the south end of Structure 2, looking west

Photo #36: Close up view of embankment tie-in on the north side of Structure 2, looking northwest

Photo #37: Close up view of embankment tie-in on the south side of Structure 2, looking southwest

The documented deficiencies at Structure No.2 were primarily due to settlement of the rock weir with the most severe settlement on the south side of the structure between the boat bay and existing bank. Under the 2012 Maintenance Project, the boat bay section and fixed crest sections will be raised to the original design elevations using rock riprap.

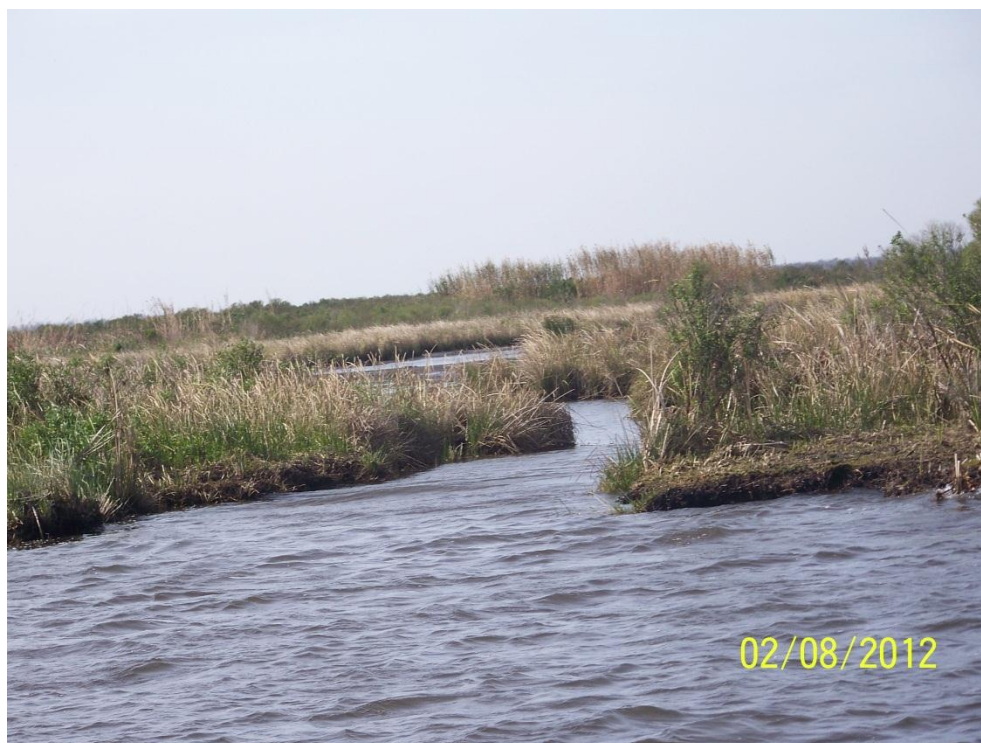
There was a breach identified in the western shoreline of Bay L'Ours between Structure 2 and Structure 4. The breach is believed to be caused by the retreating shoreline reaching the edge of an interior pond. There are no recommendations for repair at this time; however, this breach will continue to be monitored on future inspections. (See Appendix B, Photo 38)

Photo #38: Breach identified along the lake rim located in the proximity of "N29.51274; W90.23242"

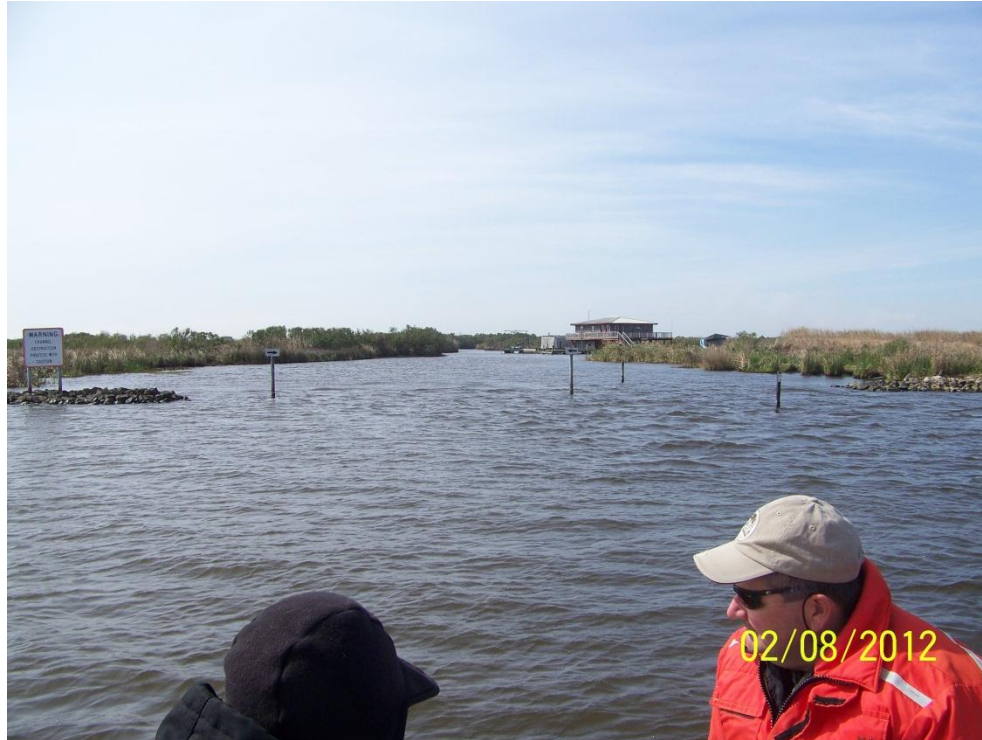
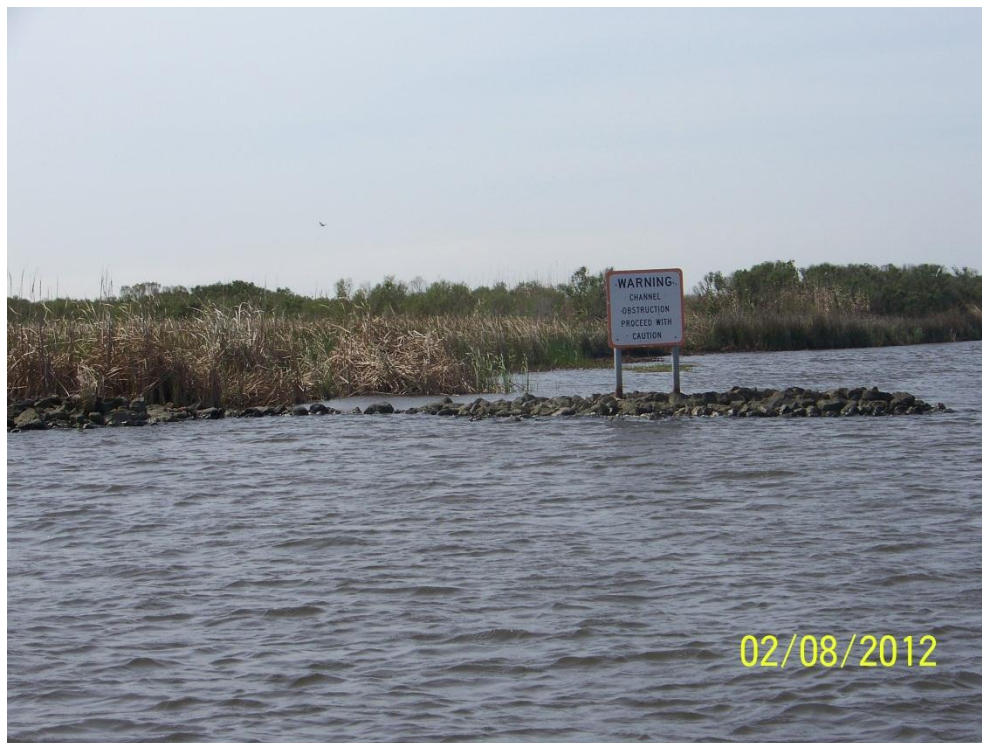
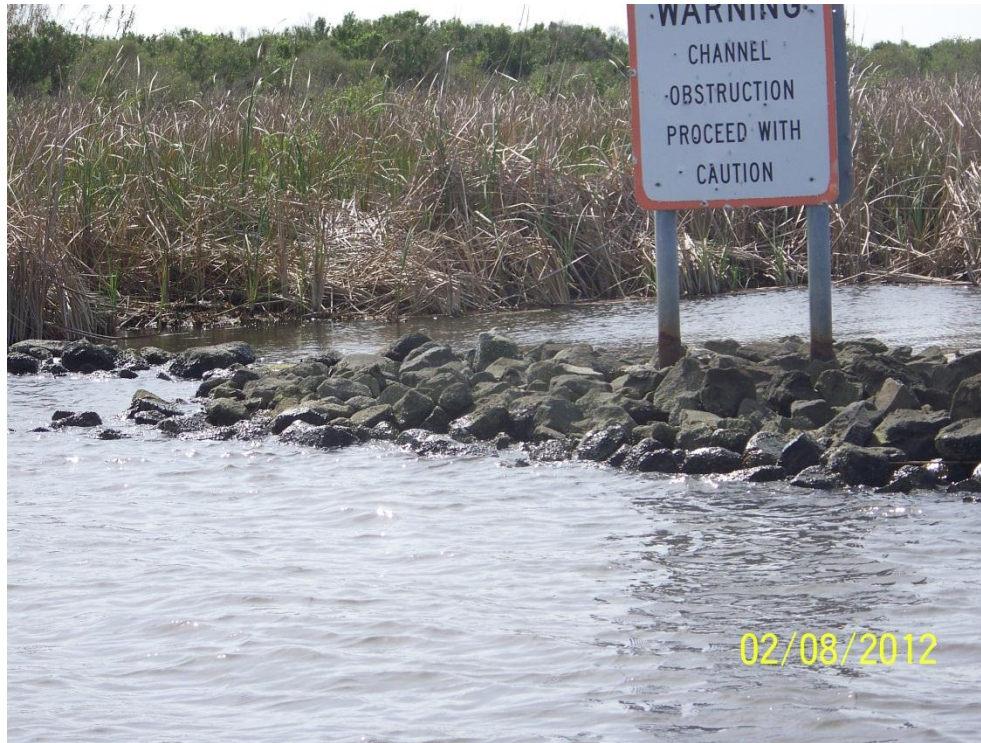
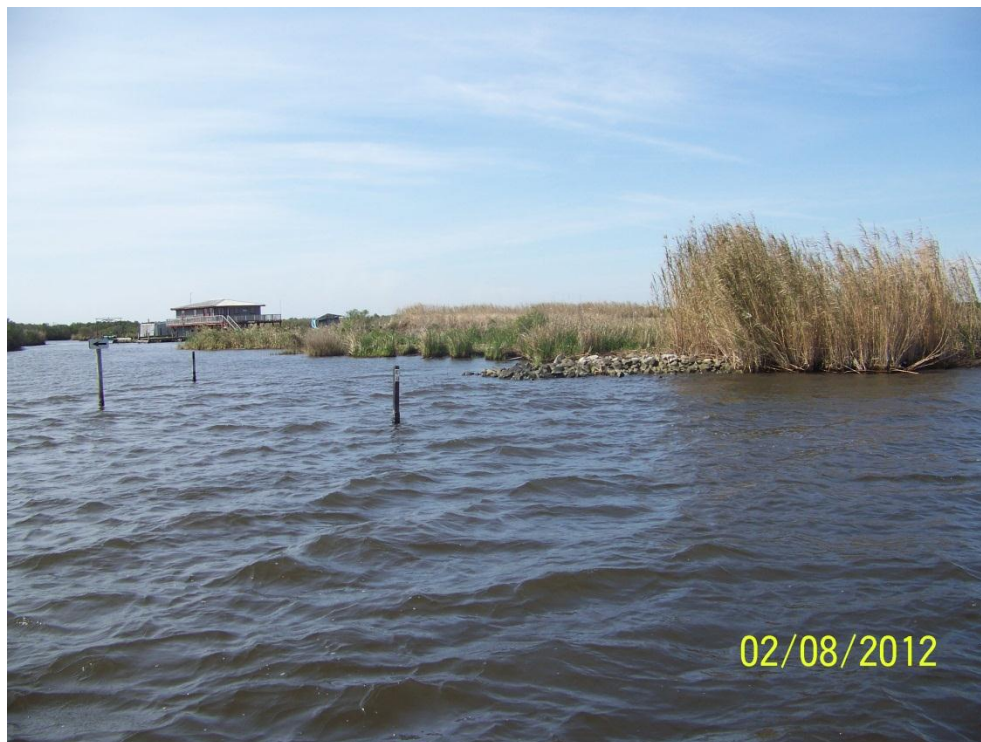
Structure 4 is also a three (3) level fixed crest weir constructed of rock riprap material. According to the as-built drawings, the sill elevation closest to the bank was constructed to an elevation of +3.8' NAVD, the section between the bank and the boat bay was constructed to +2.4' NAVD, and the boat bay was constructed to -3.9' NAVD. At the time of the inspection, the water depth in the boat bay was recorded to be 7.0' from the surface. As previously reported, there was some moderate settlement observed on the north side of the structure (approximately 1.5' to 2.0') and more severe settlement observed on the south side of the structure (approximately 6' to 7') including a breach on the south bank tie-in. The refurbishment of this rock weir has been included in the 2012 Maintenance Project. The warning signs and supports on the north side of the structure are missing and will be replaced during the maintenance event. (See Appendix B, Photos 39 through 42)

Structure No.4 was found to be in fair to poor condition with severe settlement and/or displacement of the rock material on the south side of the structure and moderate settlement of the rock lining the boat bay and rock weir section on the north side. The warning sign on the

Photo #39: Overall view of Structure 4 rock weir from Little Lake, looking west

Photo #40: View of the warning sign and embankment tie-in on the south side of Structure 4, looking west

Photo #41: Close up view of the warning sign and embankment tie-in on the south side of Structure 4, looking west

Photo #42: View of the embankment tie-in on the north side of Structure 4, looking west

north side of the structure was also missing. Under the upcoming 2012 Maintenance Project, Structure No. 4 will be refurbished with rock riprap to restore the structure to the original design elevation. The missing warning sign will also be replaced.

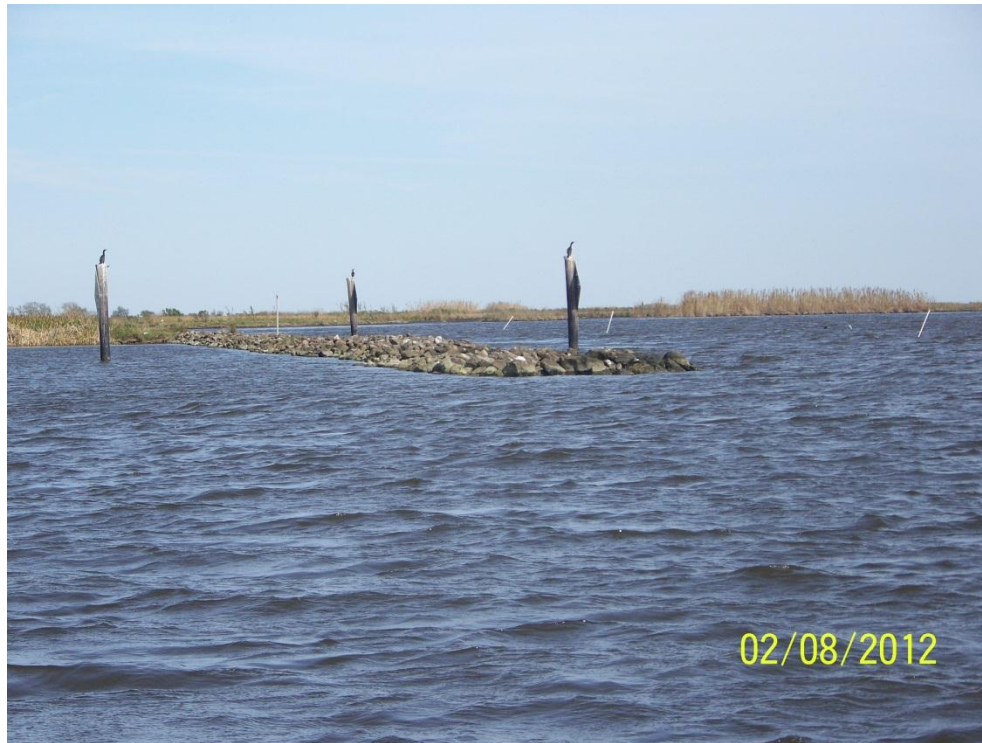
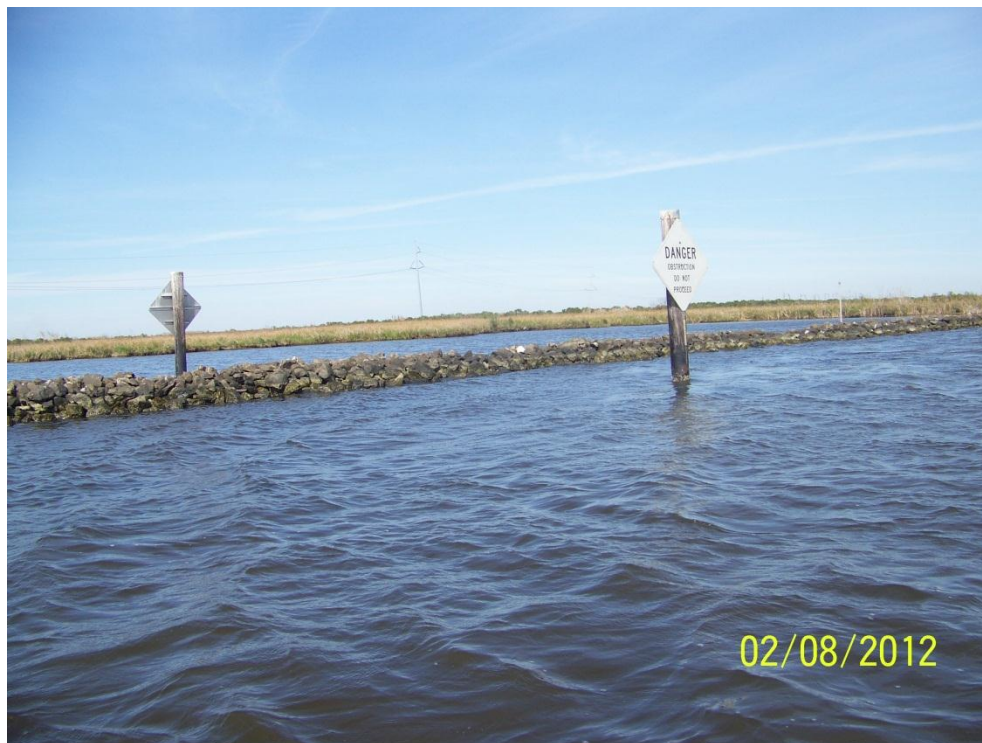
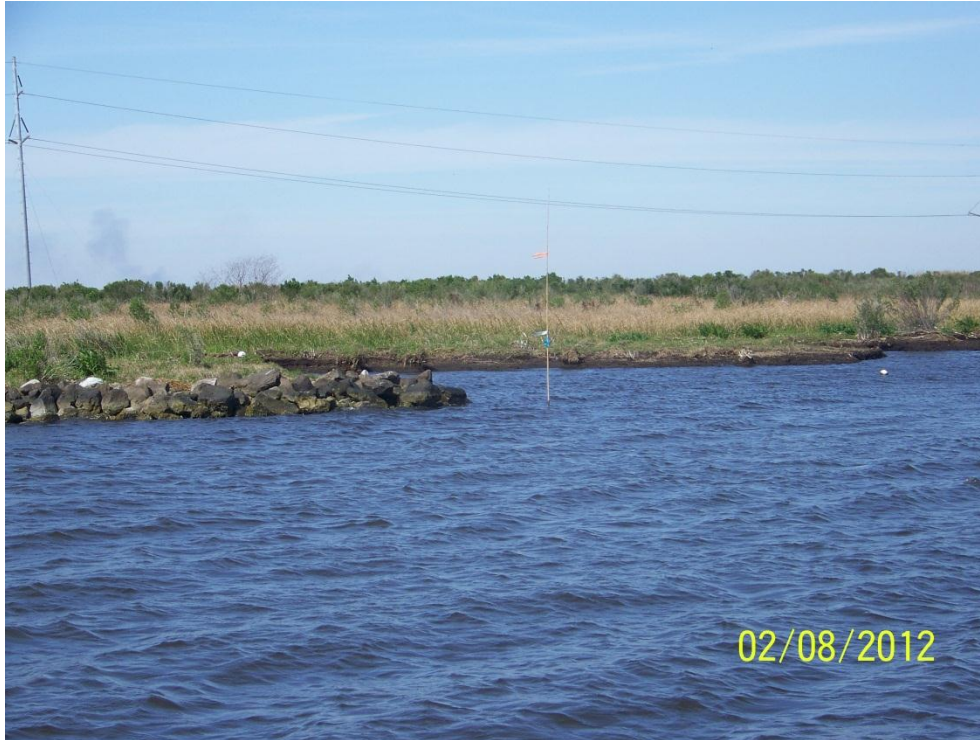
Structures 4A & 4B appear to be in poor condition with average crest elevations approximately +1.5' NAVD. According to the as-built drawings, the plug was originally constructed to a height of +3.0 NAVD. Based on these observations and supporting data from the 2008 survey profile, it is estimated the rock plug has settled approximately 1.5' to 2.0' along the entire length of the structure. In addition to the settlement, and partially caused by Hurricanes Gustav and Ike, the marsh around the plug has suffered extensive erosion. On the south side of the plug there is very large opening in the shore line approximately 1,000 feet wide. Due to the high cost of mobilizing a dredge to rebuild the marsh, it is more cost efficient to construct a rock dike across the opening. The new rock dike and the recapping of structures 4A & 4B were included in the 2012 Maintenance Project. (See Appendix B, Photos 43 through 45)

The rock plug structures appeared to be in poor condition with substantial settlement ranging between 1.5' to 2.0'. The critical area of concern associated with this structure is large breach that has developed on the south side of the structure resulting from the 2008 storms. The marsh on the south side of the structure is completely gone with very little shoreline remaining to facilitate a breach closure by extending the structure. Considering the size of the breach and the vulnerability of the interior marsh in this area, we have included a rock dike closure in the 2012 Maintenance Project that consist of refurbishing Structures 4A & 4B to the original design elevation and extending the rock plug across the breach opening and along the existing shoreline approximately 1,000 linear feet, tying into Structure 4.

Photo #43: View of the southern end of Structure 4A/B, looking northeast

Photo #44: View of the warning signs and supporting timbers of Structure 4A/B, looking north

Photo #45: View of the northern end of Structure 4A/B, looking west
