2012 Annual Inspection Report

**GIWW/ CLOVELLY HYDROLOGIC
RESTORATION**

State Project Number BA-02
Priority Project List 1

May 14, 2012
Lafourche Parish

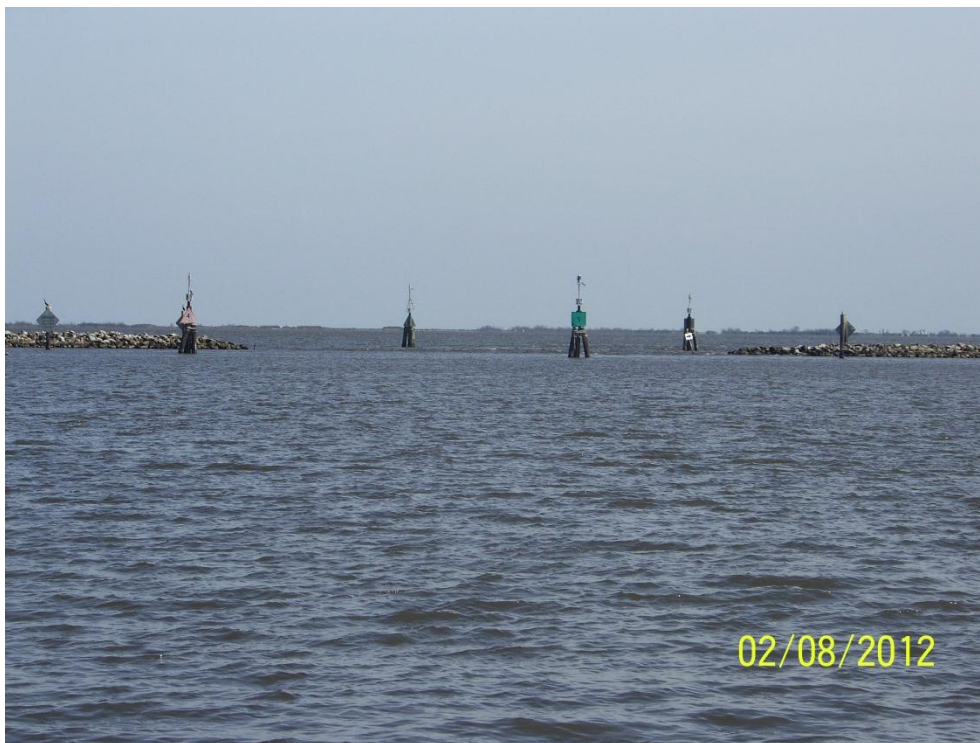
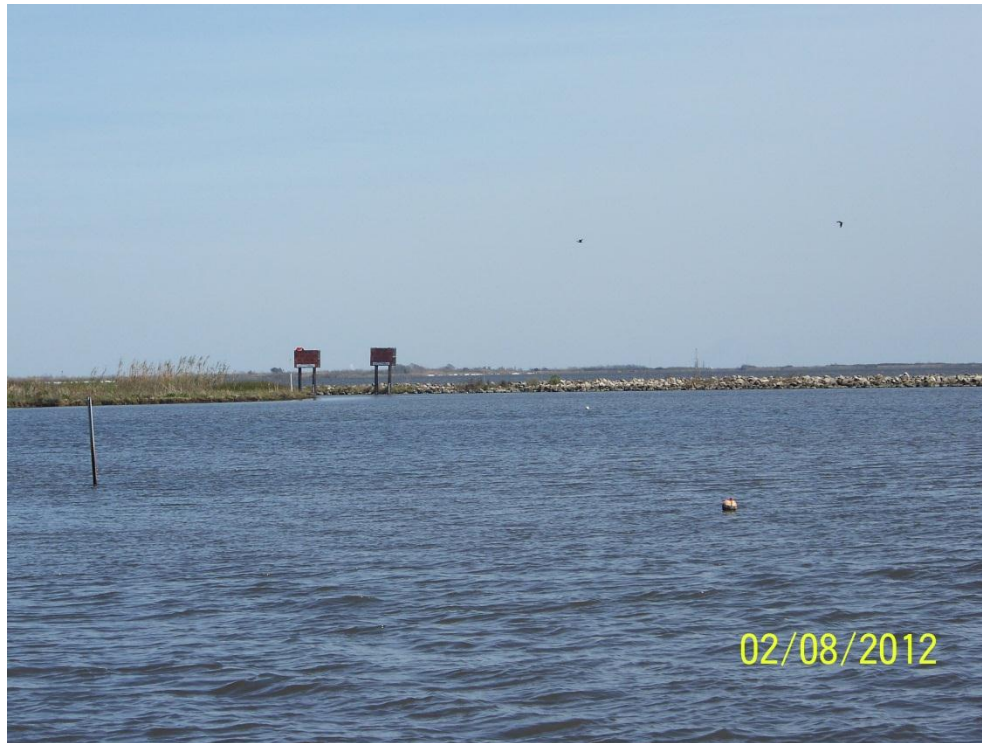
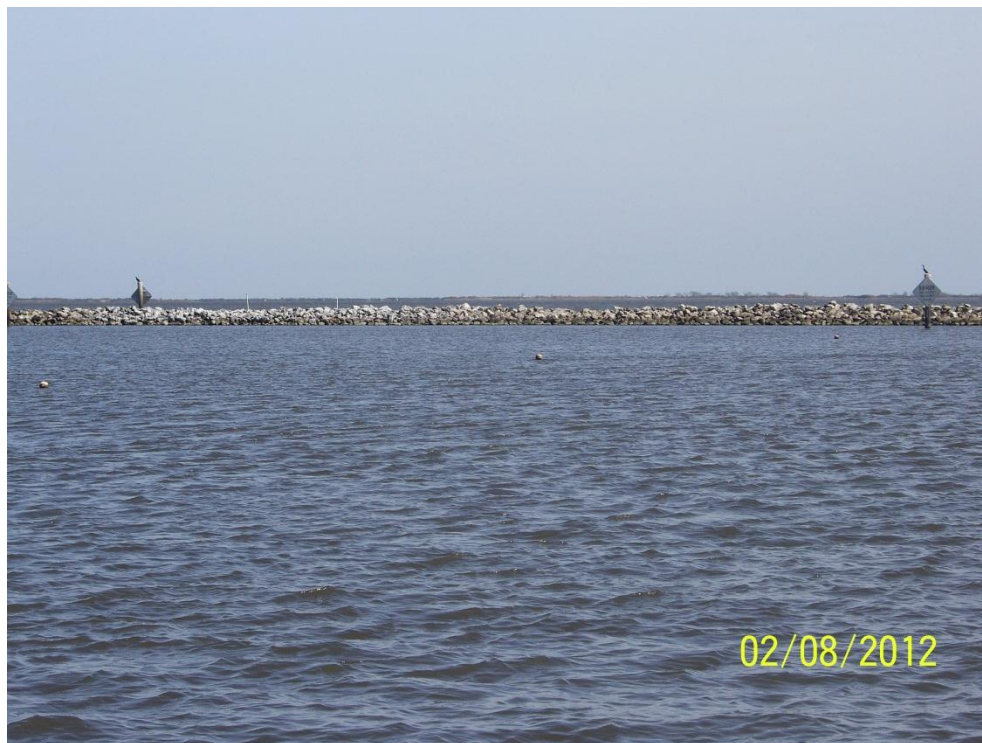
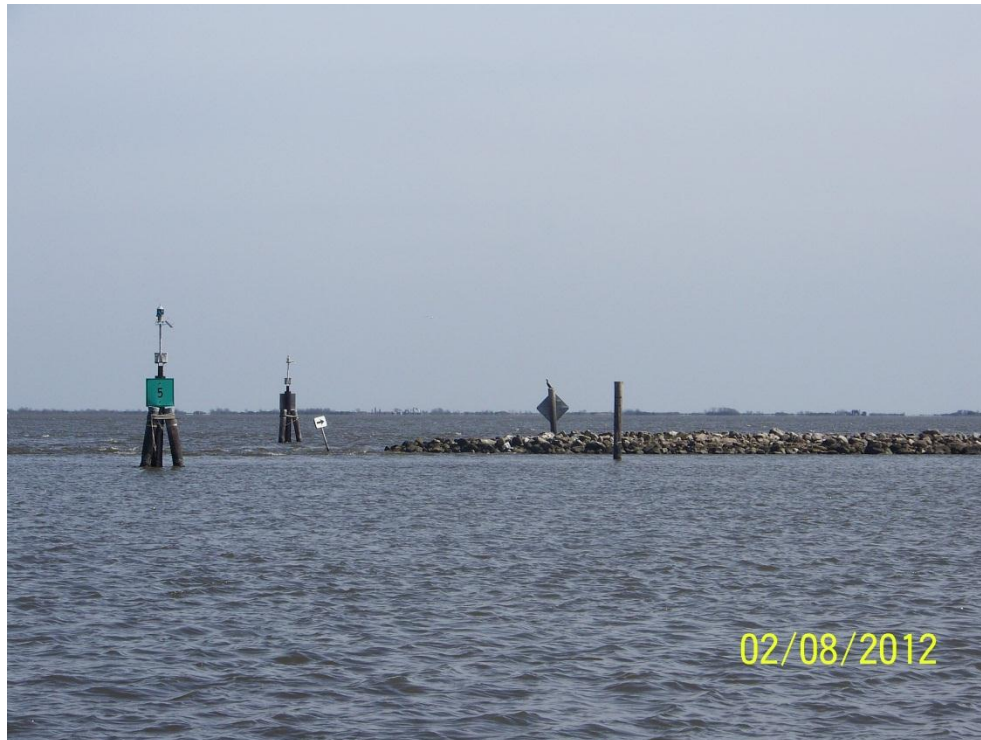
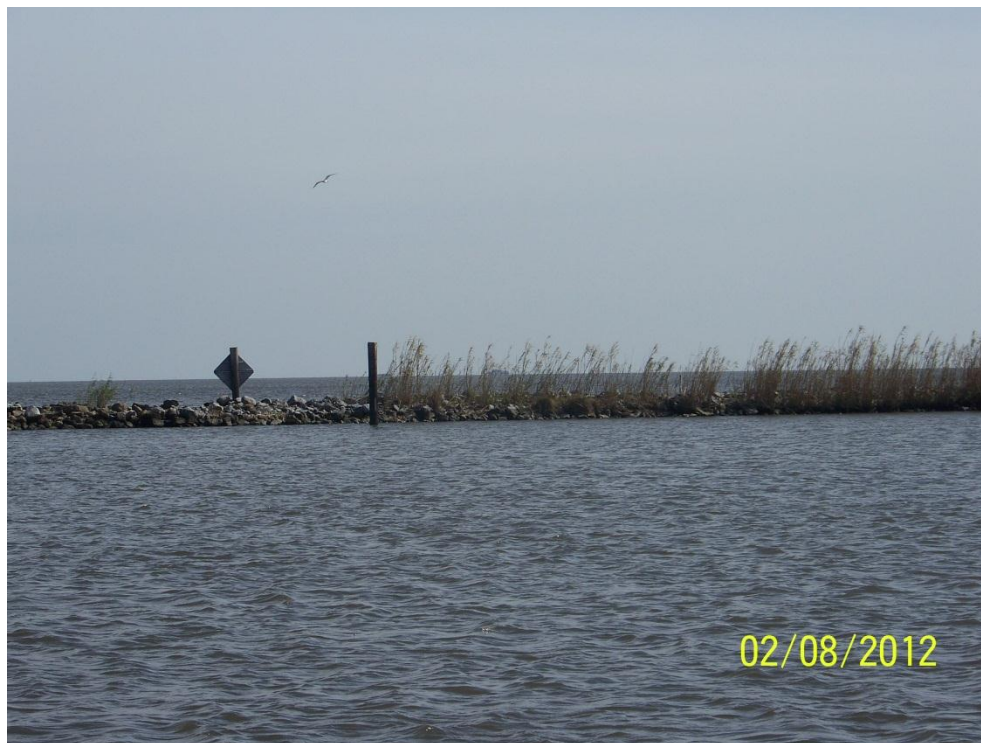
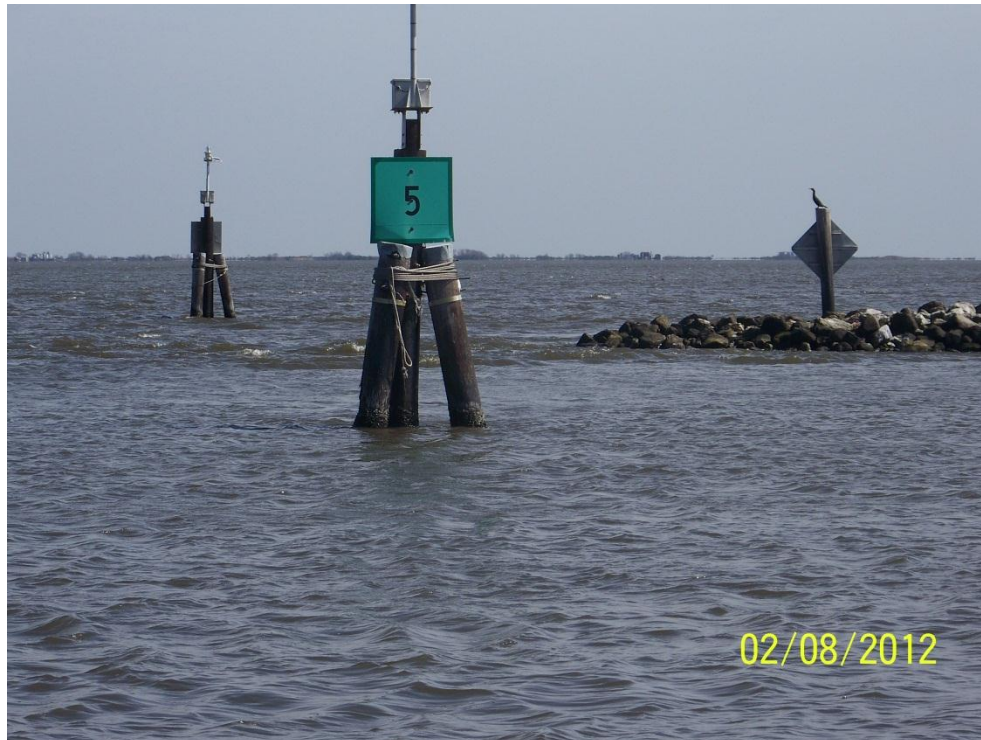
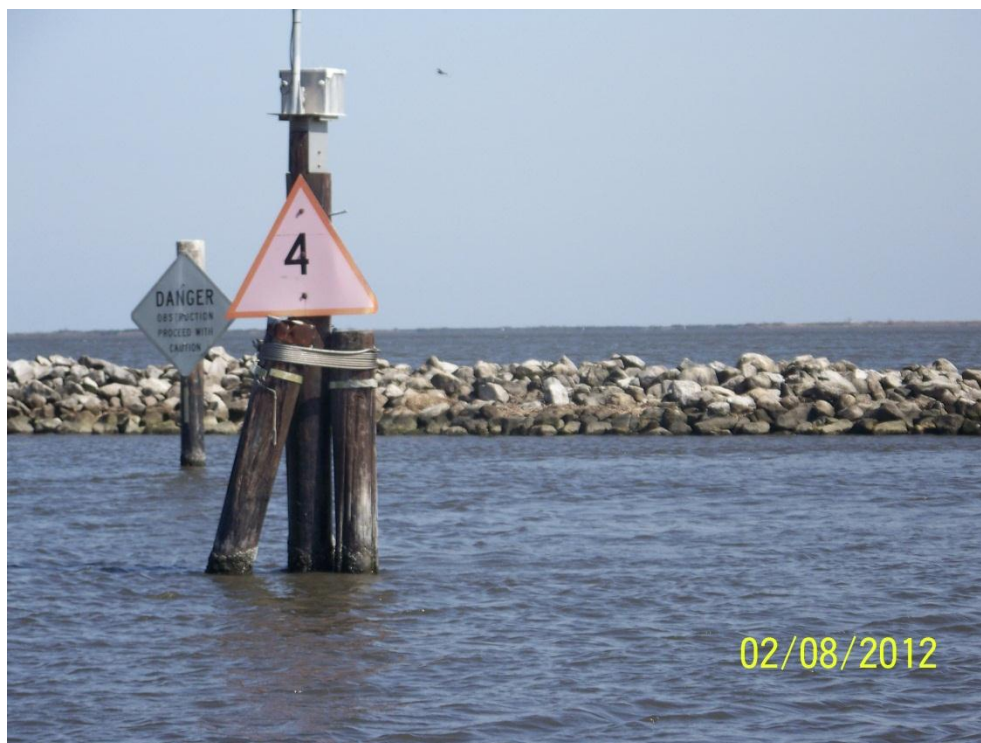
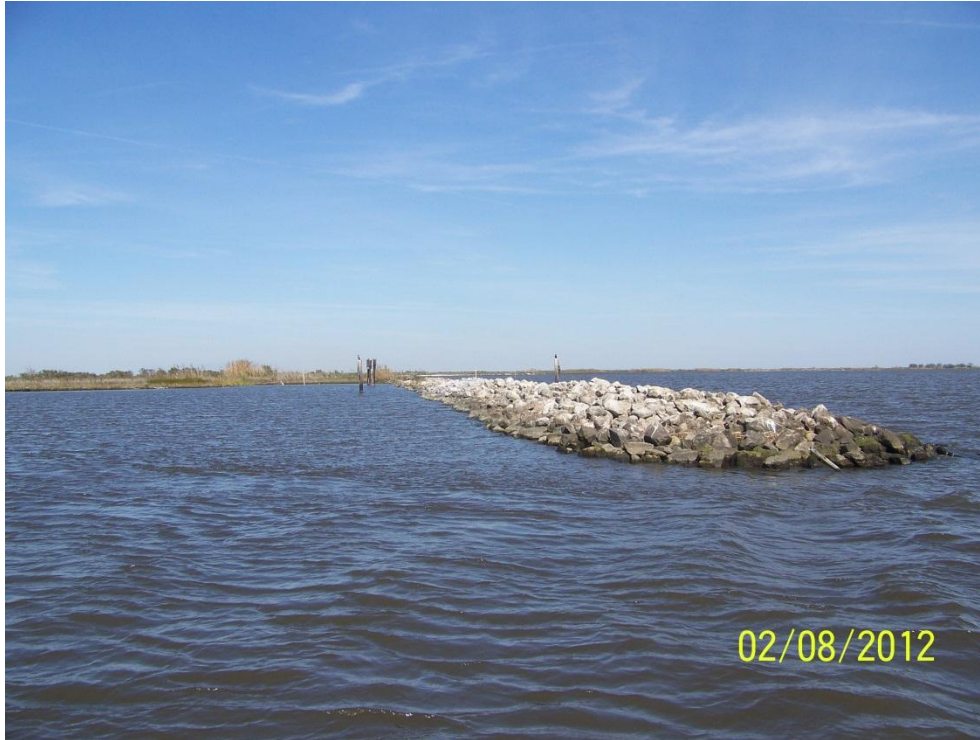
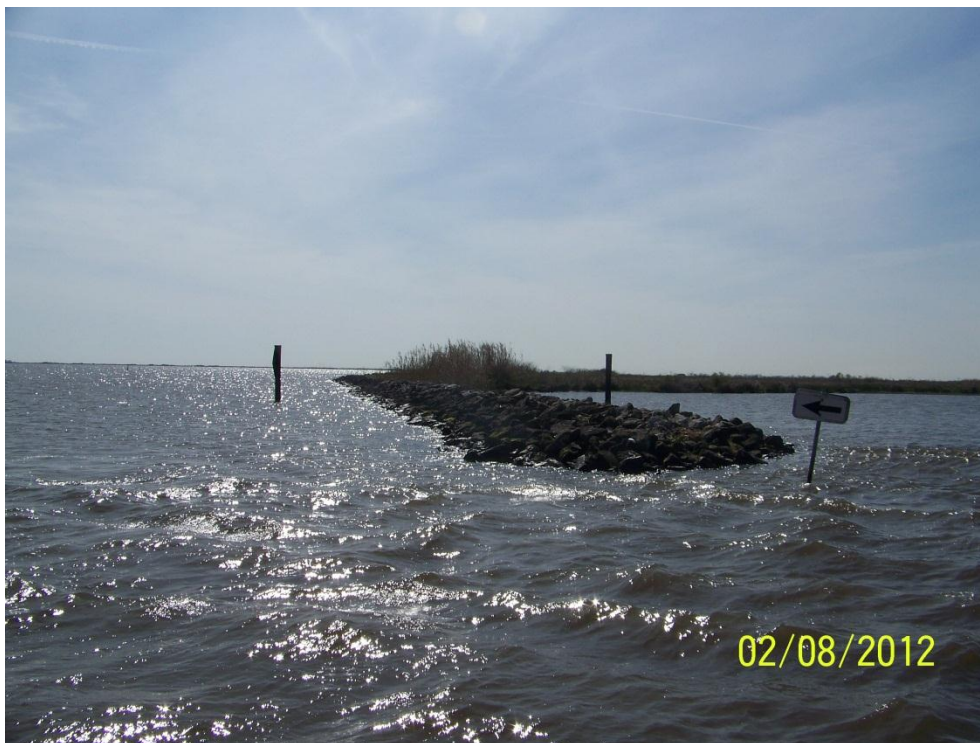
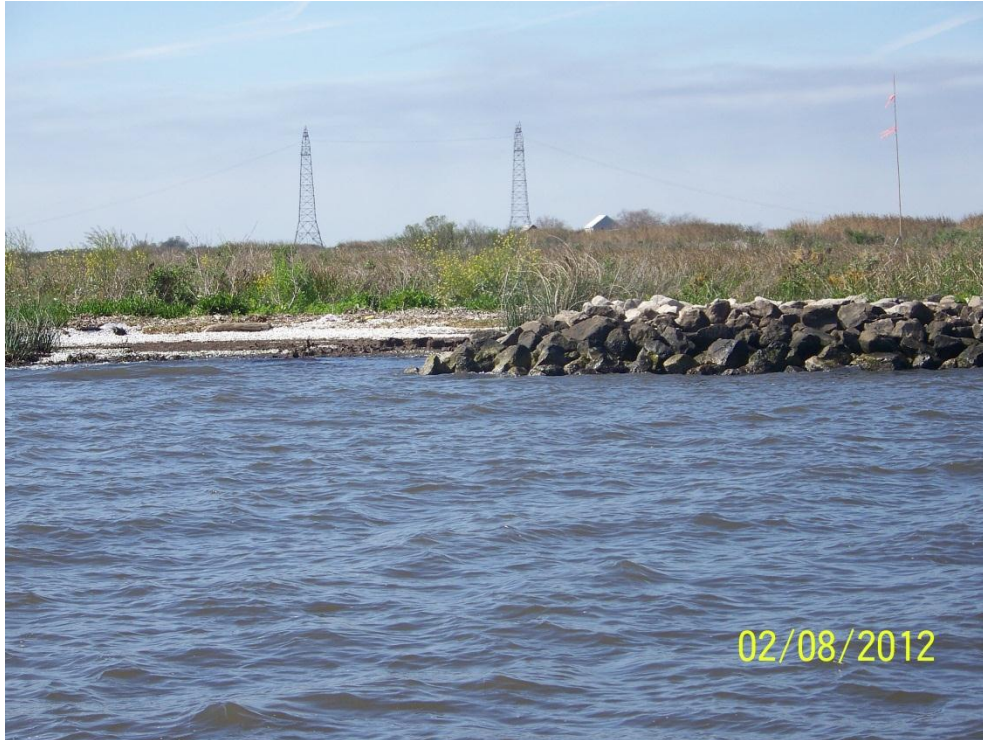
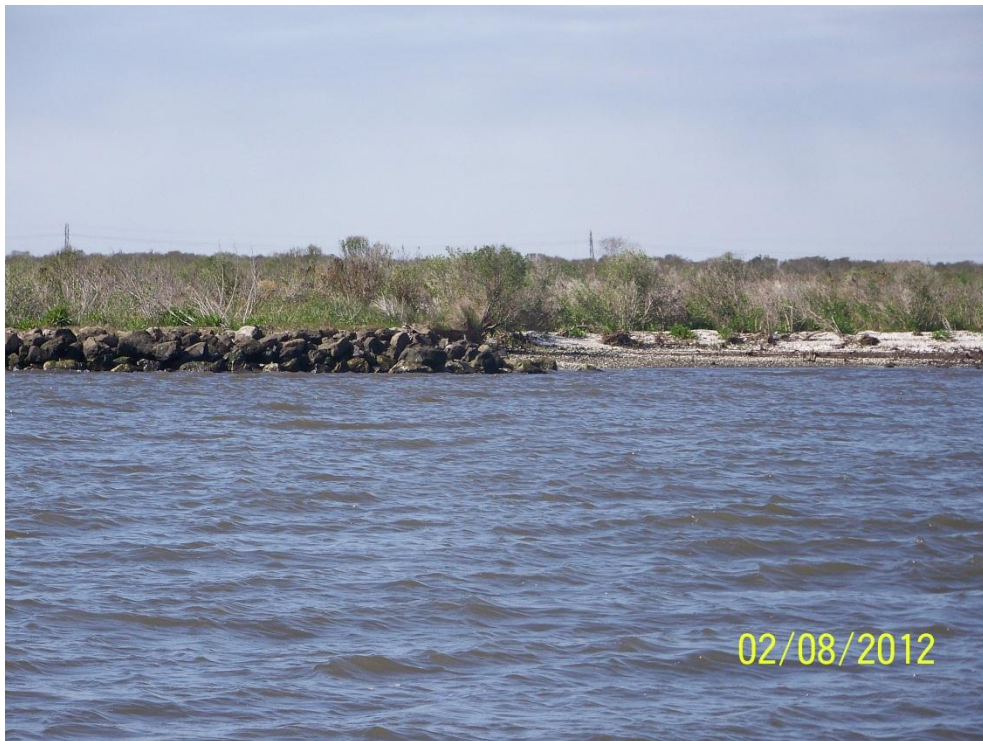
According to the as-built drawings, the crest of the weir was constructed to a height of +4.0' NAVD and the scour pad at the bottom of the barge bay was constructed to a height of -6.5' NAVD. It is estimated the rock material settlement at the crest of the weir is minimal, less than 1.0' on both sides of the barge bay. The most severe settlement and scour is near the bottom of the barge bay where previous survey data indicated bottom depths ranged between -6.5' and -15.0'. Based on the severity of the washout of the scour pad beneath the barge bay, the scour pad will be reconstructed in the 2012 Maintenance Project. The method of repair is

outlined in the conclusion of this report. The timber sub-structures supporting the navigational aids are in poor condition; there are cracks and surface damage visible on the timber pile dolphins and one of the navigational arrow signs is down. The timber pile dolphin on the southeast side of the barge bay was replaced in 2006 and remains in good condition. (See Appendix B, Photos 46 through 56)

Structure No.14A was in fair to good condition with significant damage to the timber cluster piles supporting the navigational aids and severe settlement and scour of the rock pad below the barge bay opening. We believe that the strong currents moving through the barge bay opening may be responsible for the excessive scour of the rock pad beneath the barge bay. To reduce the scour, we have included provisions in the 2012 Maintenance Project for the existing scour pad to be replaced with a larger stone. We will also be replacing three (3) of the four (4) timber pile clusters supports for the navigational aid lights as well.

Photo #46: View of Structure 14A rock weir from Clovelly Canal, looking east

Photo #51: View of navigational aids and warning signs of Structure 14A, looking east
