2012 Annual Inspection Report

**POINT AU FER ISLAND
HYDROLOGIC RESTORATION**

State Project Number TE-22
Priority Project List 2

June 15, 2012
Terrebonne Parish

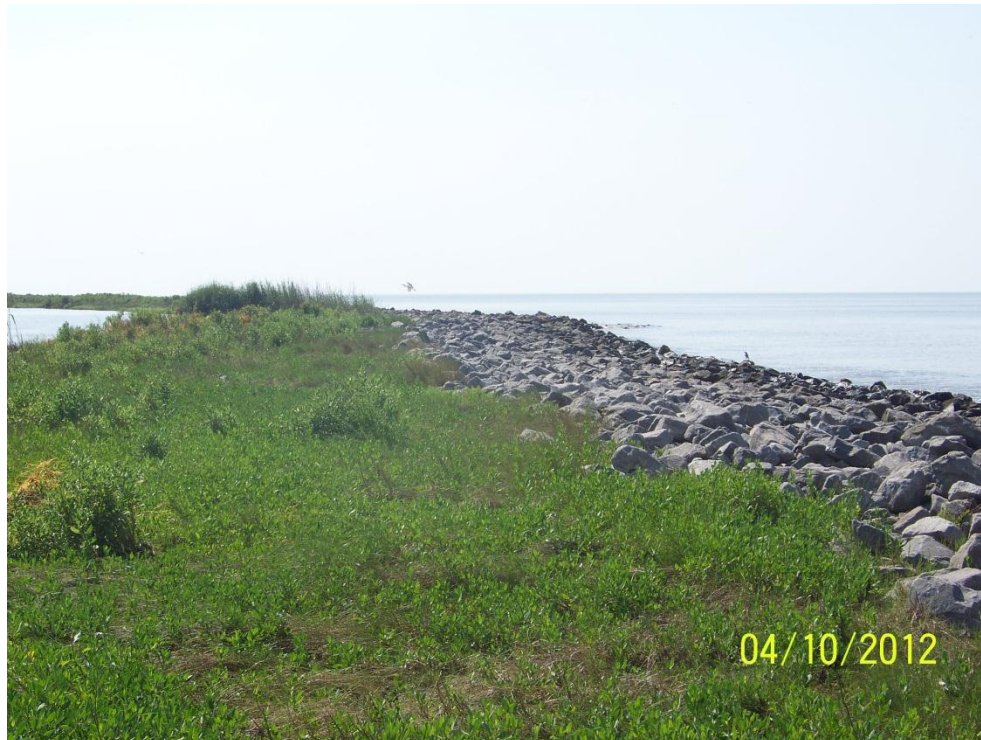
As previously reported, several areas of the rock dike appear to be low as well as narrow along the south bank of Mobil Canal. In 2010 it was recommended to survey the area for comparison to the as-built construction drawings to determine the best course of action to prevent breaching of the Gulf into the Canal. The survey was completed in August 2011 and it was determined the dike is in need of refurbishment. As of July 2012, the refurbishment project is in design and is expected to be bid in the Fall of 2012 and constructed in the Spring of 2013.

Photo No. 1: View from behind the rock dike separating Mobil Canal from the Gulf of Mexico, looking east

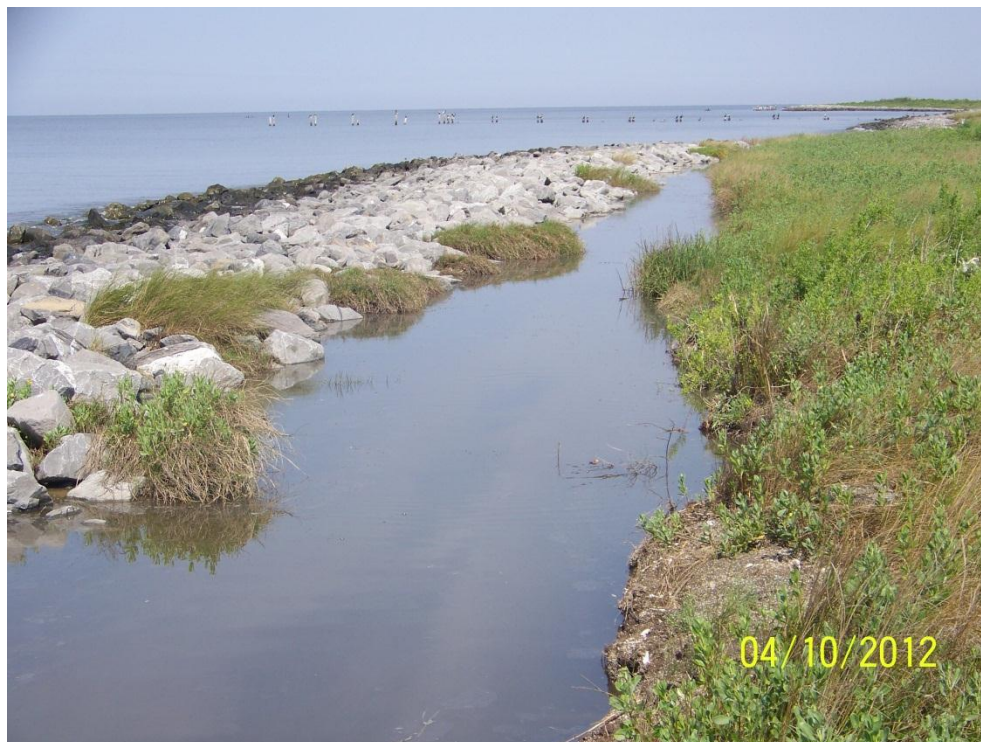
The rock dike along Area 5 of Phase III appeared to be in good condition with no noticeable settlement of the structure. Beyond the west end of the dike, erosion of the beach face has increased and the shoreline has moved inland. Consequently tidal exchange is now occurring behind the mats, and erosion of the shoreline behind the mats was observed. In 2010 it was recommended to survey the area for comparison to the as-built construction drawings to determine the best course of action to prevent breaching of the Gulf into the Canal. The

Photo No. 2: View from behind the western end of the rock dike separating Mobil Canal from the Gulf of Mexico, looking west

survey was completed in August 2011 and it was determined the dike is in need of refurbishment. As of July 2012, the refurbishment project is in design and is expected to be bid in the Fall of 2012 and constructed in the Spring of 2013.

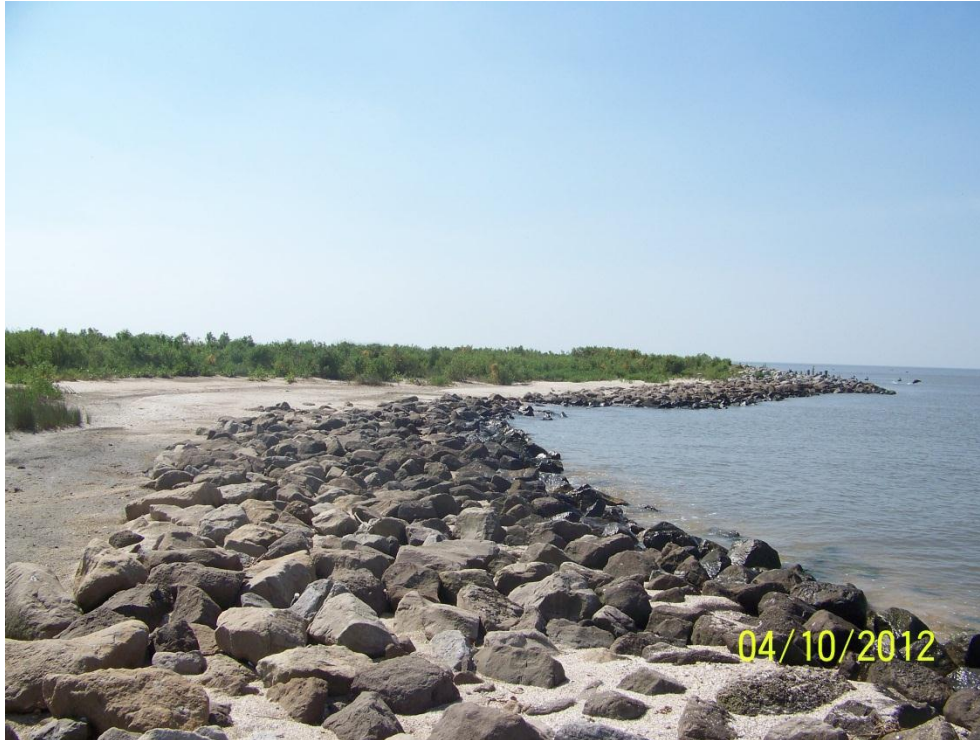
Photo No. 3: View from behind the western end of the rock dike separating Mobil Canal from the Gulf of Mexico, looking east

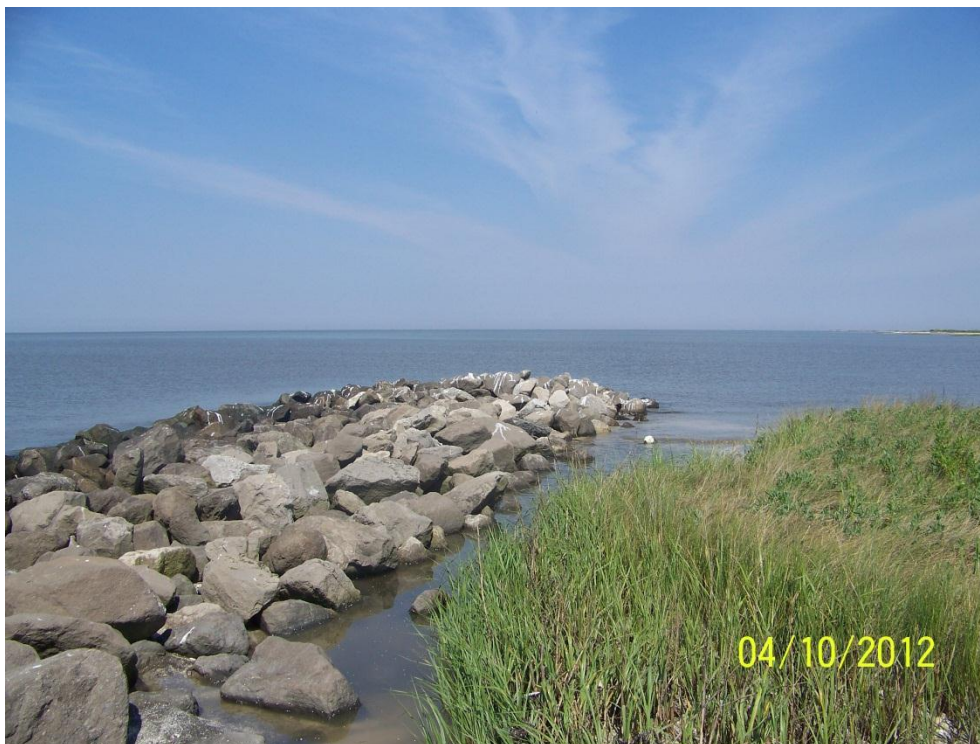
Photo No. 4: View of the westernmost end of the rock dike separating Mobil Canal from the Gulf of Mexico, looking west

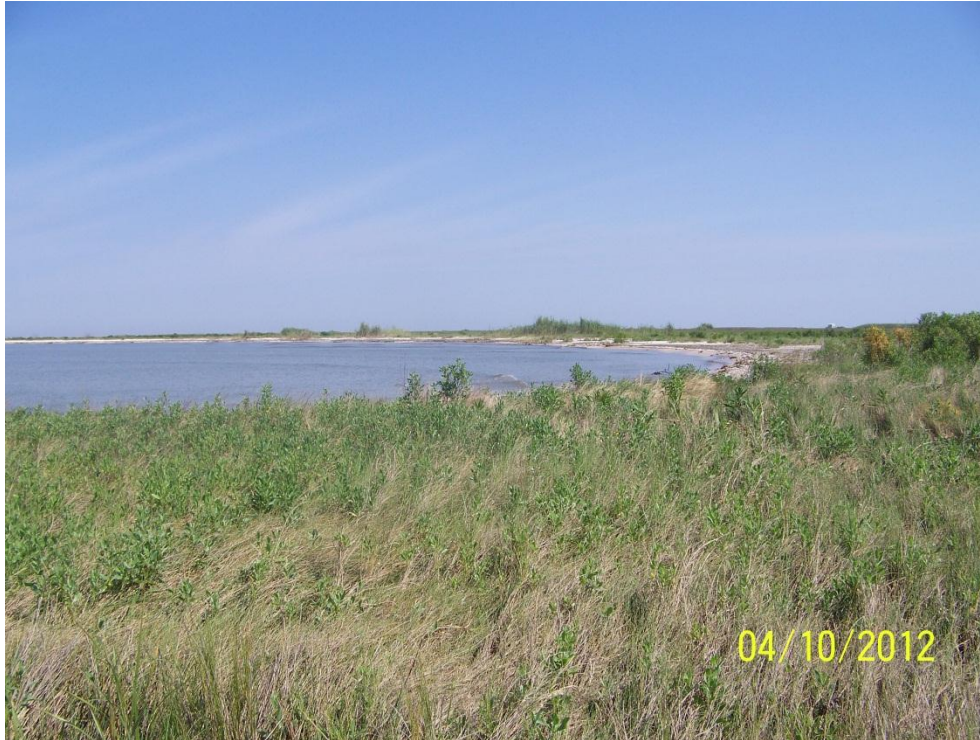
Photo No. 5: View of erosional shadowing behind the westernmost end of the rock dike separating Mobil Canal from the Gulf of Mexico, looking west

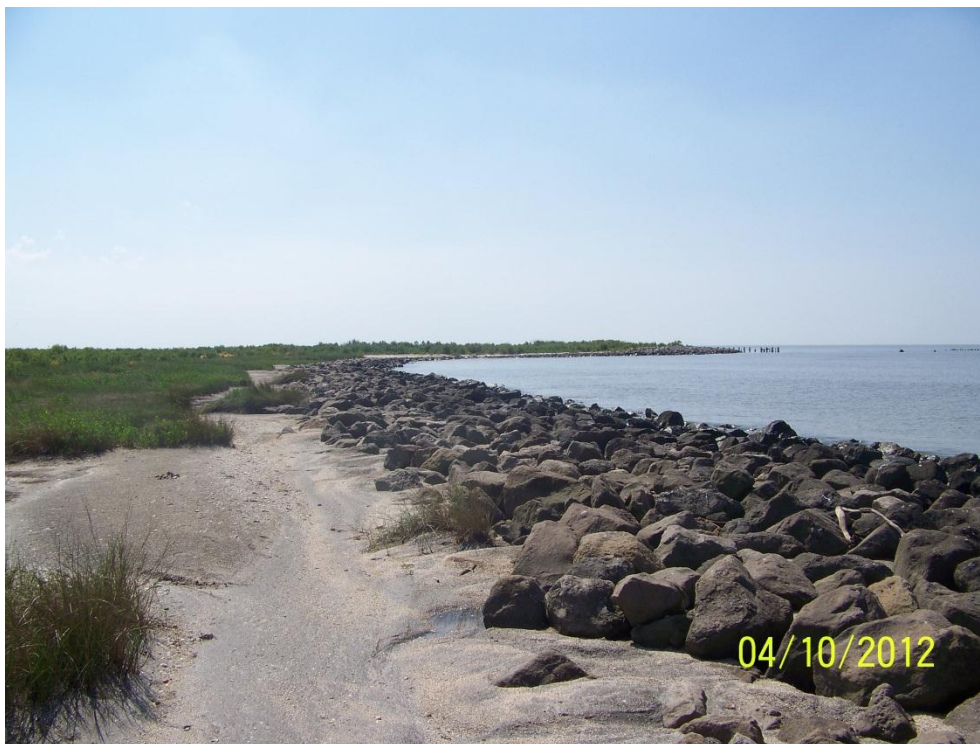
Photo No. 6: View from behind the rock dike separating Mobil Canal from the Gulf of Mexico, looking east

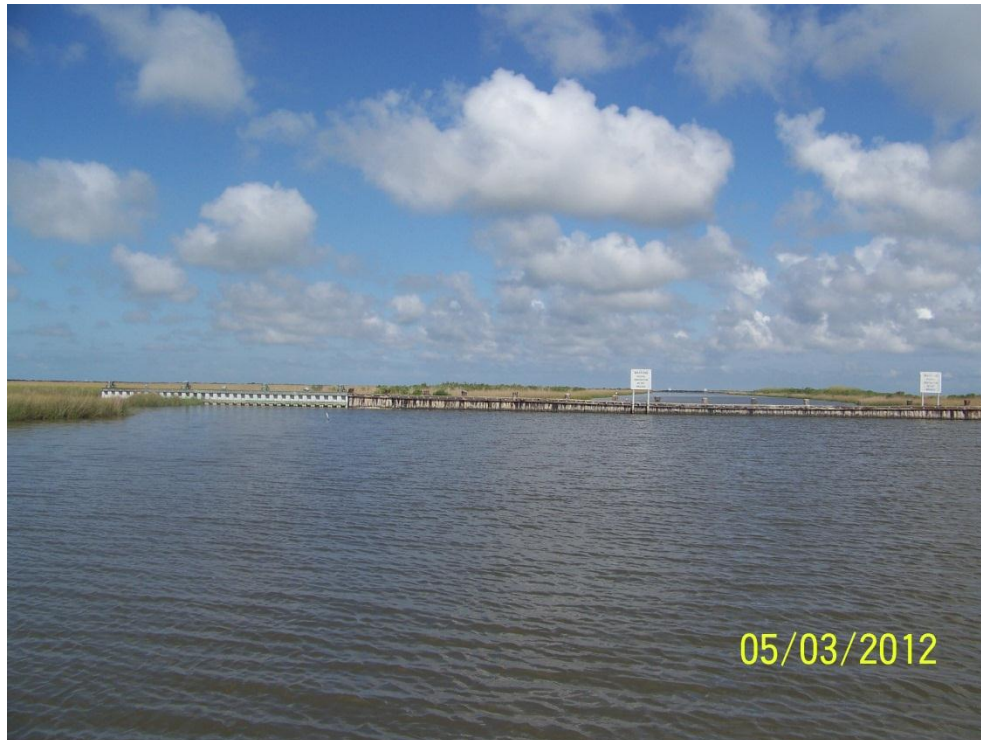
The timber bulkhead and vinyl sheet pile extension are in good condition. There is an existing breach around the southern end of the structure that occurs adjacent to the sheetpile. In addition the Submar scour mats placed on the southern end of the structure are no longer effective. It is assumed that these sections were undermined from the water rushing through the breach. The embankment tie-in on the north side of the structure has no signs of erosion or breaching. The warning signs and supports were in good overall condition. There are no recommendations for corrective action at this time, but the structure and breach should be monitored during future inspections for further deterioration.

Photo No. 7: Overall view of Plug No. 8 with vinyl sheet pile extension on the southern end of the structure, looking west

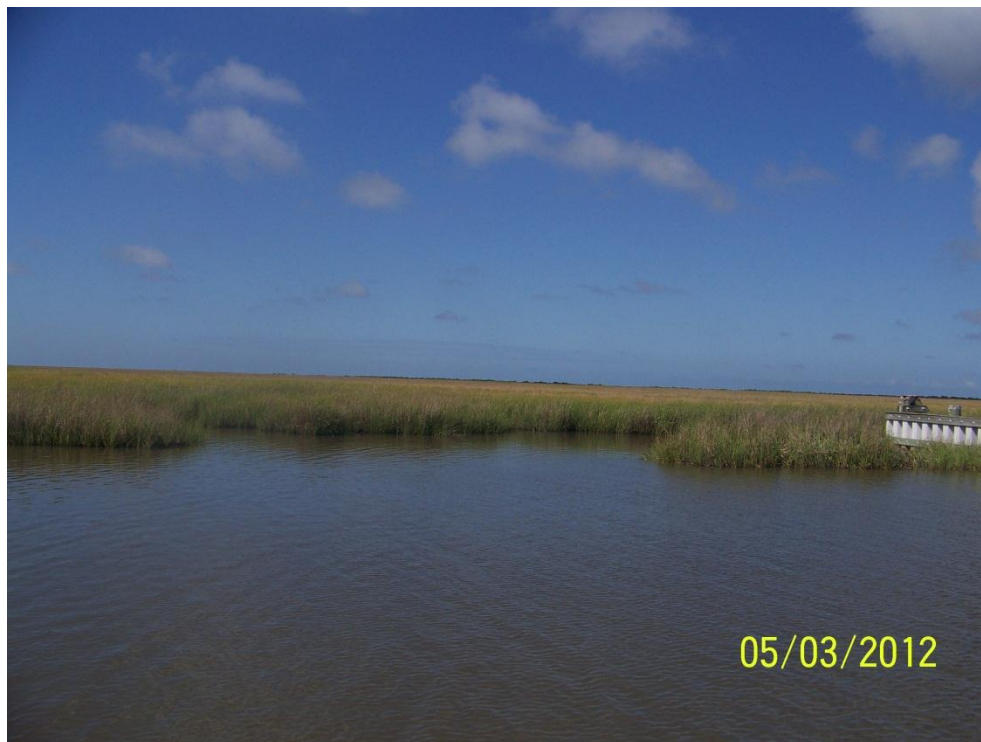
Photo No. 8: View of the breach around the southern end of Plug No. 8 from the eastern side of the structure, looking south

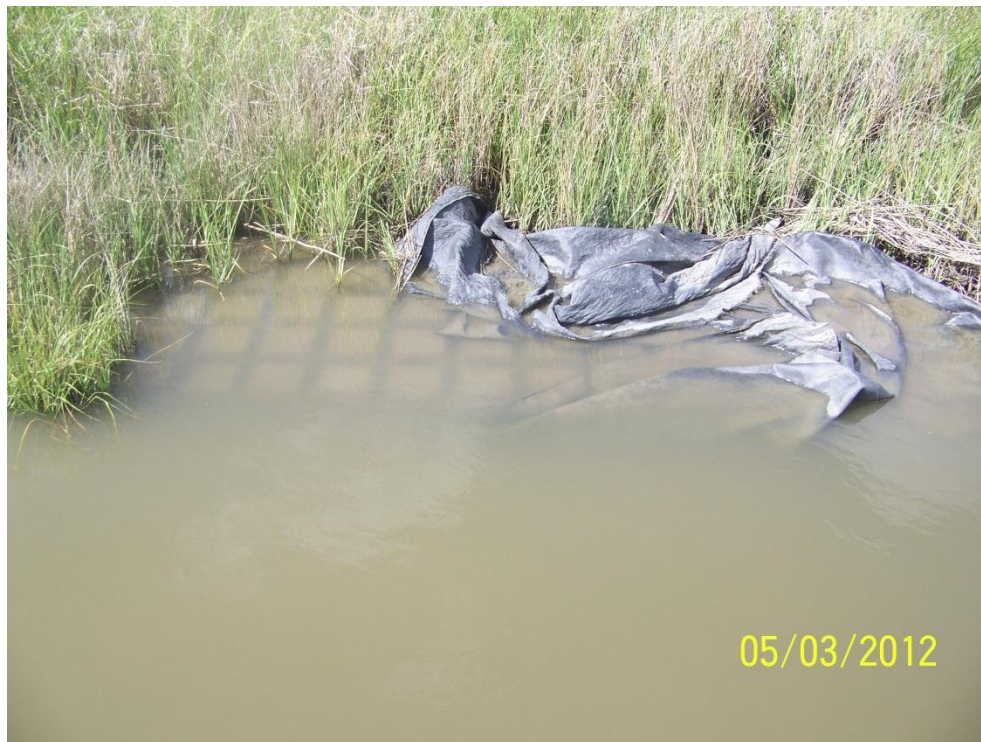
Photo No. 9: View of the Submar scour mats placed on the southern end of Plug No. 8 from on top of the structure, looking south

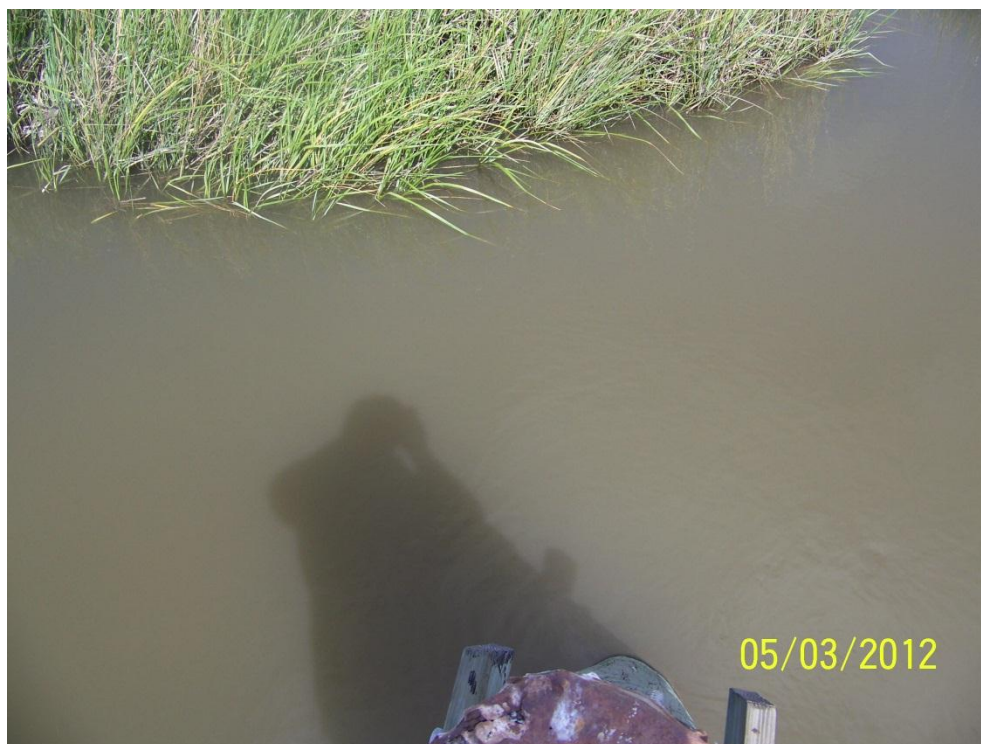
Photo No. 10: View of the breach located around the southern end of Plug No. 8 from on top of the structure, looking south

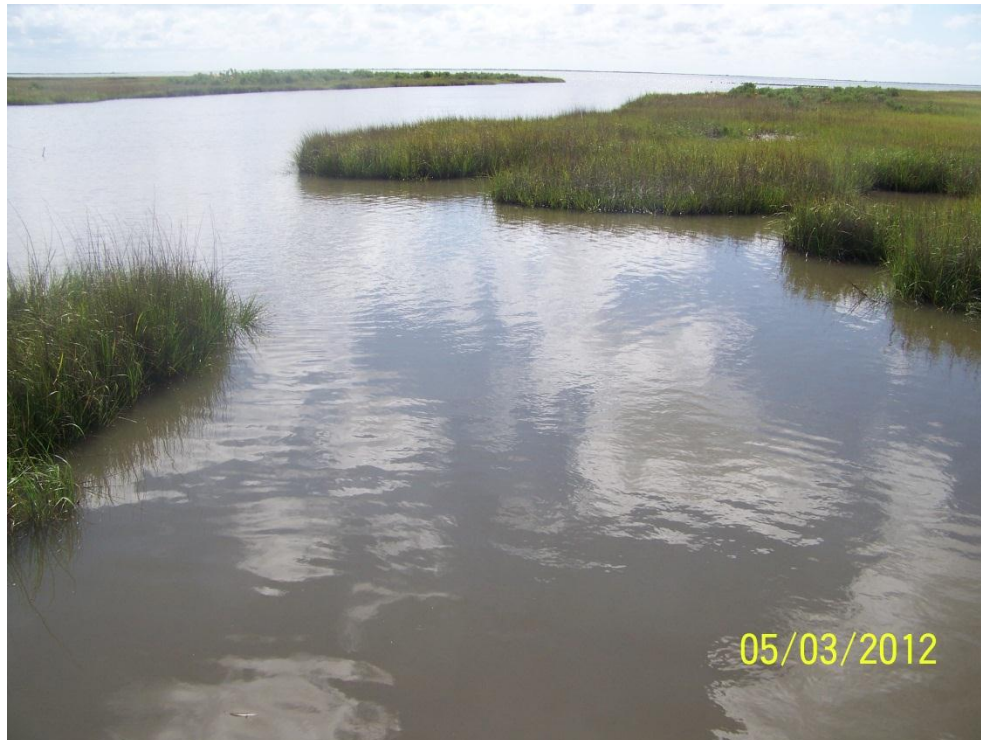
Photo No. 11: View of the breach around the southern end of Plug No. 8 from on top of the structure, looking east

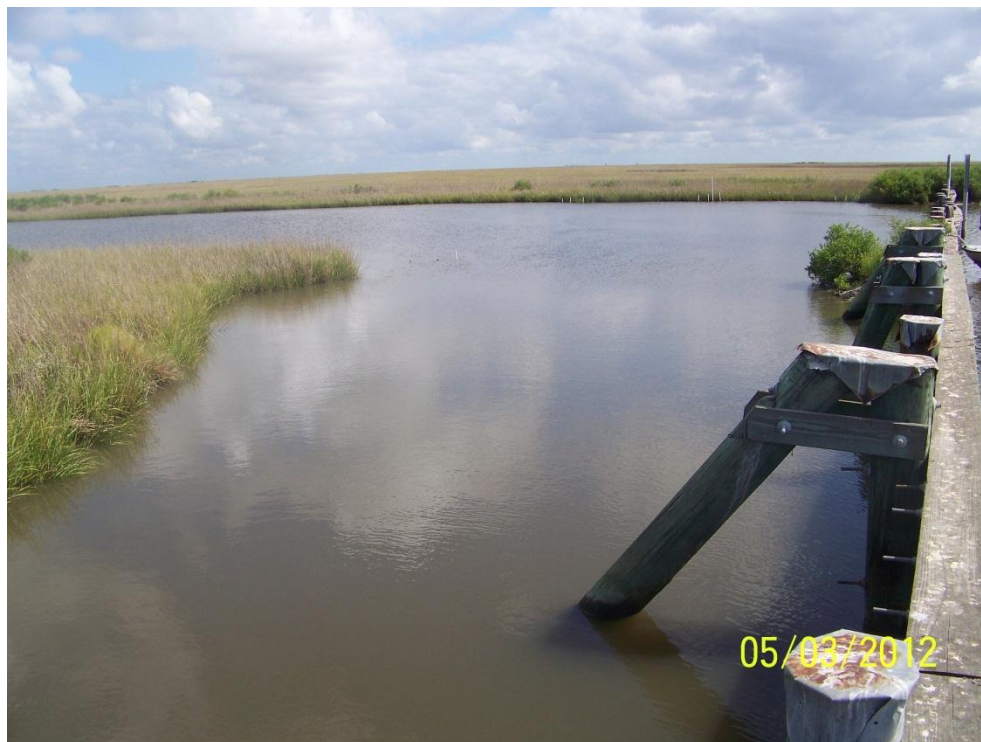
Photo No. 12: View of the breach around the southern end of Plug No. 8 from the western side of the structure, looking north

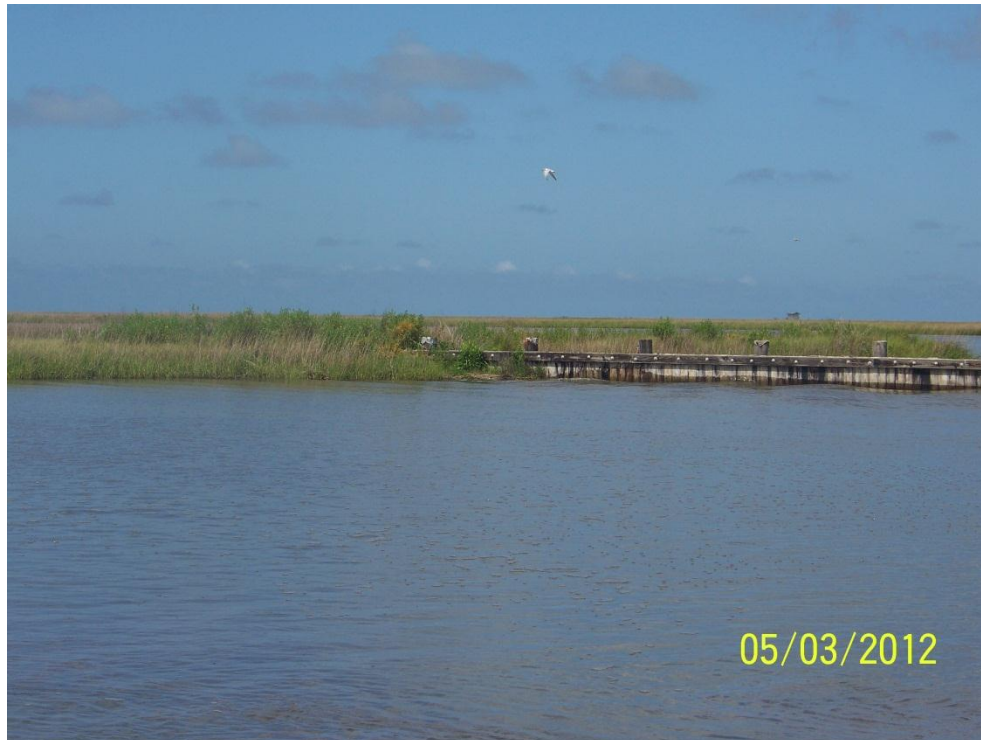
The timber bulkhead Plug No. 2 located just east of Plug No. 1 in Hester Canal appeared to be in good overall condition. All structural components are intact with no visible signs of damage. The embankment tie-ins have no signs of erosion or breaching. The warning signs and supports are also in good condition. Although the timber bulkhead and its tie-ins have no defects, the structure is considered ineffective due to a large breach (approximately 50 feet) on

the south side of the structure which allows tidal flow around Plug No. 2. There are no recommendations for corrective action at this time due to construction access constraints.

Photo No. 13: View of the southern embankment tie-in of Plug No. 2 from Hester Canal, looking east

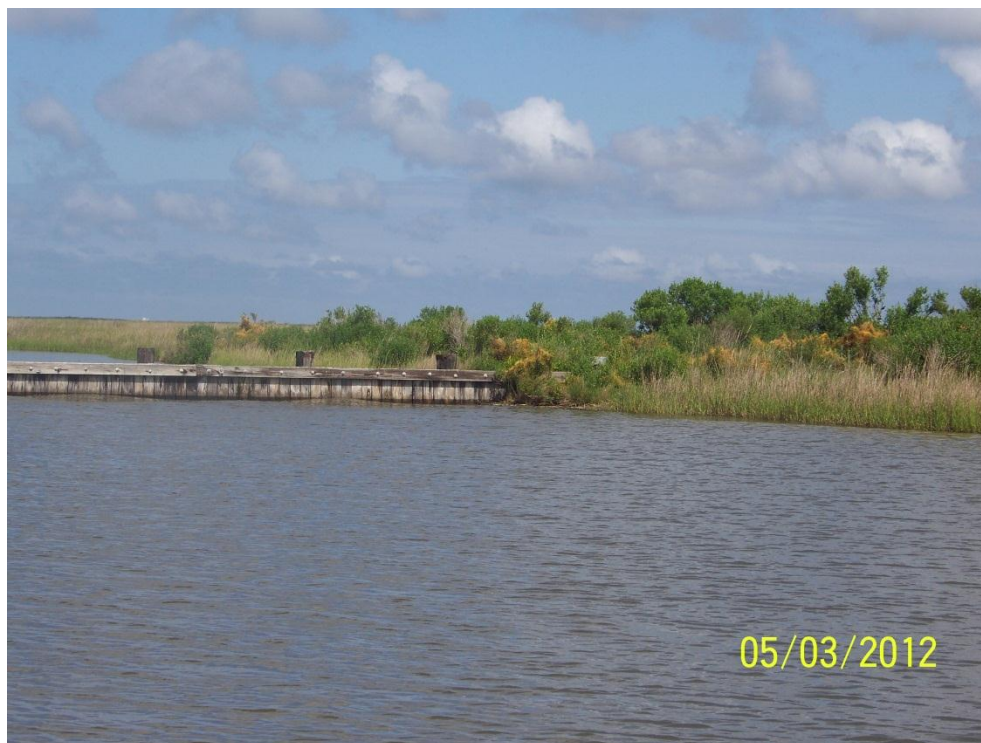
Photo No. 14: View of the northern embankment tie-in of Plug No. 2 from Hester Canal, looking east

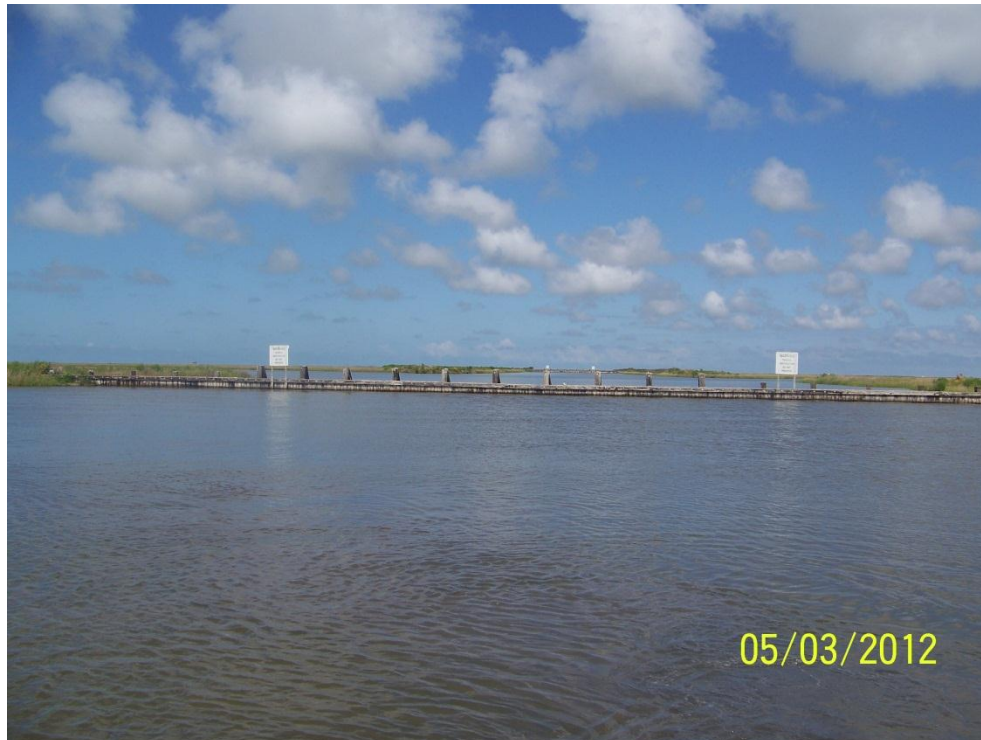
Photo No. 15: Overall view of Plug No. 2 with its warning signs and supports from Hester Canal, looking east

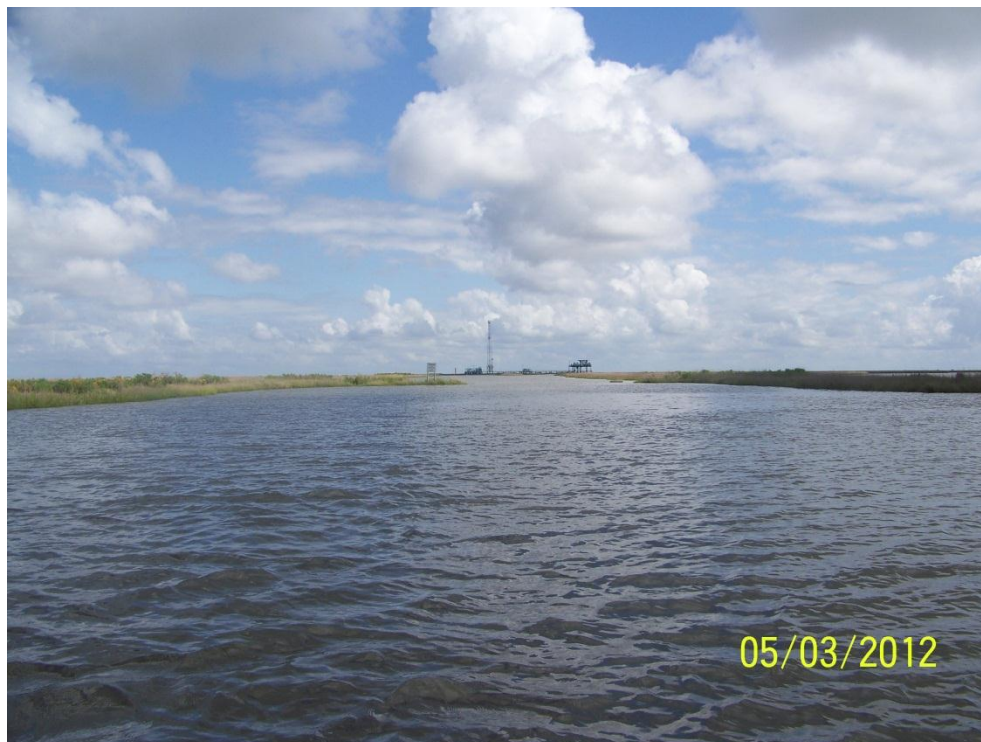
The shell Plug No. 3A located in Transco Canal just north of Hester Canal is in poor condition. As previously reported, the shell plug has eroded in the center of the structure leaving the plug crest below the water line at the time of the inspection. According to the as-built drawings and construction plans, the shell plug was constructed to elevation +4.0 NGVD. The embankment tie-ins are still intact and have no signs of erosion or breaching around the ends. The western warning sign and support is in good condition, but the eastern sign and support is missing. At this time repairing the shell plug is not recommended due to construction access constraints; however, this plug should continue to be monitored on future site visits.

Photo No. 16: Overall view of Plug No. 3A from Transco Canal, looking north

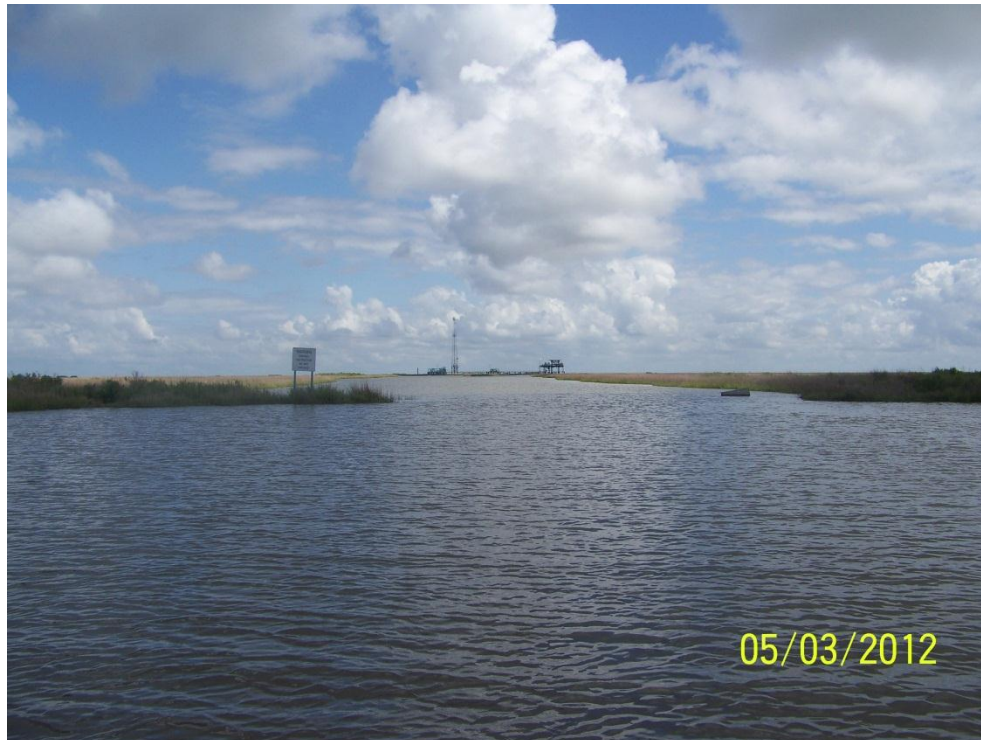
Photo No. 17: Close view of Plug No. 3A from Transco Canal, looking north. The warning sign and support on the eastern side of the structure is missing.

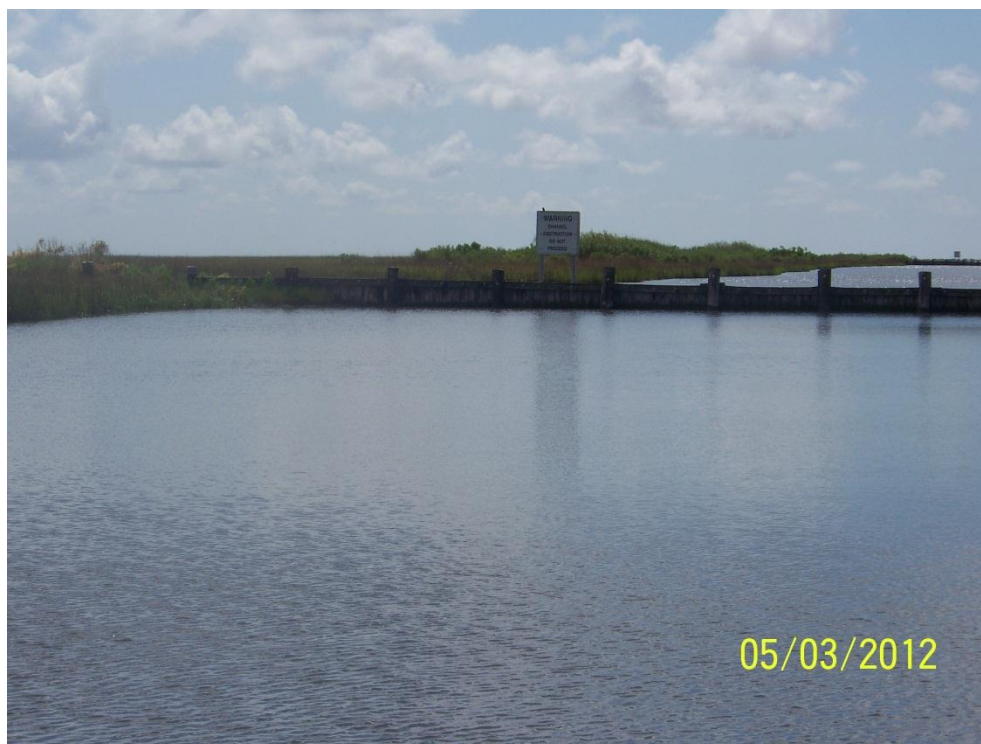
Photo No. 18: View of the embankment tie-in on the northern side of Plug No. 7 from Hester Canal, looking east

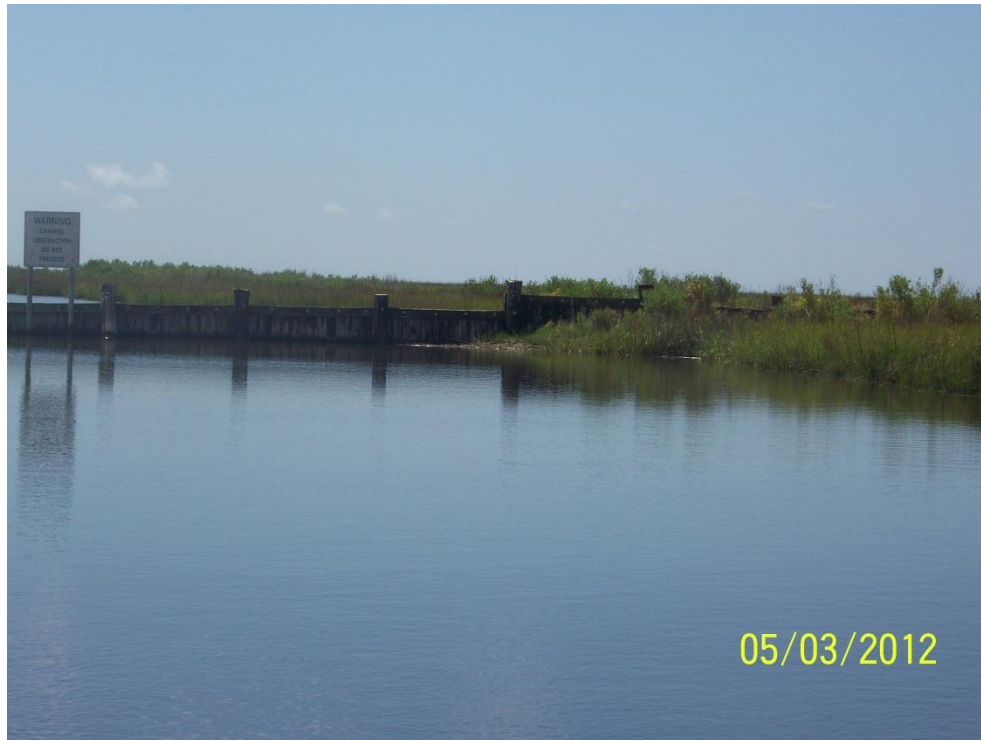
Photo No. 19: View of the embankment tie-in on the southern side of Plug No. 7 from Hester Canal, looking east

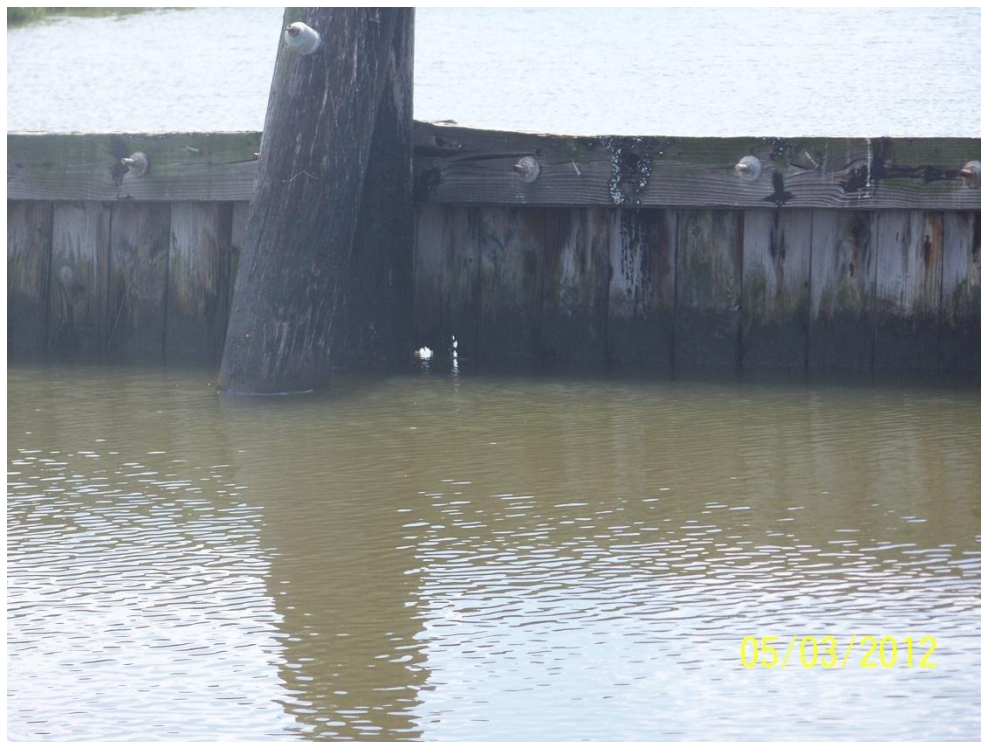
The timber bulkhead Plug No. 7 located on the east end of Hester Canal just west of Plug No. 8 appeared to be in good overall condition. All structural components are intact with no visible signs of damage. The embankment tie-ins have no signs of erosion or breaching. The warning signs and supports are also in good condition. There are no recommendations for corrective action at this time.

Photo No. 20: View of deteriorated timber boards along the waterline on Plug No. 7, looking east

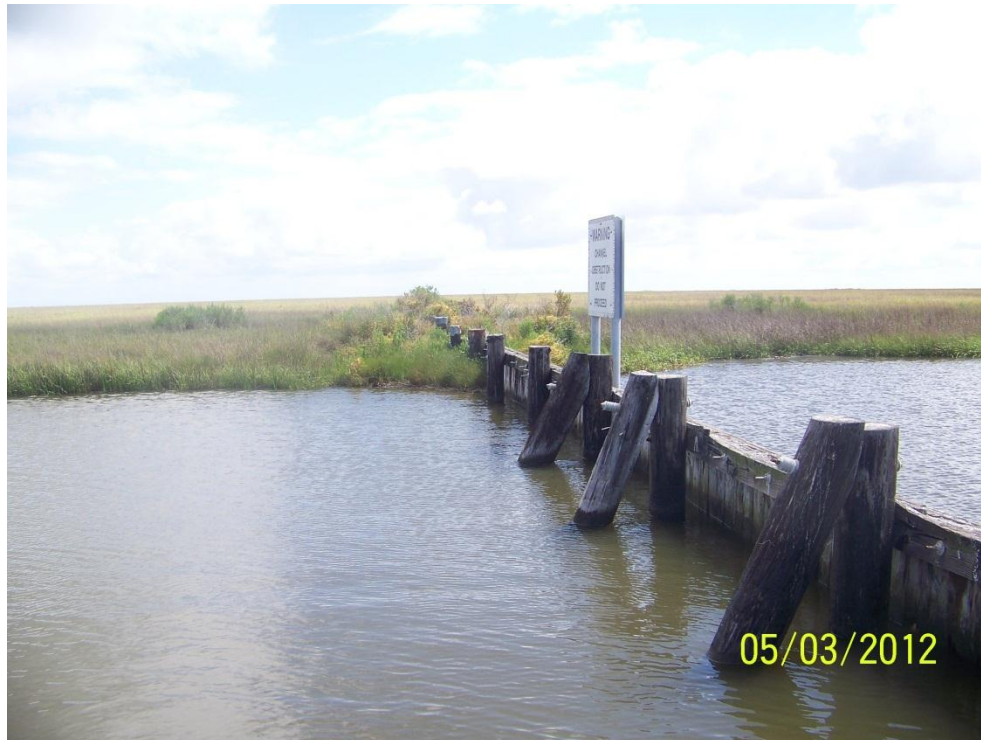
Photo No. 21: View of batter piles on the western side of Plug No. 7, looking north

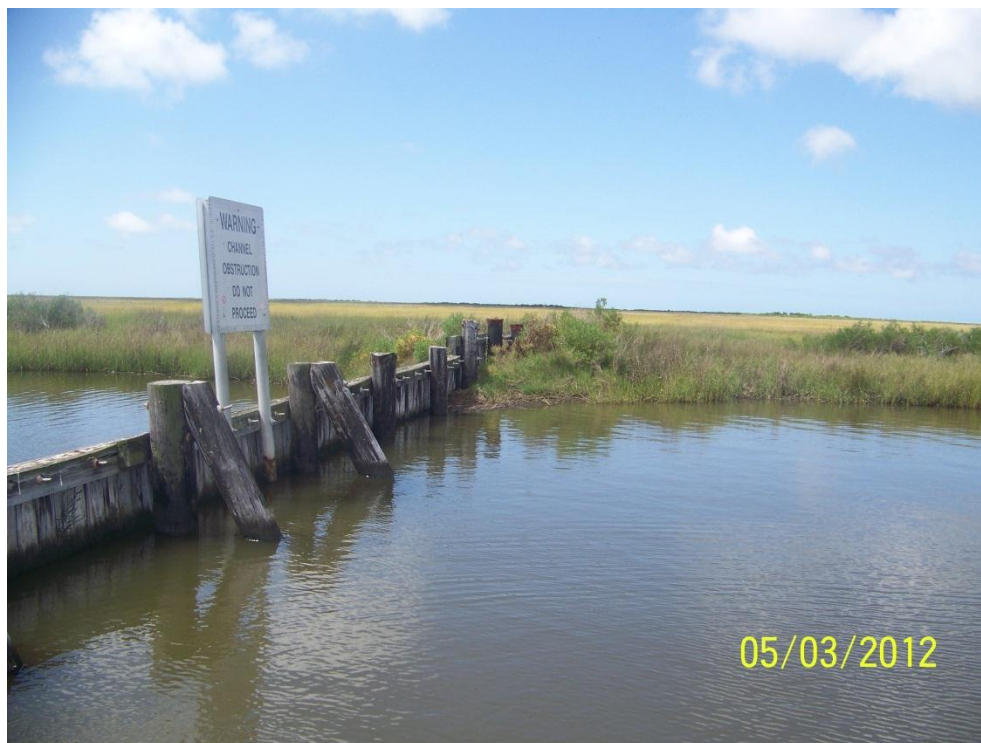
Photo No. 22: View of batter piles on the western side of Plug No. 7, looking south

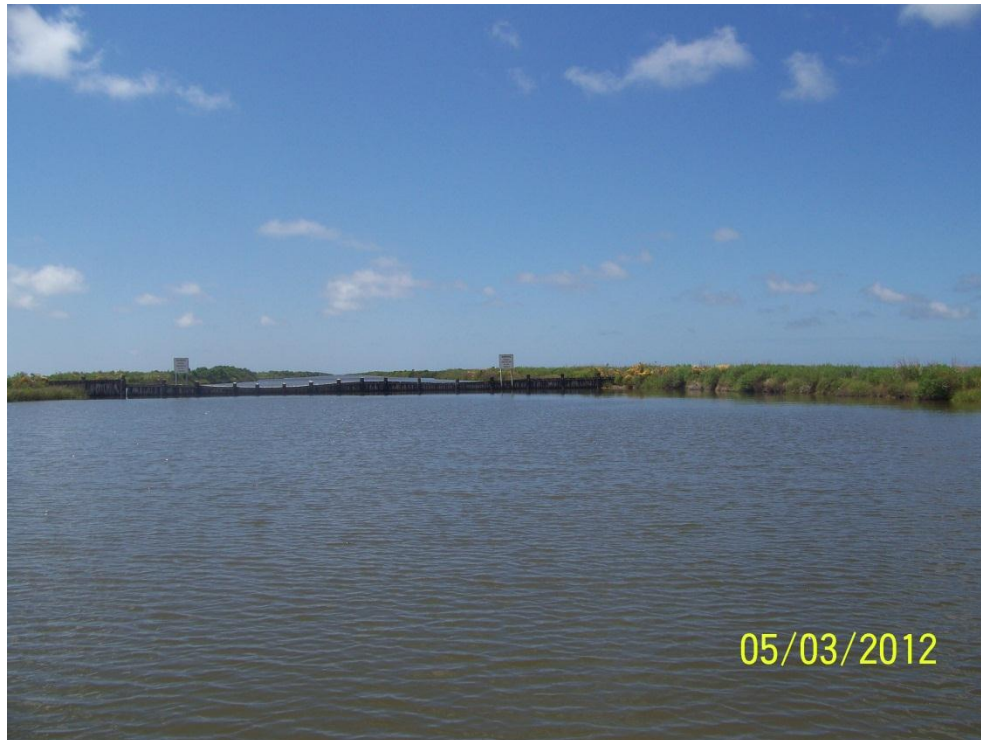
The Plug No. 6 timber bulkhead showed signs of deflection (wavy pattern across canal) shortly after construction. The deflection is now more apparent during the annual inspection than what was observed during construction. Also, there is a separation of the bulkhead (or missing board) near the embankment tie-in on the east side of the structure. This separation is allowing small amounts of water to pass through the bulkhead. The warning signs and supports appear to be in overall good condition. There are no recommendations for corrective

Photo No. 23: Overall view of Plug No. 6 from Transco Canal, looking south

actions at this time, but the condition of the structure should continue to be monitored on future site visits.

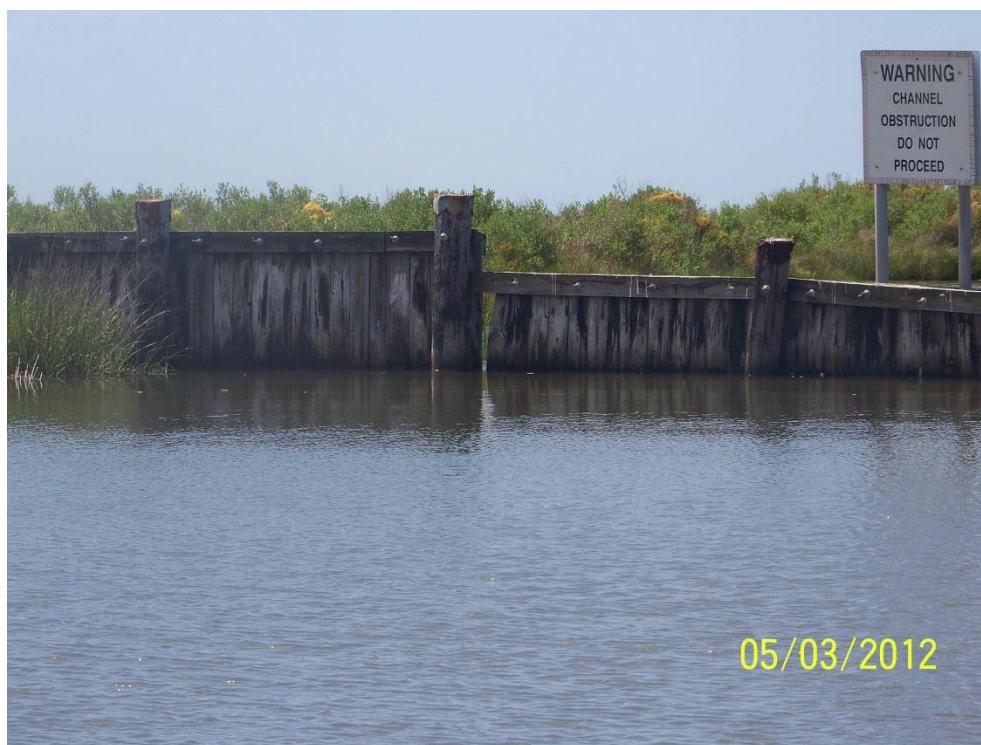
Photo No. 24: View of a separation in the timber bulkhead of Plug No. 6 from Transco Canal, looking south

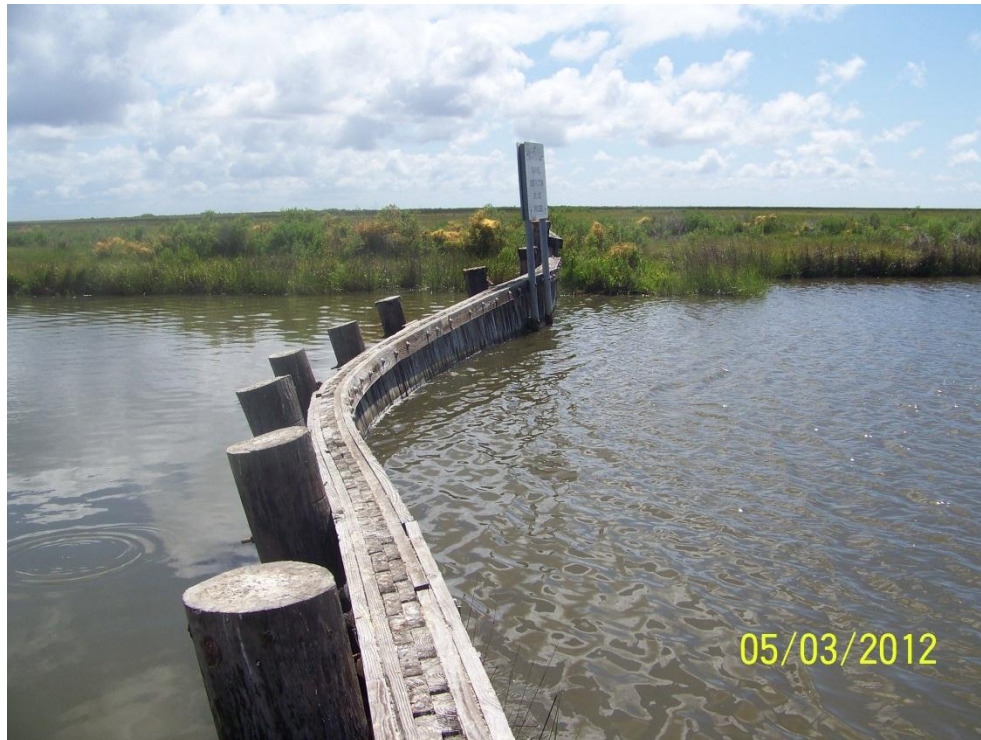
Photo No. 25: View of the timber bulkhead deflection on Plug No. 6 from on top of the structure, looking east

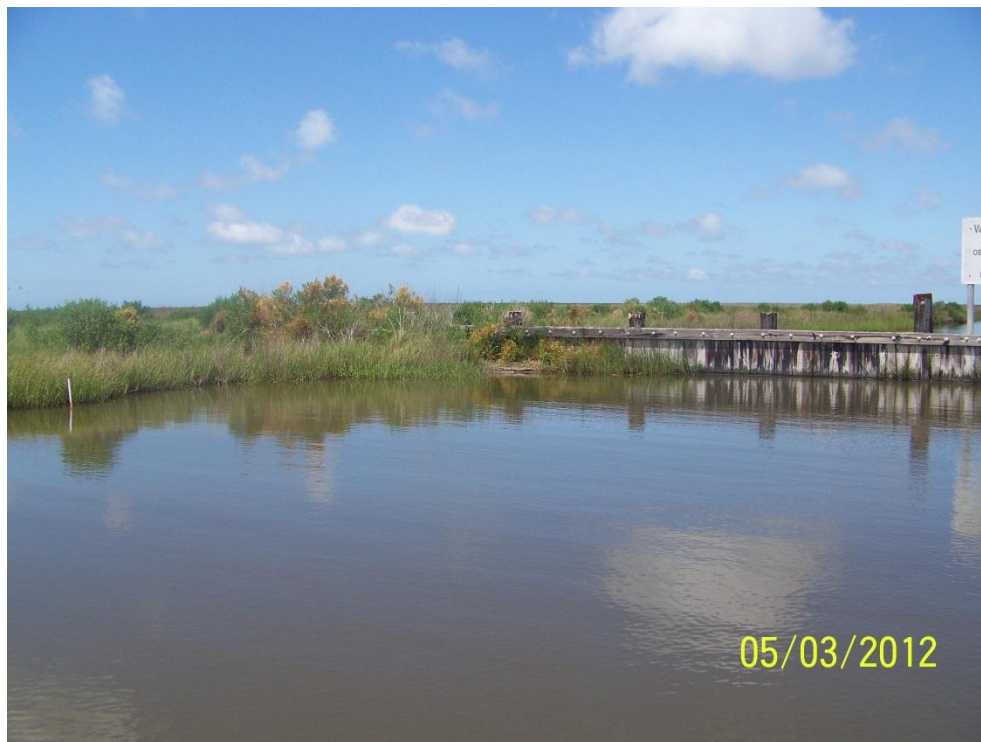
Photo No. 26: View of the embankment tie-in on the southern end of Plug No. 1 from Hester Canal, looking east

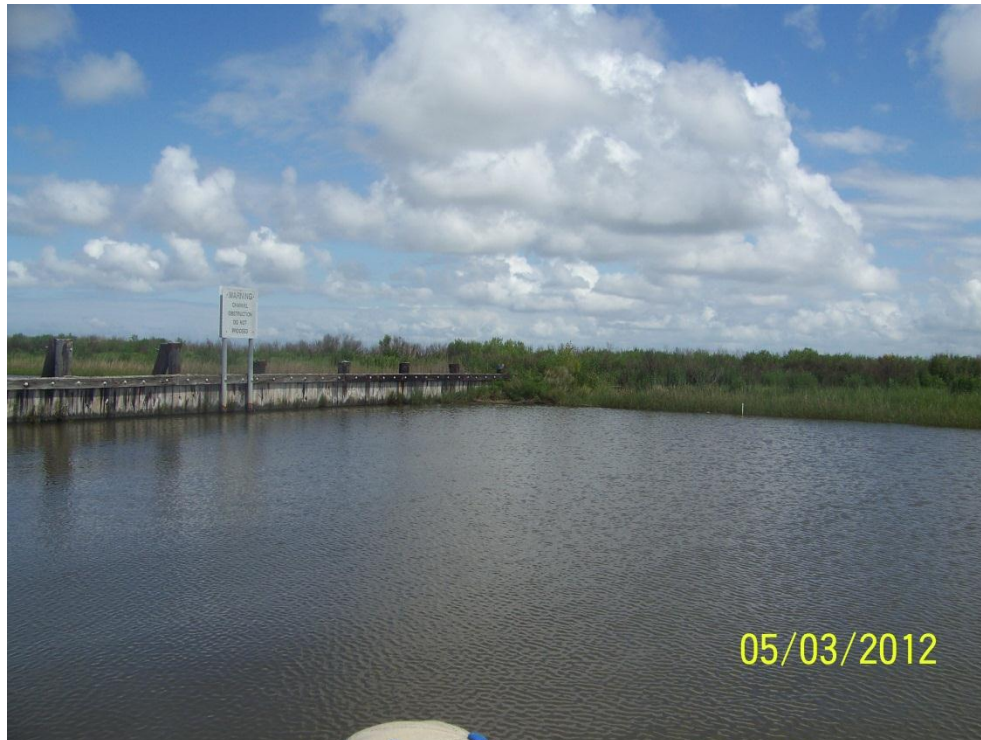
Photo No. 27: View of the embankment tie-in on the northern end of Plug No. 1 from Hester Canal, looking east

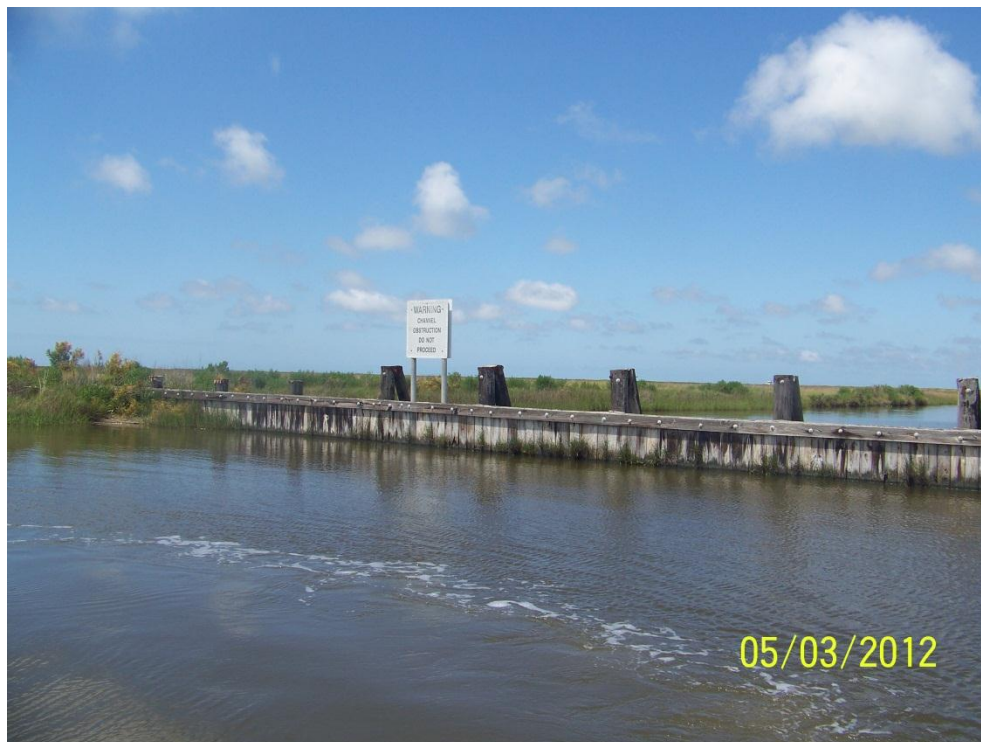
Photo No. 28: Overall view of Plug No. 1 with its warning signs and supports from Hester Canal, looking east
