2012 Annual Inspection Report

**POINT AU FER ISLAND
HYDROLOGIC RESTORATION**

State Project Number TE-22
Priority Project List 2

June 15, 2012
Terrebonne Parish

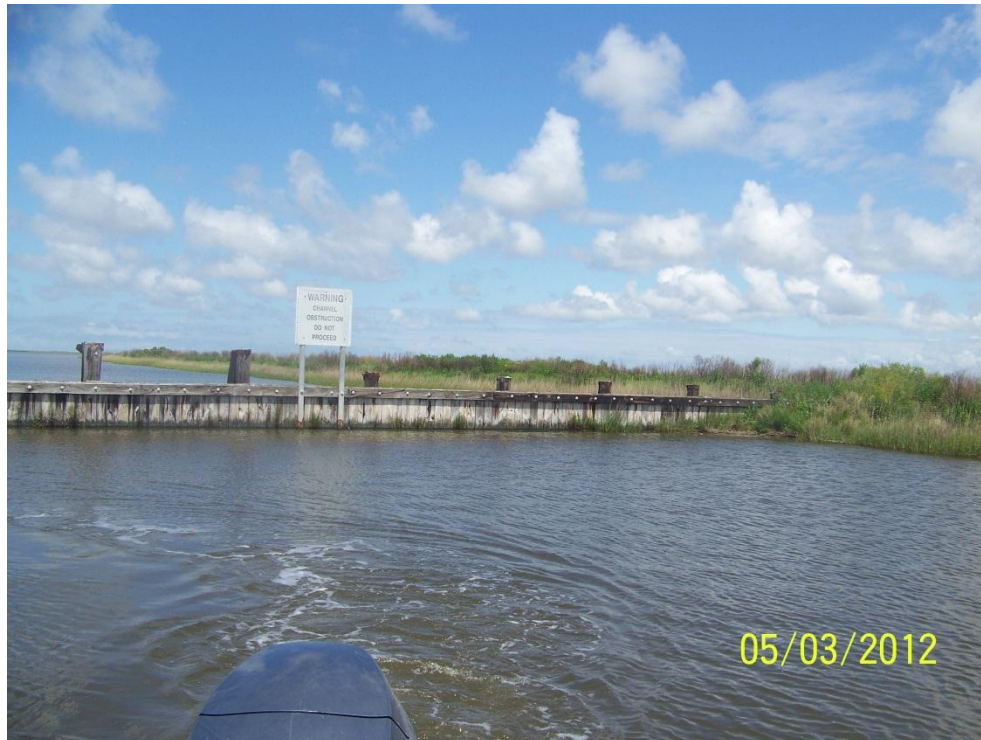
Photo No. 29: Overall view of Plug No. 1 with its warning signs and supports from Hester Canal, looking east

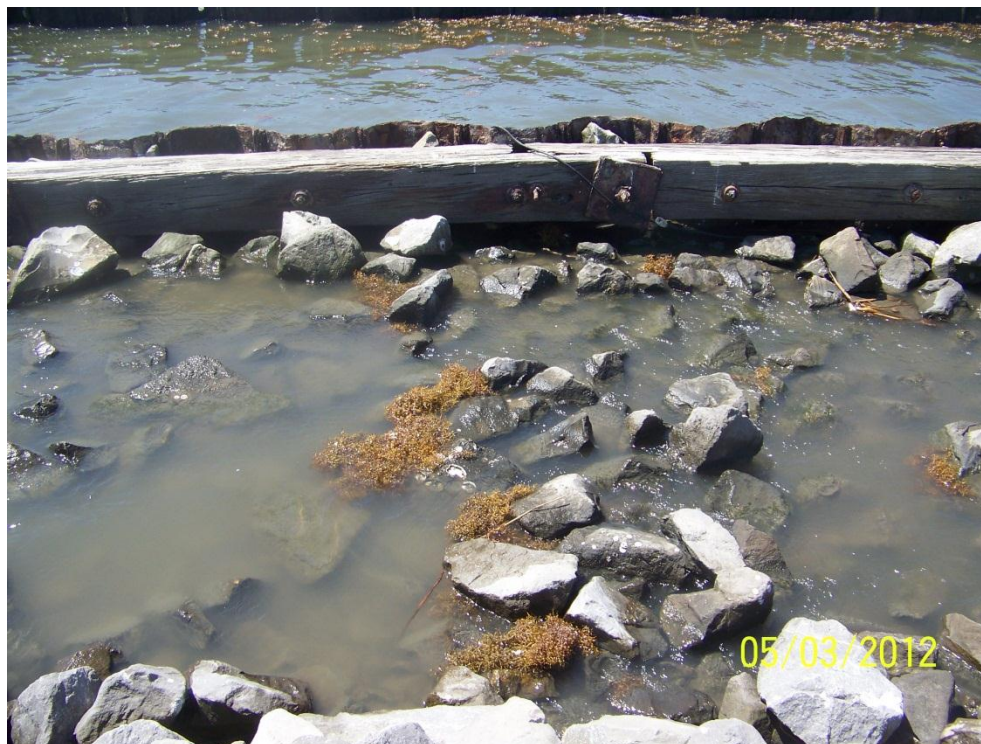
Shoreline erosion continues to be observed at the east embankment tie-in. The erosion directly behind the mats on the east side of the structure has been slowed or halted since the maintenance rock lift in 2005. Material has been accumulated behind the rock lift and that deposited material is now vegetated. On the other end of the structure, the west mats have settled and are over washed during normal tidal events. In addition, due to erosion around the embankment tie-in, the mats no longer connect to the shoreline. This allows tidal exchange behind the mats similar to the east end before the 2005 maintenance. At the existing Transco bulkhead, tidal exchange occurs between the Gulf and Transco Canal where water passes behind the bulkhead and over the rocks into the canal. This has been observed in previous inspections but seems to be increasing. The steel sheetpile and tie-rods are heavily corroded and should continue to be monitored.

Photo No. 30: View from behind the Transco Canal bulkhead Plug No. 4A, looking south

In 2010 it was recommended to survey the area for comparison to the as-built construction drawings to determine the best course of action to prevent breaching of the Gulf into the Canal. The survey was completed in August 2011 and it was determined the rock dike is in need of refurbishment. As of July 2012, the refurbishment project is in design and is expected to be bid in the Fall of 2012 and constructed in the Spring of 2013.

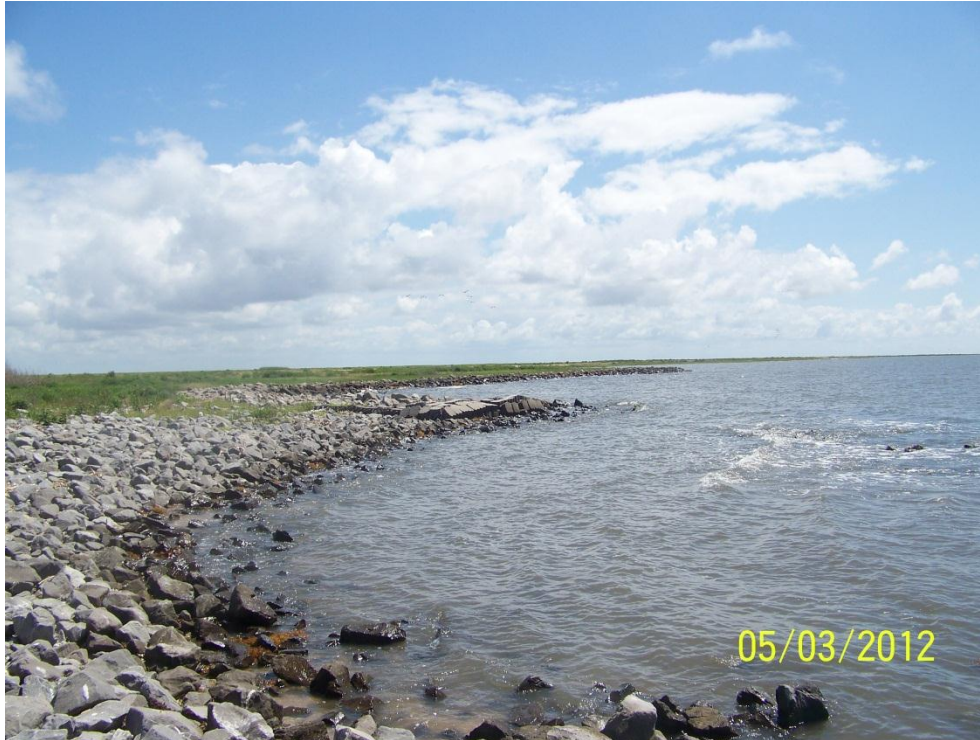
Photo No. 31: View of the Transco Canal rock dike from on top of the bulkhead, looking east

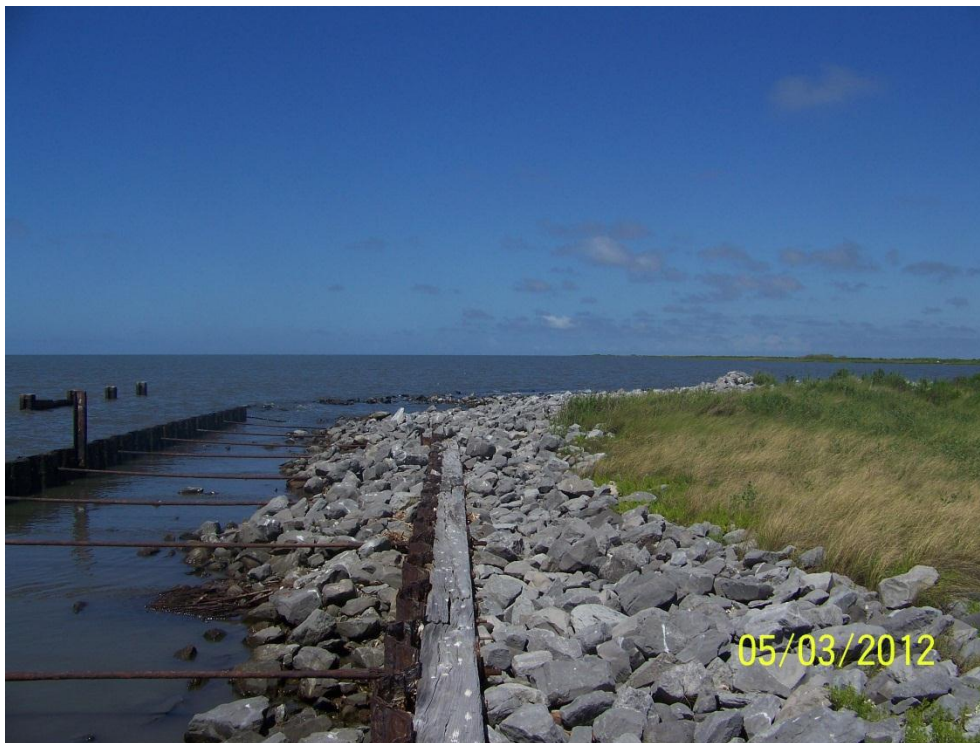
Photo No. 32: View of the Transco Canal rock dike from on top of the bulkhead, looking west

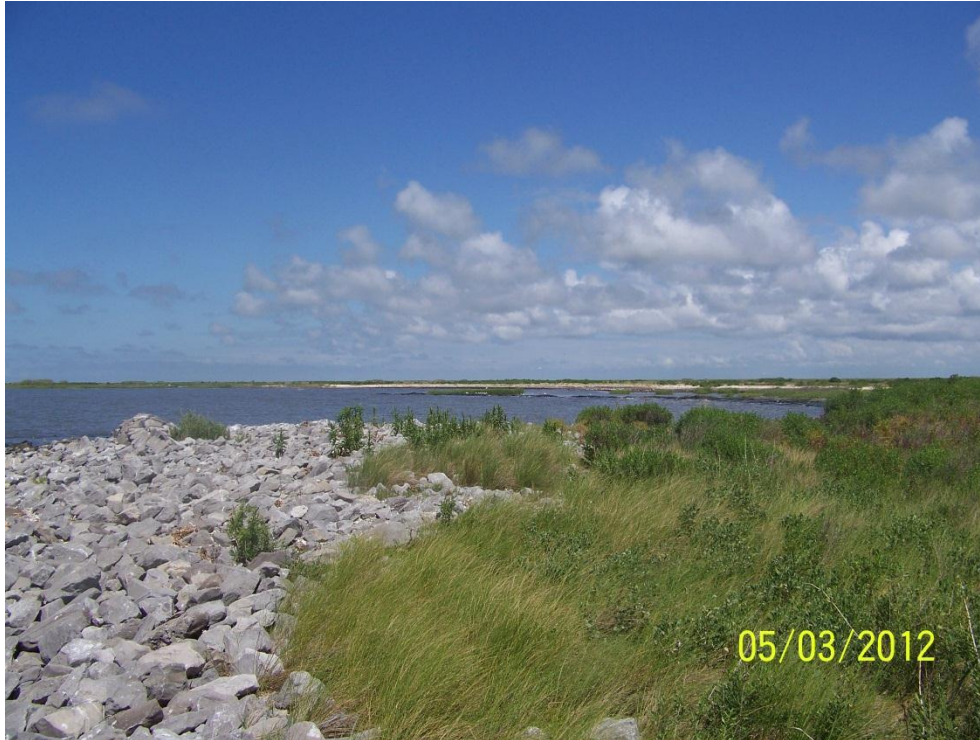
Photo No. 33: View of the Transco Canal rock dike from on top of the structure, looking east

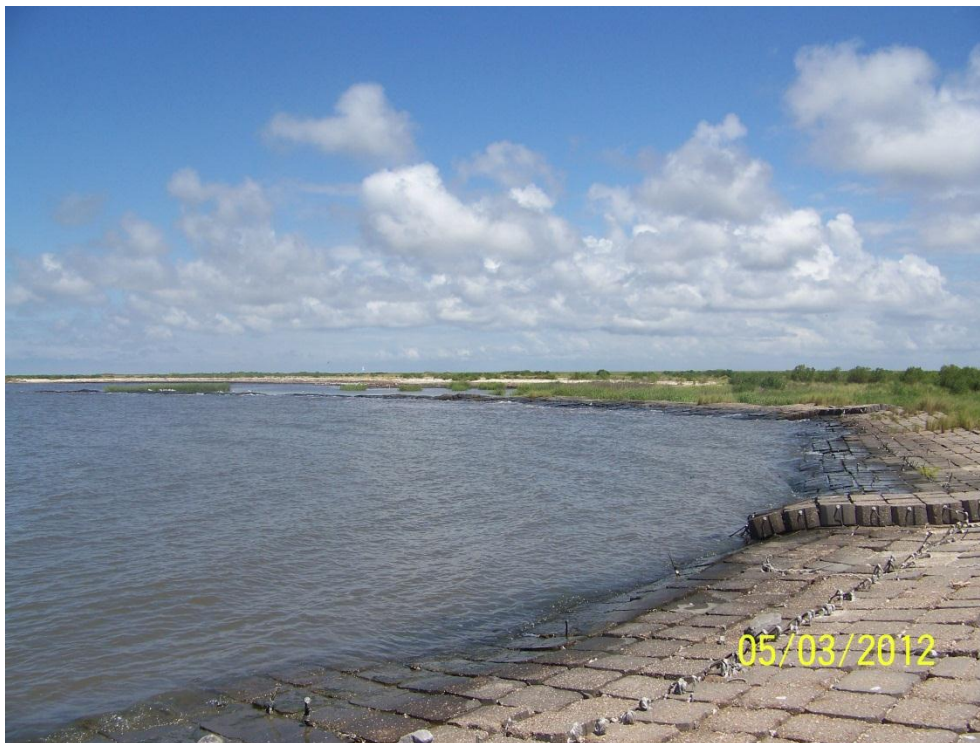
Photo No. 34: View of the articulated concrete mats on the western end of the Transco Canal rock dike, looking east

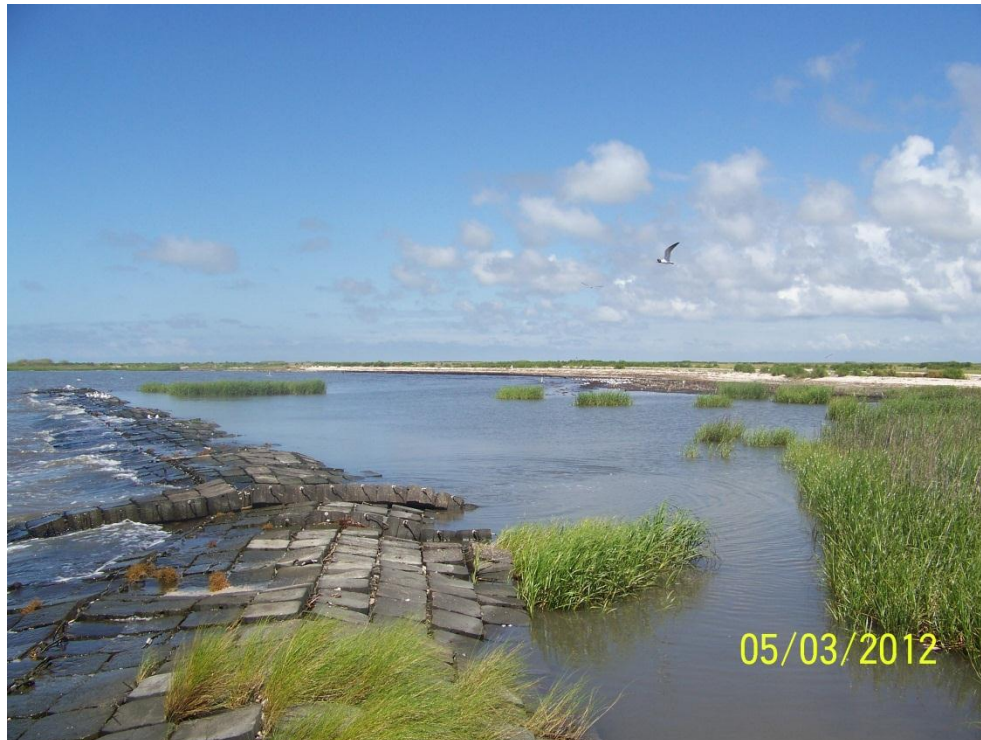
Photo No. 35: View of erosional shadowing behind the end of the articulated concrete mats on the western end of the Transco Canal rock dike, looking east

At Plug No. 4A (Transco at Gulf) in order to address the continued erosion at the west shoreline tie-in, behind the west mats, and at the east shoreline tie-in, a survey was recommended in the 2010 Annual Inspection Report. At the time of the 2012 inspection and report, this survey has been completed and the maintenance project is currently in design. Maintenance recommendations will include constructing a rock lift on the west mats, closing off the connection behind those mats with a rock dike extension back to the shoreline, and for the east extending and constructing a rock lift on the 2005 extension dike (See Appendix D). This maintenance event is expected to go through the bidding process in Fall 2012 and into construction by Spring 2013.

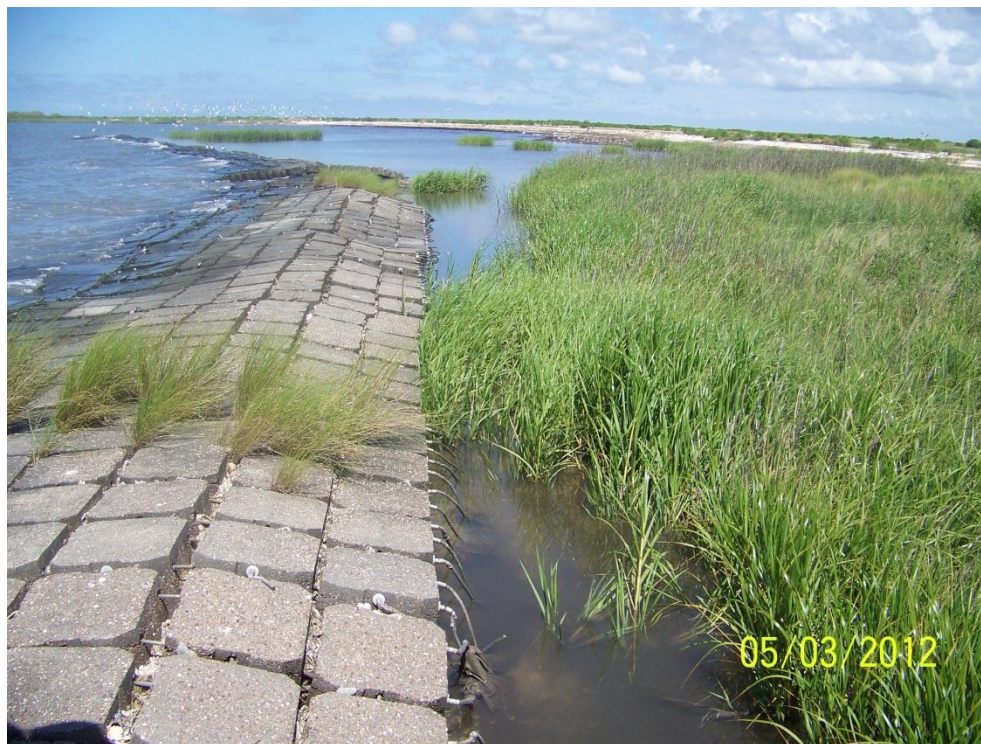
Photo No. 36: View of water wrapping around the articulated concrete mats, looking east. The water has no progressed far enough to reach Transco Canal.

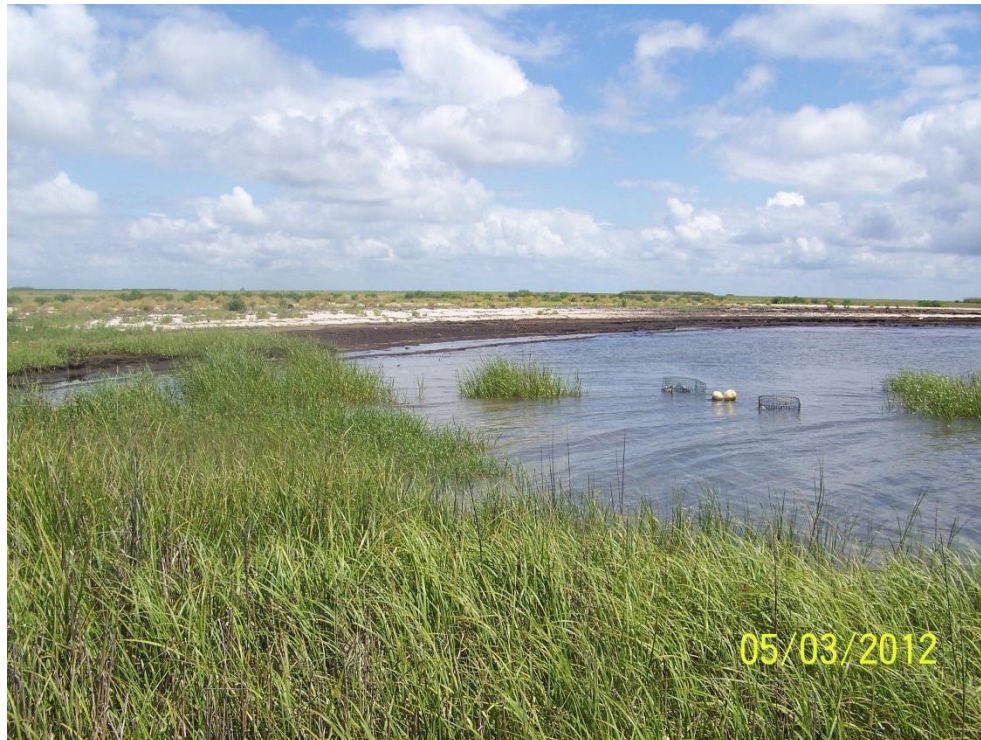
Photo No. 37: View of erosional shadowing behind the easternmost end of the Transco Canal rock dike, looking east

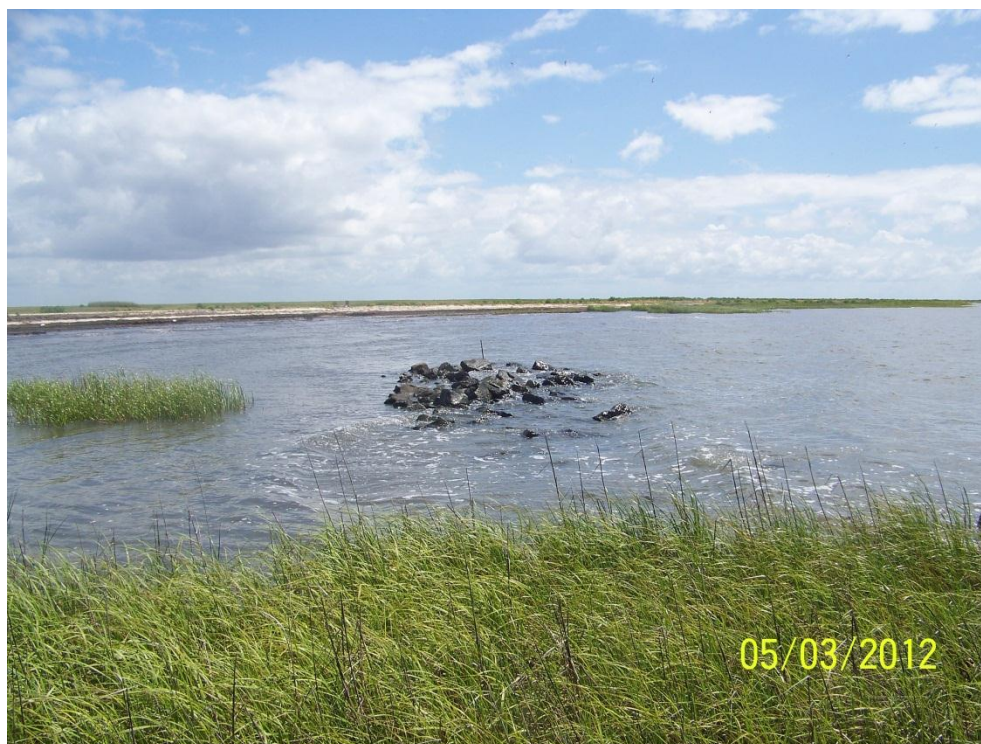
Photo No. 38: View of the easternmost end of the Transco Canal rock dike from on top of the structure, looking east
