**State of Louisiana
Coastal Protection and Restoration
Authority**

2012 Annual Inspection Report

**LAKE CHAPEAU SEDIMENT INPUT
AND HYDROLOGIC RESTORATION
PROJECT**

State Project Number TE-26
Priority Project List 3

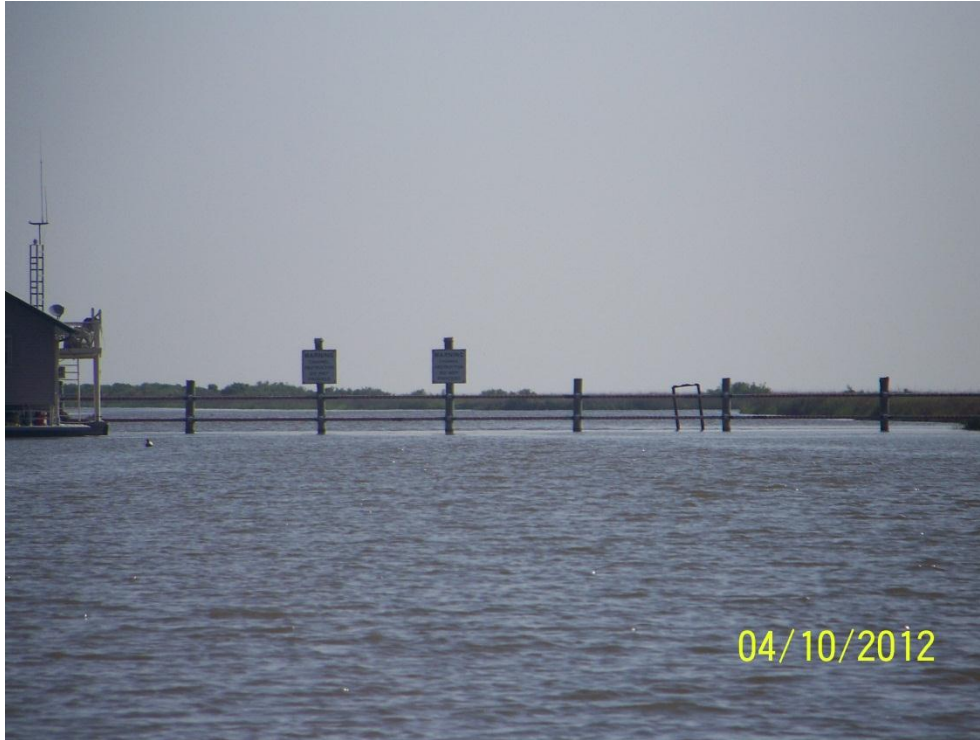
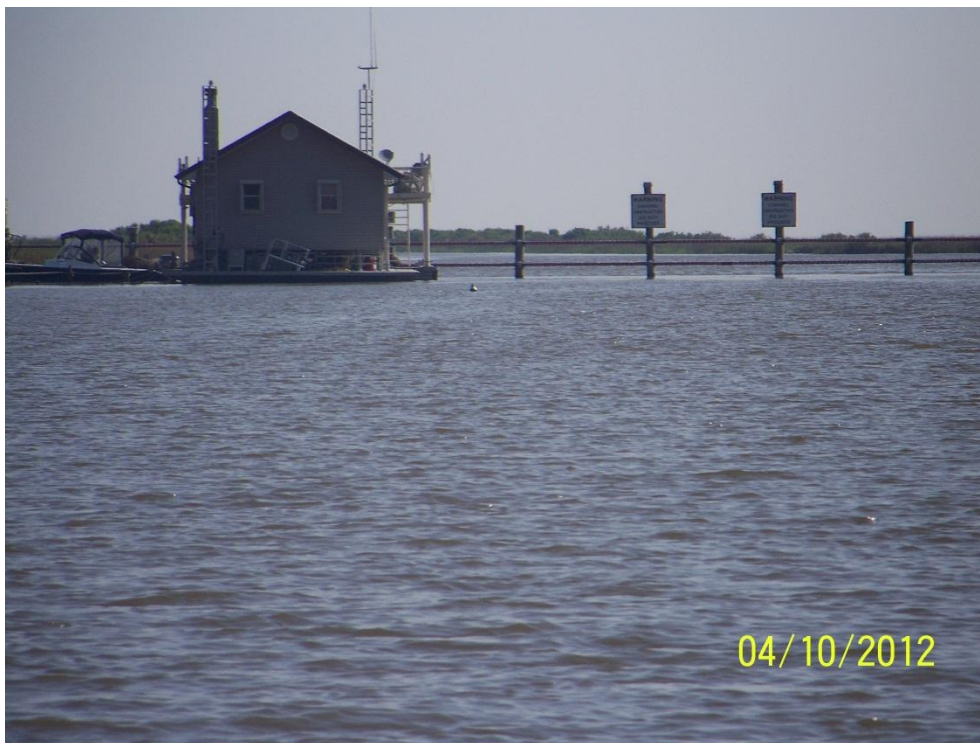
A close inspection of Site No. 1 was not possible due to access constraints. There is a floating gate approximately 500' southwest of the rock weir, preventing access to the canal. Using the camera to zoom in from a distance, it appears the structure is in good overall condition. There are no signs of breaching or erosion around the embankment tie-ins. Also, the timber barricade and warning signs show no signs of damage. Two (2) timber piles were identified in the 2009 Annual Inspection to be missing their protective galvanized cap. Due to the floating gate, we were unable to get close enough to the structure to determine if these timber piles have experienced any deterioration due to weathering. The latest elevation data available from the 2004 survey profile of the structure indicates that the crest of the rock weir has settled approximately 1.39' since 1999. (See Appendix B, Photos # 1-2)

Photo #1: View of Site No. 1 from afar, access blocked by floating barrels, looking northeast

Photo #2: View of Site No. 1 from afar, access blocked by floating barrels, looking northeast

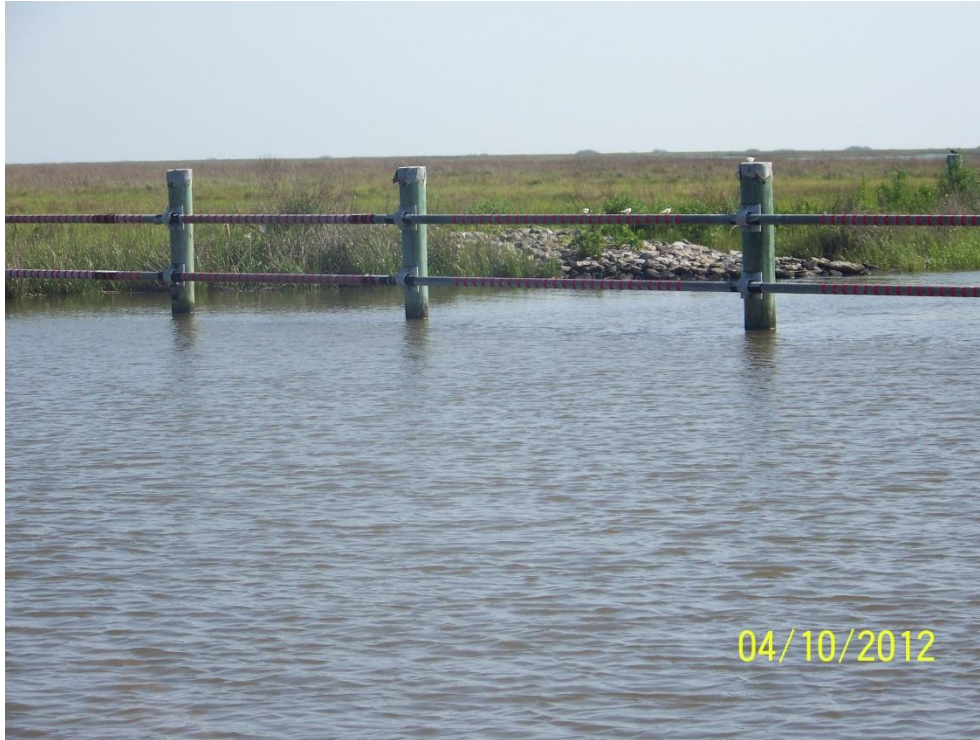
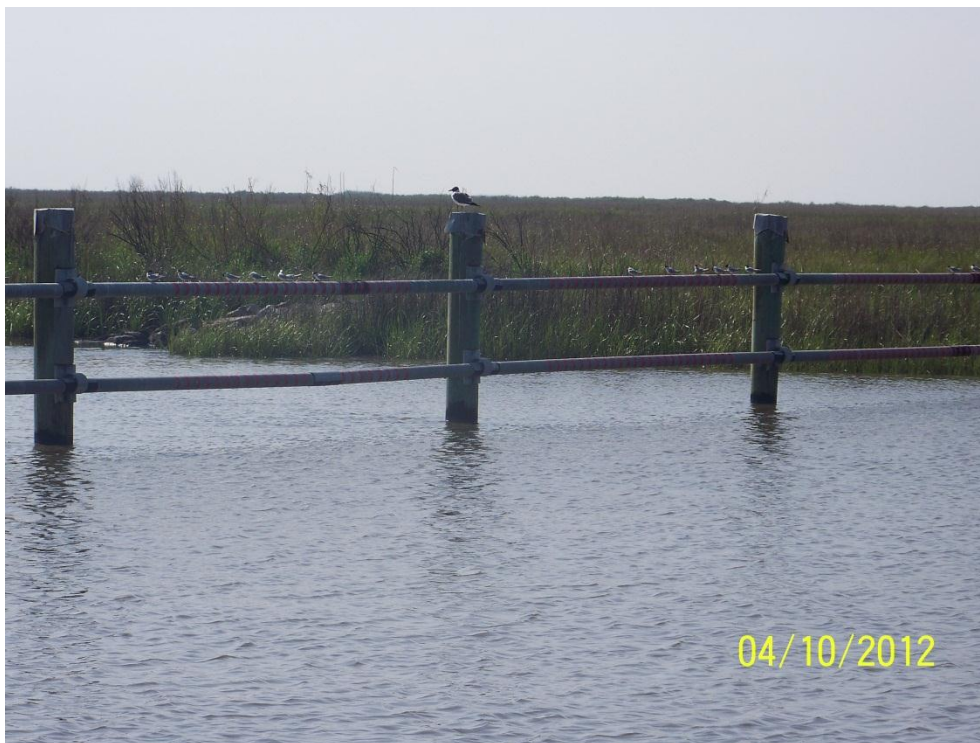
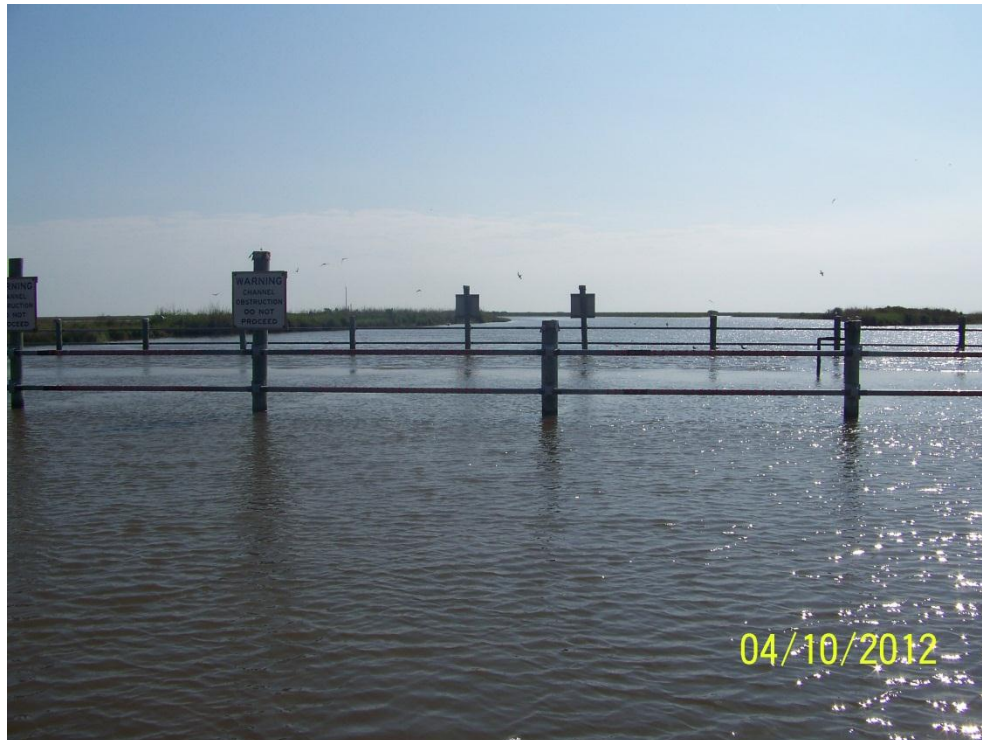
The Site No.9 rock weir was in good overall condition. There are no visual signs of erosion or breaching around the embankment tie-ins. A few of the galvanized pile caps are missing and

several have visual corrosion and rust. The rest of the timber barricade system shows no sign of corrosion or deterioration due to weathering. The warning signs and supports have no apparent damage and appear to be in good condition. Based on a survey profile of the rock weir in 2004, the structure has settled approximately 1.7' from its designed elevation. There is a small breach in the south canal bank near Site No.9 (located at point N29° 17m 4.4s W91° 17m 1.7s). Due to the location and the size of the breach, it not believed to be detrimental to the structure and that the rock weir is operating as designed. At this time there are no recommendations for corrective actions, but this site will continue to be monitored during future inspections to determine if the breach enlarges and requires maintenance. (See Appendix B, Photos # 3-7)

Photo #3: View of barricade and embankment tie-ins on north side of Site No. 9, looking northeast

Photo #4: View of barricade and embankment tie-ins on south side of Site No. 9, looking southeast

Photo #5: Overall view of warning signs and barricades of Site No. 9, looking east

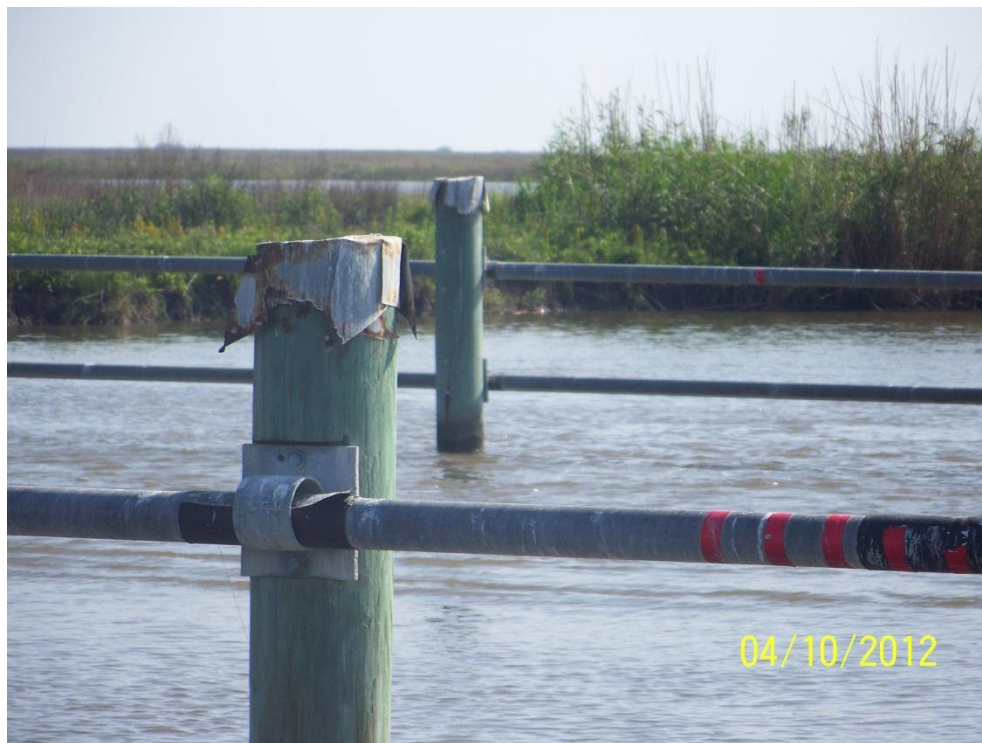
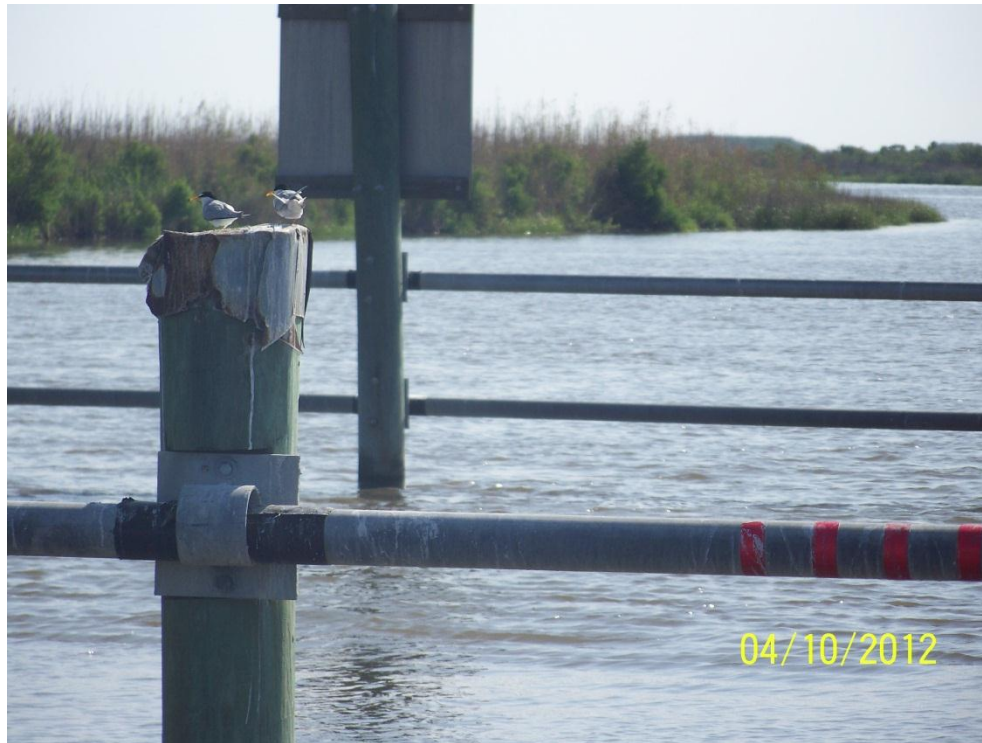
Photo #6: Visible corrosion of galvanized end caps on the timber barricade supports in Site No. 9

Photo #7: Visible corrosion of galvanized end caps on the timber barricade supports in Site No. 9

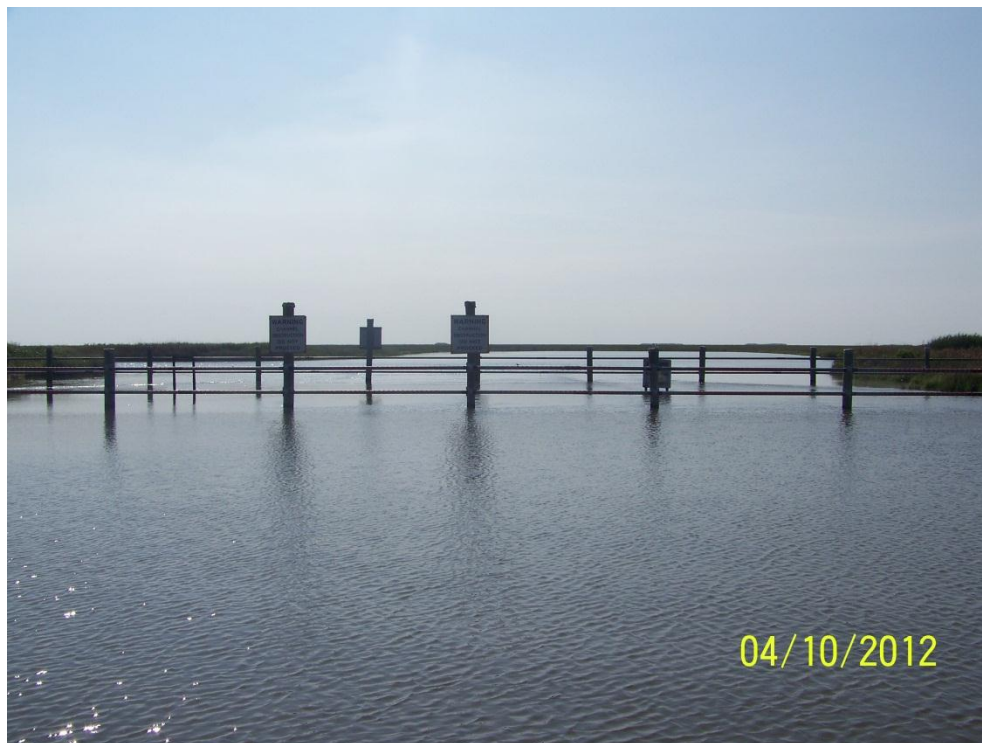
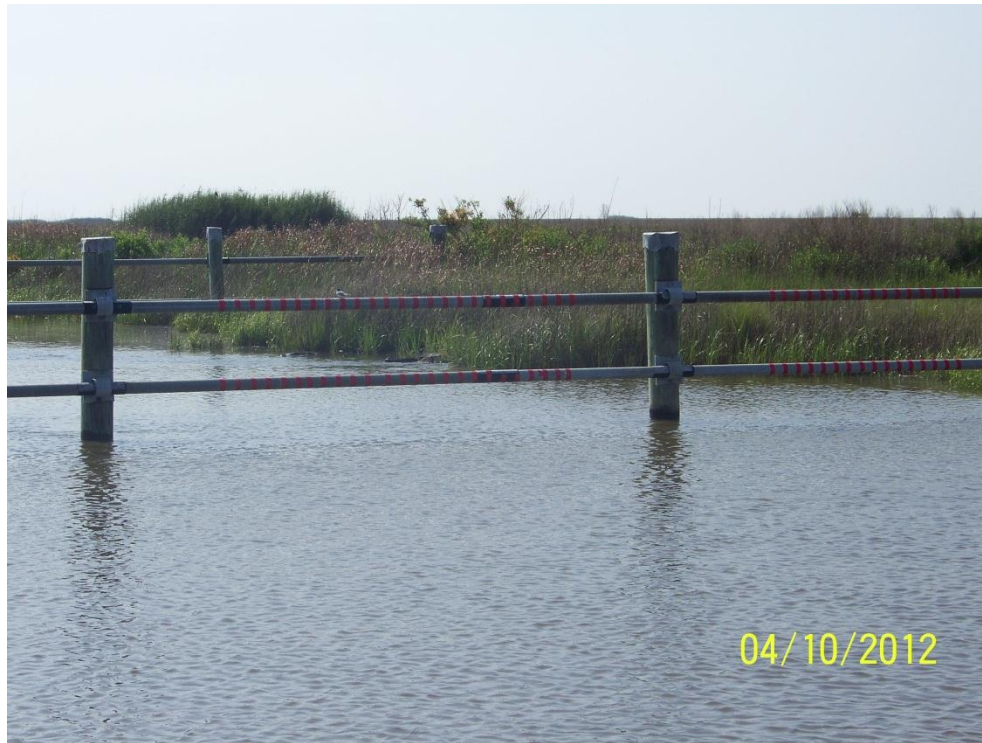
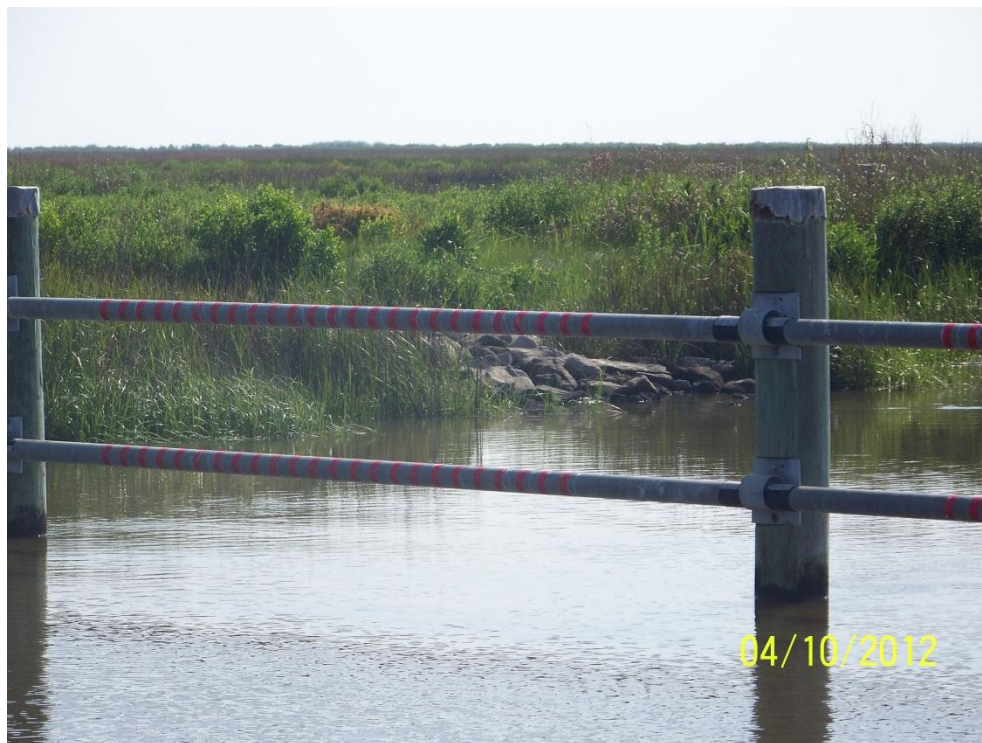
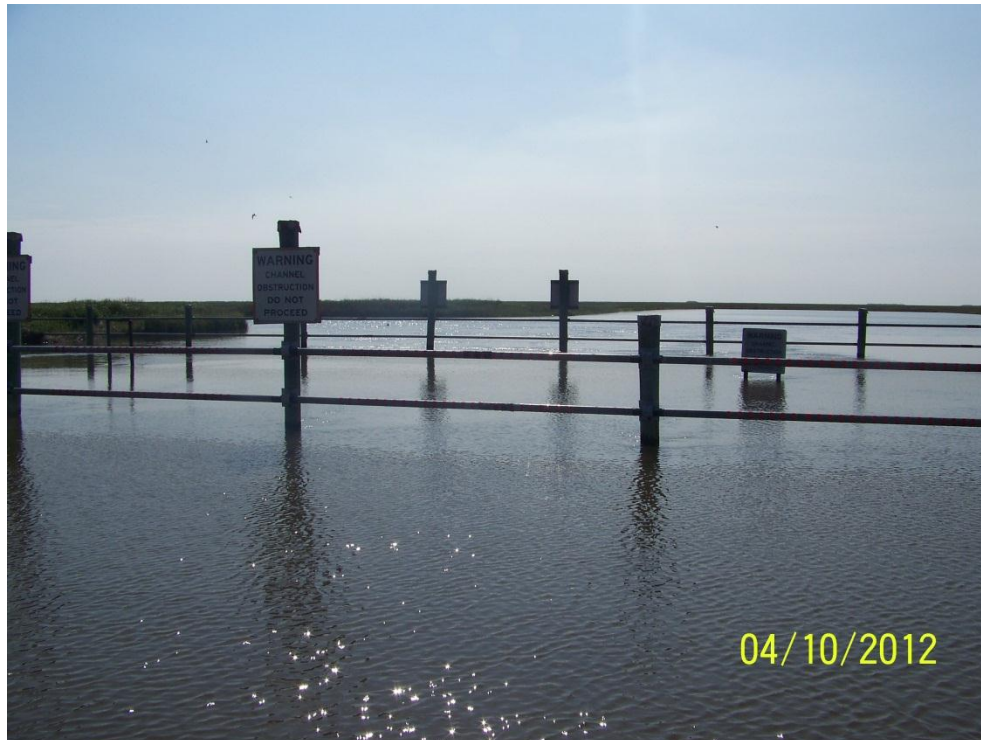
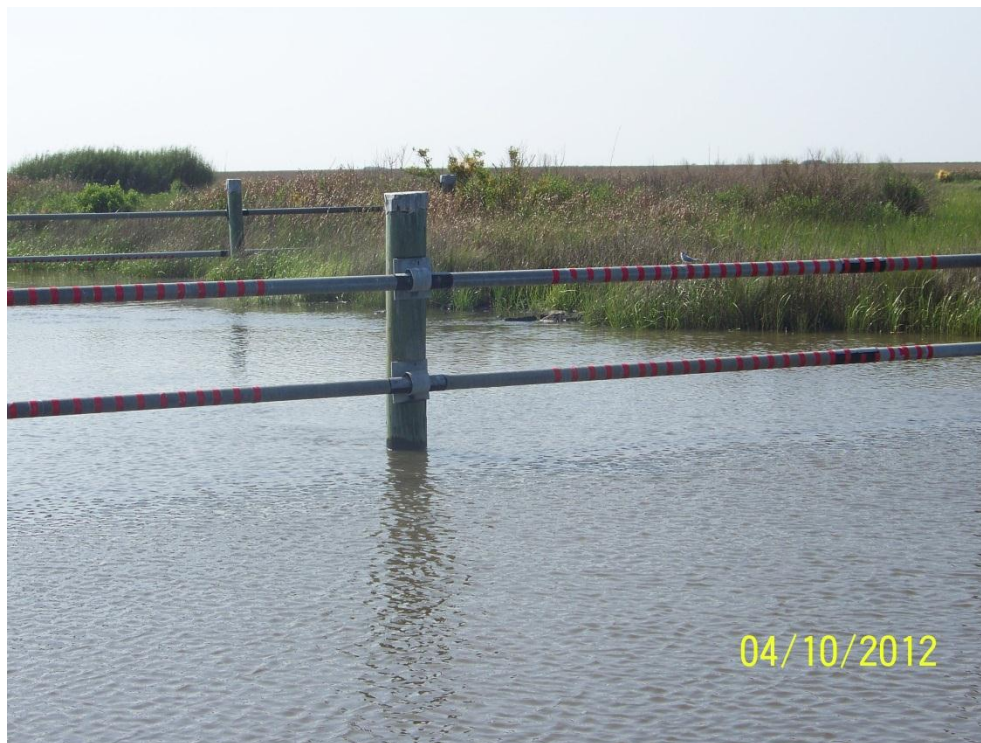
The Site No. 7 rock weir is in good overall condition. There are no visual signs of breaching or erosion around the embankment tie-ins. The timber barricade is in good condition with slight corrosion on the timber pile caps. The warning signs and their supports have no apparent damage and appear to be in good condition also. Based on a survey profile of the rock weir in 2004, the structure has settled approximately 1.7' from its designed elevation. (See Appendix B, Photos # 8-12)

Photo #8: Overall view of warning signs and barricade system of Site No. 7, looking southeast

Photo #9: View of barricade and embankment tie-in on northeast end of Site No. 7, looking east

Photo #10: View of barricade and embankment tie-in on southwest end of Site No. 7, looking south

Photo #11: View of warning signs and barricade system of Site No. 7, looking southeast

Photo #12: View of barricade and embankment tie-in on northeast end of Site No. 7, looking east

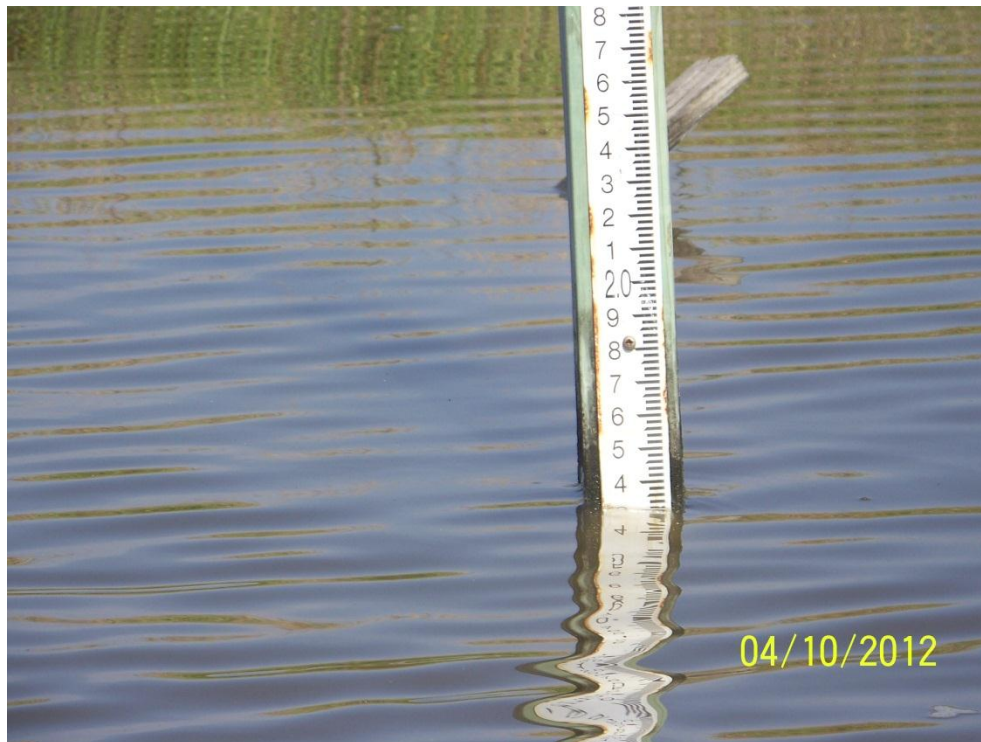
Photo #13: View of Staff Gage TE-26-05 reading +1.35' NAVD during the annual inspection

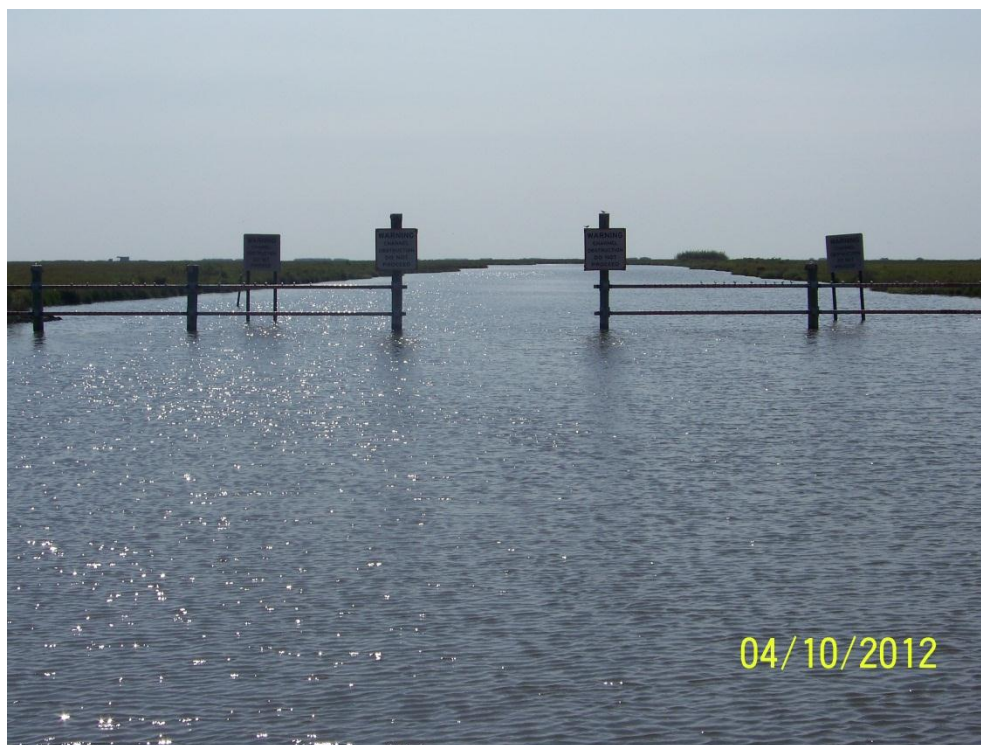
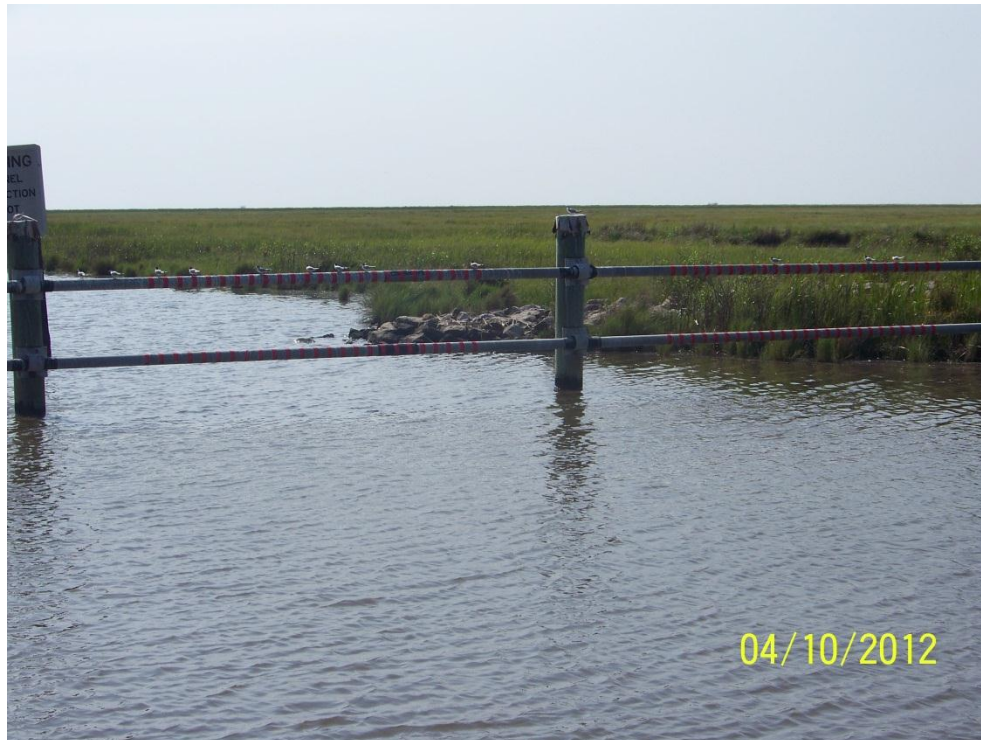
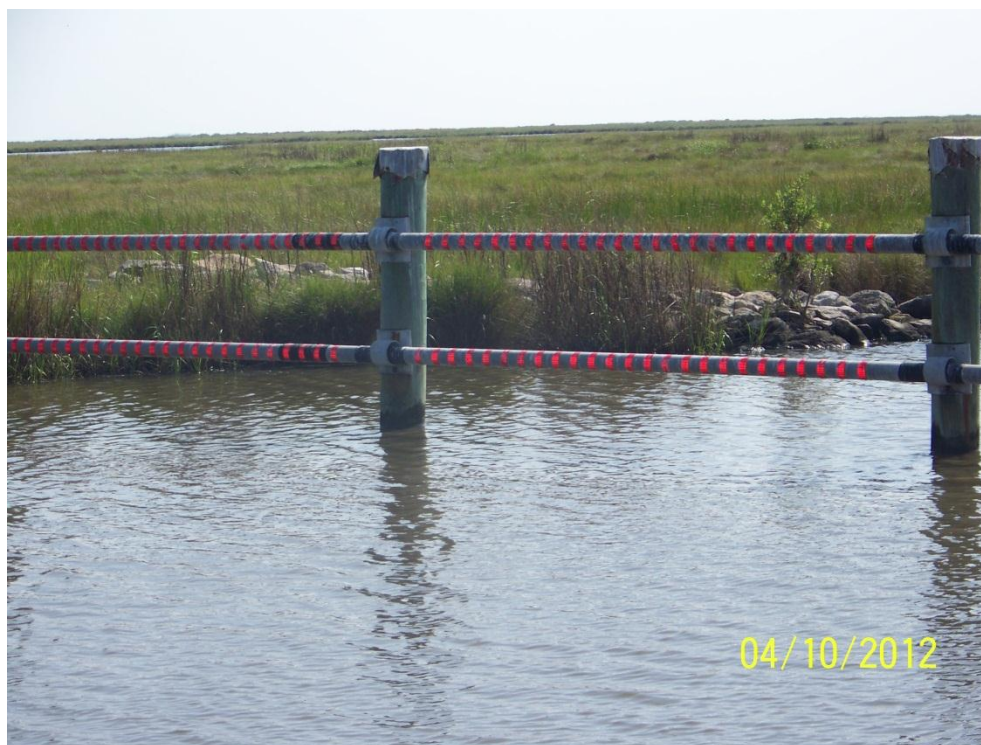
It was discovered during the 2008 Annual Inspection that the timber barricade system in front of the structure had been vandalized. Large sections (approximately 10 feet) on both of the steel pipe cross members had been cut with a torch and are missing. It remains our opinion that an attempt to repair the damage would be unsuccessful; therefore there are no recommendations for corrective actions at this time. Other than the cut sections, the barricade system is in good condition with no signs of damage. The rock weir appeared to be in good overall condition with no signs of erosion or breaching around the embankment tie-ins. The warning signs and supports are also in very good condition. The timber barricade system is in good overall condition with some minor rust and corrosion on the timber pile caps. From the 2004 profile survey of the structure, it was determined that the rock weir had settled an average of approximately 1.1 ft. (See Appendix B, Photos # 14-16)

Photo #14: Overall view of barricades and warning signs of Site No. 6, looking southeast

Photo #15: View of the embankment tie-in on the south side of Site No. 6, looking south

Photo #16: View of the embankment tie-in on the north side of Site No. 6, looking northeast

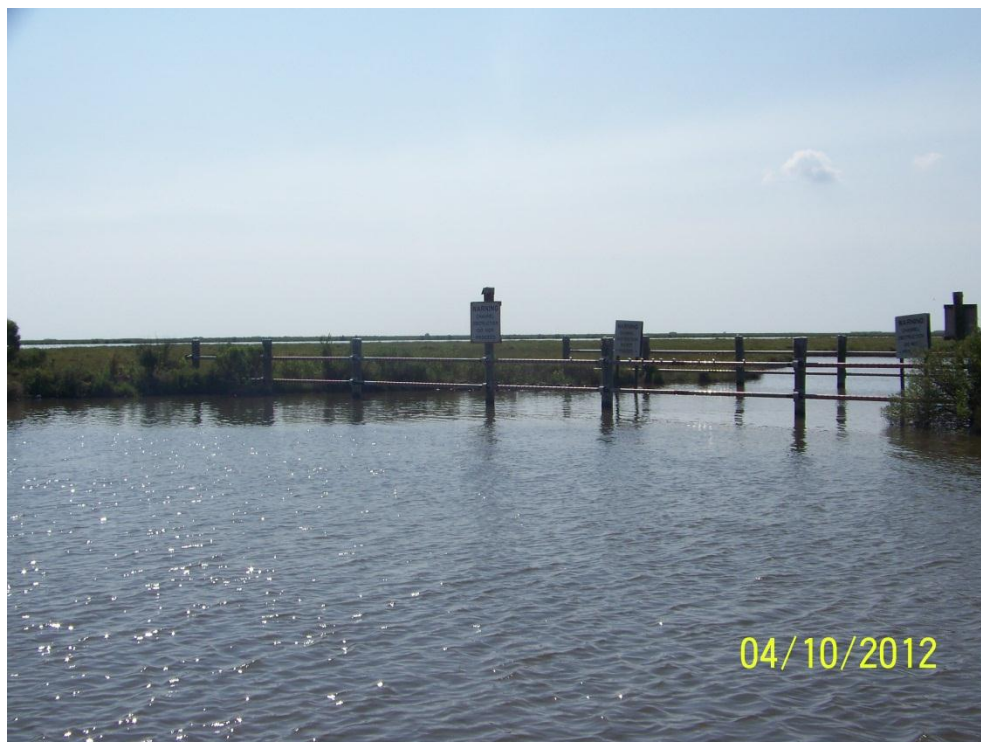
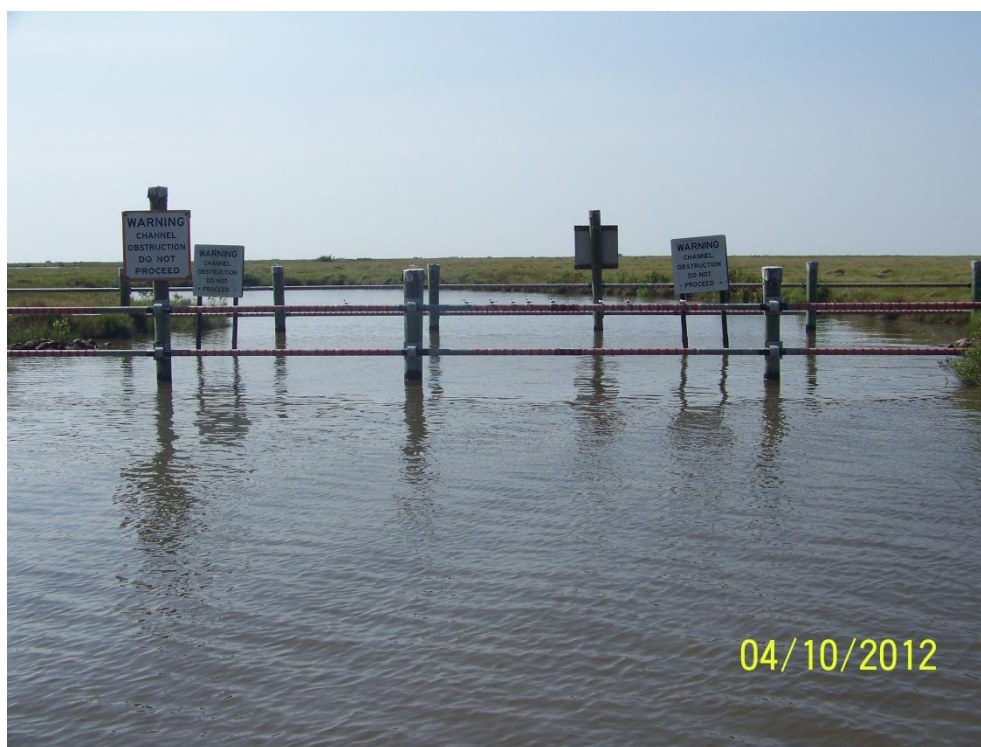
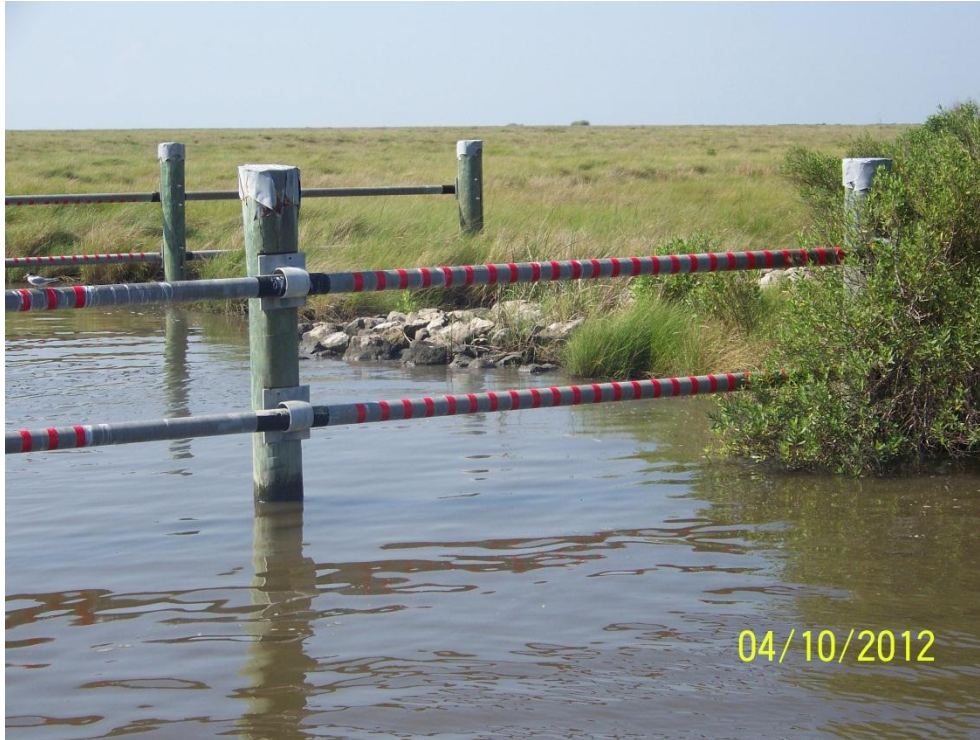
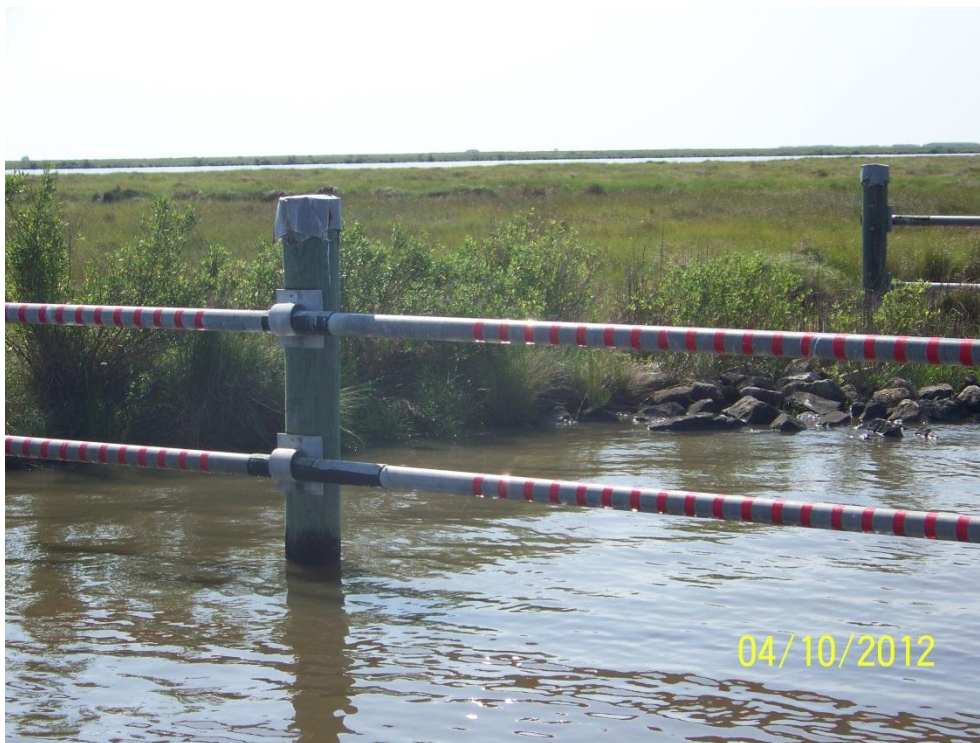
Site No.5 rock weir is in good overall condition. The embankment tie-ins showed no signs of marsh erosion or breaching. The barricade system and timber piles show no sign of damage or corrosion. The warning signs and supports are also in good condition. The latest elevation data from the 2004 survey profile of Structure No.5 indicates that the structure has settled on average of 0.14' from the designed elevation. (See Appendix B, Photos # 17-20)

Photo #17: Overall view of Site No. 5, looking southeast

Photo #18: View of barricade and warning signs of Site No. 5, looking south

Photo #19: View of embankment tie-in on the west side of Site No. 5, looking southwest

Photo #20: View of embankment tie-in on the east side of Site No. 5, looking southeast

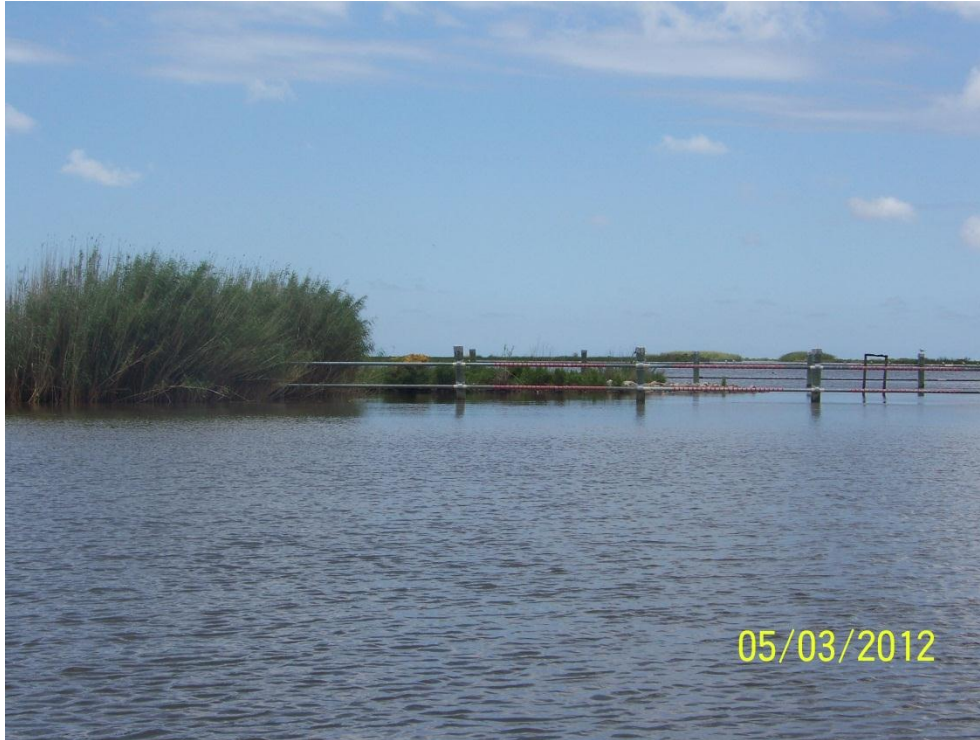
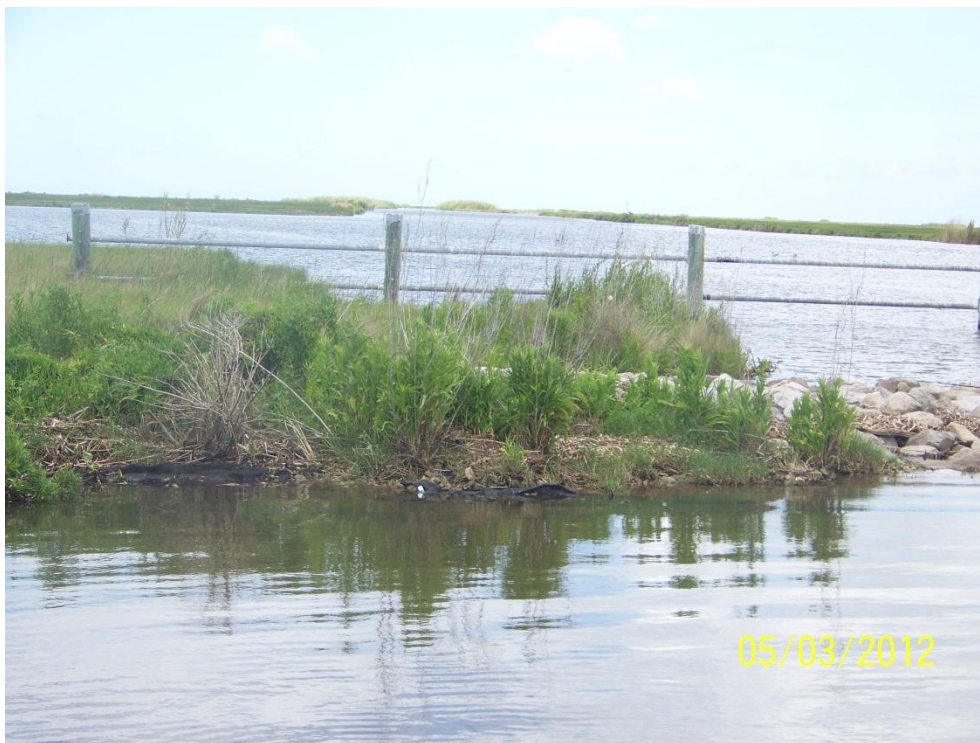
The rock weir appeared to be in good condition with no breaching around the ends. As in previous inspections, we found that the existing marsh connecting the structure to land on the south side of the weir was thin. However it didn't seem that there was any significant erosion since the last inspection. The timber barricade system appears to be in good condition. As previously reported, the two (2) center pilings are slightly unstable thought to be due to inadequate embedment and poor soil conditions. Also, a 10' section of pipe was cut by vandals on the northwest side of the structure. We do not believe the instability or cut section will have a detrimental effect to the structure, therefore there will be no recommendations for repair at this time, but will continue to monitor the situation on future inspections. (See Appendix B, Photos # 21-24)

Photo #21: View of the barricade system and embankment tie-in on the south side of Site No. 4

Photo #22: Close up view of the embankment tie-in on the south side of Site No. 4, looking west

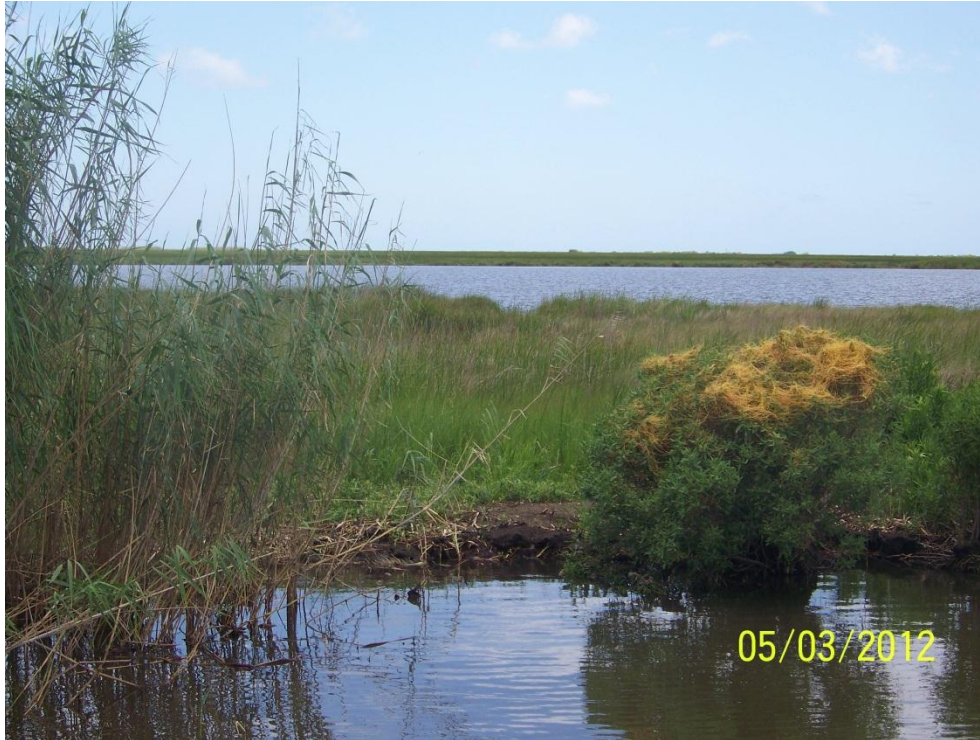
Site No.4 rock weir appears to be in overall good condition. By comparing the current and past assessments, there seems to be no noticeable erosion along the shoreline. Based on the current short-term shoreline erosion rates, there is a chance Site No.4 will remain intact for the remainder of the project life, barring any extreme storm events. Based on these observations there are no recommendations for corrective actions at this time, but we will continue to monitor the condition of the marsh surrounding Site No.4 to determine the extent of the shoreline degradation.

Photo # 23: View of retreating shoreline on south side of Site No. 4, looking west

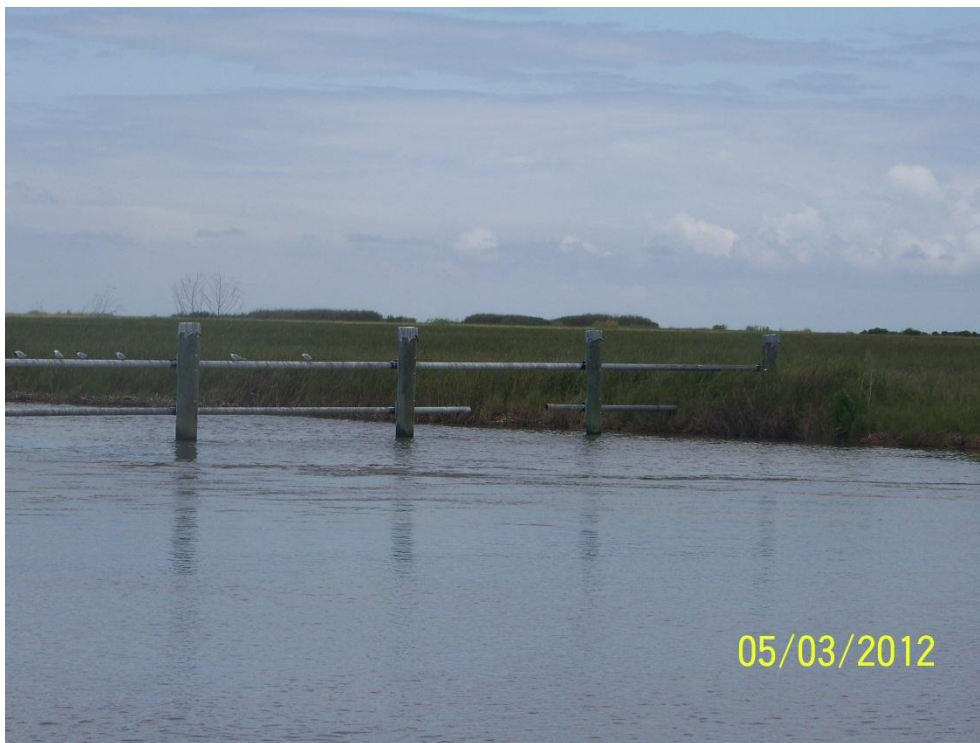
Photo #24: View of missing section on interior barricade system of Site No. 4, looking west.

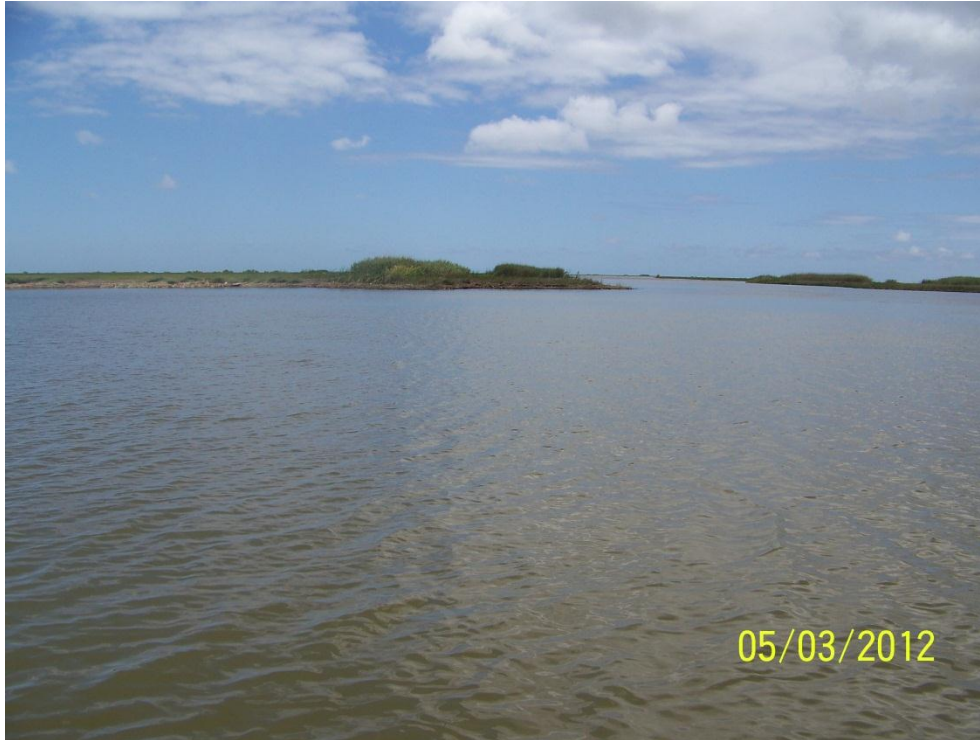
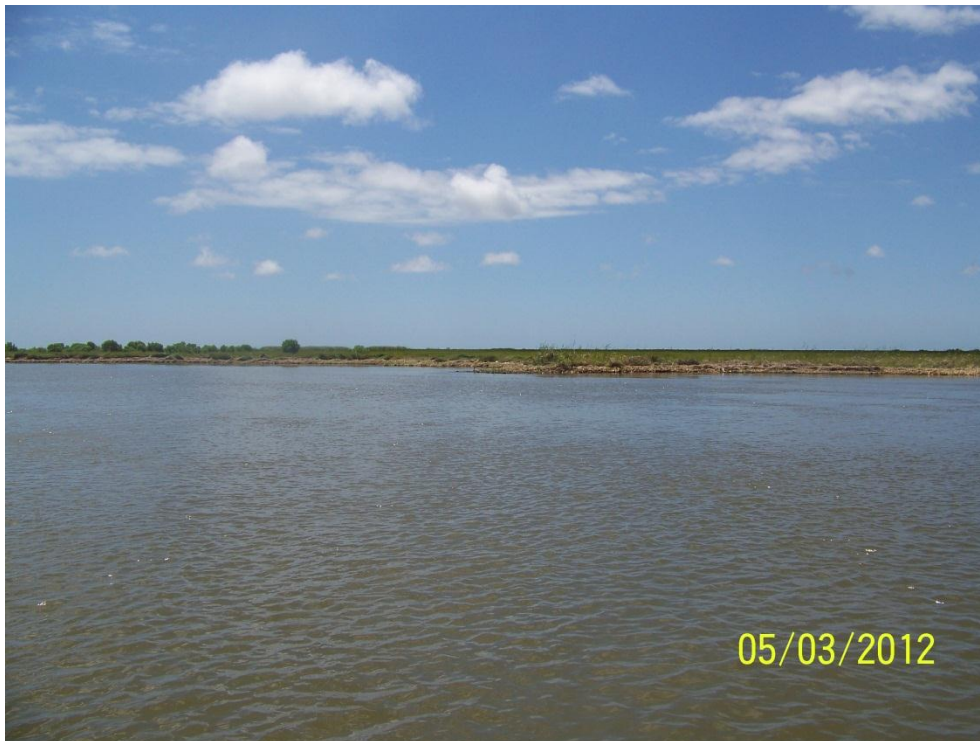
With erosion rates in the area exceeding 60 ft/year, this structure which was constructed in the canal leading from Fourleague Bay to Lake Chapeau is no longer tied into the canal. The shoreline has eroded so that the structure is in open water, making it no longer effective to the project goals or feasible to maintain, in addition to becoming a danger to boat traffic. In May 2011 this rock weir was degraded to an elevation of -8.0' NAVD88 to remove any navigation

hazard the remaining weir may pose. Now that the weir has been degraded and no longer visible above the water line, it will not be included in further annual inspections. (See Appendix B, Photos # 25-26)

At the time of the 2012 annual inspection, the degrading of the Site No. 3 rock weir was complete. The structure was deemed ineffective due to the extreme erosion around the north end of the rock weir. It was decided to the best course of action was to degrade the weir to a - 8.0' NAVD88 so that it is no longer a navigational hazard. Since the degrading has been completed, Site No. 3 will no longer be monitored or maintained as part of project TE-26.

Photo #25: The degraded structure of Site No. 3 no longer visible, looking west

Photo #26: The degraded structure of Site No. 3 no longer visible, looking west
