2012 Annual Inspection Report

**North Lake Mechant Landbridge
Restoration Project (TE-44)**

State Project Number TE-44
Priority Project List 10

July 10, 2012
Terrebonne Parish

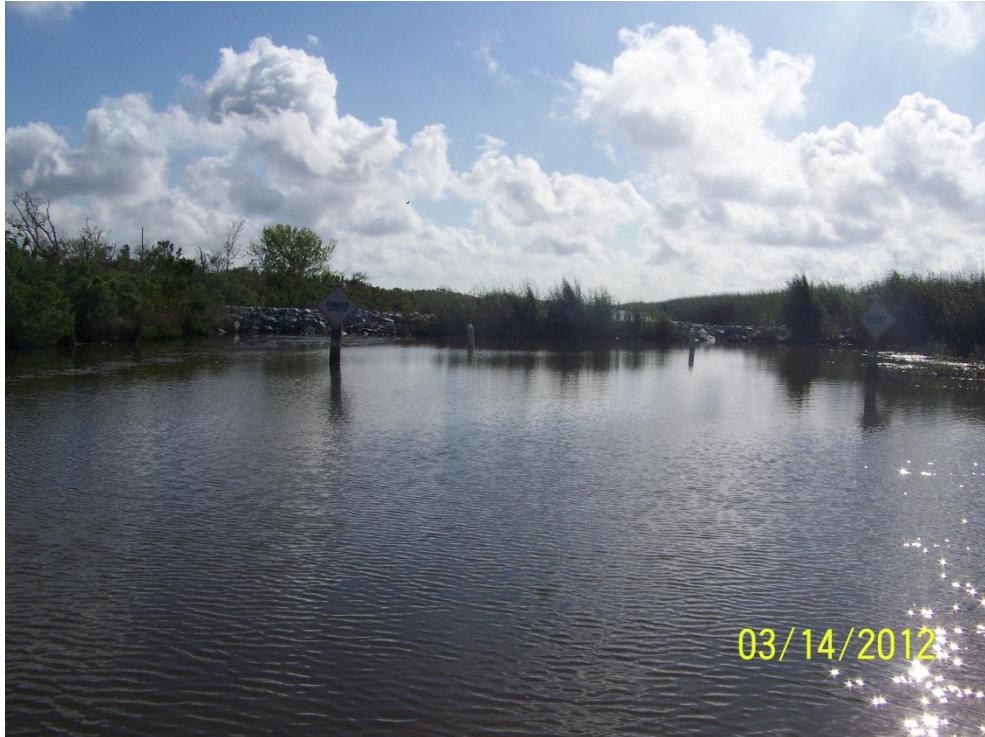
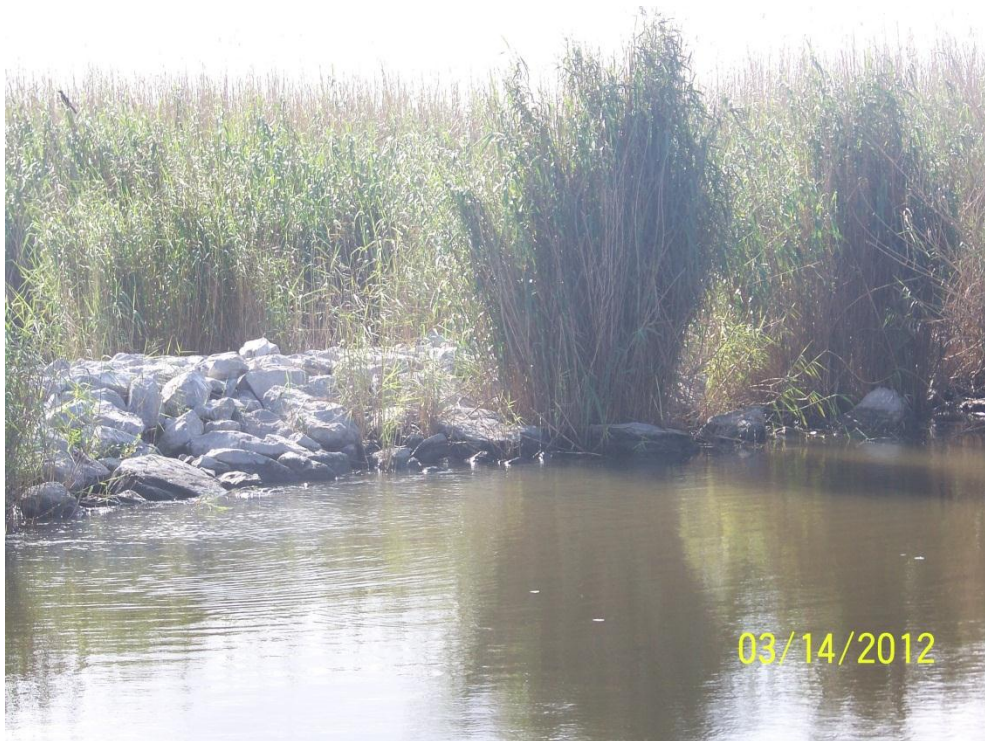
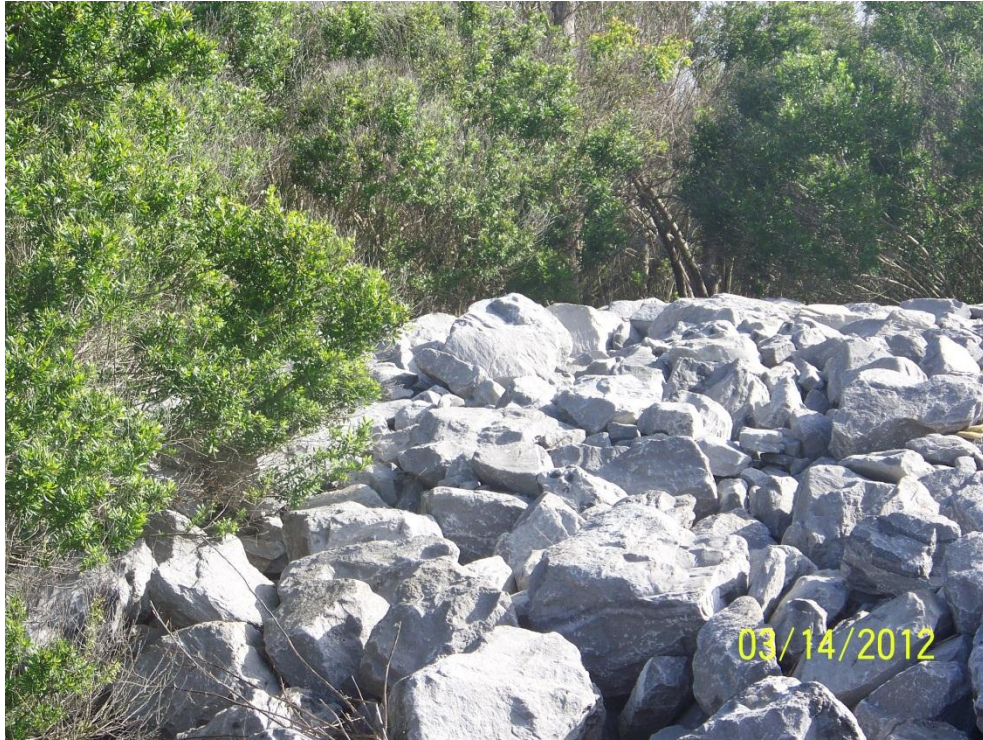
Rock Plug No. 2 (see Appendix B, photo # 1-3)

Rock plug 2 appears to be in good overall condition. During its initial construction, the structure experienced some settlement of the rock riprap material and erosion causing a breach around its northern embankment tie-in. In order to repair this situation and prevent further breaching, extra rock riprap material was placed on this northern end of the structure raising its elevation. The as-built drawings indicate the north end was constructed to an elevation of approximately 5.5' NAVD with a gradual slope to the southern end at an elevation of approximately 3.0' NAVD. Our observations during the 2012 annual inspection are congruent with the as-built drawings, as the northern end is approximately 2.0'-3.0' higher in elevation than the southern end. There is no observed settlement from the construction height and no evidence of water breaching the embankment tie-ins. There are no recommendations for repair at this time.

Photo 1: Overall view of Rock Plug 2 and warning signs, looking east

Photo 2: View of the embankment tie-in on the southern end of Rock Plug 2, looking south

Photo 3: View of the embankment tie-in on the northern end of Rock Plug 2, looking north

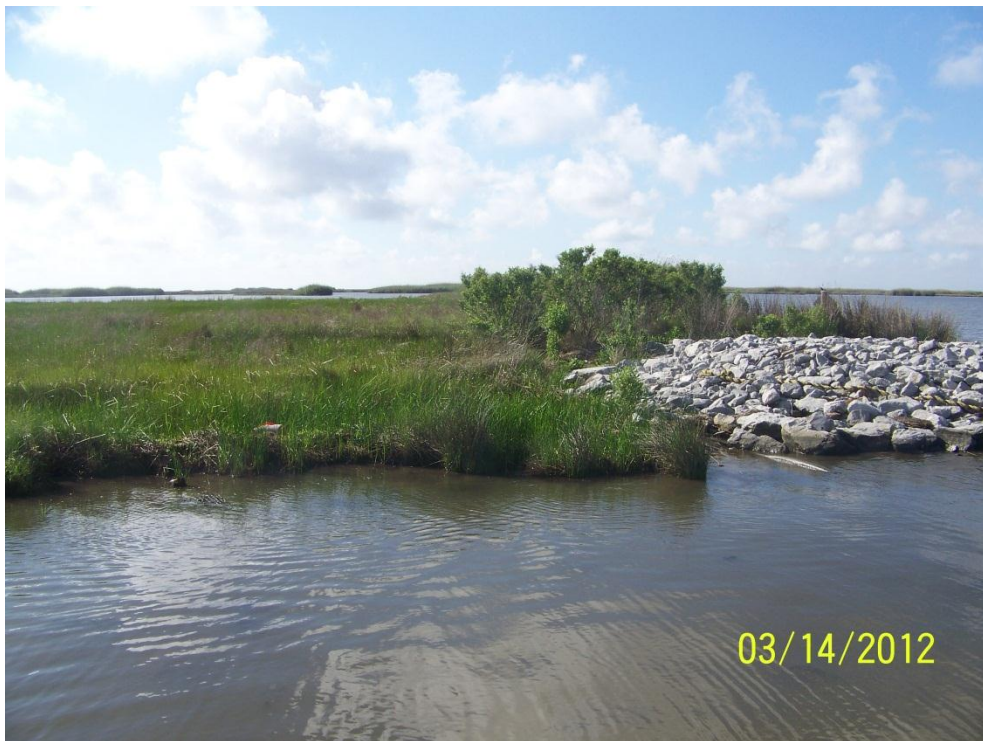
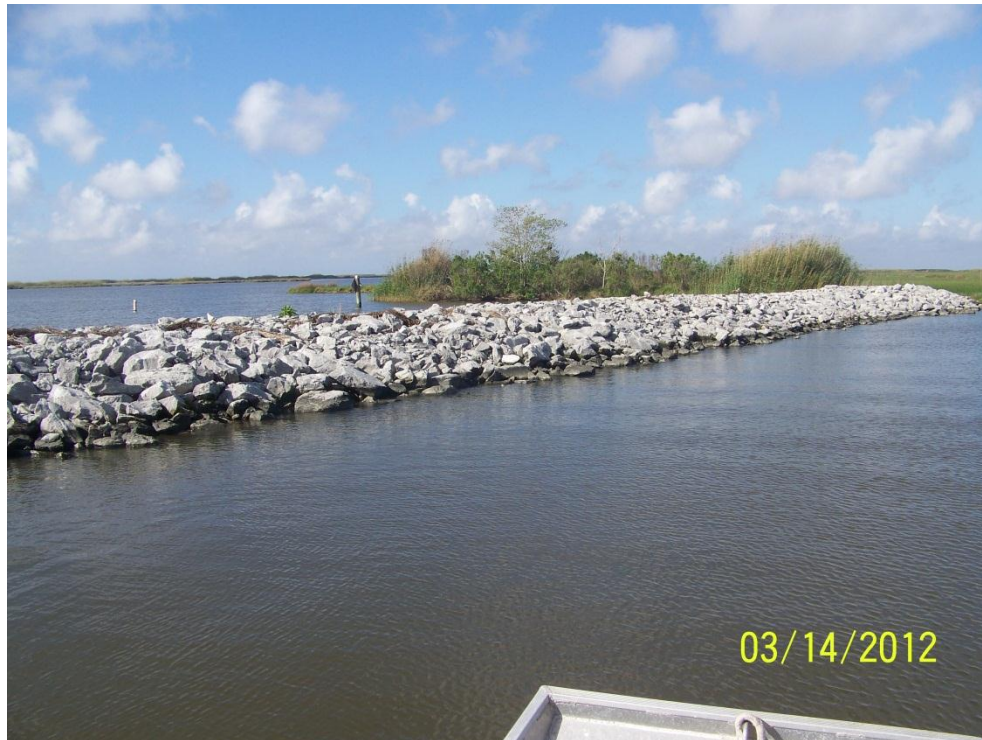
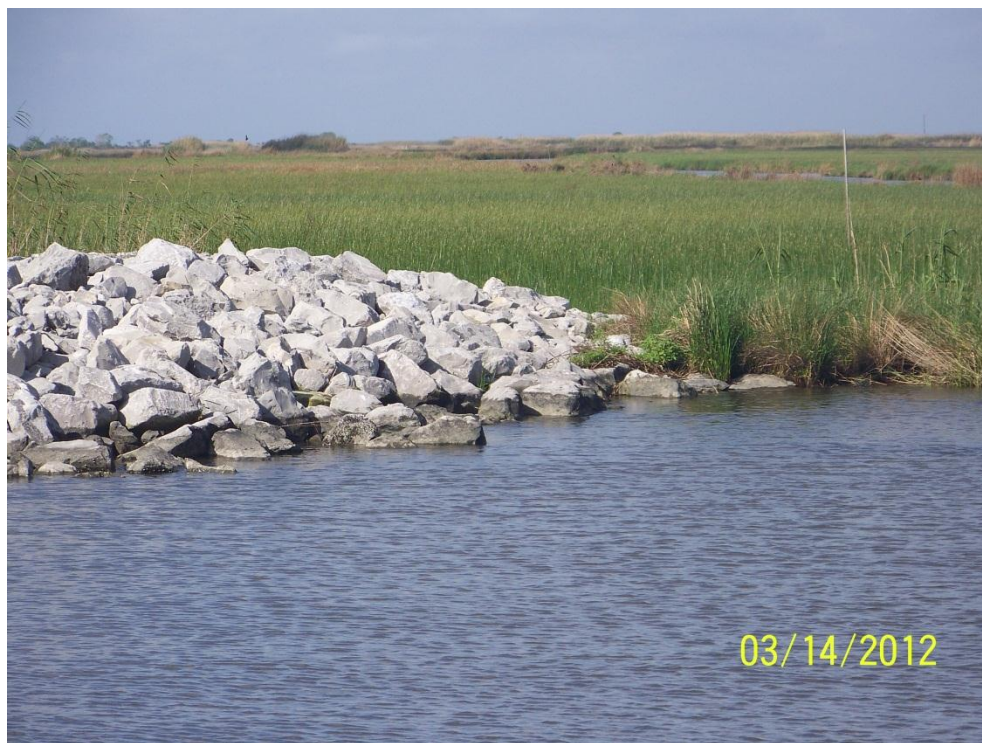
Rock Plug No. 1 (see Appendix B, photo # 4-6)

Rock Plug No.1 located along the south bank of Small Bayou LaPointe appeared to be in very good shape. There was no observed settlement or displacement of the rock. There was no erosion or washouts around the embankment tie-ins. The rock plug is still functioning as designed; therefore there are no recommendations for corrective action at this time.

Photo 4: View of the embankment tie-in on the eastern side of Rock Plug 1, looking south

Photo 5: Overall view of Rock Plug 1, looking southwest

Photo 6: View of the embankment tie-in on the western side of Rock Plug 1, looking south

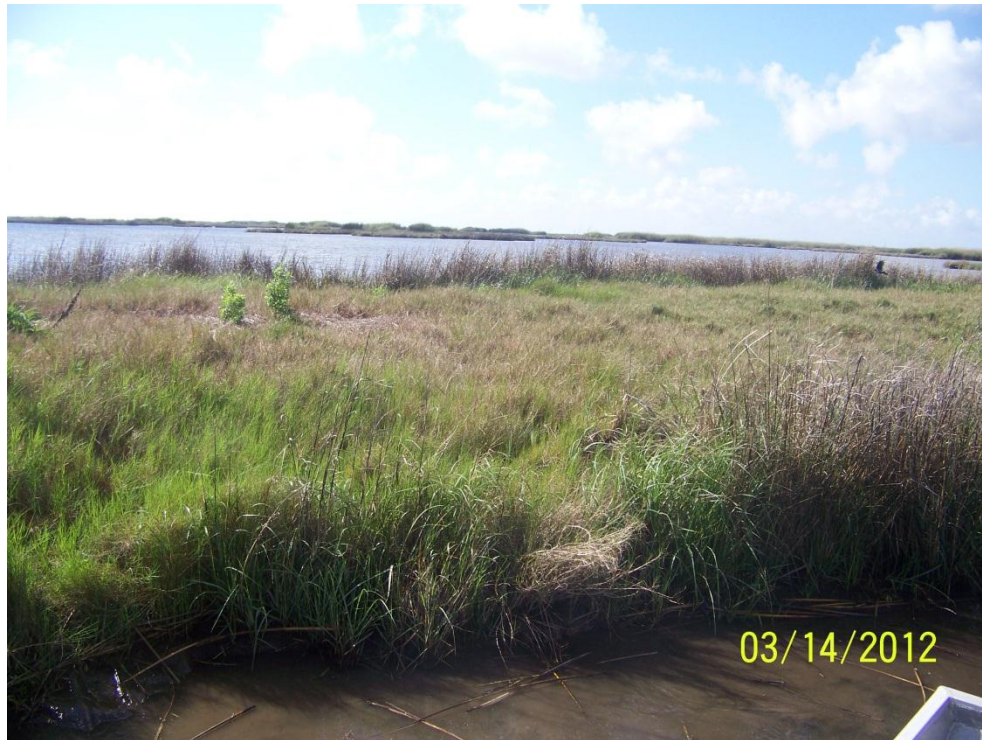
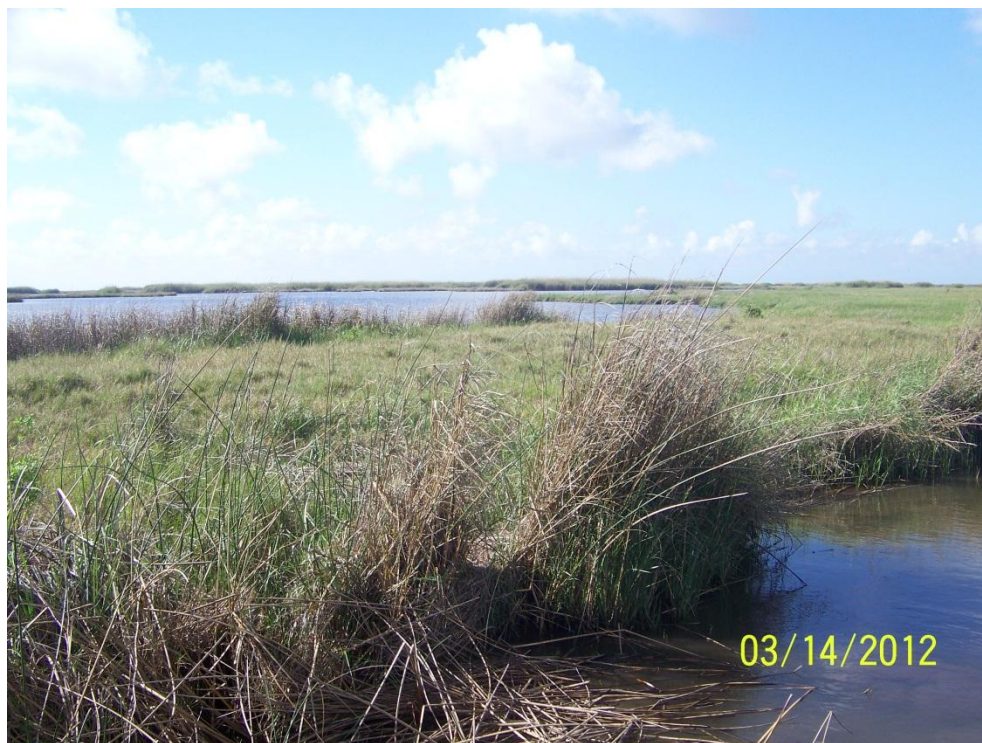
Earthen Plug No. 2 (see Appendix B, photo # 7-8)

The earthen plug 2 structure located along the southern edge of Small Bayou LaPointe is difficult to access and difficult to locate now that the structure has fully vegetated. The earthen plug has a slightly higher elevation than the adjacent marsh. The structure is in good overall condition with no observed settlement or erosion of the plug. In addition, there are no signs of erosion around the plug or around the embankment tie-ins. There are no recommendations for corrective action at this time.

Photo 7: View of Earthen Plug 2 from Small Bayou LaPointe, looking southwest

Photo 8: View of Earthen Plug 2 from Small Bayou LaPointe, looking southwest

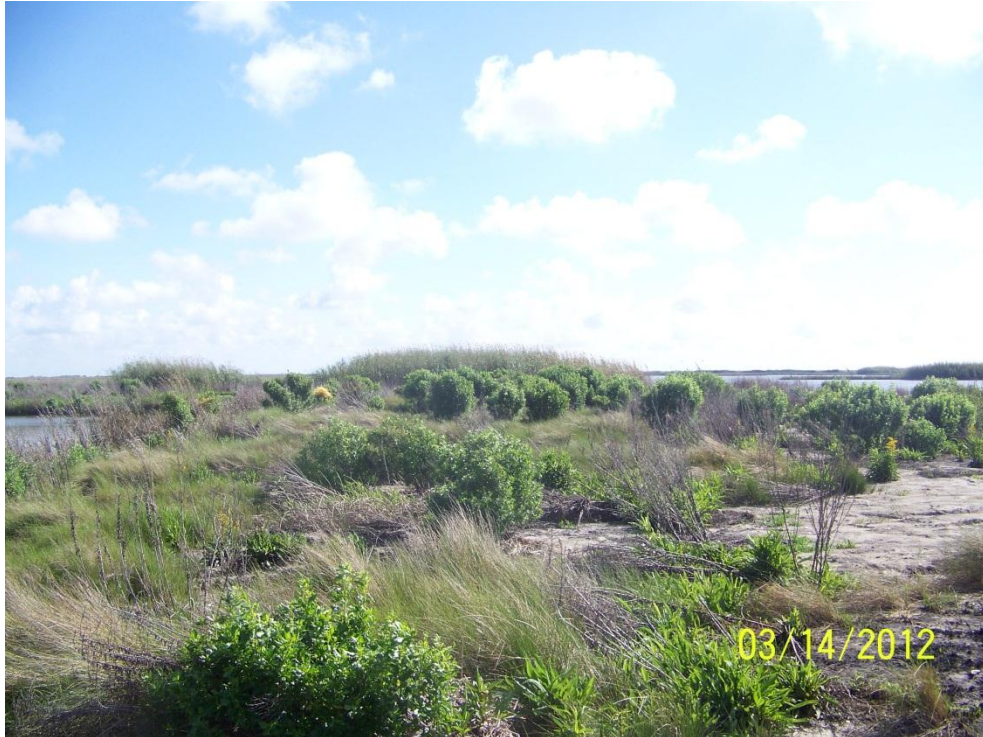
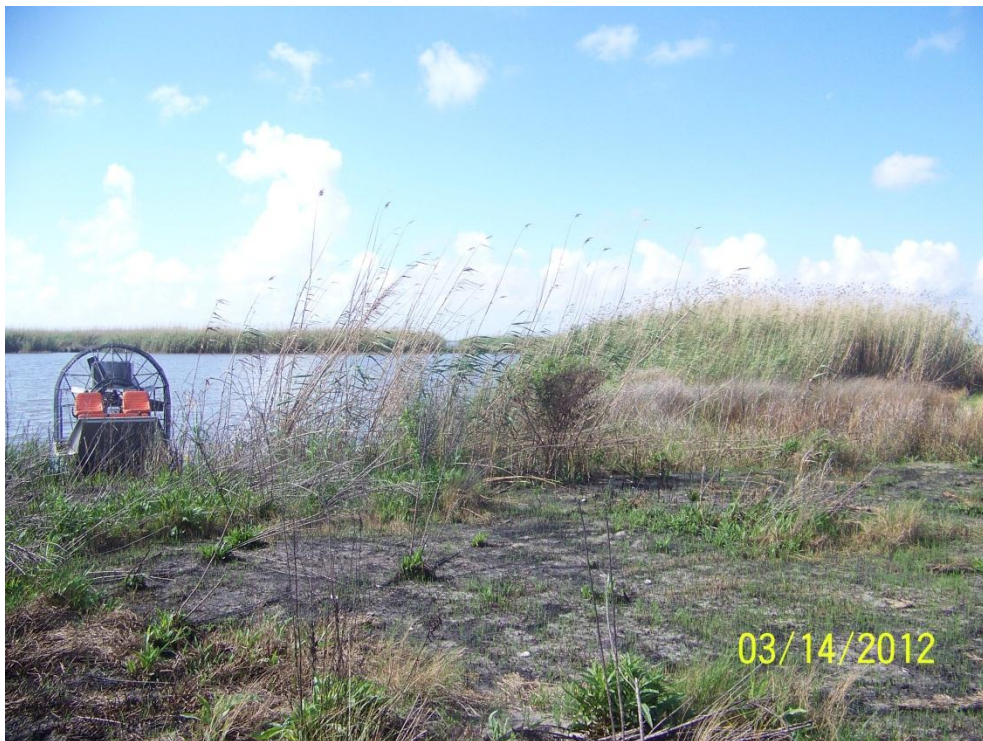
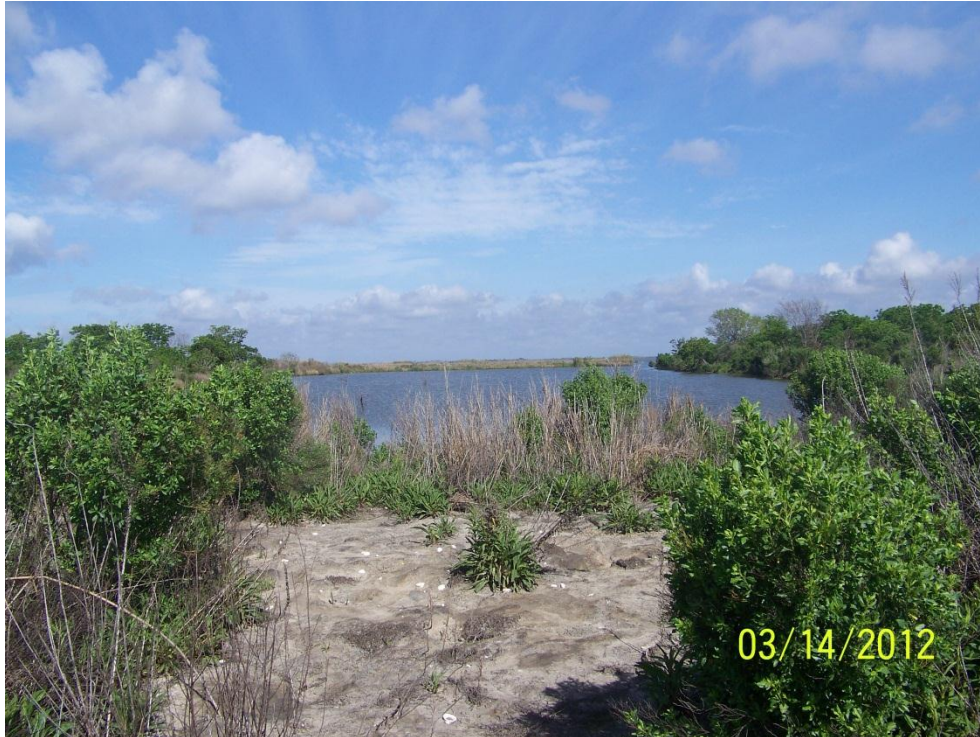
Earthen Plug No. 3 (see Appendix B, photo # 9-11)

Earthen plug 3 appears to be in good condition. This structure located between fill areas 7 & 8 has been partially vegetated with about half of the surface of the plug composed of the original construction material. The structure is in good overall condition with no observed settlement or erosion of the plug. In addition, there are no signs of erosion around the plug or around the embankment tie-ins. There are no recommendations for corrective action at this time.

Photo 9: View of Earthen Plug 3 from on top of the plug, looking northeast

Photo 10: View of Earthen Plug 3 from on top of the plug, looking southwest

Photo 11: View of Earthen Plug 3 from on top of the plug, looking northwest

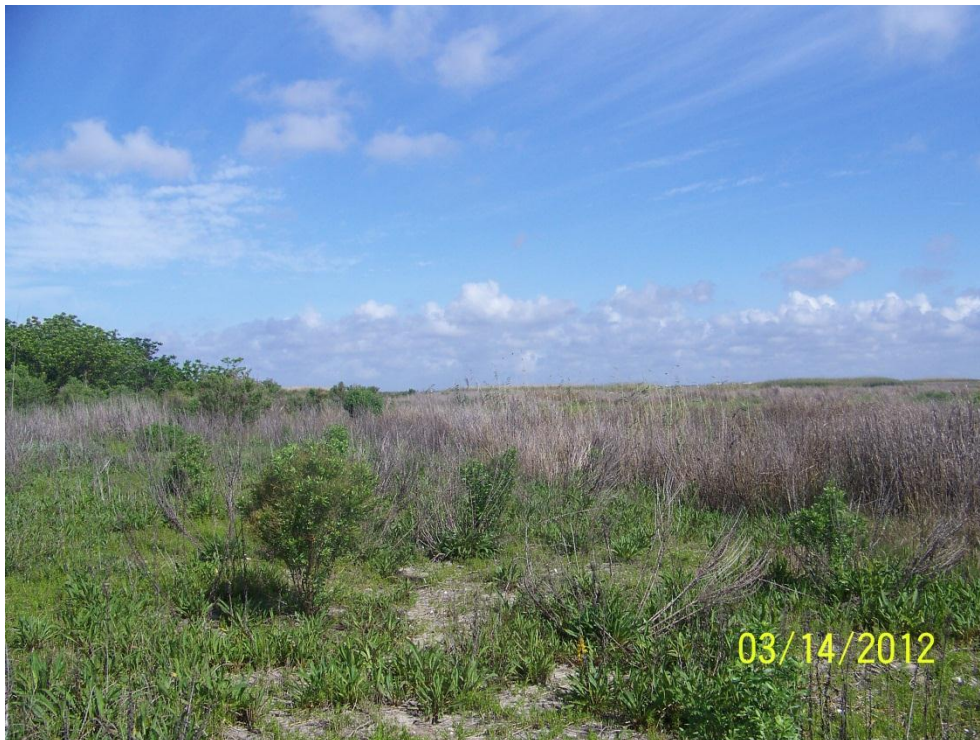
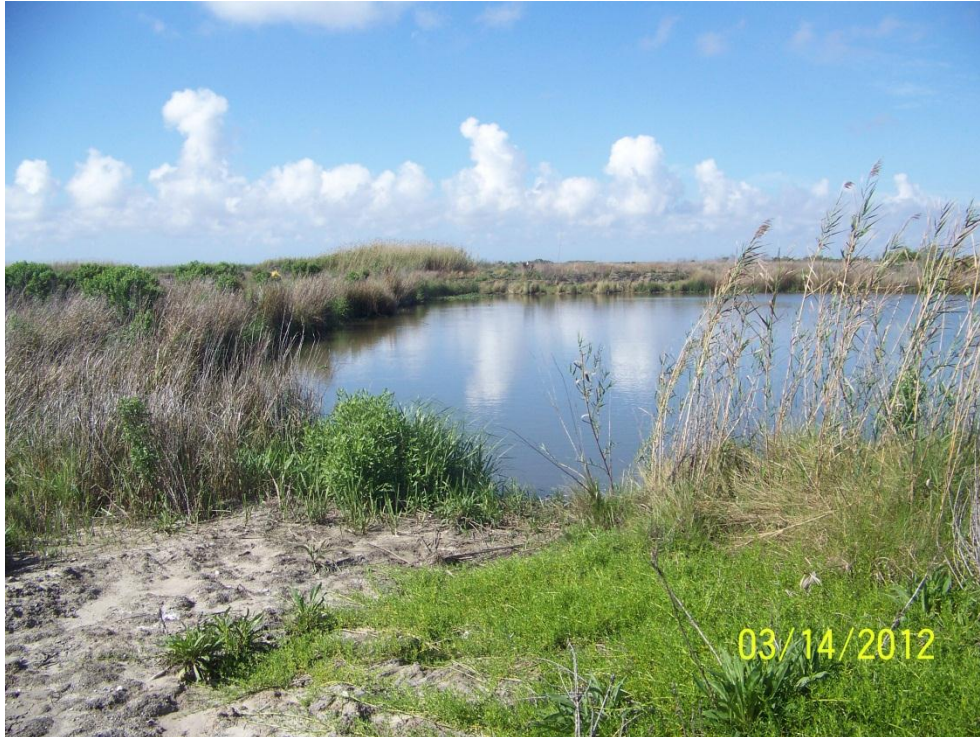
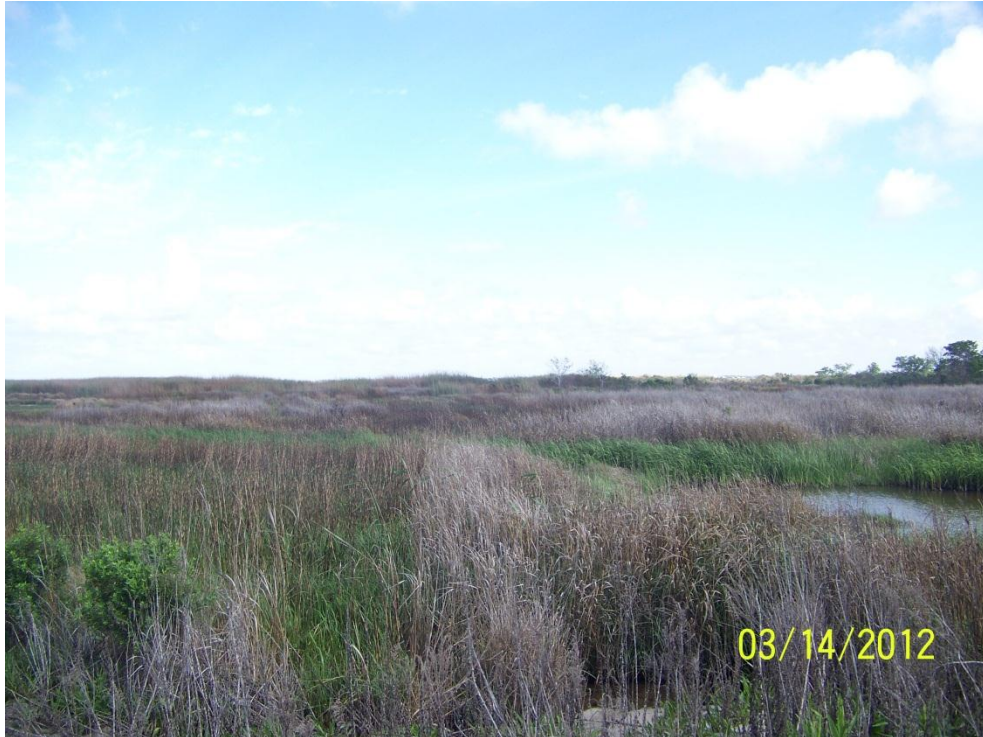
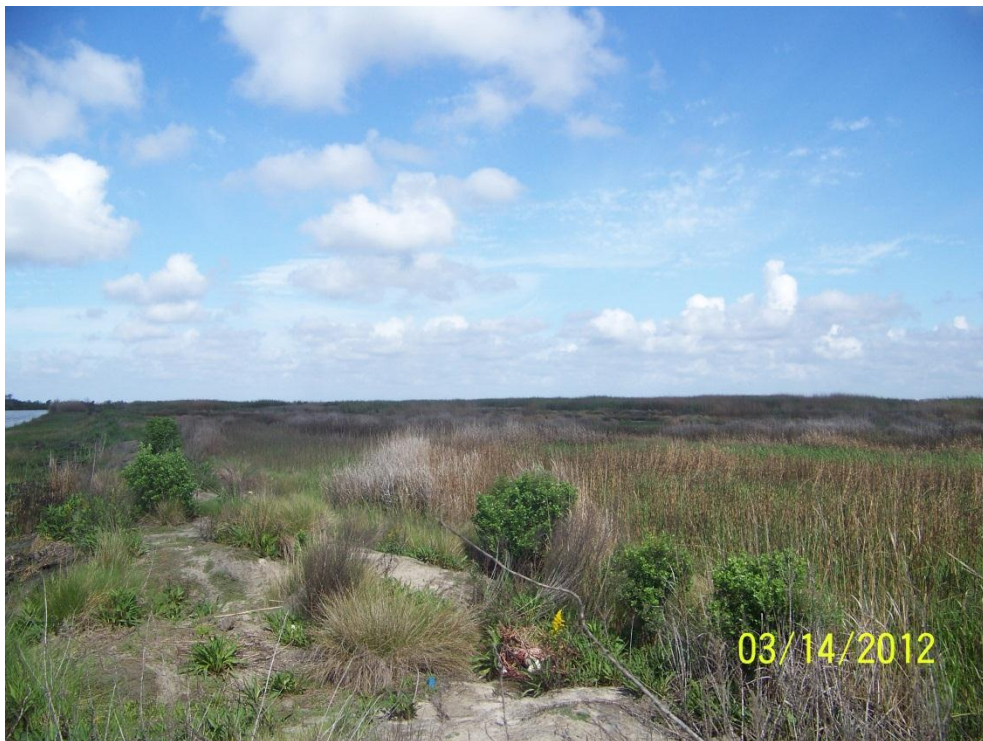
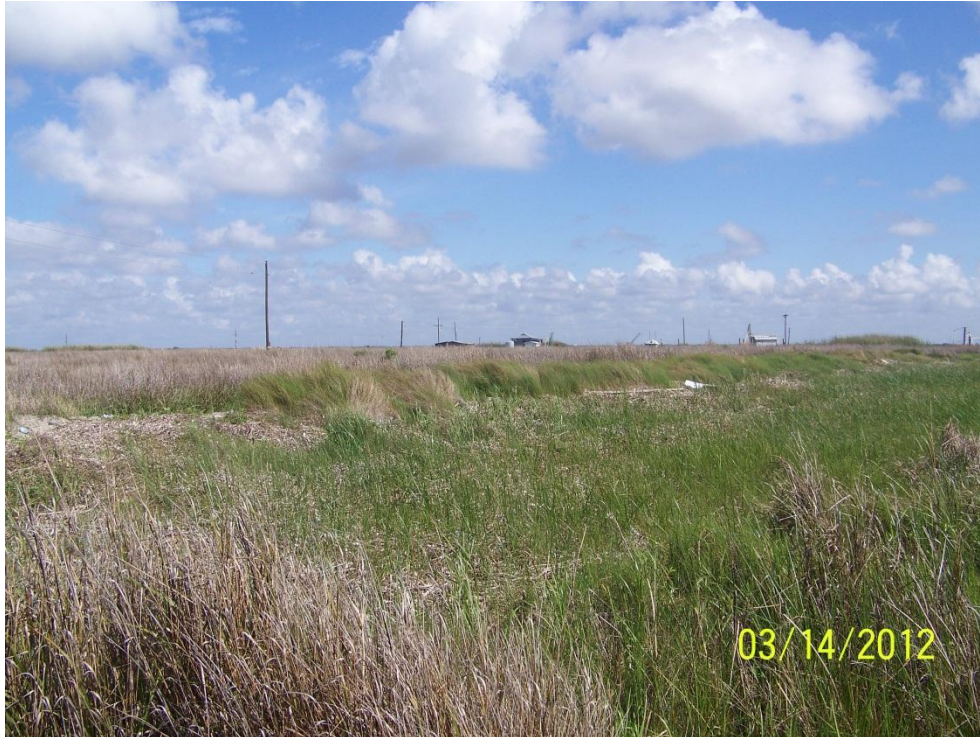
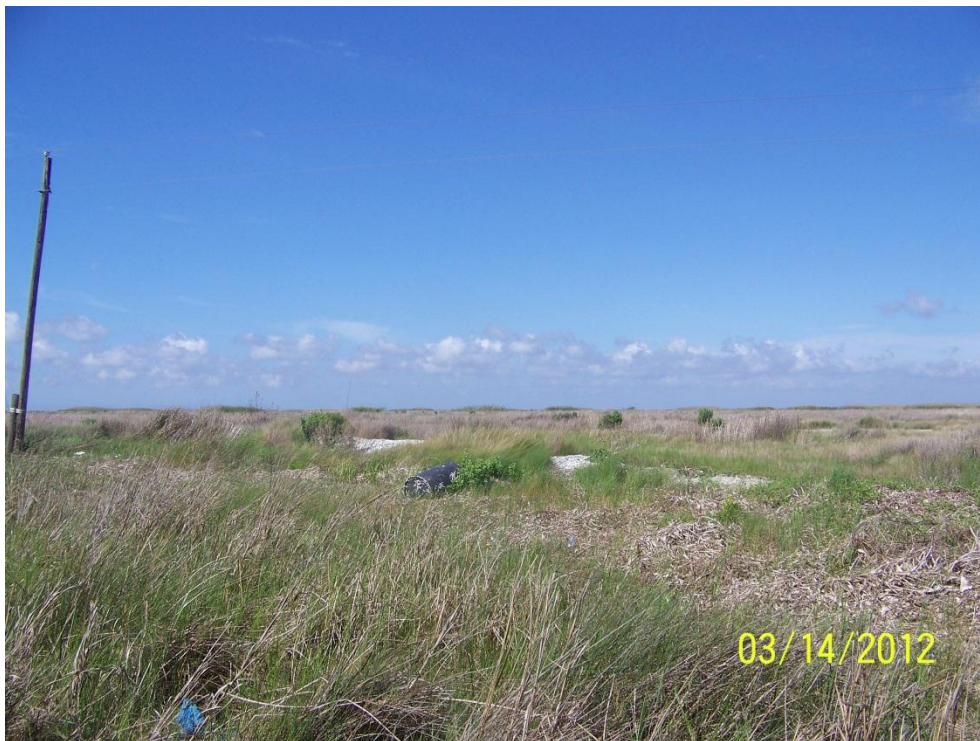
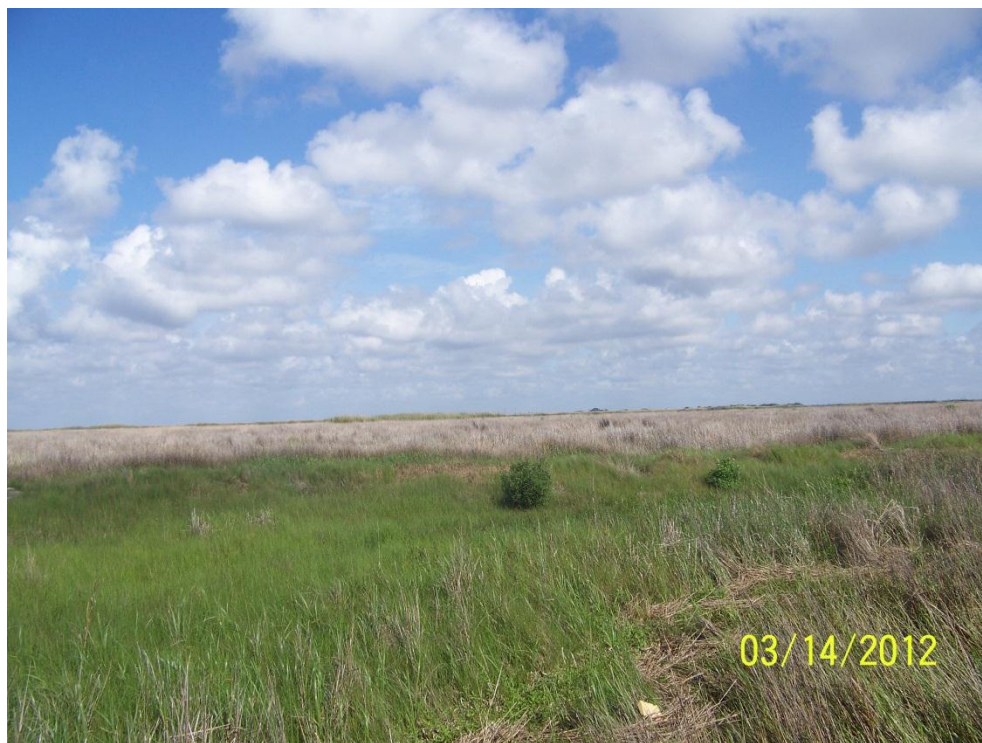
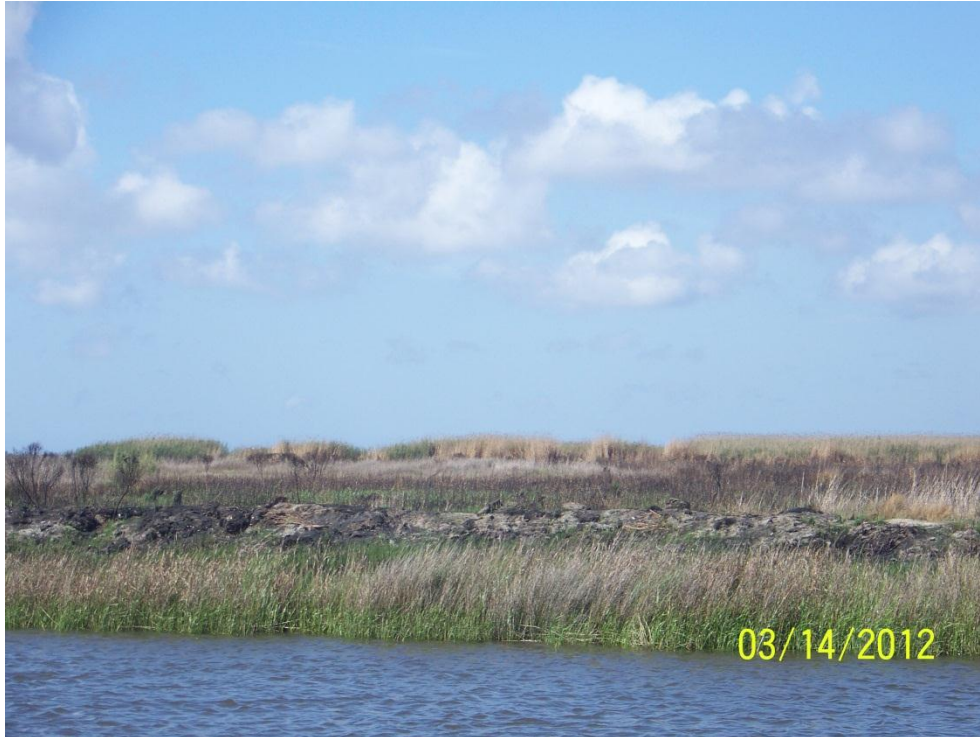
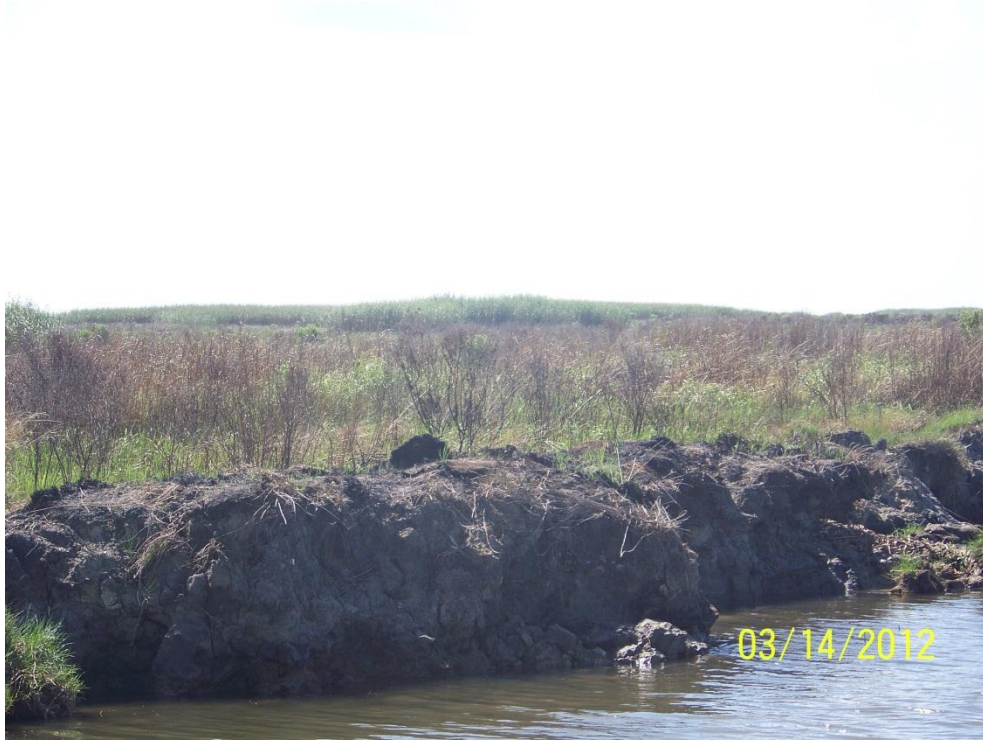
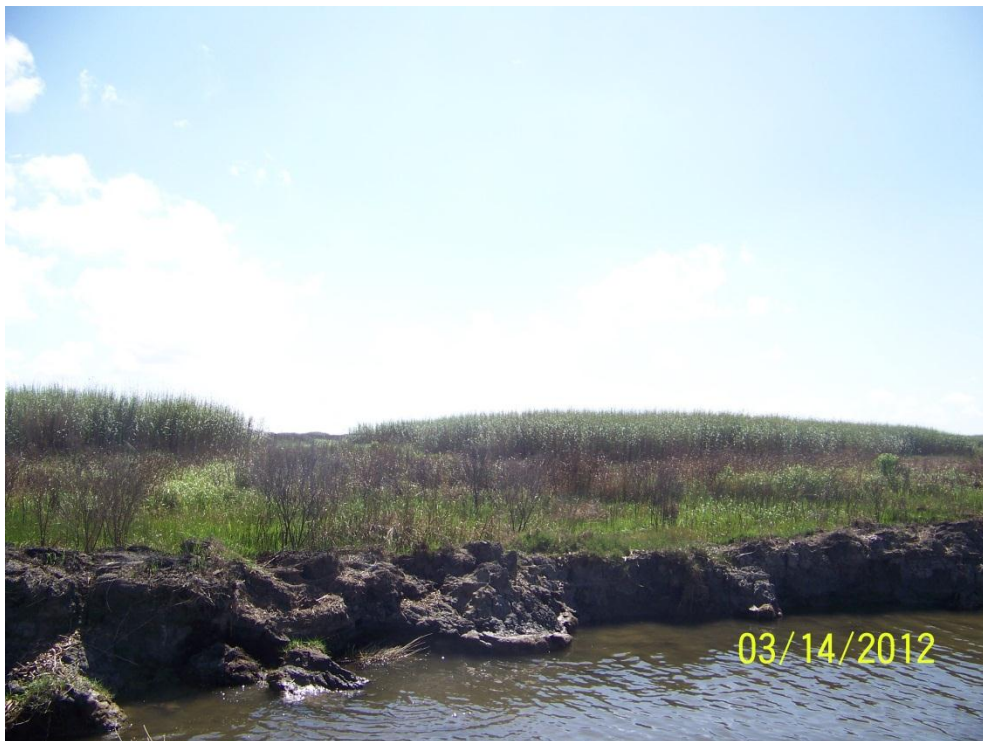
Dredged Material Fill Areas (see Appendix B, photo # 12-13, 19-20, 25-26, 30, 35, 43-44) Due to access constraints, all of the fill areas in the project were inspected and photographed from the perimeter of the individual areas. From our observations, it appears the fill areas are promoting the growth of vegetation, with the majority of the area vegetated. Also, there are no signs of extreme settlement of the fill material, as the elevation of the fill area remains fairly consistent with some slight variations as expected. Overall the fill areas appear to be in very good condition and there are no recommendations for corrective actions at this time.

Photo 12: View of Fill Area 8 from on top of Earthen Plug 3, looking north

Photo 13: View of Fill Area 7 from on top of Earthen Plug 3, looking west

Photo 19: View of Fill Area 8 from on top of Sheetpile Plug 3, looking northeast

Photo 20: View of Fill Area 8 from on top of Sheetpile Plug 3, looking northwest

Photo 25: View of Fill Area 5 from Bayou Raccourci, looking northwest

Photo 26: View of Fill Area 5 from Bayou Raccourci, looking southwest

Photo 30: View of Fill Area 4 from the northern edge of Lake Mechant, looking north

Photo 35: View of Fill Area 3 from near Sheetpile Plug 2, looking west

Photo 43: View of Fill Area 2A from Lake Pagie, looking southeast

Photo 44: View of Fill Area 2B from Lake Pagie, looking southeast

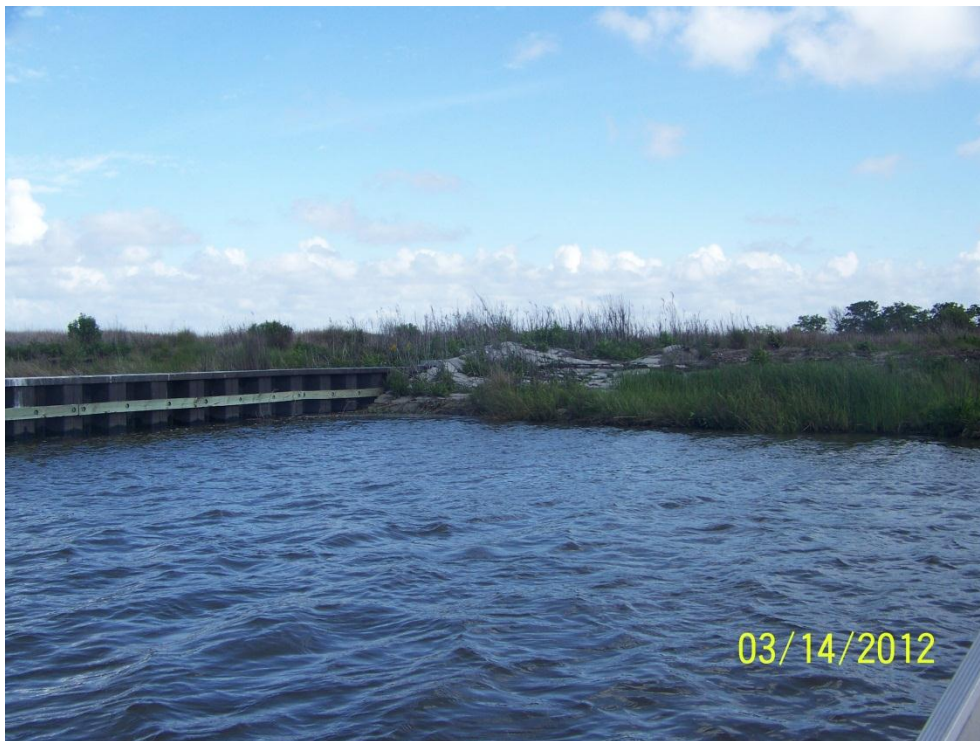
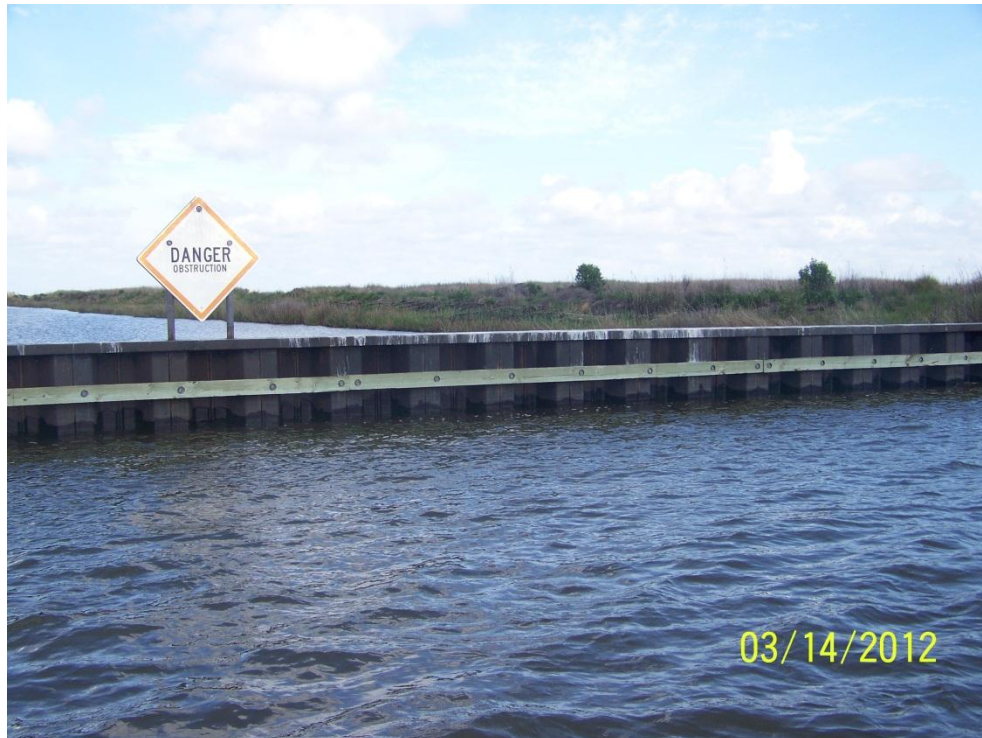
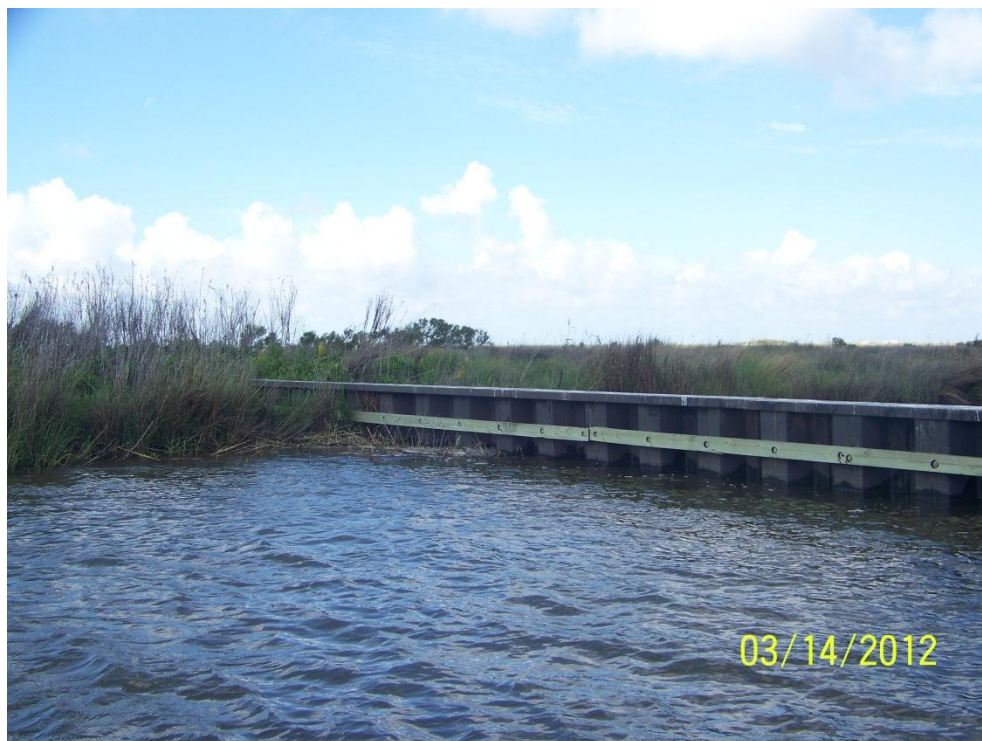
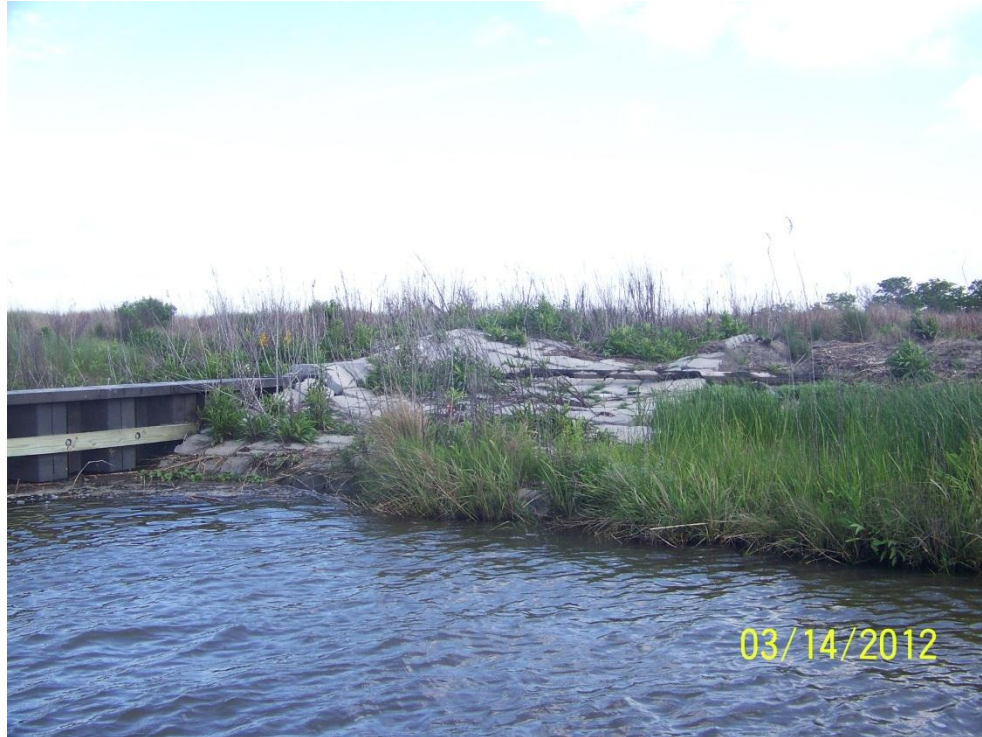
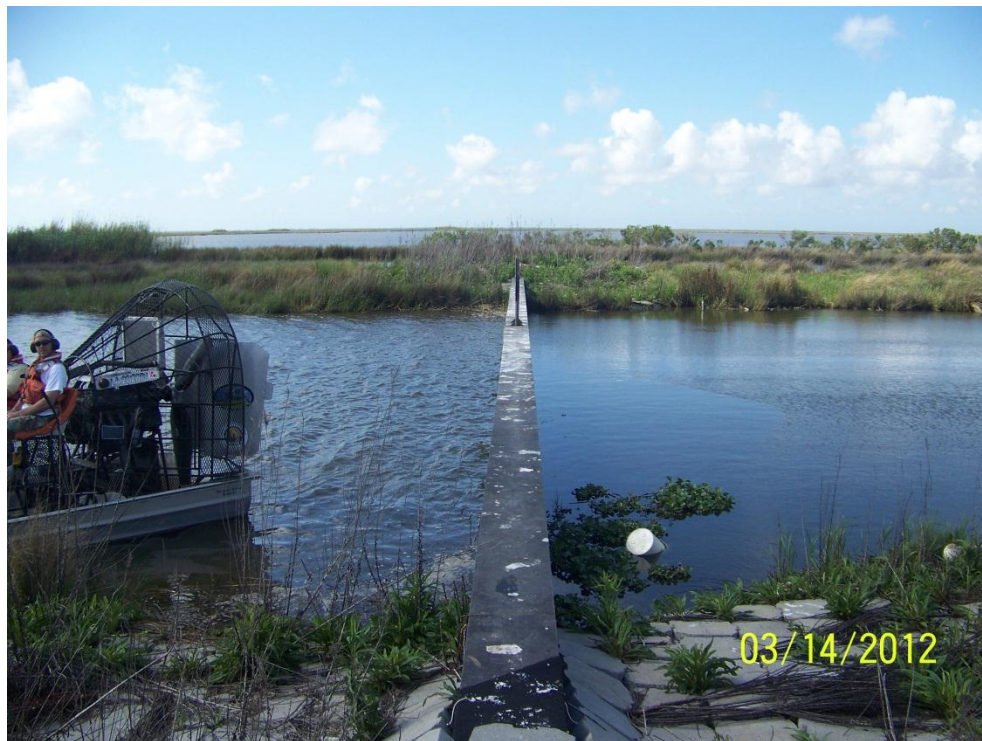
Sheet Pile Plug No. 3 (see Appendix B, photo # 14-18)

Sheet Pile Plug No. 3 appears to be in good overall condition. The sheet pile and top cap showed no signs of damage or corrosion, and the embankment tie-ins had no signs of erosion or washouts. In addition, the warning signs were intact and visible. There are no recommendations for corrective action at this time.

Photo 14: View of northeast embankment tie-in of Sheetpile Plug 3, looking north

Photo 15: View of Sheetpile Plug 3, looking northwest

Photo 16: View of southwest embankment tie-in of Sheetpile Plug 3, looking west

Photo 17: View of articulated concrete mat used to armor the embankment tie-in on Sheetpile Plug 3

Photo 18: View of top cap of Sheetpile Plug 3, looking southwest
