2012 Annual Inspection Report

**North Lake Mechant Landbridge
Restoration Project (TE-44)**

State Project Number TE-44
Priority Project List 10

July 10, 2012
Terrebonne Parish

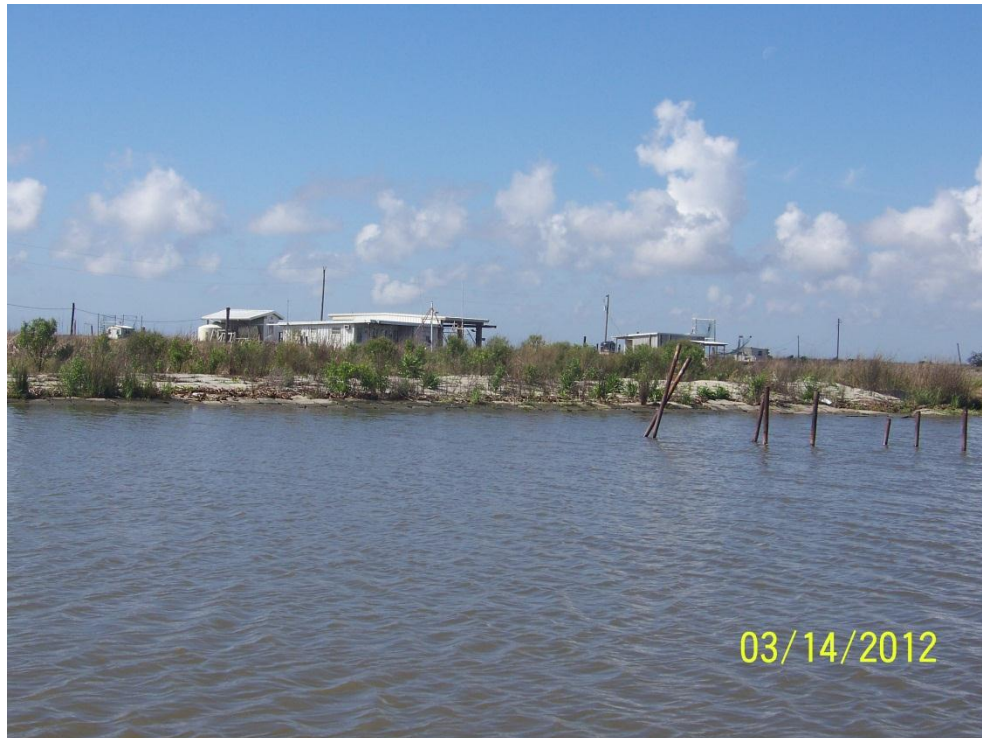
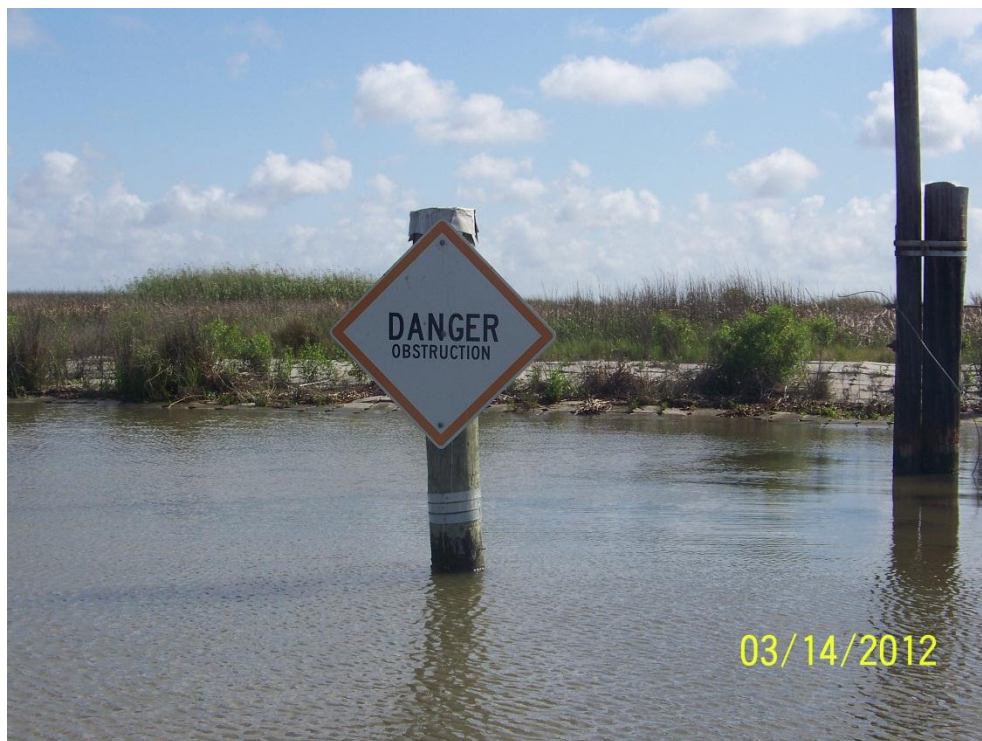
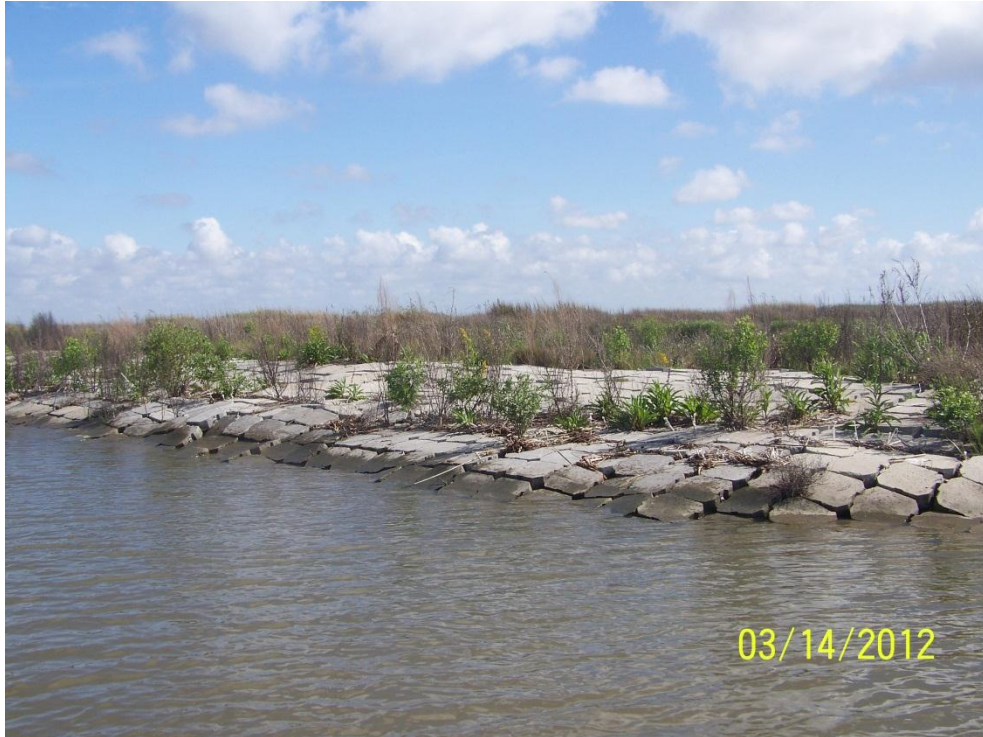
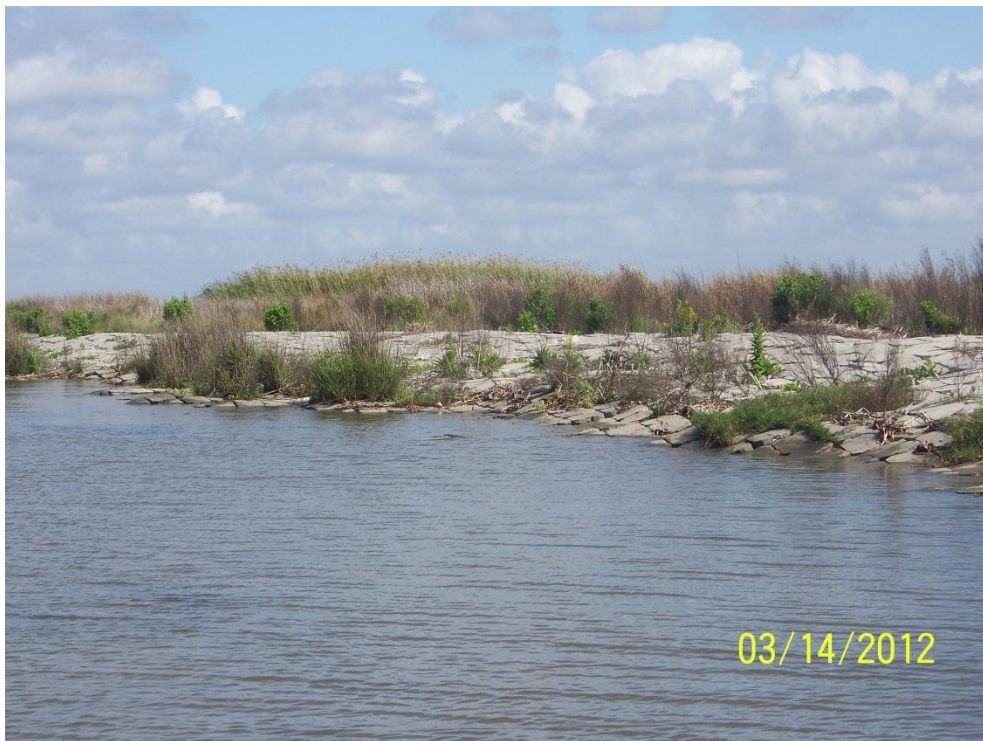
Armored Earthen Dike (see Appendix B, photo # 21-24)

The armored earthen dike on the west bank of Bayou Raccourci appears to be in good overall condition. The warning sign and its support timber show no signs of damage. The articulated concrete mats are still coupled by the copolymer rope with vegetation emerging through the seams. As expected, there is some variation in height along the length of the armored earthen dike. This is believed to be caused by a difference in dredged material settling at different rates under the weight of the articulated concrete mats and placement of the mats on earthen material that was not fully compacted. The armored earthen dike is

still performing as designed; therefore, there are no recommendations for corrective actions at this time.

Photo 21: View of Armored Earthen Dike along Bayou Raccourci, looking southeast

Photo 22: View of warning signs in Bayou Raccourci used to mark the Armored Earthen Dike

Photo 23: Close up view of articulated concrete mats along Bayou Raccourci, looking east

Photo 24: Close up view of articulated concrete mats along Bayou Raccourci, looking east

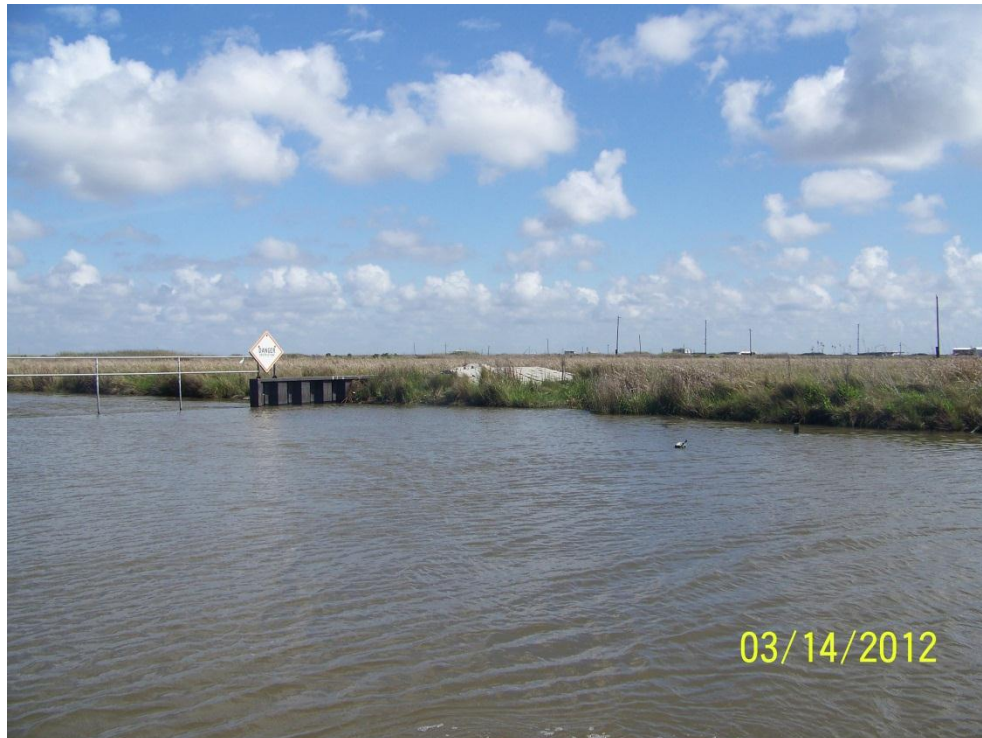
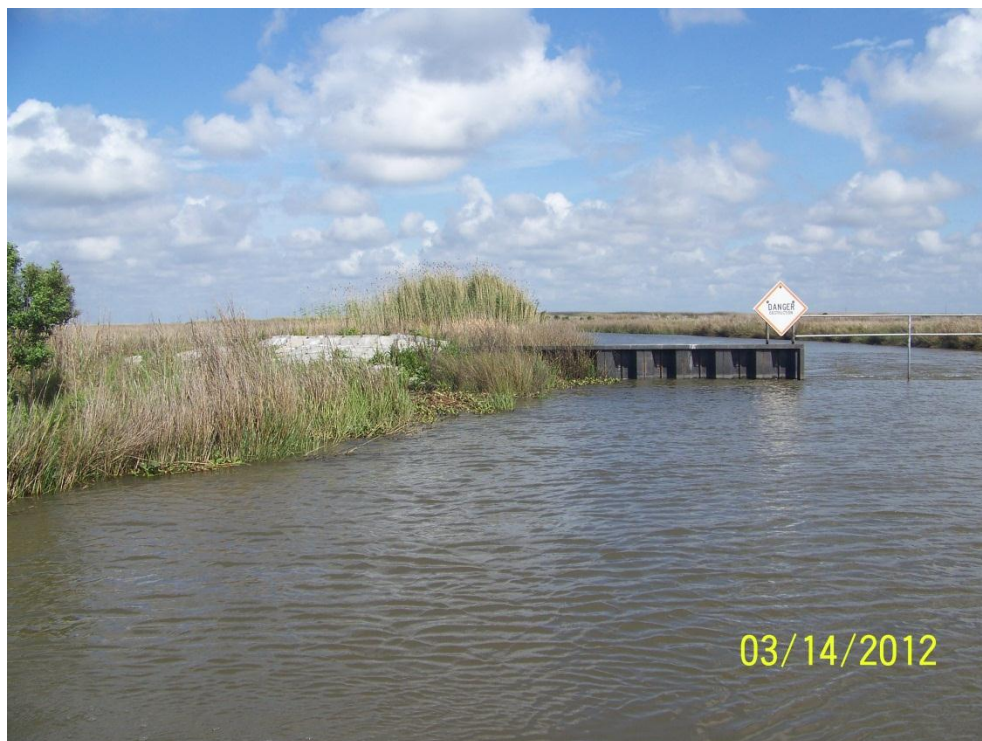
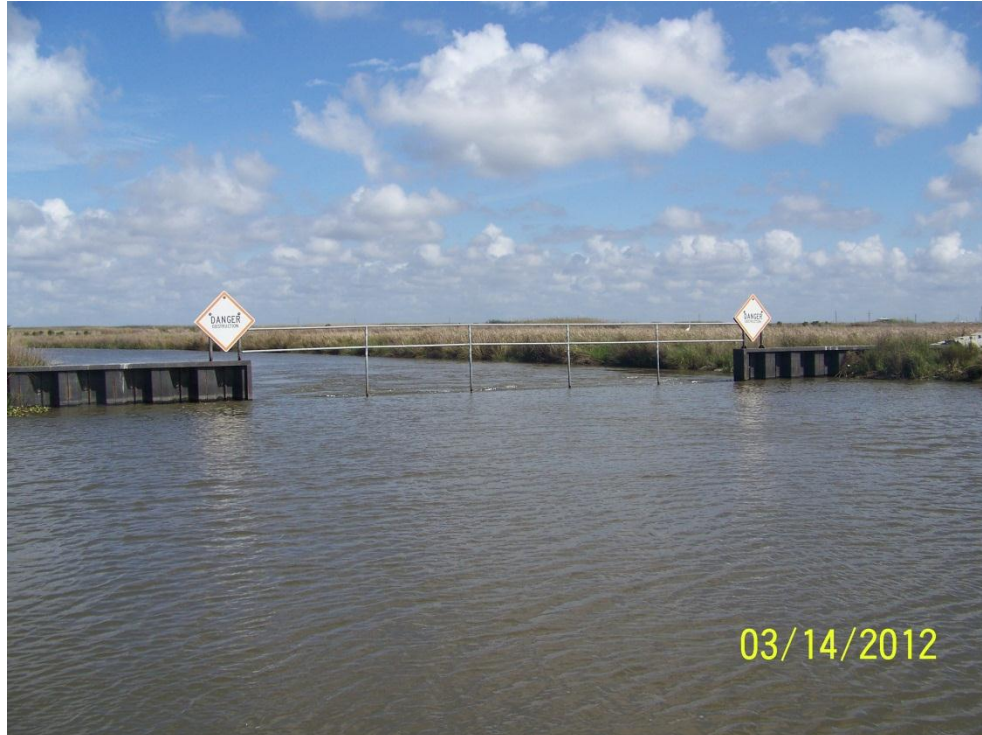
Sheet Pile Weir (existing weir replacement) (see Appendix B, photo # 27-29)

The sheet pile weir appears to be in good overall condition. There are no signs of corrosion or damage to the sheet pile or top cap. There appears to be no erosion or washouts around the embankment tie-ins. The warning signs and supports are also in good condition. There are no recommendations for corrective action at this time.

Photo 27: View of the Sheetpile Weir embankment tie-in on the east side, looking north

Photo 28: View of the Sheetpile Weir embankment tie-in on the west side, looking north

Photo 29: Overall view of Sheetpile Weir, looking north

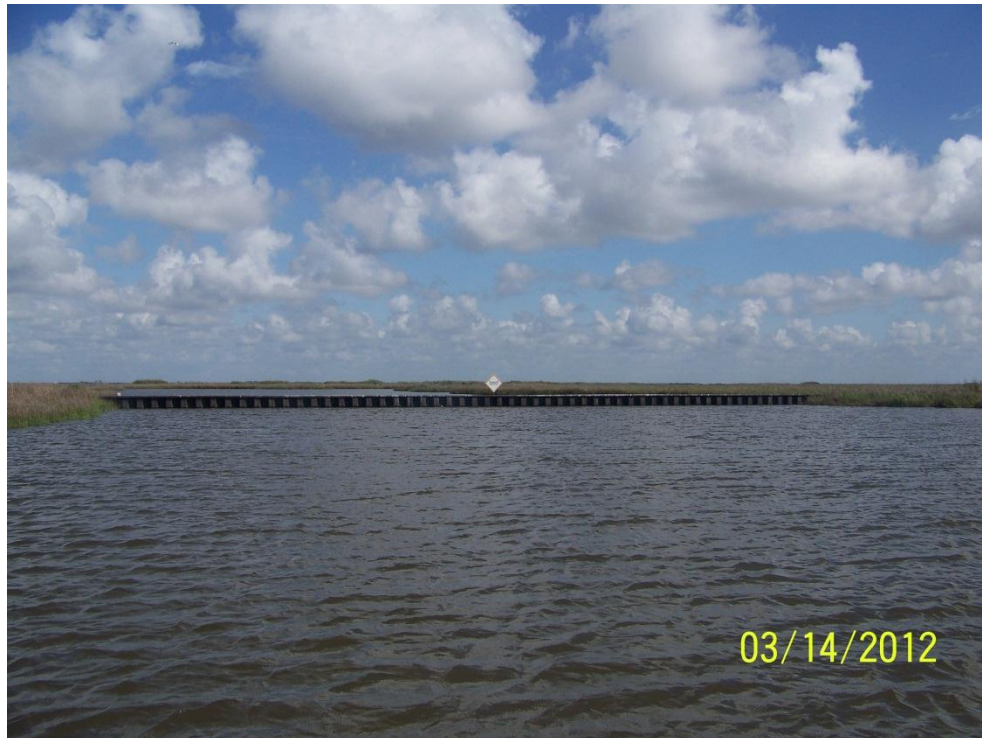
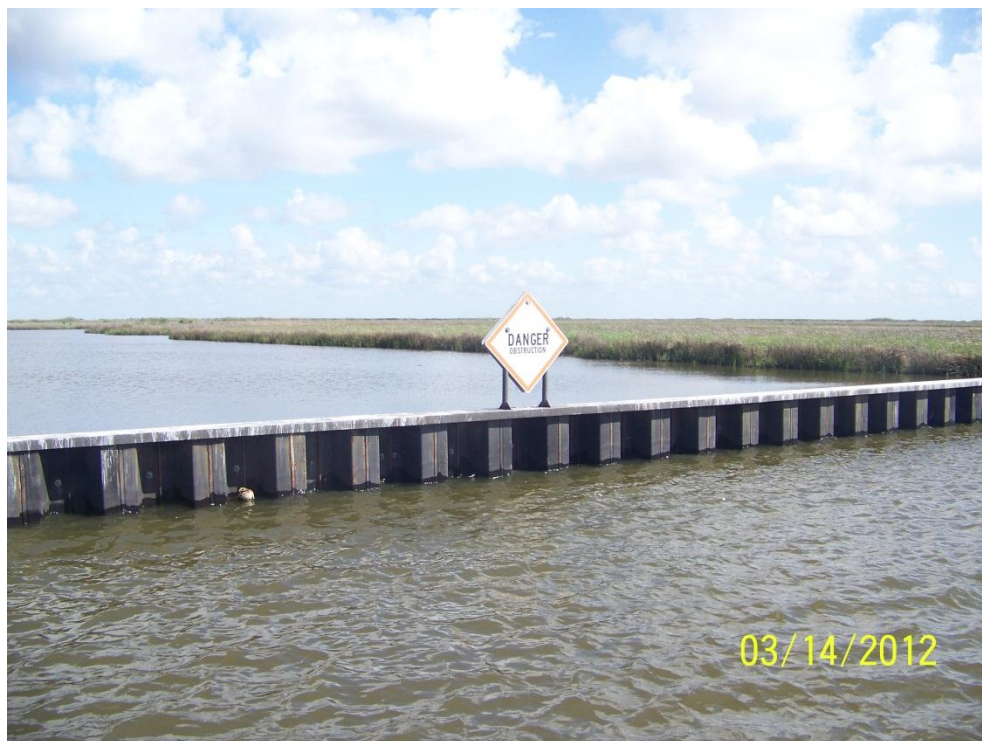
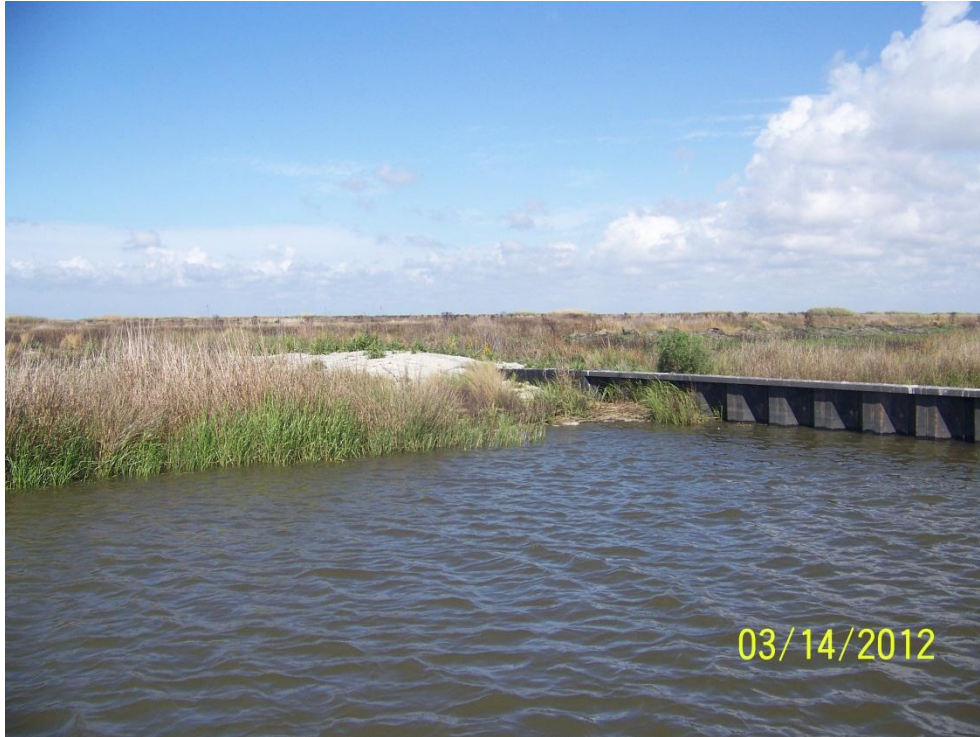
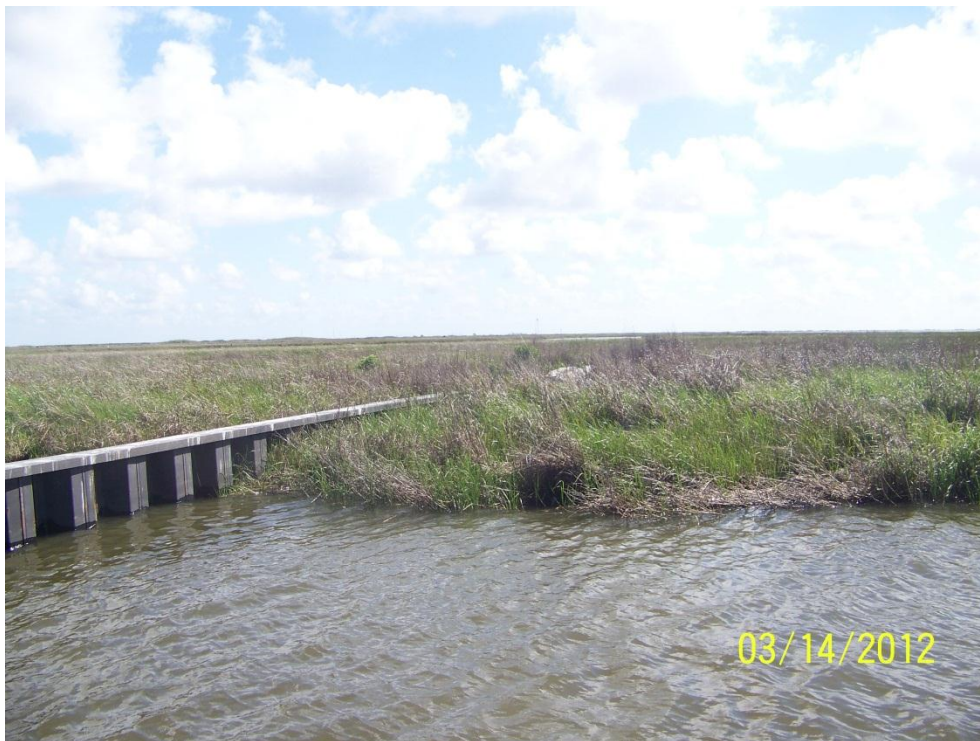
Sheet Pile Plug No. 2 (see Appendix B, photo # 31-34)

Sheet Pile Plug No. 2 appears to be in good overall condition. The sheet pile and top cap showed no signs of damage or corrosion, and the embankment tie-ins had no signs of erosion or washouts. In addition, the warning signs were intact and visible. There are no recommendations for corrective action at this time.

Photo 31: Overall view of Sheetpile Plug 2, looking north

Photo 32: Close up view of warning sign on Sheetpile Plug 2, looking north

Photo 33: View of the armored earthen embankment tie-in on the west side of Sheetpile Plug 2

Photo 34: View of the armored earthen embankment tie-in on the east side of Sheetpile Plug 2

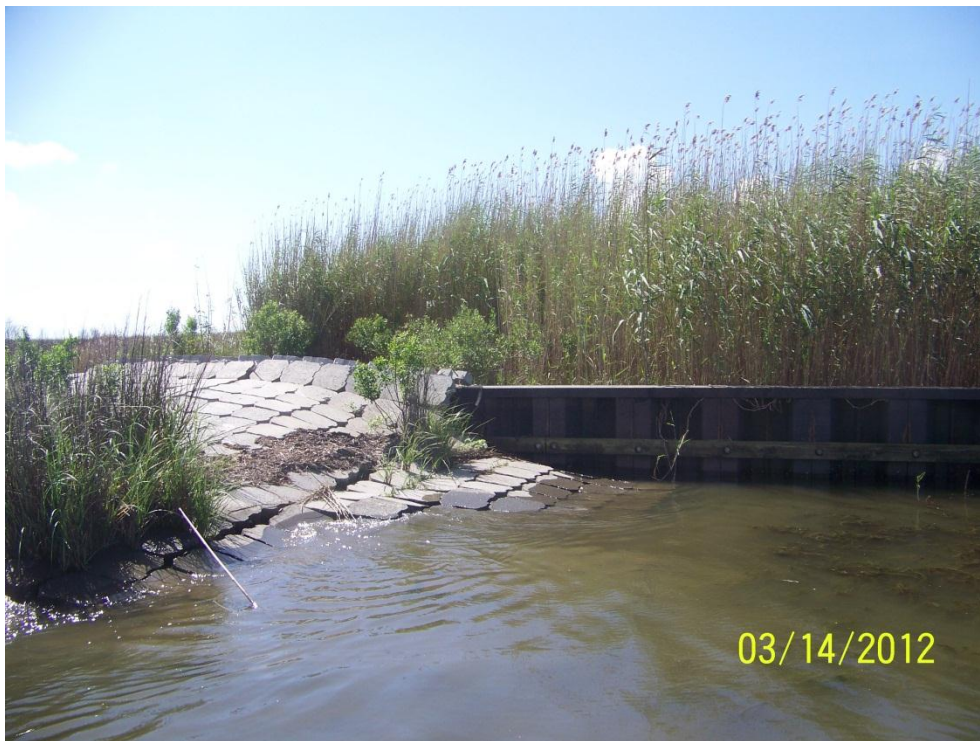
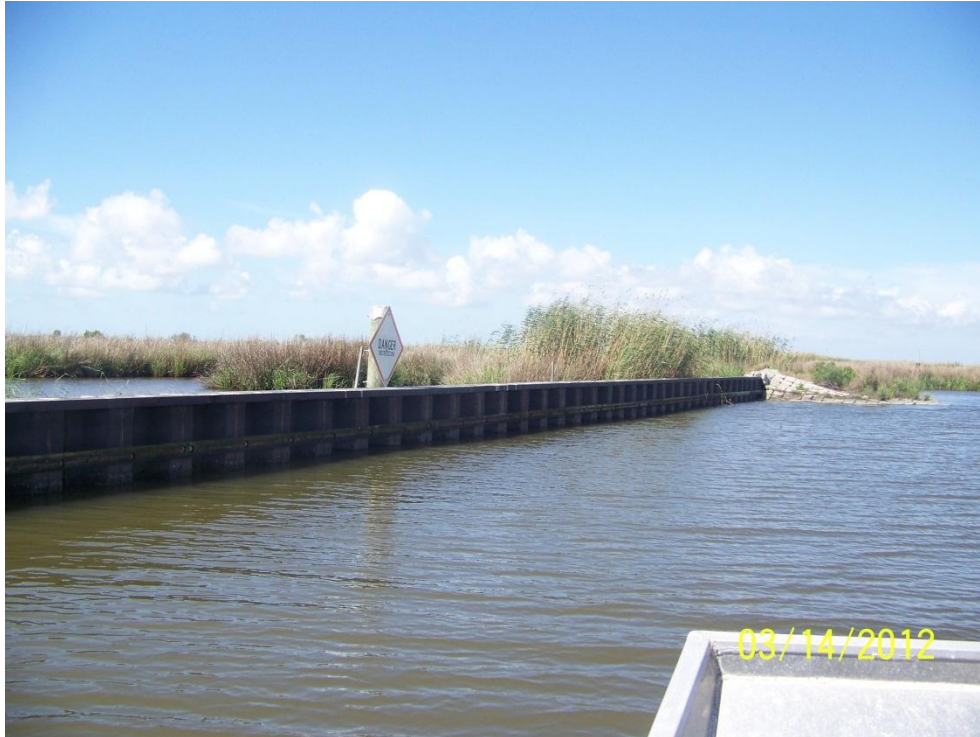
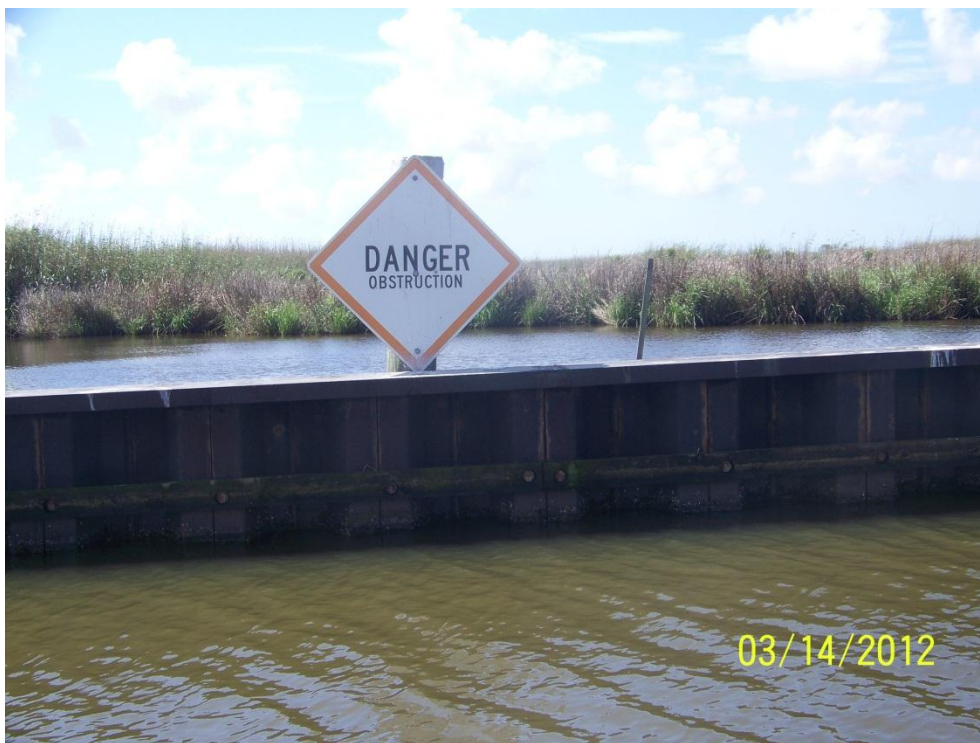
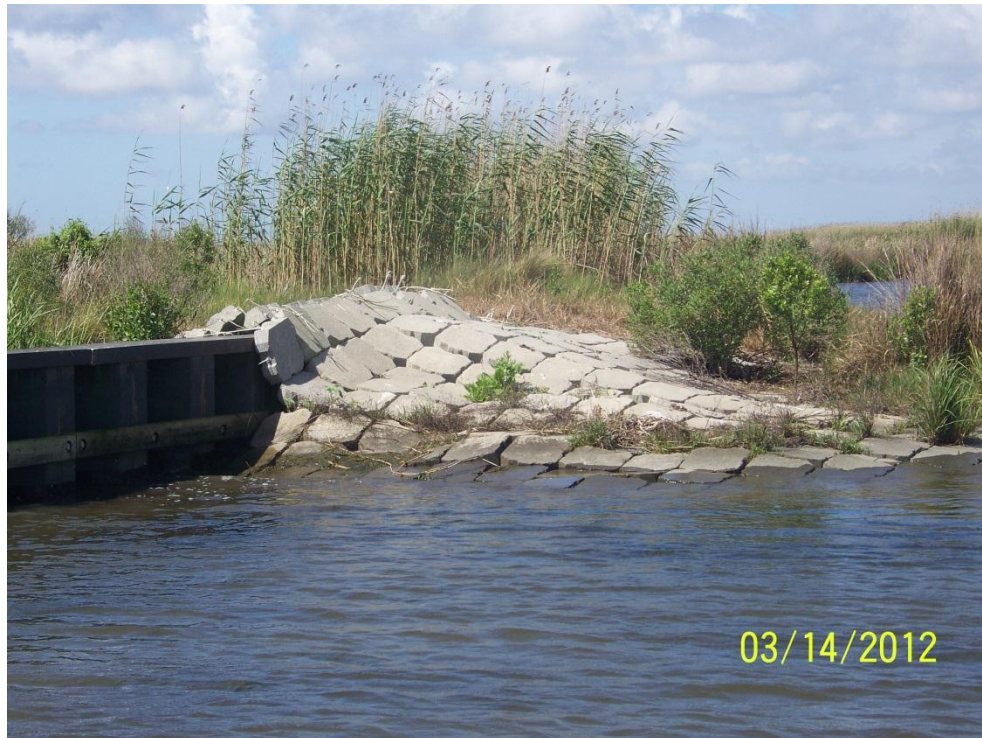
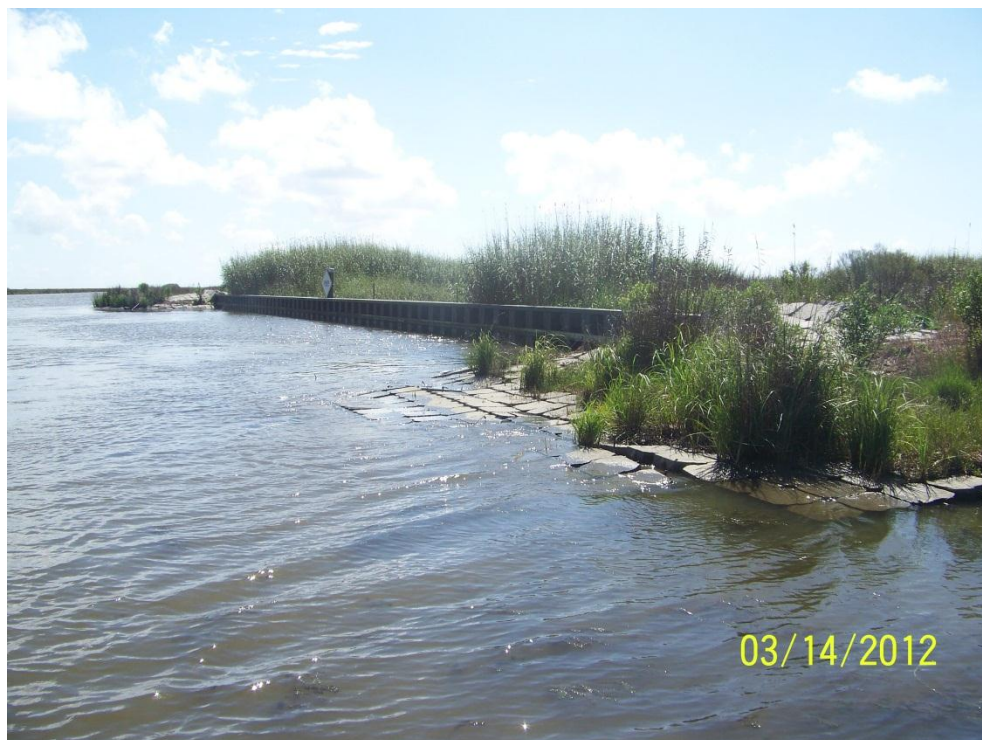
Sheet Pile Plug No. 1 (see Appendix B, photo # 36-40)

Sheet pile plug 1 is in good condition. There are no signs of settlement or corrosion of the sheet pile, cap, warning signs and supports. The embankment tie-ins are armored with articulated concrete mats and also show no signs of settlement or erosion around its ends. The structure appears to be stable and functioning as intended. There are no recommendations for corrective actions at this time.

Photo 36: View of the armored earthen embankment tie-in on the eastern side of Sheetpile Plug 1, looking south

Photo 37: Overall view of Sheetpile Plug 1, looking southwest

Photo 38: Close up view of warning sign on Sheetpile Plug 1, looking south

Photo 39: View of the armored earthen embankment tie-in on the western side of Sheetpile Plug 1, looking southwest

Photo 40: Overall view of Sheetpile Plug 1, looking southeast

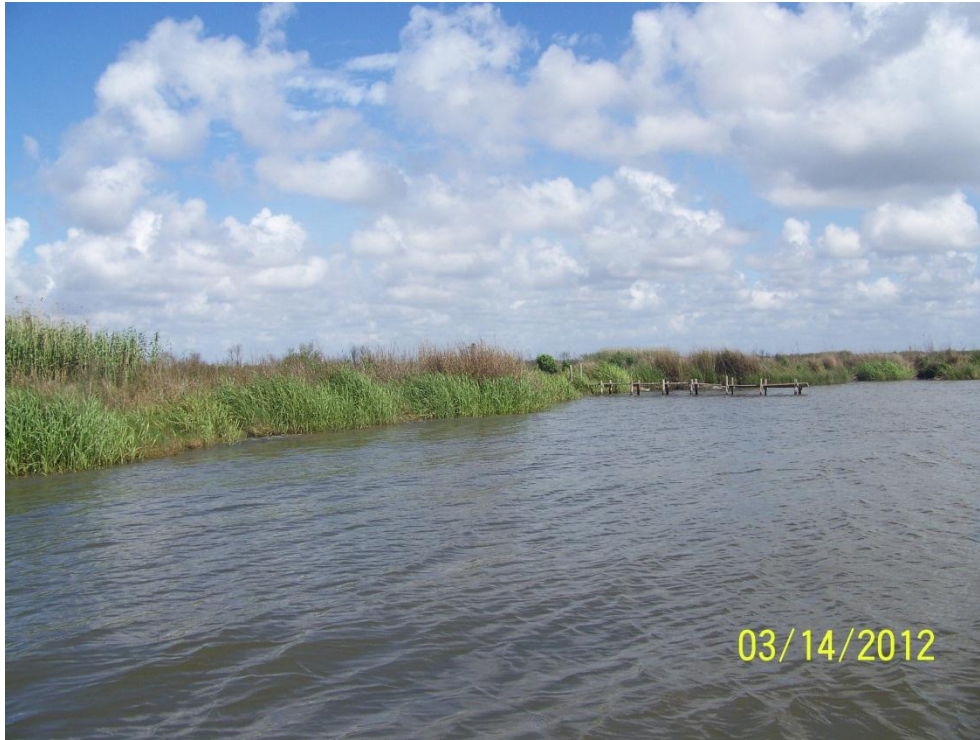
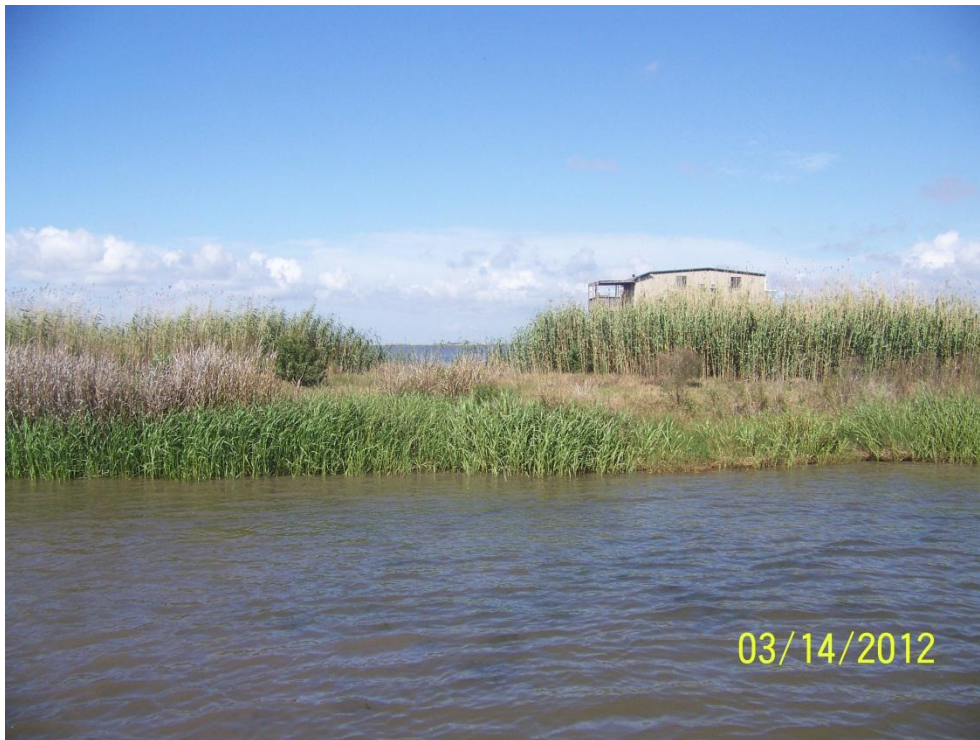
Earthen Plug No. 1 (see Appendix B, photo # 41-42)

The earthen plug 1 located on the eastern edge of Lake Pagie appeared to be in good overall condition. During the 2012 annual inspection, we were able to access and photograph the east side of the structure which is unreachable by water from Lake Pagie. There was no observed settlement or erosion of the plug. Also, there were no signs of erosion or a washout around the embankment tie-ins. Earthen plug 1 is in good shape and there are no recommendations for corrective action at this time.

Photo 41: View of Earthen Plug 1, looking north

Photo 42: View of Earthen Plug 1 looking west
