2012 Annual Inspection Report

**LITTLE LAKE SHORELINE
PROTECTION / DEDICATED
DREDGING NEAR ROUND LAKE
(BA-37)**

State Project Number BA-37
Priority Project List 11

September 5, 2012
Lafourche Parish

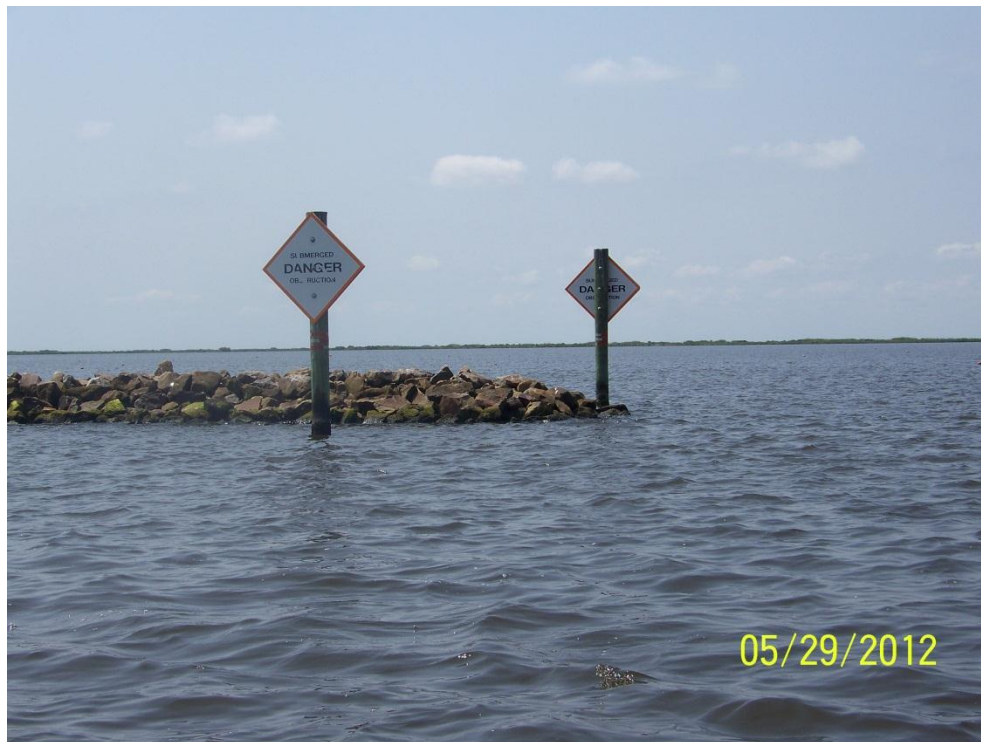
Currently, Rock Segments 1 and 2 have no marsh or vegetation along their southern edge, only open water. The fringe marsh that once separated Brusle Lake and Bay L'Ours, located along Rock Segments 1 and 2, has been eroded below the water level by Hurricane Katrina. This land loss occurred during construction of the project and the rock segments were put in place as designed and contracted. There are no recommendations for maintenance at this time; however this site will continue to be monitored to determine if the rock segments have become a hazard, and corrective actions will be conducted as needed.

Photo #1: View of the end of Rock Segment #1 closest to Benton Canal, looking south

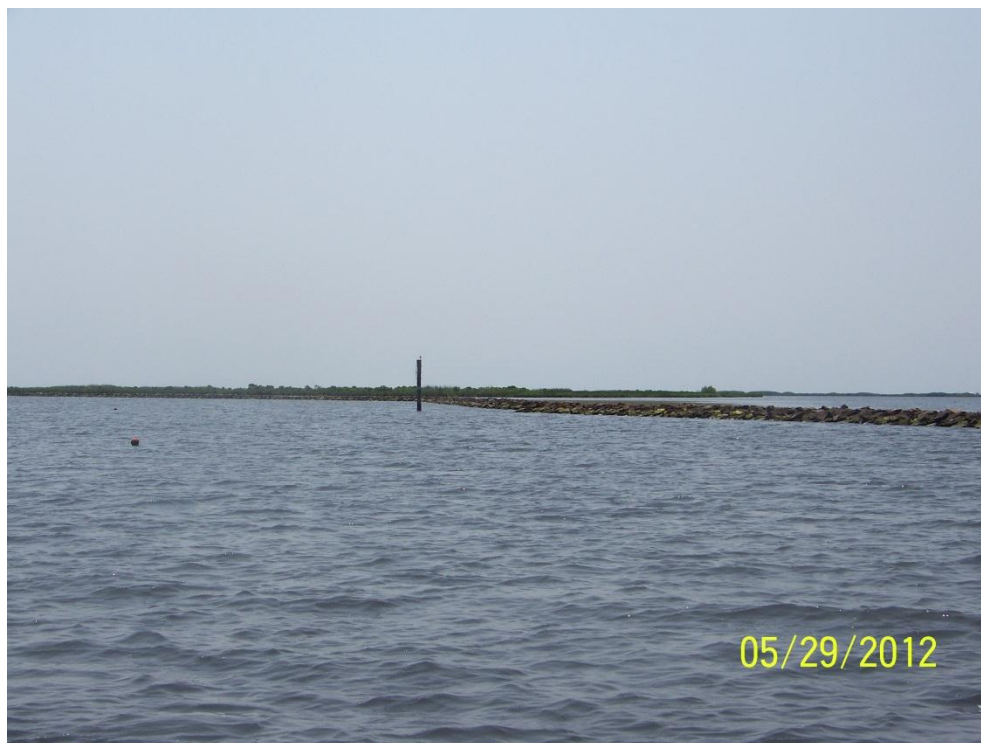
Photo #2: View along Rock Segment #1 closest to Benton Canal, looking east.

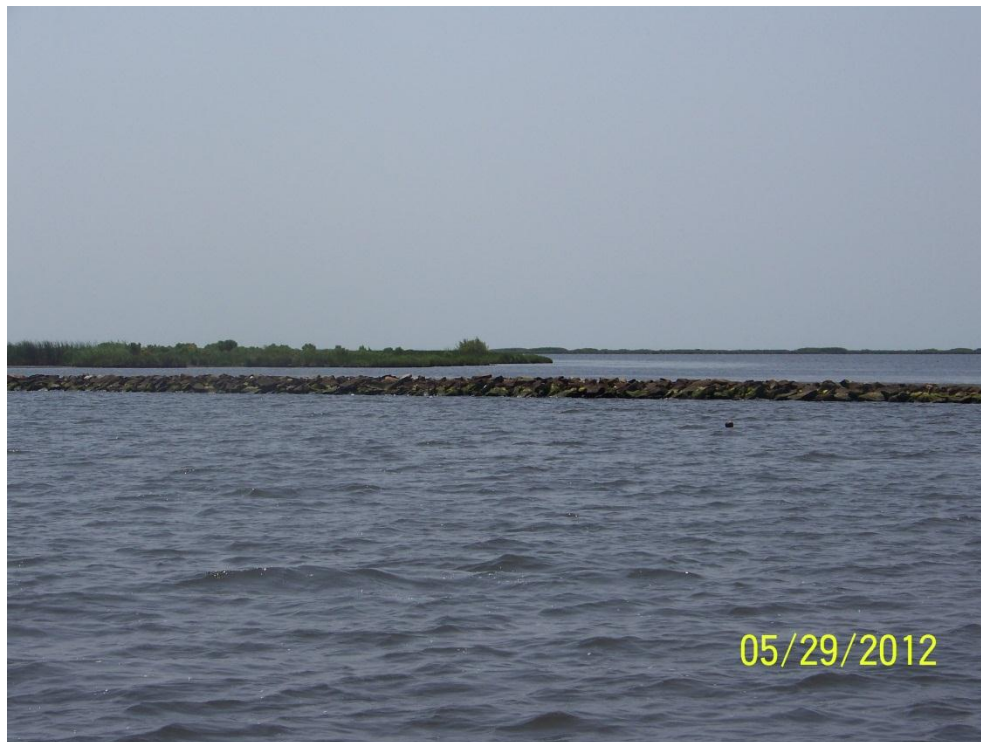
Photo #5: View along Rock Segment #2, looking southeast.

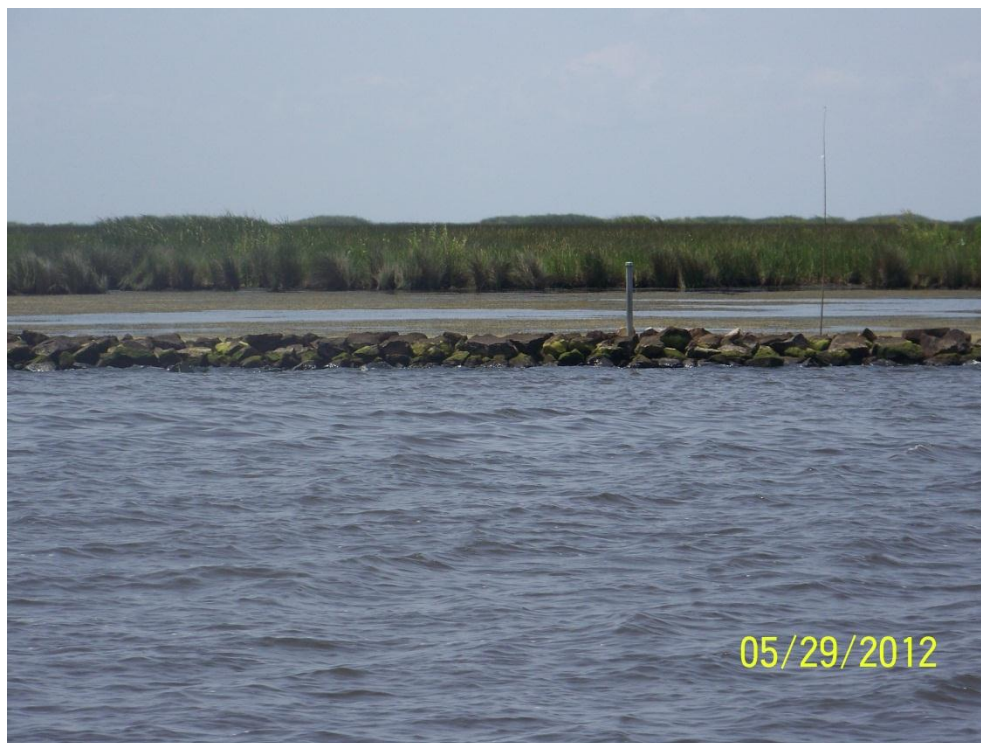
All rock segments were visually inspected by boat. As expected, it appears all rock segments have experienced some amount of rock settlement. Some segments have portions that are below EL 2.5 FT including those that did not receive a third lift during construction (1-5, 8, 9). There are no recommendations for corrective action at this time; however the segments should continue to be monitored for further settlement.

Photo #8: View of settlement plate in Rock Segment #4, looking southeast

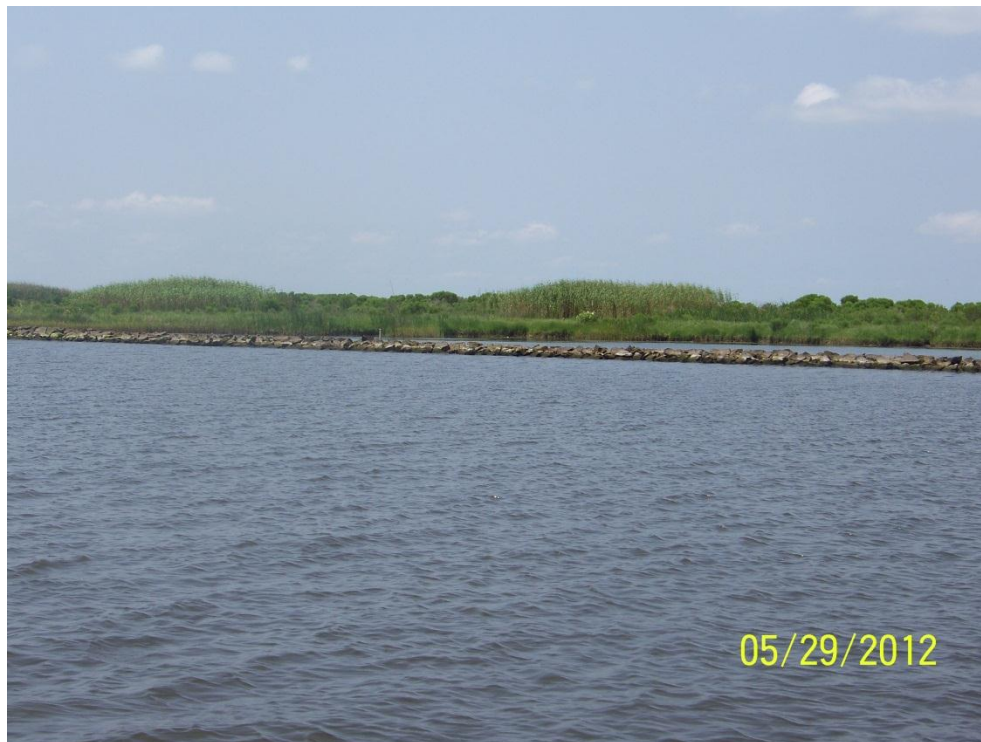
Photo #13: View along Rock Segment #7, looking southwest

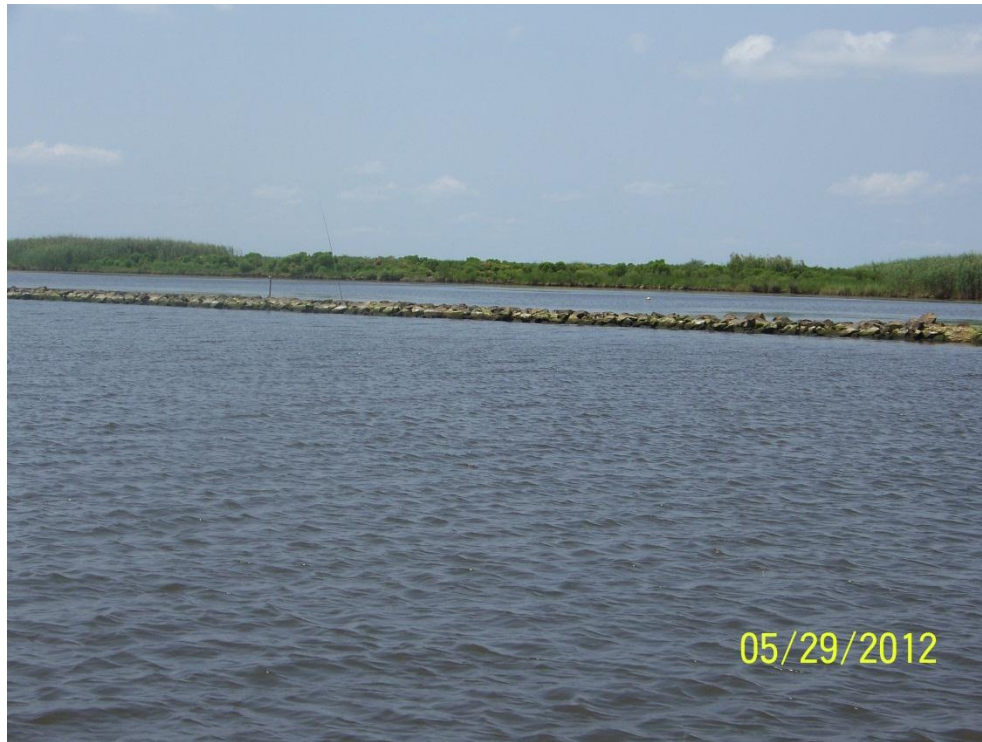
Photo #15: View along Rock Segment #8, looking southwest

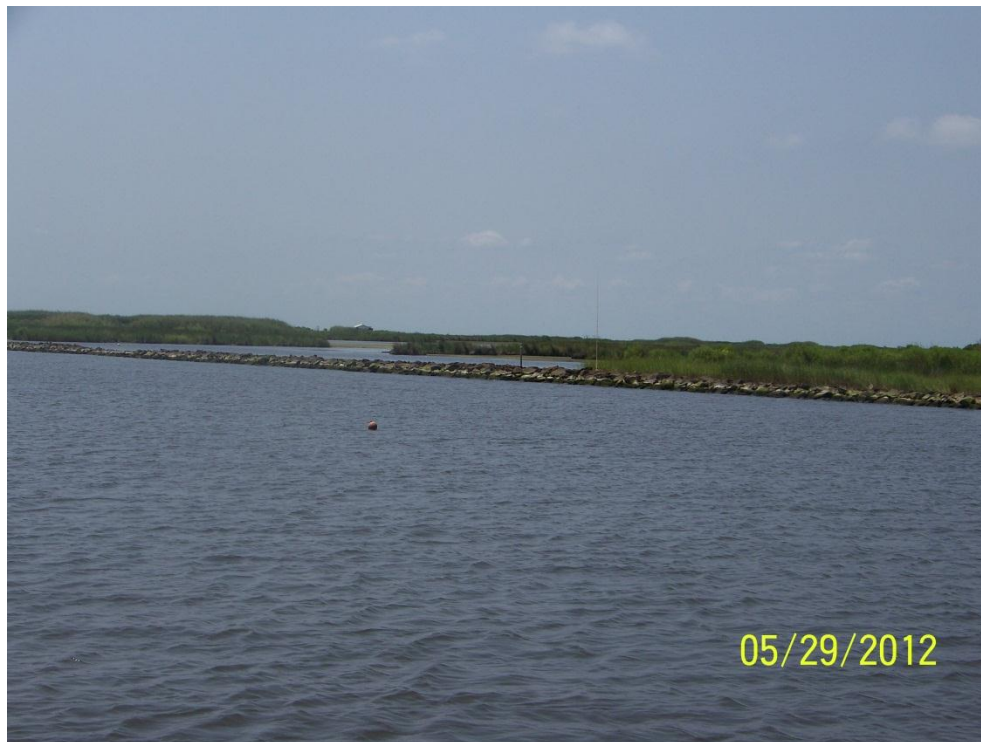
Photo #17: View along Rock Segment #9, looking southwest

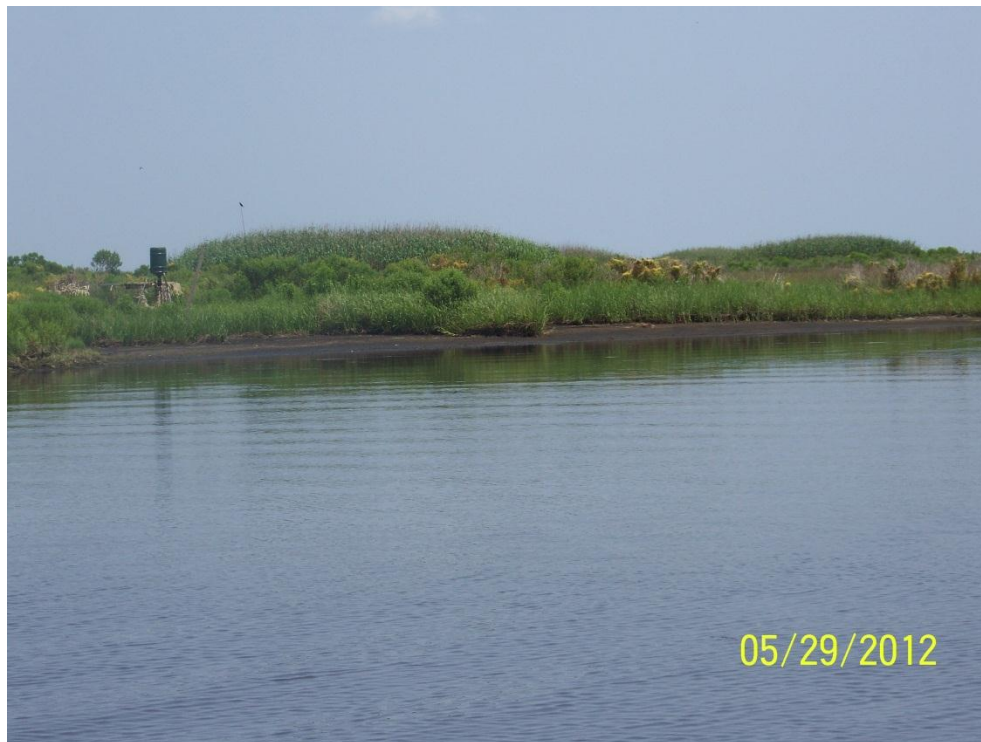
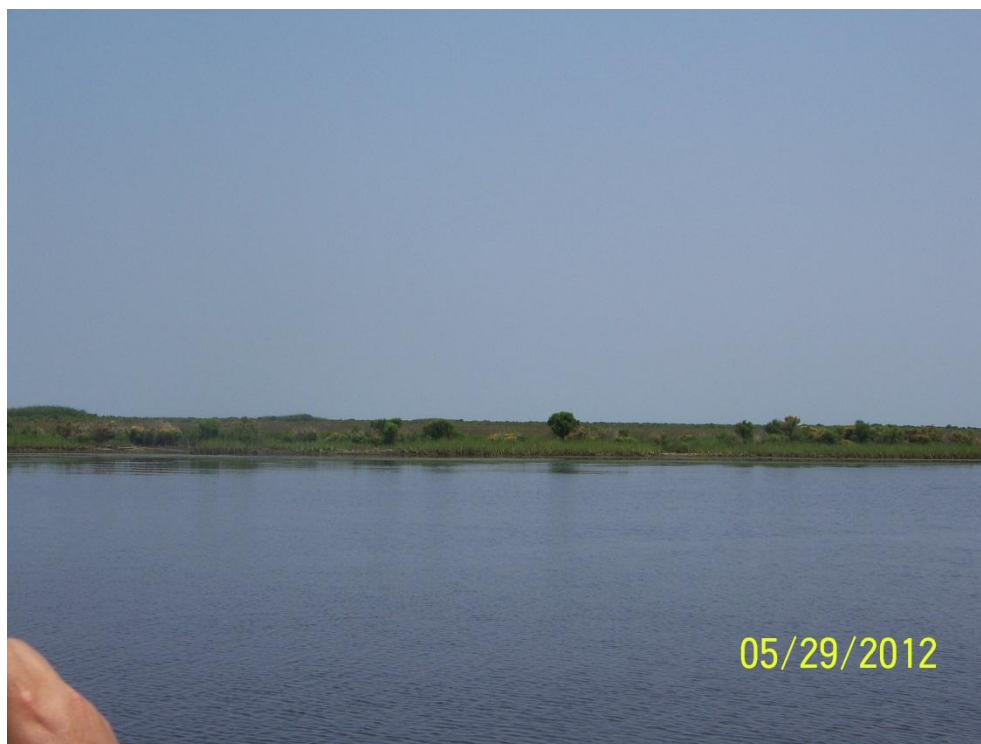
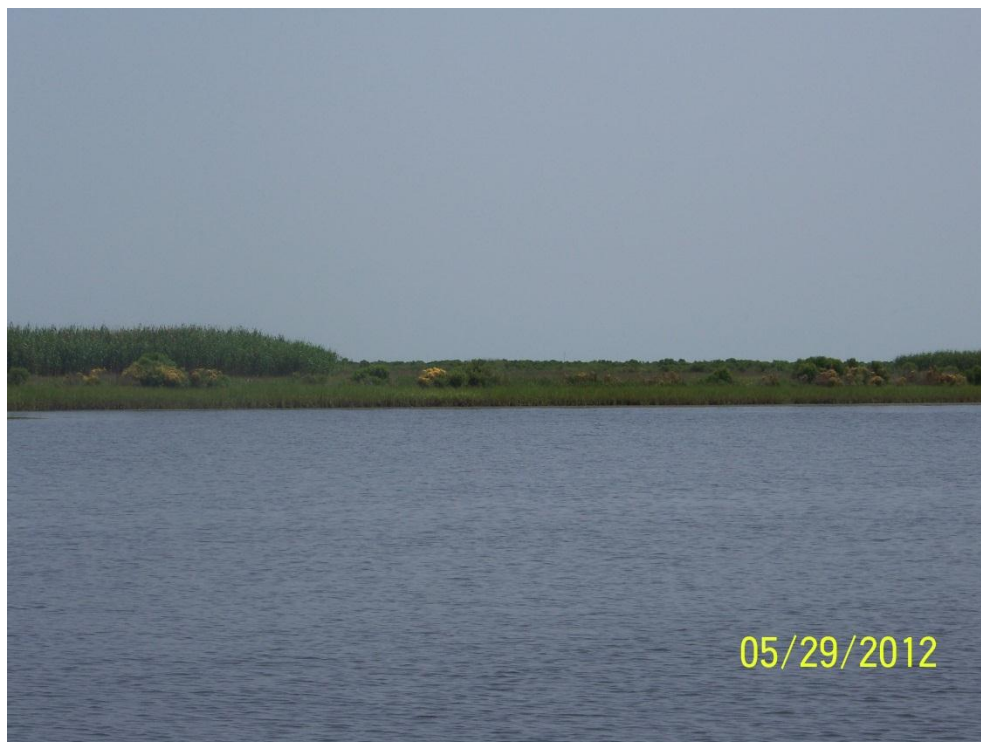
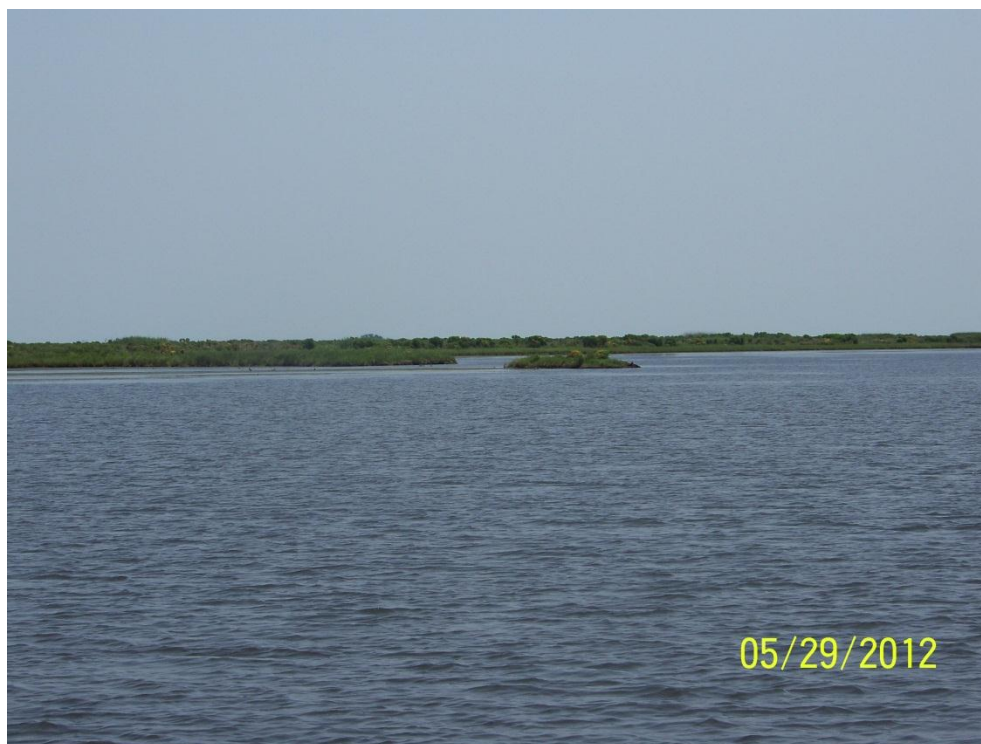
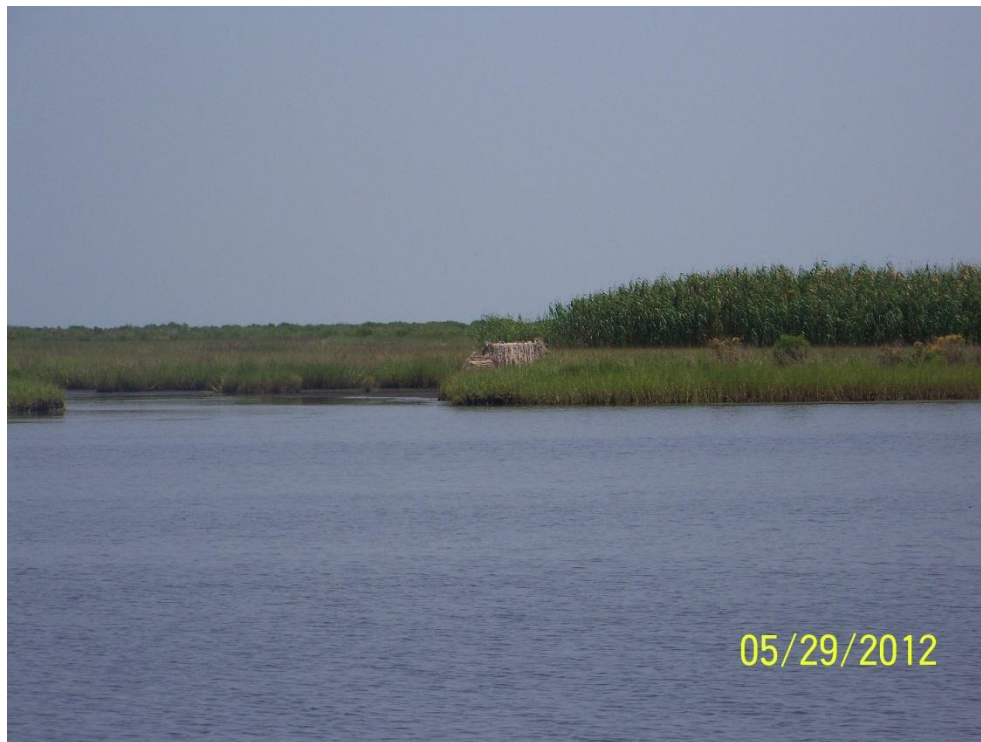
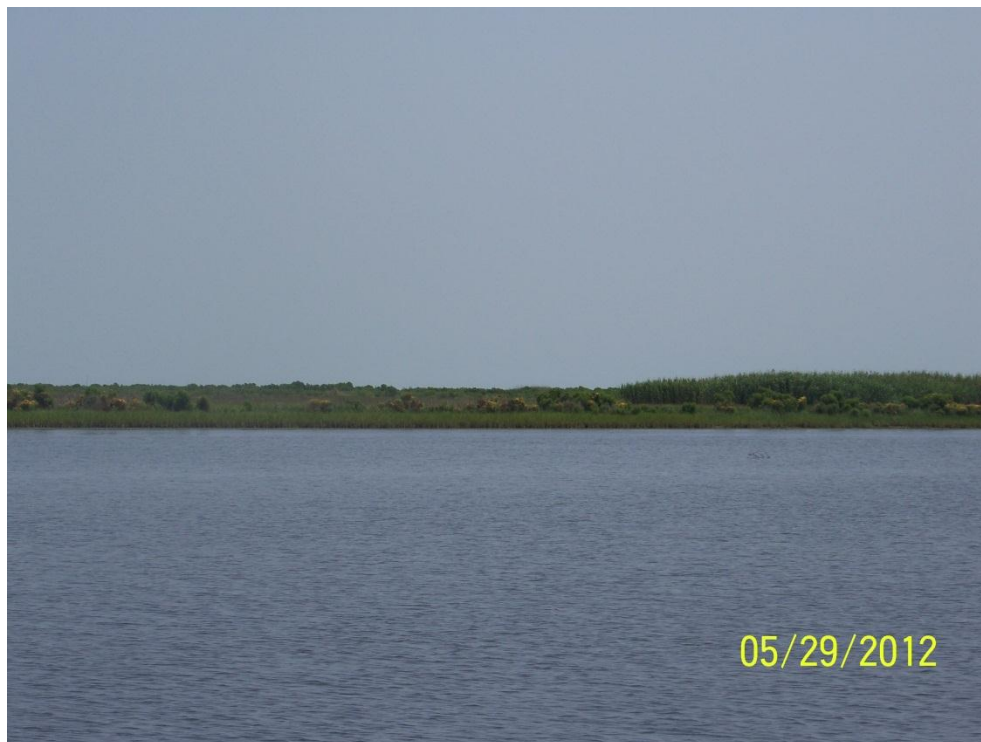
The fill material in the marsh creation area has fully vegetated. As mentioned above, marsh creation area grid point "O&M" surveys were performed in May 2008, June 2009, July 2010, and September 2011 as well as "as-built" and 9-month post-placement (May 2007) surveys. Figure 5 through Figure 10 displays the change in marsh creation elevation from the time of construction to the time of the latest available data (September 2011).

Photo #23: View of the Marsh Creation Area from the southern boundary of the containment dike, looking north

The marsh creation area appears to be completely vegetated and the surveys indicate its elevations are approaching the average marsh elevation for the area. There are no funds allocated for the marsh creation portion of the project other than the surveying of the area grid points. We recommend that the 2011 survey be the last of the first five annual surveys as we will have five total data sets for post-construction analysis, in addition to the 10 and 15 year survey as per the O&M Plan. The survey data along with the annual visual inspections will monitor the consolidation and settlement of the fill material and the resulting elevations within the marsh creation area.

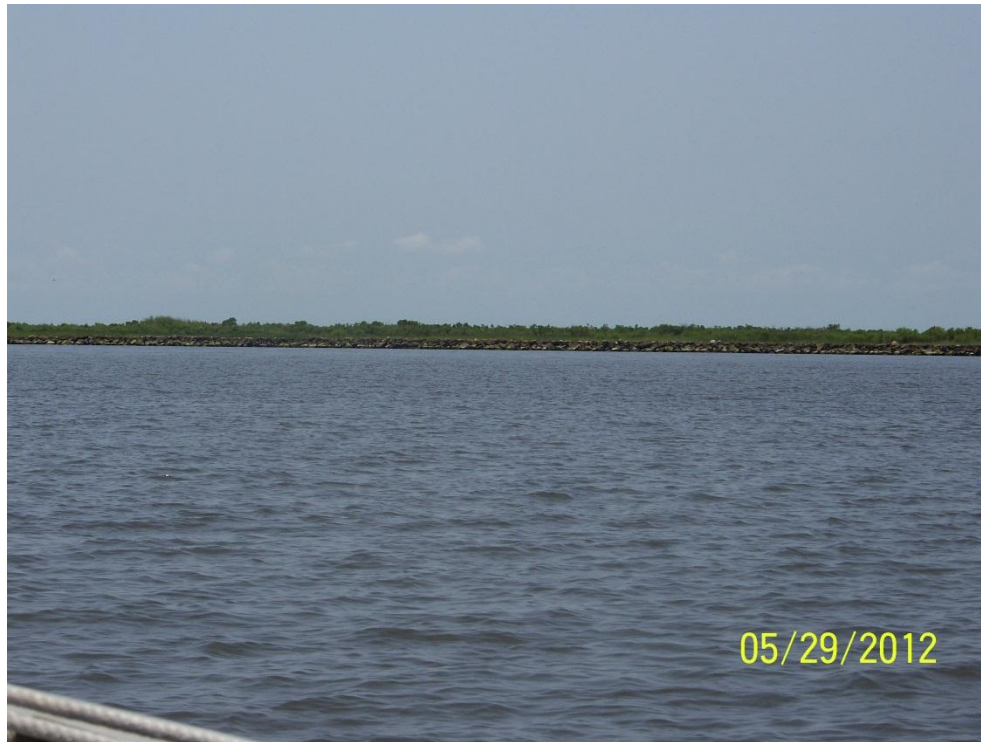
Photo #29: View along Rock Segment #14, looking southwest

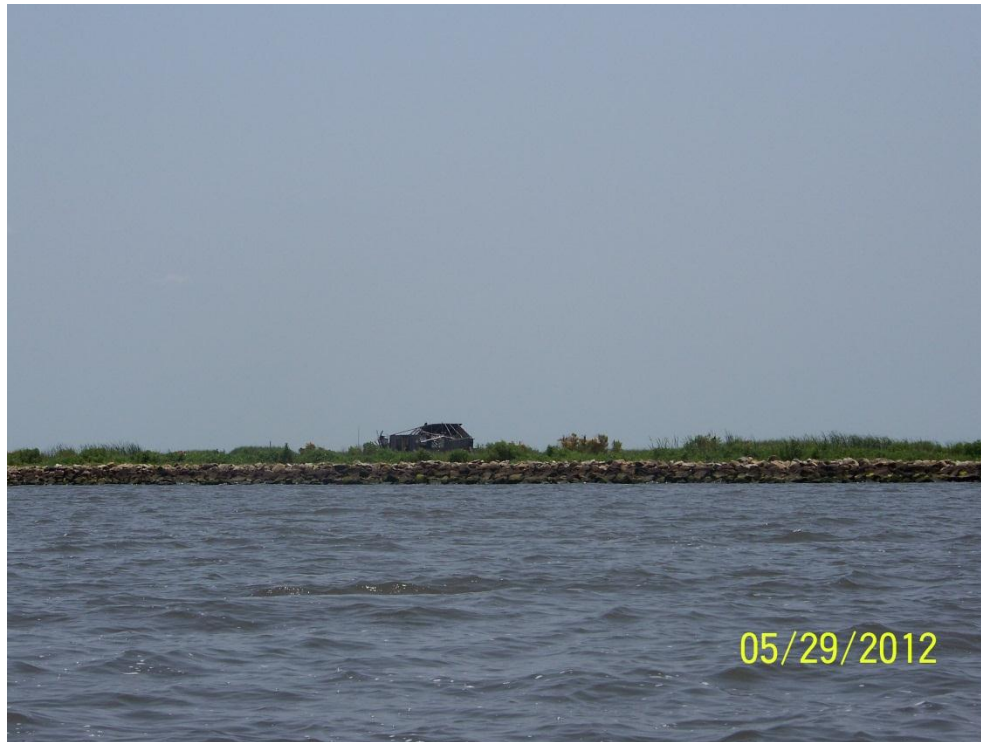
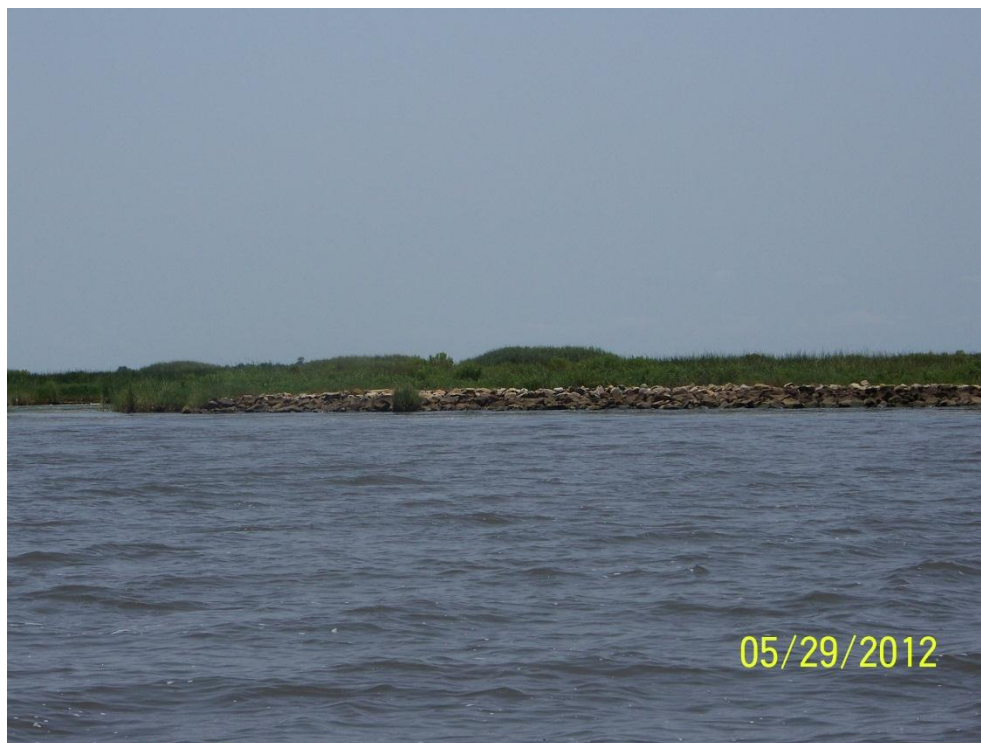
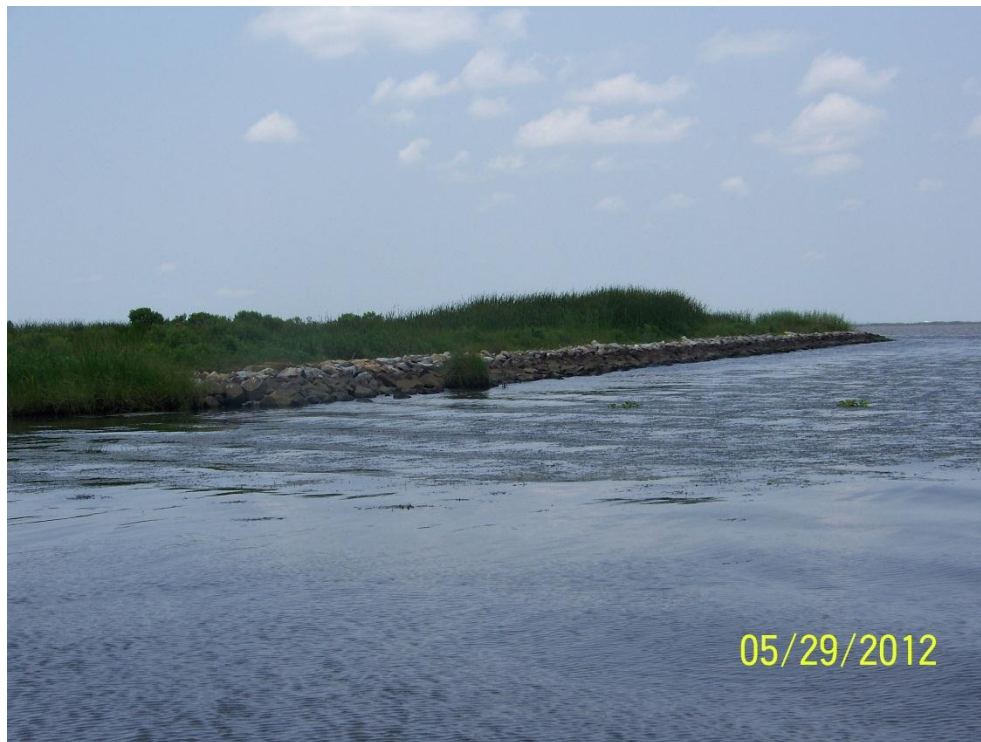
Photo #33: View of Rock Segment #24 closest to John the Fool Bayou, looking southwest
