2012 Operations, Maintenance, and Monitoring Report

East Sabine Lake Hydrologic Restoration (CS-32)

State Project Number CS-32
Priority Project List 10

July 2012
Cameron Parish

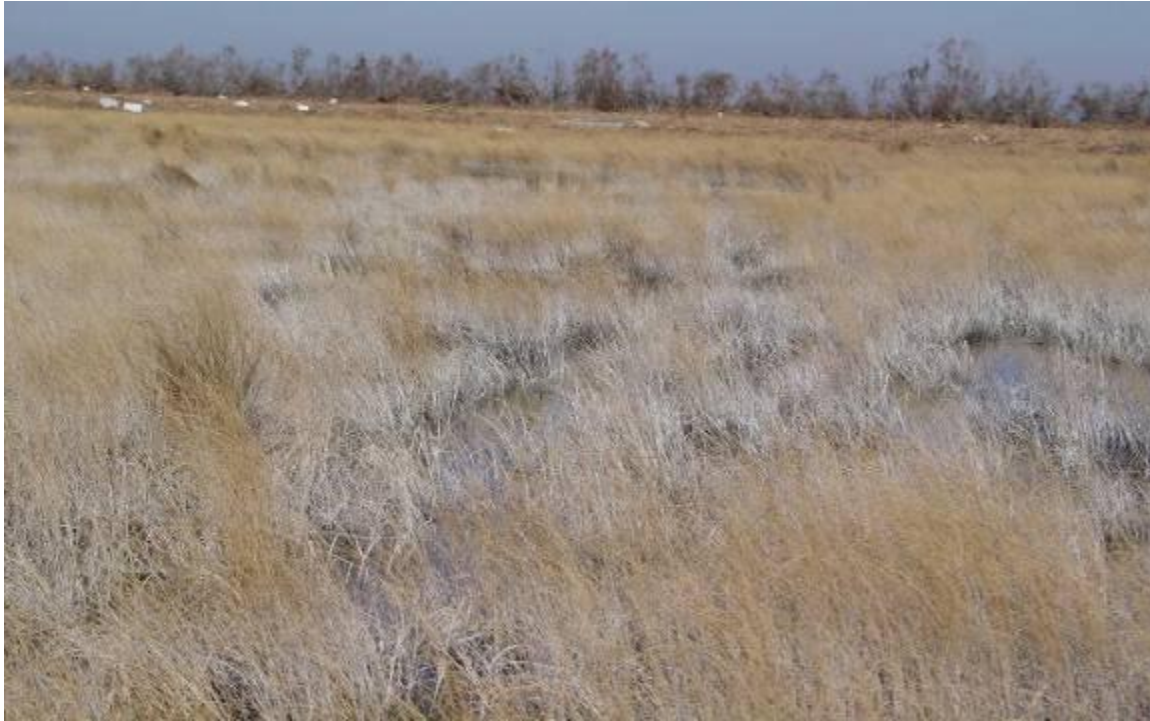
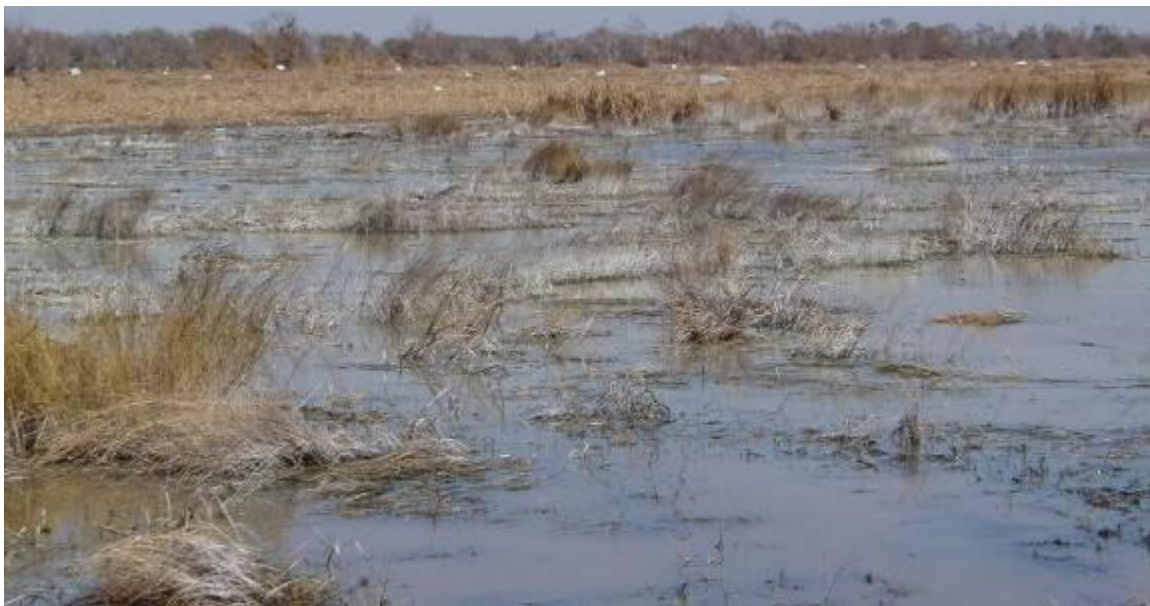
On the October 2005 trip, the investigating party traveled west by airboat, from near USFWS Sabine Refuge Headquarters on Hwy 27, across Refuge marshes to the project area. Huge swaths of wrack, composed of vegetative and anthropogenic material (tanks, lumber, 18-wheeler trailers, etc.), had been deposited on top of the marshes. All emergent marsh vegetation that could be seen was completely brown and much of it was covered with what appeared to be fine-grained sediment and precipitated salt (below).

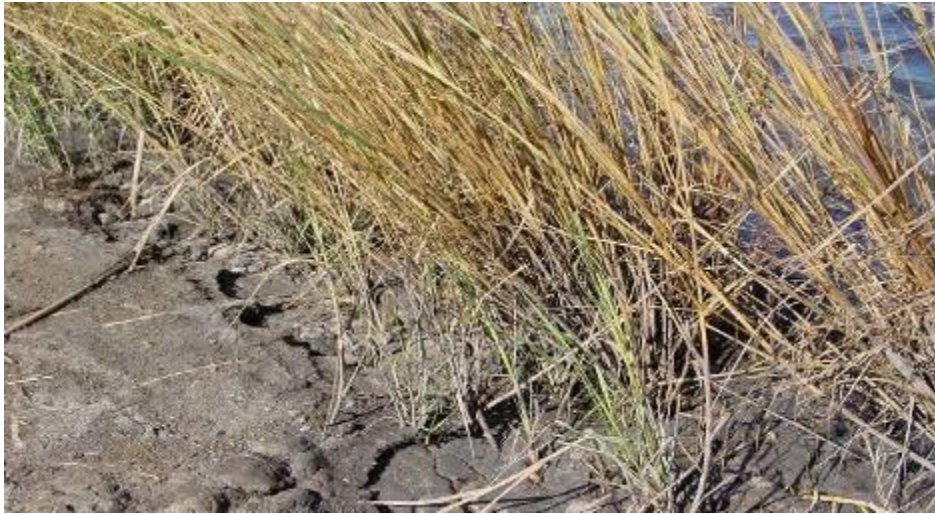
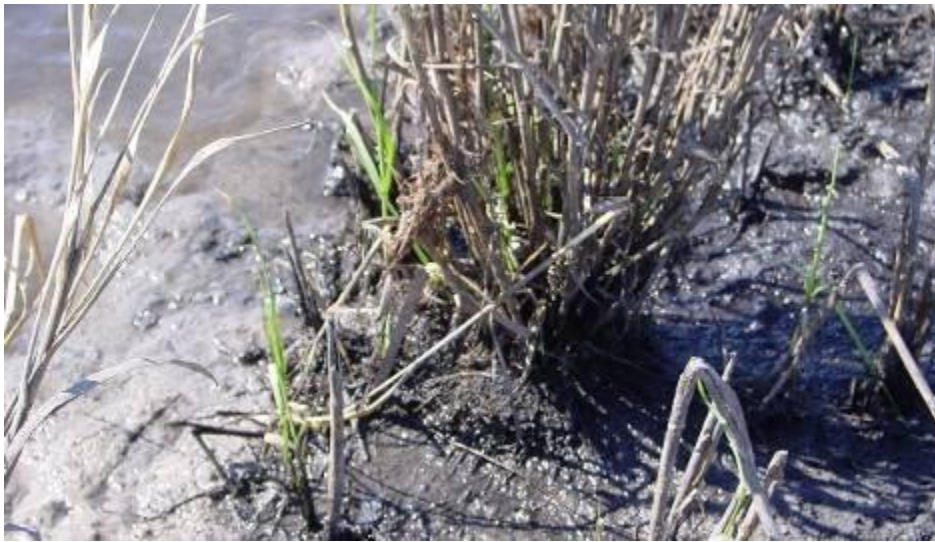
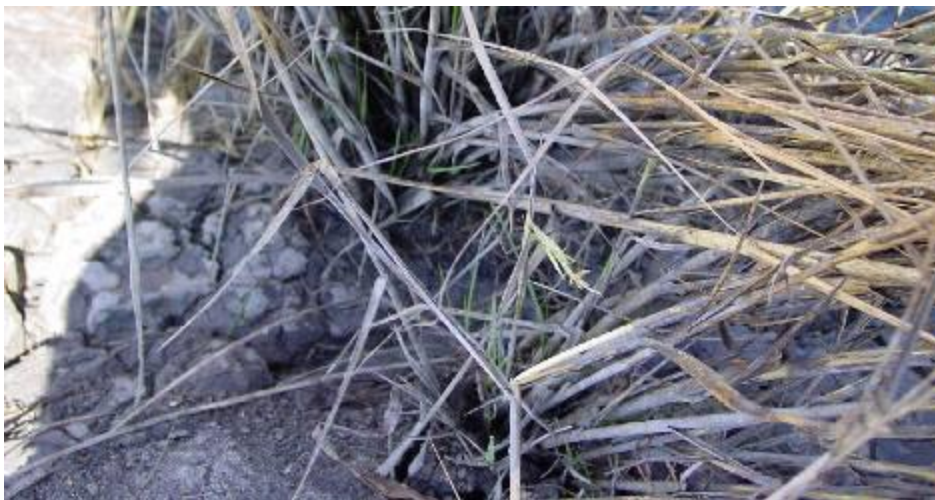
At the project area, although the plants on the southernmost terrace rows appeared to have produced significant growth and spread prior to the storm and the plants' physical structure was mostly intact, we found that all contract plantings on all of the terraces were considerably browned (below).

On the southern terraces, a few very young green stems were found emerging from the roots or stem tips of the plants, with the oldest transplants showing the most new growth.

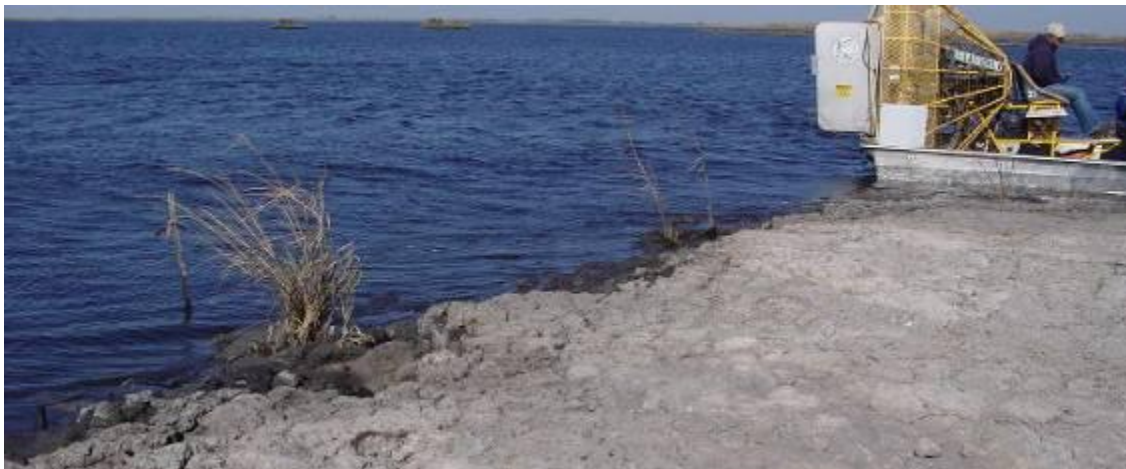
Proceeding northward, we began to note gaps in the planted rows and the number of plants missing on each terrace segment progressively increased.

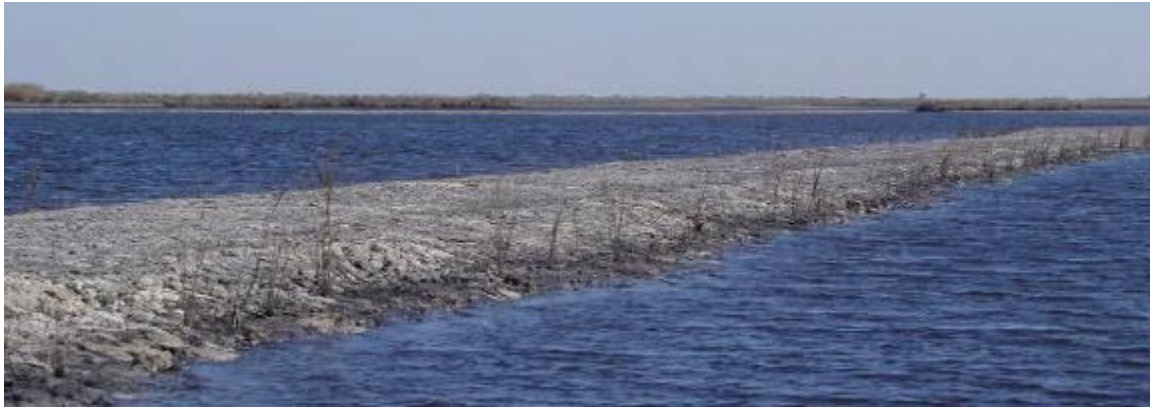
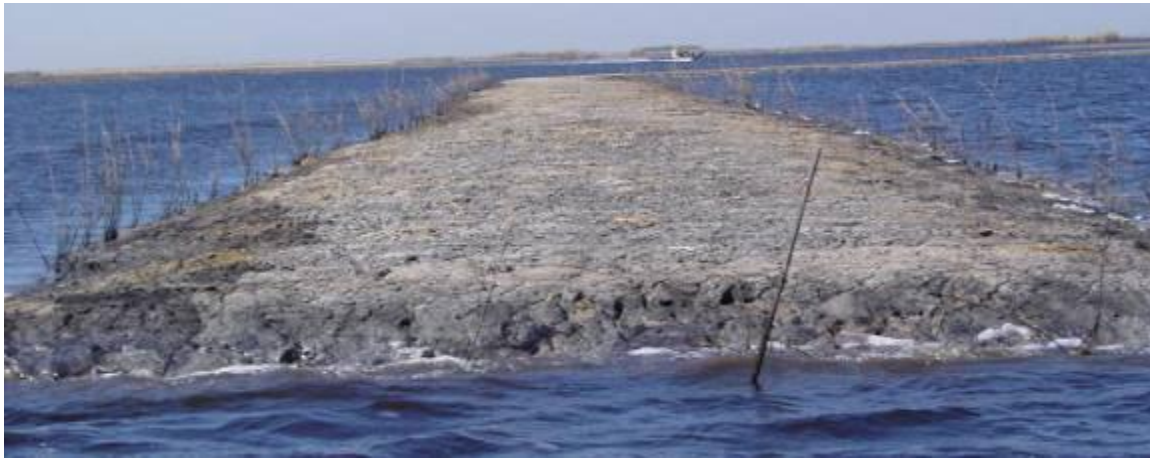
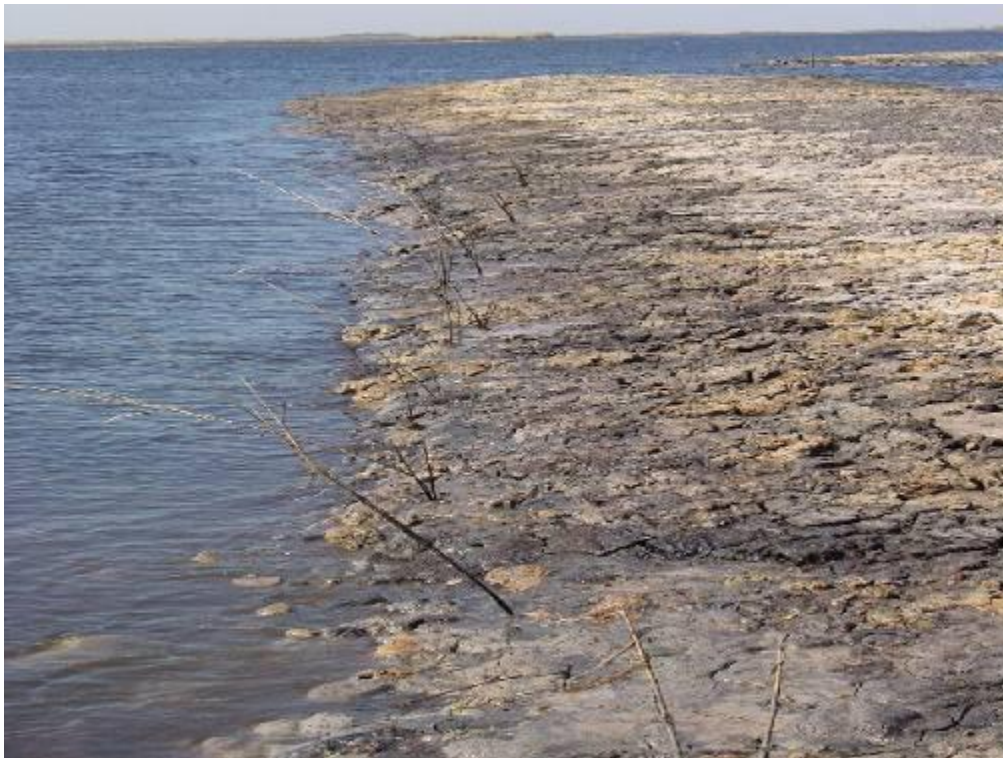
In addition, the younger a transplant was, the less old and new growth was present. From oldest to youngest, mortality increased, and the base of the plant stems ranged in color from pale yellow/green to brown/black and rotten at the base.

On the most recently built terrace segments, the number of live plants remaining appeared very low. Because I was unable to determine whether some plants were at the point of decline or

recovery, and the growing season was over and conditions had not yet returned to normal (water salinities were found to be 19 to 22 ppt in the terraced ponds), I recommended that another field investigation be conducted in the spring to more accurately determine the amount of plant mortality.

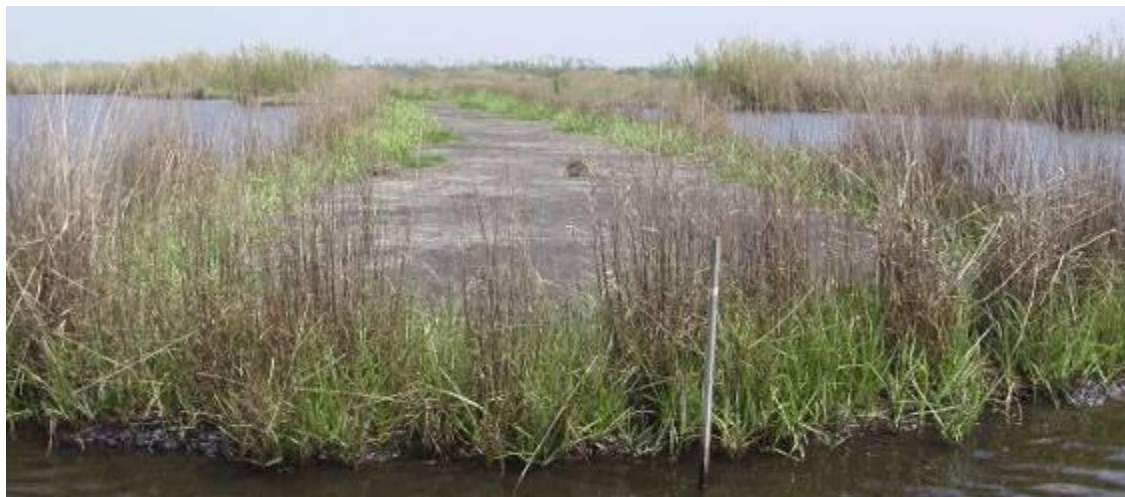
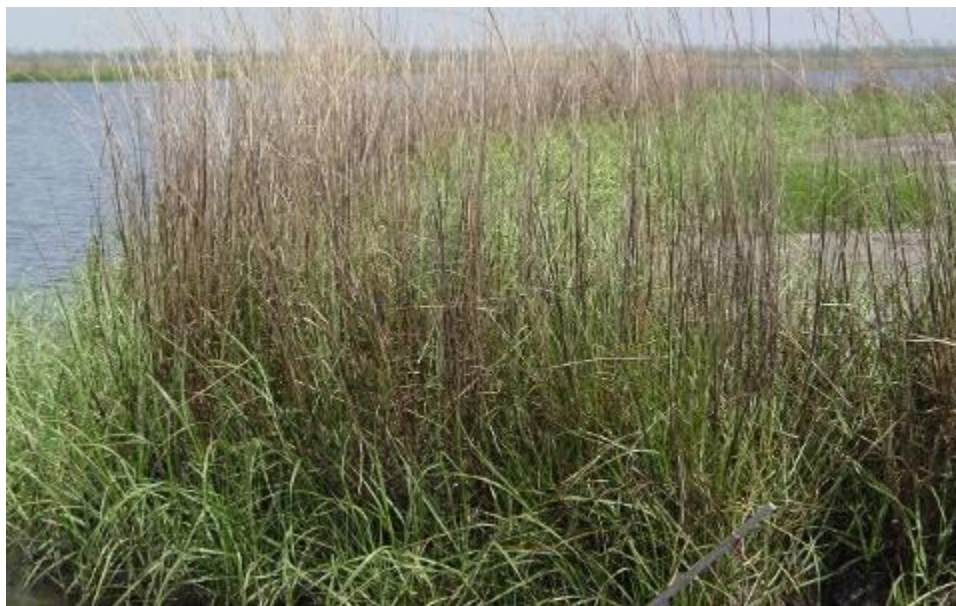
The oldest vegetative plantings on the southern terraces appeared to have recovered very well, having produced significant new growth and lateral spread (below).

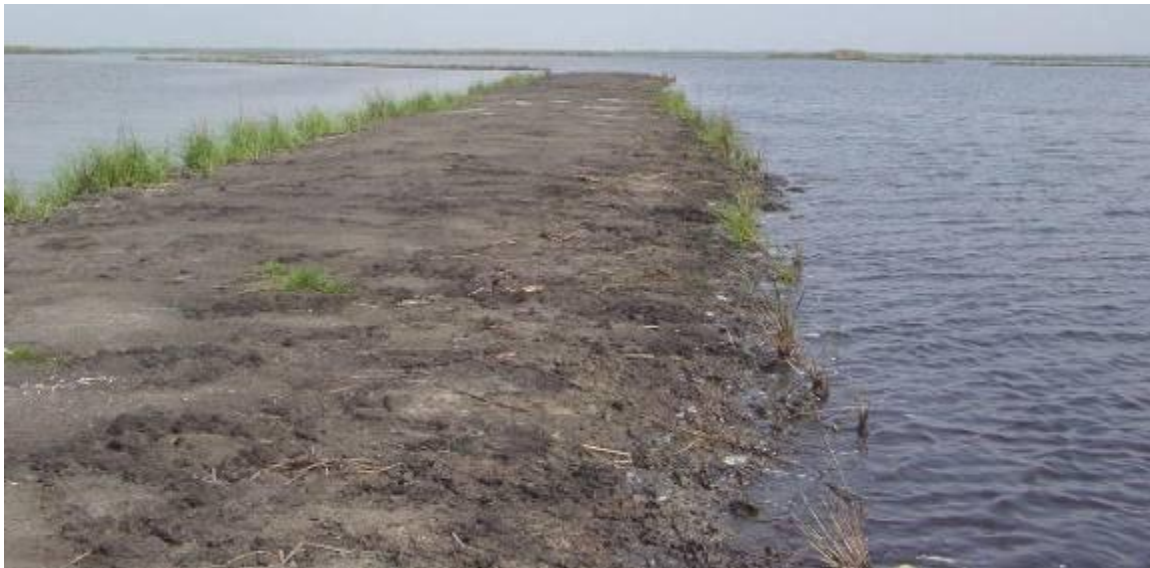
However, moving northward, we found that as age of the plantings decreased, mortality increased, until the plantings no longer formed a continuous vegetative hedge at the toe of the terrace segments. On the newest terrace segments, remaining plants formed very sparsely

distributed live clumps, or single plants with a couple of stems each. There was no longer difficulty in calculating the plant mortality.

It is recommended that the destroyed plantings be replaced as soon as possible, in order to achieve the necessary stabilizing vegetative cover on the exposed tops and edges of the earthen terraces, particularly now that the start of hurricane season is days away. Please contact me and the LDNR and USFWS project and O&M managers to discuss how, and how soon, this can be accomplished.

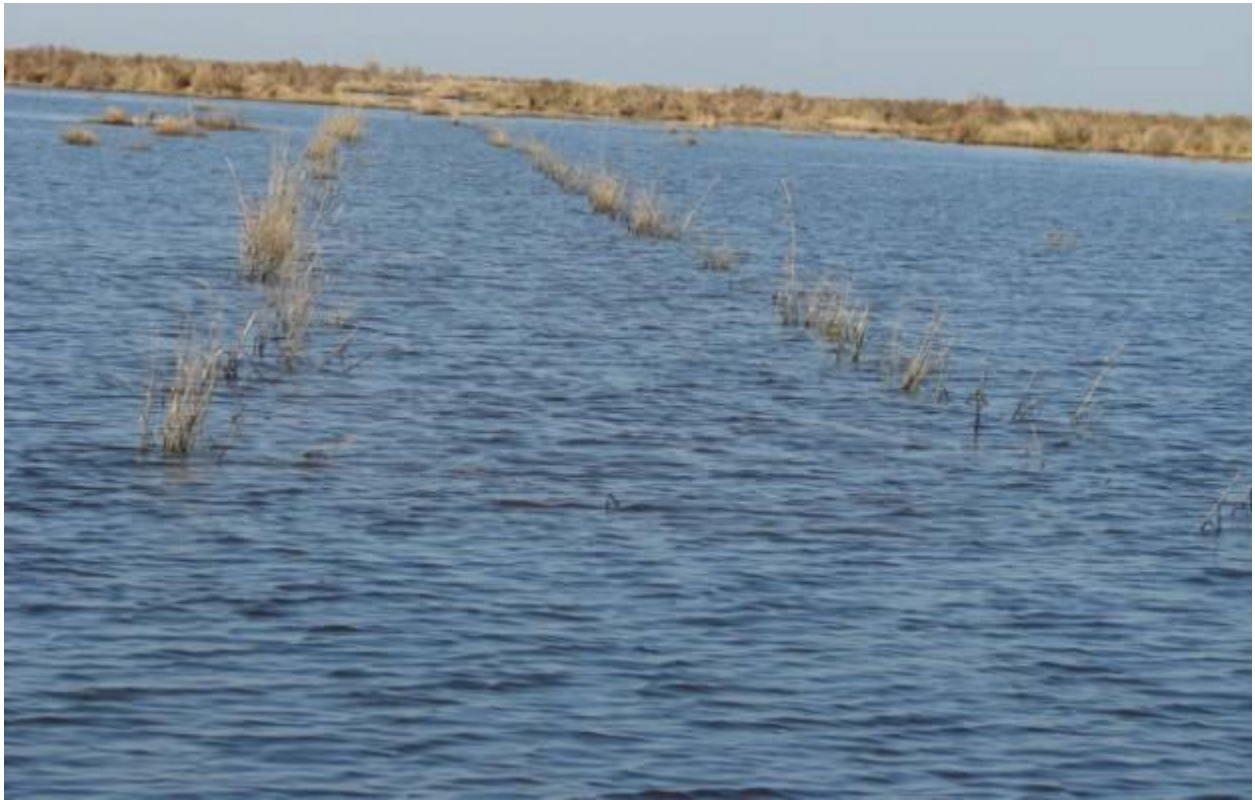
Figure 5. Project terraces remained flooded one month following Hurricane Ike landfall.

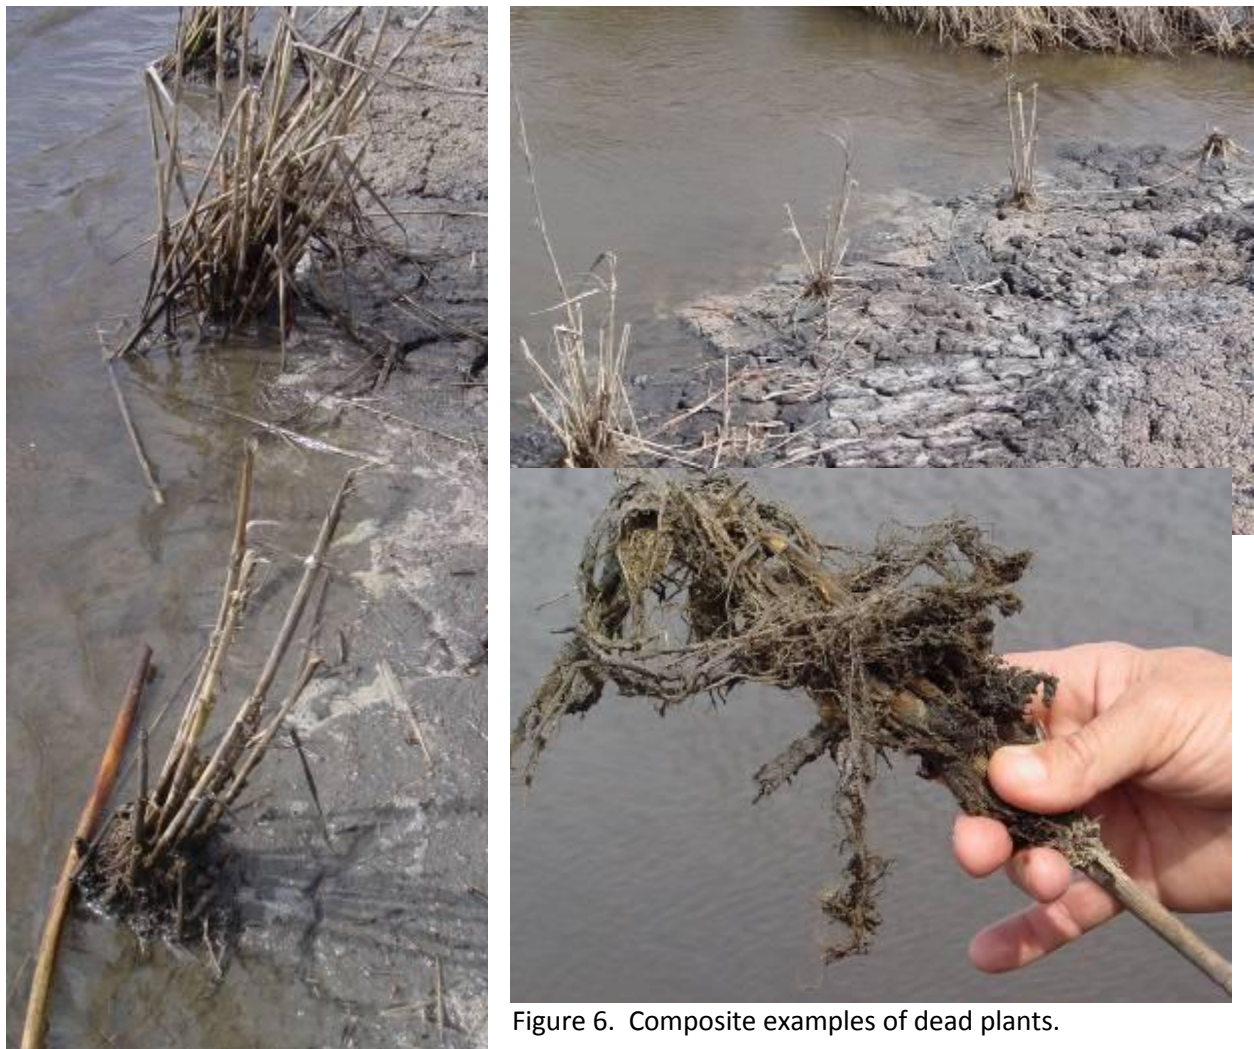
Figure 6. Composite examples of dead plants.

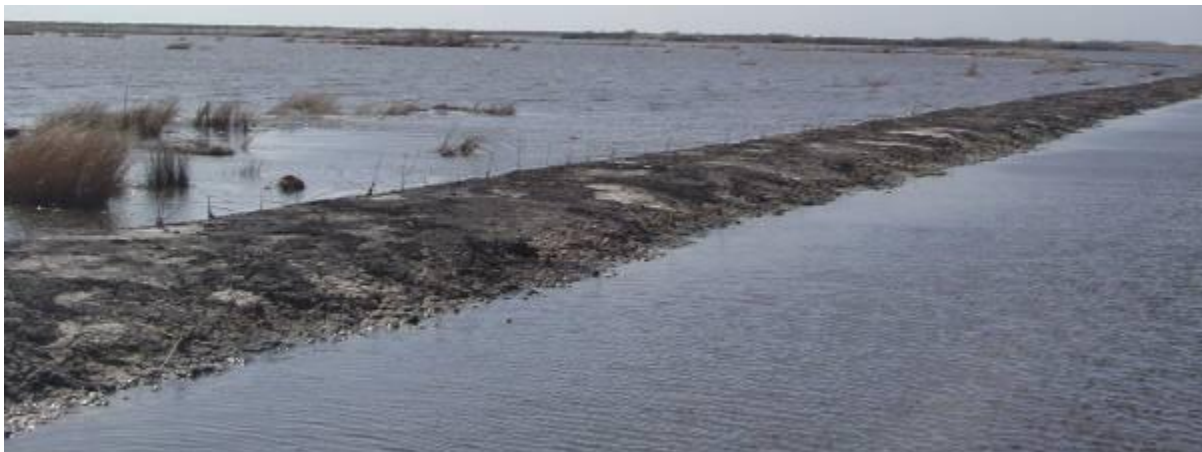
Figure 11. Less evidence of recovery was seen from the most recently planted transplants.

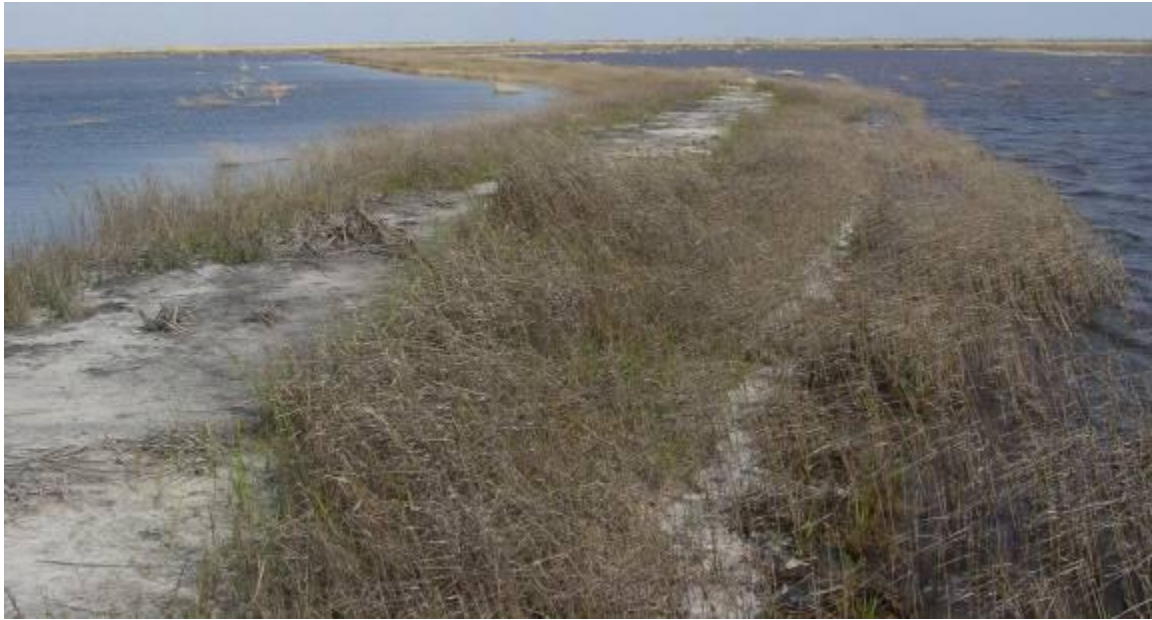
The plants on the Construction Unit 1 terraces that were completed in 2007 were also significantly impacted. The vegetation had obviously spread and was forming fairly dense cover on those terrace segments prior to the storm, but all emergent stems that remained post storm were completely browned. Nevertheless, new plant growth emerging at sufficient density was observed on all the CU-1 terrace segments (Figures 12 through 14).

Figure 12. Post hurricane condition of vegetation on CU 1 terraces.

Recommendations: I do not recommend that any CU-1 terrace segments be replanted, since the density of the new growth we found there indicates that sufficient cover will likely be achieved from the remaining plant material. I do recommend that the dead and missing CU-1A plants be replaced as soon as possible, in order to achieve the necessary stabilizing vegetative cover on the exposed tops and edges of the earthen terraces. I also recommend that all Row 1 terrace segments that were built (segments 1 through 7) be planted, whether or not the construction work on this row was completed.

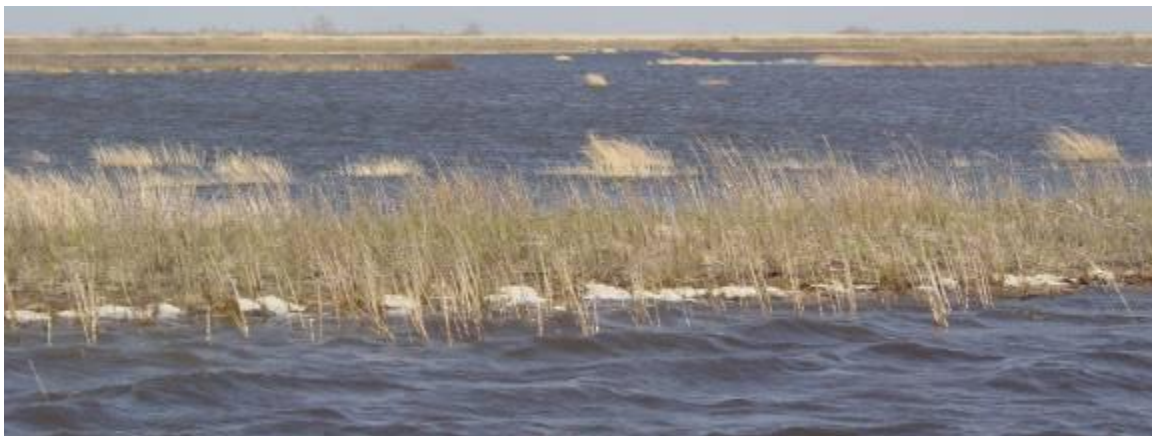
Figure 13. Post hurricane condition of vegetation on CU 1 terraces.

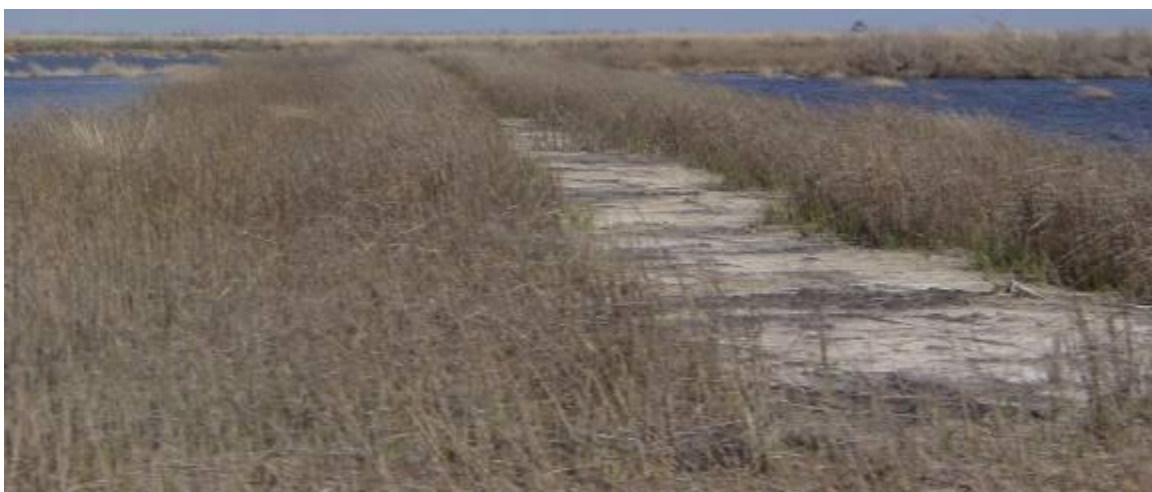
Figure 14. Post hurricane condition of vegetation on CU 1 terraces.

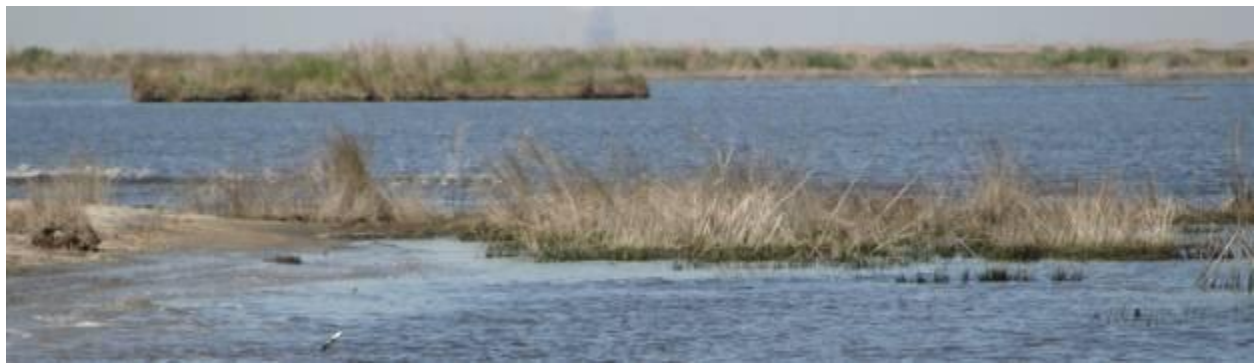
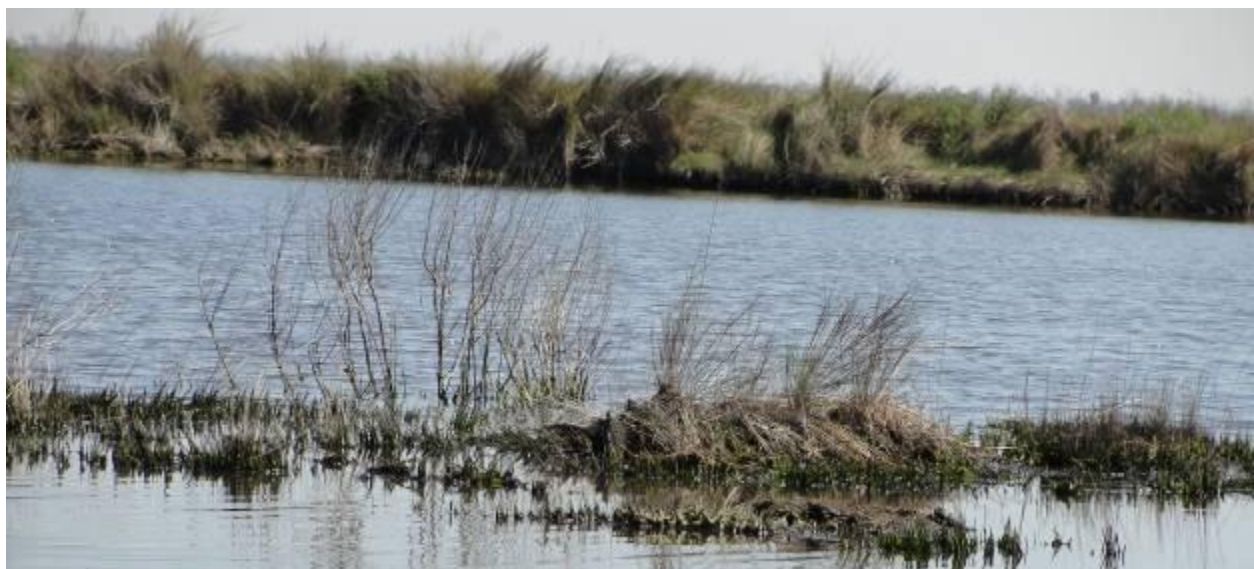
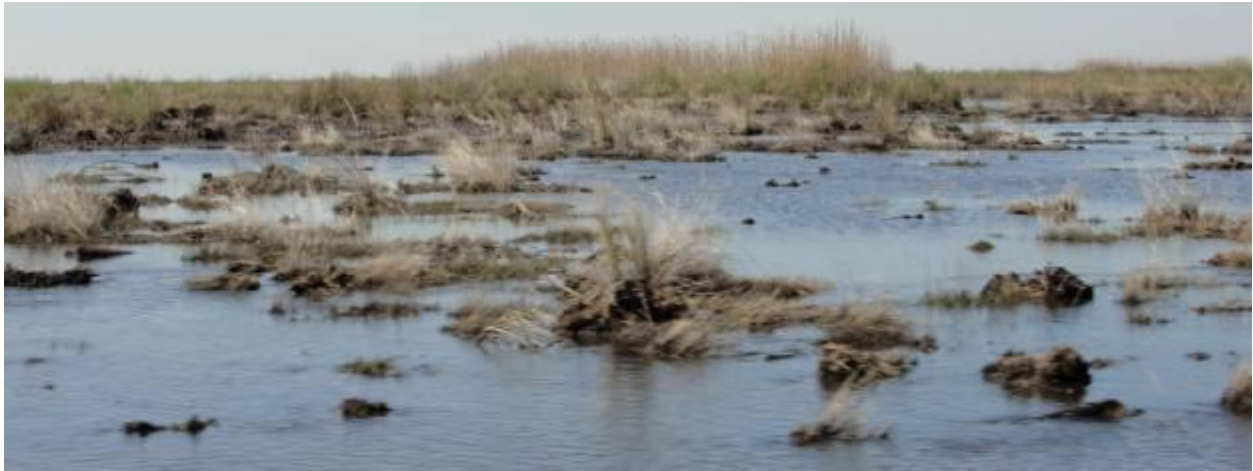
Condition of existing natural emergent marsh next to terraces:

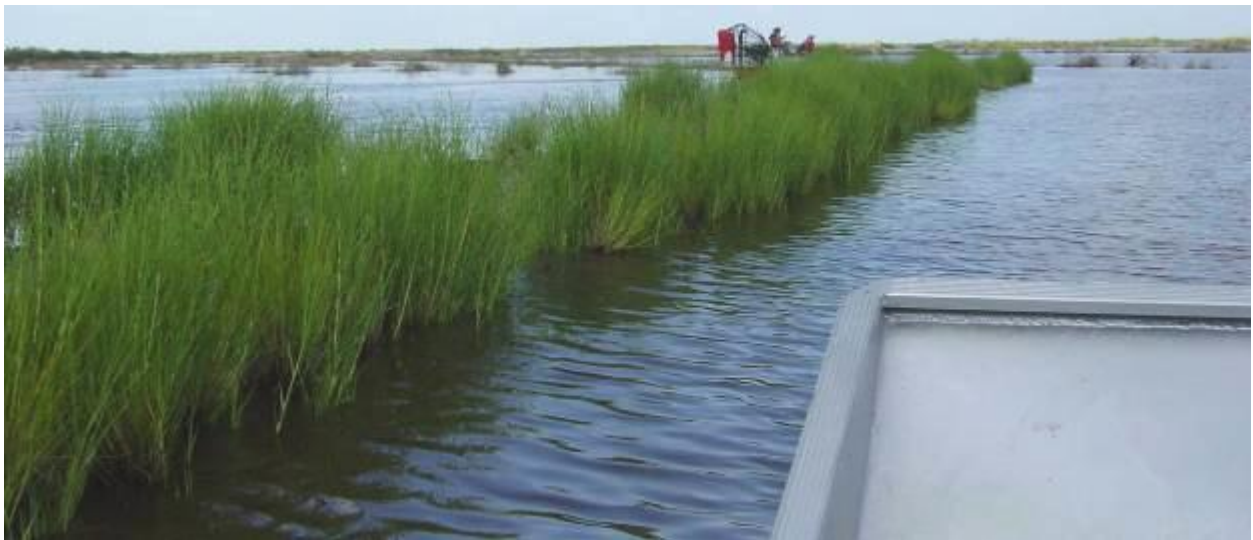
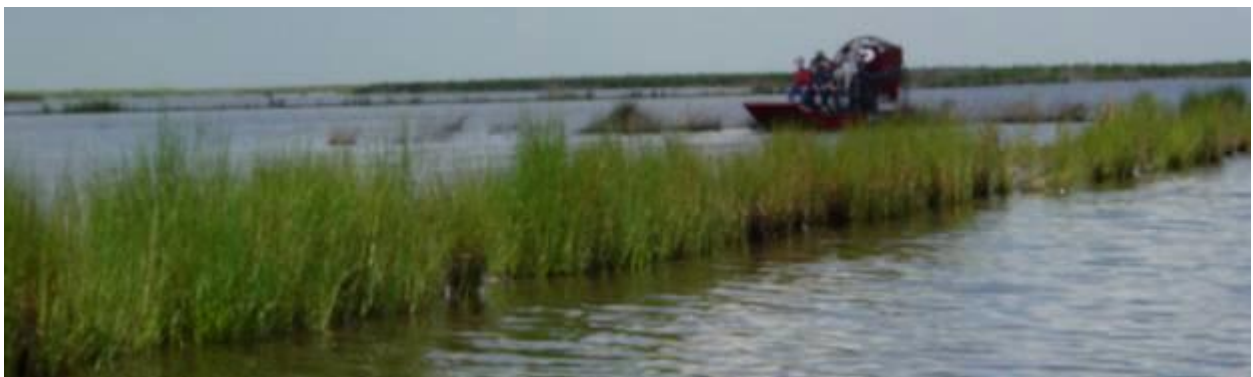
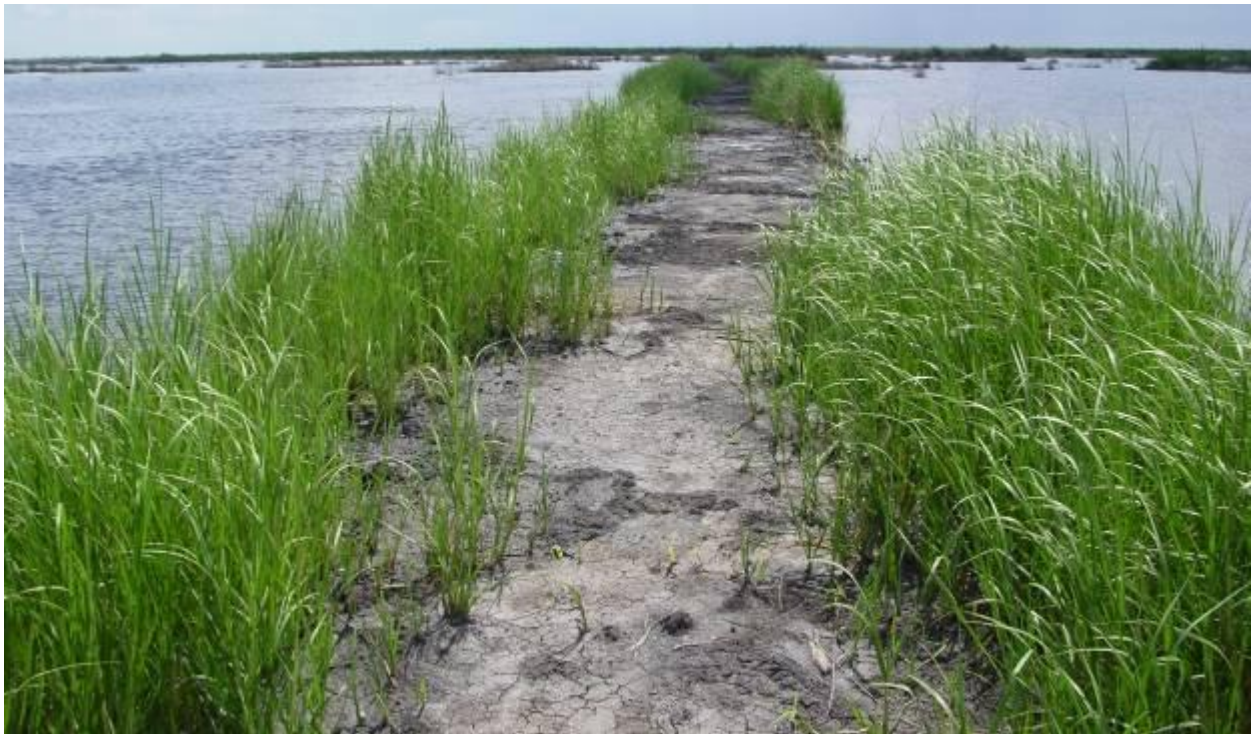
Examples of condition of older plantings when appeared to be recovering well in August 2009:

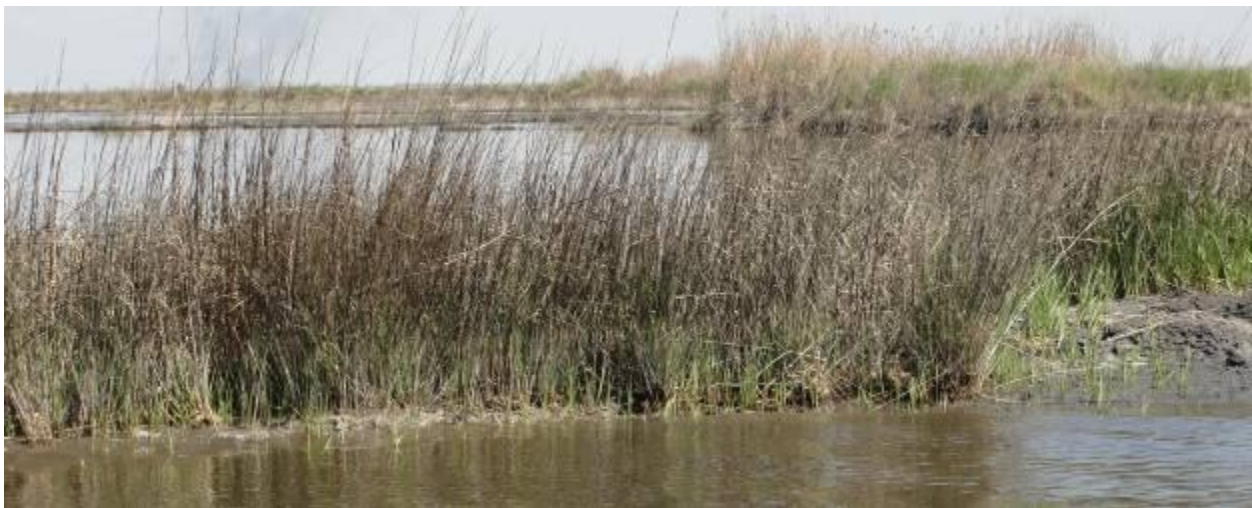
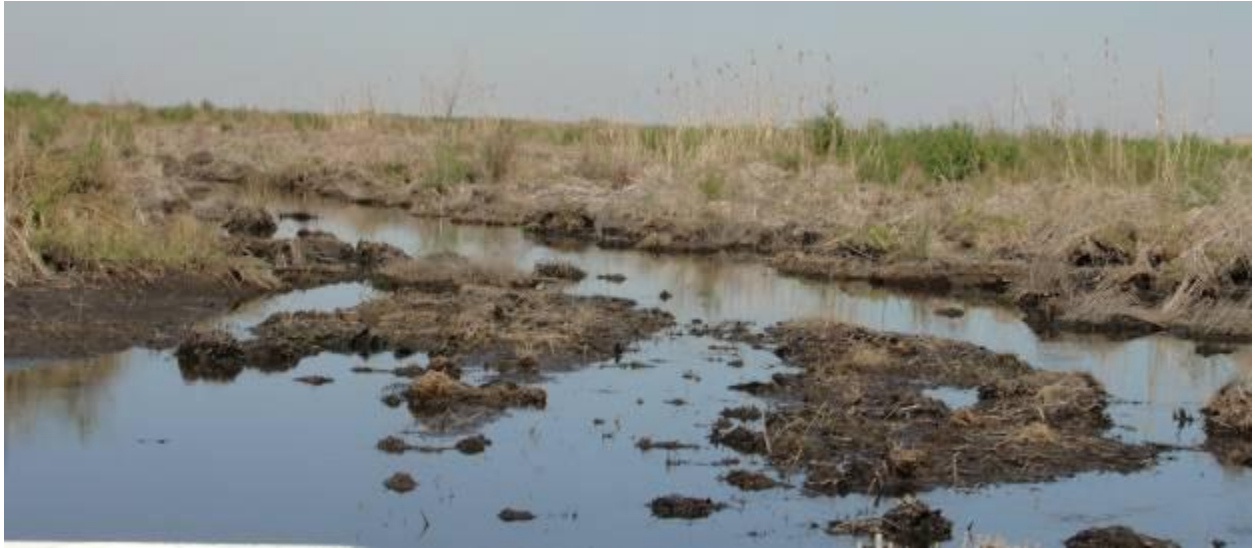
Contrast above with the appearance of the condition of those older plantings in March 2010:

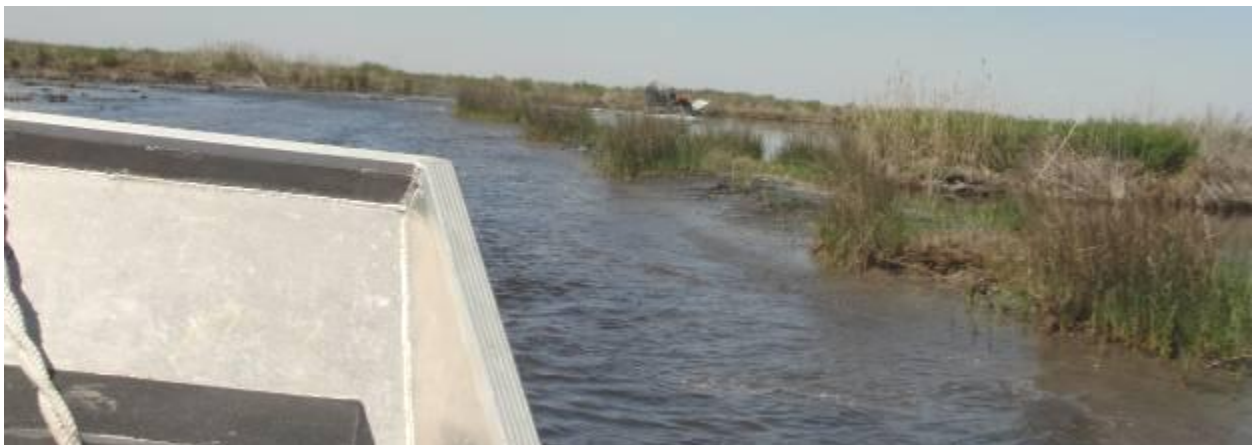
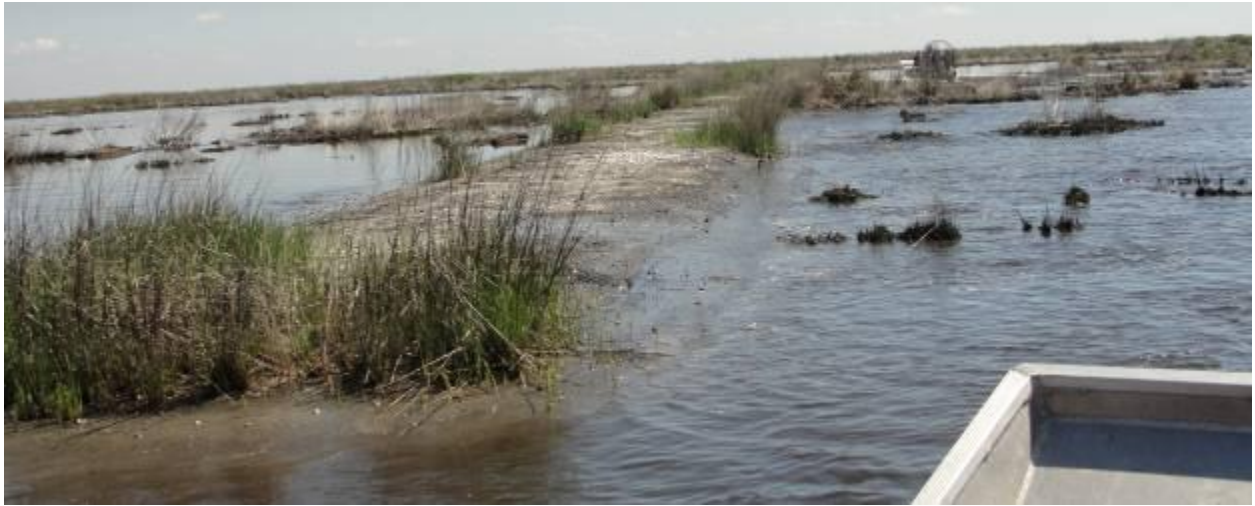
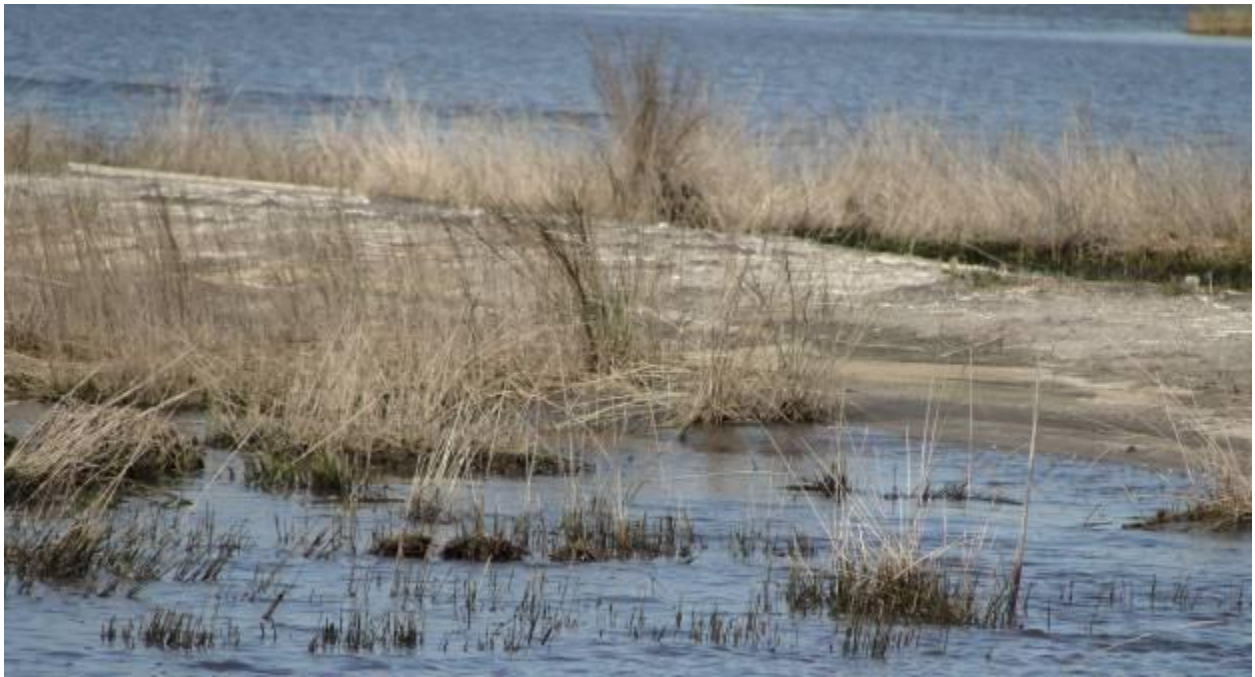
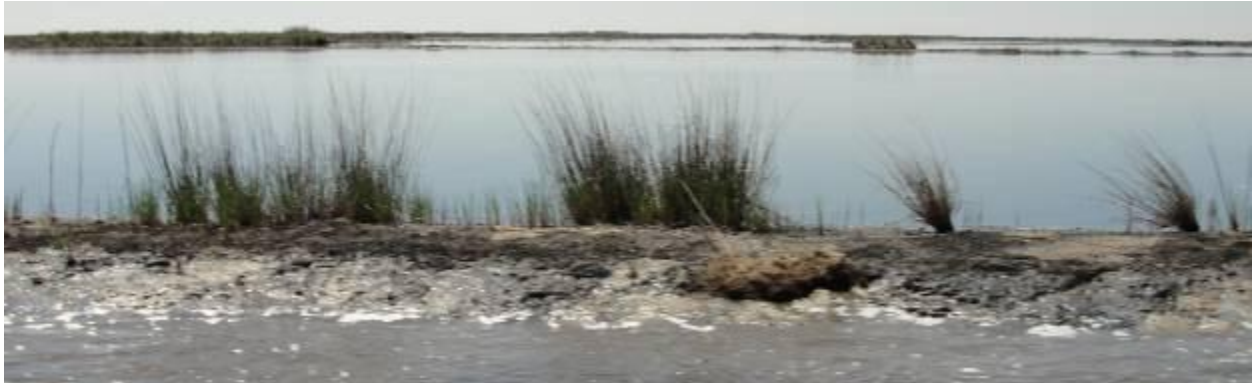
March 2010 condition of terrace segments with combination of older and recent plantings:

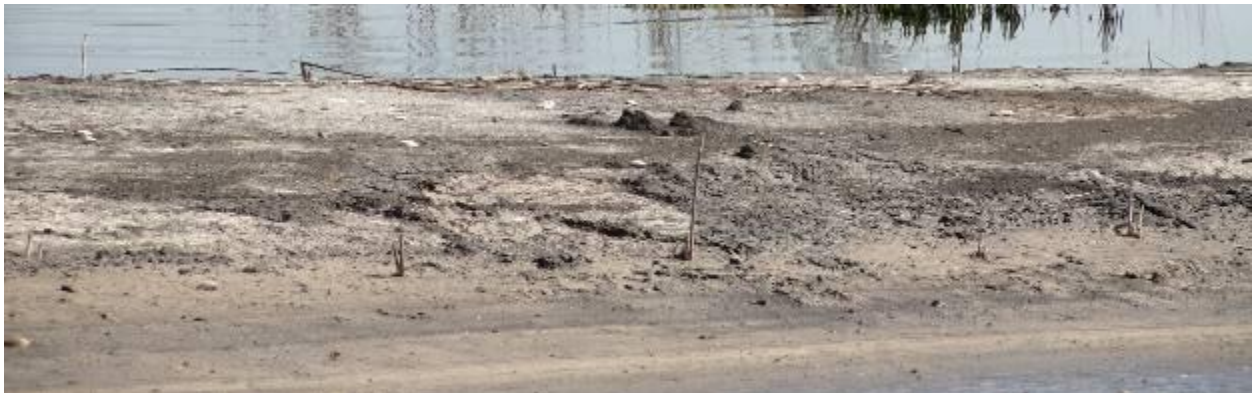
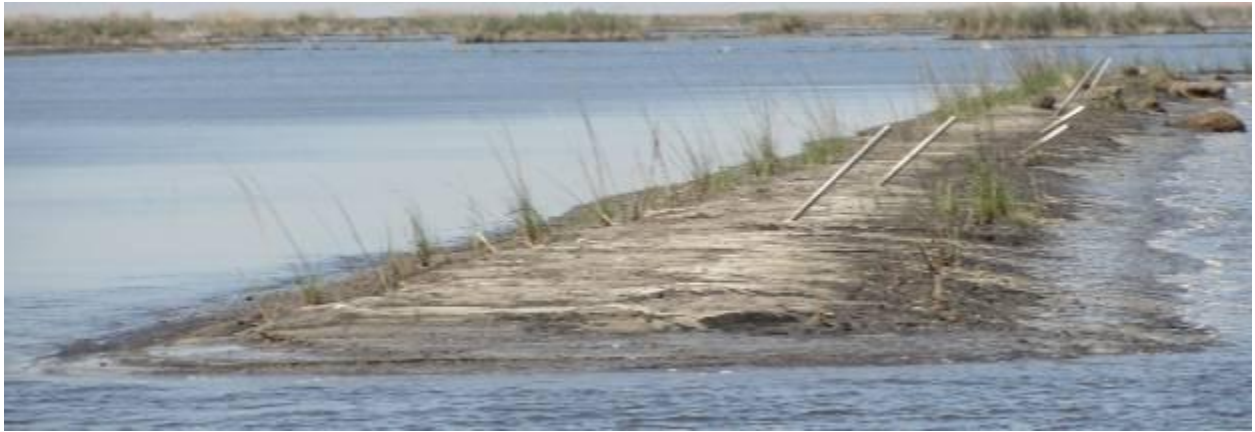
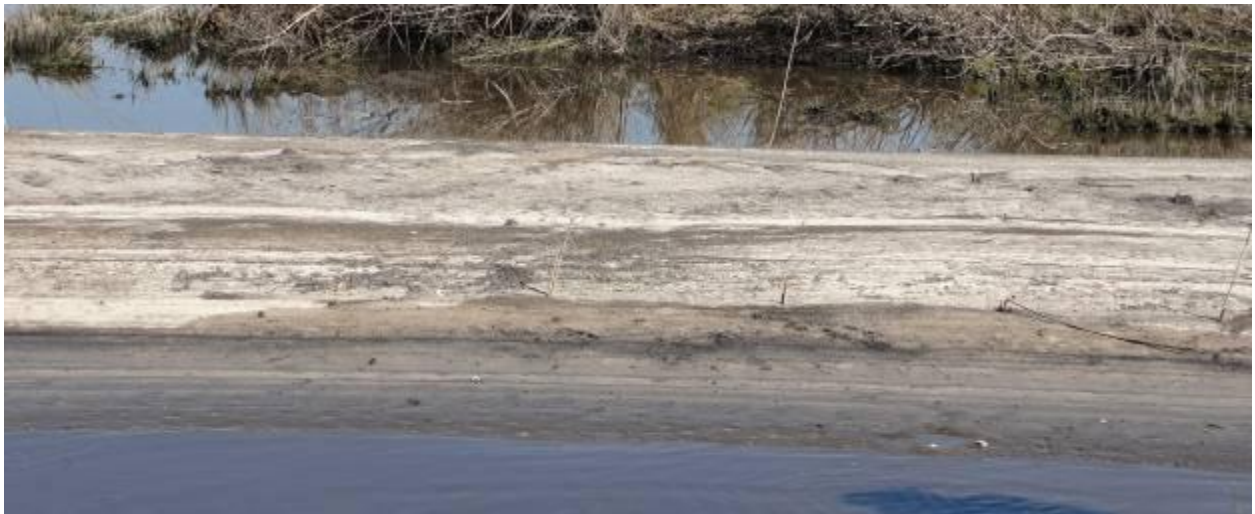
March 2010 condition of newest plantings:

Although mainly conjecture, weather could have played a causative role in the overall plant condition we observed. Installation of the CU-1B plantings was completed in July 2009 which turned out to be less than an ideal time for bare-root plant establishment. Following the extreme and prolonged saltwater inundation from hurricane Ike surge in September 2008, southwest LA experienced severe drought conditions in the first half of 2009, with a precipitation deficit persisting until October. In addition, discreet and continuous measurements during the summer revealed that salinities in the project area were significantly higher than normal - greater than 12ppt, and with water temperatures remaining around 85°F until September (CRMS). This may have led to stagnant or phytotoxic soil conditions until precipitation levels returned to normal in October, but by that time it was already at the end of the growing season when plants are beginning to senesce. This period was then followed by an unusually cold winter pattern that began in late November and persisted throughout south Louisiana. Minimum temperatures frequently dropped into the 30's or below for at least half of Jan and Feb 2010 dates (NWS monthly summaries for the Lake Charles/Port Arthur area). It is possible that the newest plantings experienced higher mortality or dieback of aboveground tissue from the combination of elevated stress during initial acclimation and then additional impact by the ensuing cold temperatures to any new shoot growth that did occur. Further, following a typical winter season, robust new growth is not usually seen in smooth cordgrass until March when warmer spring temperatures become entrenched. So it is also possible that this year's new growth expected for all plants in the area may still be absent because it's been retarded by the persistent winter weather pattern and the late freeze in early March.

Because of the high uncertainty at this date of what below-ground tissue remains viable, a mortality rate or pattern cannot reasonably be determined for any of the plantings, regardless of age. I recommend returning to the project site in September near the end of this year's growing season when a much more accurate assessment of the extent of plant survival can be made. Collection and analysis of soil samples may also provide additional insight in discerning actual causes of the apparent poor performance of all the plants.
