2012 Operations, Maintenance, and Monitoring Report

East Sabine Lake Hydrologic Restoration (CS-32)

State Project Number CS-32
Priority Project List 10

July 2012
Cameron Parish

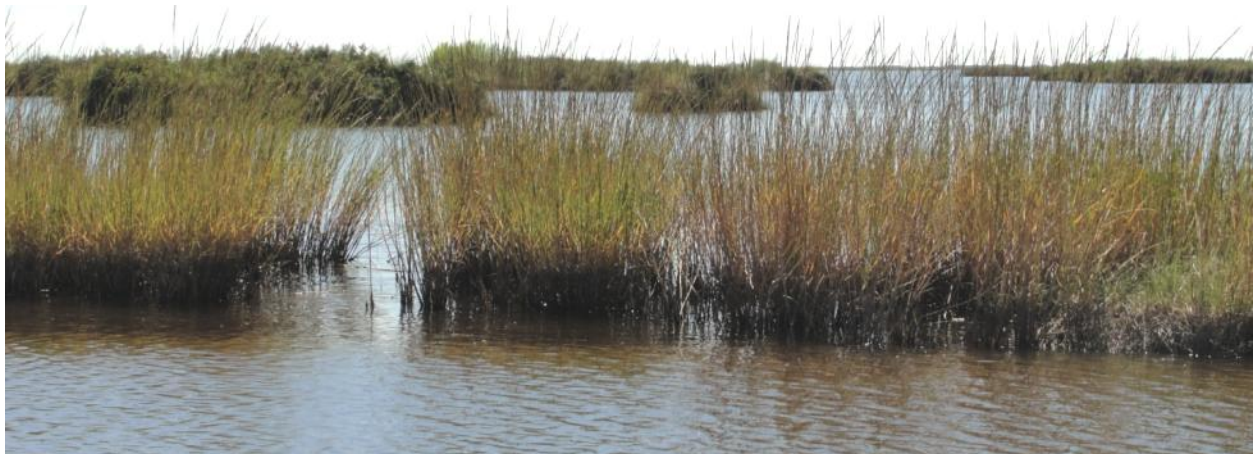
The vegetative growth of smooth cordgrass on the oldest and southeasternmost CU-1 Rows 16 to 25 looked excellent, as did that on newer CU-1A/B Rows 11 to 8, and the coverage was nearly 100%. The few gaps that were occasionally present on a few segments were minor and some gaps were occupied by other species such as seashore paspalum (*Paspalum vaginatum*) where the terrace crown was above the water elevation on this date.

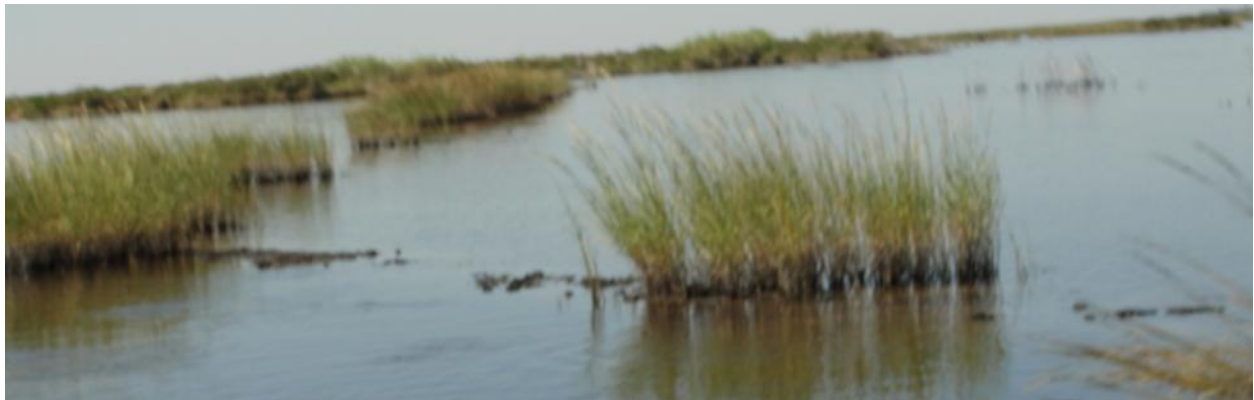
As the party continued north, the survival estimates for the rows dropped dramatically and ranged from fair to poor (5% to 50%) on the CU-1A/B Rows 4 to 2, but the vegetation that did remain appeared to be recovering well and for the most part looked very healthy.

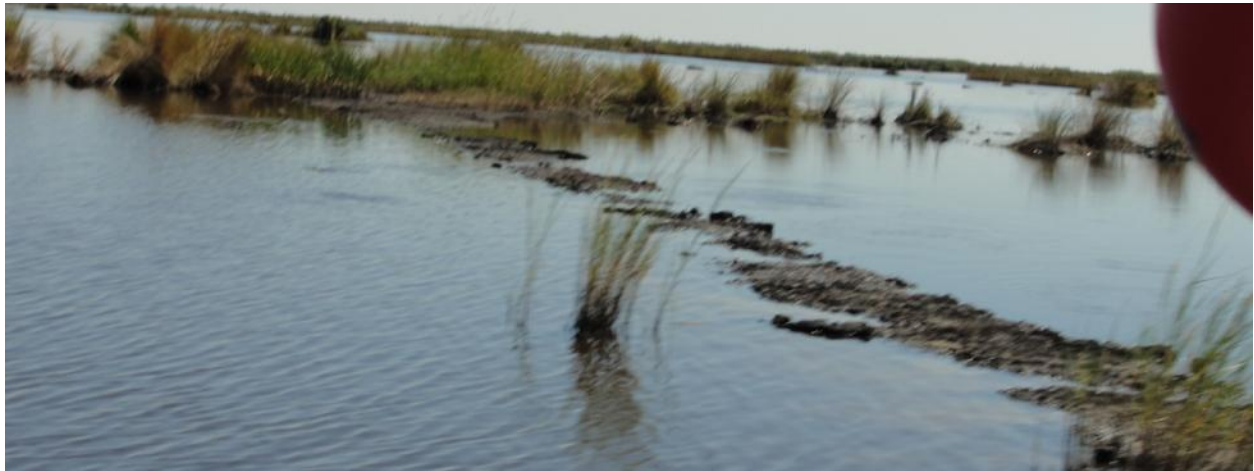
There were a few exceptions however where some plants appeared to be struggling, but those were generally found where the terrace segments were severely impacted and were obviously narrowed with lower crown elevation.

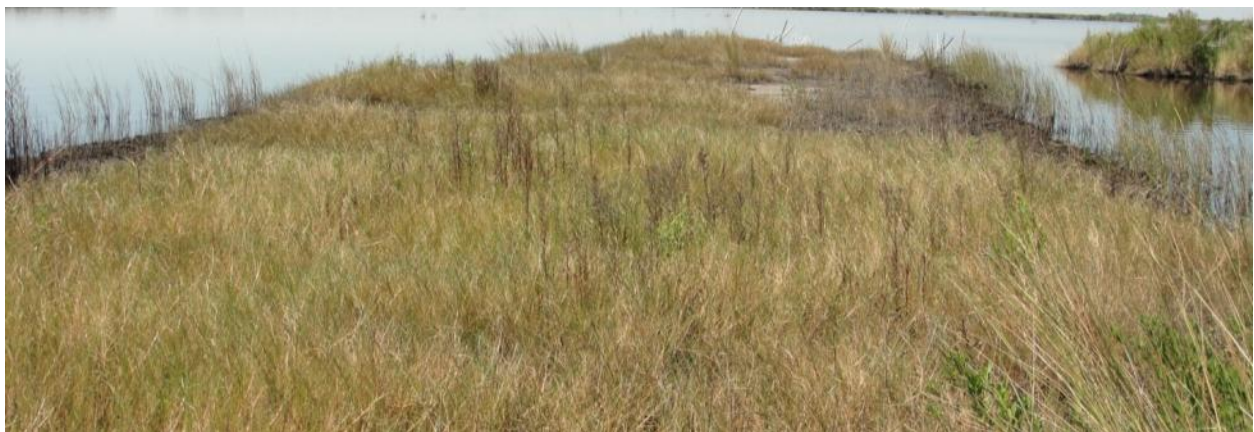
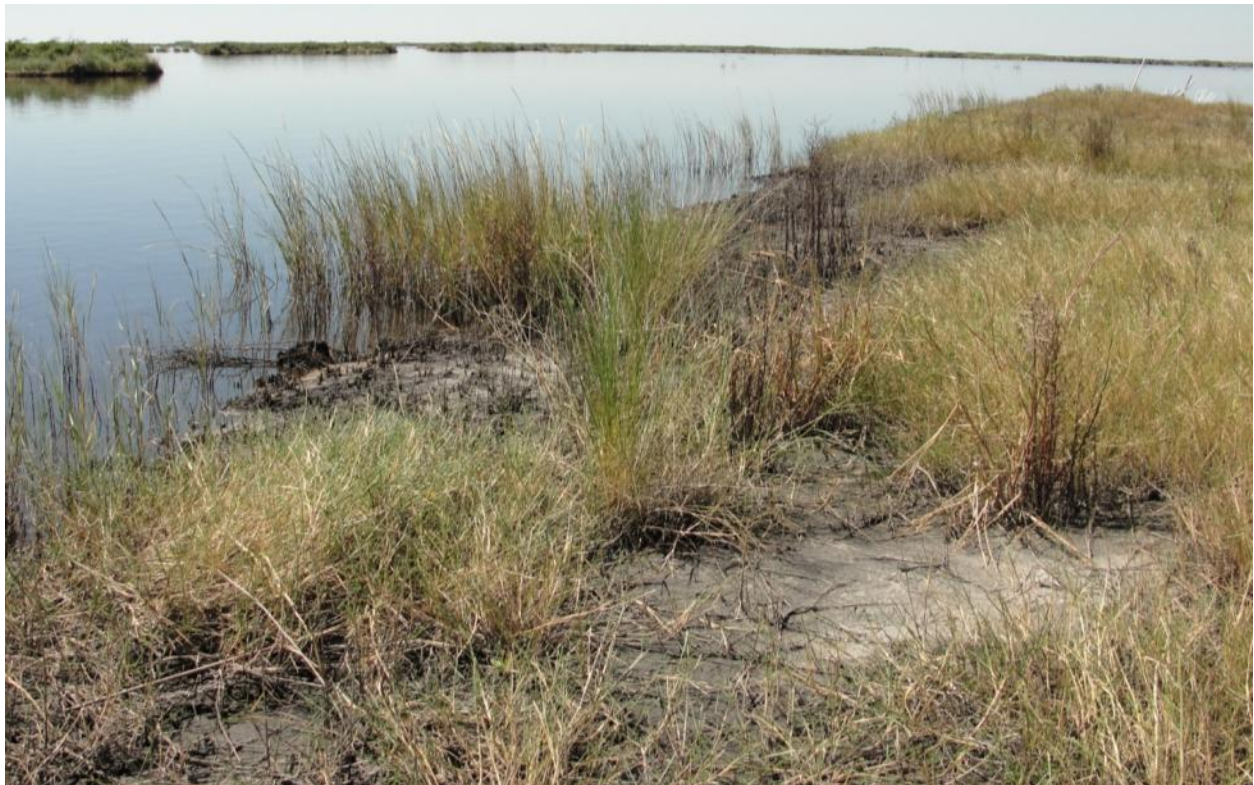
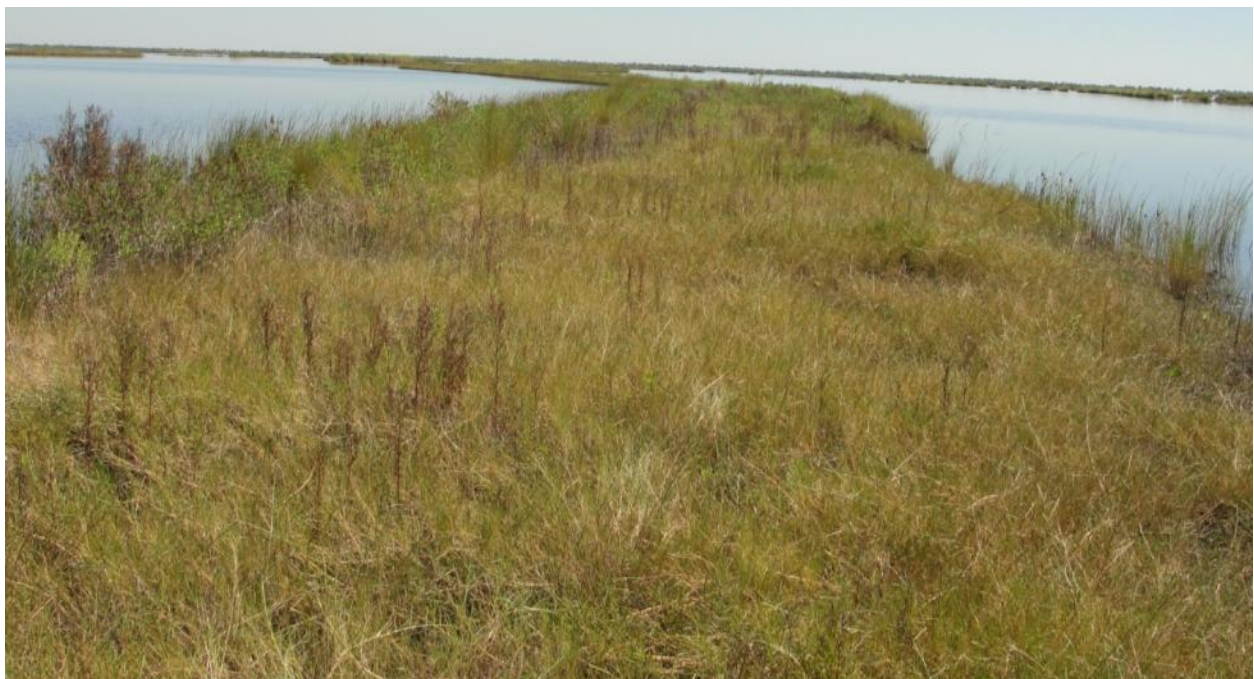
The older CU-1 Row 14A terraces continue to be in very good shape, and well covered with vegetation (below). Most of the crown cover however was from a variety of other pioneering species, mainly seashore paspalum and marshhay cordgrass (*Spartina patens*), but seashore elder (*Iva imbricata*), leafy three-square (*Schoenoplectus maritimus*), goldenrod (*Solidago* sp.) and sedges (*Cyperus* spp.) were also present, as well as saltmarsh aster (*aster tenuifolius*), cattail (*Typha* spp.), camphorweed (*Pluchea camphorata*) and marsh morningglory (*Ipomoea sagittata*), and walter's millet (*Echinochloa walteri*). The smooth cordgrass at the toe of this row's segments actually looked in poor shape, and the cover it provided was sparse along some edges.

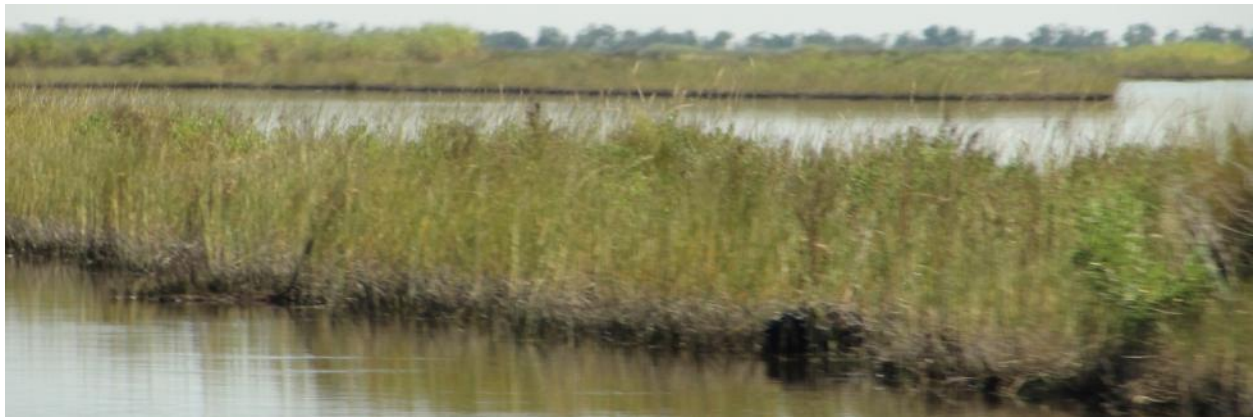
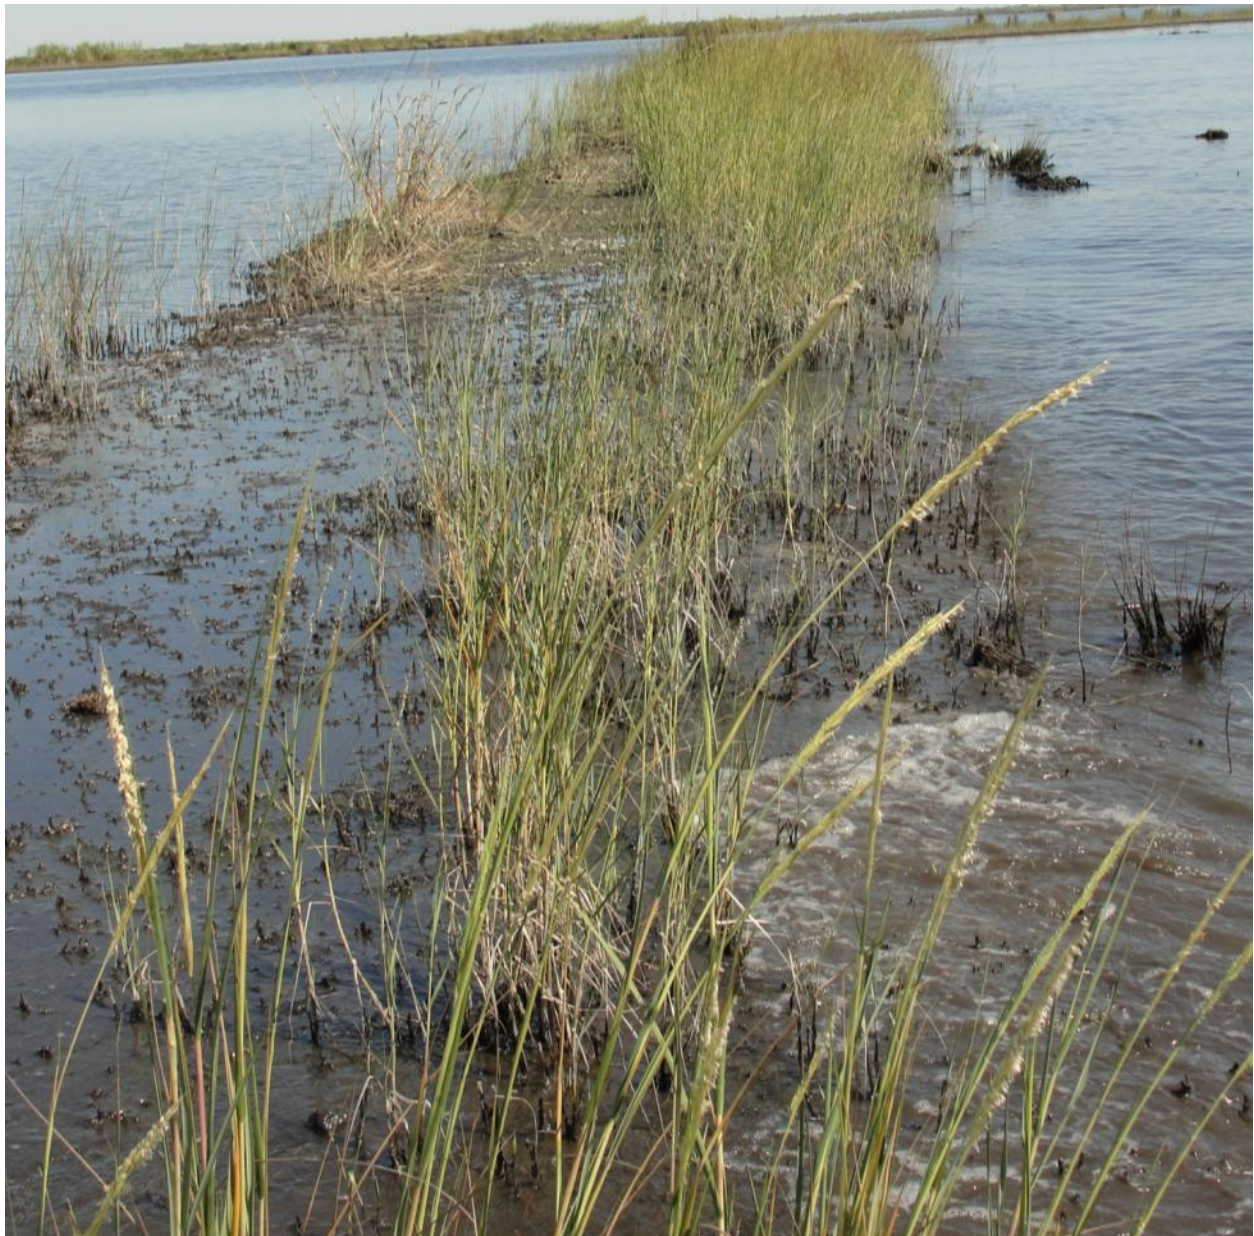
Overall, the southern rows of CU-1 group looked stable though some had obviously narrowed. There were some areas of loss observed, but there was no discernable pattern that might explain the loss, or why the smooth cordgrass was not recovering well on some segments or in spots, but on others, though providing thin cover, the individual plants looked fairly robust.

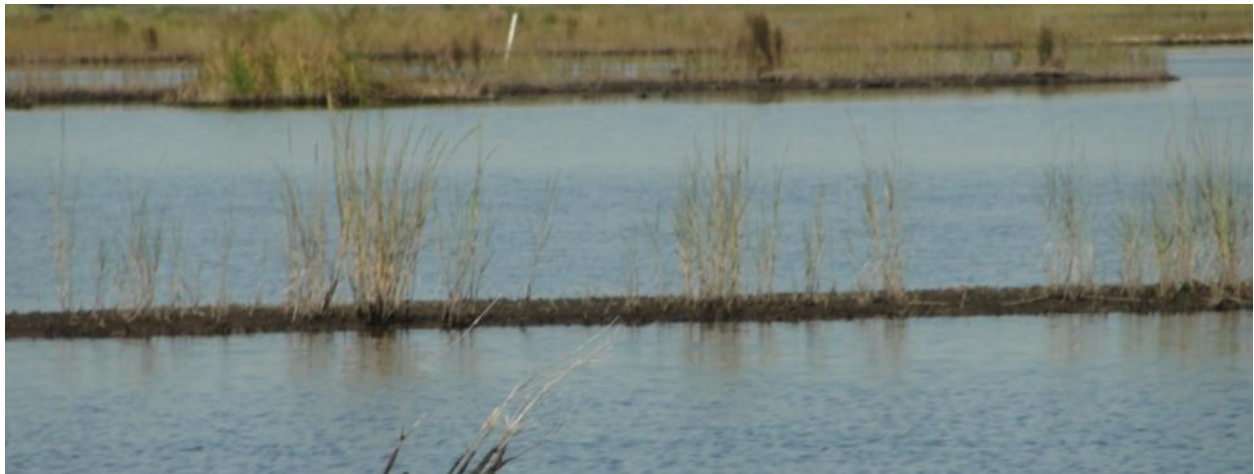
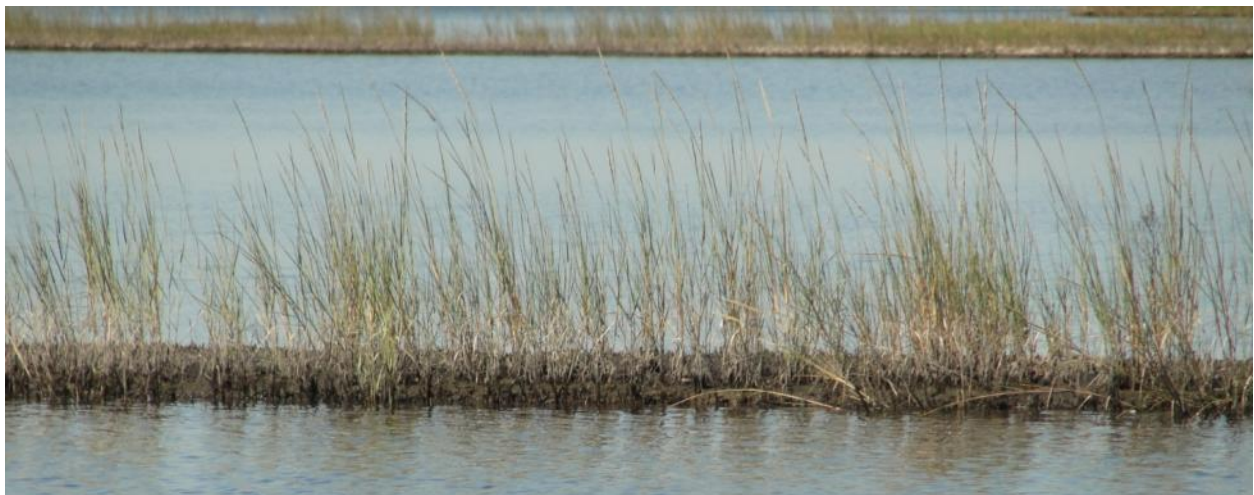
Continuing north, the survival and cover on the CU-1 terraces was found to vary quite a lot. Many terrace segments were much narrower and had poor to no cover, but there were other segments where the cover was good and the terraces retained their width. Overall though, there were only a few sites found where individual smooth cordgrass plants looked as robust as those seen to the south. It almost appeared that some plantings were just beginning to re-emerge and expand the cover.

Recommendation: The project team discussed options and it is recommended that the construction phase of this project be closed out. The remaining plantings are expected to continue to recover and expand but where there are large stretches of missing plants, it is advisable to re-vegetate with additional plantings that can be conducted through O&M. I recommend that an O&M planting to target areas with poor to no cover be planned for TY1 or 2, and could probably be accomplished for less than \$100,000 (not amortized \$). To provide for adequate cover to be maintained throughout the 20-year project life, O&M funds should also be available for an additional O&M planting event if it becomes necessary later in the project life. Darryl Clark has confirmed that there currently is \$254,428.04 in the project O&M budget, which is sufficient to fund a TY1 or 2 planting. OCPR typically implements the O&M activities, but if USFWS & OCPR agree, NRCS can design and implement the planting.
