**State of Louisiana
Coastal Protection and Restoration Authority
Office of Coastal Protection and Restoration**

2012 Operations, Maintenance, and Monitoring Report

East Timbalier Island Sediment Restoration, Phase 1 & 2 (TE-25 & TE- 30)

July 2012
Lafourche Parish

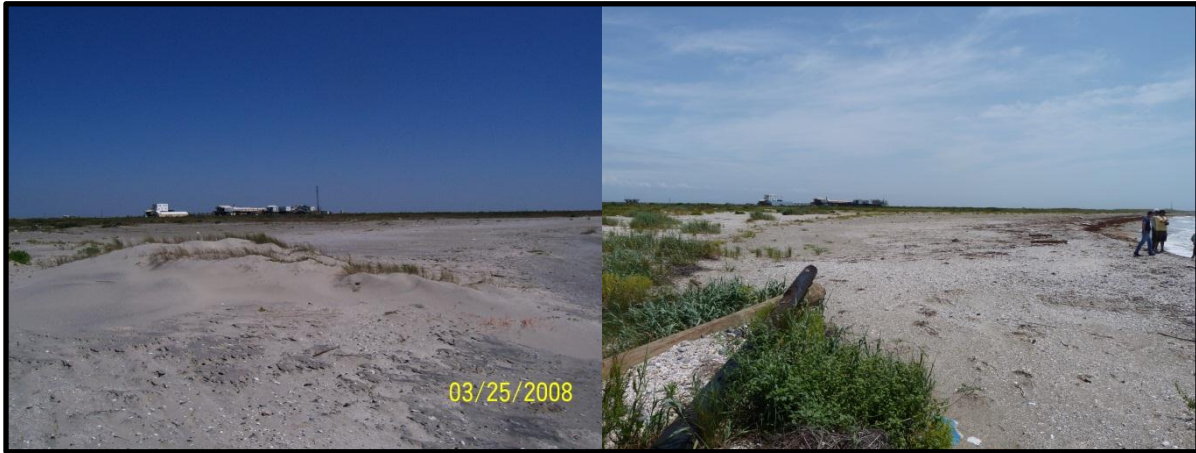
sediment within the shoreface profile to allow dune formation in fair weather conditions (Figure 6).

Figure 6. View of dune features near station 30+00 in March 2008 (left) and again in June 2012 (right). Note that there was enough sediment in the system in 2008 to maintain dune formations even with high shoreline erosion rates, while July 2012 inspection photos indicate very little sediment transport onshore even with little tropical activity in recent years.

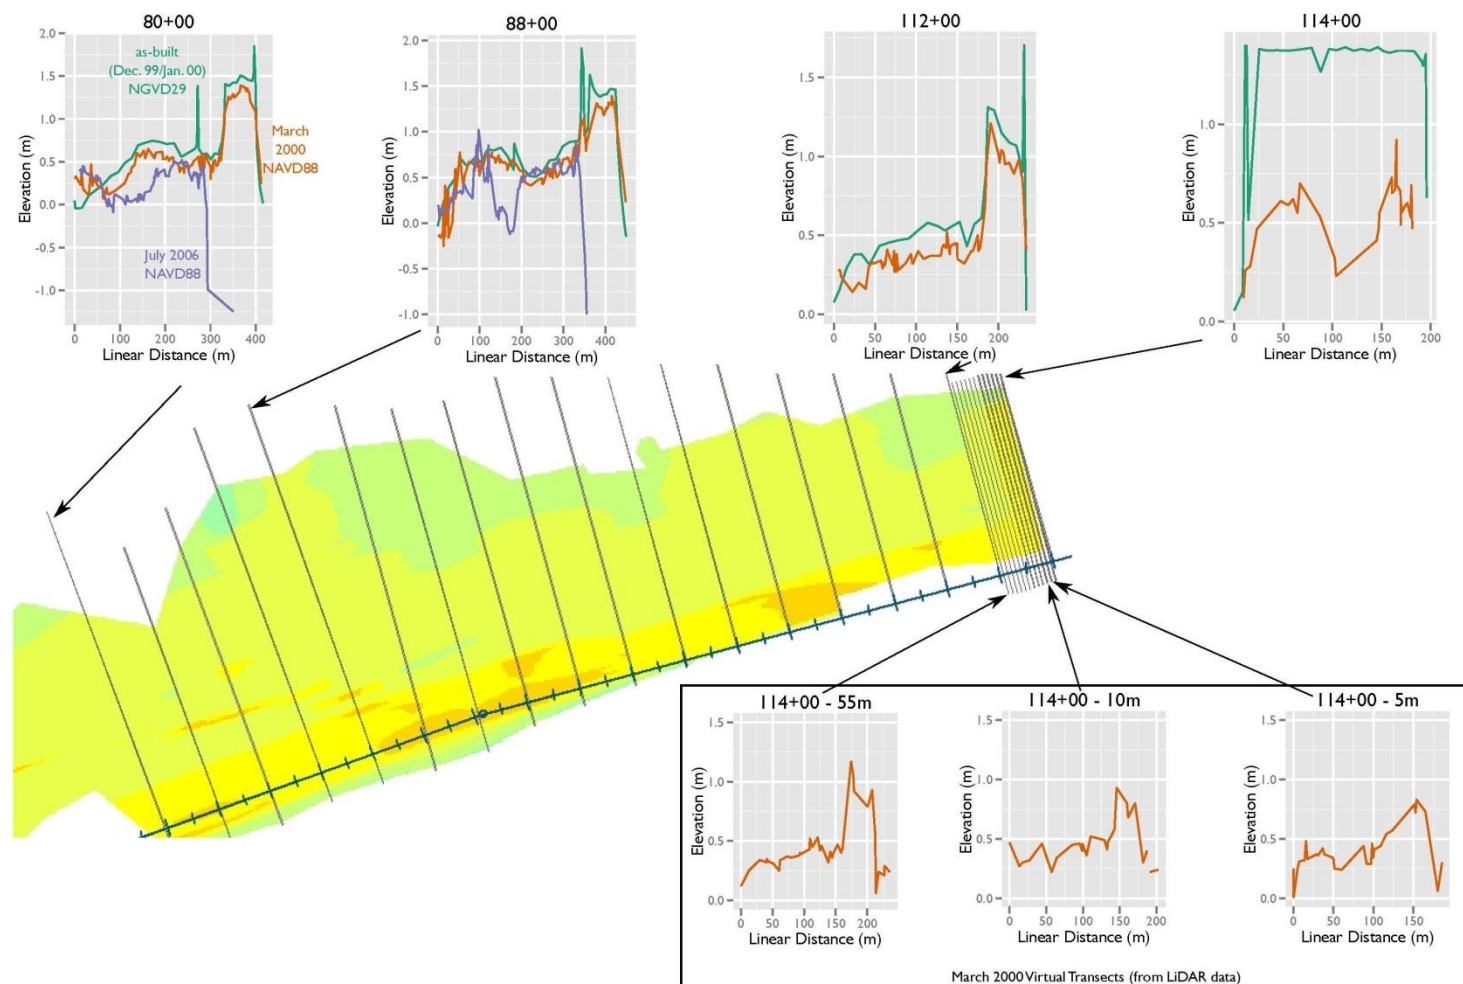
In contrast to the remarkable agreement found in nearly all the elevation profiles analyzed, the easternmost profile (114+00) shows poor agreement between the as-built and March 2000 survey (Figure 12). Consistent with the as-built elevation grid model, the as-built cross-section shows an elevation of ~1.3 m (4.3 ft) across the ~200 m (643 ft) transect. We interpret this feature as a dune that was built at the easternmost section of the project area. The March 2000 survey shows a significant decrease in elevation, far greater than can be accounted for by the difference in datums. In addition, the profiles are remarkably different. Whereas the as-built profile shows level dune, the March 2000 profile shows significant sloping.

The elevation data present a picture of rapid deterioration of the project due to environmental forces, particularly tropical events. The as-built and March 2000 elevation profiles are in good agreement, with one critical exception—transect 114+00 at the easternmost end of the project area. Further dissection of the profiles at this end of the island shows degraded dune nearly 10 m inshore from the eastern end. These data indicate that within three months of construction the eastern end of the project had been compromised.

Figure 12. As built and March 2000 elevation profiles of the eastern portion of TE-30 derived from GIS elevation modeling. The x-axis is north to south, with 0 meters representing the bay (or northernmost) side of the island.

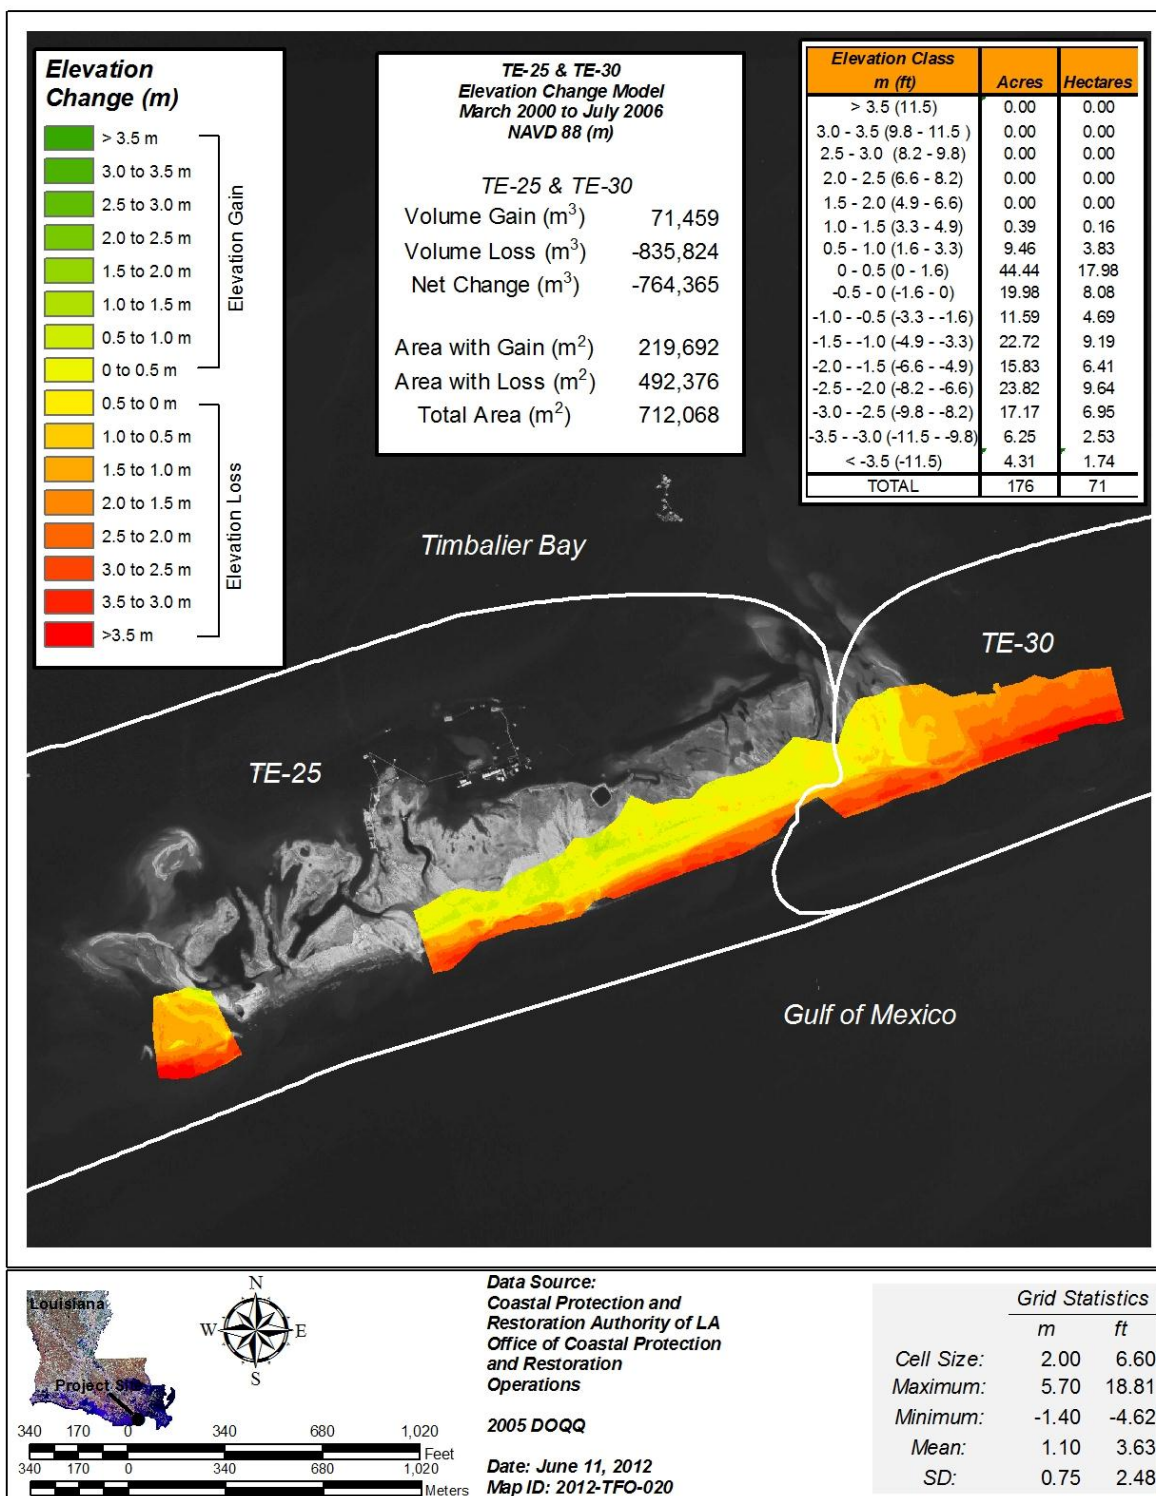
LiDAR data and built elevation grid and elevation change models. The grid elevation change model for March 2000 to July 2006 represents a culmination of the degradation that began immediately after construction (Figure 16). Over two-thirds (69%) of the project area showed a loss in elevation from 2000 to 2006. The remaining 31% showed a slight increase in elevation, with most positive elevation change being limited to less than 0.5 m. Overall, the project lost 764,365 m³ of sediment which is 9,481 m³ in excess of the sediment added for the TE-25/TE-30 project construction. Not surprisingly, the greatest losses (red shading) are at the eastern end of the project area, where nearly the entire TE-30 project fill template was eliminated. In addition, the southeast (or Gulf of Mexico) facing side of the project experienced substantial losses in both the TE-30 and TE-25 project areas. The small, far western fill area of TE-25 also sustained substantial losses. In contrast to the eastern and southeastern facing sections of the island, this far western portion seemed quite stable prior to the 2002 hurricane season. Overall, the analysis suggests that within 6 years the project has degraded beyond its initial pre-construction state.

Figure 16. March 2000 to July 2006 digital elevation change model for the TE-25 and TE-30 fill areas.

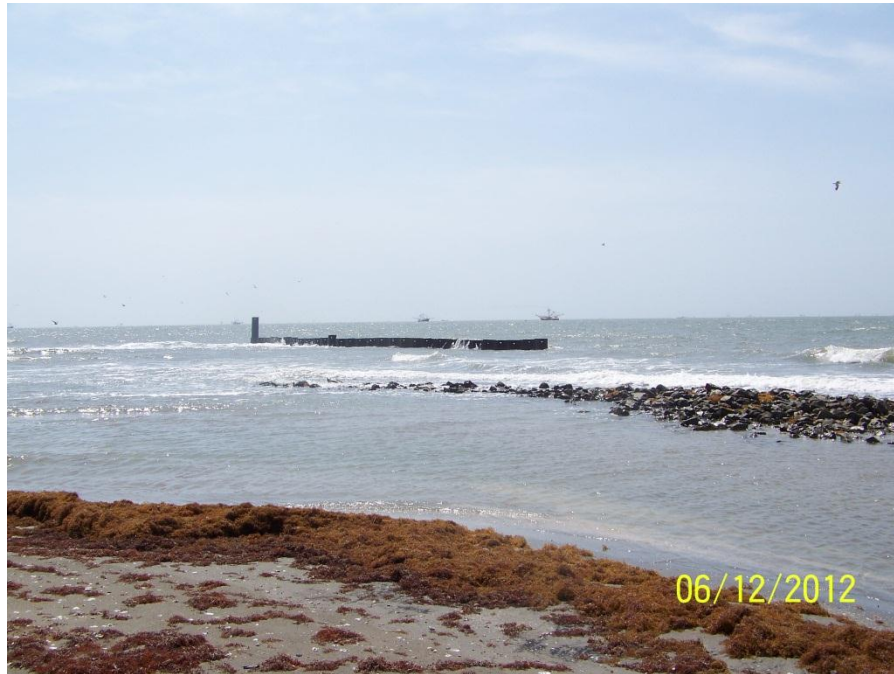
Photo 1: Gulf Shoreline near station 66+00 looking E (CPRA #100_6469). Note pre-project rocks formerly on the bayside of the island are now on the gulf shoreline.

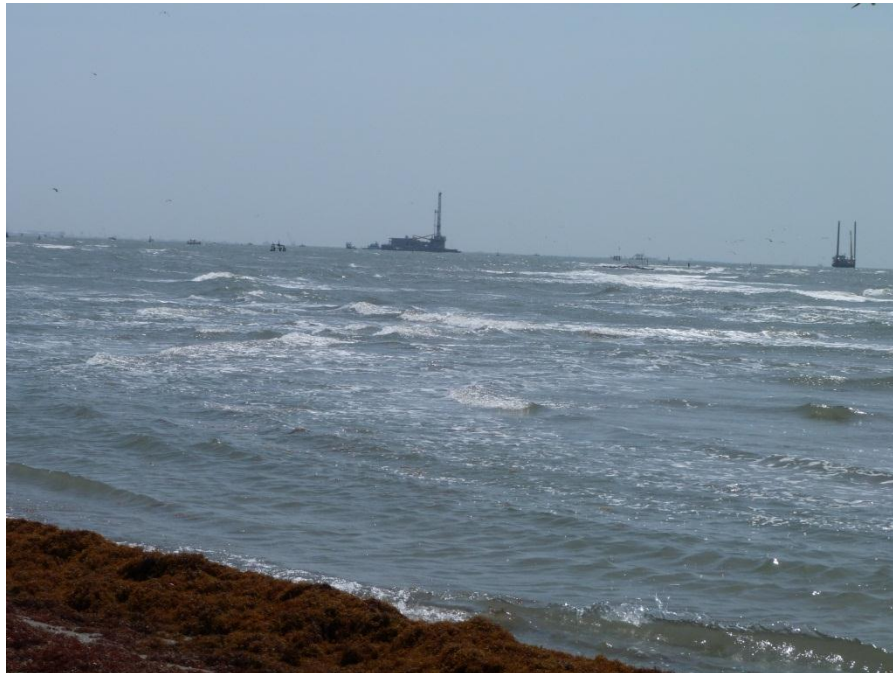
Photo 6: Gulf Shoreline near station 66+00 looking ENE (NOAA #P1000062). Note the lack of fill template evident above the waterline.

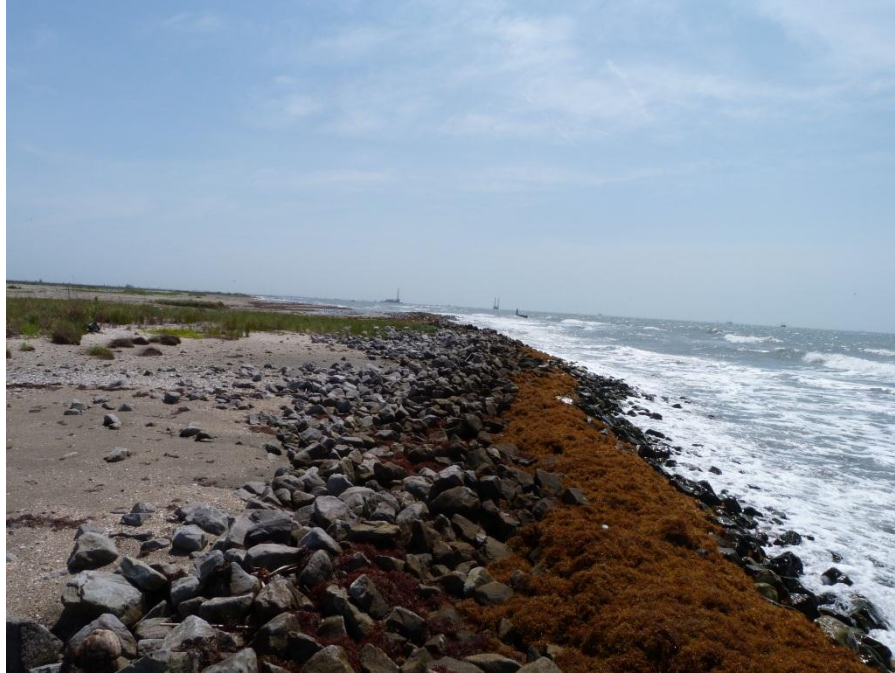
Photo 7: Gulf Shoreline near station 62+00 looking ENE (NOAA #P000054). Note that GPS data confirms that these are pre-existing rock features formerly on the bayside of the island, now located on the gulf shoreline.

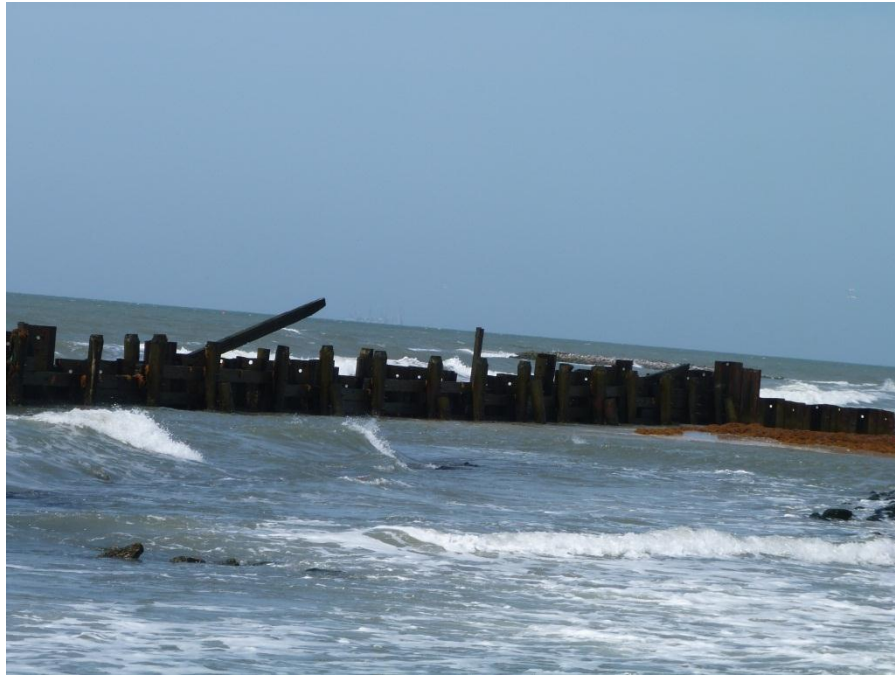
Photo 8: Gulf Shoreline near station 58+00 looking SSW (NOAA #P1000057). Note the timber bulkhead formerly behind the project dune feature now in the gulf shoreline.

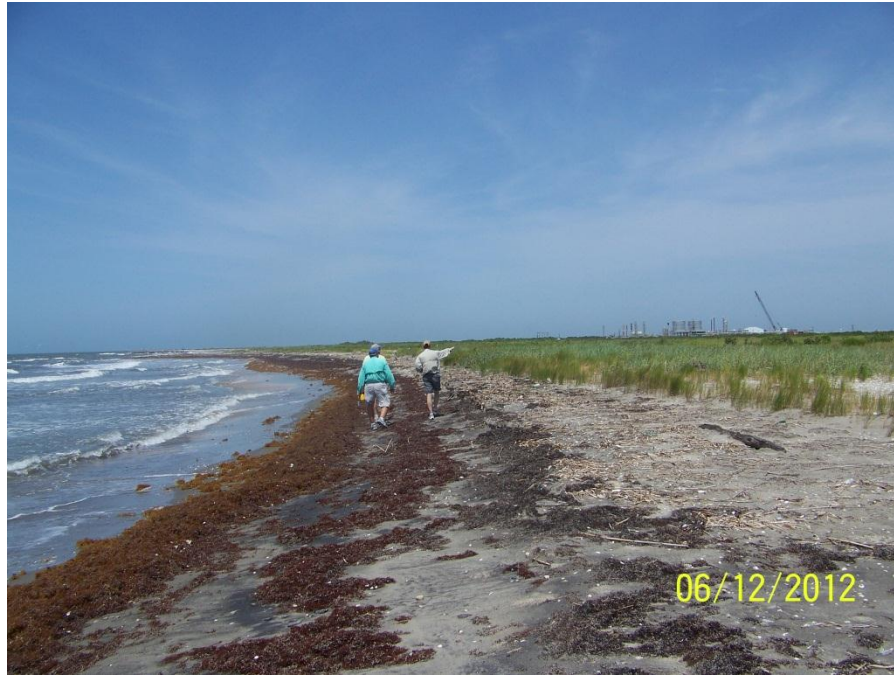
Photo 9: Gulf Shoreline near station 49+00 looking SW (CPRA #100_6476). Note the steep shoreline profile and lack of beach. Also there is little elevation to the dune habitat.

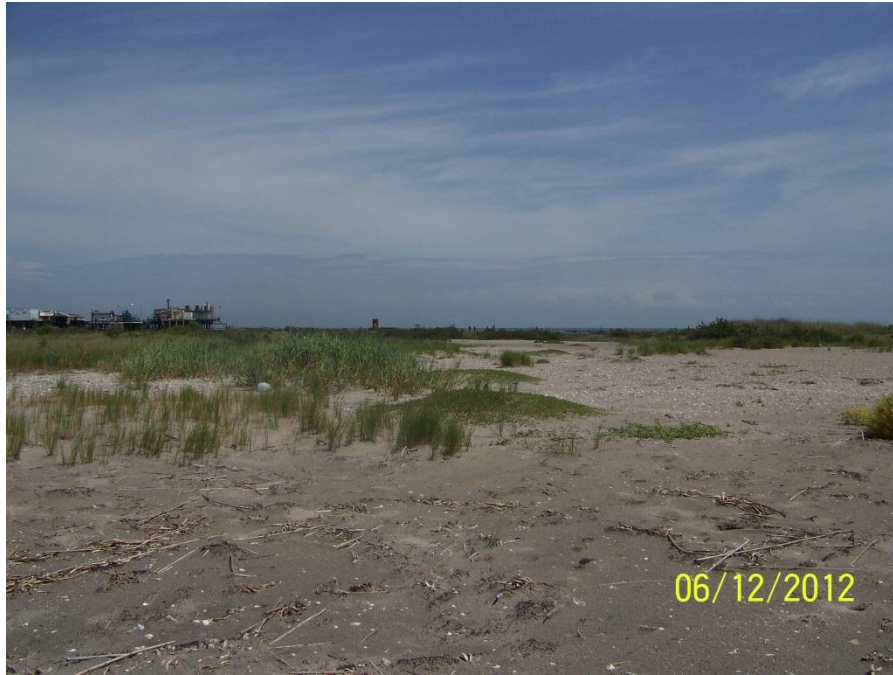
Photo 10: Looking NNW near station 49+00 (CPRA #100_6474). Note the former marsh platform has been converted to dune and back barrier habitats due to over wash processes, yet there is little dune elevation.

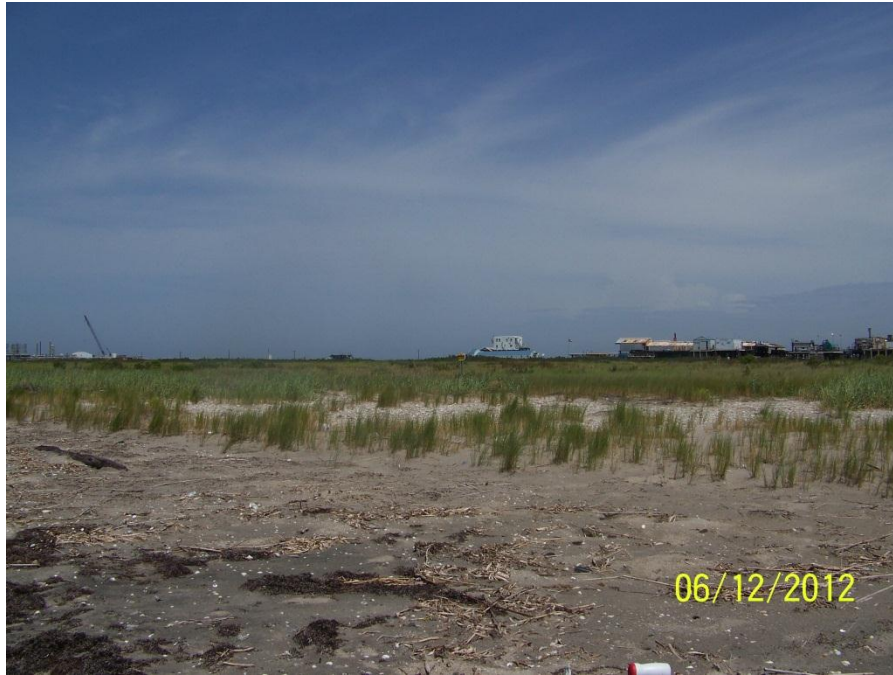
Photo 11: Gulf Shoreline near station 49+00 looking NW (CPRA #100_6475). Note the former marsh platform has been converted to dune and back barrier habitats due to over wash processes, yet there is little dune elevation.

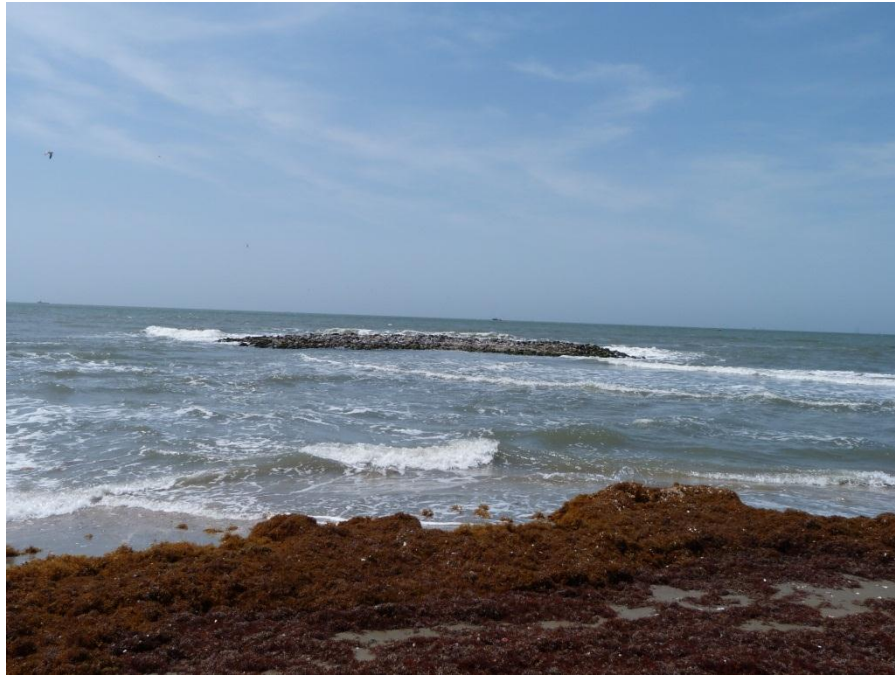
Photo 12: Gulf Shoreline near station 50+00 looking SSE (NOAA #P1000070). Note pre-existing rocks formerly on the bayside of the island, currently gulfward of the shoreline.

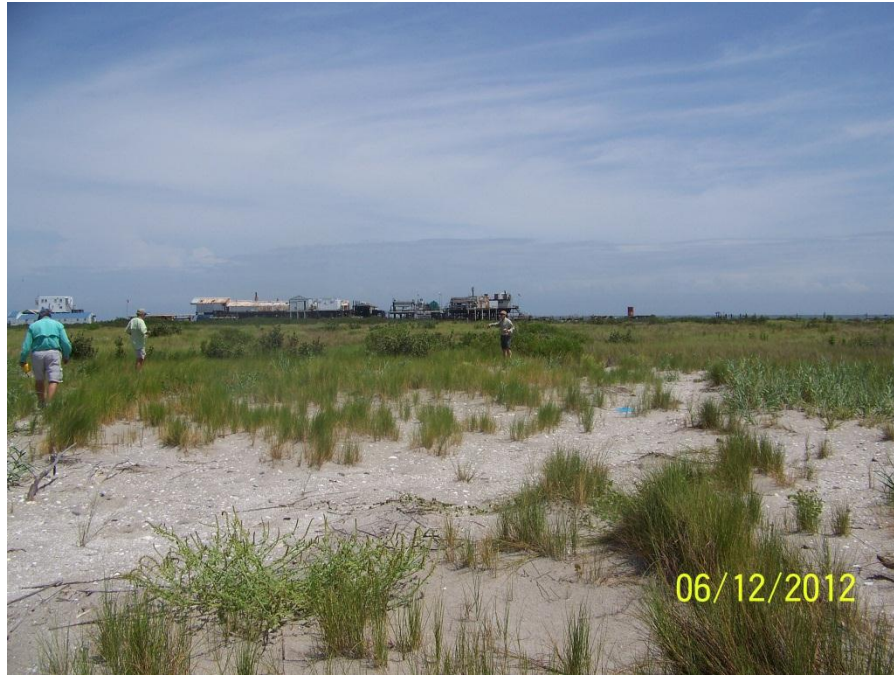
Photo 13: Gulf Shoreline near station 46+00 looking NW (CPRA #100_6479). Note the former marsh platform has been converted to low dune and back barrier habitats and the CPRA employee on the right is located at bayside marsh fill boundary approximately 50 yards from the gulf.

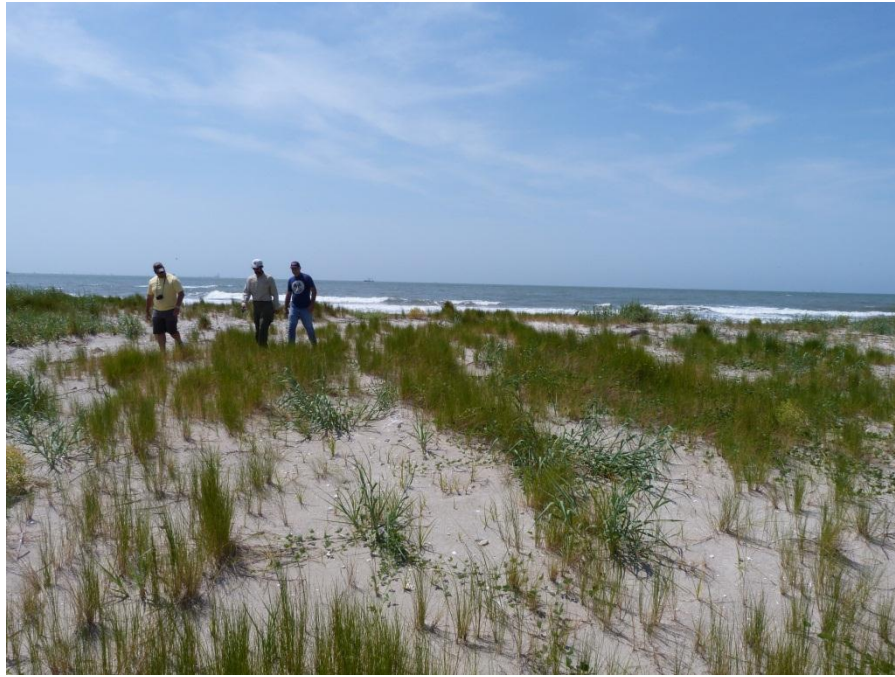
Photo 14: Marsh fill bayside boundary near station 46+00 looking SE (NOAA #P1000074). Note distance to gulf shoreline approximately 50 yards and marsh is now low dune habitat.

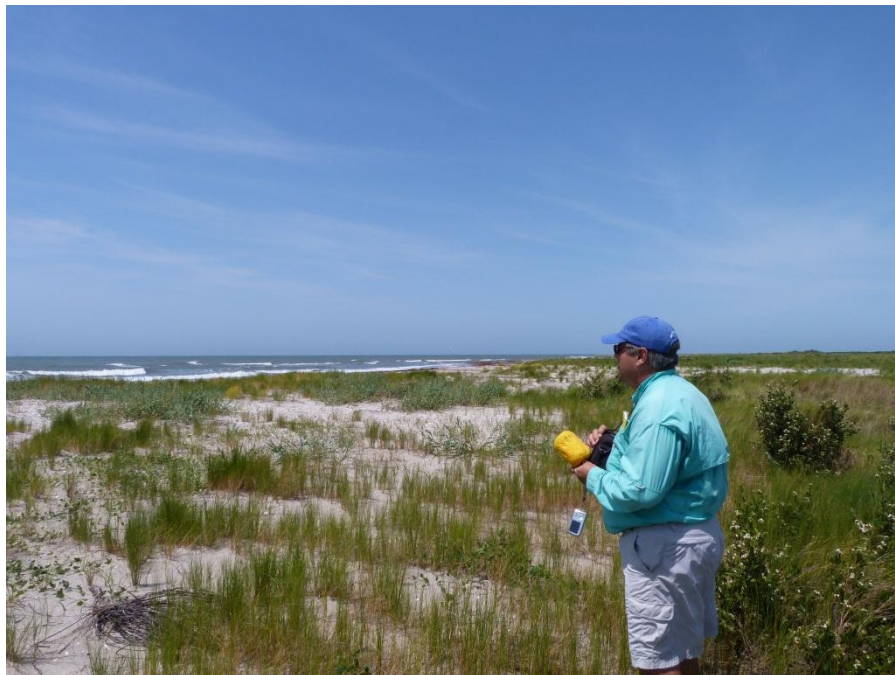
Photo 15: Marsh fill bayside boundary near station 46+00 looking SW (NOAA #P1000075). Note distance to gulf shoreline approximately 50 yards and marsh is now low dune habitat.

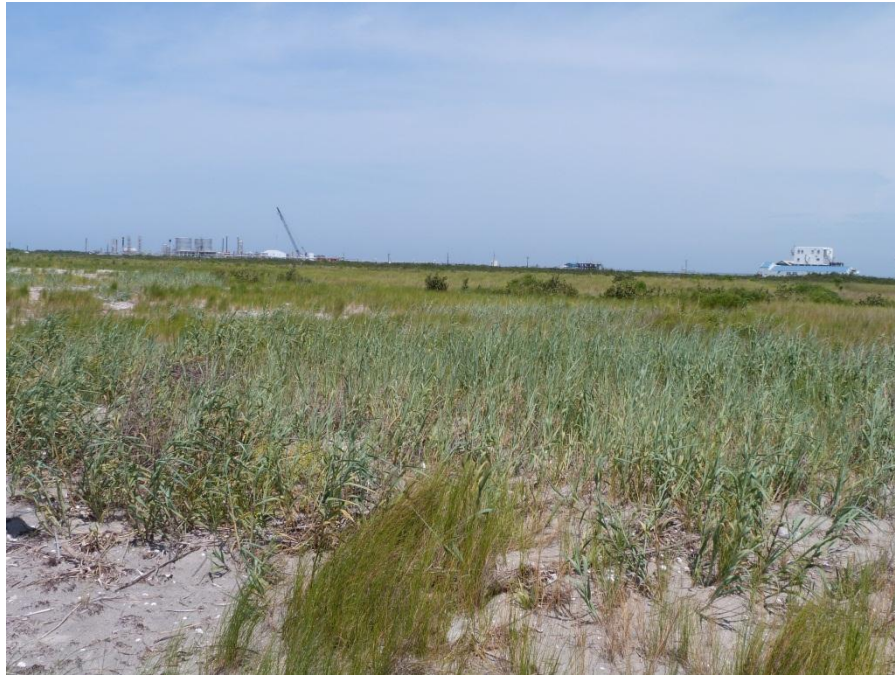
Photo 16: Low dune habitat near station 46+00 looking WNW (NOAA #P1000071). Note Bitter Panicum (*Panicum amarum*) coverage as former marsh fill has converted to low dune.

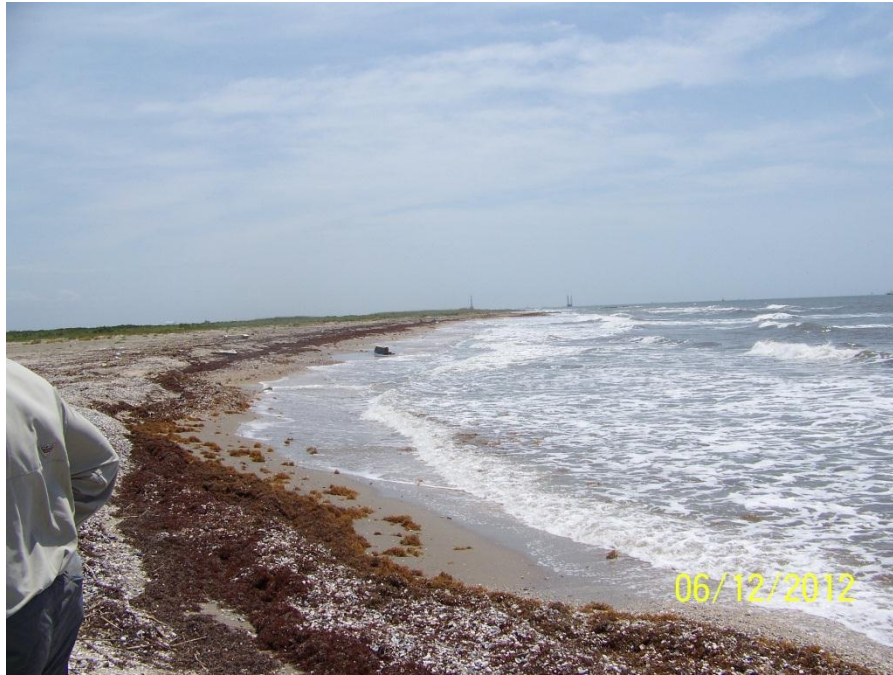
Photo 17: Gulf Shoreline near station 30+00 looking NE (CPRA #100_6488). Note steep shoreline profile and lack of beach. This location is near NW corner of the eastern fill area.

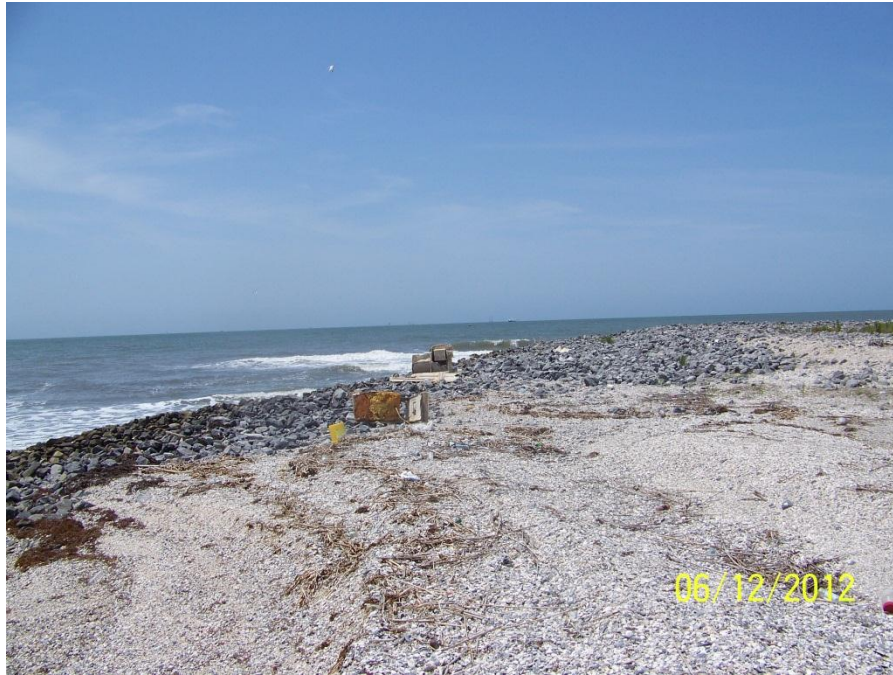
Photo 18: Gulf Shoreline near station 30+00 looking SW (CPRA #100_6484). Note pre-existing bayside rocks now on the gulf shoreline.

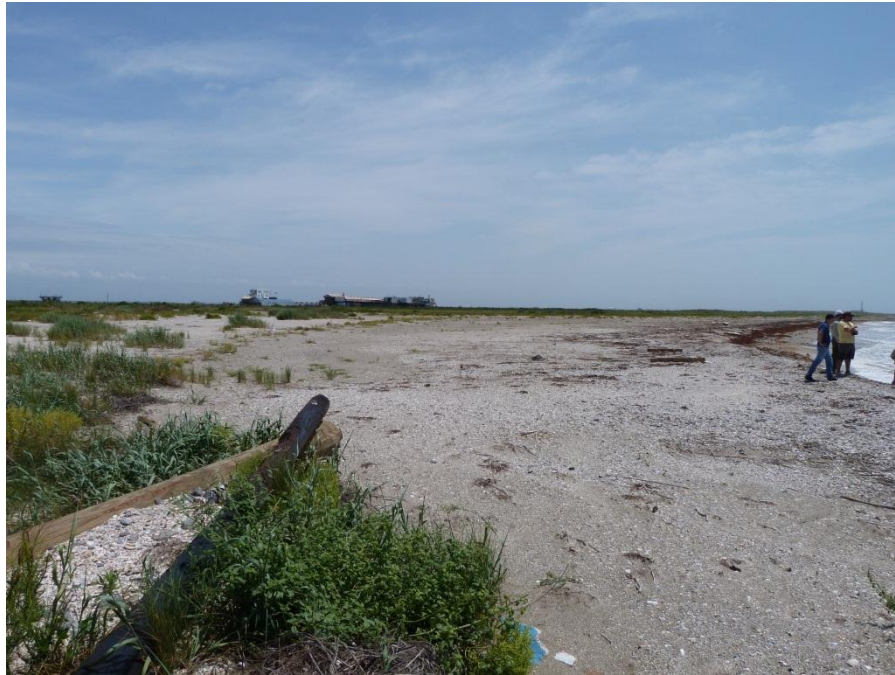
Photo 21: Gulf Shoreline near station 30+00 looking NNE (NOAA #P1000082). Note the personnel on the right of the photo are standing at the former NW corner of the eastern fill area.

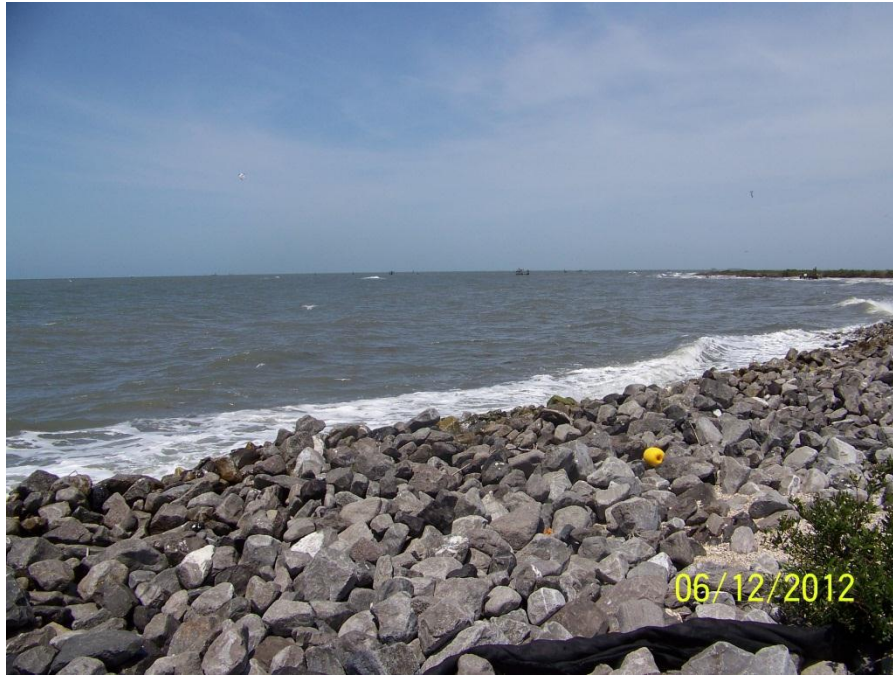
Photo 22: Gulf Shoreline near station 26+00 looking SW (CPRA #100_6482). Note there is no evidence of the western fill area.

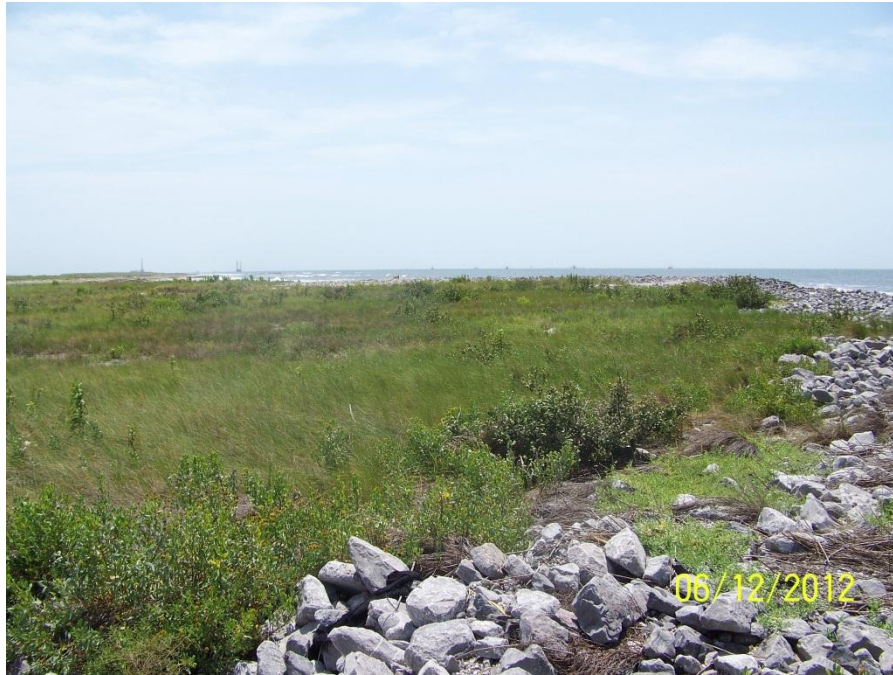
Photo 23: Gulf Shoreline near station 26+00 looking NE (CPRA #100_6480). Note these rocks pre-existed the project and the foreground habitats were not a part of the CWPPRA projects.

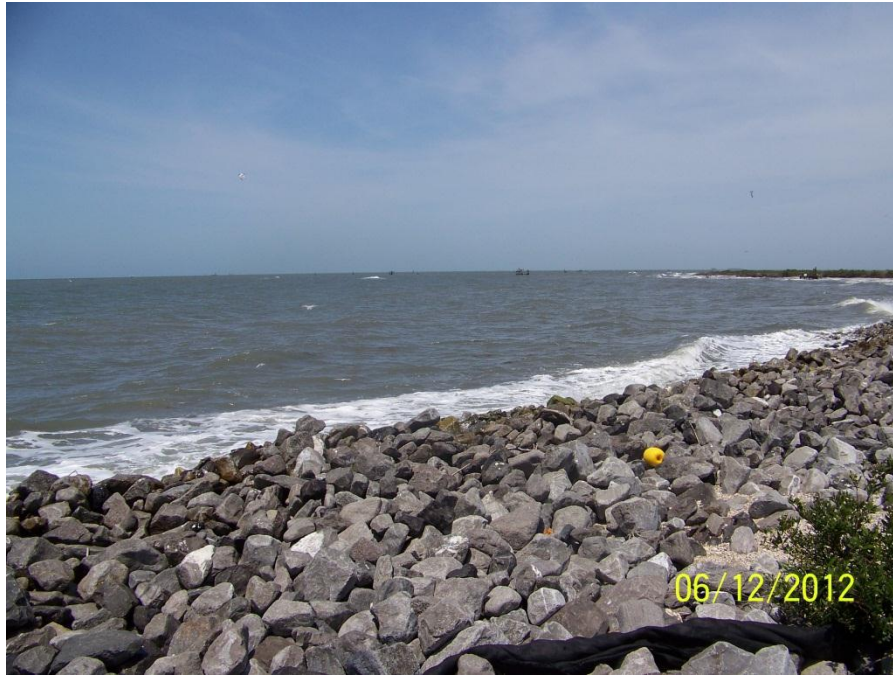
Photo 24: Gulf Shoreline near station 26+00 looking SW (CPRA #100_6482). Note there is no evidence of the western fill area.

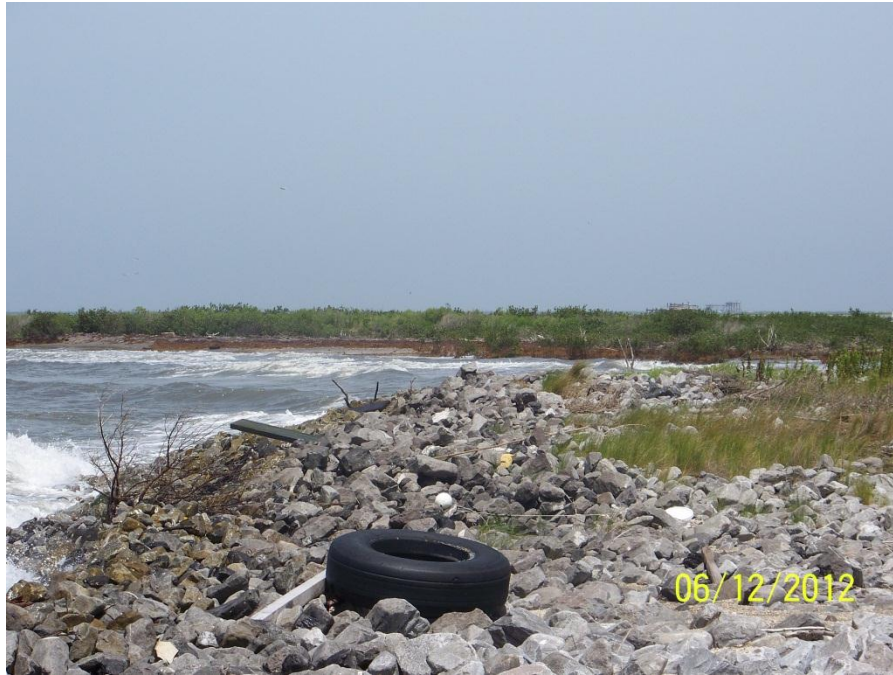
Photo 25: Gulf Shoreline near station 26+00 looking W (CPRA #100_6481). Note these rocks pre-existed the project and the foreground habitats were not a part of the CWPPRA projects. Also, note the breach in the shoreline just west of the rocks near station 20+00
