**2011/2012 Annual Inspection
Report**

**SWEET LAKE/ WILLOW LAKE
HYDROLOGIC RESTORATION
PROJECT
(CS-11b)**

State Project Number CS-11b
Priority Project List 5

March 28, 2012
Calcasieu Parish

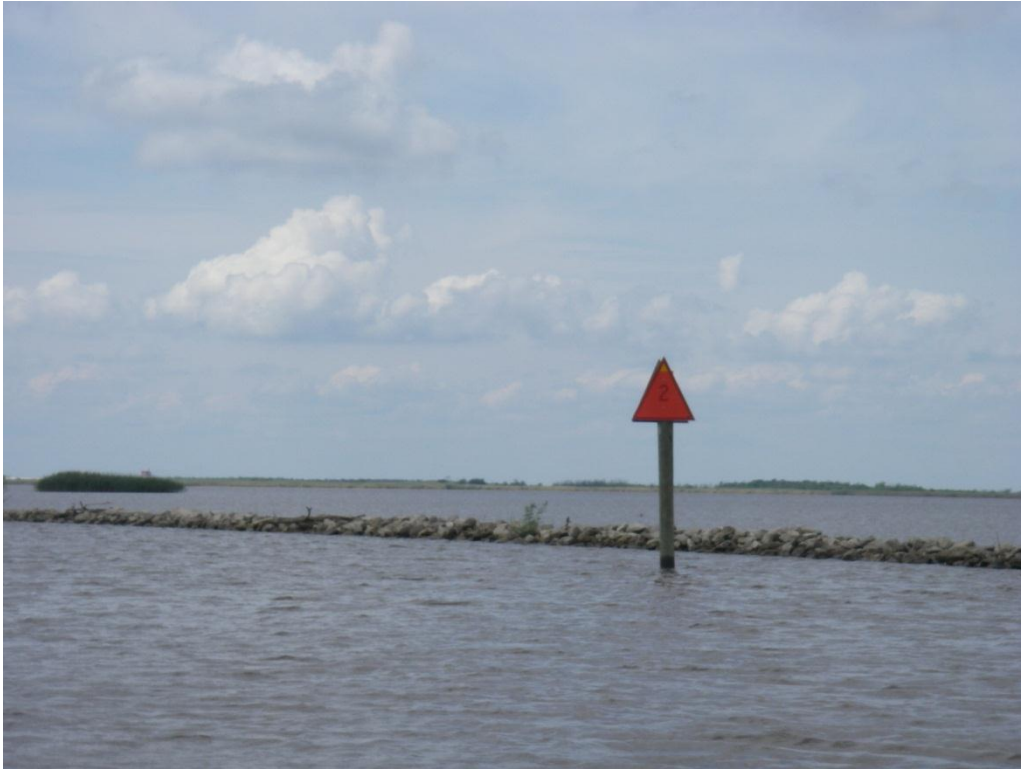
The dikes are in reasonably good condition. (See Appendix B, Photo 1-3 & 5). There are a few low places along the length of the rock dike with the most significant stretches along the open water areas adjacent to Sweet Lake along with an area approximately 50 feet wide along the very eastern end of the project area in which the dike appears to have been “pushed back” 10-12 feet apparently by a barge. (See Appendix B, Photo 4) There is another area approximately 4 feet wide in which the dike appears to have been removed by hunters or fishermen. Several settlement plates are either broken or leaning and are of no use. No gauges were available in the vicinity to determine water levels. The shallow water terraces feature of the project was not inspected at this time. The terraces were not visible during prior inspections.

Photo No. 1, (Sweet Lake) Typical rock dike

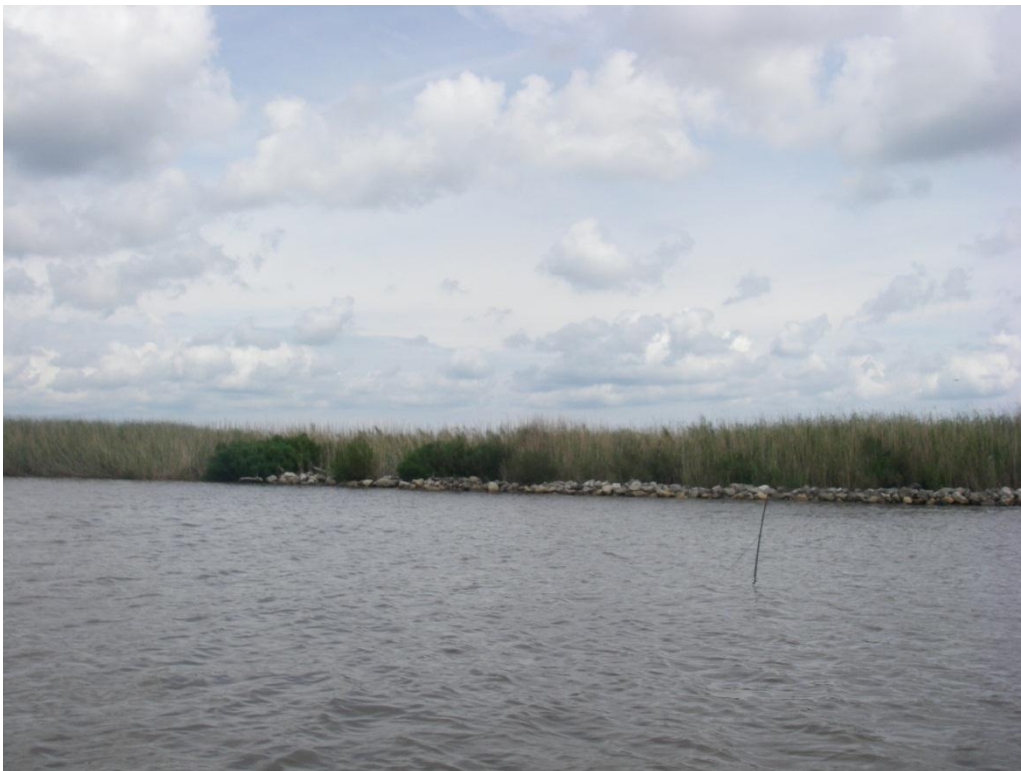
Photo No. 2, Western End of Sweet Lake Rock Dike

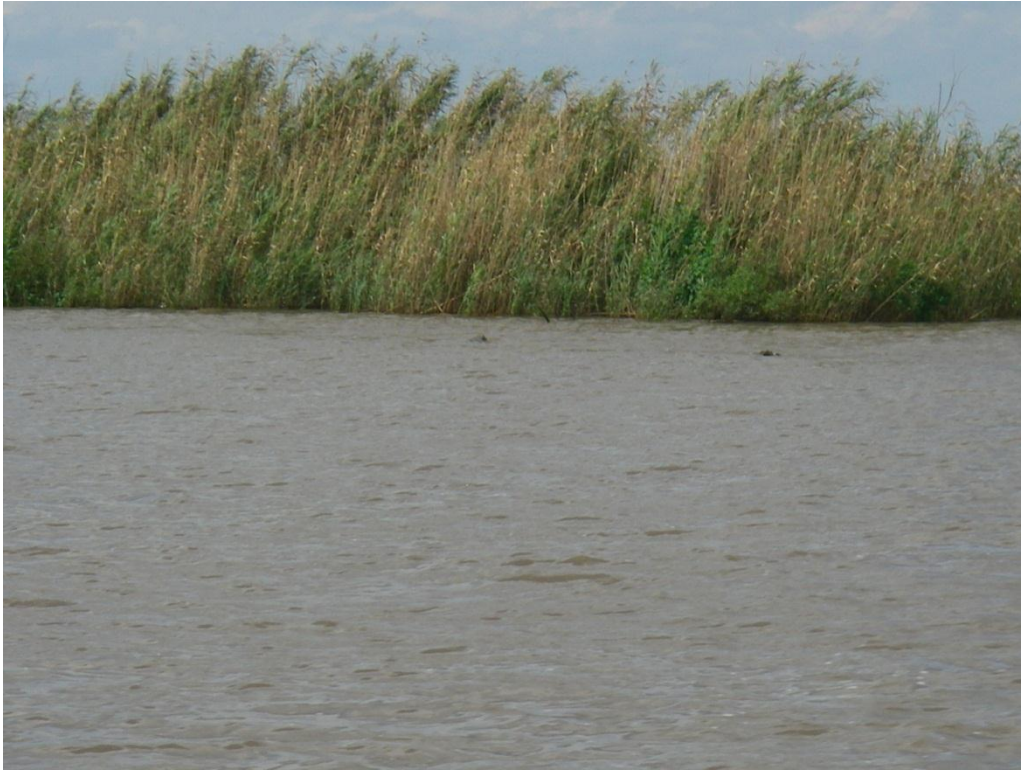
The foreshore rock dike feature of the Sweet Lake/Willow Lake Hydrologic Restoration Project is in good condition and functioning as designed. The areas along the foreshore rock dike identified as being below constructed height were noted in previous inspections and will continue to be monitored.

Photo No. 3, Sweet Lake Low Area in Rock Dike

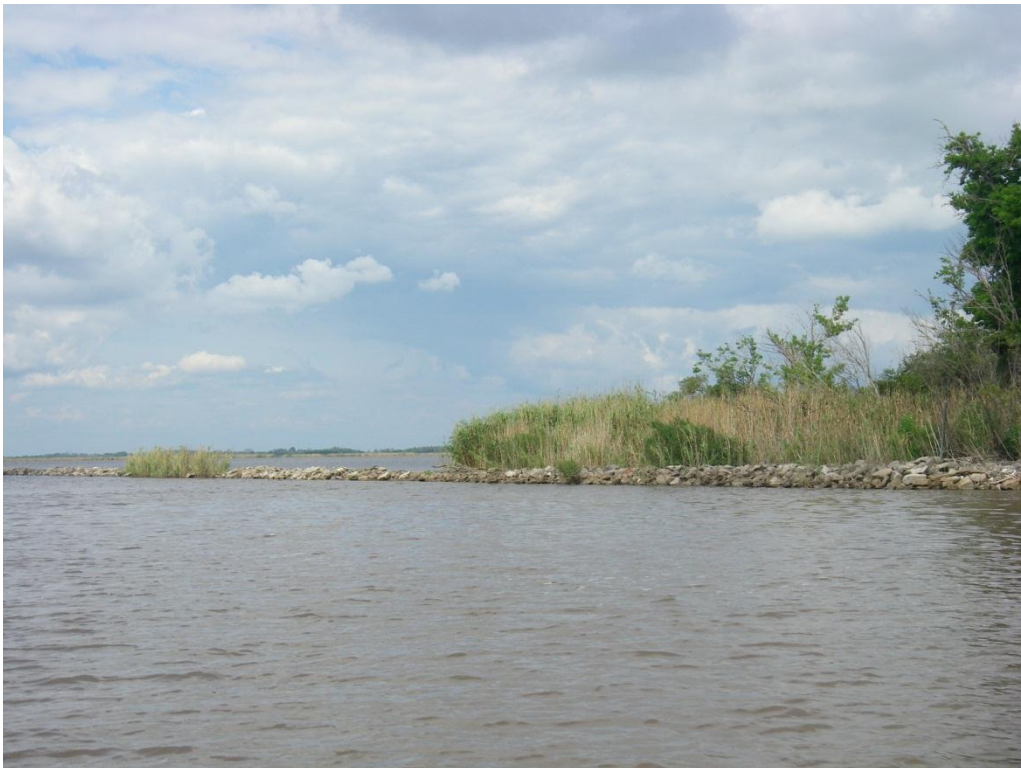
Photo No. 4, Willow Lake Rock Dike (Southeastern End)

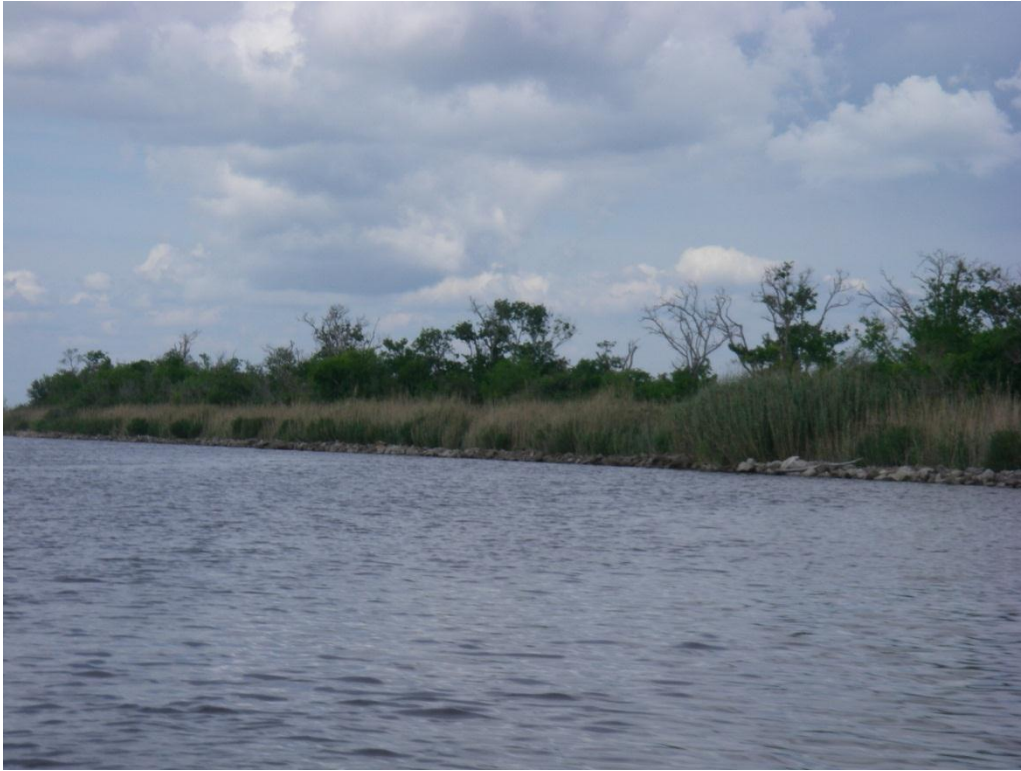
Photo No. 5, Willow Lake Rock Dike (Northwestern End)
