**Coastal Protection and Restoration
Authority of Louisiana (CPRA)**

**2011/2012 Annual Inspection
Report**

**EAST MUD LAKE MARSH
MANAGEMENT PROJECT
(CS-20)**

June 29, 2012
Cameron Parish

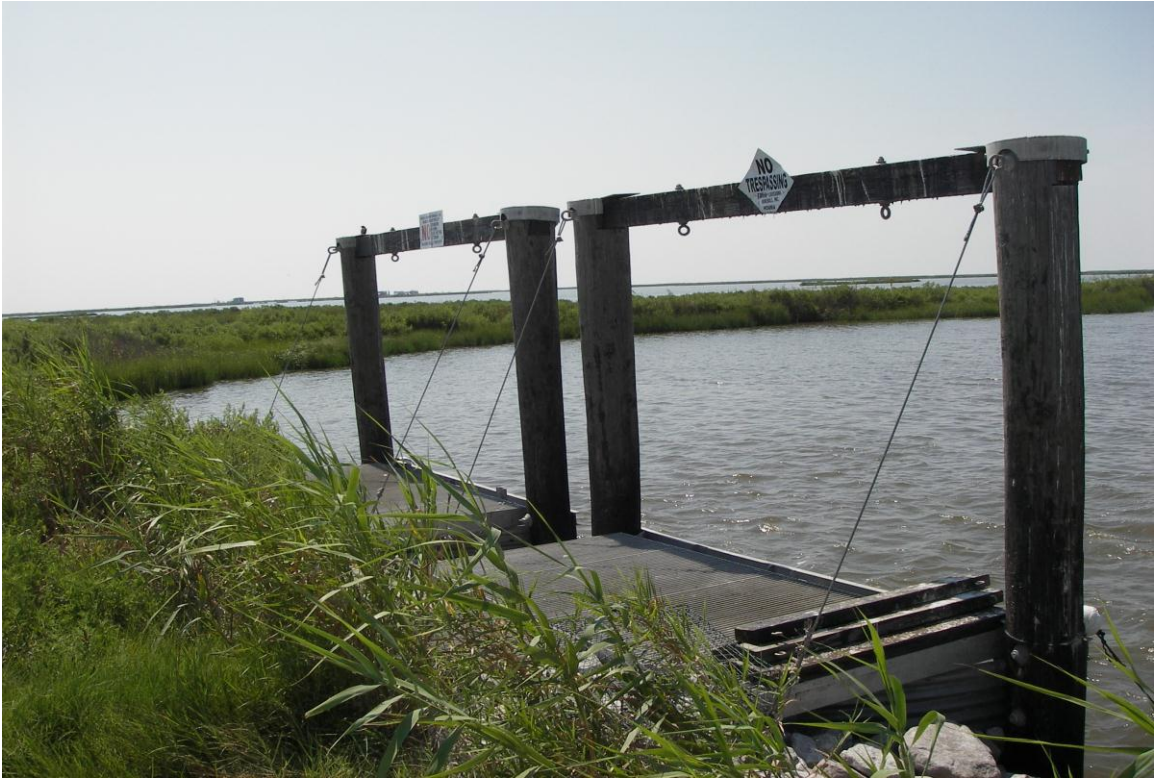
Photo No.1 Structure No. 6

The condition of Structure No. 6 is very good. The timber piles, stop logs, grating, etc. are in good condition. (Photos: Appendix B, Photo 1).

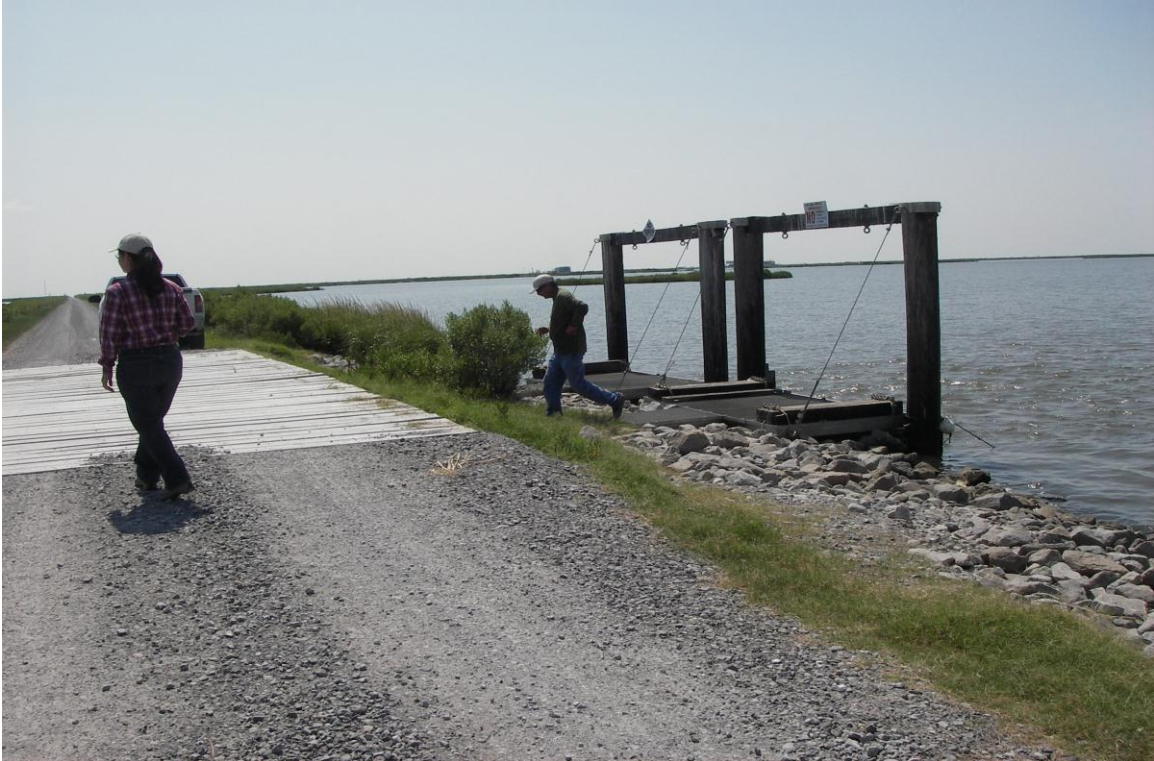
Photo No. 2 Structure No. 7

Structure No. 7 is also in very good condition. The timber piles, stop logs, grating, etc. are in good condition. (Photos: Appendix B, Photo 2).

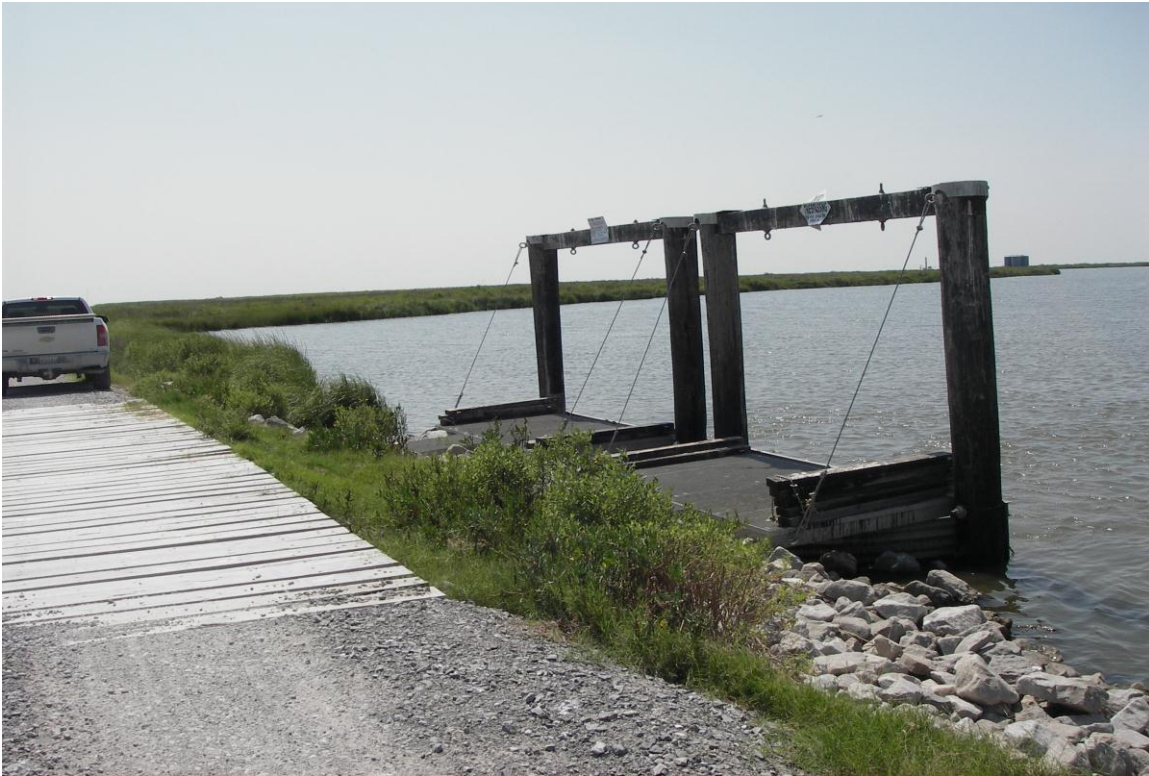
Photo No. 3, Structure No. 8

Structure No. 8 is in very good condition. The timber piles, stop logs, grating, etc. are in good condition. (Photos: Appendix B, Photo 3).

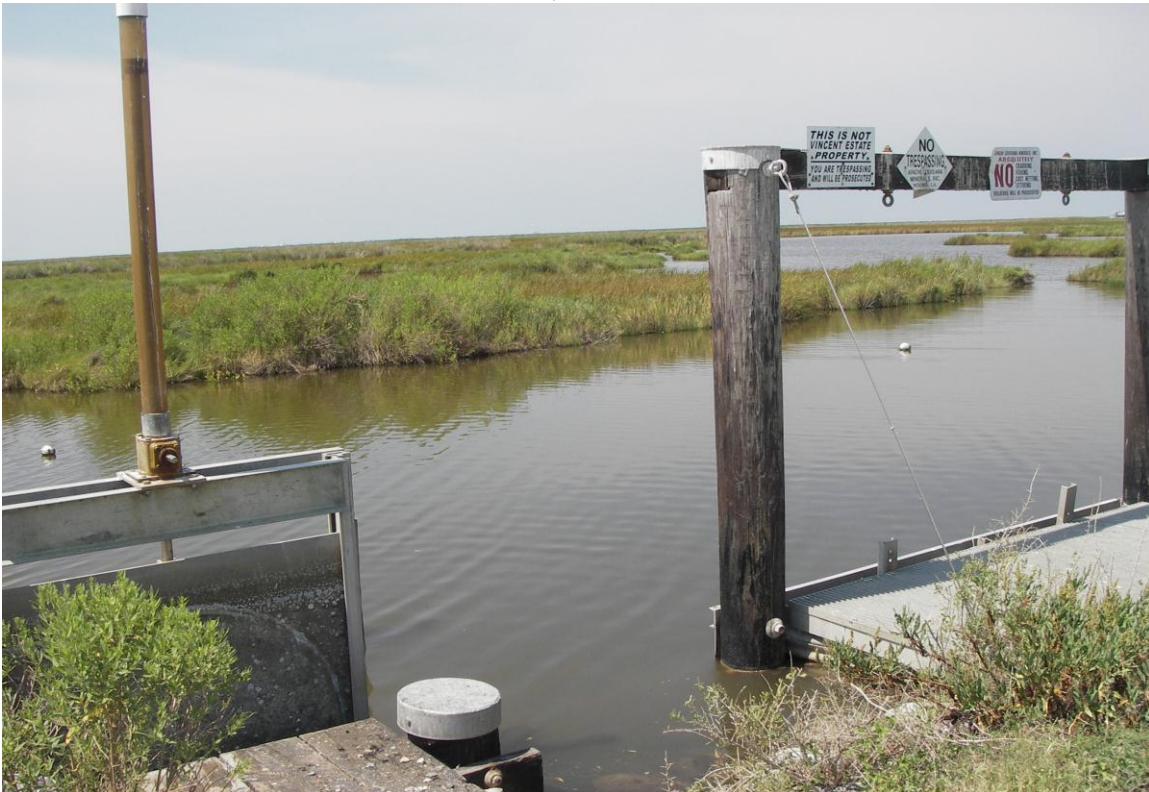
Photo No. 4, Structure No. 9a & 9b

Structure No. 9a is in good condition and functioning as intended. (Photos: Appendix B, Photo 4).

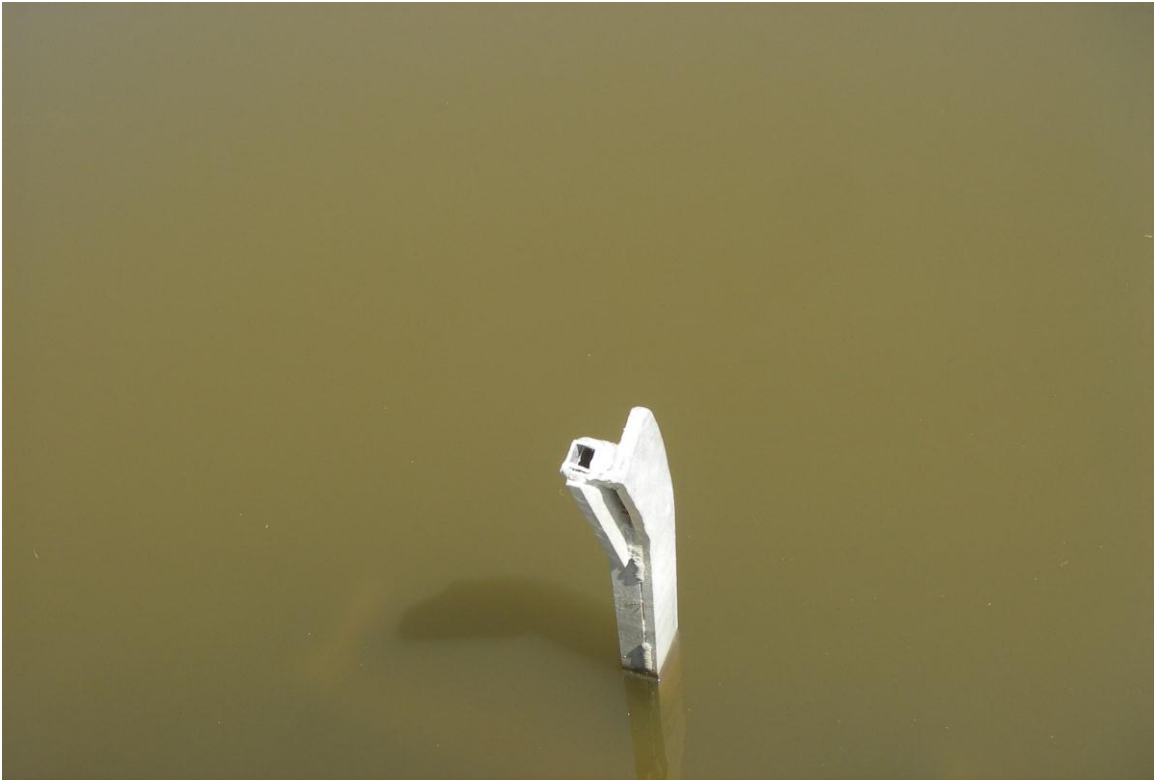
Structure No. 9b is in good condition. Vandals have broken the flapgate lifting arm. Apache has filed a police report. The structure is still functional and all other components are in good shape. (Photos: Appendix B, Photo 5).

Photo No. 5, Broken Lifting Arm on Structure 9b

Item	Condition	Physical Damage	Corrosion	Photo #	Observations and Remarks
Steel Bulkhead / Caps	N/A				
Steel Grating	Good				
Stop Logs	Good				
Hardware	Good			5	broken flap gate lifting arm. Still functional.
Timber Piles	Good				
Timber Walkway	Good				
Timber Wales	Good				
Galv. Pile Caps	Good				
Cables	Good				
Signage / Supports	Good				
Staff Gages	Good				
Rip Rap (fill)	Good				
Earthen Embankment	Good

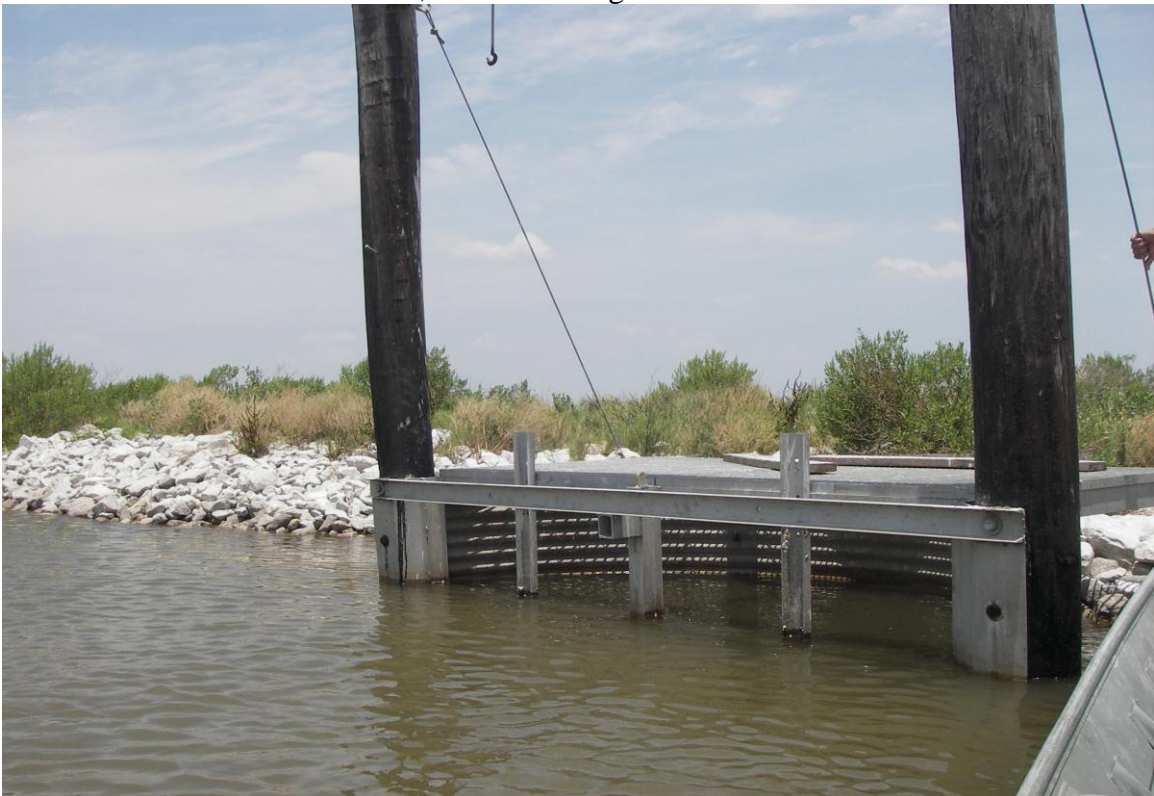
Photo No. 6, Structure No. 11

The structure is in good condition. Rock has stabilized the bank on both sides of the structure. (Photos: Appendix B, Photos 6 & 7).

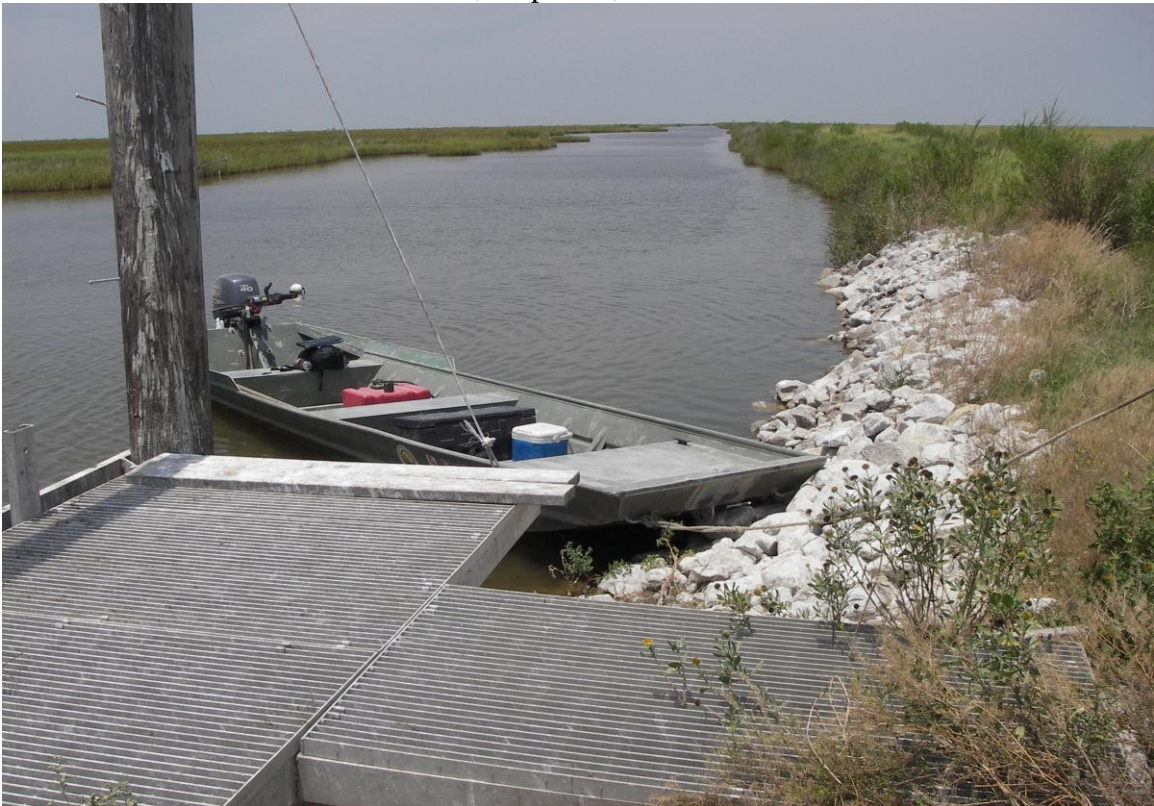
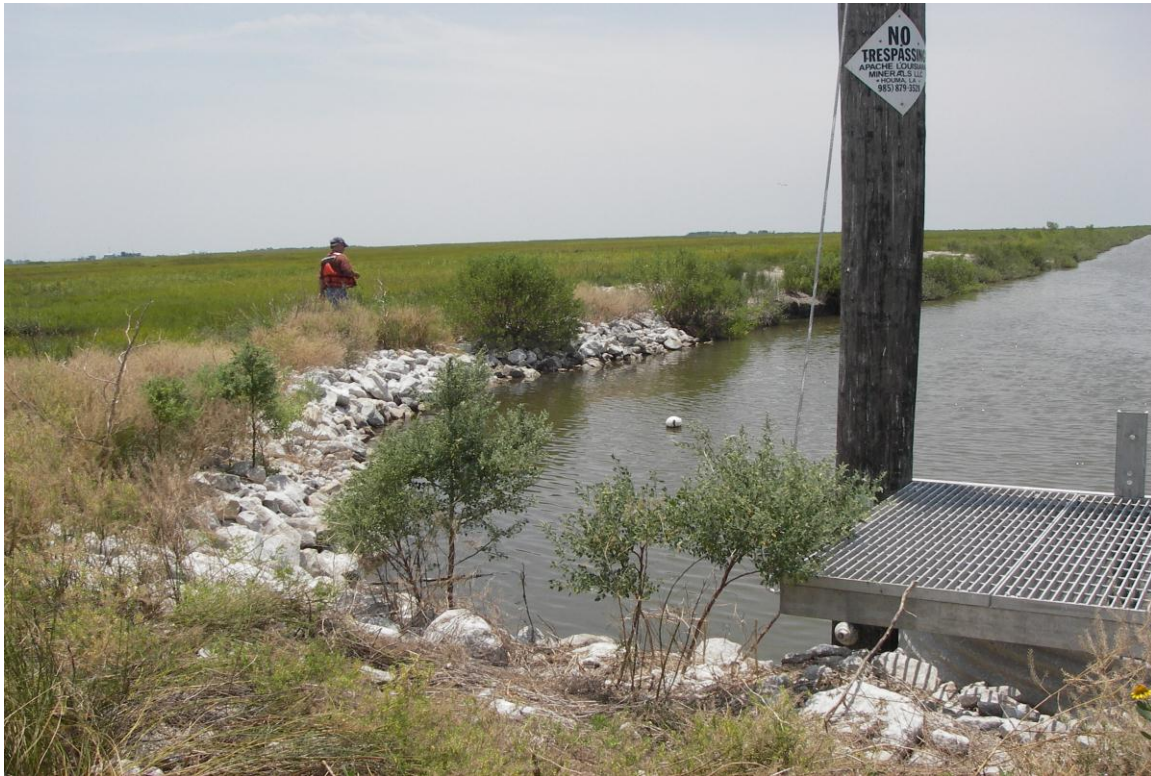
The structure itself is in good condition. Rock placed here has worked very well also. (Photos: Appendix B, Photo 8 - 10).

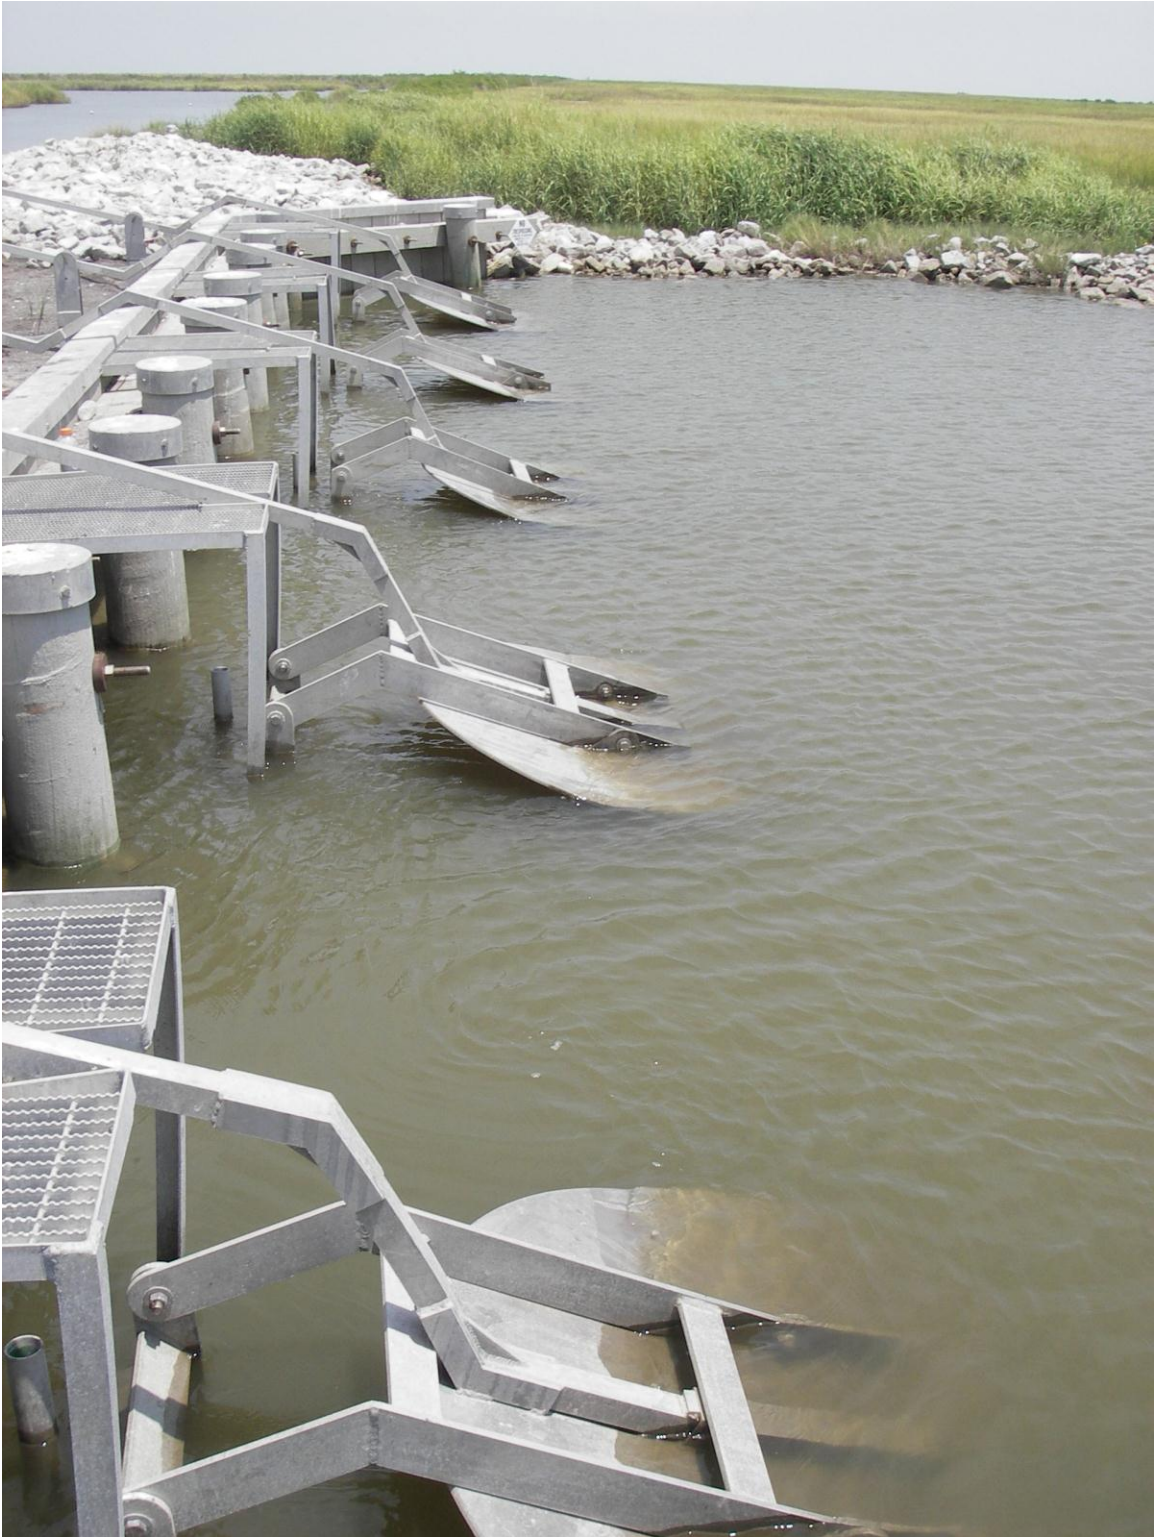
Photo No. 11, Flap Side, Structure No.4

This structure was completely replaced with a new 48 inch diameter five barrel drainage structure, including timber supports, and rock armoring. The pre-existing structure No. 4 was abandoned in place by driving steel sheet piles through the mid-section of the culverts. Vandals have stolen locks, stoplog locking devices and stoplogs. They have placed their own locks on some of the bays. They have also cut, and replaced with their own, one of the boards on the boat barrier that was installed on the lake side of the project area. Police reports have been filed. The dirt placed on top of the new structure has settled significantly and will be monitored. Sinkholes have developed on the stoplog side of the structure and will also have to be closely monitored. (Photos: Appendix B, Photos 11 - 14).

Item	Condition	Physical Damage	Corrosion	Photo #	Observations and Remarks
Steel Bulkhead / Caps	Good			11	
Steel Grating	Good				
Stop Logs	Good				some stoplogs have been stolen
Hardware	Good				some locks have been stolen
Timber Piles	Good				
Timber Walkway	Good				
Timber Wales	Good			13	
Galv. Pile Caps	Good				
Cables	Good				
Signage / Supports	Good				
Staff Gages	Good				
Rip Rap (fill)	Good				
Earthen Embankment	Fair			12,14	sinkholes forming on stoplog side of structure

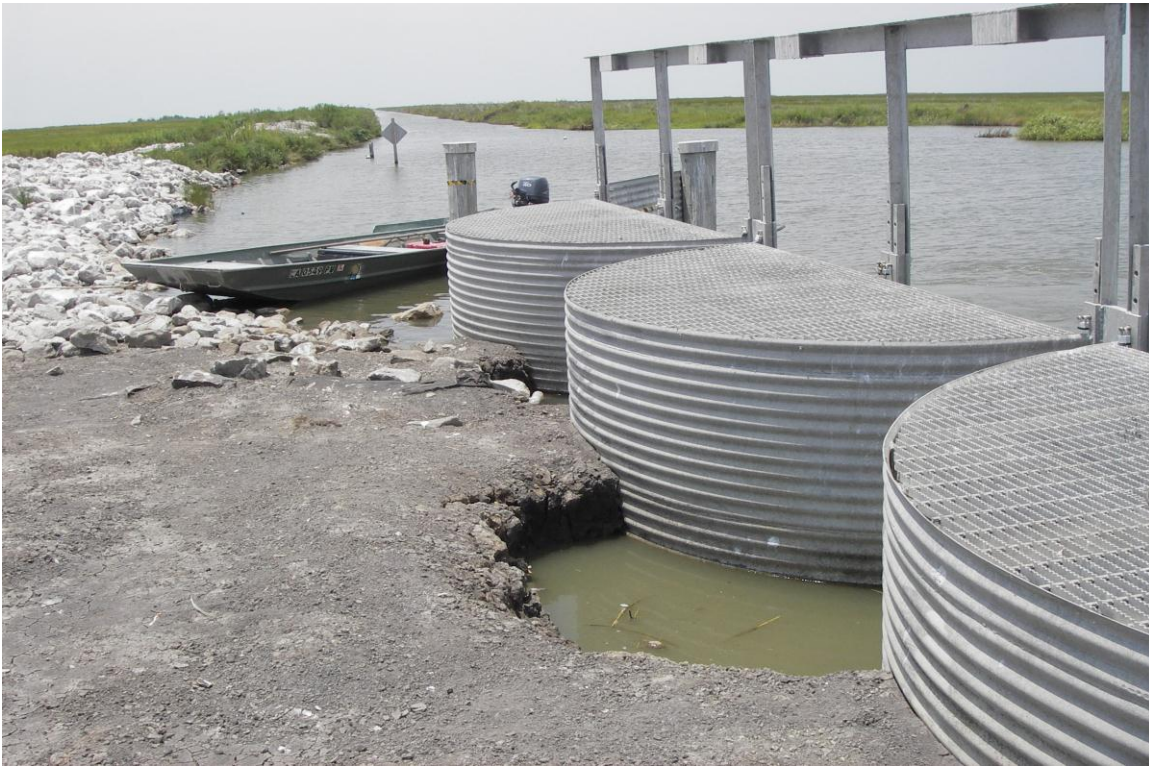
Photo 14, Sinkholes Developing Behind Structure 4 Stoplog Bays

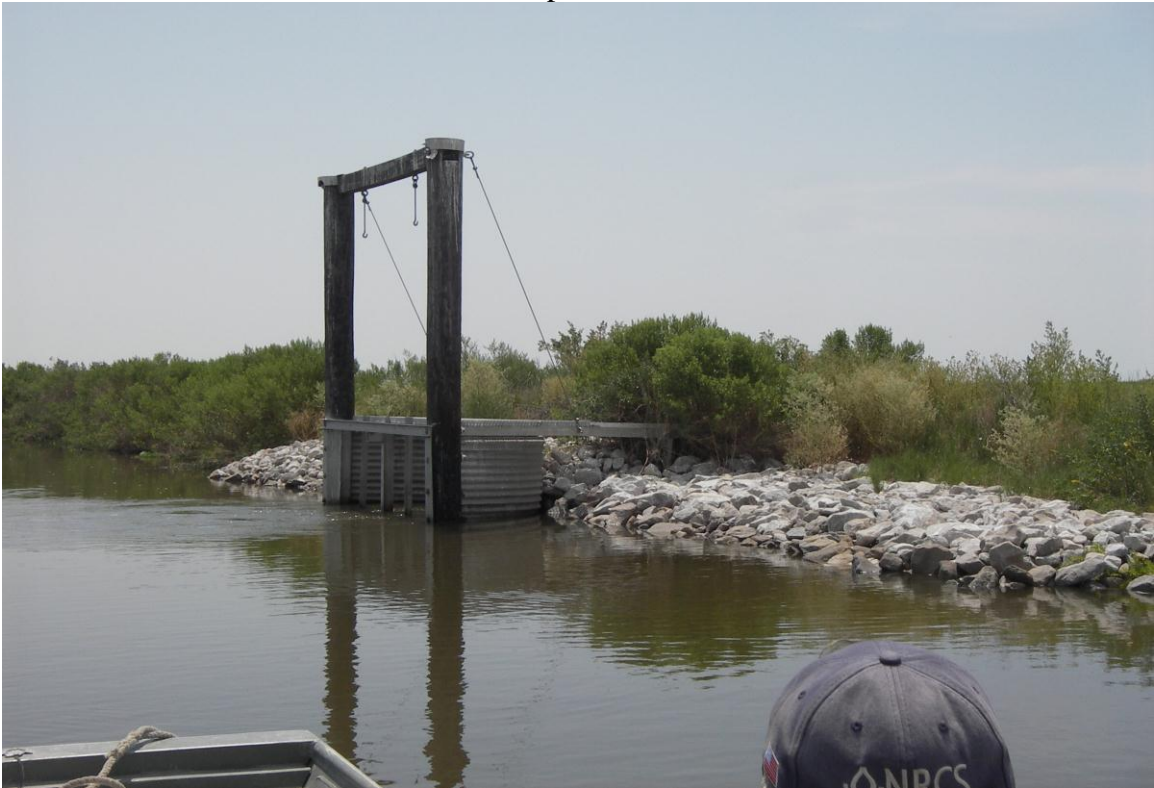
Photo 17, Structure 1

This structure is in good condition. Walkways have been tacked into place. No vandalism at this structure. Rock has stabilized the banks. (Photo: Appendix B, Photos 17 & 18).

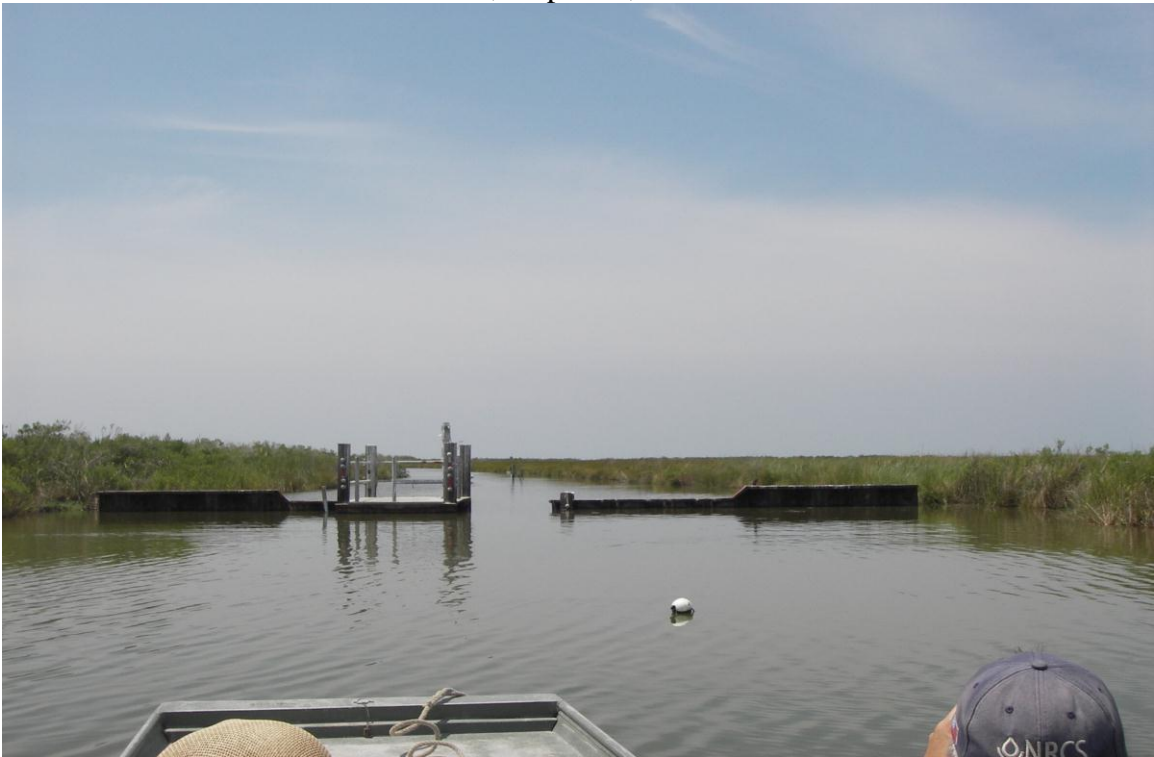
The sheet pile cap is severely rusted out on both sides of the structure. The locking tabs on the landing side of the stop log slots are missing. The warning sign is missing. The padlocks on the stop log locking devices have rusted and cannot be operated. The metal pile cap covers are rusted out. Erosion has occurred on both ends of the structure to the extent that water is bypassing the structure on both sides. CPRA, Apache and NRCS agree that no maintenance work will be performed at this site unless or until another drawdown within the project area is required or needed. Should a decision be made to perform a drawdown in the area, consideration will have to be given to replacing the entire sheet pile wall. (Photo: Appendix B, Photos 19 & 20).

Photo 19, Flanking Around Structure 17

Item	Condition	Physical Damage	Corrosion	Photo #	Observations and Remarks
Steel Bulkhead / Caps	Poor			20	Pile cap and sheet piles severely deteriorated.
Steel Grating	Good				
Stop Logs	Good				
Hardware	Good				
Timber Piles	Good				
Timber Walkway	Good				
Timber Wales	Good				
Galv. Pile Caps	Good				
Cables	Good				
Signage / Supports	Good				
Staff Gages	Good				
Rip Rap (fill)	Good				
Earthen Embankment	Good			19	Water is flanking structure.

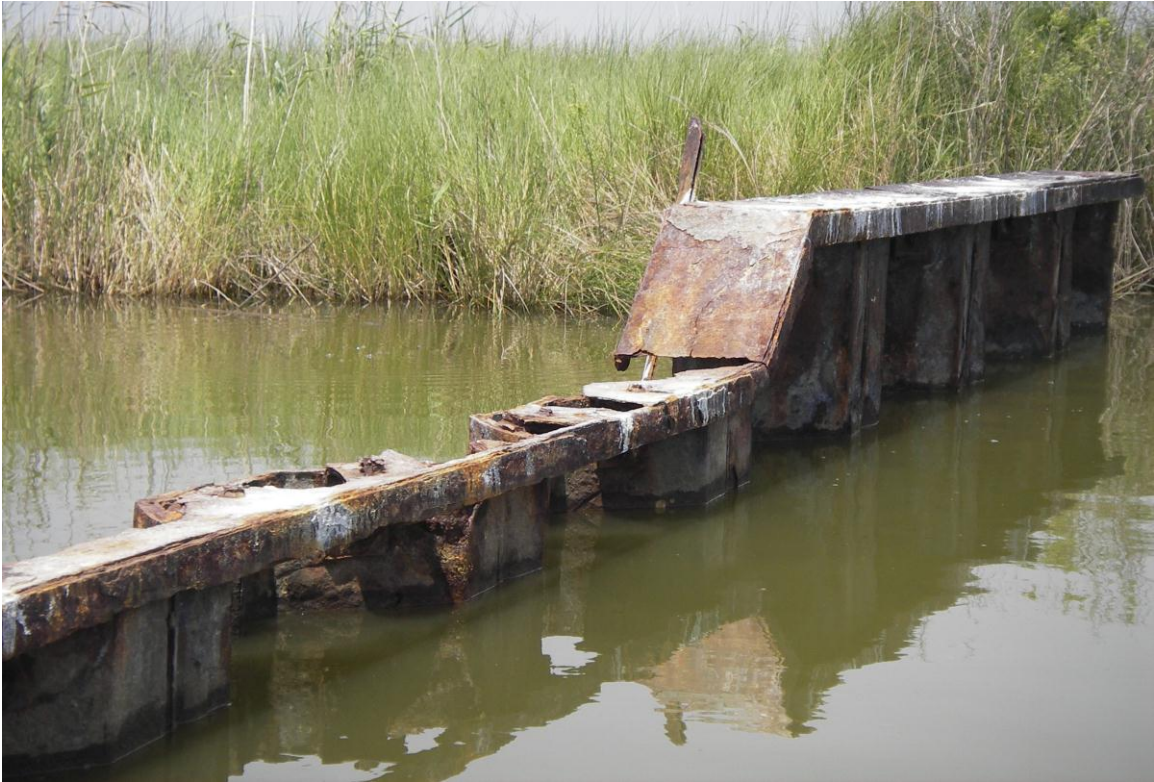
Photo 20, Rusted Sheet Piles on Structure 17

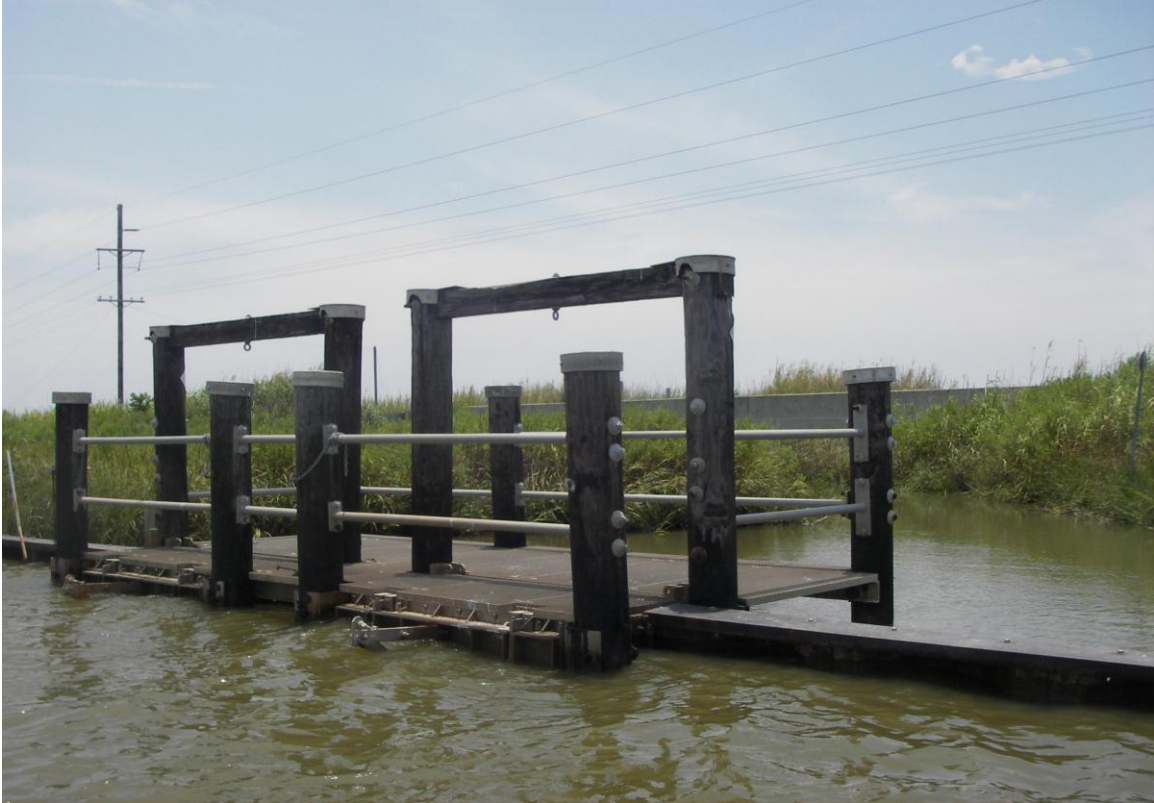
Photo 21, Structure 13

This structure is in very good condition. Flow is now possible through the structure. (Photos: Appendix B, Photo 21).

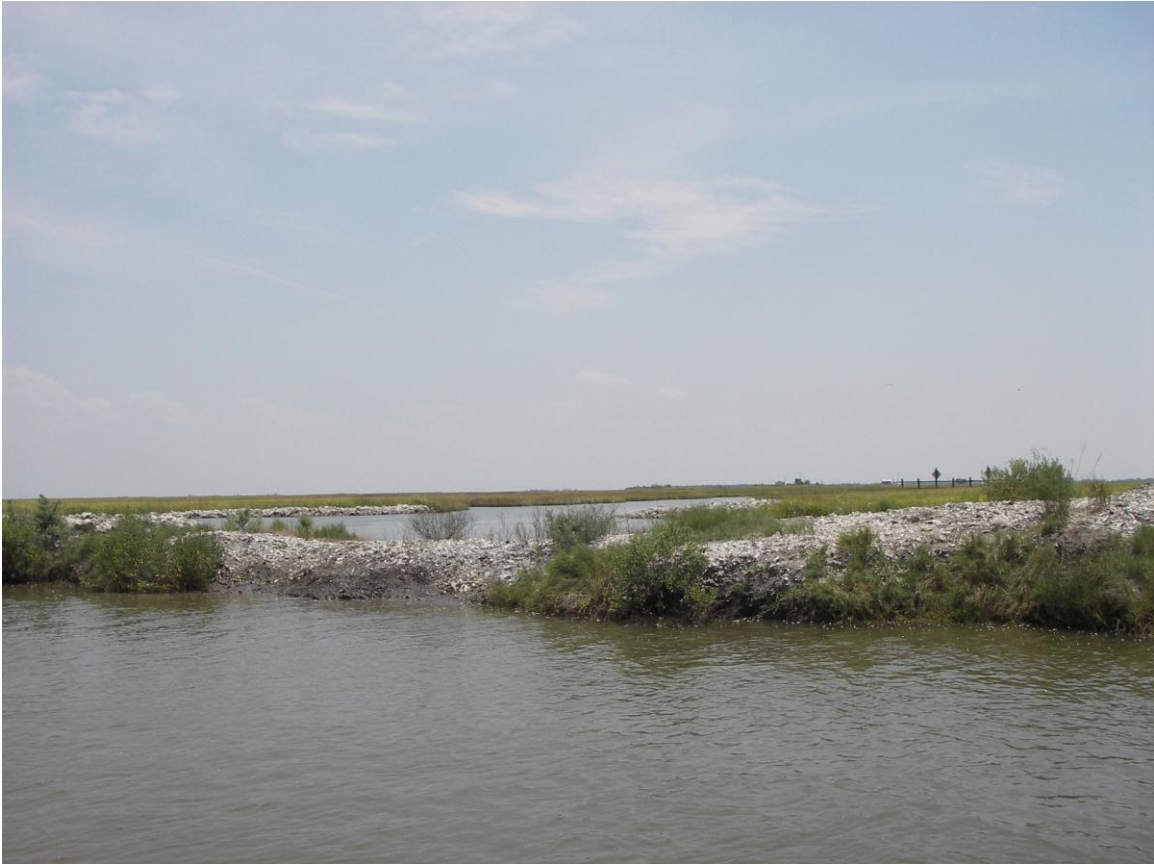
Photo 22, Low Section of Step Canal Levee South of Structure 4

Item	Condition	Physical Damage	Corrosion	Photo #	Observations and Remarks
Steel Bulkhead / Caps	N/A				
Steel Grating	Good				
Stop Logs	Good				
Hardware	Good				
Timber Piles	Good				
Timber Walkway	Good				
Timber Wales	Good				
Galv. Pile Caps	Good				
Cables	Good				
Signage / Supports	Good				
Staff Gages	Good				
Rip Rap (fill)	Good				
Earthen Embankment	Good			22	low section near structure 4
