**2011/2012 Annual Inspection
Report**

**CAMERON PRAIRIE REFUGE
PROTECTION PROJECT
(ME-09)**

State Project Number ME-09
Priority Project List 1

March 28, 2012
Cameron Parish

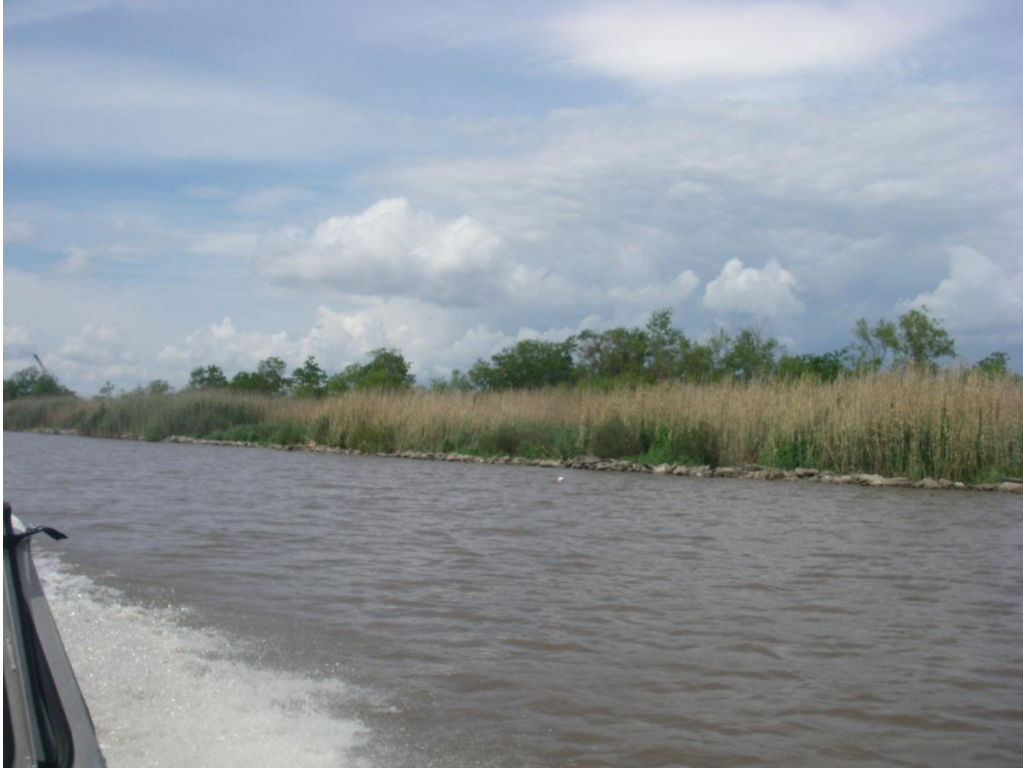
The foreshore rock dike is in good condition.(See Appendix B, Photos 1 & 2) Two small sections were noted where the rock was lower than post construction conditions near the western most warning sign. There is a section of dike near the second warning sign traveling East in the GIWW that is allowing exchange of water across the displaced rock. (See Appendix B, Photo 3) Substantial vegetation was noted behind the foreshore rock dike. (See Appendix B, Photo 4) There is no need for maintenance at this time. The low area mentioned above was present during previous inspections and will continue to be monitored for further deterioration. It is recommended; however, that a staff gage is installed.

Photo No. 1, (Northern Bank of GIWW) Typical rock dike

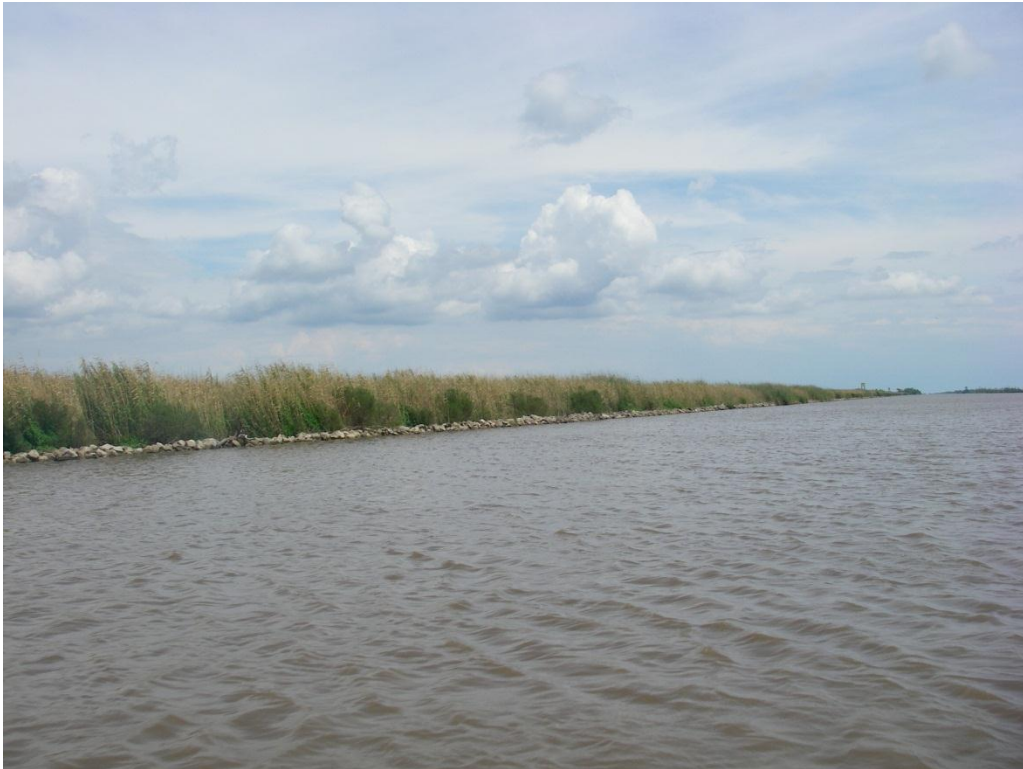
Photo No. 2, (Northern Bank of GIWW) Typical rock dike

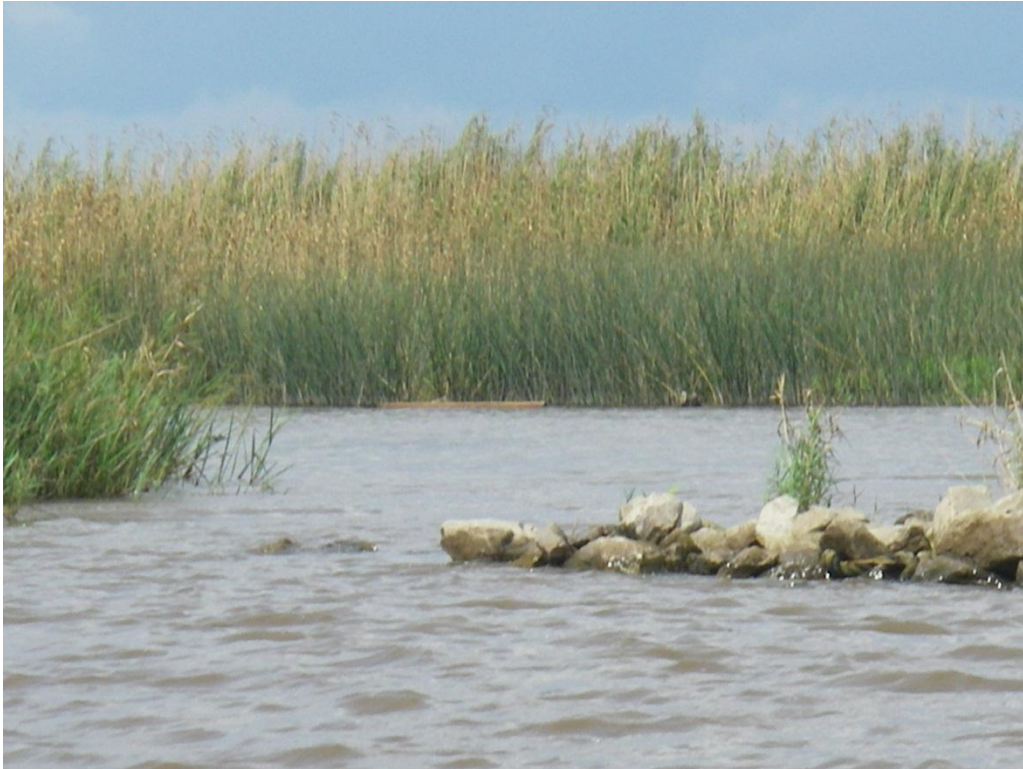
Photo No. 3, Low Area with Displaced Rock

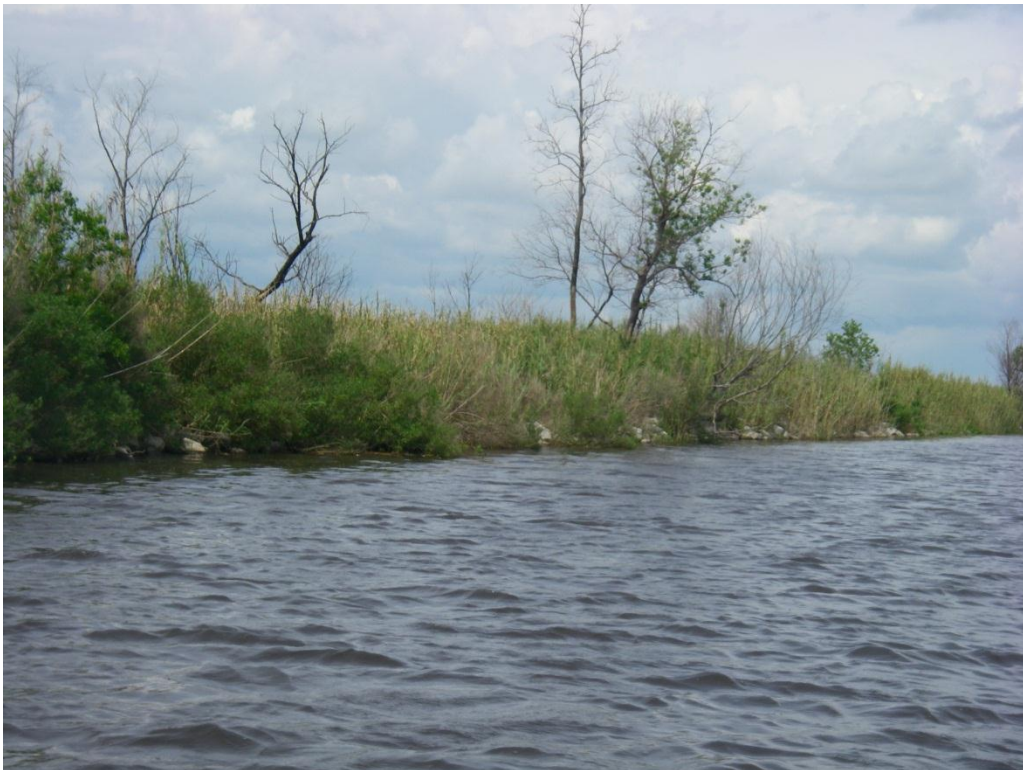
Photo No. 4, Vegetation along North/South Canal at GIWW
