**2011/2012 Annual Inspection
Report**

**HUMBLE CANAL HYDROLOGIC
RESTORATION PROJECT
(ME-11)**

State Project Number ME-11
Priority Project List 8

March 24, 2011
Cameron Parish

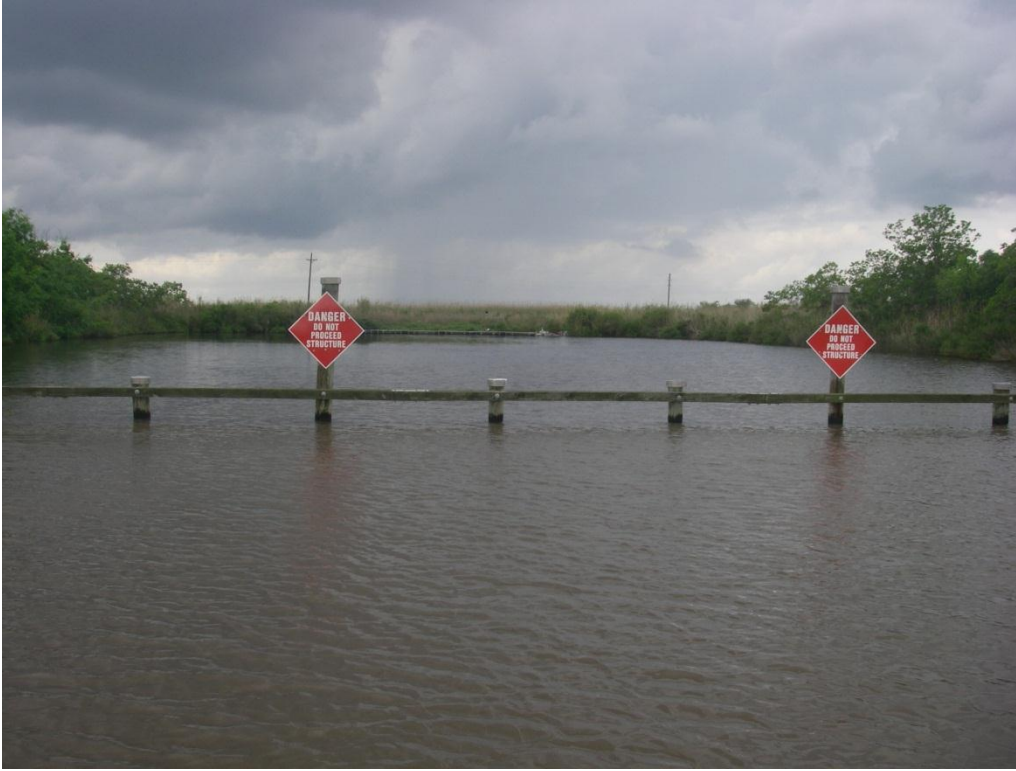
The structure is in excellent condition and the warning signs were intact. (Photos: Appendix B, Photo 1)

Photo No. 1, Marine barrier with signage.

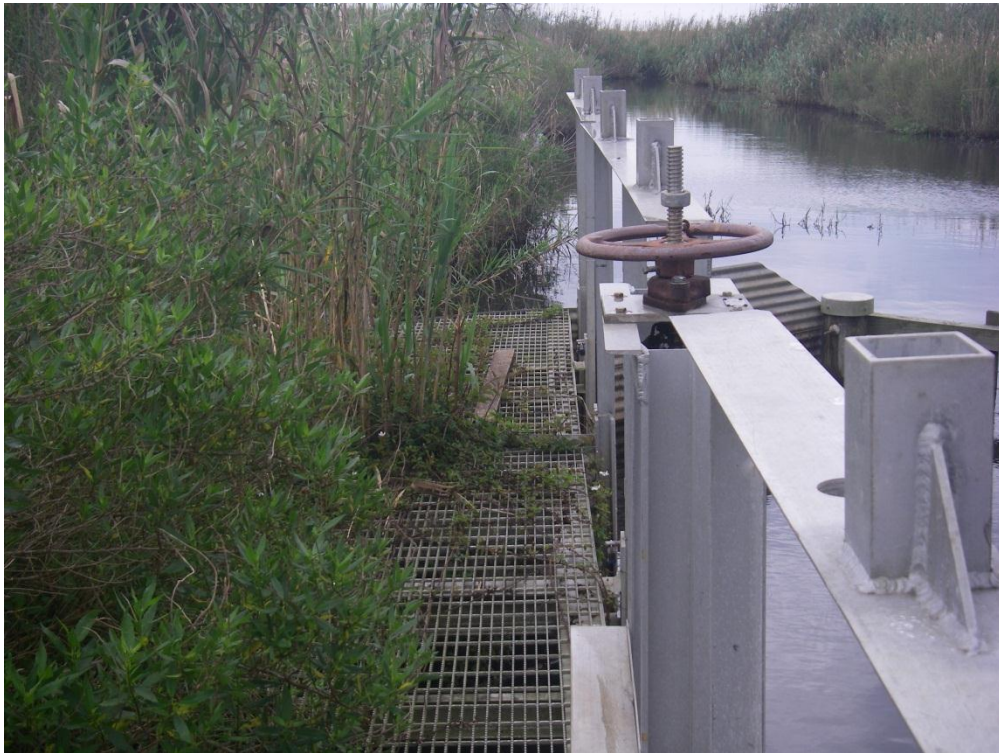
The structure is in good condition. The stoplogs, flap gates, and screw gate appear to be functioning as intended. The wingwall rock armor on the inlet and outlet side of the structure and the crushed stone aggregate on the top of the structure are intact. The water level was at 2.3 on the staff gauge. (Photos: Appendix B, Photos 2, 3 & 4)

Photo No. 2, Inlet side of structure

Overall, the Humble Canal Hydrologic Restoration Project structural components are in good condition and functioning as designed. It is recommended that grass control is included in the operations contract.

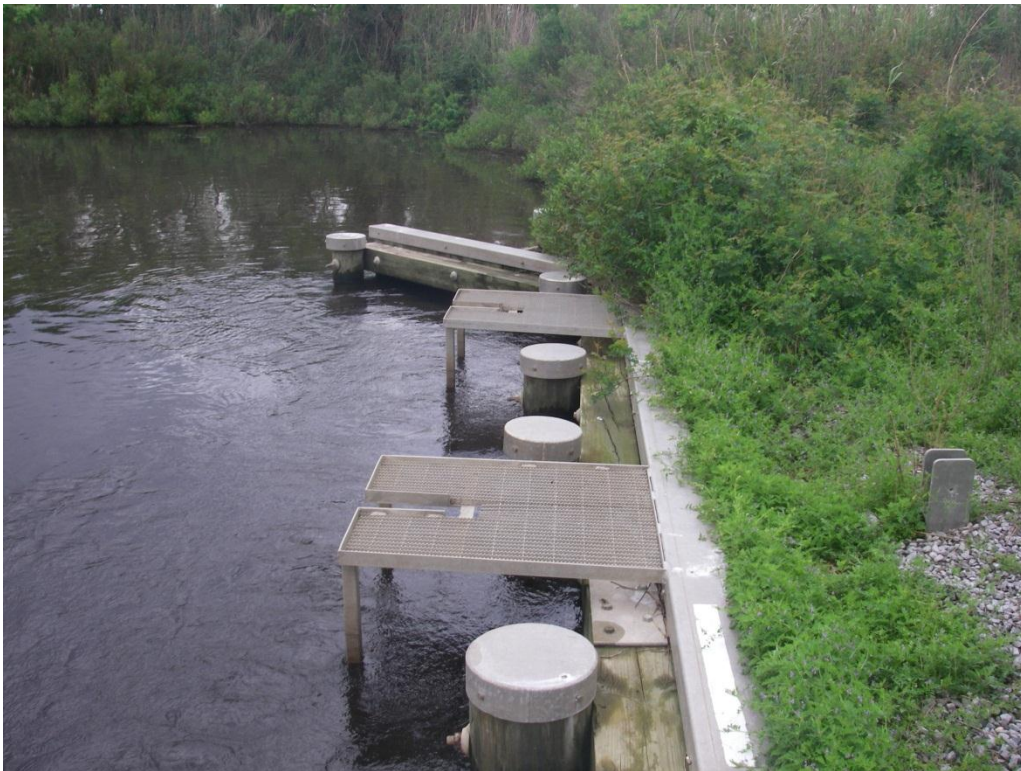
Photo No. 4, Outlet side of structure
