**2011/2012 Annual Inspection
Report**

**GRAND-WHITE LAKES
LANDBRIDGE PROTECTION
PROJECT
(ME-19)**

State Project Number ME-19
Priority Project List 10

May 17, 2012
Cameron Parish

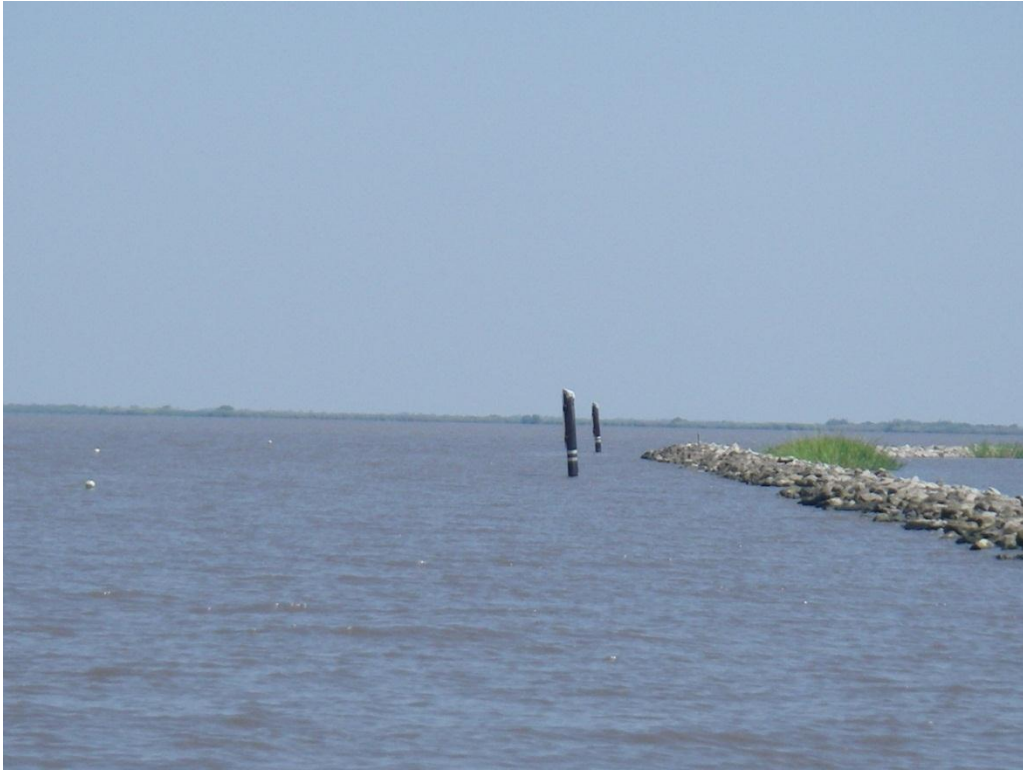
The foreshore rock dike feature is in excellent condition. Warning signs are present. There is vegetation behind the rock dike over the majority of length of dike. No maintenance is required at this time. (Photos: Appendix B, Photo 1-3)

Photo No. 1, Rock Dike and Signs on East Shoreline of Grand Lake

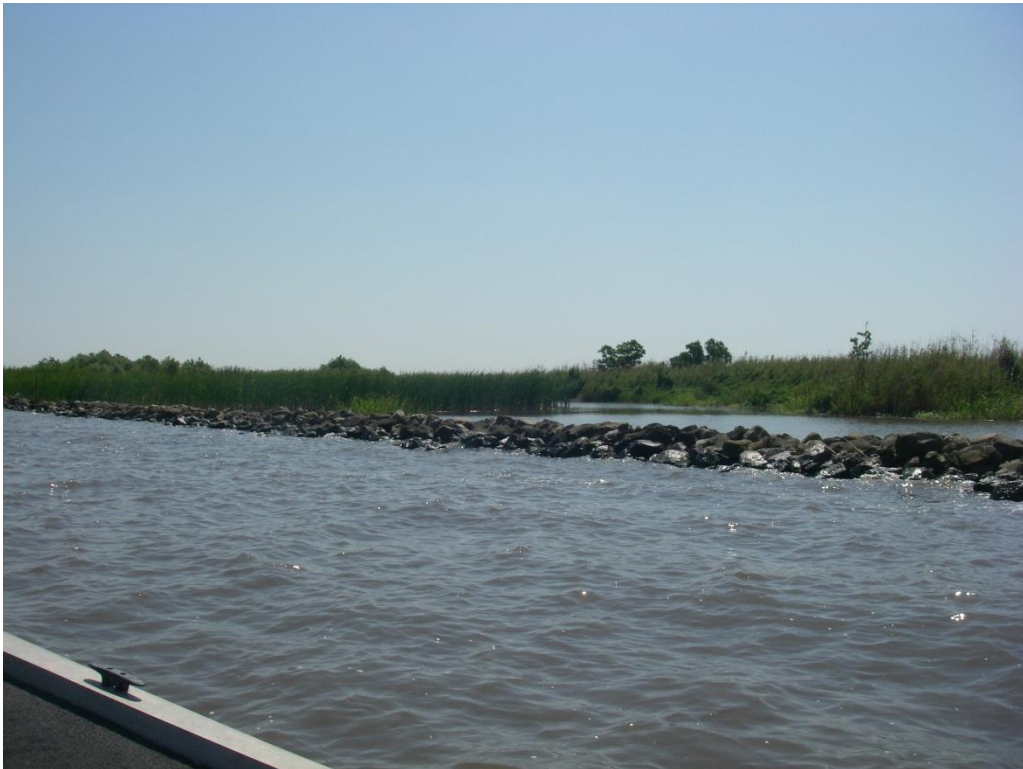
Photo No. 2, Vegetation and Rock Dike on East Shoreline of Grand Lake

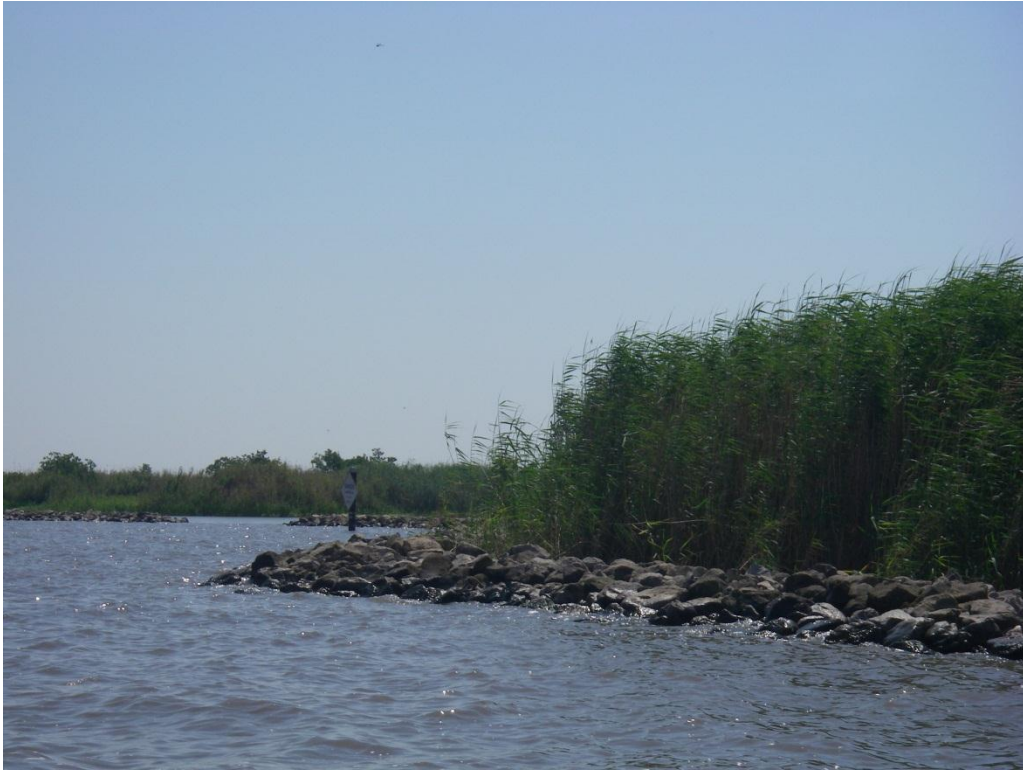
Photo No. 3, Rock Dike on East Shoreline of Grand Lake

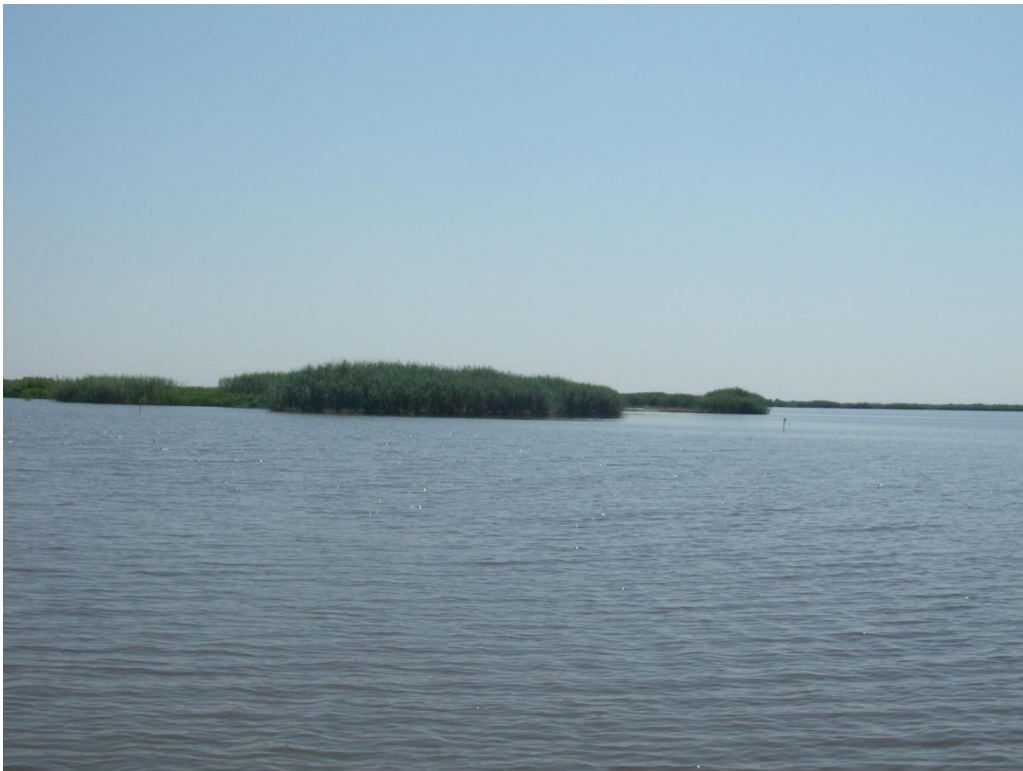
Marsh side and lake side earthen terraces along Collicon Lake continue to experience erosion. Several terraces along the northwest and west shoreline of Collicon Lake are no longer visible. (Photos: Appendix B, Photo 5) The northern and southern most sections of terraces are flourishing with Roseau Cane; however, it was difficult to distinguish by boat whether two rows of terraces remain. (Photos: Appendix B, Photo 4 &6)

Photo No. 4, Earthen Terraces on North End of Collicon Lake

The foreshore rock dike feature of the Grand-White Lake Landbridge Project is in excellent condition and is functioning as designed; however, there is still concern about the erosion of the sacrificial terraces on Lake Collicon. Maintenance is being planned to armor these terraces into the future. An IDIQ contractor has been tasked to do surveying and a design report.

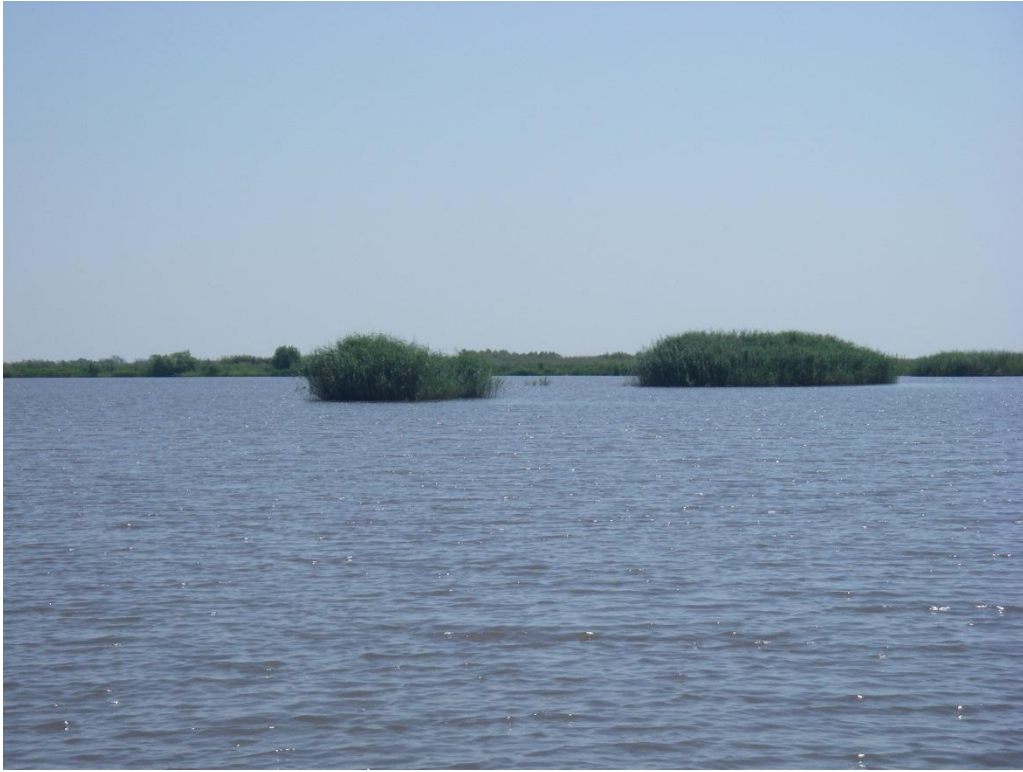
Photo No. 5, Earthen Terraces on Northwest and West Sides of Collicon Lake

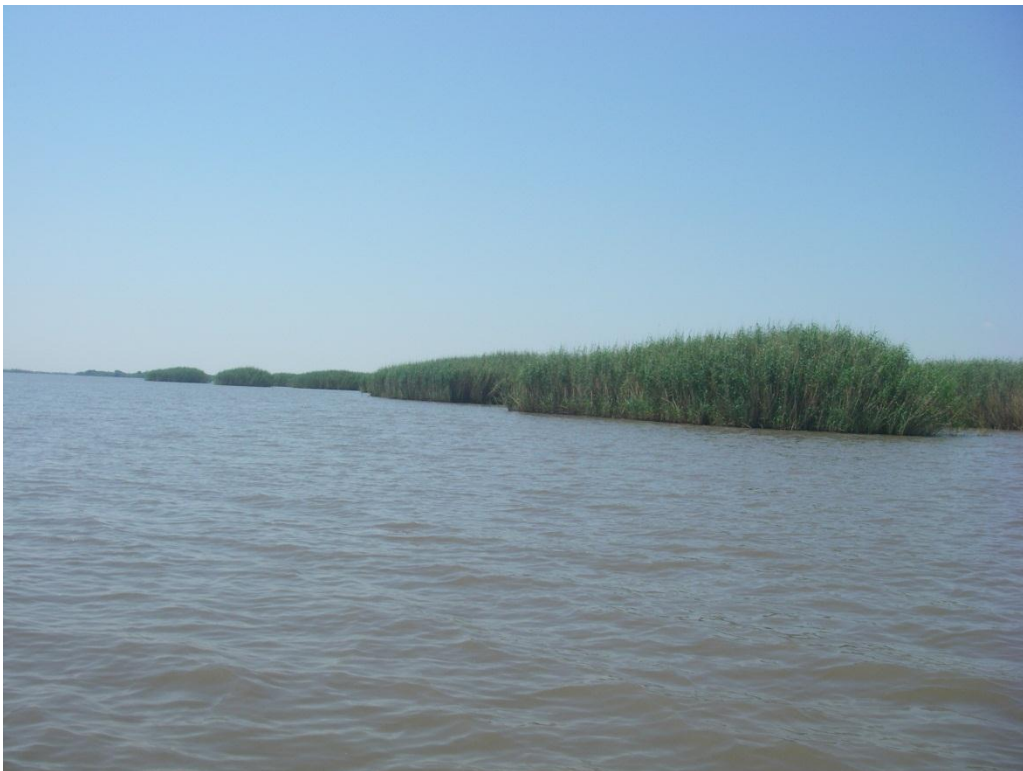
Photo No. 6, Earthen Terraces on Southwest End of Collicon Lake
