**2011/2012 Annual Inspection  
Report**

**SOUTH WHITE LAKE  
SHORELINE PROTECTION  
PROJECT  
(ME-22)**

State Project Number ME-22  
Priority Project List 12

June 19, 2012  
Vermilion Parish

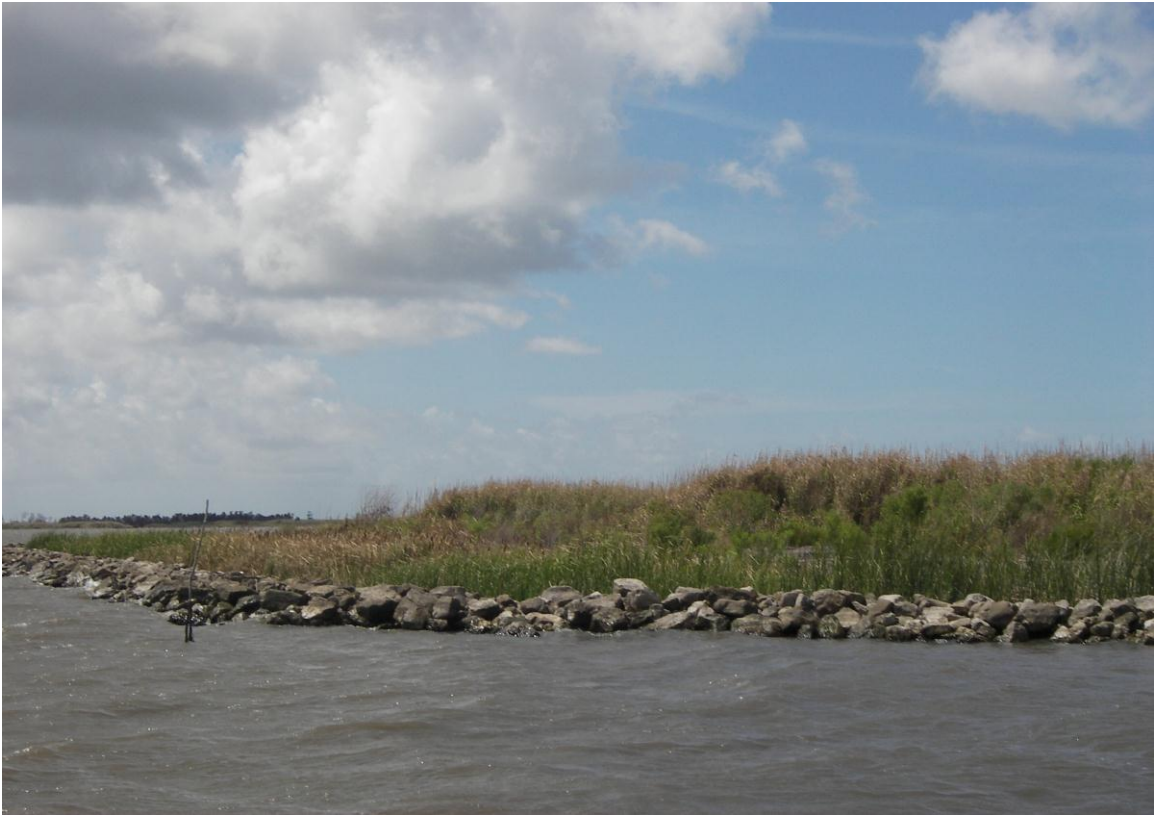
The rock dike is in excellent post construction condition. Low areas noticed during previous inspections along Bear Lake where there was some initial settling during construction has stabilized and the dike is still functional in these areas. They will continue to be monitored during future inspections. Signage along the entire project is also in good condition. A total of three signs were noticed as completely missing. The spoil bank material placed behind the rock dike generated from the flotation excavation is nearly covered in natural vegetation. (Photos: Appendix B, Photo 1)

**Photo No. 1**, typical section of rock dike

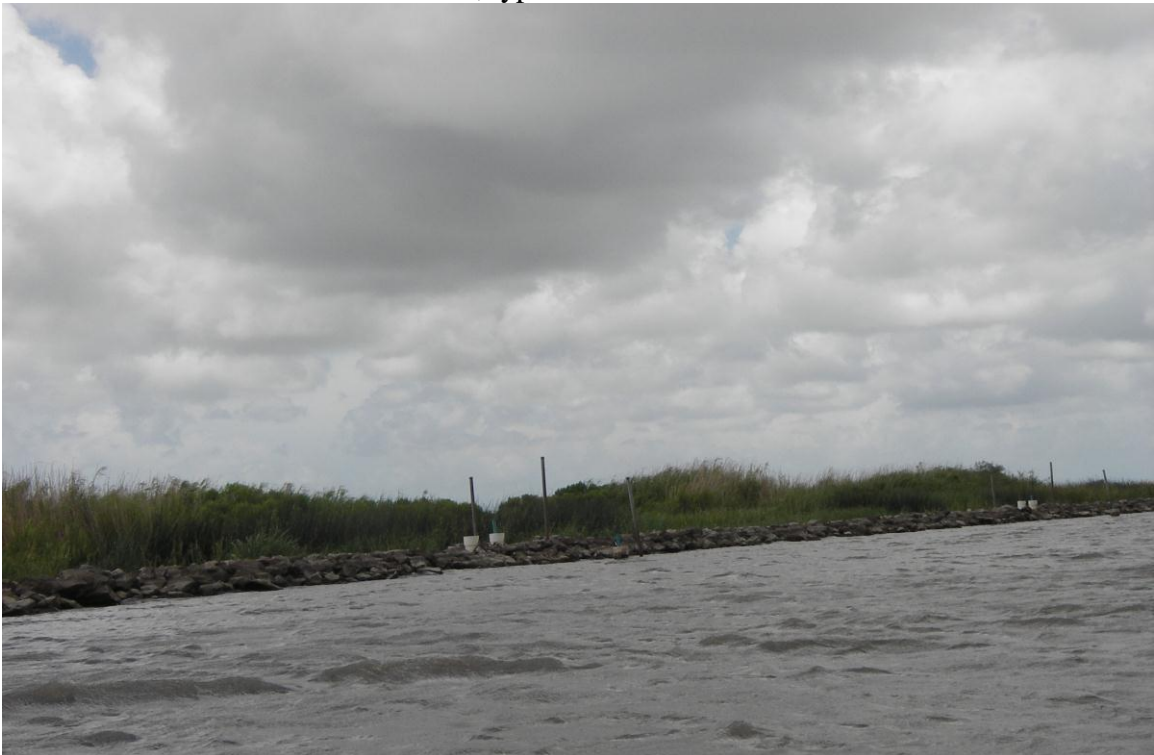
The six different demonstration areas are in the same condition as noticed during previous inspections. No difference from the rest of the dike is noticeable. The various instrumentation devices at each demonstration section appear to still be intact. According to USACE personnel, a final report on the monitoring conducted at these sites will be coming soon. (Photos: Appendix B, Photo 2)

**Photo No. 2**, test section
