## **2011/2012 Annual Inspection Report**

### **COTE BLANCHE HYDROLOGIC RESTORATION PROJECT (TV-04)**

State Project Number TV-04  
Priority Project List 3

May 30, 2012  
St. Mary Parish

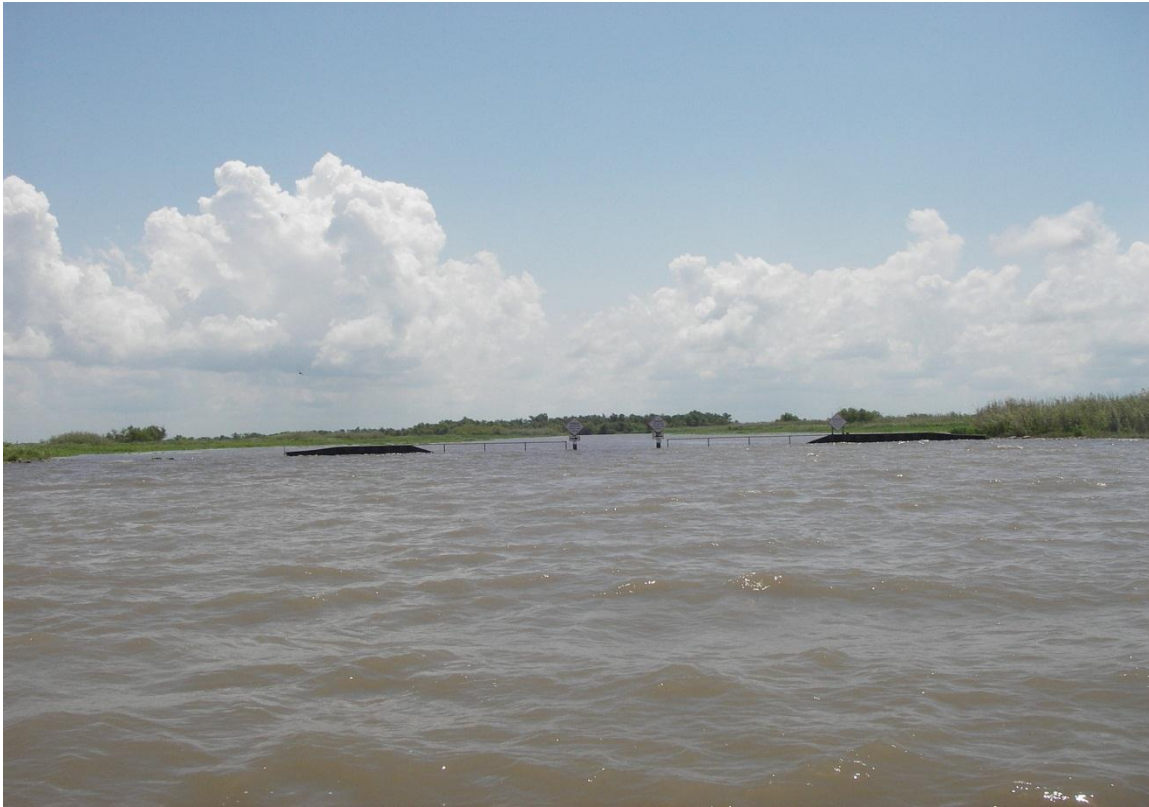
**Photo 1--Mud Bayou Structure**

The Mud Bayou structure appears to be holding up fairly well. The coating on the sheet piles is peeling. The steel is beginning to show signs of rust and will need to be monitored. The north danger sign is missing, but was not replaced. Staff gauges no longer functional. (Photos: Appendix B, Photo 1)

Item	Condition	Physical Damage	Corrosion	Photo #	Observations and Remarks
Steel Bulkhead / Caps	good			1	Structure in good condition and functioning as intended. Rust continues to be monitored. Staff gauges need to be replaced.
Steel Grating	N/A				
Stop Logs	N/A				
Hardware	good				
Timber Piles	good				
Timber Wales	N/A				
Galv. Pile Caps	N/A				
Cables	N/A				
Signage / Supports	good				
Rip Rap (fill)	good				
Earthen Embankment	N/A

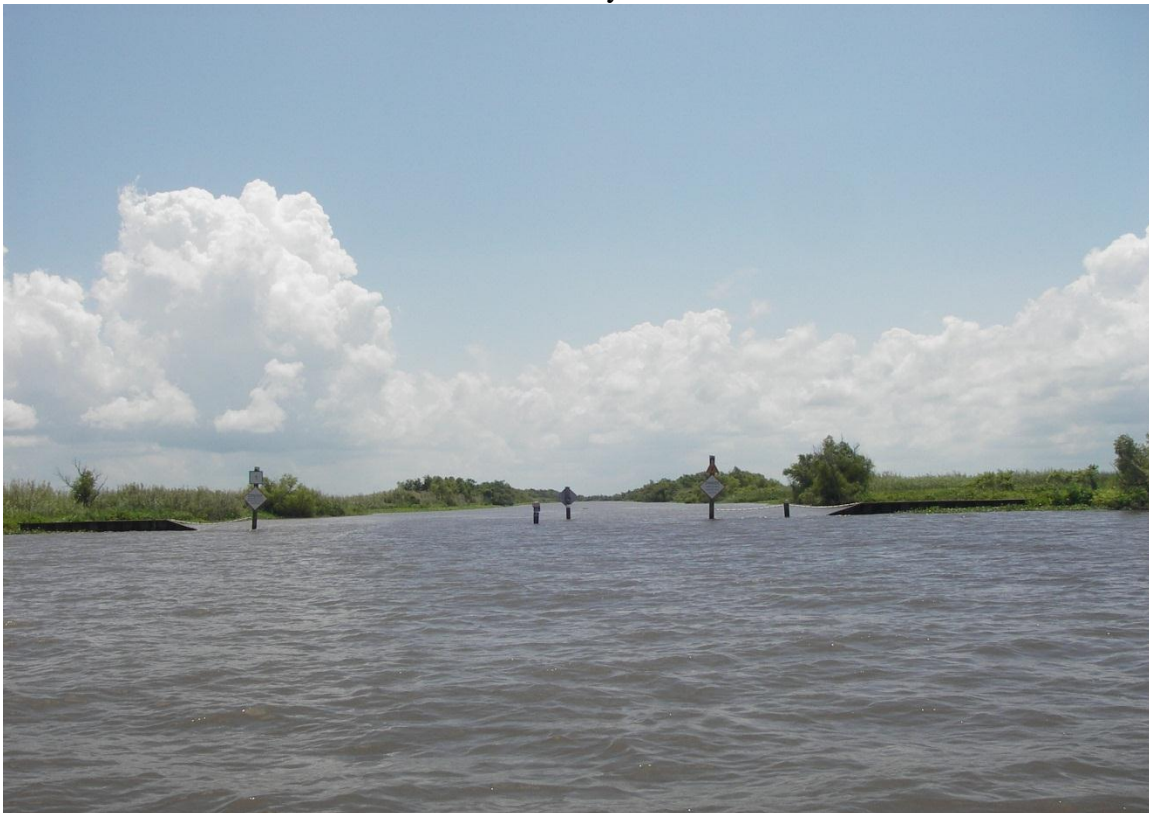
**Photo 2--Humble F Canal Structure**

The piling and arrow sign replaced during the last maintenance event is already missing. Sheet piles and rocks on the end of the structure are stable and functioning as intended. The coating on the sheet piles is rusting on this structure and will be monitored as well. The south arrow sign has been replaced. Signs have been re-taped. Damaged sections of railing were replaced by driving timber pilings and attaching stainless steel cables in the sections where the railing was damaged or missing. (Photos: Appendix B, Photo 2)

Item	Condition	Physical Damage	Corrosion	Photo #	Observations and Remarks
Steel Bulkhead / Caps	good			2	Structure in good condition. Some slight rusting of pile caps.
Steel Grating	N/A				
Stop Logs	N/A				
Hardware	good				
Timber Piles	good				
Timber Wales	N/A				
Galv. Pile Caps	N/A				
Cables	N/A				
Signage / Supports	good				
Rip Rap (fill)	good				
Earthen Embankment	N/A

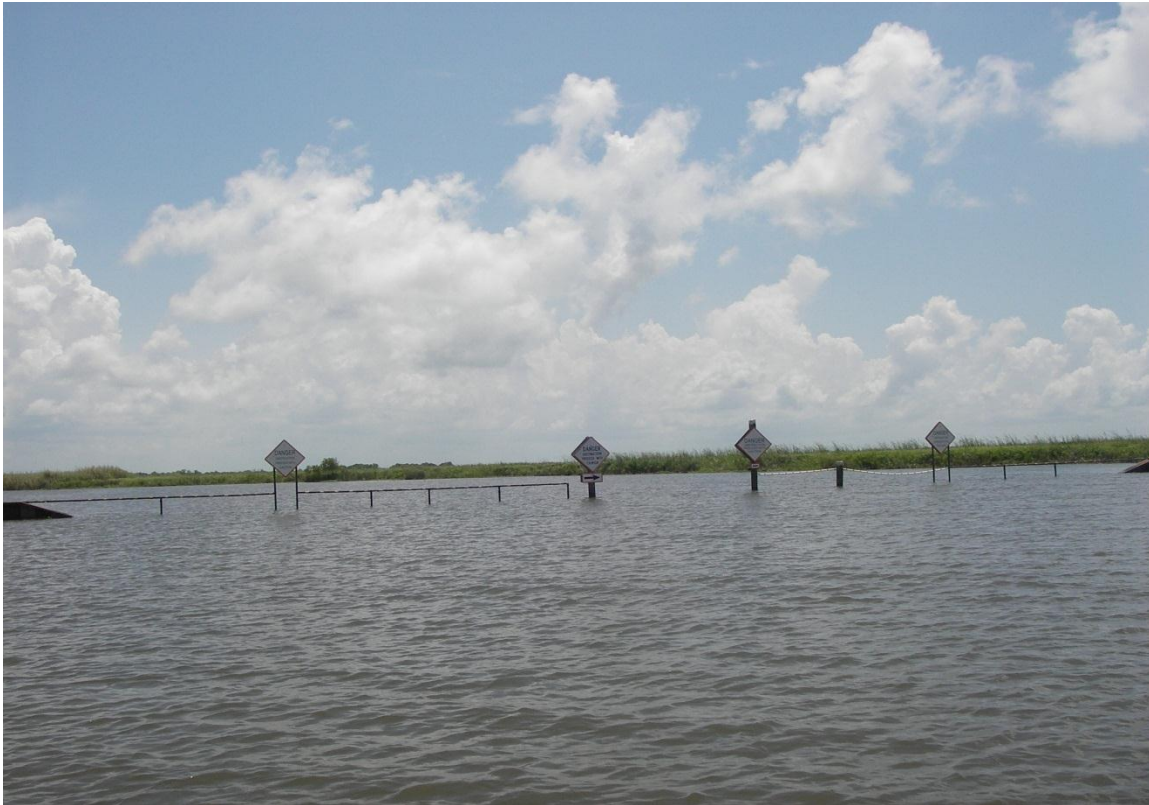
**Photo 3--**Bayou Long Structure

All's well at this site. Pilings and SS cables that replaced the railing on the structure is working well. Rusting on the sheet piles will be monitored. (Photos: Appendix B, Photo 3)

Item	Condition	Physical Damage	Corrosion	Photo #	Observations and Remarks
Steel Bulkhead / Caps	good				
Steel Grating	N/A				
Stop Logs	N/A				
Hardware	good				
Timber Piles	good				
Timber Wales	N/A				
Galv. Pile Caps	N/A				
Cables	N/A				
Signage / Supports	good			3	
Rip Rap (fill)	good				
Earthen Embankment	N/A

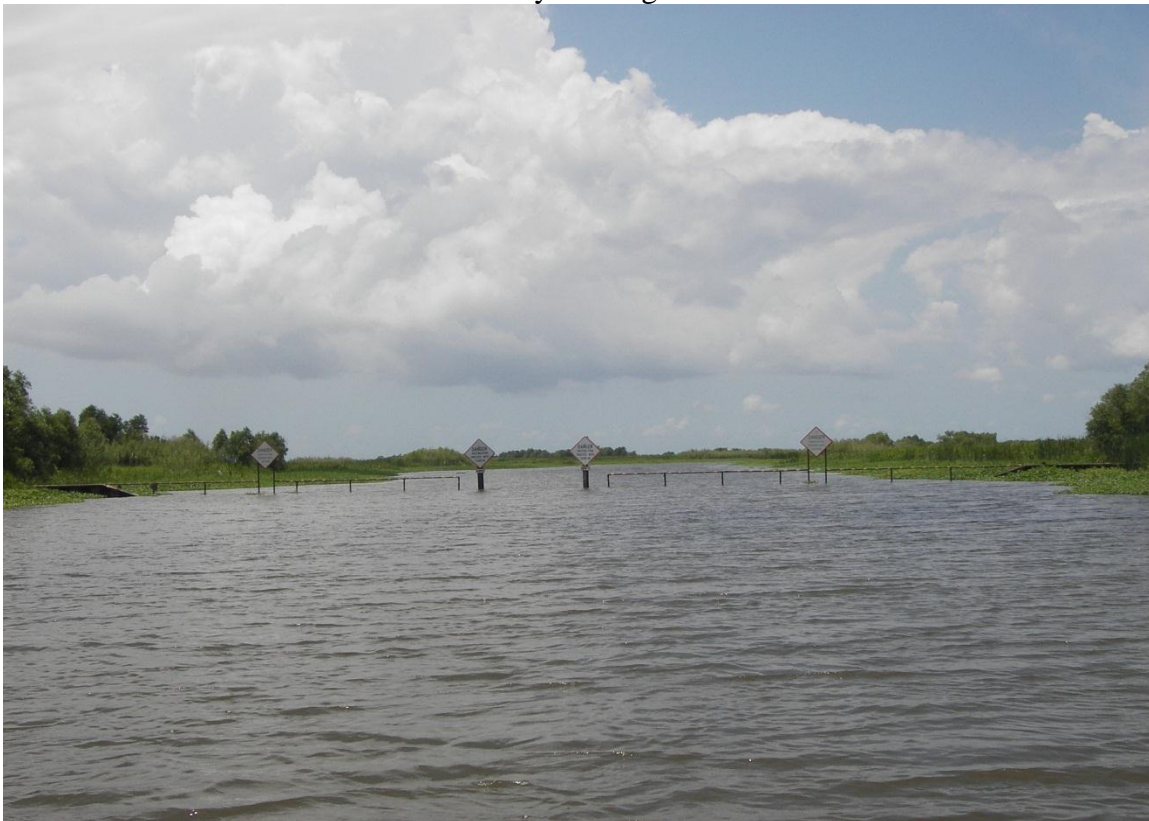
**Photo 4--**Bayou Carlin Structure

The structure is still in excellent post-construction condition. The Bayou Carlin structure and signage are stable. The coating on the sheet piles is rusting and will be monitored as the others. (Photos: Appendix B, Photo 4)

Item	Condition	Physical Damage	Corrosion	Photo #	Observations and Remarks
				4	Structure in pristine post-construction condition. Some slight rusting of pile caps. No immediate action necessary.
Steel Bulkhead / Caps	good				
Steel Grating	N/A				
Stop Logs	N/A				
Hardware	good				
Timber Piles	good				
Timber Wales	N/A				
Galv. Pile Caps	N/A				
Cables	N/A				
Signage / Supports	good				
Rip Rap (fill)	N/A				
Earthen Embankment	N/A

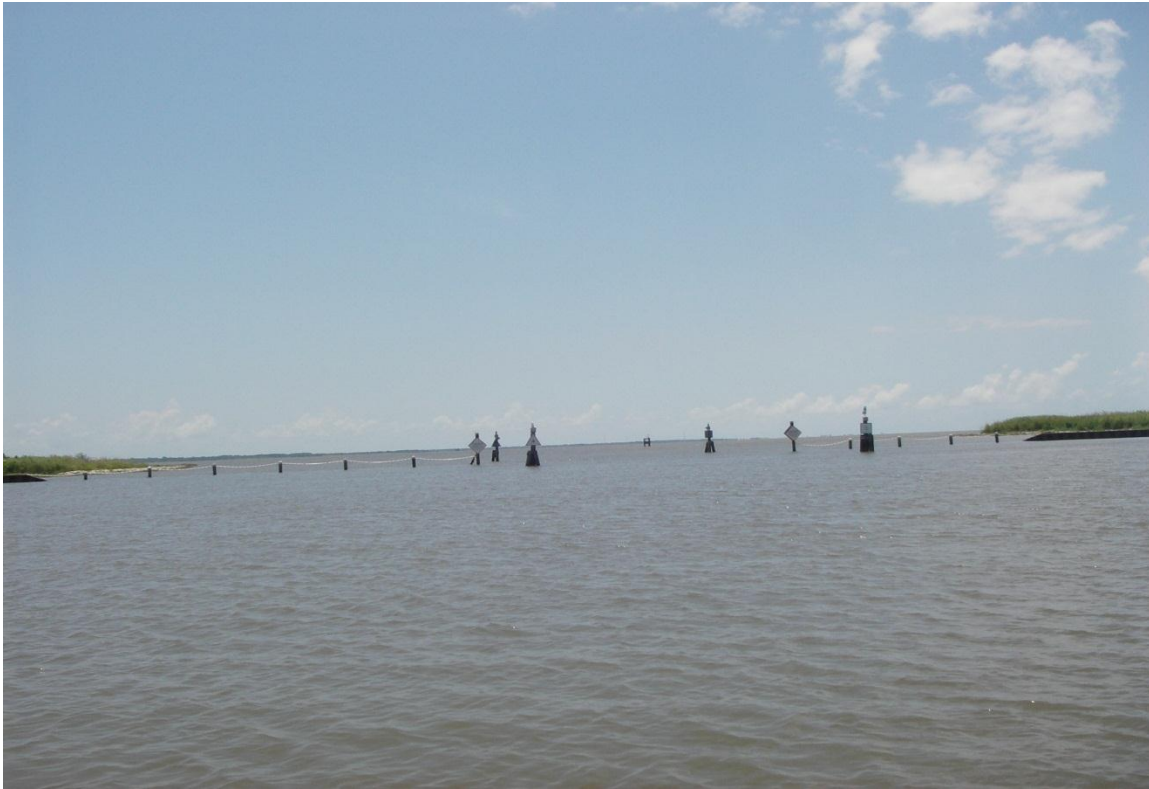
**Photo 5--**Humble Canal Structure

Rail damage on the west end of the structure was replaced with pilings and SS cables. Existing pile cap was deteriorated to the extent that there was no way to bolt a new railing to replace the damaged one. The danger signs on both ends of the structure have been mounted to the new pilings. The gap on the southern end of the rock dike on the eastern end of Humble Canal has been repaired. Rock was extended to the south for approximately 900 feet. The rest of the rock around the structure is stable and functioning. The NW coast guard sign (port side) has been replaced. (Photos: Appendix B, Photos 5-7)

Item	Condition	Physical Damage	Corrosion	Photo #	Observations and Remarks
Steel Bulkhead / Caps	good				Some initial post construction rusting. No immediate action needed.
Steel Grating	N/A				
Stop Logs	N/A				
Hardware	fair				
Timber Piles	N/A				
Timber Wales	N/A				
Galv. Pile Caps	good				
USCG Lights	good			5	
Signage / Supports	good			6	
Rip Rap (fill)	good			7	
Earthen Embankment	N/A

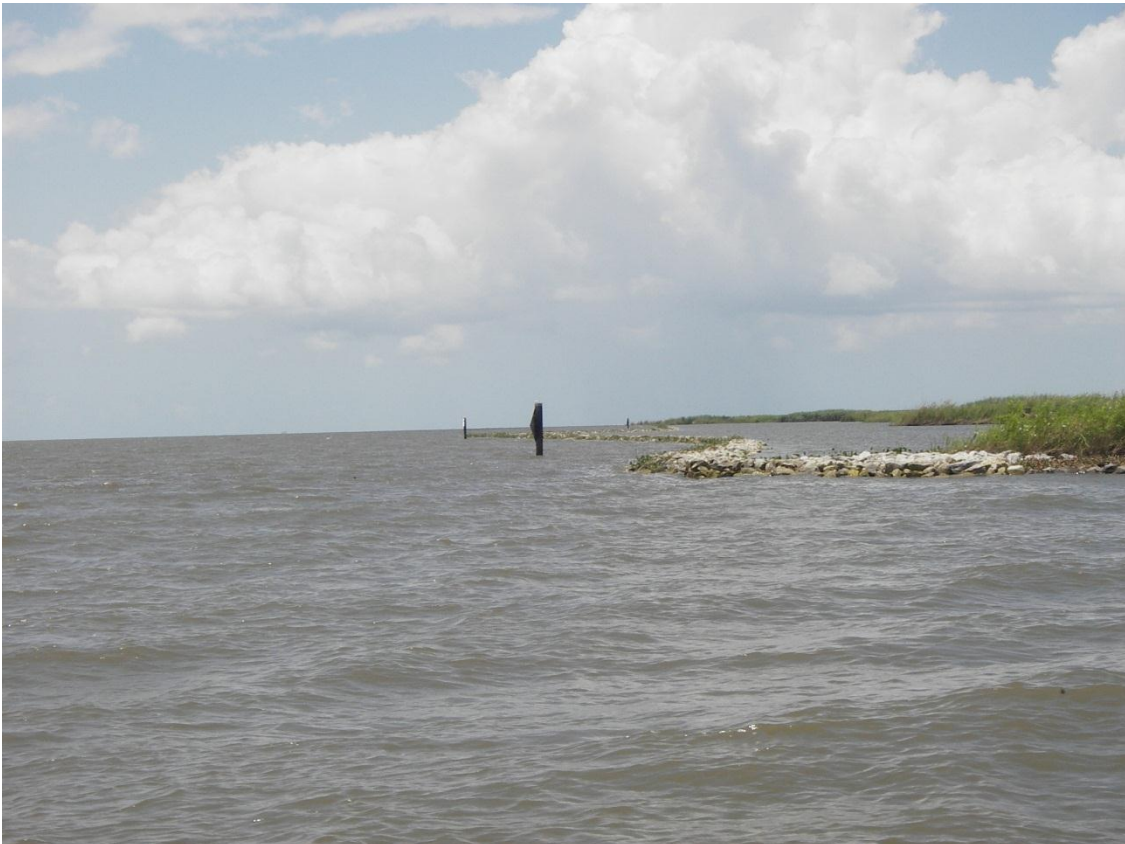
**Photo 8—Typical Section of School Bus Bayou Dike**

The dike has been raised to design heights and is functioning as intended. The missing sign has been replaced. The rock on the western end of School Bus Bayou at its intersection with Humble Canal has been brought back to grade. Signage at the crossings is ok. (Photos: Appendix B, Photos 8-10)

Item	Condition	Physical Damage	Corrosion	Photo #	Observations and Remarks
Steel Bulkhead / Caps	N/A				
Steel Grating	N/A				
Stop Logs	N/A				
Hardware	N/A				
Timber Piles	N/A				
Timber Wales	N/A				
Galv. Pile Caps	N/A				
Cables	N/A				
Signage / Supports	Good			8	
Rip Rap (fill)					
School Bus Bayou	Good			8	
Low Level Weirs	Good			9,10	
Earthen Embankment	N/A

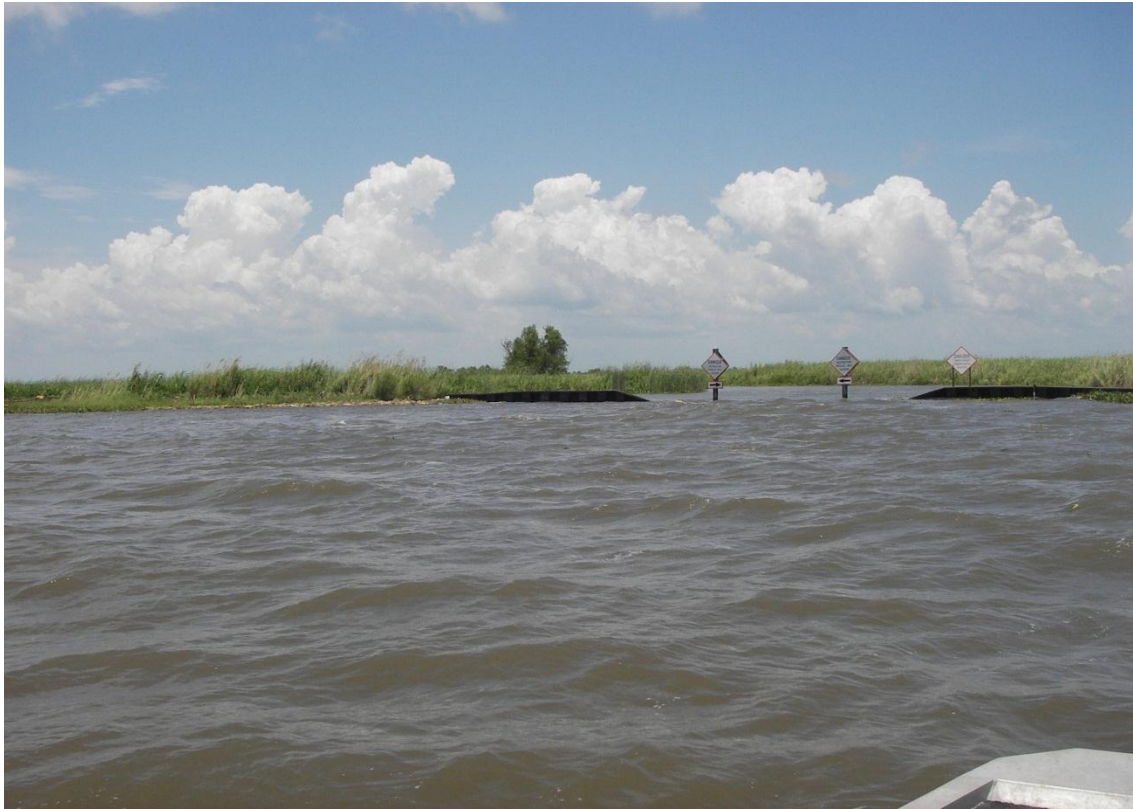
**Photo 11**—Jackson Bayou Structure

The warning sign mounted on the left side of the structure is gone and will not be replaced. Existing signs have been re-taped. The shoreline on the eastern side of the structure has eroded nearly all the way through on the back side of the bay shore rock. This area will need to be addressed in the near future to prevent circumvention of the structure. The coating on the sheet piles is rusting on this structure and will be monitored. (Photos: Appendix B, Photos 11-12)

Item	Condition	Physical Damage	Corrosion	Photo #	Observations and Remarks
				12	Some slight rusting of pile caps.
Steel Bulkhead / Caps	good				
Steel Grating	N/A				
Stop Logs	N/A				
Hardware	good				
Timber Piles	poor				
Timber Wales	N/A				
Galv. Pile Caps	N/A				
Cables	N/A				
Signage / Supports	good				
Rip Rap (fill)	good				Shoreline where rock was placed has stabilized the shoreline however the shore on the eastern end of the structure has eroded to the point that water will soon circumvent the structure. This area will need to be addressed should additional funding be provided.
Earthen Embankment	N/A

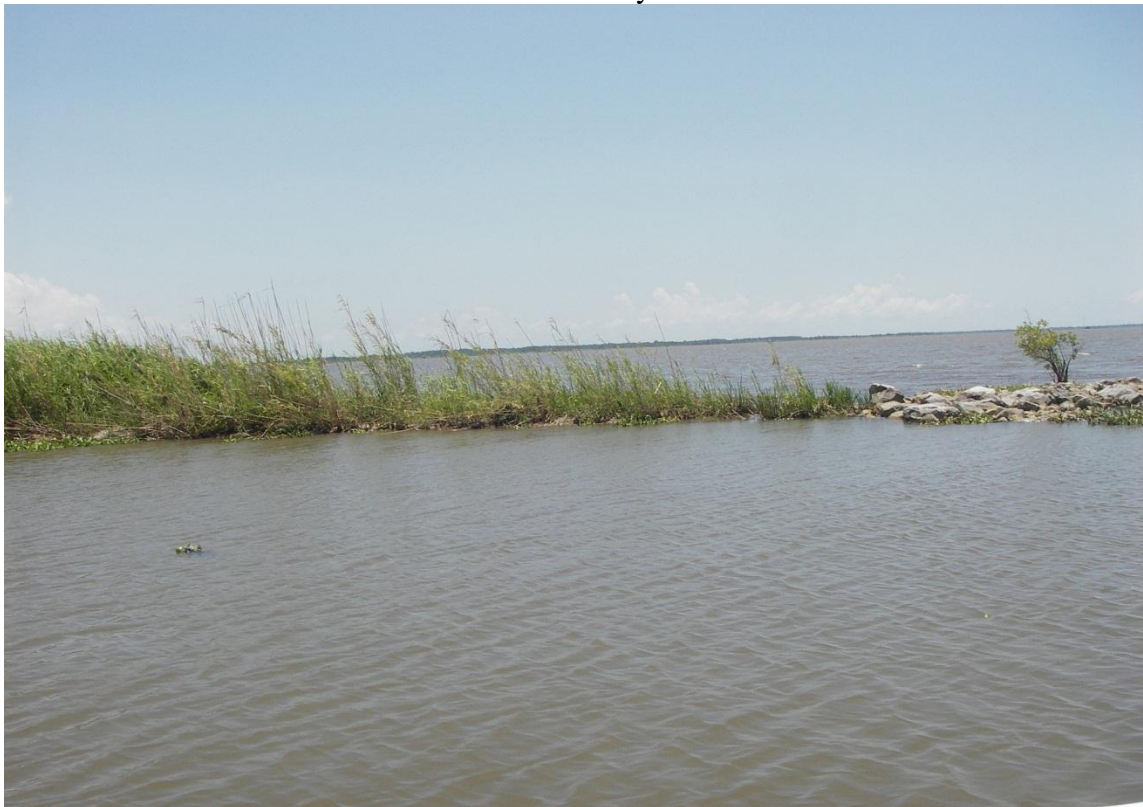
The Cote Blanche Hydrologic Restoration Project is in basically good condition and functioning as designed. The shoreline on the southern end of the project continues to suffer from severe erosion. The eastern end of Jackson Bayou has eroded to the point that it will breach in the near future. A request for additional funding will be submitted during the fall of 2012. Should this funding request be approved, the eastern end of Jackson Bayou along with as much of the shoreline between Humble Canal and the PVC wall will be protected. Work on this area should take place during the summer of 2013.

**Photo 12**—Near Breach on Eastern End of Jackson Bayou Structure

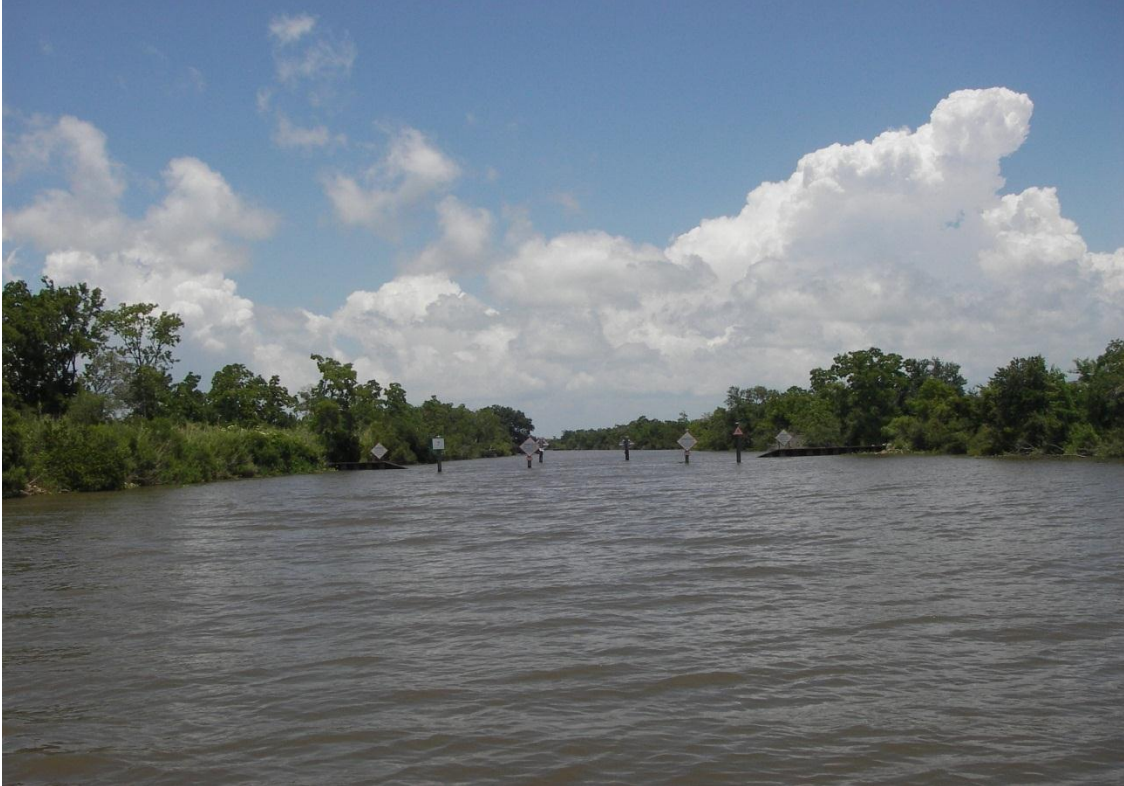
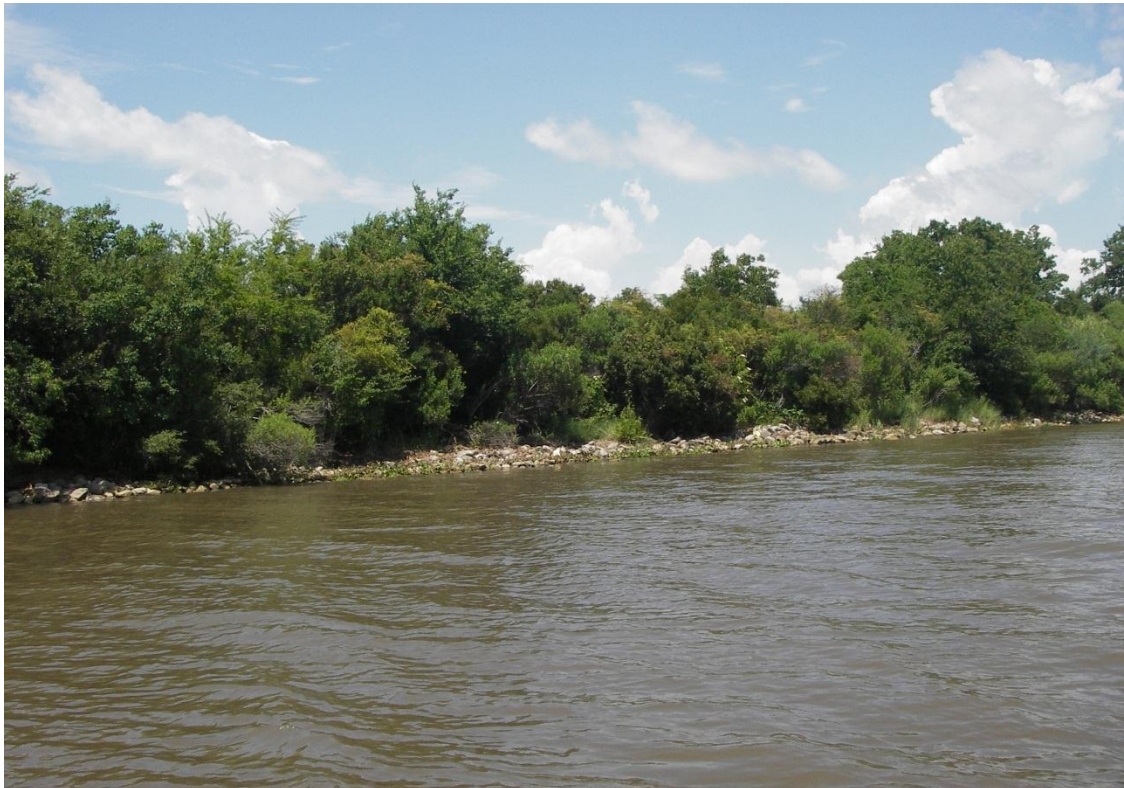
The western (green) navigational aid marker has been replaced. The coating on the sheet piles is rusting on this structure and will be monitored as well. Warning signs and arrows have been replaced. Other signs have been re-taped. The rock on the wingwalls of the structure as well as the rock along the canal is stable. Settlement of the rock between the PVC wall and the bank has stabilized. (Photos: Appendix B, Photos 13-14)

Item	Condition	Physical Damage	Corrosion	Photo #	Observations and Remarks
Steel Bulkhead / Caps	good			13, 14	Some initial post construction rusting. No action needed.
Steel Grating	N/A				
Stop Logs	N/A				
Hardware	good				
Timber Piles	see signage				
Timber Wales	N/A				
Galv. Pile Caps	N/A				
Cables	N/A				
Signage / Supports	fair				
Rip Rap (fill)	good				Rock between PVC wall and shoreline has settled but is still functional.
Earthen Embankment	N/A

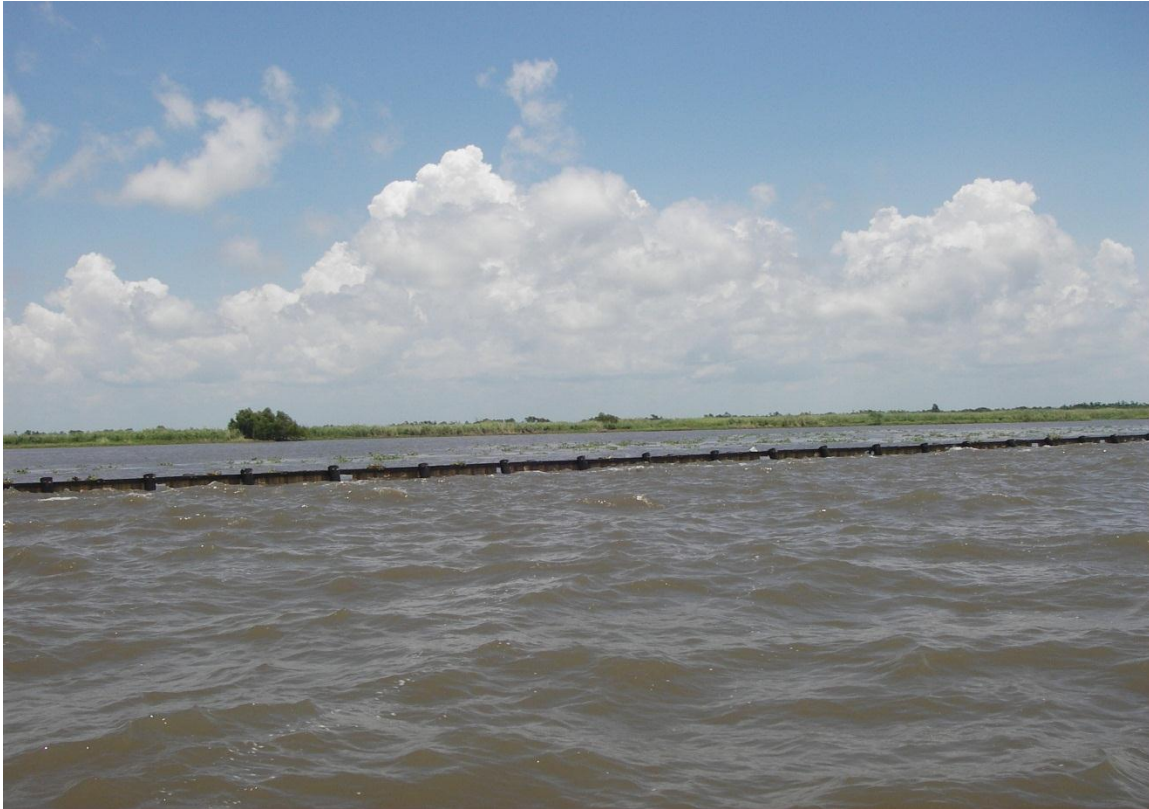
**Photo 15**—Typical Section of PVC Wall

The PVC shoreline protection wall and signage are stable. There are virtually no pile caps remaining, but no damage to the timber piles was noticed. Previous attempts to replace these pile caps have been unsuccessful. The piles will be monitored and should the need arise, will be painted or coated for protection. Sheet piles in several locations are missing, however no

gaps are wider than 3-4 feet. Replacement of these sheet piles may not be possible due to the rock at the base. The wall is still functioning as intended. Signs are all in place and have been re-taped. (Photos: Appendix B, Photo 15)

Item	Condition	Physical Damage	Corrosion	Photo #	Observations and Remarks
PVC sheet piling / Caps	fair			15	PVC wall appears to be in post construction condition and holding up well. Some piles have been broken or displaced. No gaps are wider than 3-4 feet however and the wall is still functioning
Steel Grating					
Stop Logs					
Hardware	good				
Timber Piles	good				Nearly all pile caps missing. Attempts to replace these have been unsuccessful. Condition of the piles will be monitored.
Timber Wales	good				
Galv. Pile Caps					
Cables					
Signage / Supports	good				All signs are in place. Some retaping with reflective tape is required.
Rip Rap (fill)	good				Rock placed along the inside and outside of the PVC wall is still in place and functional. No action necessary.
Earthen Embankment
