**2011/2012 Annual Inspection  
Report**

**BOSTON CANAL/VERMILION  
BAY SHORE RESTORATION  
PROJECT  
(TV-09)**

State Project Number TV-09  
Priority Project List 2

May 16, 2012  
Vermilion Parish

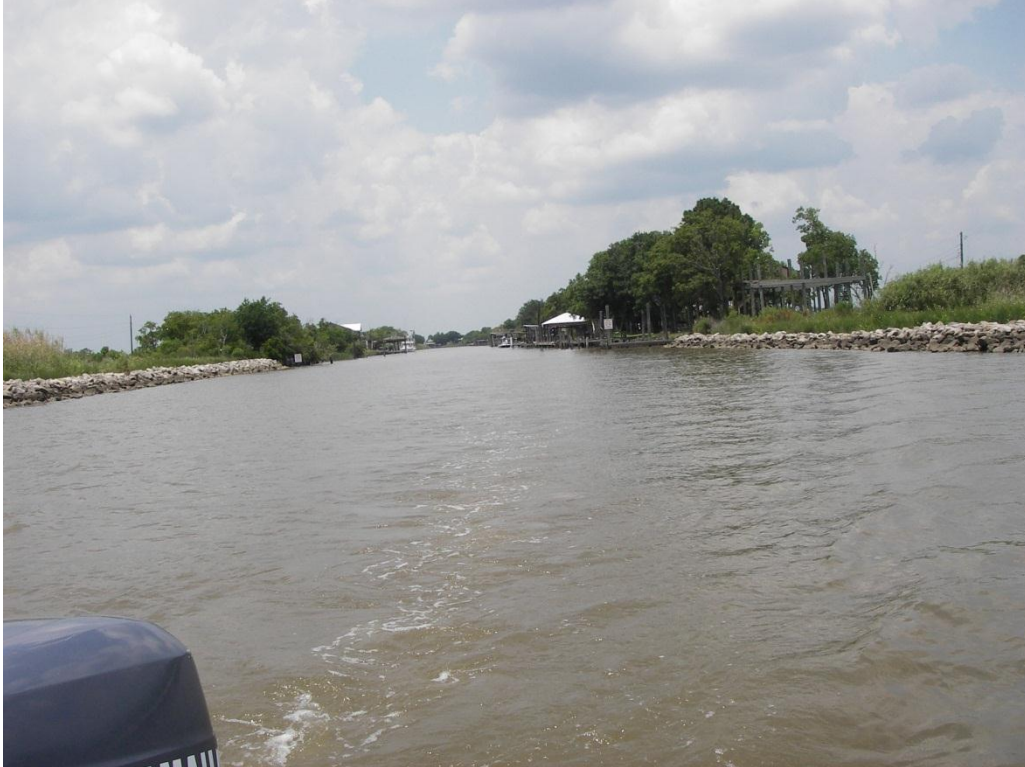
**Photo No. 1,** View of Boston Canal Looking North into Canal

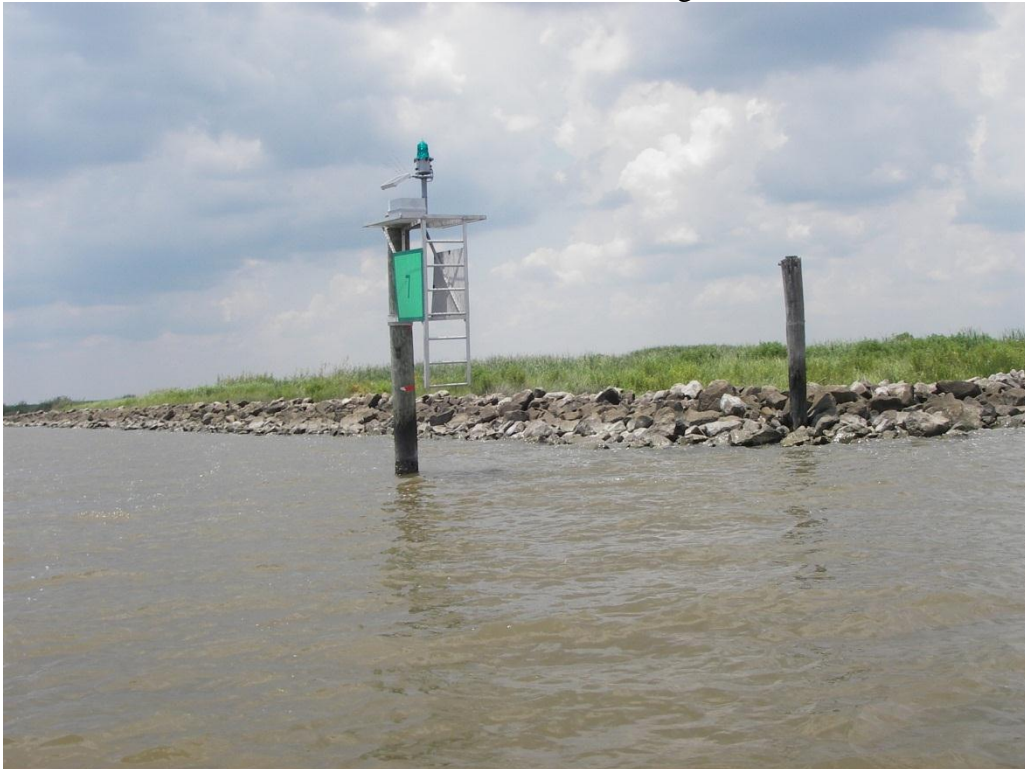
The rock dikes are in excellent condition. The Vermilion Bay shoreline erosion to the west and east of the rock dike tie-ins have not worsened. It was noted during previous inspections that a small gap left on the western tie-in during the original construction caused shoreline erosion. Recommendations made during the 2003 O & M inspection were reconsidered due

**Photo No. 2,** Rock Dike along the Bay Shore Looking West, Vegetation behind Rock

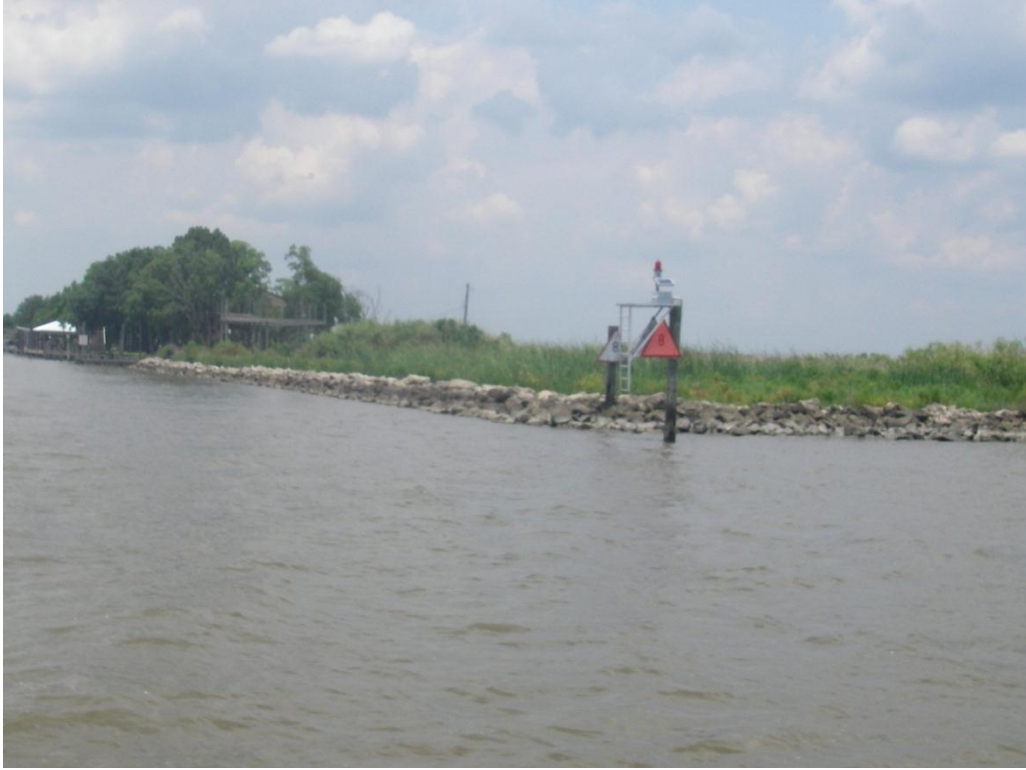
to costs and logistics associated with the repairs. These areas will continue to be monitored. If it is seen that the situation worsens, steps will be taken to stabilize the area at that time. The west day marker installed as part of the TV-09 project is missing; however, the piling remains. The east day marker is still present. Additional day/night markers have been installed by others. (Photos: Appendix B, Photos 1 - 5)

**Photo No. 3, View of East Rock Dike, Vegetation, and Signs**

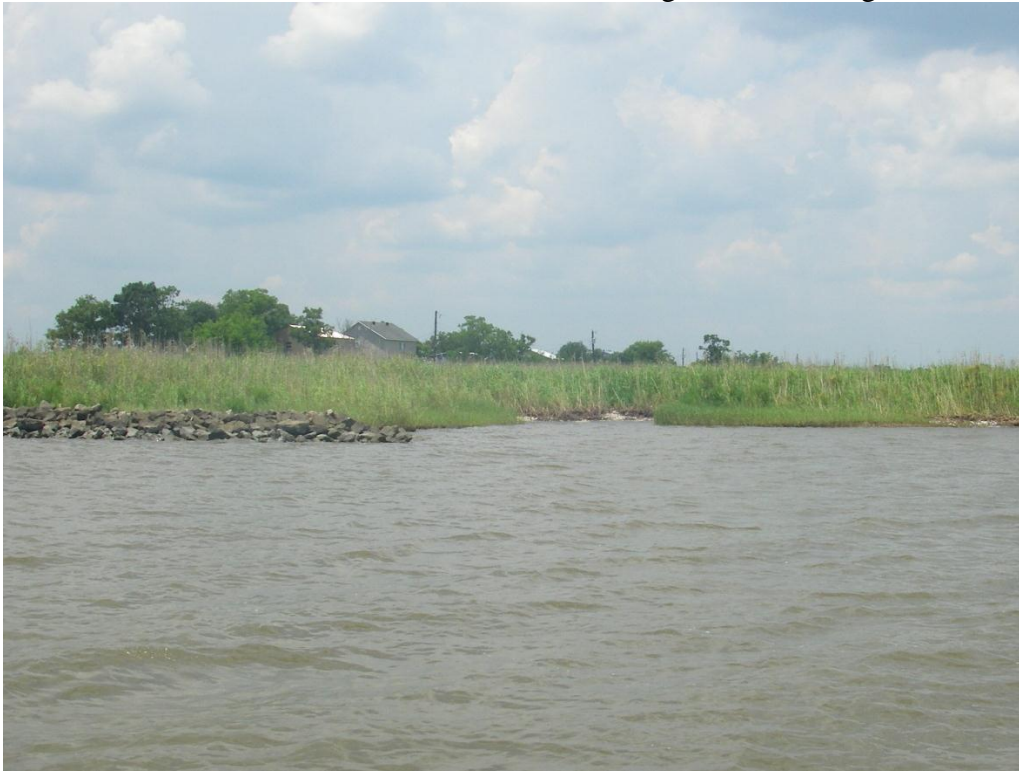
**Photo No. 4, East Tie In at Shoreline**

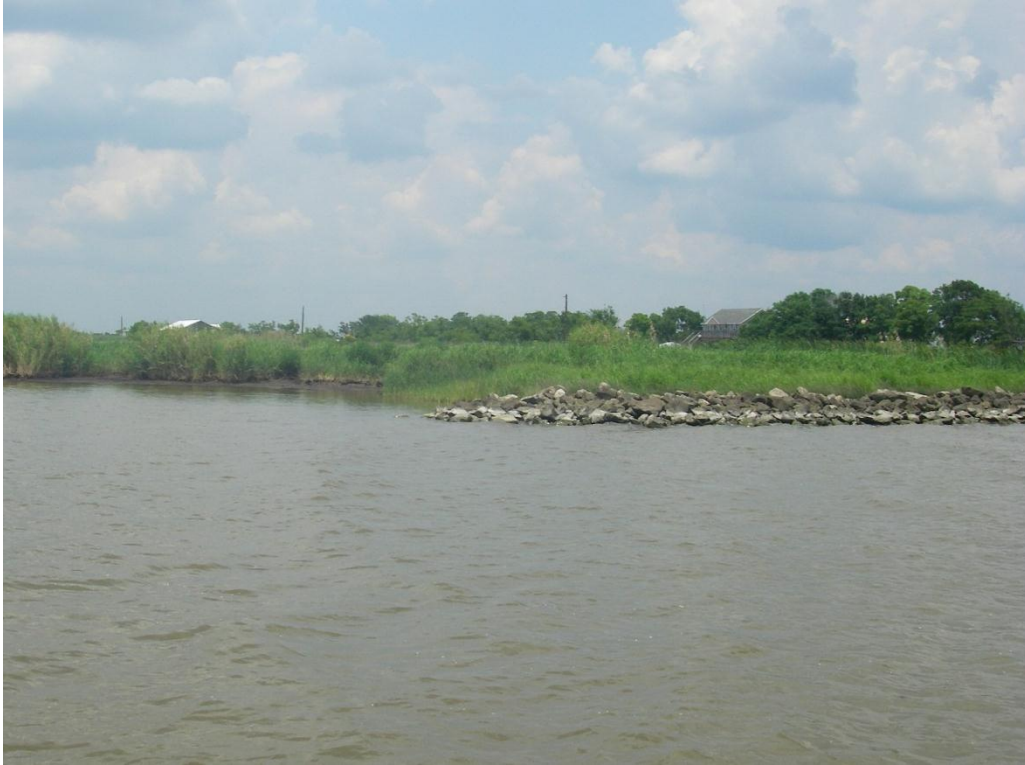
**Photo No. 5, West Tie In at Shoreline**
