## **2011/2012 Annual Inspection Report**

### **LAKE PORTAGE LAND BRIDGE PROJECT (TV-17)**

State Project Number TV-17  
Priority Project List 8

May 29, 2012  
Vermilion Parish

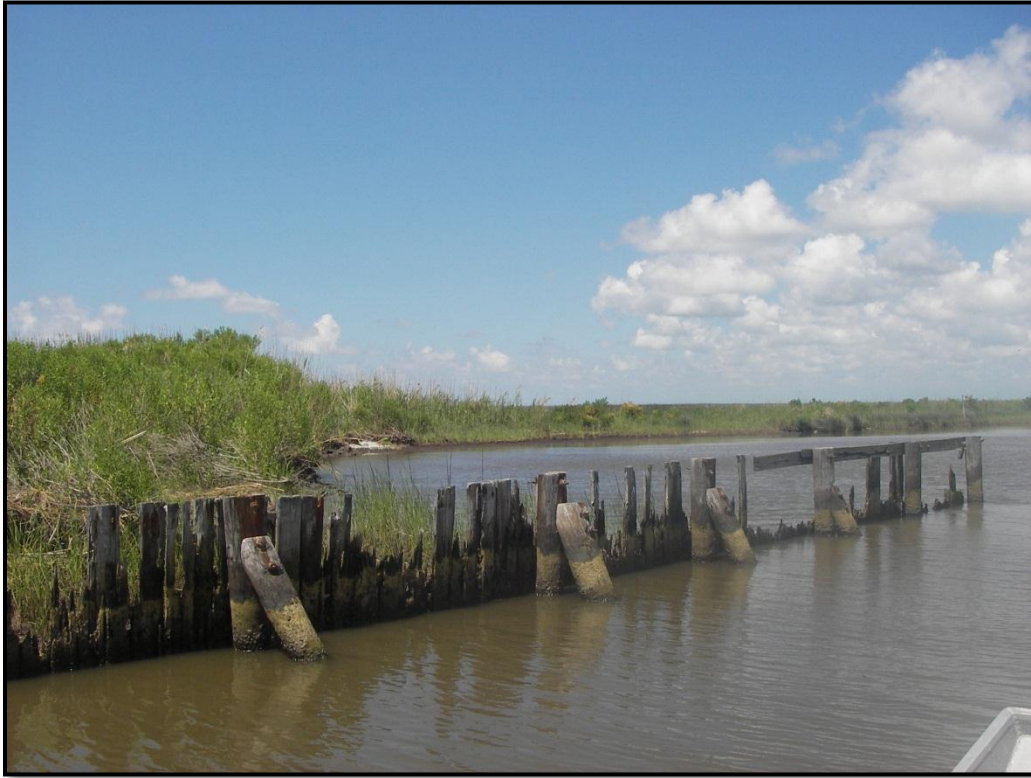
**Photo 1:** Area 1- Timber Bulkhead

Area 1 is in good condition and vegetation has continued to expand from the containment banks moving towards the center of the channel and is 100 per cent vegetated. As a result of the inspection of Area 1, CPRA and NRCS agree that no corrective actions will be required this year. An aerial photo taken by Edmond Mouton of LDWF shows the pipeline canal has established a healthy vegetative stand. (Photos: Appendix B, Photo 1 & 6).

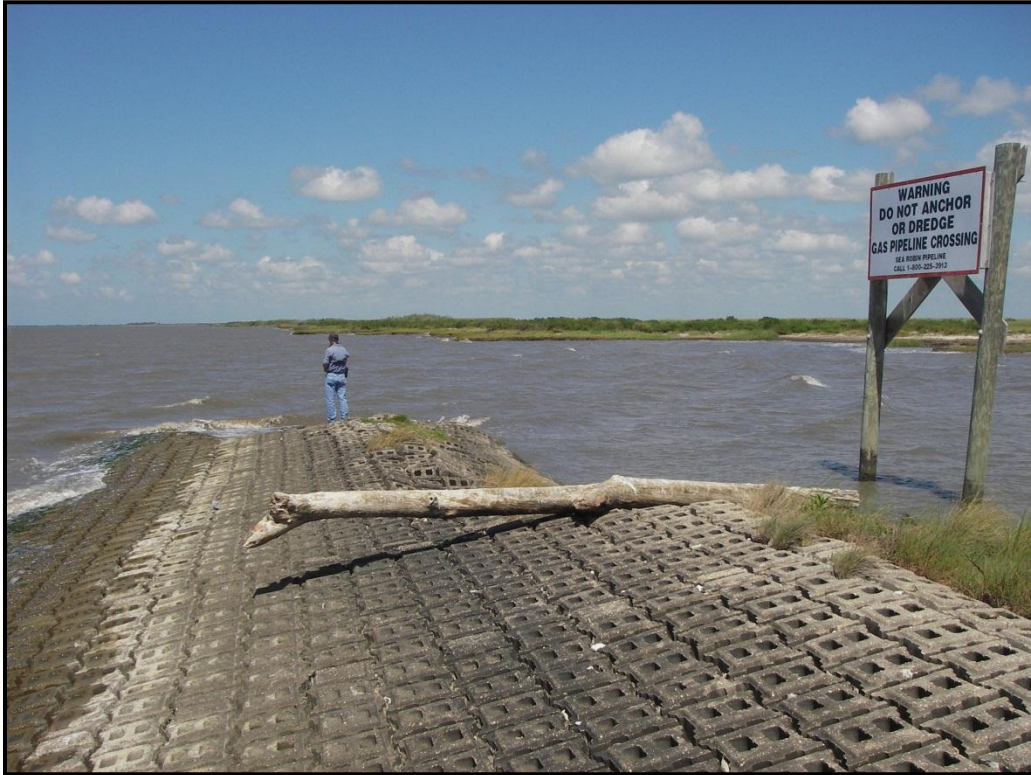
**Photo 2:** Area 2- West Side of Concrete Mats

Area 2 is also in good condition and is fully vegetated, such that this reach was preexisting with additional dredge material added through this project to fill in any trenasses. Some erosion at the ends of the concrete mats along the Gulf shoreline has occurred over time and part of the mat system is showing signs of failure. Although the concrete mat system is not a feature to be maintained as part of this project, this area is experiencing erosion that may threaten the integrity of the overall project. Therefore, CPRA and NRCS agree that maintenance may be required at sometime in the future. (Photos: Appendix B, Photos 2, 3, 4 & 6).

| MAINTENANCE INSPECTION REPORT CHECK SHEET | | | | | |
|---|---|---|---|---|---|
| Concrete Mats | Good | | | 2, 3, 4, 6 | Some erosion each side of concrete mats along Gulf shoreline. |

Overall, the Lake Portage Land Bridge Project is in good condition and functioning as designed. However, the erosion problem occurring at the Gulf shoreline will need to be addressed. Preliminary survey work to develop an accurate estimate of costs was performed in 2008 and a subsequent request made to CWPPRA for additional funds. The Task Force decided that monitoring of the shoreline should continue and opted not to take any action at this time.

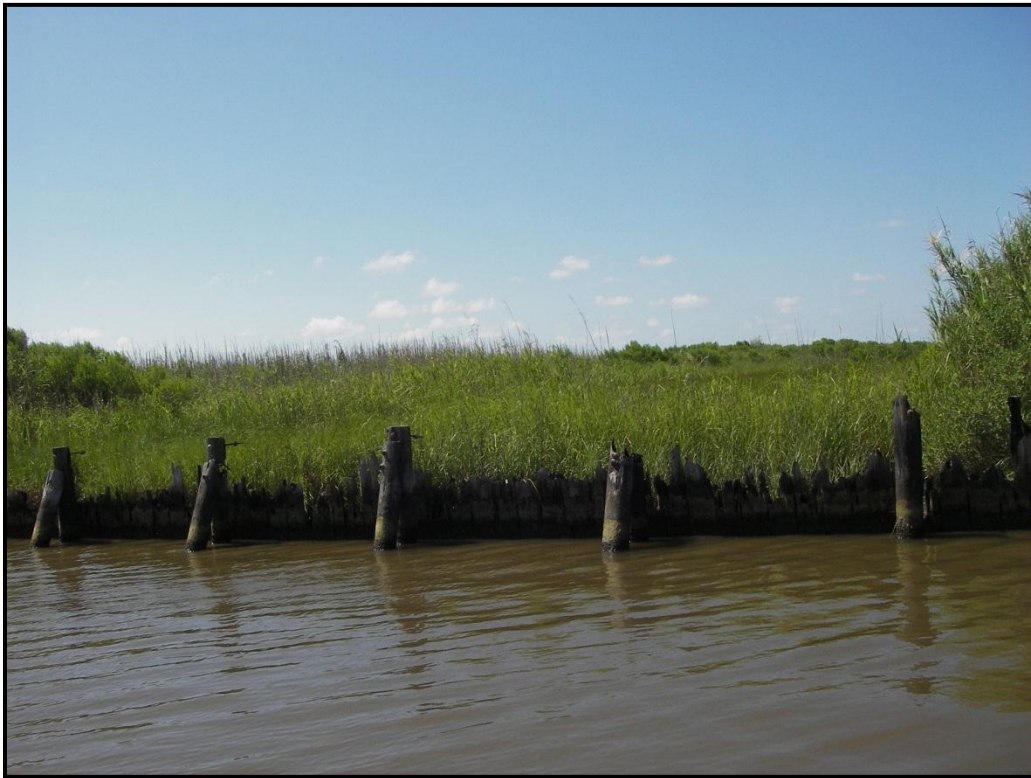
**Photo 5:** Area 3- Near Bulkhead on North End

Area 3 also is in good condition. The northern part of this reach is fully vegetated, mainly due to the fact that this reach was constructed first, and has been in place since May, 2003. There is some minor erosion occurring on each side of the northern timber bulkhead which will need to be monitored on future annual inspections. CPRA and NRCS agree that this area is in good condition and no maintenance will be required at this time. (Photos: Appendix B, Photos 5 & 7).

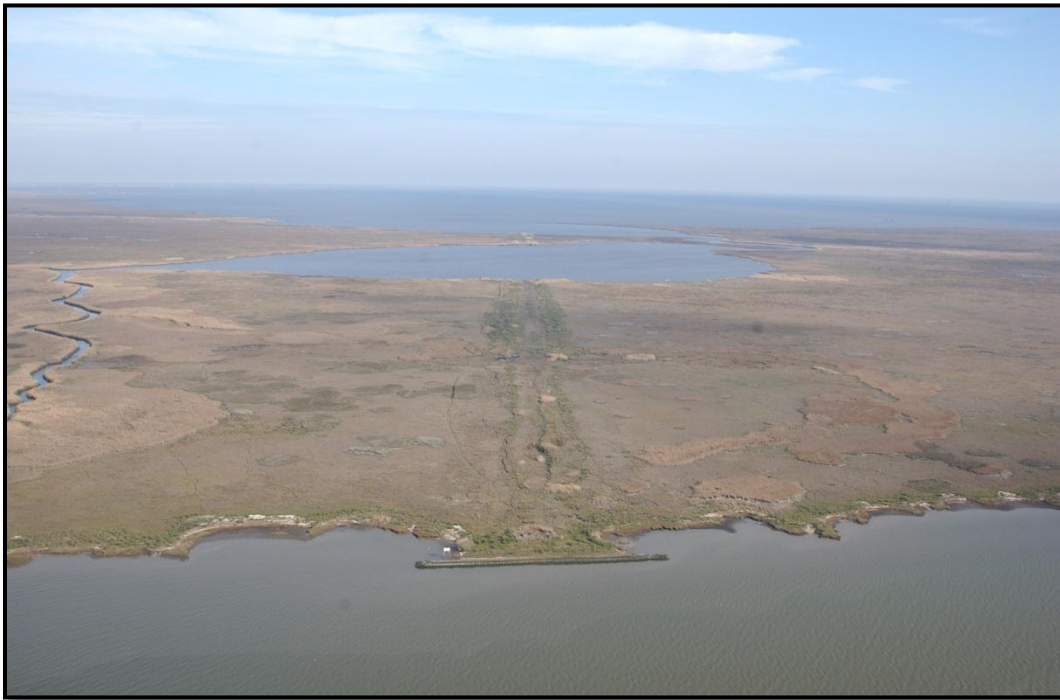
**Photo 6:** Areas 1 & 2 - Aerial View from Gulf of Mexico Looking North to Lake Portage

| MAINTENANCE INSPECTION REPORT CHECK SHEET | | | | | |
|---|---|---|---|---|---|
| Vegetation | Good | | | 6, 7 | Area 3 fully vegetated, Area 2 existing vegetation, Area 1 fully vegetated. |
