**2011/2012 Annual Inspection
Report**

**FOUR MILE CANAL TERRACING
AND SEDIMENT TRAPPING
PROJECT (TV-18)**

State Project Number TV-18
Priority Project List 9

April 12, 2012
Vermilion Parish

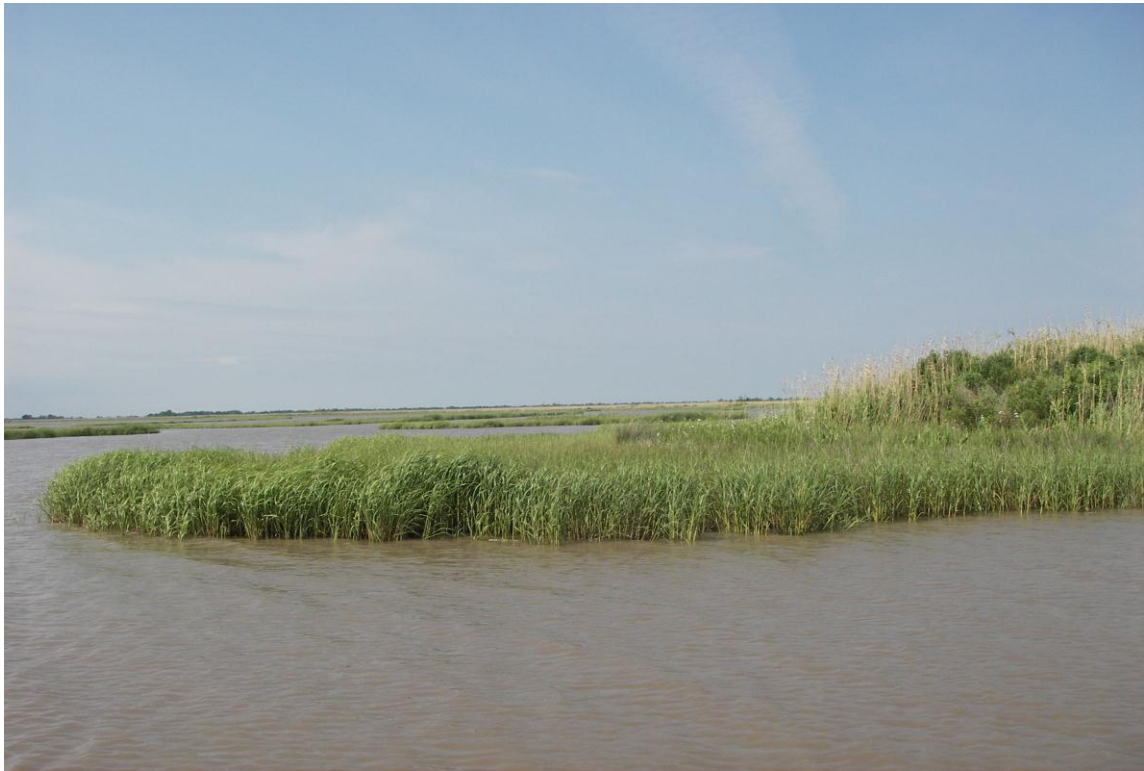
In Little White Lake, the 4th row of terraces has gradually continued to erode. The 3rd row is still in fairly decent shape. The 1st and 2nd rows are in excellent condition. The channels are continuing to silt in. This was the first inspection that was performed in a tunnel boat. All future inspections will need to be done in a tunnel boat as well. The eastern terraces adjacent to the Four Mile Canal continue to erode as well as the western most terraces. Some type of closure along Four Mile Canal is continuing to be considered. The boat wakes continue to damage these terraces. Channels between the terraces are silting in. (Photos: Appendix B, Photo 1-4)

Photo No. 1—Little White Lake terraces (interior row)

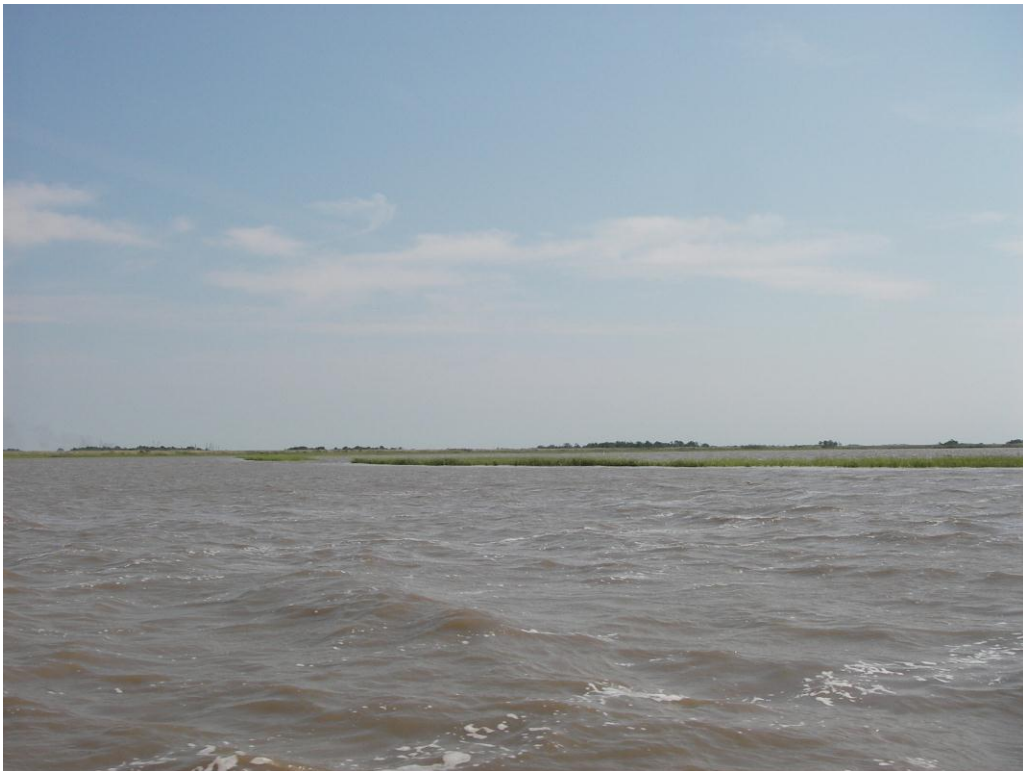
Photo No. 2—Little White Lake terraces (outer row)

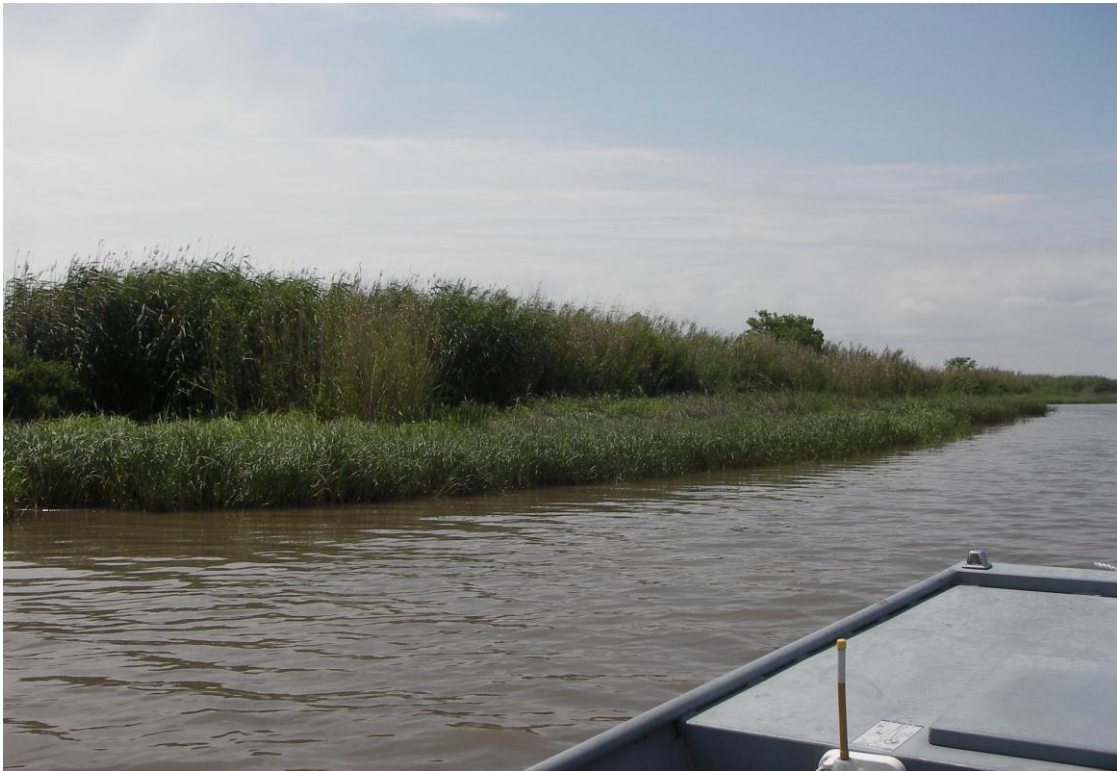
Photo 3—Four Mile Canal terraces

The Four Mile Canal Terracing and Sediment Trapping Project is in very good condition and functioning as intended. The terraces along Four Mile Canal, however, will need to be protected.

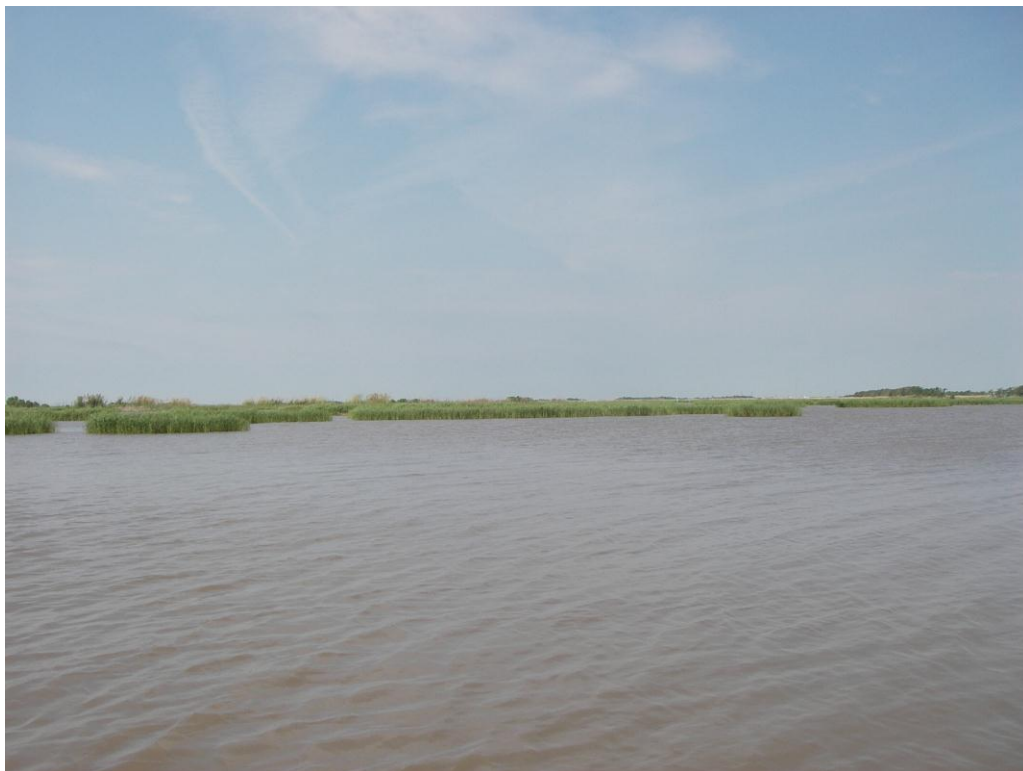
Vegetation on stable terraces in both areas is doing extremely well. Emergent vegetation is becoming established. No maintenance with regard to the plantings is needed at this time.

Photo 4—emergent vegetation within Four Mile Canal terraces
