**2011/2012 Annual Inspection
Report**

**LITTLE VERMILION BAY
SEDIMENT TRAPPING
PROJECT (TV-12)**

State Project Number TV-12
Priority Project List 5

April 12, 2012
Vermilion Parish

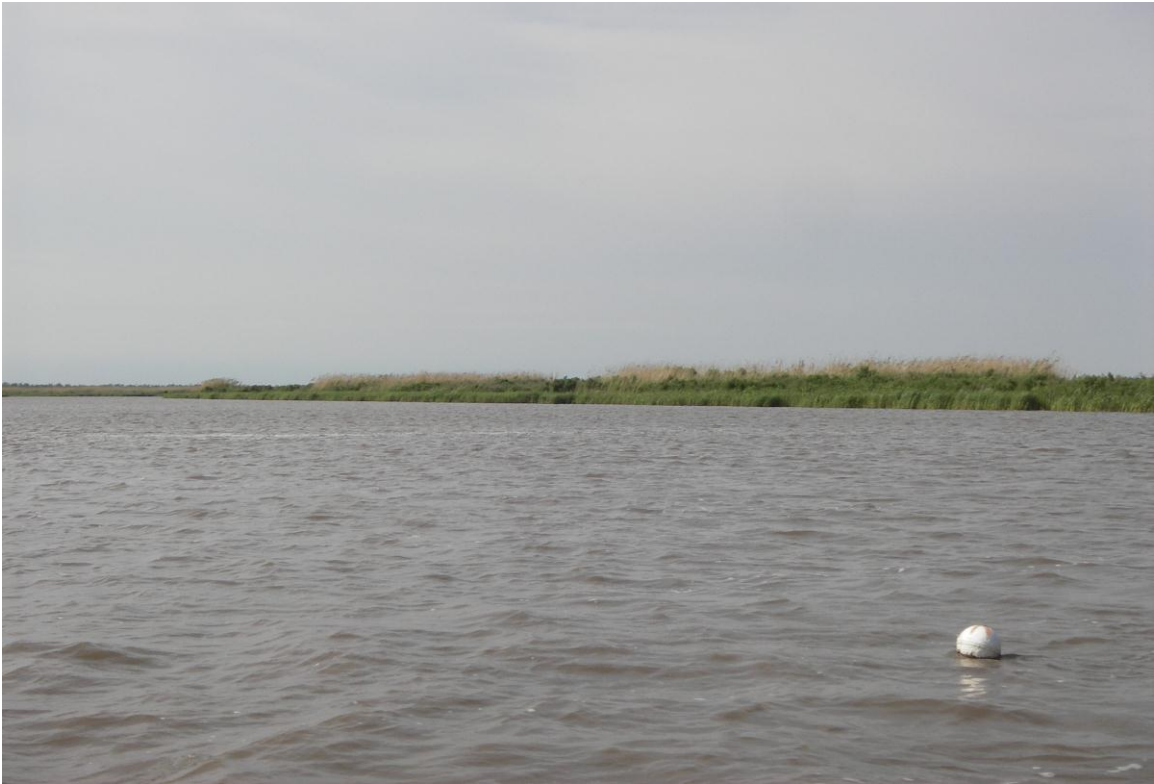
The terraces remain in very good condition with the exception of the terraces nearest Freshwater Bayou Canal (FWB) and the southernmost sacrificial terrace. Still, only three terraces remain on this southern row. The terraces nearest FWB continue to erode as the bankline along Freshwater Bayou continues to worsen. Measurements from 2010 aerial photography show this opening to have widened to over 1700 feet with about 500 linear feet

of narrow marsh left along the northeast corner that remains vulnerable. Consideration is still being given to what will be the best method to reduce the opening to FWB. Additional funding will be required. Surveys have been performed assisting in the estimation of the costs associated with possible actions. (Photos: Appendix B, Photos 1-2)

Photo No. 1—typical terrace

The Little Vermilion Bay Sediment Trapping Project is in very good condition and still functioning as intended. Emergent vegetation is becoming established. Narrowing the opening into FWB and re-establishing the sacrificial terraces to the south will allow this project to continue to be successful.

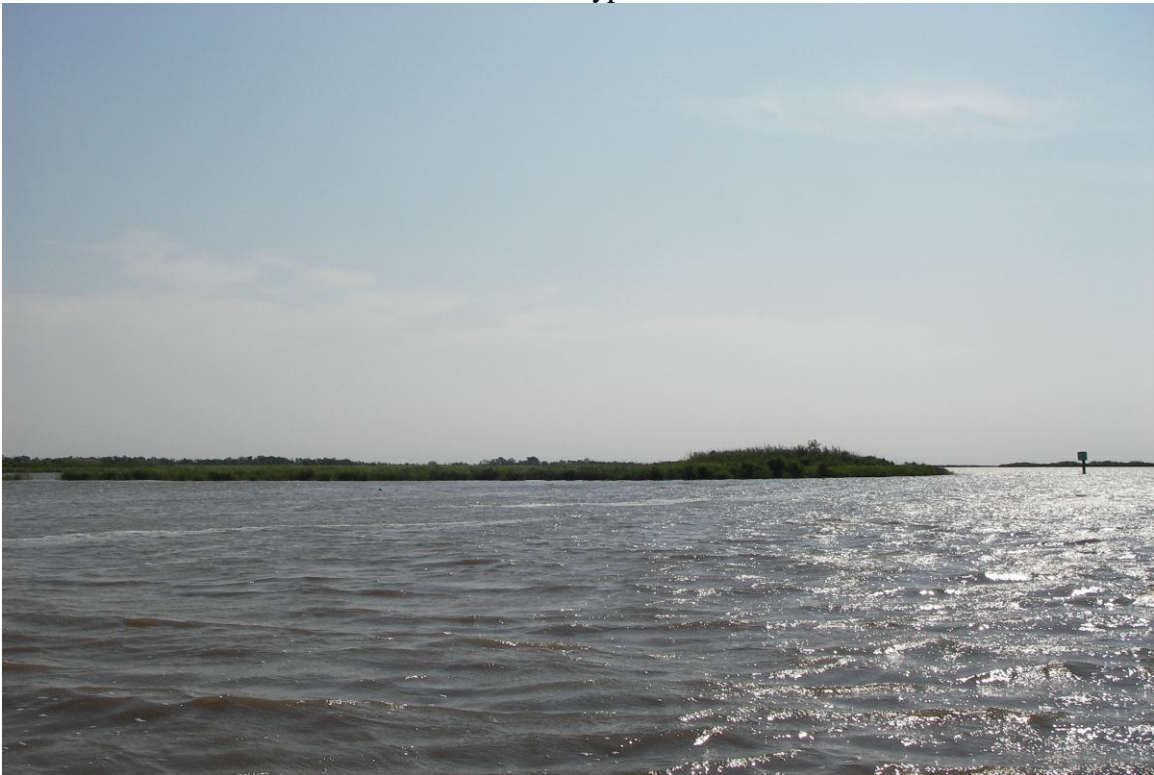
Photo No. 2—terrace near Freshwater Bayou Canal
