**Coastal Protection and Restoration
Authority of Louisiana (CPRA)**

2011/2012 Annual Inspection Report

MARSH ISLAND HYDROLOGIC RESTORATION PROJECT (TV-14)

March 14, 2012
Iberia Parish

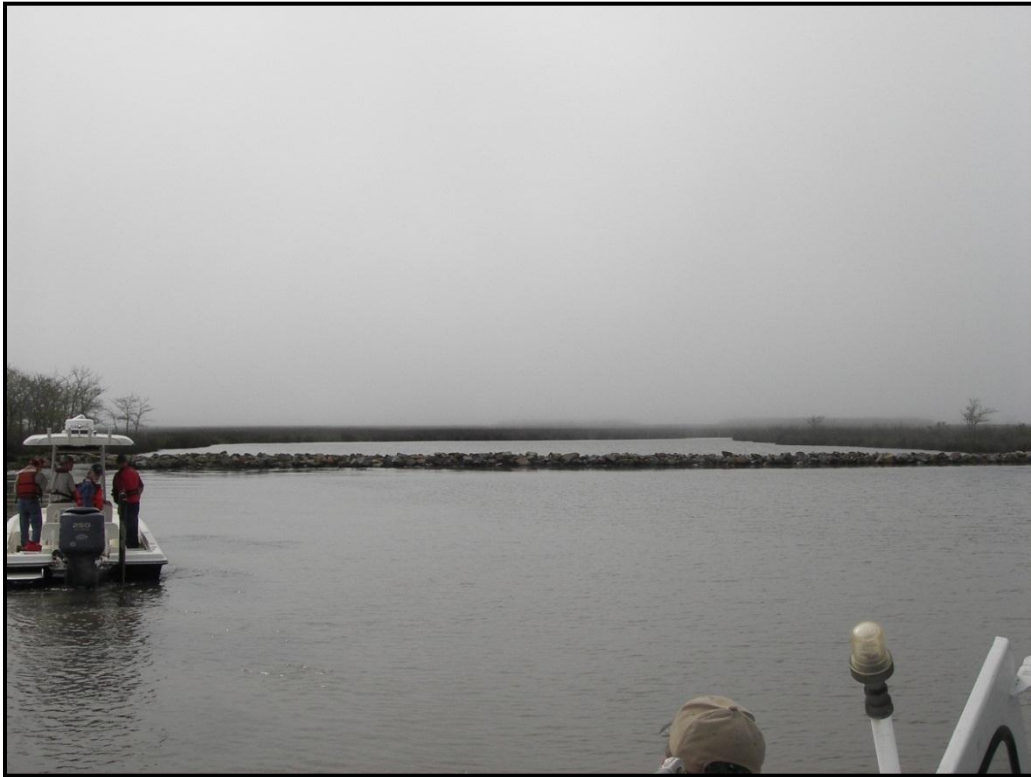
Photo No.1, Closure No.1

The erosion problems and Hurricane Rita damages have been repaired through the recent maintenance project that was completed in February 2009. The dike was capped and bank paving installed on both ends of the closure. This site is in good condition since this work was performed. This site is showing significant silt deposition on the north side of the dike on both the east and west sides, with the majority of the silt appearing on the west side of the dike continuing along the shoreline for several hundred feet. (Photos: Appendix B, Photo 1).

Item	Condition	Physical Damage	Corrosion	Photo #	Observations and Remarks
Steel Bulkhead / Caps	N/A				
Steel Grating	N/A				
Stop Logs	N/A				
Hardware	N/A				
Timber Piles	N/A				
Timber Wales	N/A				
Galv. Pile Caps	N/A				
Cables	N/A				
Signage / Supports	N/A				
Rip Rap (fill)	Good			1	Looks good. Good silt deposition occurring on east and west side of closure.
Earthen Embankment	N/A				
What are the conditions of the existing levees?					
Are there any noticeable breaches?					
Settlement of rock plugs and rock weirs?					
Position of stoplogs at the time of the inspection?					
Are there any signs of vandalism?

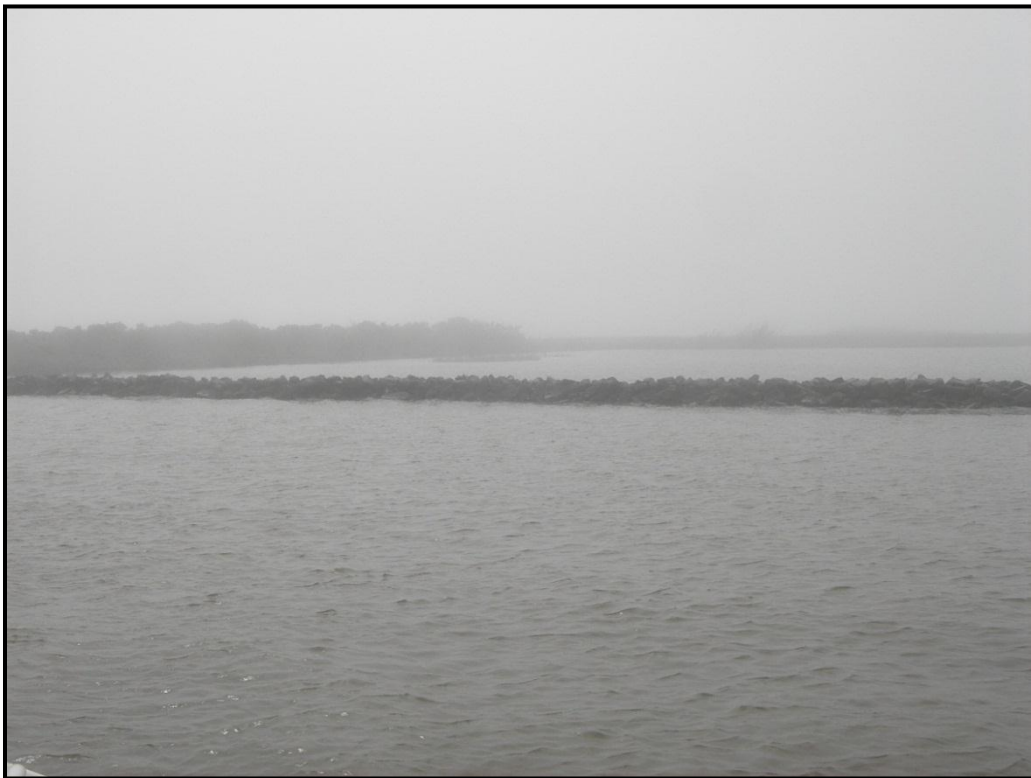
Photo No. 2, Closure No. 2

The dike was capped and bank paving installed as noted above and is in good condition since the work was performed. (Photos: Appendix B, Photo 2).

Item	Condition	Physical Damage	Corrosion	Photo #	Observations and Remarks
Steel Bulkhead / Caps	N/A				
Steel Grating	N/A				
Stop Logs	N/A				
Hardware	N/A				
Timber Piles	N/A				
Timber Wales	N/A				
Galv. Pile Caps	N/A				
Cables	N/A				
Signage / Supports	N/A				
Rip Rap (fill)	Good			2	Looks good
Earthen Embankment	N/A				
What are the conditions of the existing levees?					
Are there any noticeable breaches?					
Settlement of rock plugs and rock weirs?					
Position of stoplogs at the time of the inspection?					
Are there any signs of vandalism?

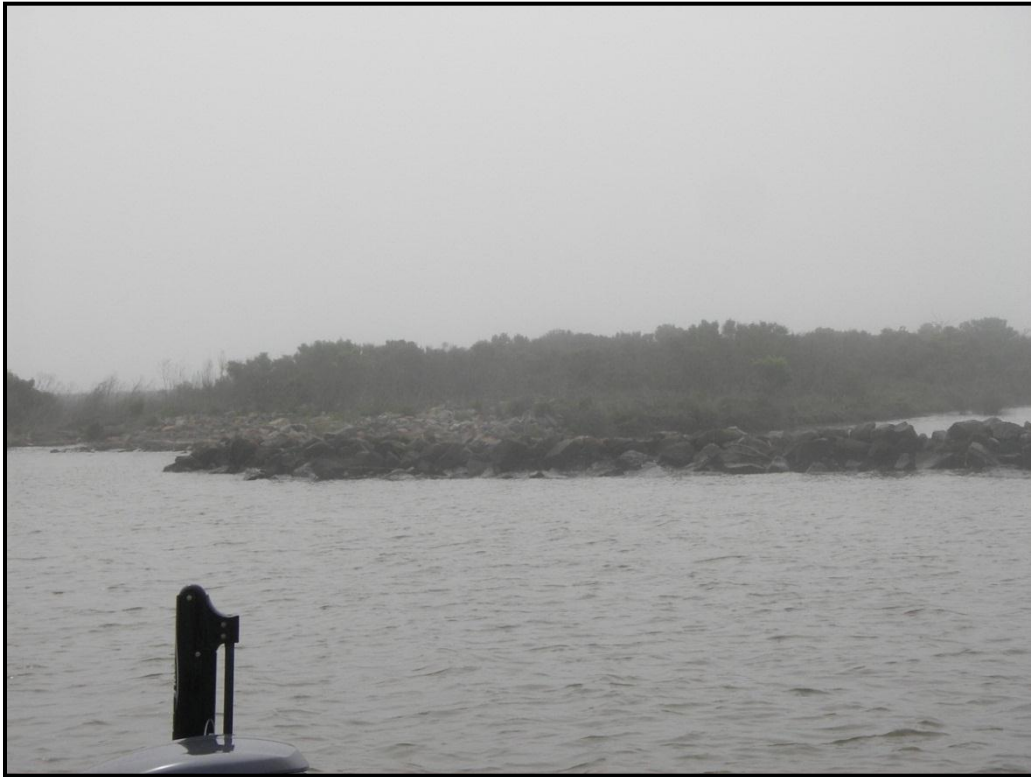
Photo No. 3, Closure No. 3

The rock closure dike appears in good condition and was extended on the western end along with installing bank paving during the recent maintenance event. Also, it was observed (and confirmed with aerial photography post Hurricane RITA) that a large open water area has developed within the marsh near the western terminus of Closure No. 3 and that the bankline between that point and the eastern end of Closure No. 2 has eroded very severely and such that the "landbridge" between Vermilion Bay on the north of Marsh Island and the northwestern portion of Lake Sand proper is now narrow and may become subject to breaching thus allowing an undesirable water connection between the two bodies of water. CPRA and COE agree that this area is in poor condition and should be considered for maintenance at some point in time. It is recommended that an additional reach of shoreline protection dike be constructed, an estimated 1,500 to 1,800 linear feet, to connect the western end of Closure No. 3 to the eastern end of Closure No. 2. This reach of bank has been recently surveyed and the estimated cost for rock dike and flotation is approximately \$800,000. CPRA and COE agreed that due to this area being of concern but not yet critical status; and budget constraints, this maintenance work would be undertaken at a later time. (Photos: Appendix B, Photo 3).

Item	Condition	Physical Damage	Corrosion	Photo #	Observations and Remarks
Steel Bulkhead / Caps	N/A				
Steel Grating	N/A				
Stop Logs	N/A				
Hardware	N/A				
Timber Piles	N/A				
Timber Wales	N/A				
Galv. Pile Caps	N/A				
Cables	N/A				
Signage / Supports	N/A				
Rip Rap (fill)	Good			3	Looks good
Earthen Embankment	N/A				
What are the conditions of the existing levees?					
Are there any noticeable breaches?					
Settlement of rock plugs and rock weirs?					
Position of stoplogs at the time of the inspection?					
Are there any signs of vandalism?

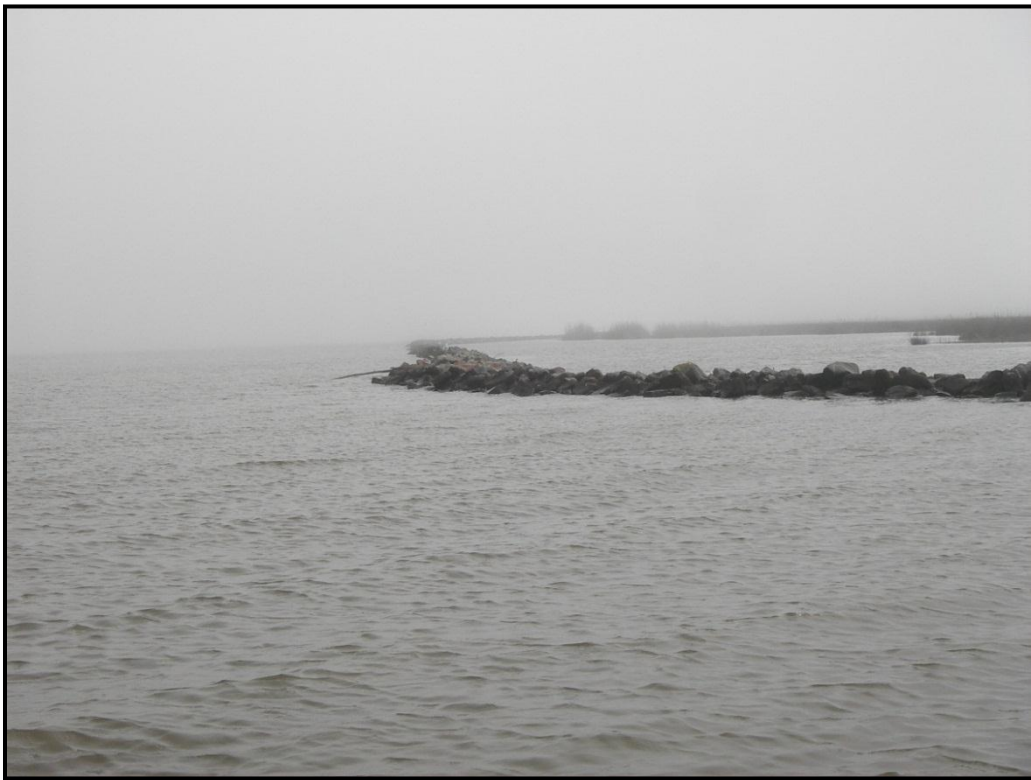
Photo No. 4, Closure No. 4

The Lake Sand Dike closure as originally constructed and recently repaired for Hurricane Rita damages, appears in good condition. The dike was capped in those areas where it was below elevation +3.0 as well as extended on the eastern end with bank paving. Dike has maintained elevation in capped areas. There is some settlement on the eastern end of the dike. (Photos: Appendix B, Photos 4).

Item	Condition	Physical Damage	Corrosion	Photo #	Observations and Remarks
Steel Bulkhead / Caps	N/A				
Steel Grating	N/A				
Stop Logs	N/A				
Hardware	N/A				
Timber Piles	N/A				
Timber Wales	N/A				
Galv. Pile Caps	N/A				
Cables	N/A				
Signage / Supports	N/A				
Rock Dike	Good			4	Lake Sand looks good. The rock cap is holding up well. Some Settlement on East end.
Earthen Embankment	N/A				
What are the conditions of the existing levees?					
Are there any noticeable breaches?					
Settlement of rock plugs and rock weirs?					
Position of stoplogs at the time of the inspection?					
Are there any signs of vandalism?

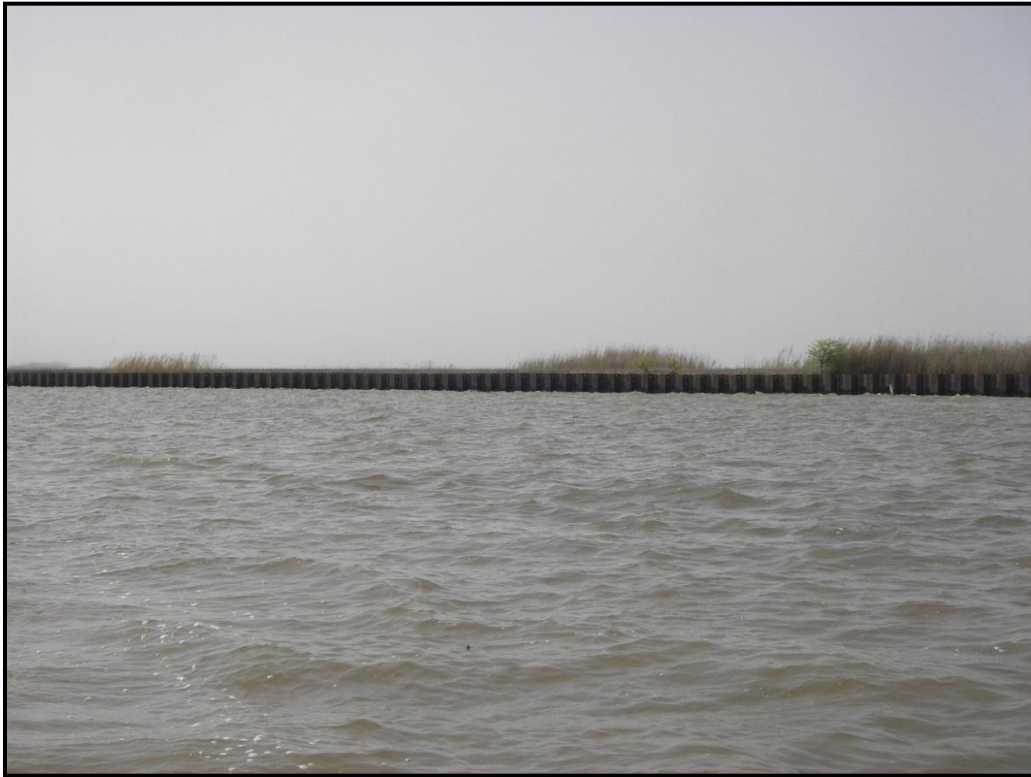
Photo No. 5, Closure No. 5

The steel sheet pile, rock riprap wingwalls, and stone bank/marsh paving placed as part of the Hurricane LILJ repair project is in good condition and were apparently very effective in preventing additional damage by the erosive action of Hurricane RITA. The staff gage was re-set as part of the recent maintenance event. The overbank marsh areas paved to make same “hard” and paid for with O & M funding needs to be continually evaluated for its effectiveness. There is a breach on the southern side of the bank paving where water is passing through. (Photos: Appendix B, Photo 5).

Item	Condition	Physical Damage	Corrosion	Photo #	Observations and Remarks
Steel Bulkhead / Caps	Good			5	
Steel Grating	N/A				
Stop Logs	N/A				
Hardware	N/A				
Timber Piles	N/A				
Timber Wales	N/A				
Galv. Pile Caps	N/A				
Cables	N/A				
Signage / Supports	N/A				
Rip Rap (fill)	Good			5	Looks good. No change since previous inspection. Bank paving is holding up well. There is a small breach on the Northern side.
Earthen Embankment	N/A				
What are the conditions of the existing levees?					
Are there any noticeable breaches?					
Settlement of rock plugs and rock weirs?					
Position of stoplogs at the time of the inspection?					
Are there any signs of vandalism?

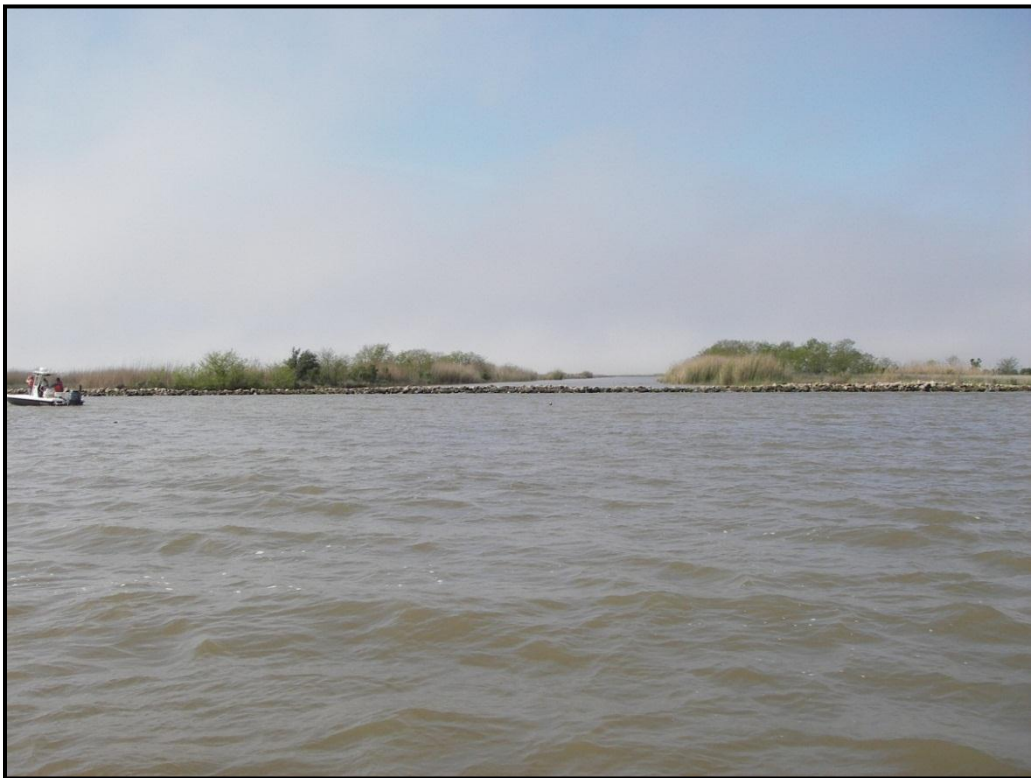
Photo No. 6, Closure No. 6

The breach on the southern end of the dike that had occurred prior to Hurricane Rita and subsequently worsened as a result of the tidal surge has been repaired as part of the recent maintenance event. The dike was extended on the northern end and bank paving was installed on both ends of the closure. This site is in good condition since the repairs have been made. There is good sediment deposition on the southern end of the dike. (Photos: Appendix B, Photo 6).

Item	Condition	Physical Damage	Corrosion	Photo #	Observations and Remarks
Steel Bulkhead / Caps	N/A				
Steel Grating	N/A				
Stop Logs	N/A				
Hardware	N/A				
Timber Piles	N/A				
Timber Wales	N/A				
Galv. Pile Caps	N/A				
Cables	N/A				
Signage / Supports	N/A				
Rock Dike	Good			6	Looks good. Sediment depositing on Northern end.
Earthen Embankment	N/A				
What are the conditions of the existing levees?					
Are there any noticeable breaches?					
Settlement of rock plugs and rock weirs?					
Position of stoplogs at the time of the inspection?					
Are there any signs of vandalism?

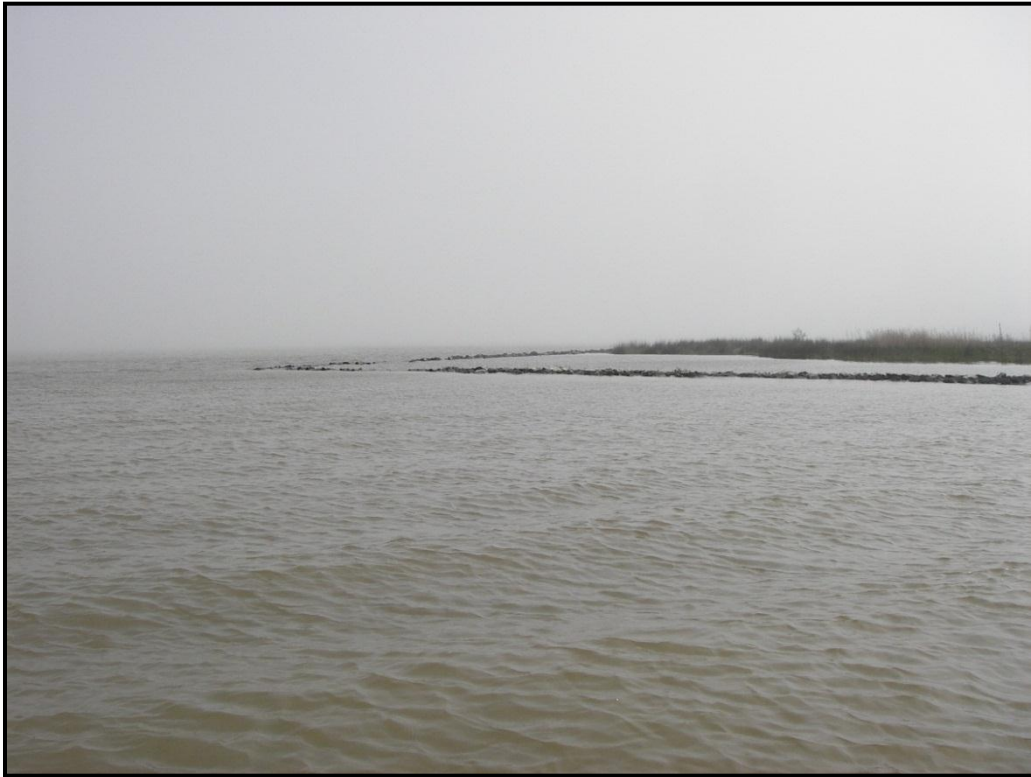
Photo No. 7, Structure No. 7

This closure site is in good condition and spoil material from the dredging of the north-south canal in 2008 was placed along the eastern end of the rock dike in an effort to stabilize this section of shore. In addition dredge spoil material was pumped behind the rock dike as part of this same access dredging and a small area of marsh creation was formed which is now starting to vegetate. There is some settlement along two (2) 150 foot lengths of the rock dike. (Photos: Appendix B, Photos 7).

Item	Condition	Physical Damage	Corrosion	Photo #	Observations and Remarks
Steel Bulkhead / Caps	N/A				
Steel Grating	N/A				
Stop Logs	N/A				
Hardware	N/A				
Timber Piles	N/A				
Timber Wales	N/A				
Galv. Pile Caps	N/A				
Cables	N/A				
Signage / Supports	N/A				
Rock Dike	Good			7	Looks good. Grass establishing nicely in the two (2) marsh creation cells just east of the plug. Some settlement in two (2) 150 foot sections.
Earthen Embankment	N/A				
What are the conditions of the existing levees?					
Are there any noticeable breaches?					
Settlement of rock plugs and rock weirs?					
Position of stoplogs at the time of the inspection?					
Are there any signs of vandalism?

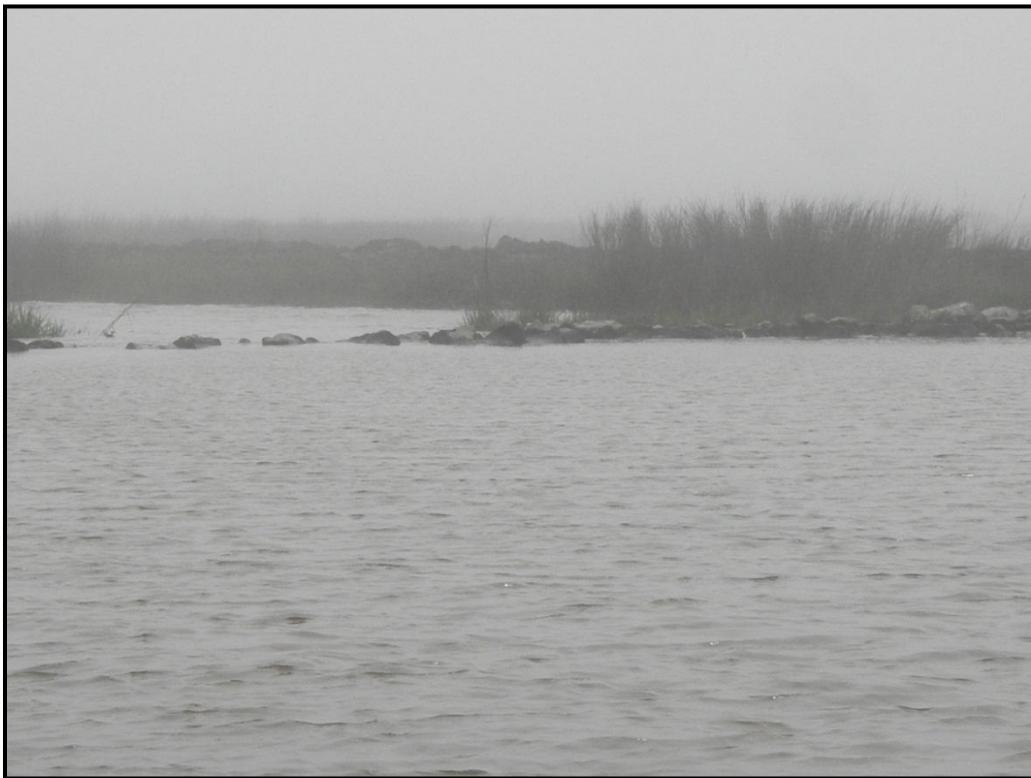
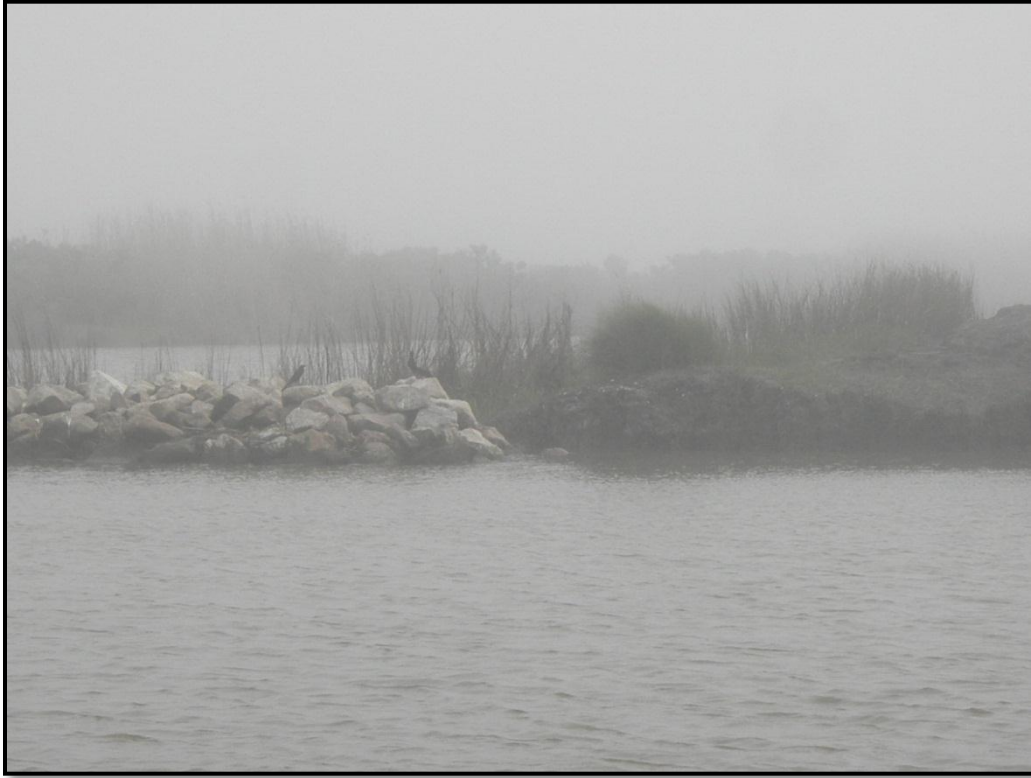
This closure site is in good condition since the existing breach on the south side of the closure was repaired in the 2008 maintenance event noted above in Section IV. Spoil material was placed to close off the breach and also placed on top of the existing rock dike. Spoil material was also placed from the north end of the rock dike towards the bay to make a connection to the existing mitigation rock dike along the bayshore. The rock is starting to settle. (Photos: Appendix B, Photos 8-9).

Item	Condition	Physical Damage	Corrosion	Photo #	Observations and Remarks
Steel Bulkhead / Caps	N/A				
Steel Grating	N/A				
Stop Logs	N/A				
Hardware	N/A				
Timber Piles	N/A				
Timber Wales	N/A				
Galv. Pile Caps	N/A				
Cables	N/A				
Signage / Supports	N/A				
Rock Plug	Good			8,9	Looks good. Grass establishing nicely in the two (2) marsh creation cells just east of the plug. Rock is settling at mouth of canal.
Earthen Embankment	N/A				
What are the conditions of the existing levees?					
Are there any noticeable breaches?					
Settlement of rock plugs and rock weirs?					
Position of stoplogs at the time of the inspection?					
Are there any signs of vandalism?

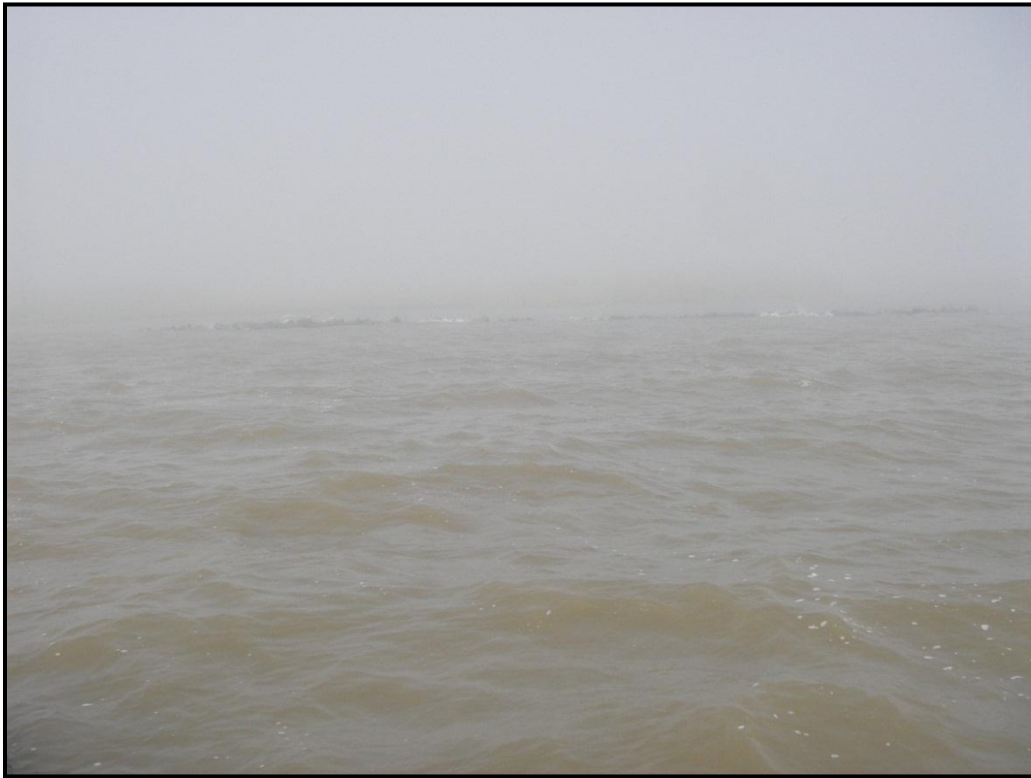
Photo No. 10, Structure No. 9 rock dike

The rock riprap shoreline protection dike constructed on the south shoreline of Marsh Island was noted to now sit out further into the waters of the Gulf as discussed in the last inspection. Conditions were such that the feature was functioning well and that sediment had accreted and a growth of marsh vegetation had extended over the new fill. This rock shoreline feature will still function as a breakwater and extend the life of the earthen pipeline closure to the north. The recent construction of the TV-21 East Marsh Island Marsh Creation project has helped to reinforce the breach that had occurred on the southeast corner of the pipeline canal since the last inspection. The pipeline canal north of the rock breakwater was filled in with sediment from the marsh creation project and construction of containment dikes have now closed off the breach at the shoreline. No maintenance will be necessary at closure No. 9 as a result of the work performed through the TV-21 project. (Photos: Appendix B, Photos 10).

Item	Condition	Physical Damage	Corrosion	Photo #	Observations and Remarks
Steel Bulkhead / Caps	N/A				
Steel Grating	N/A				
Stop Logs	N/A				
Hardware	N/A				
Timber Piles	N/A				
Timber Wales	N/A				
Galv. Pile Caps	N/A				
Cables	N/A				
Signage / Supports	N/A				
Rock Dike	Fair			10	Dike is settling in some areas. Breach is closed and shoreline looks good since the TV-21 project.
Earthen Embankment	N/A				
What are the conditions of the existing levees?					
Are there any noticeable breaches?					
Settlement of rock plugs and rock weirs?					
Position of stoplogs at the time of the inspection?					
Are there any signs of vandalism?
