**Coastal Protection and Restoration
Authority of Louisiana**

2012 Operations, Maintenance, and Monitoring Report

Black Bayou Hydrologic Restoration

State Project Number CS-27
Priority Project List 6

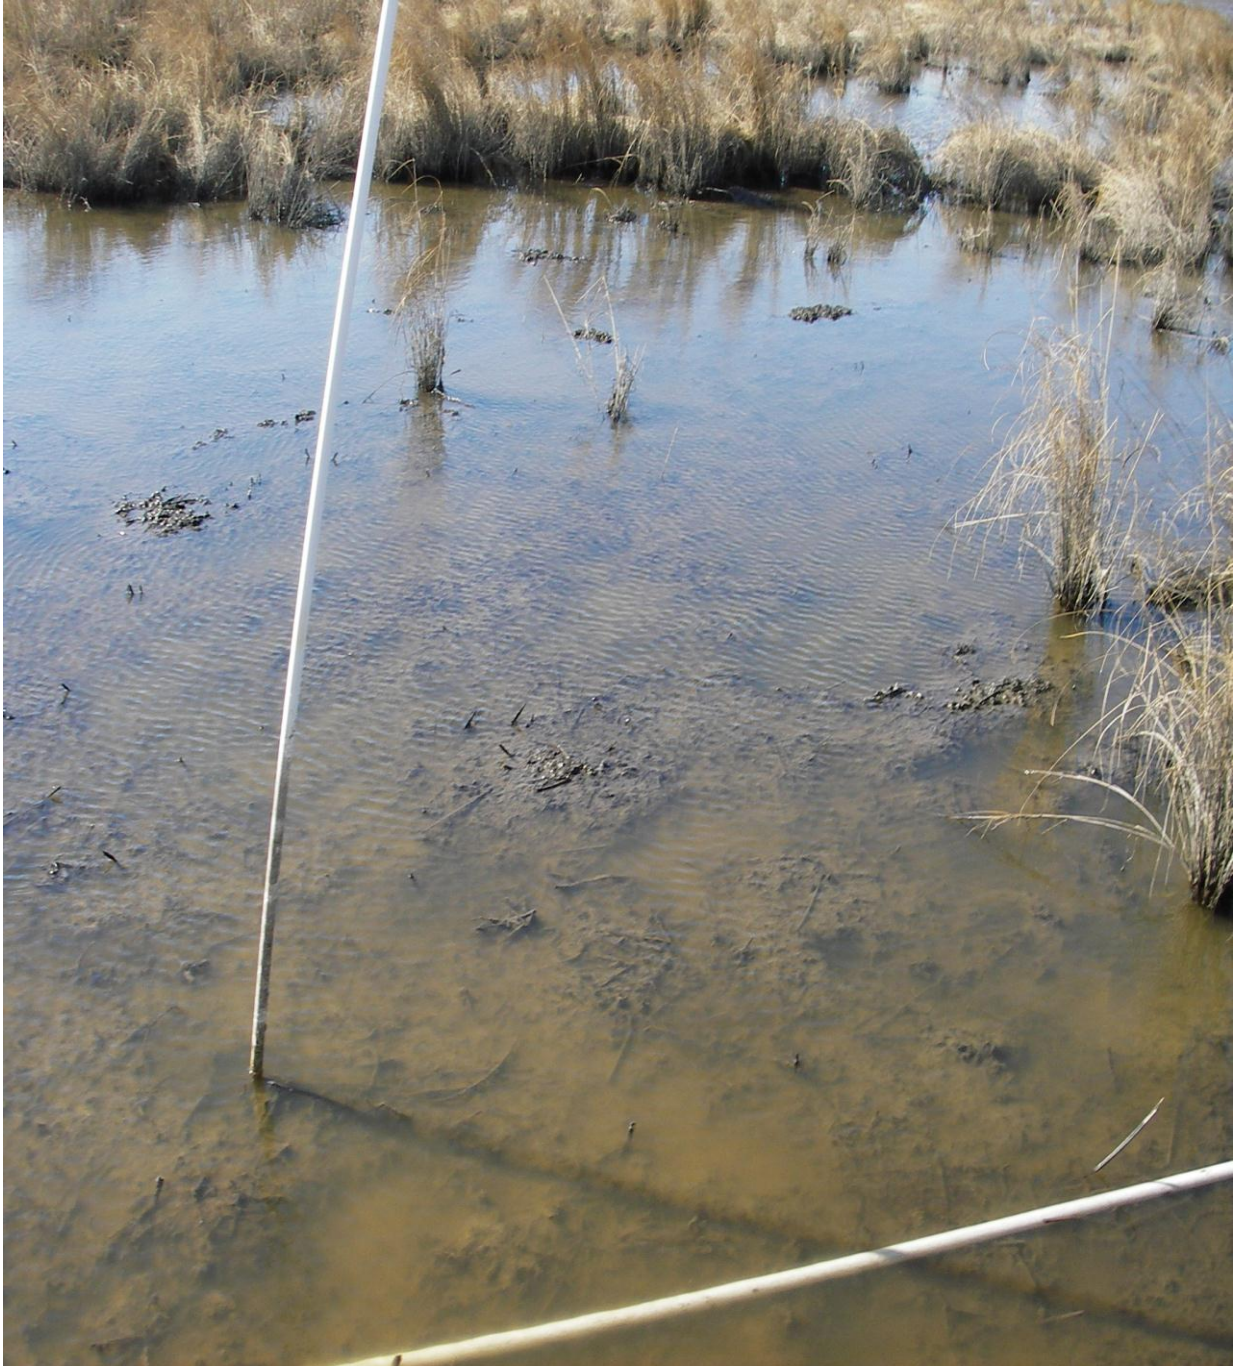
Figure 5. Area of marsh scour converted to open water in the region near CS-27.

The foreshore dike has effectively reduced shoreline erosion along the GIWW. The widening of the shoreline along the northern boundary of the impoundment should provide protection to the emergent wetland vegetation within this portion of the project. However, at least one breach still exists which allows for hydrologic exchange and causes localized scouring.

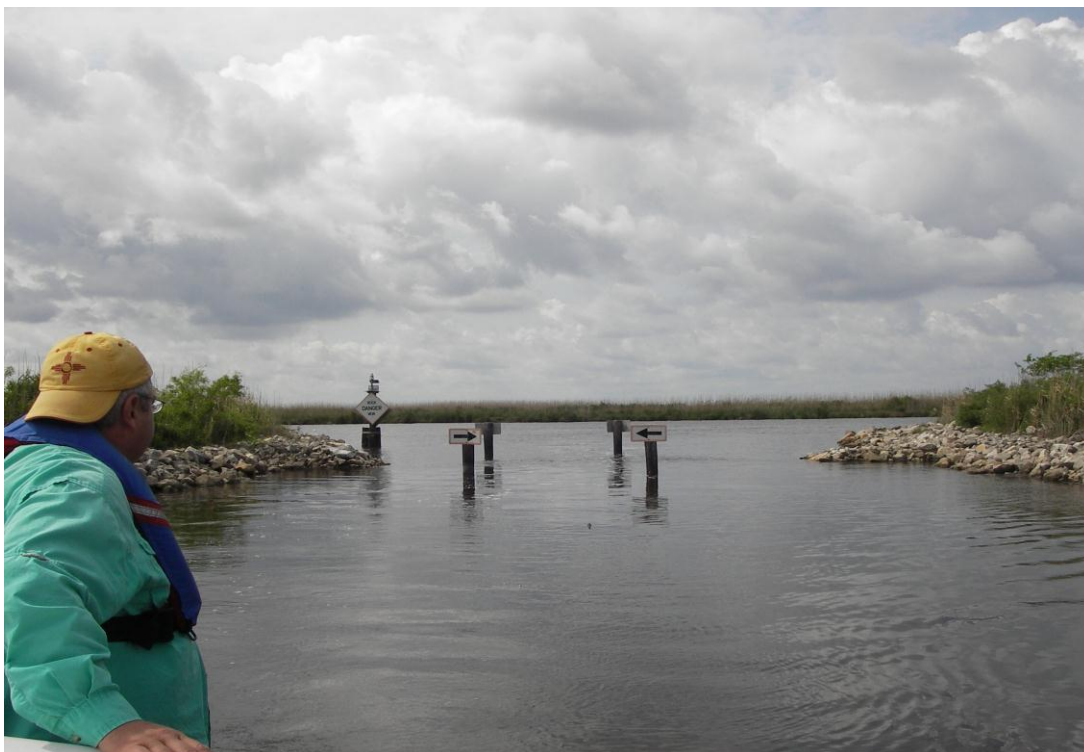
Photo 1—Navigational Aids and Signage at Block’s Creek

The rock weir is in excellent condition. Signage is stable. The erosion on the SE will continue to be monitored, but has stabilized. No need for maintenance at this structure. Conditions of the Navigational Aid Lights were last inspected on 03/13/12 (Appendix A, Photo 1)

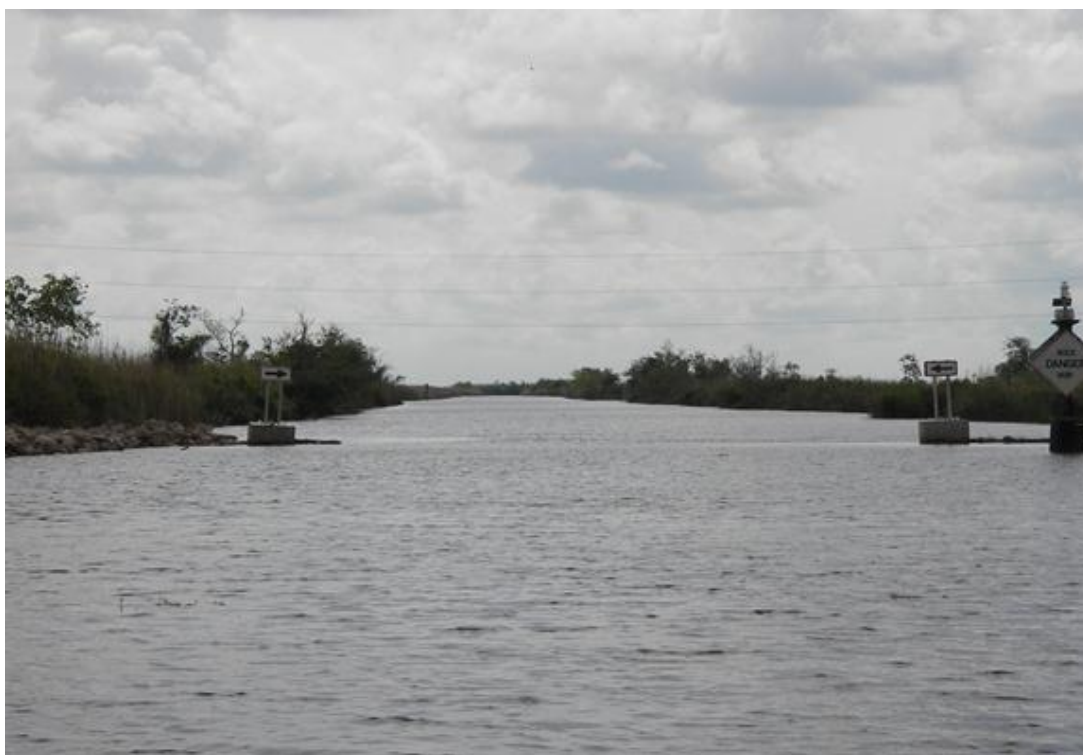
Photo 2—Burton Canal Structure

The weir is in good condition. The scouring along the canal banks inside of the weir at the end of the dike has stabilized. Arrow signs installed as part of the last maintenance event are working well. No need for any maintenance at this time. The Navigational Aid Lights were last inspected on 03/13/12. (Appendix A, Photo 2)

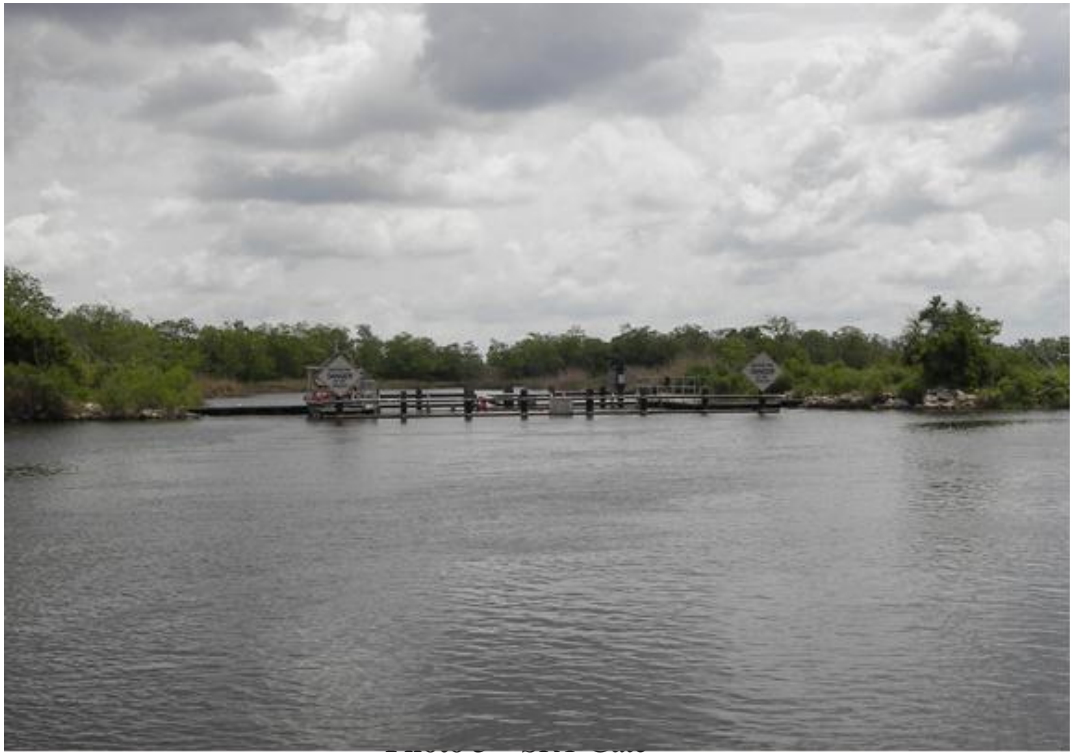
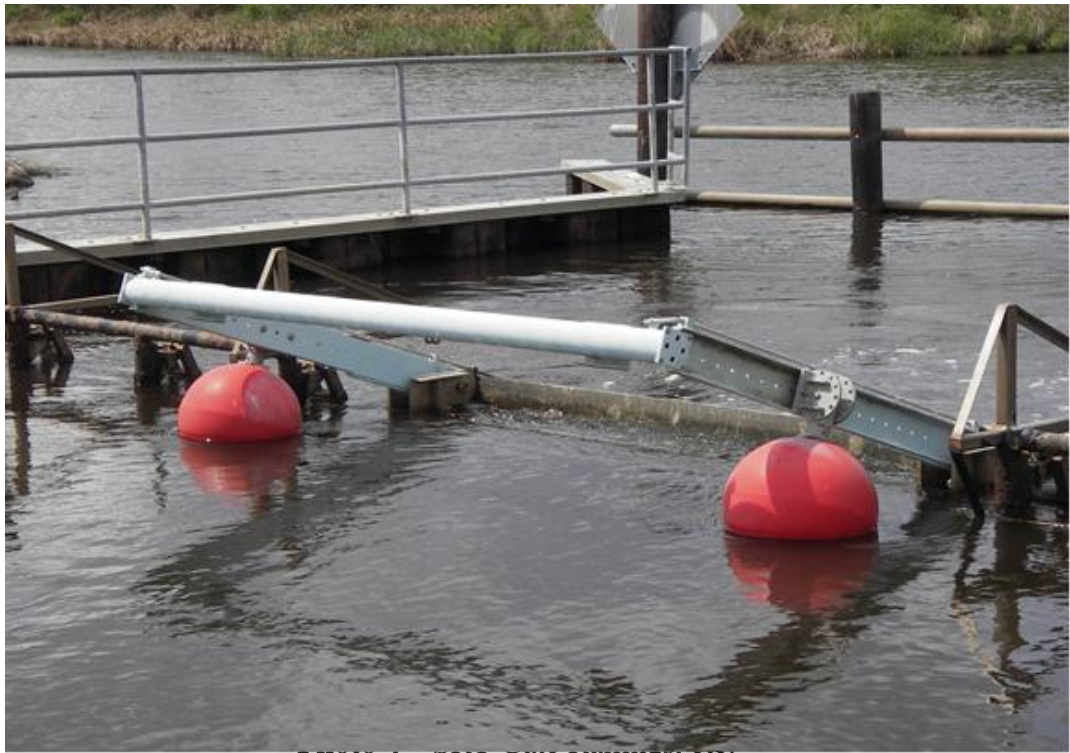
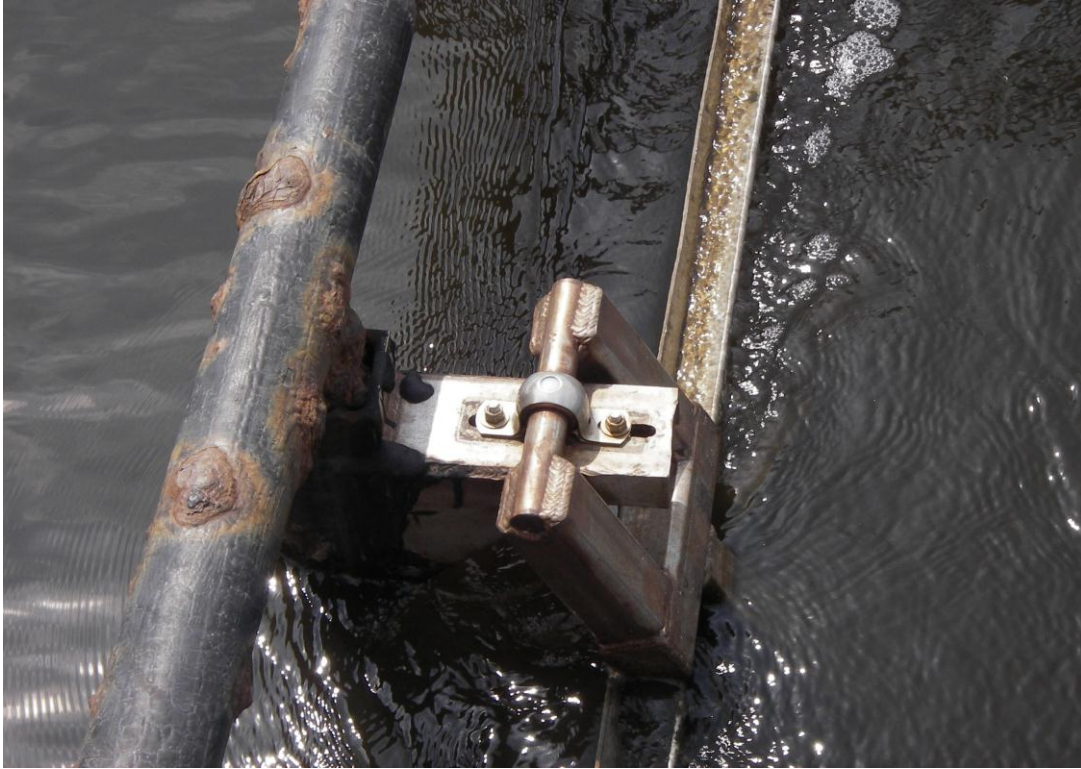
Photo 5—Pillow Block on SRT Gate Flap & Railing Rust

The structure itself is in very good condition. The pillow blocks replaced during the last maintenance event, signage, railings, wingwalls, etc. are in excellent condition. The railing along the top of the gate is showing fairly significant rust. The seams at the sheet piles are rusting also, however there is no need for maintenance at this time. (Appendix A, Photos 3-5)

Item	Condition	Physical Damage	Corrosion	Photo #	Observations and Remarks
Steel Bulkhead / Caps	Good			3 & 4	Rusting at sheet pile seams. Will continue to monitor.
Steel Grating					
Stop Logs					
Hardware					
Timber Piles	Good			3	
Timber Wales					
Galv. Pile Caps	Good			3	
SRT Gate	Good		Moderate	3-5	Pillow blocks were replaced during last inspection. Gate is in good condition. The railing above the gate is showing signs of corrosion. No maintenance required at this time.
Signage /Supports Vinton Canal	Good			3	Good condition.
Rip Rap (fill)					
Rock Plug	Good			6	Repaired with concrete sacks.

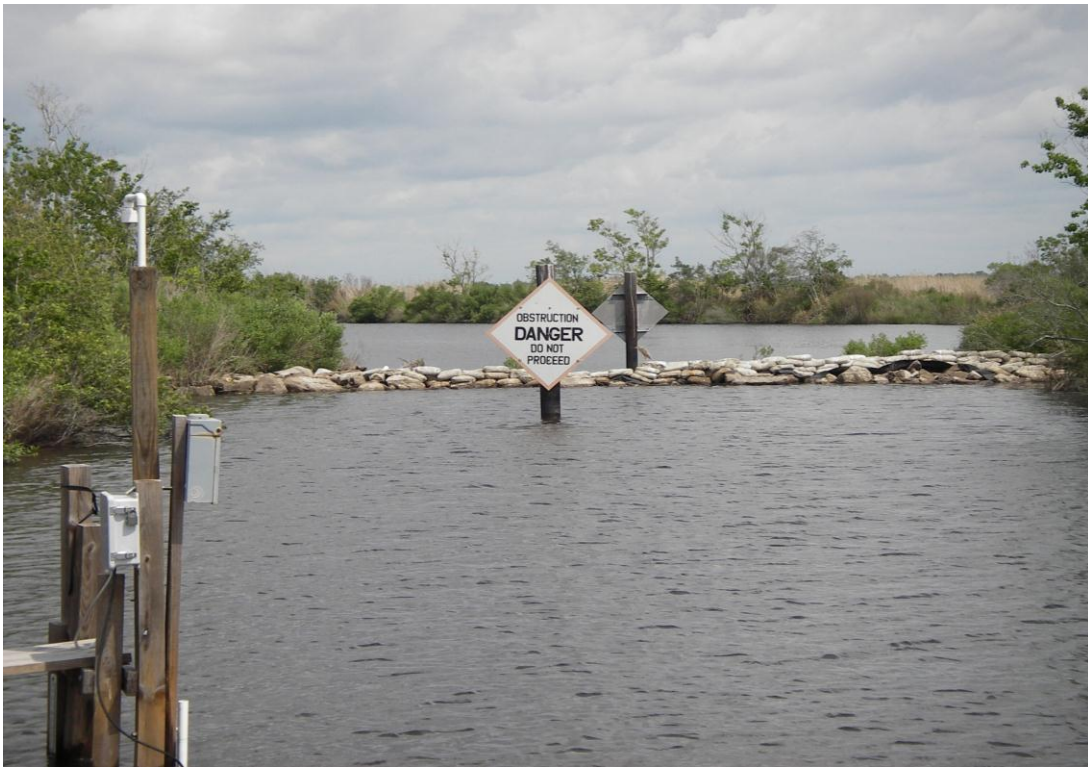
Photo 6—Plug Near SRT Gate

The rock dike, as repaired with the concrete sacks is functioning as designed. Tie-ins are stable. No maintenance required. (Photos: Appendix A, Photo 6)

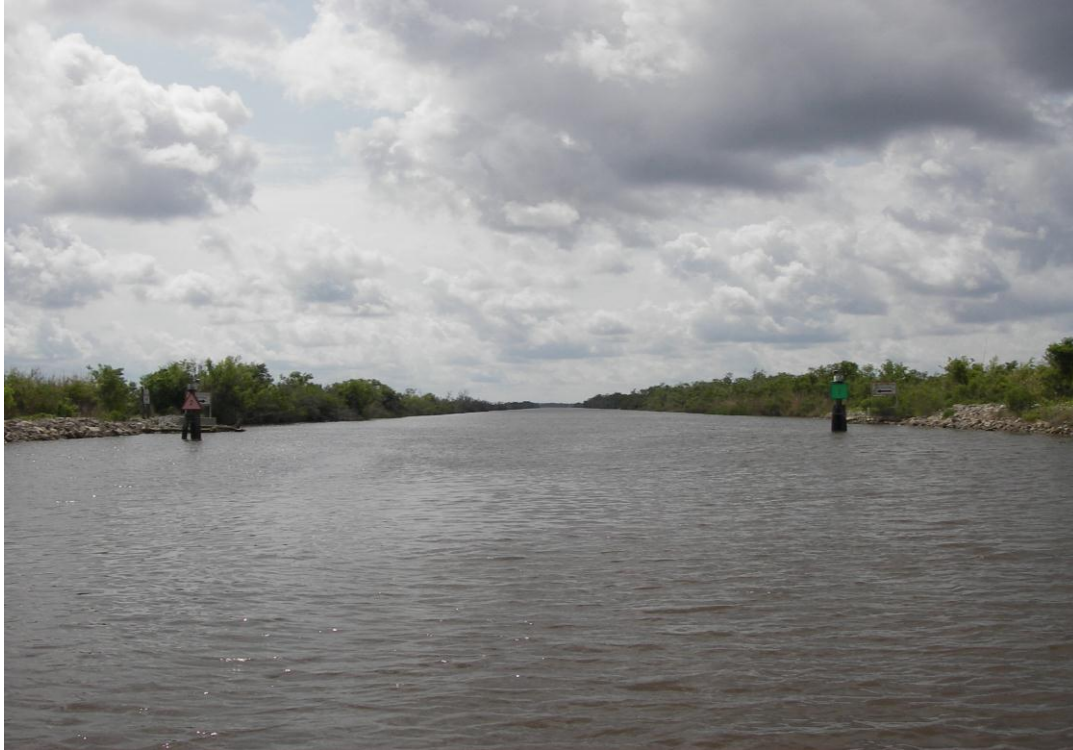
Photo 7—Black Bayou Cut-off Canal structure

This component is in immediate post construction condition. No need for maintenance at this time. Conditions of the Navigational Aid Lights are inspected quarterly and were last inspected on 3/13/12. (Appendix A, Photo 7)

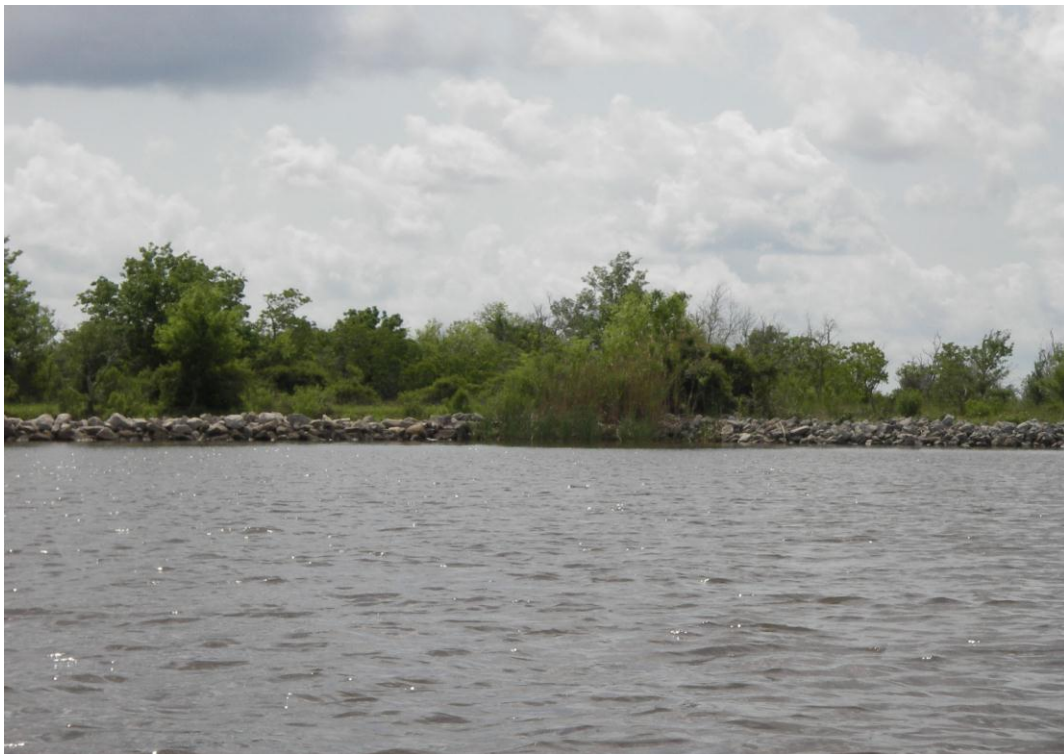
Photo 8—Typical Section of Rock Dike

Tie-ins on both the east and west end of the dike are stable. As mentioned in previous inspections, the warning signs at both the Vinton and Black Bayou closures have been stolen. The spoil placed behind the rock dike at the Black Bayou Canal has washed away on the western end. There is also a gap in the dike in front of this area. Rock is still at the base, but exchange is taking place. Landowner repairs to the four C-stone closures have been completed. Small gaps were left at two of these repairs to allow high tidal events to pass around the plugs without continuing to wash away the banks. There are a few low spots on the rest of the main dike, apparently caused by barges but these areas are still functioning and not in need of repair. The repair to the dike across from the Vinton Canal with concrete sacks is working extremely well. (Photos: Appendix A, Photos 8-12)

Replace stolen warning signs at both the Vinton and Black Bayou closures.

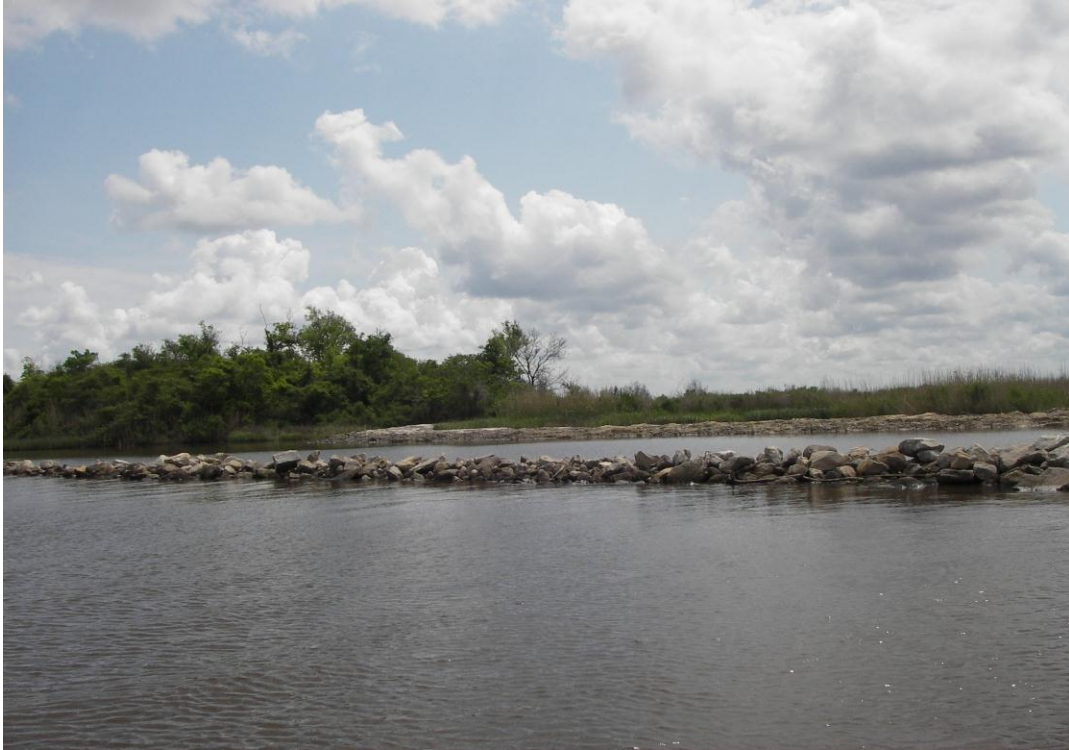
Photo 11—Interior Levee as Repaired by Landowner

In early 2012, the landowners in the area, under their own construction contract, repaired breaches which occurred around two of the four plugs behind the rock dike.

The constructed components of the project are in very good condition. Erosion at previously noted weir locations has stabilized. Repairs made during the last maintenance event are in good post construction condition. The breaches which occurred around two of the four plugs behind the GIWW rock dike have been addressed by landowners at no cost to the project. Observations made during this year's annual inspection such as rusting on the SRT Gate railing and noted sections of displaced rock on the GIWW rock dike do not require maintenance at this time and will continue to be monitored.
