**State of Louisiana
Coastal Protection and Restoration
Authority**

**2013 Operations, Maintenance,
and Monitoring Report**

**BARATARIA BASIN LANDBRIDGE
SHORELINE PROTECTION
PROJECT (PHASES 1&2, 3, and 4)**

July 2, 2013
Lafourche & Jefferson Parishes

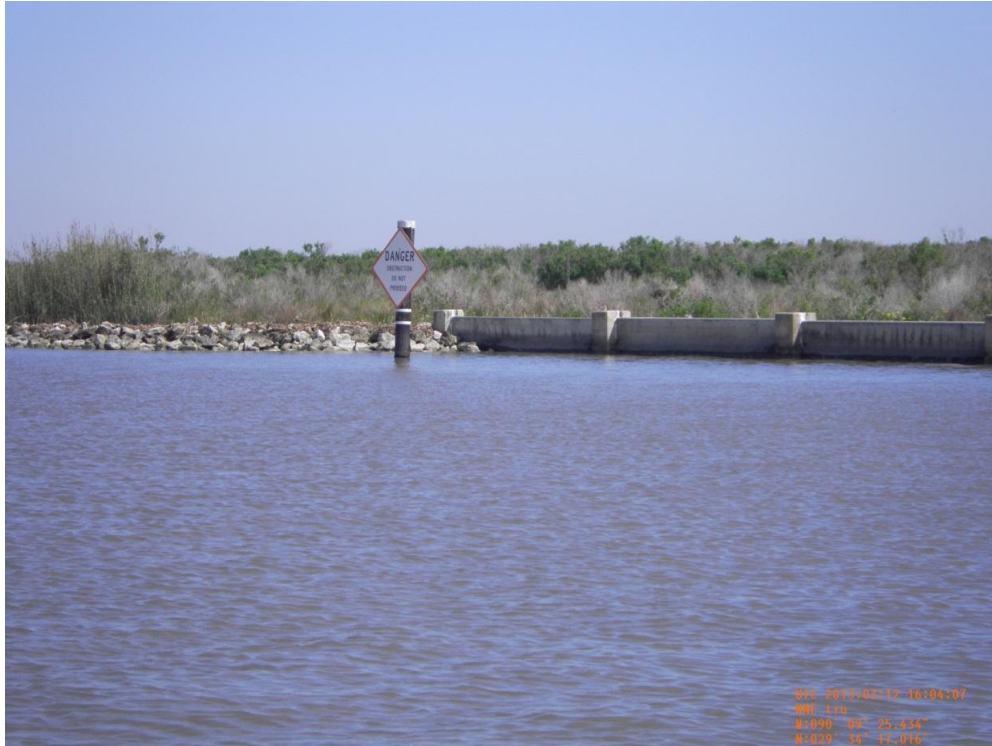
Reach 1. All of the transitions from rock riprap to concrete wall were in good condition. The rock riprap embankment tie-ins were also in good condition. A warning sign and its support marking the concrete pile on the west side of the oilfield canal in Reach 3 were missing. It is recommended this sign and its support should be replaced. Also, a timber piling was resting on the concrete wall on the east bank of Harvey Cutoff in Reach 1. This timber piling did not appear to be damaging the concrete wall, but it is recommended that it should be removed. There are no other recommendations for maintenance at this time. (Appendix B, Photos #1 & #15-32)

Photo 1: View of transition from CU#4 concrete wall to CU#2 rock dike

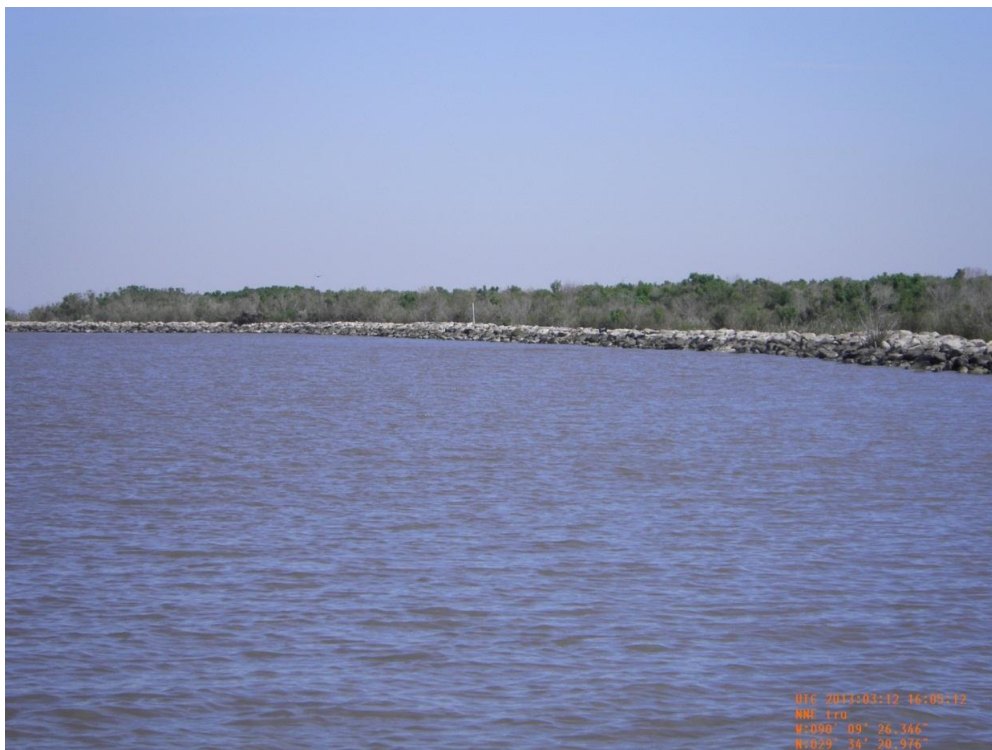
CU 2 appeared to be in good overall condition. The inspection of CU 2 began at the west end near Sta. 0+42 and proceeded to the east end of the reach near Sta. 36+83. As previously reported, a low area of the rock dike approximately 200 feet wide exists from Sta. 31+50 to Sta. 29+50. In comparison to the photos taken last year, there appeared to be no further settlement of the rock dike in this section. Directly behind this low area is a containment dike and newly created marsh constructed under the Dedicated Dredging on the Barataria Basin Landbridge (BA-36) project. Satellite images of this containment dike shows this area is not degrading or eroding due to the low area of the rock dike. Also previously reported was a slight dip in the rock dike above the Exxon/Humble pipeline right-of-way located near Sta. 12+33. Again, comparison with images taken in previous years shows no indication of further settlement of the rock dike or deterioration of the containment dike directly behind it. Due to the lack of marsh degradation and high construction cost associated with repairing small sections of dike, we are not recommending any corrective actions at this time, but these areas will continue to be monitored should their conditions change. (Appendix B, Photos #1-7)

Photo 2: View of CU#2 rock dike along the southern end of Bayou Perot looking east

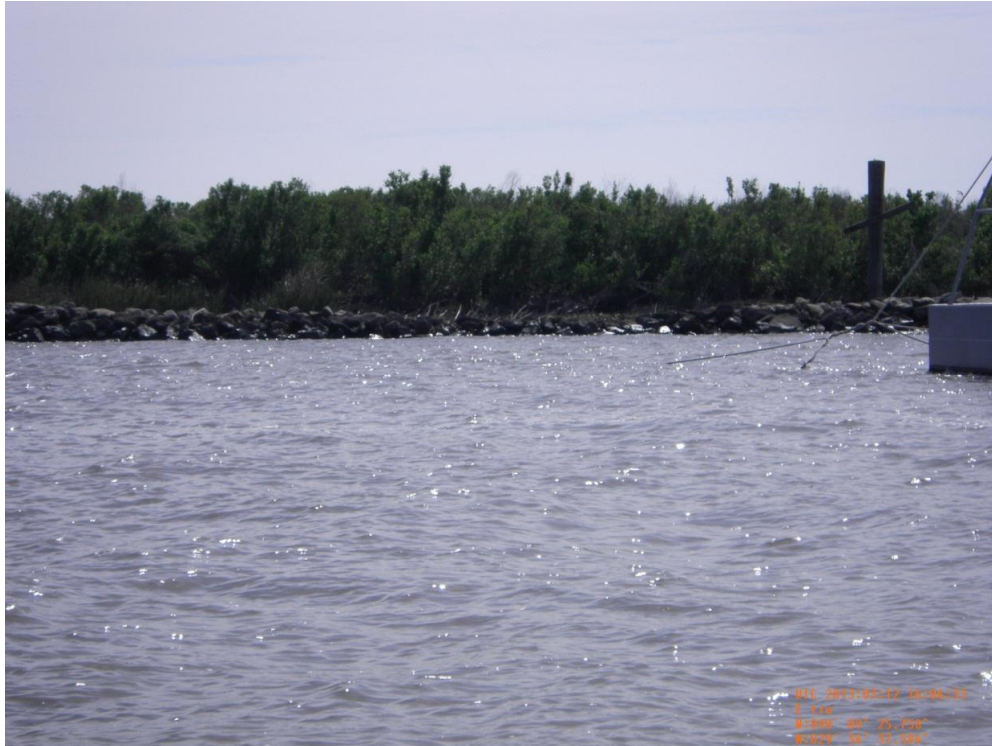
Photo 3: View of a low section of the CU#2 rock dike along the southern end of Bayou Perot

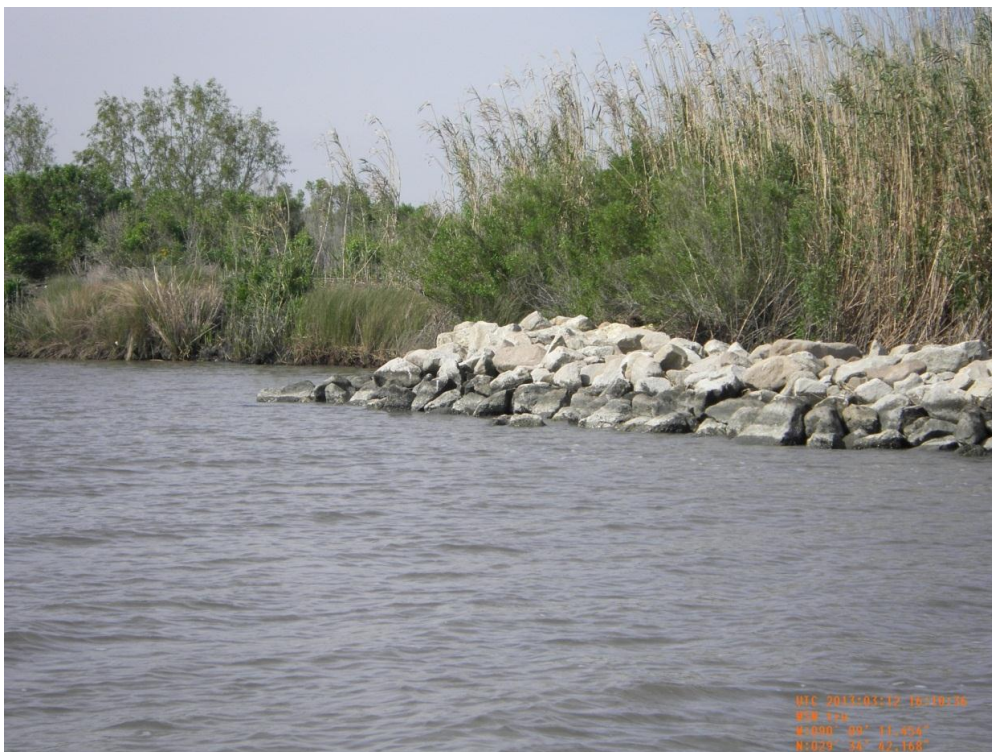
Photo 4: View of CU#2 embankment tie-in on west side of oilfield canal

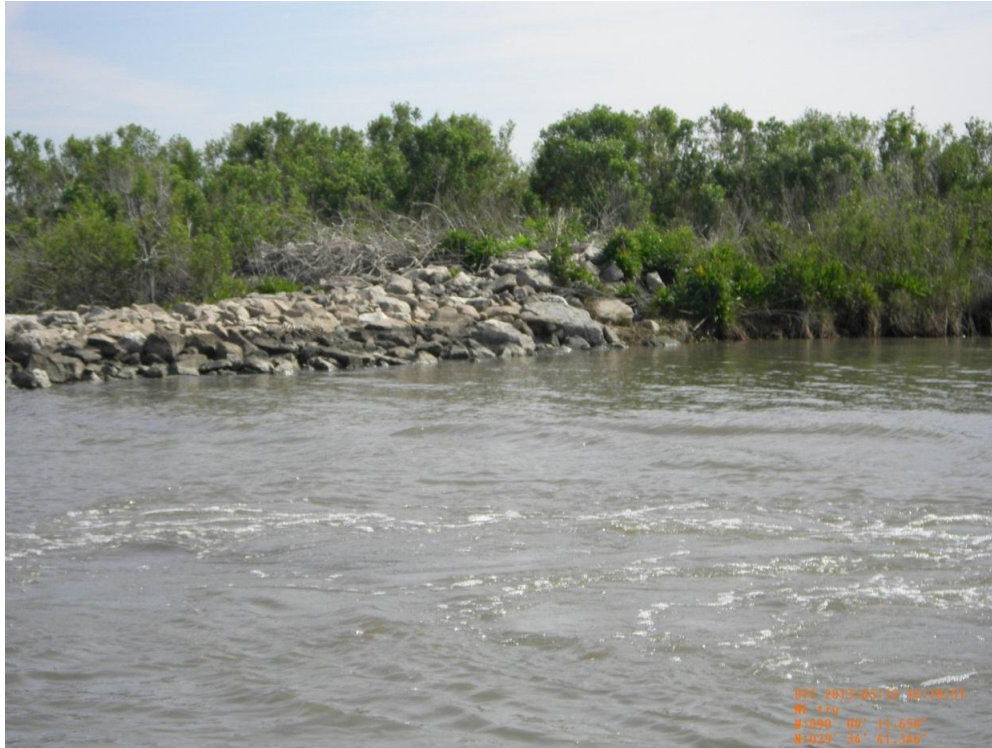
Photo 5: View of CU#2 embankment tie-in on east side of oilfield canal

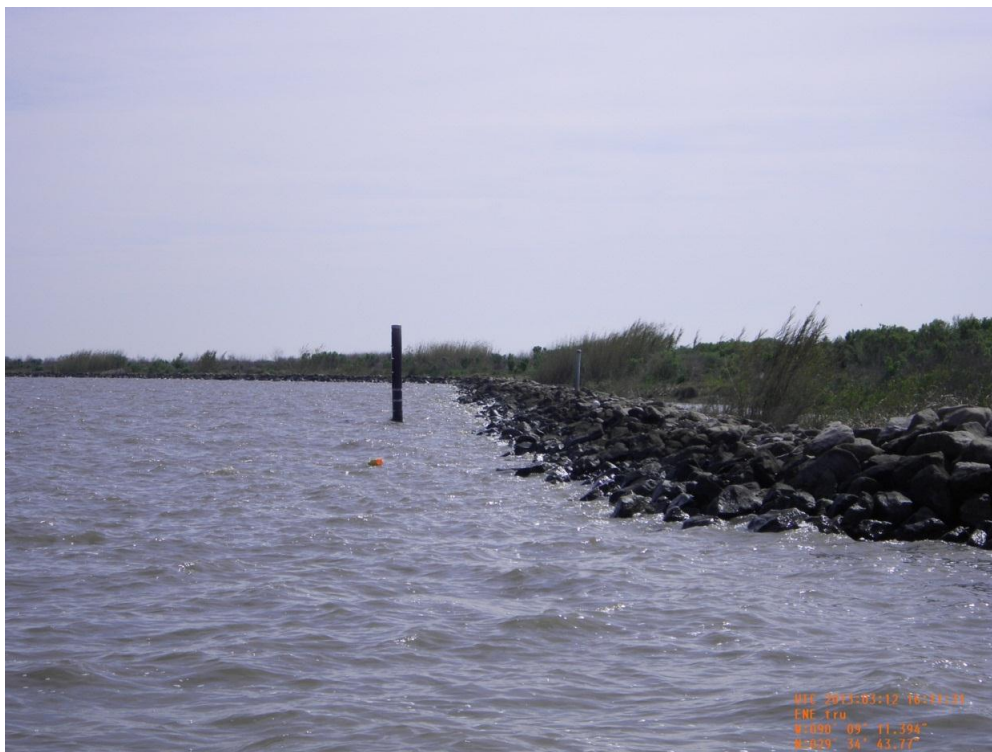
Photo 6: View of CU#2 rock dike along the southern end of Bayou Rigolettes looking northeast

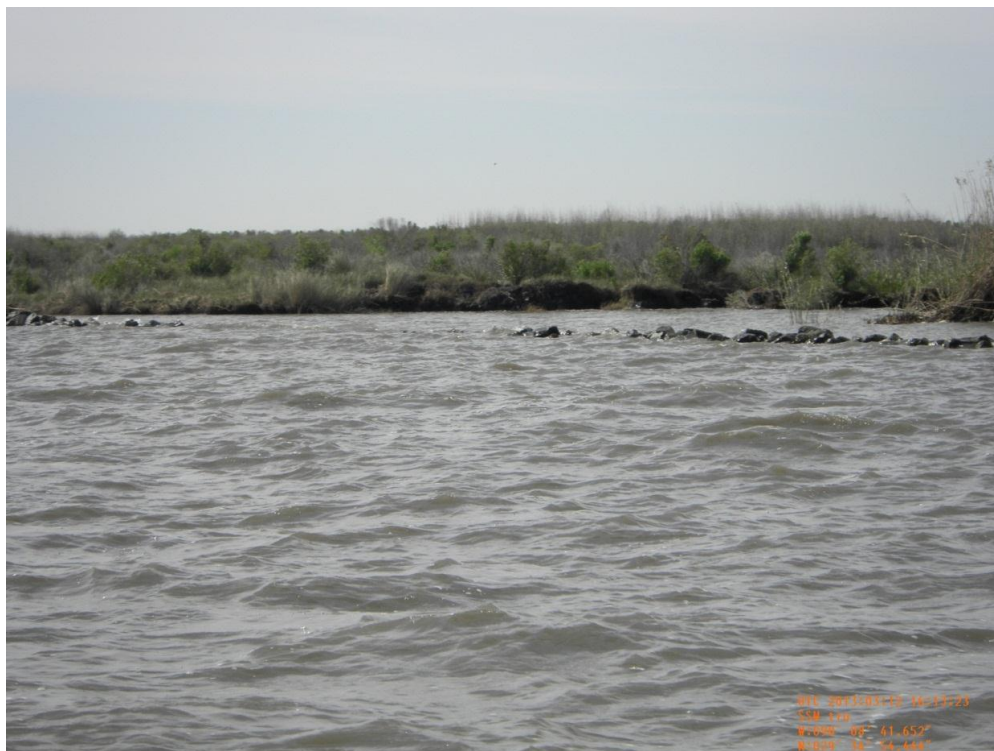
Photo 7: View of a low section along the CU#2 rock dike near the Harvey Cutoff canal

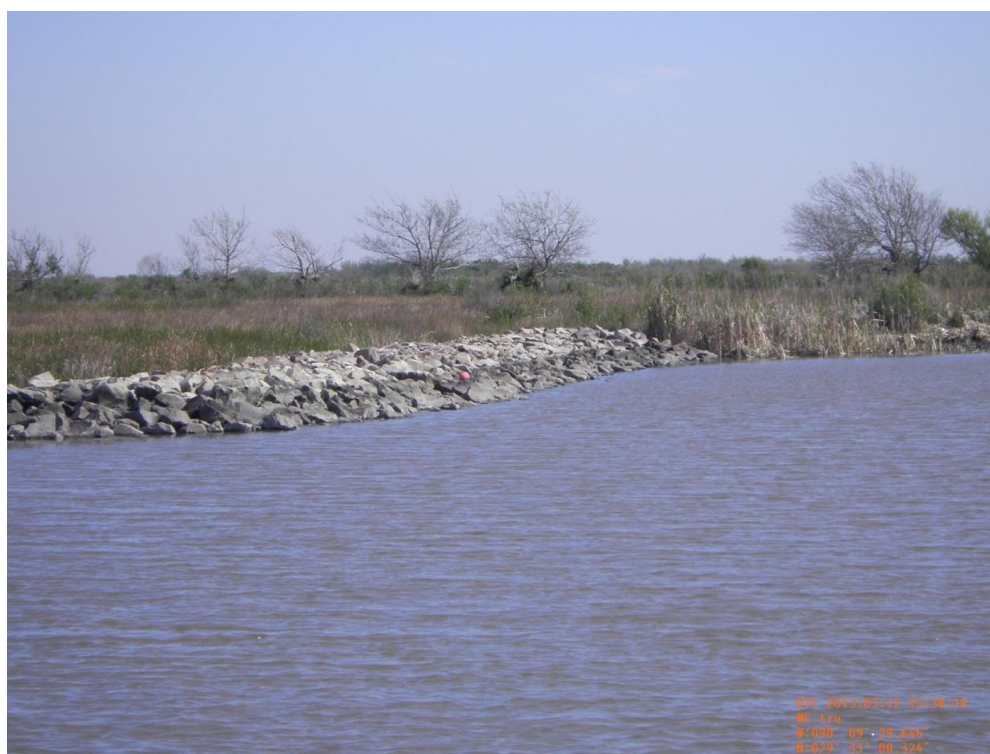
CU 3 was in good overall condition. The inspection of CU 3 began on the east bank of Little Lake at Sta. 108+65 and progressed along the northeast bank of Little Lake to the mouth of Bayou Perot at Sta. 0+00. A visual inspection of this unit revealed the rock dike in good overall condition with minor settlement near the BP pipeline crossing at Sta. 67+00. Despite the settlement, the structure appeared to provide adequate shoreline protection and does not require maintenance at this time. The embankment tie-ins were in overall good condition with no visible erosion or wash-outs on both ends. (Appendix B, Photos #8-14)

Photo 8: View of the southern embankment tie-in of CU#3 along the eastern edge of Little Lake

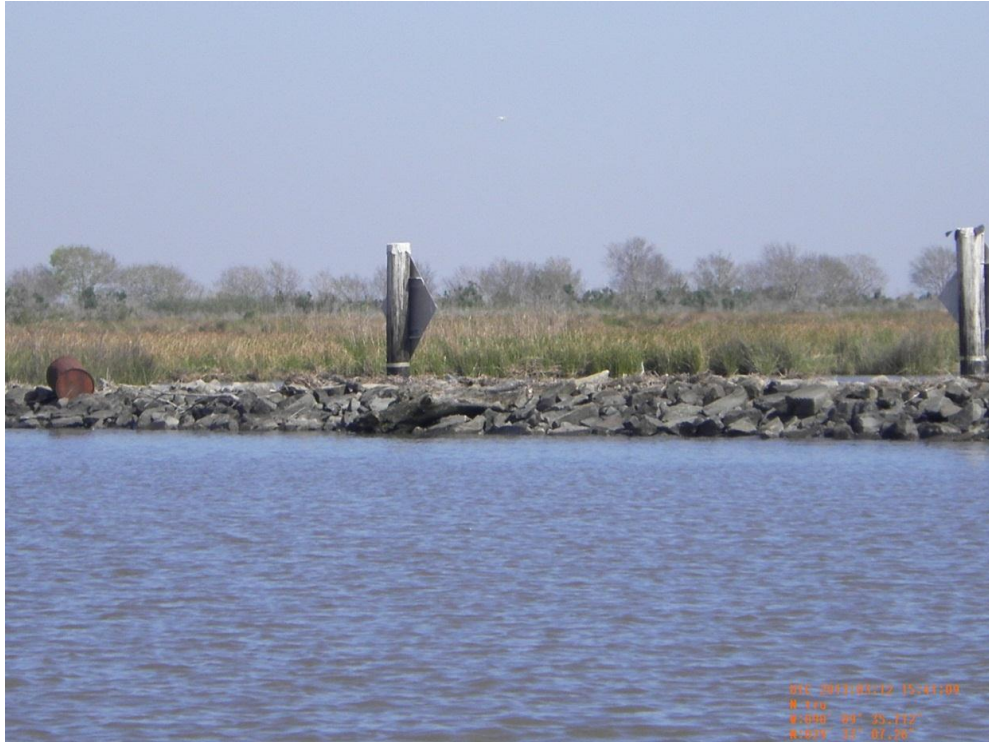
Photo 9: View of CU#3 rock dike and warning signs on the eastern edge of Little Lake

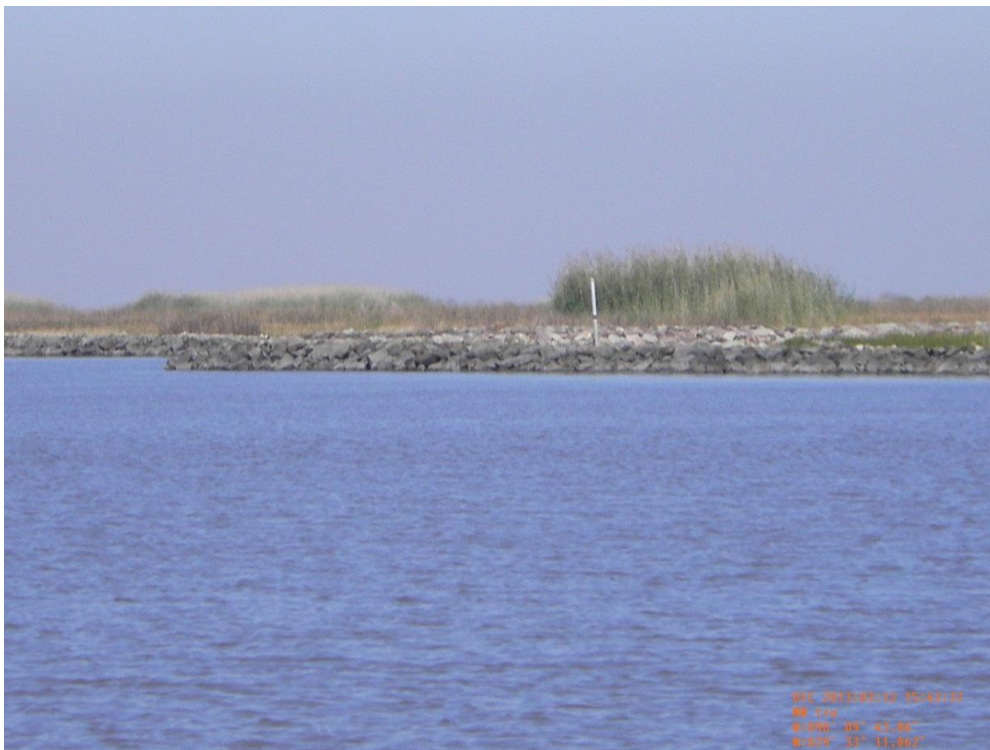
Photo 10: View of CU#3 rock dike on the eastern edge of Little Lake looking north

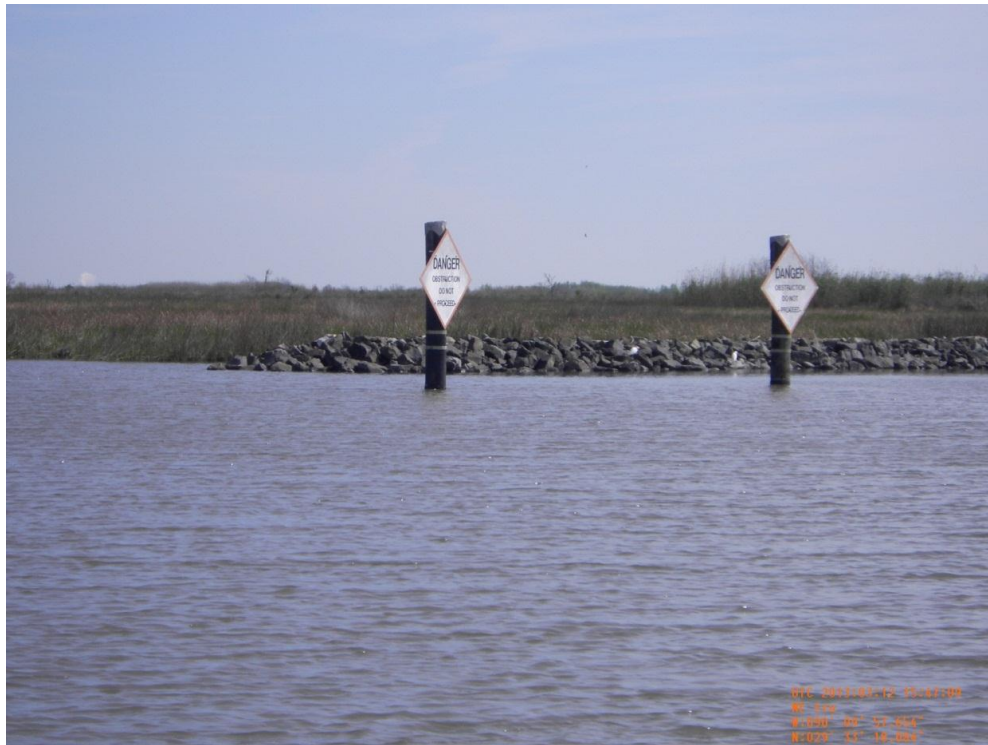
Photo 11: View of a rock dike opening and warning signs along CU#3

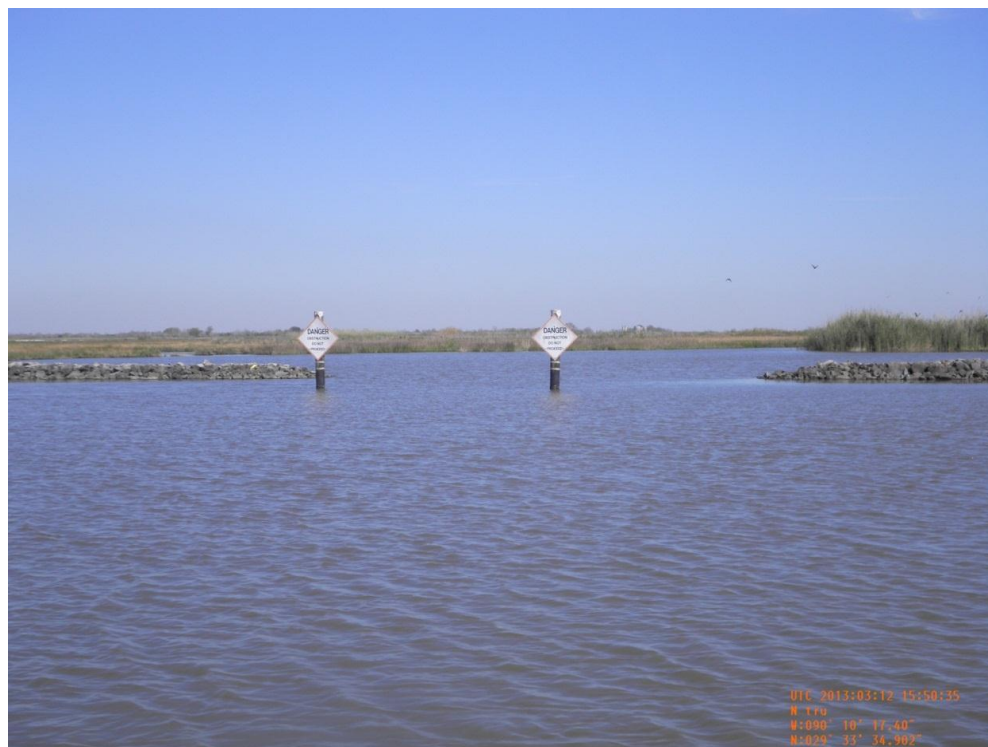
Photo 12: View of a rock dike opening and warning signs along CU#3

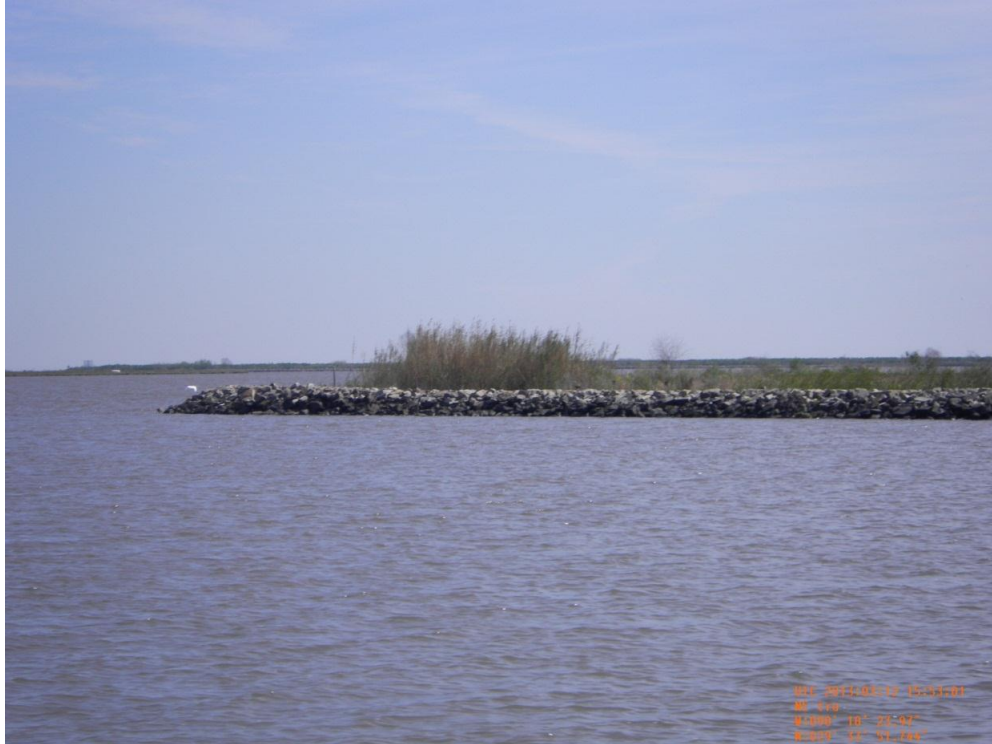
Photo 13: View of the CU#3 rock dike along the southern end of Bayou Perot

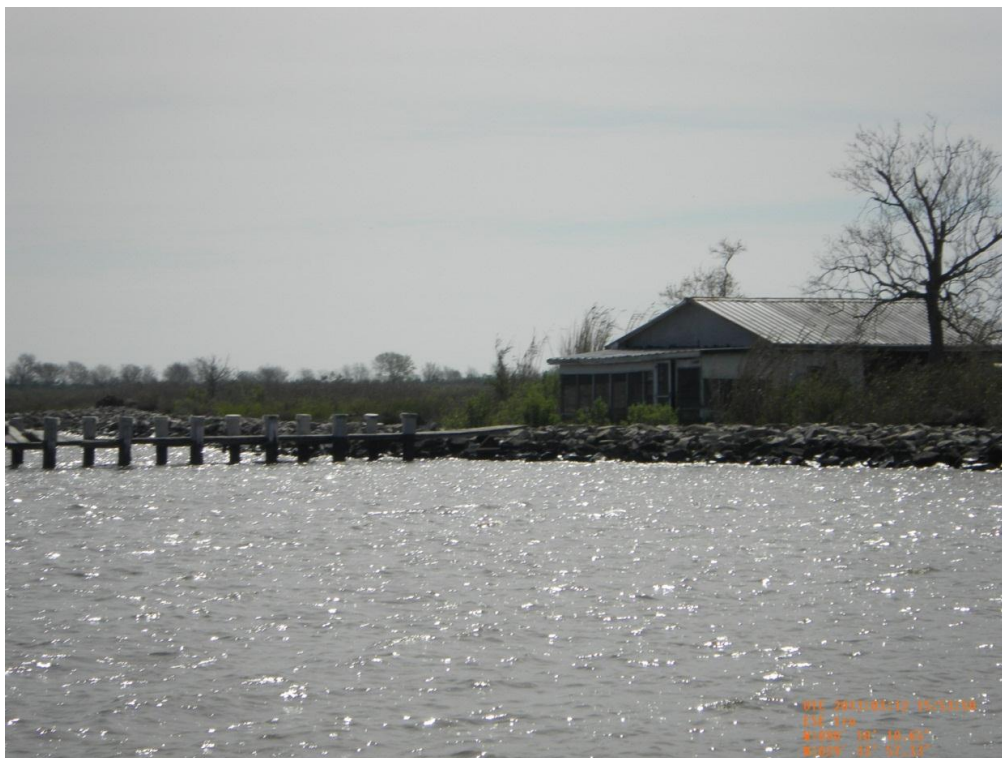
Photo 14: View of the CU#3 rock dike along the southern end of Bayou Perot

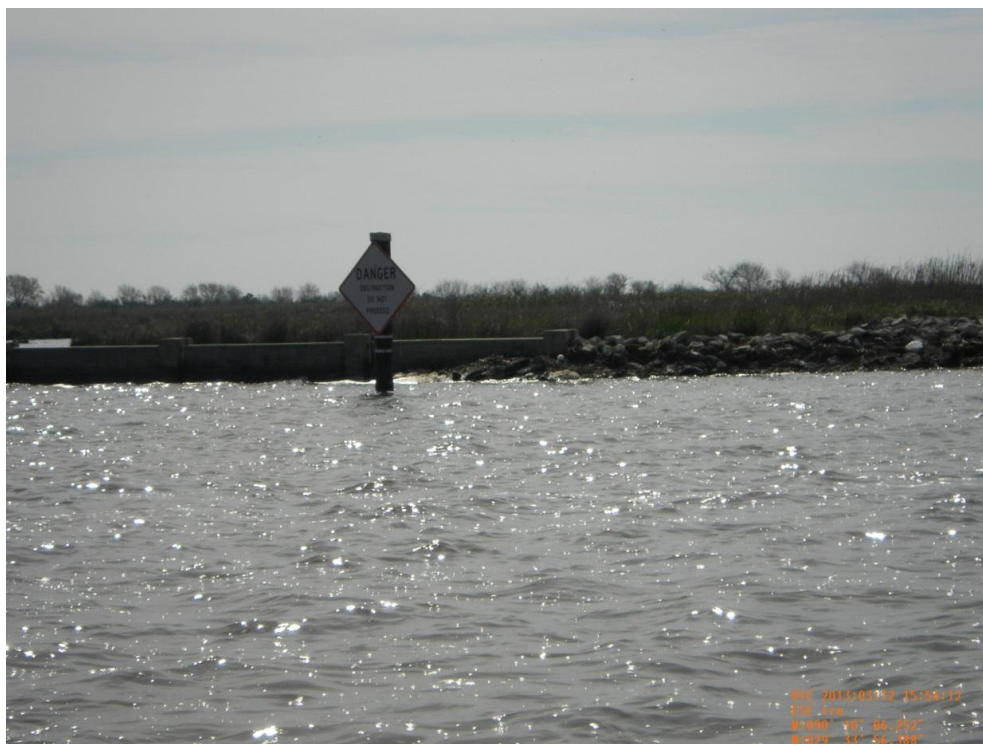
Photo 15: View of rock revetment tie-in on the western end of CU#4

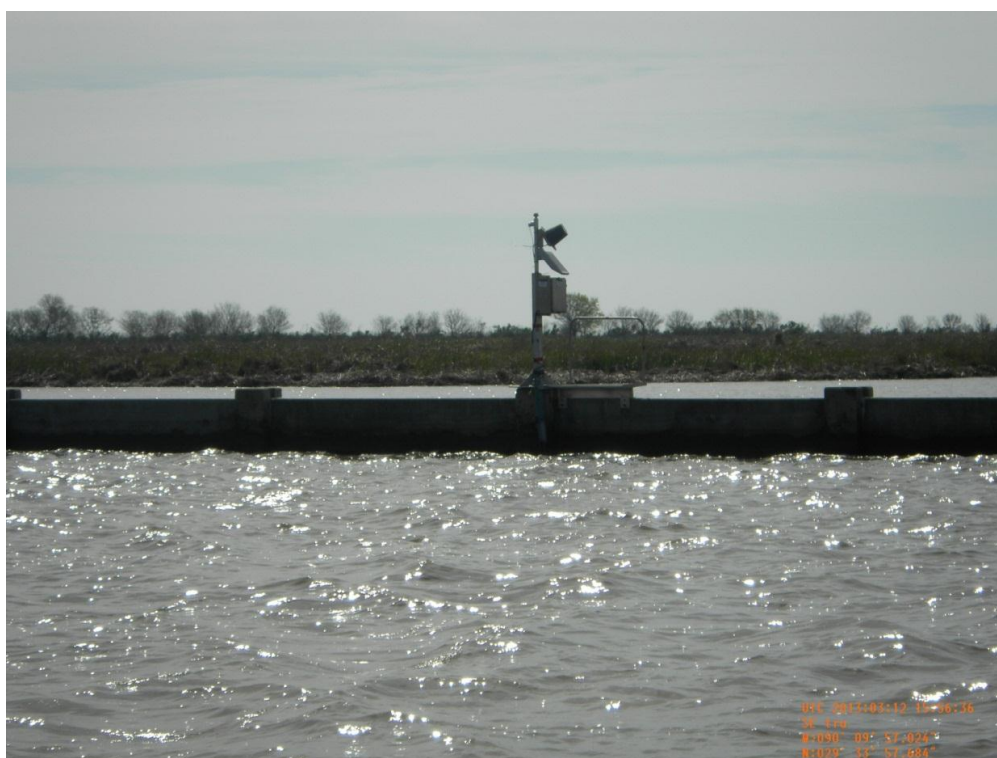
Photo 16: View of data station illicitly installed on the CU#4 concrete wall

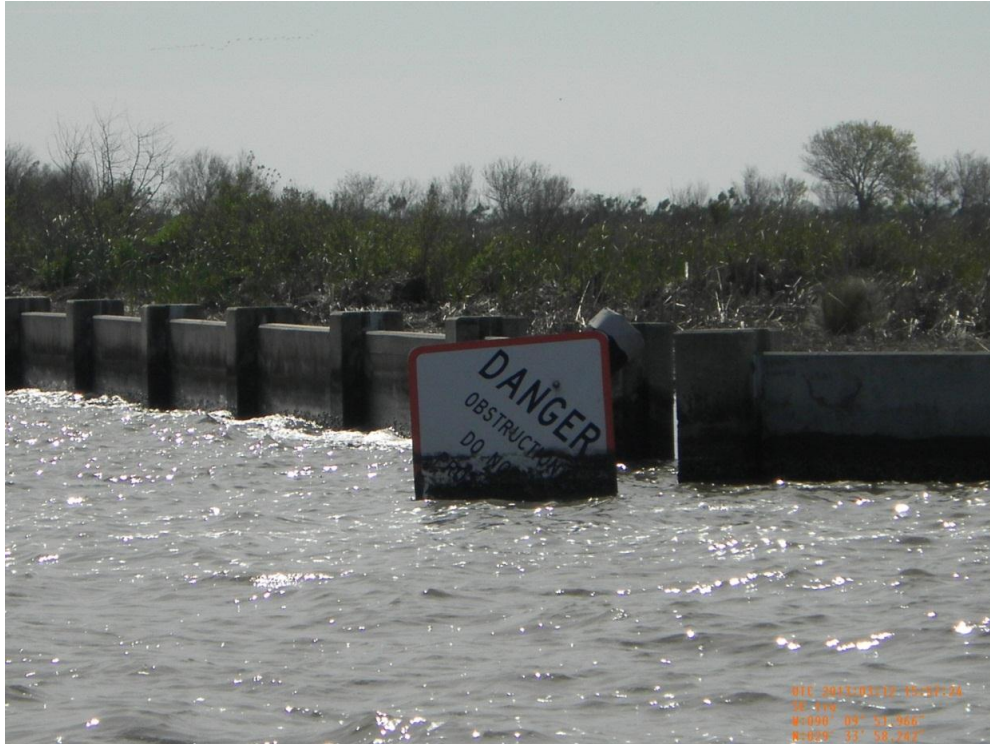
Photo 17: View of damaged warning sign along CU#4 concrete wall near an oilfield canal

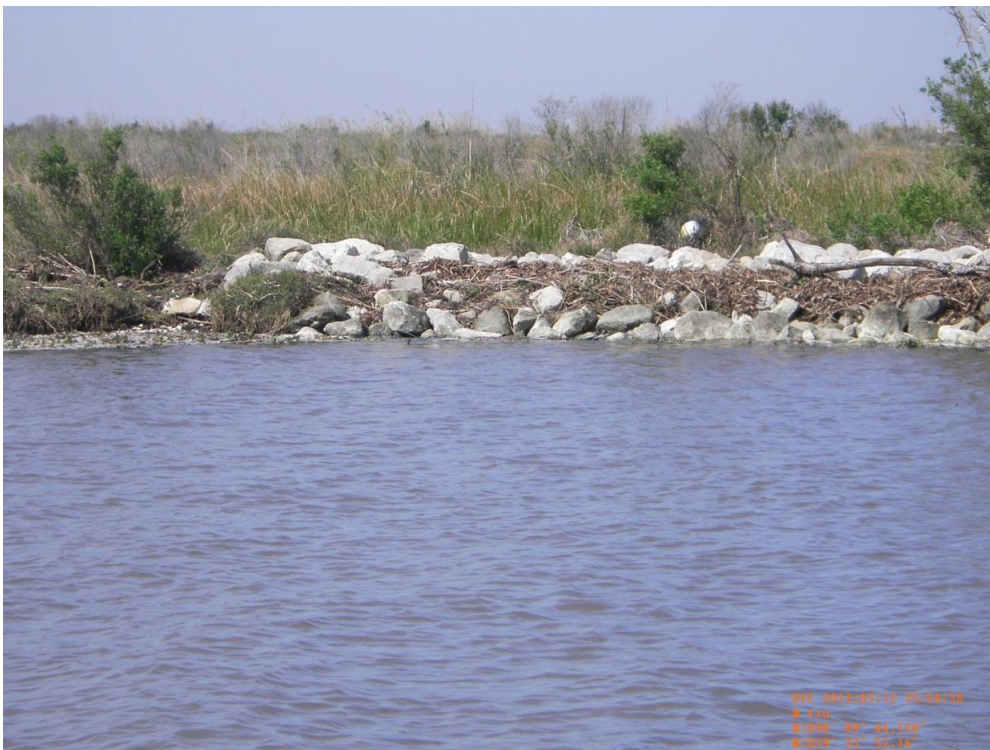
Photo 18: View of CU#4 rock tie-in on south side of oilfield canal

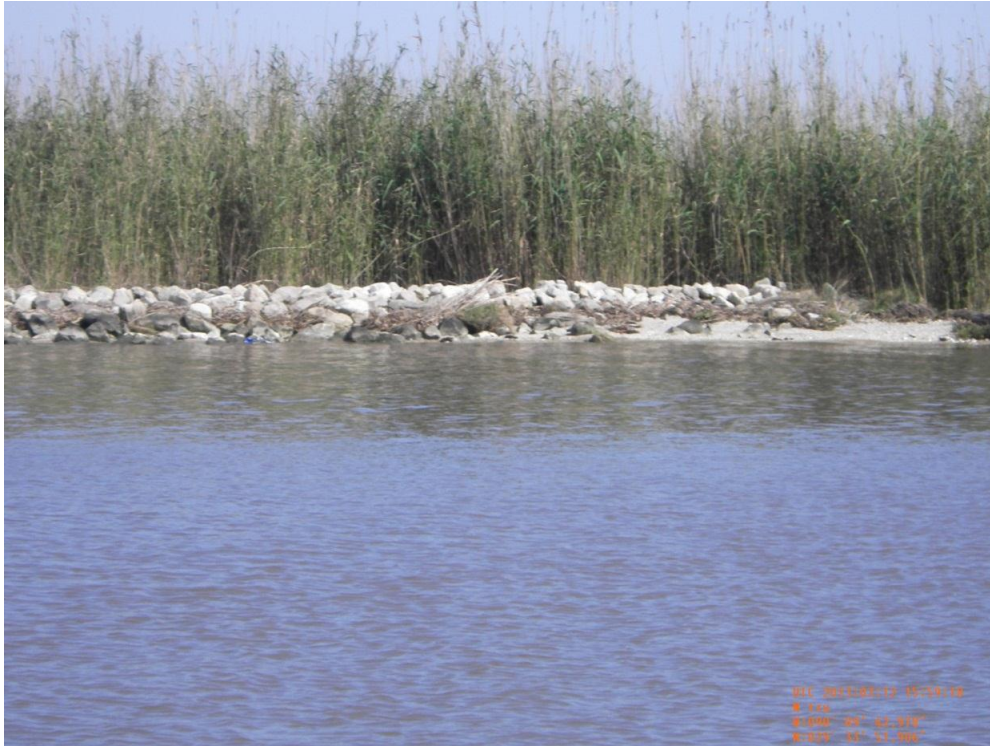
Photo 19: View of CU#4 rock tie-in on north side of oilfield canal

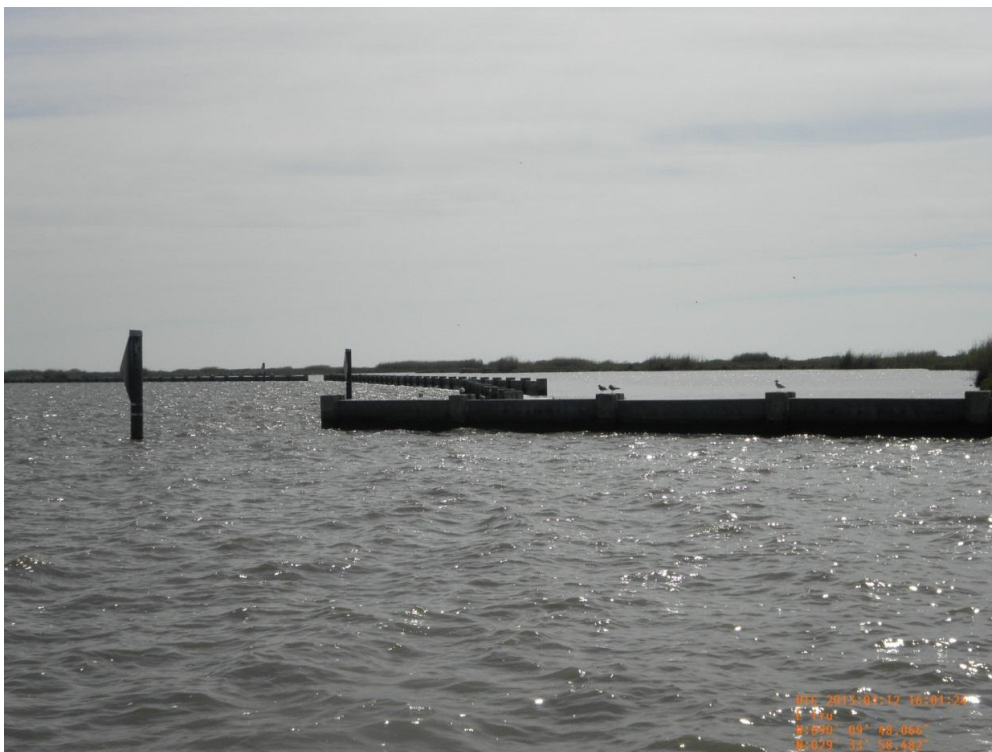
Photo 20: View of CU#4 concrete wall along southern end of Bayou Perot looking east

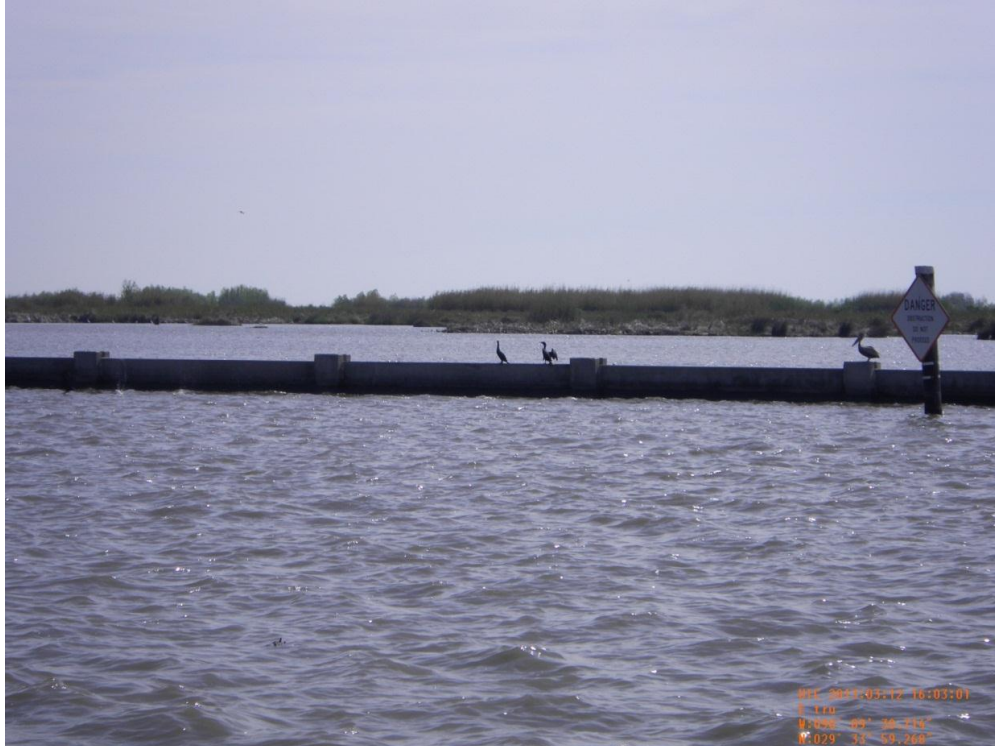
Photo 21: View of CU#4 concrete wall along southern end of Bayou Perot looking south

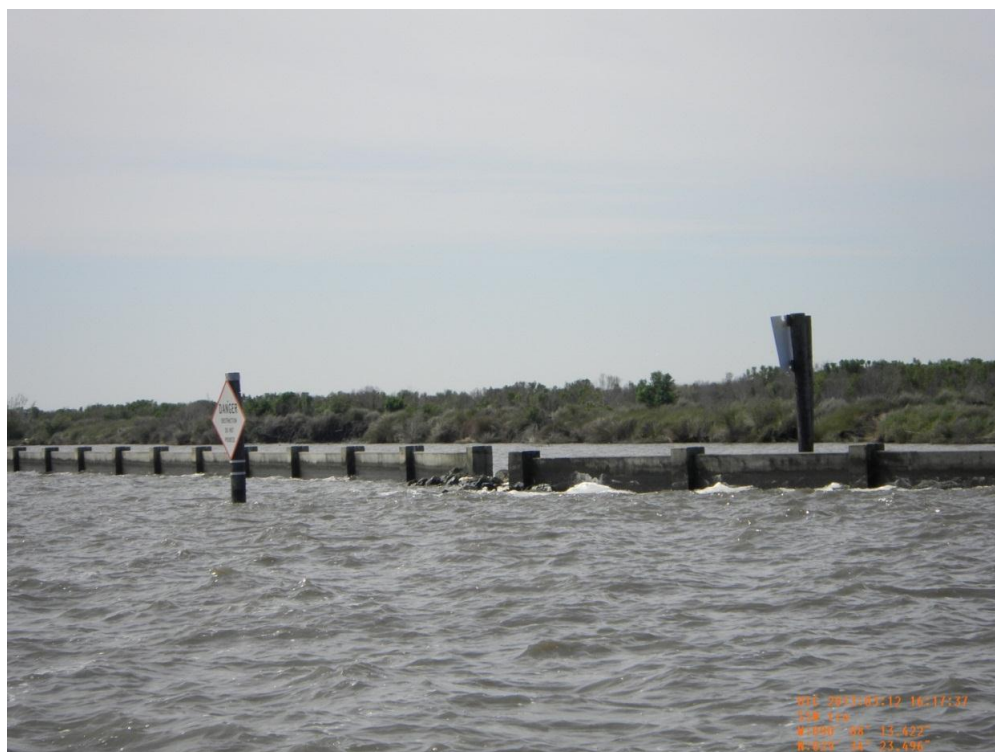
Photo 22: View of the CU#4 concrete wall near the Harvey Cutoff canal

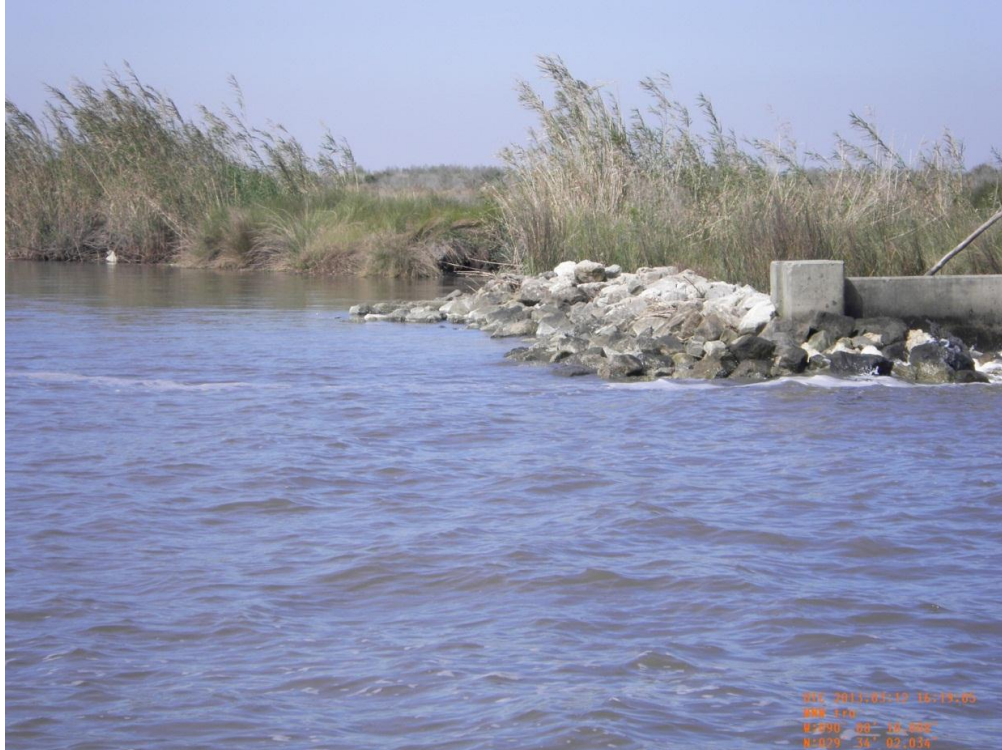
Photo 23: View of the CU#4 rock tie-in on the west side of Harvey Cutoff canal

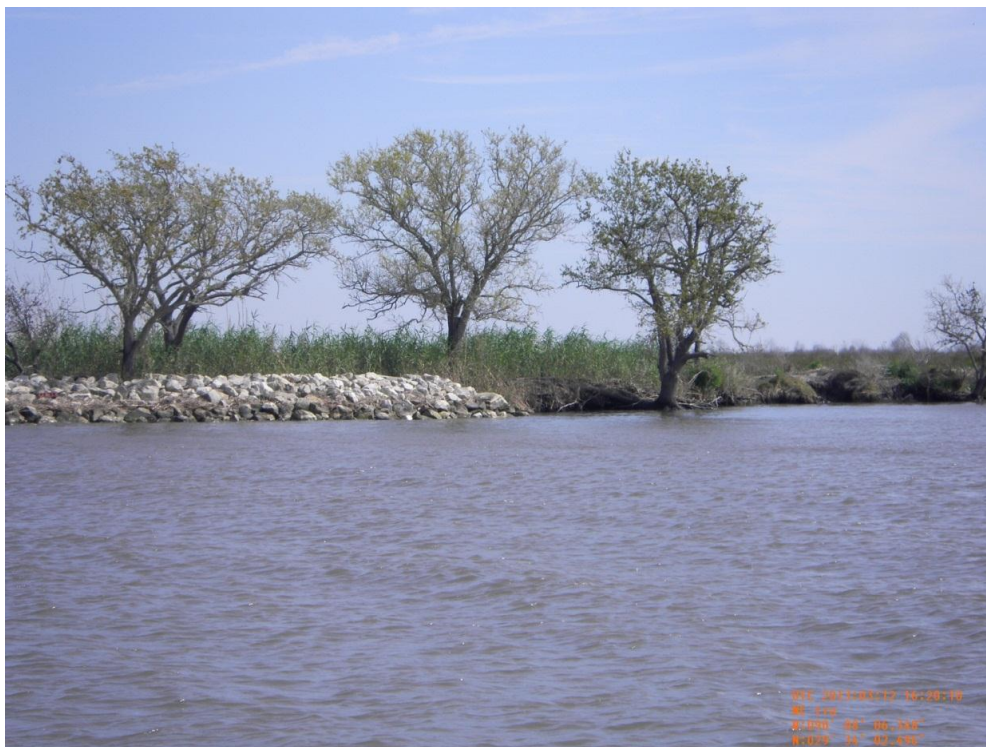
Photo 24: View of the CU#4 rock tie-in on the east side of Harvey Cutoff canal

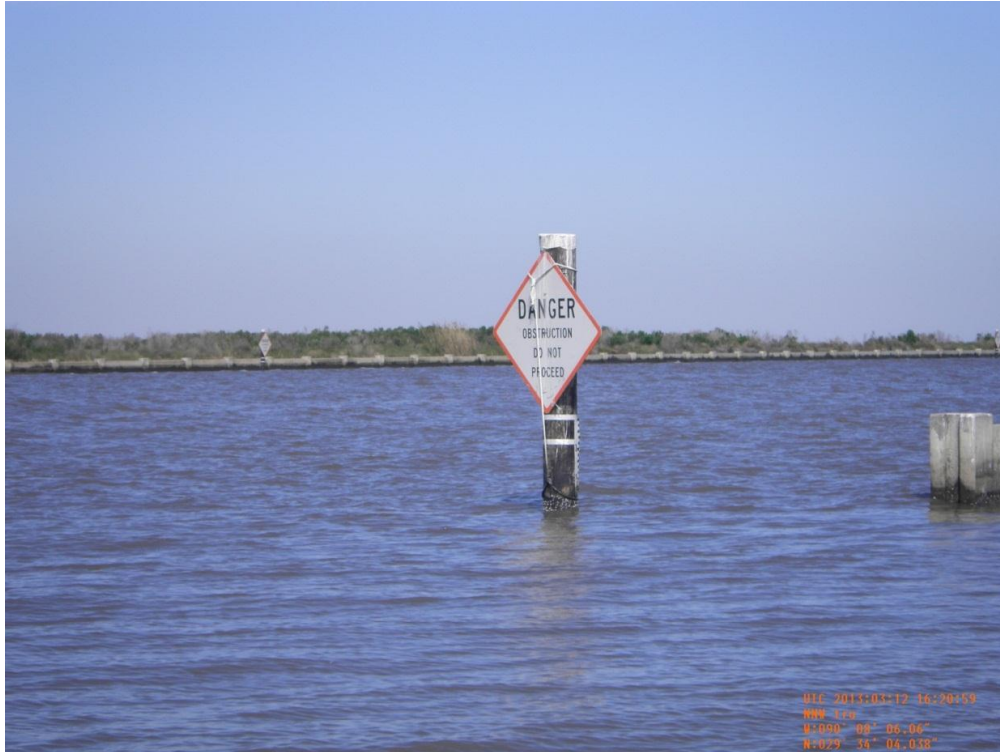
Photo 25: View of rope hanging off of warning sign in the Harvey Cutoff canal

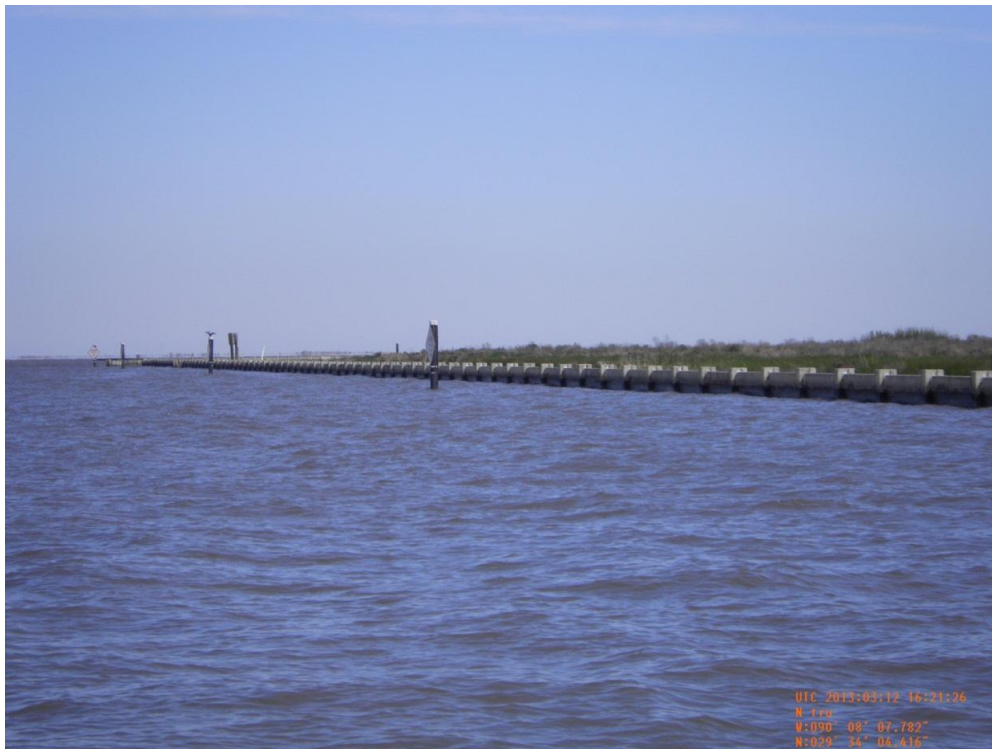
Photo 26: View of the CU#4 concrete wall along the east side of Harvey Cutoff canal

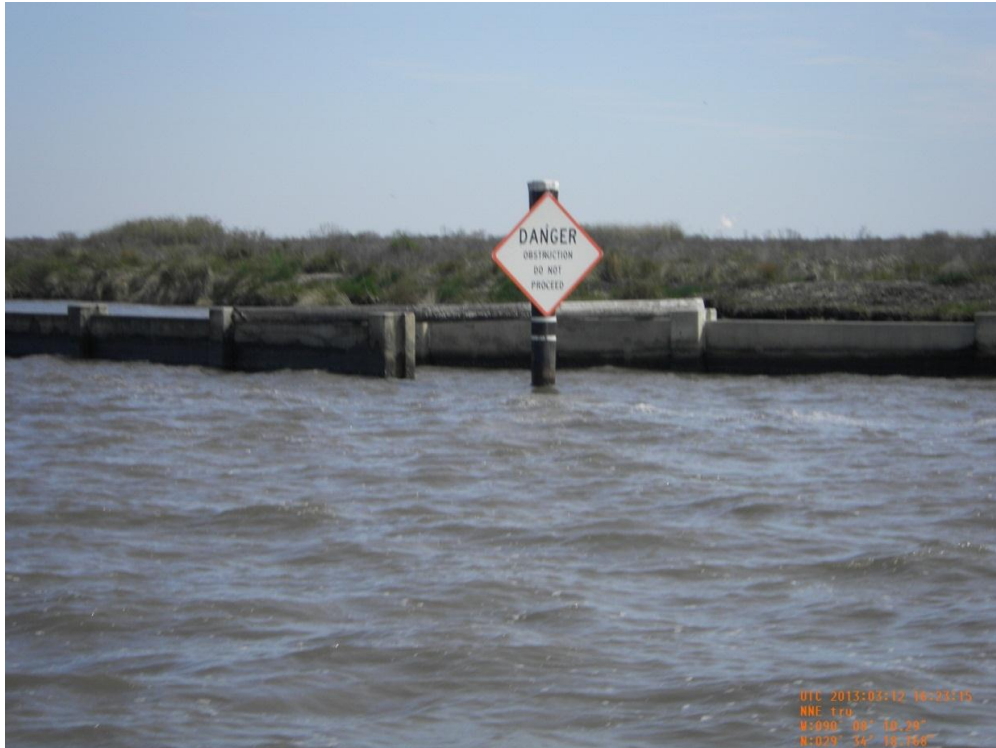
Photo 27: View of timber piling resting on top of the CU#4 concrete wall near Harvey Cutoff canal

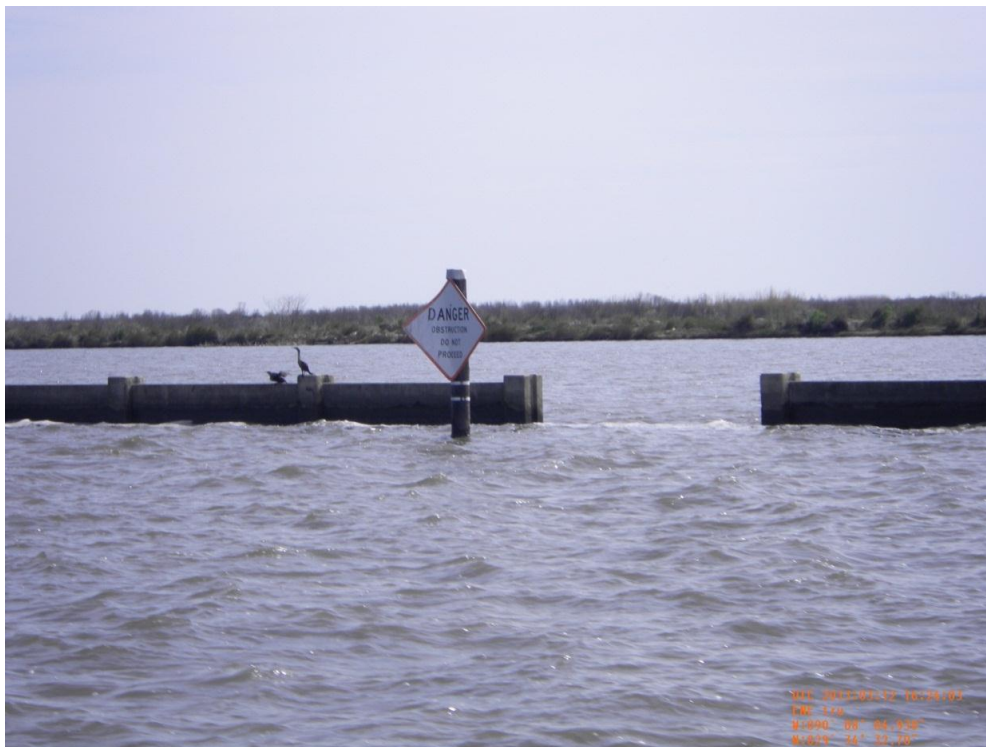
Photo 28: View of a bent warning sign along CU#4 concrete wall near Harvey Cutoff canal

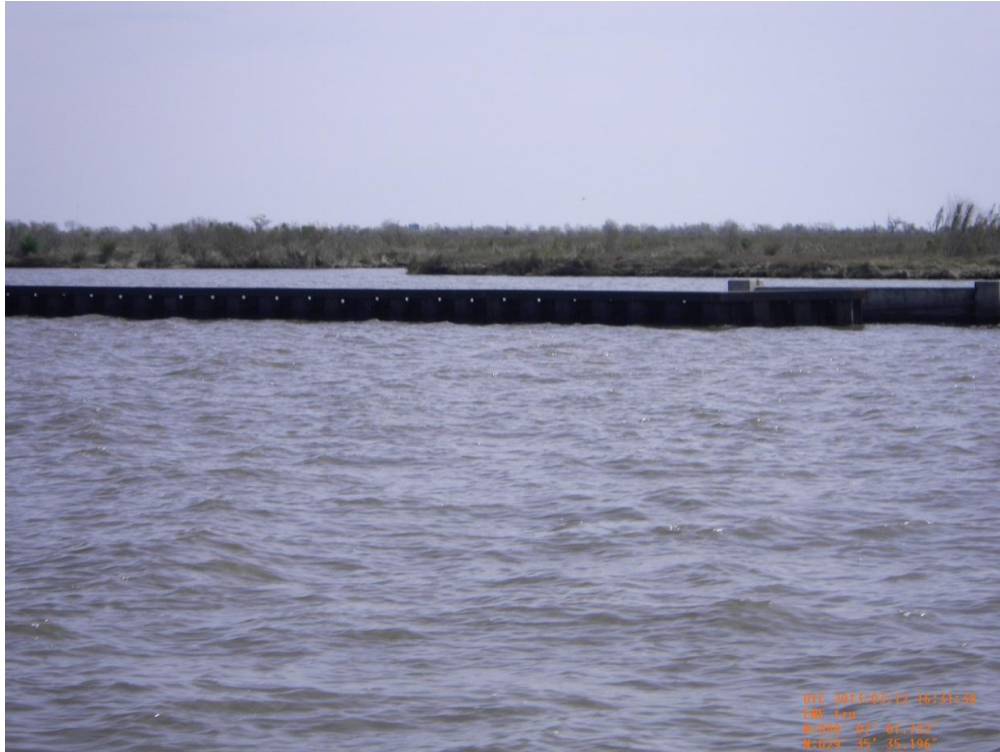
Photo 29: View of steel bulkhead placed to close gap left in CU#4 concrete wall
