**State of Louisiana
Coastal Protection and Restoration
Authority**

**2013 Operations, Maintenance,
and Monitoring Report**

**BARATARIA BASIN LANDBRIDGE
SHORELINE PROTECTION
PROJECT (PHASES 1&2, 3, and 4)**

July 2, 2013
Lafourche & Jefferson Parishes

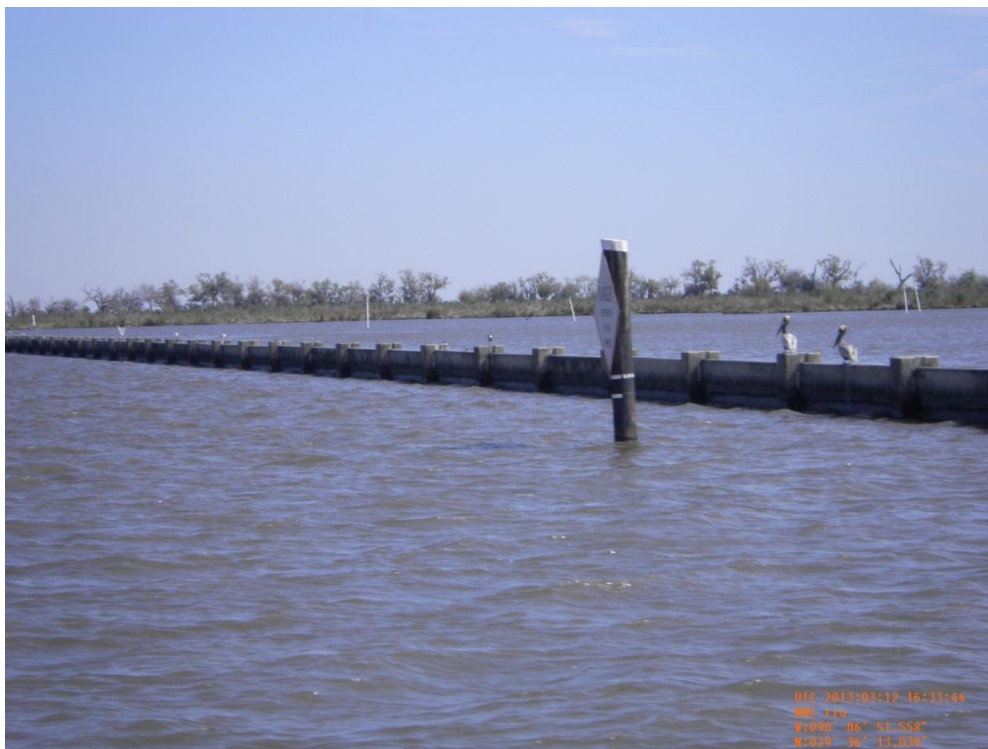
Reach 1. All of the transitions from rock riprap to concrete wall were in good condition. The rock riprap embankment tie-ins were also in good condition. A warning sign and its support marking the concrete pile on the west side of the oilfield canal in Reach 3 were missing. It is recommended this sign and its support should be replaced. Also, a timber piling was resting on the concrete wall on the east bank of Harvey Cutoff in Reach 1. This timber piling did not appear to be damaging the concrete wall, but it is recommended that it should be removed. There are no other recommendations for maintenance at this time. (Appendix B, Photos #1 & #15-32)

Photo 30: View of CU#4 concrete wall along the eastern side of Bayou Rigolettes

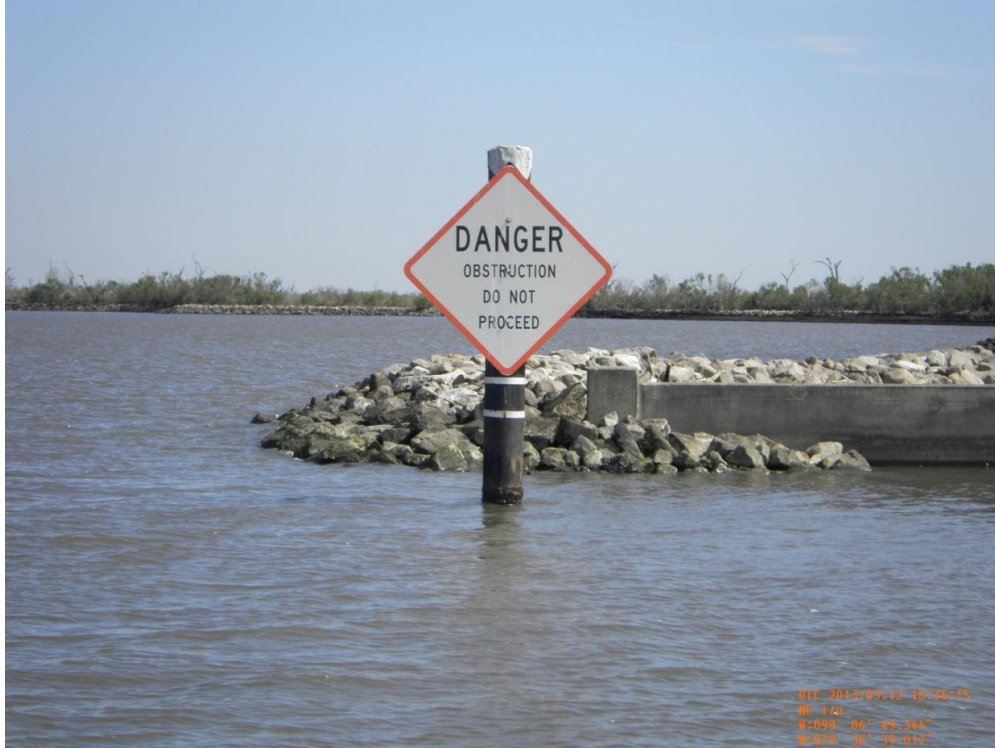
Photo 31: View of warning sign and CU#4 concrete wall transition to rock revetment tie-in

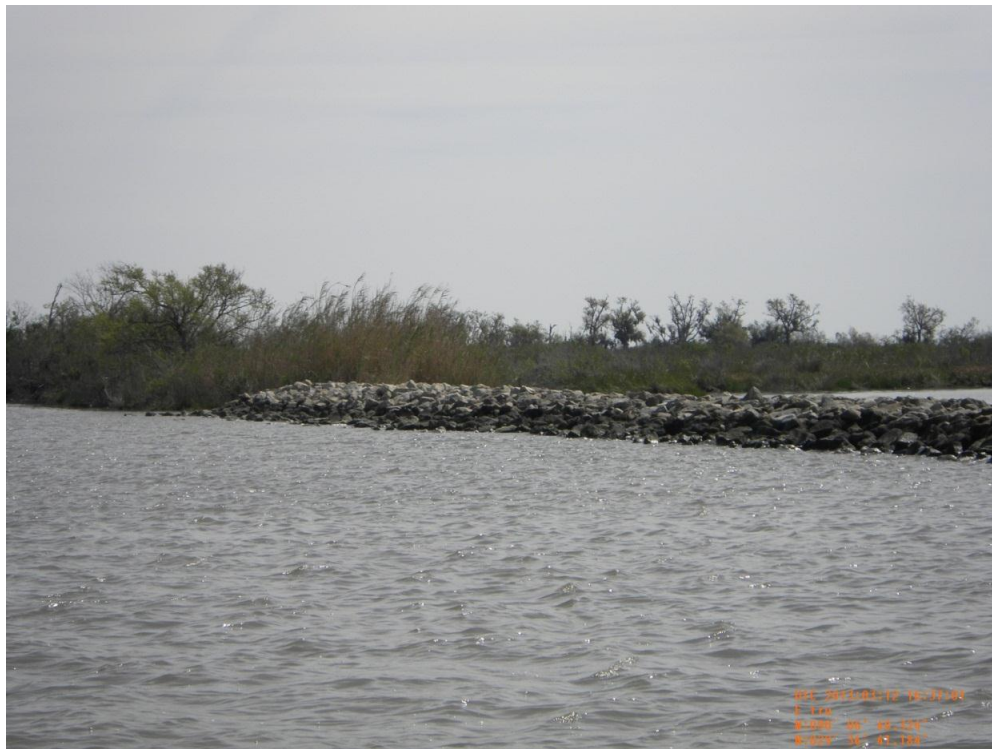
Photo 32: View of CU#4 rock embankment tie-in on south side of oilfield canal

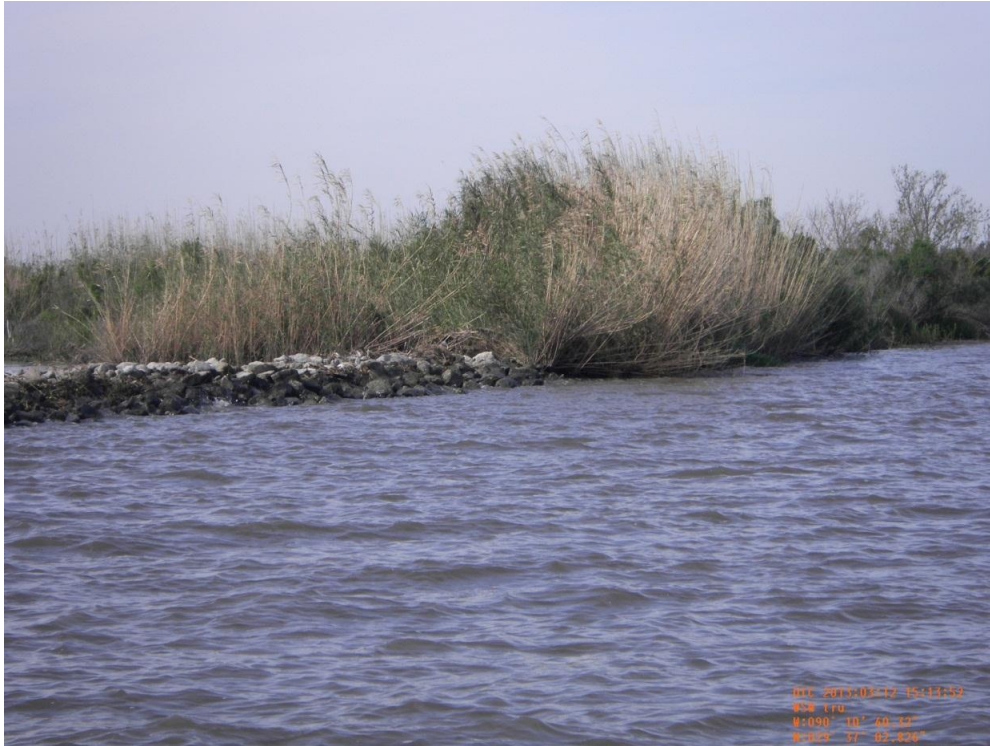
CU 5 was also constructed in early 2009 and appeared to be in good condition with no displacement or cracked panels. The inspection began at the northernmost point of CU 5 on the west bank of Bayou Perot near the Enbridge Pipeline Canal and progressed southward along the shoreline to the southernmost point of CU 5 at an existing location canal. The rock tie-ins were also in very good condition with no obvious washouts or erosion. There are no recommendations for maintenance of CU 5 at this time. (Appendix B, Photos #33-37)

Photo 33: View of rock revetment embankment tie-in on the north end of CU#5

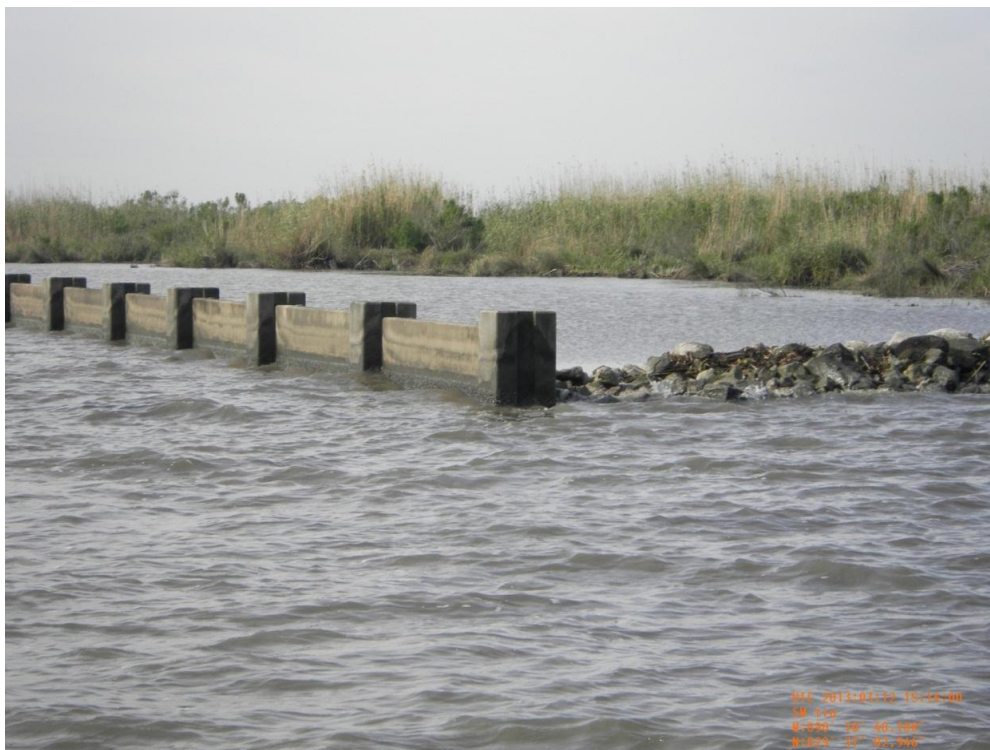
Photo 34: View of transition between rock revetment and concrete wall on north end of CU#5

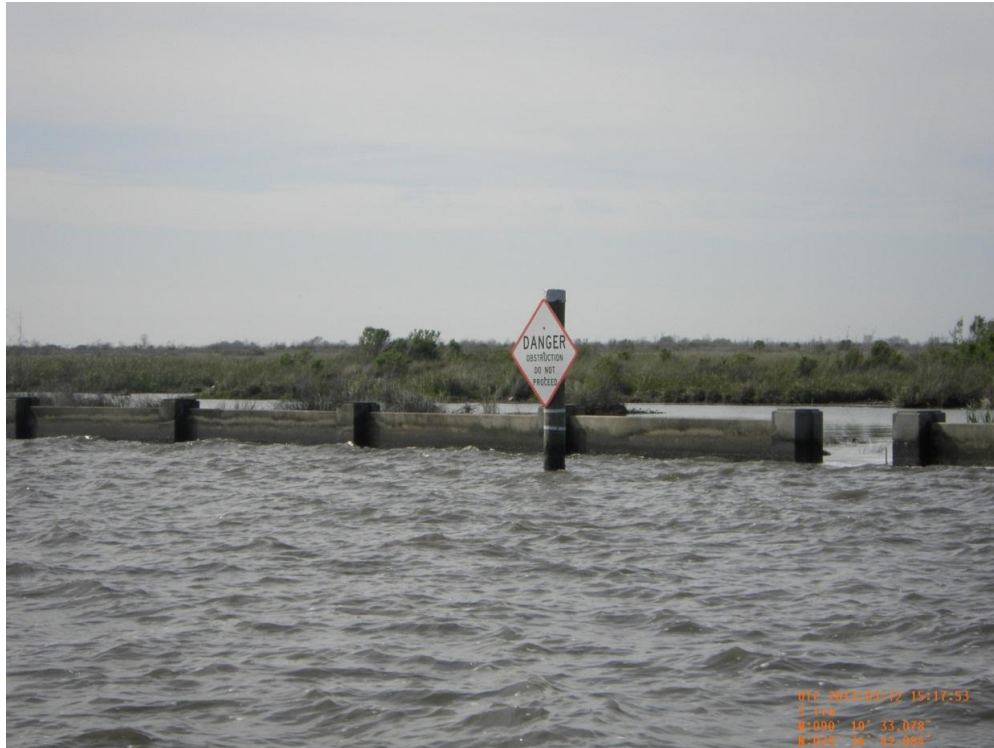
Photo 35: View of concrete wall and warning sign along CU#5

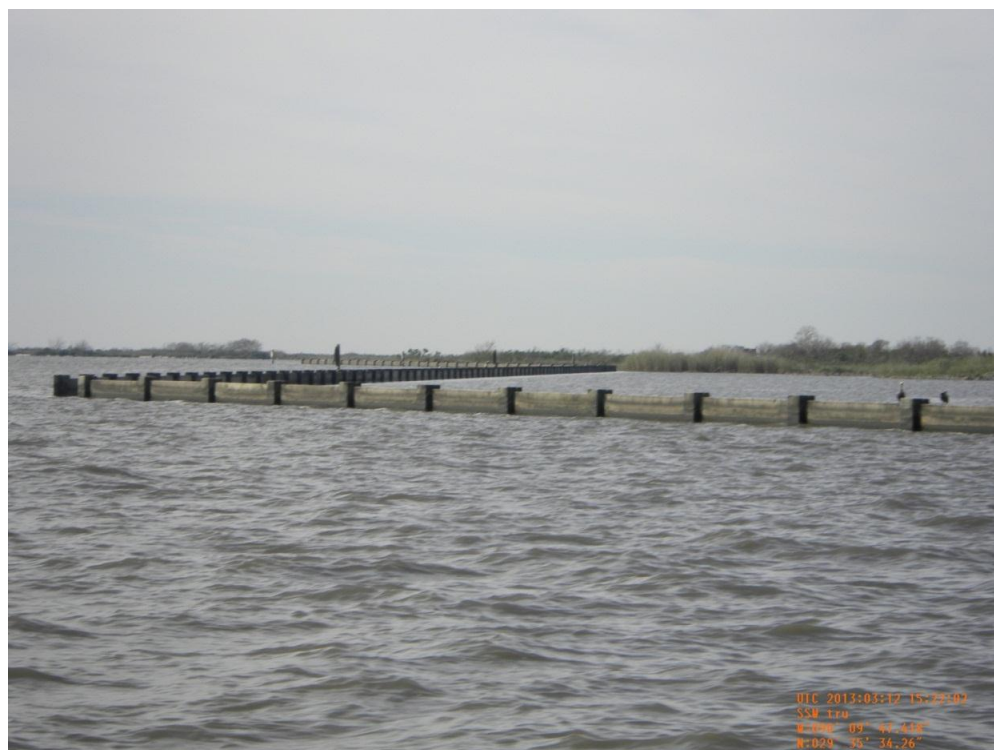
Photo 36: View of concrete wall of CU#5 along Bayou Perot looking south

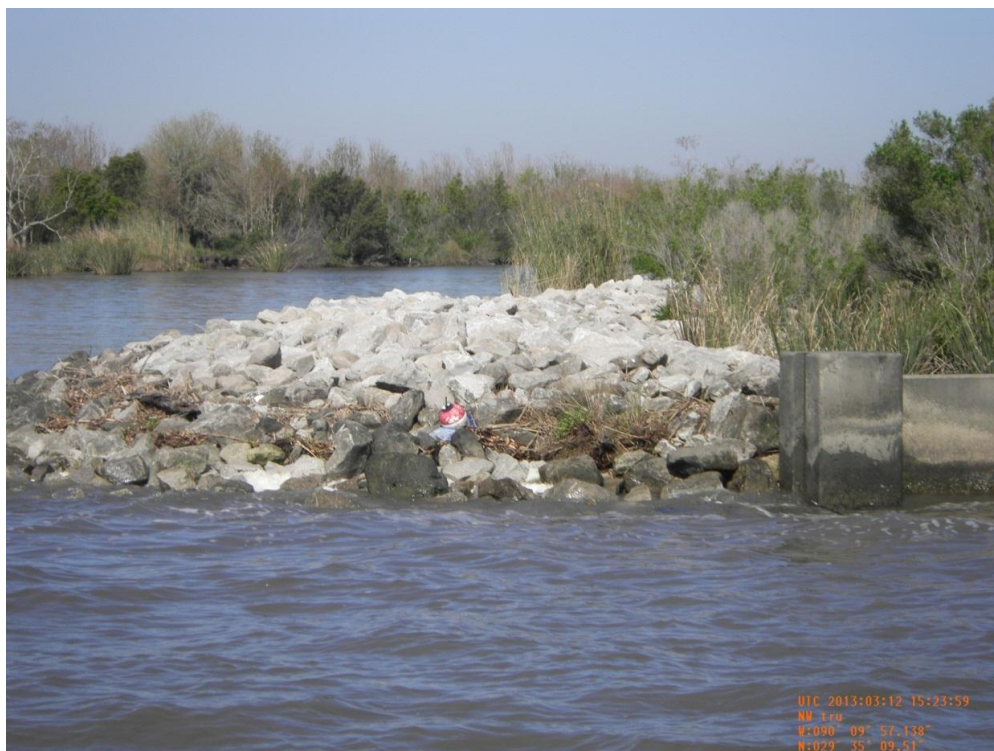
Photo 37: View of rock revetment embankment tie-in on the south end of CU#5

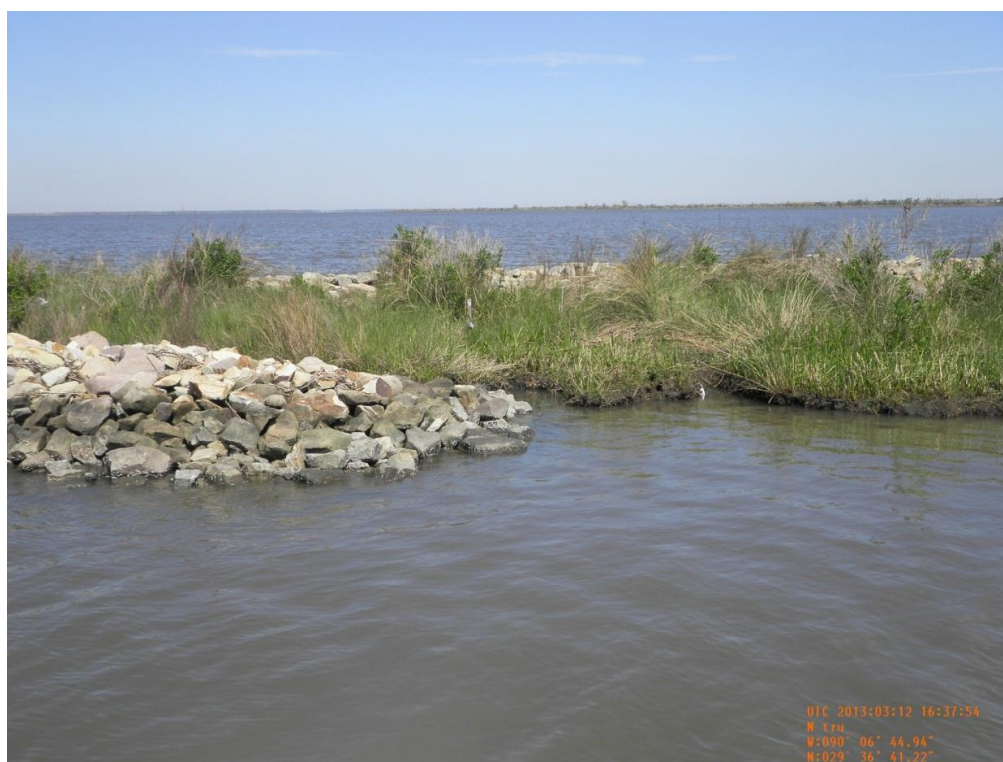
The rock dike appeared to be in good overall condition with no visual displacement or settlement of rock material. The inspection of CU 6 began at Sta. 0+00 near an existing oilfield access canal and proceeded along the east bank of Bayou Rigolettes to Sta. 307+78 near the Barataria Waterway. All signs and supports at the fish dip locations were also in good condition. We are not recommending any corrective actions at this time. (Appendix B, Photos # 38-48)

Photo 38: View of CU#6 rock embankment tie-in on north side of oilfield canal

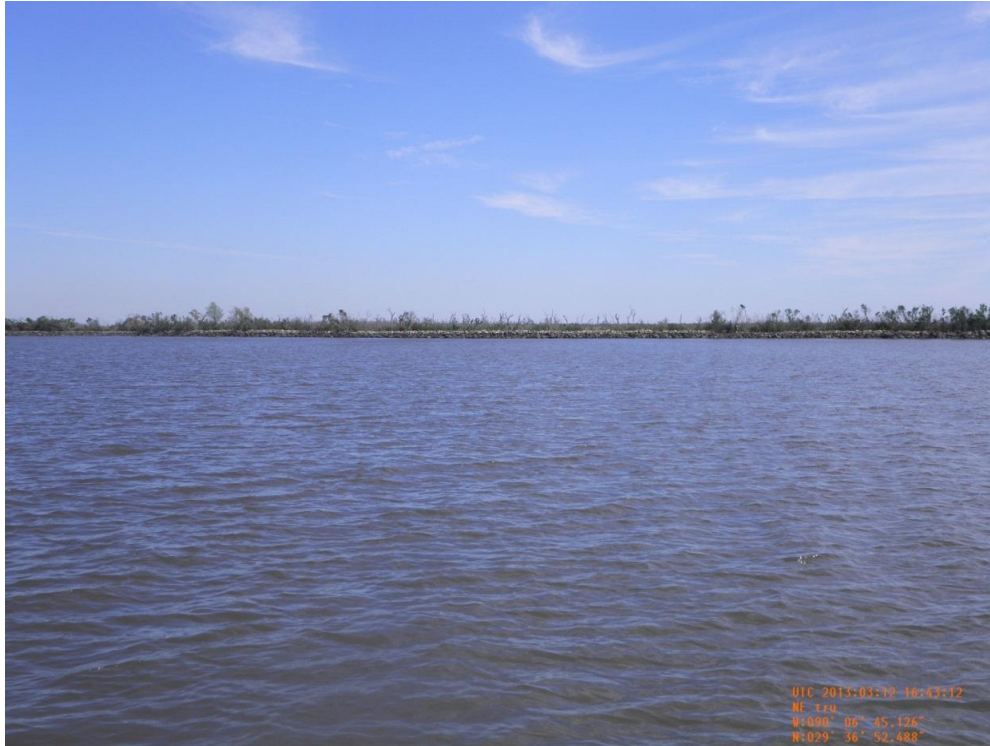
Photo 39: View of CU#6 rock dike along the eastern side of Bayou Rigolettes

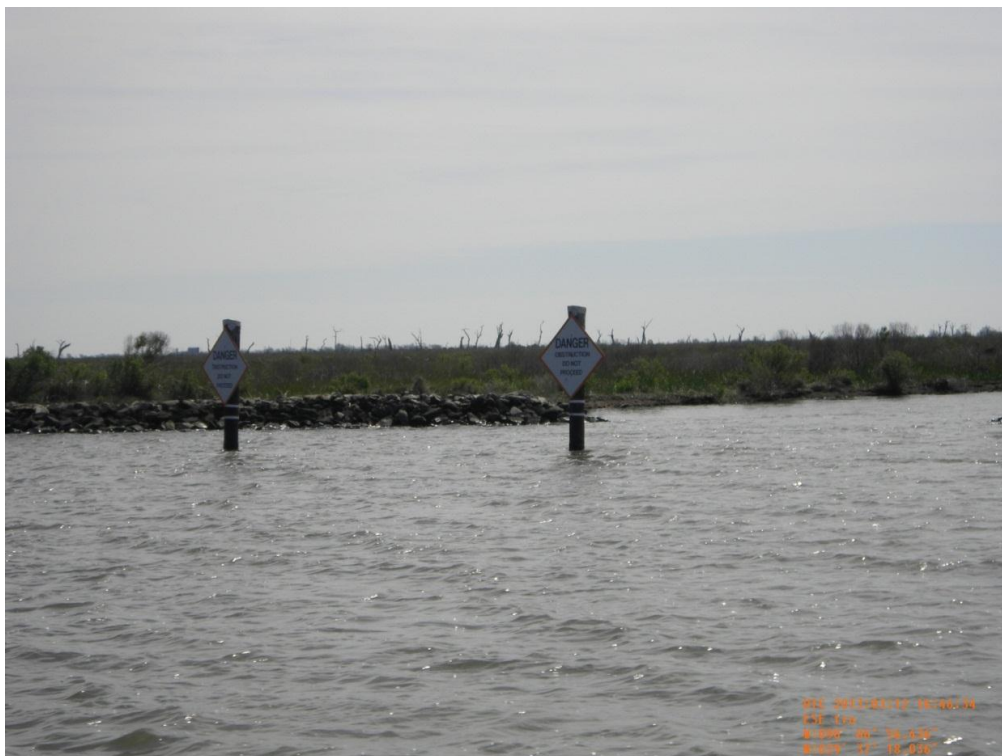
Photo 40: View of warning signs and CU#6 rock dike along eastern side of Bayou Rigolettes

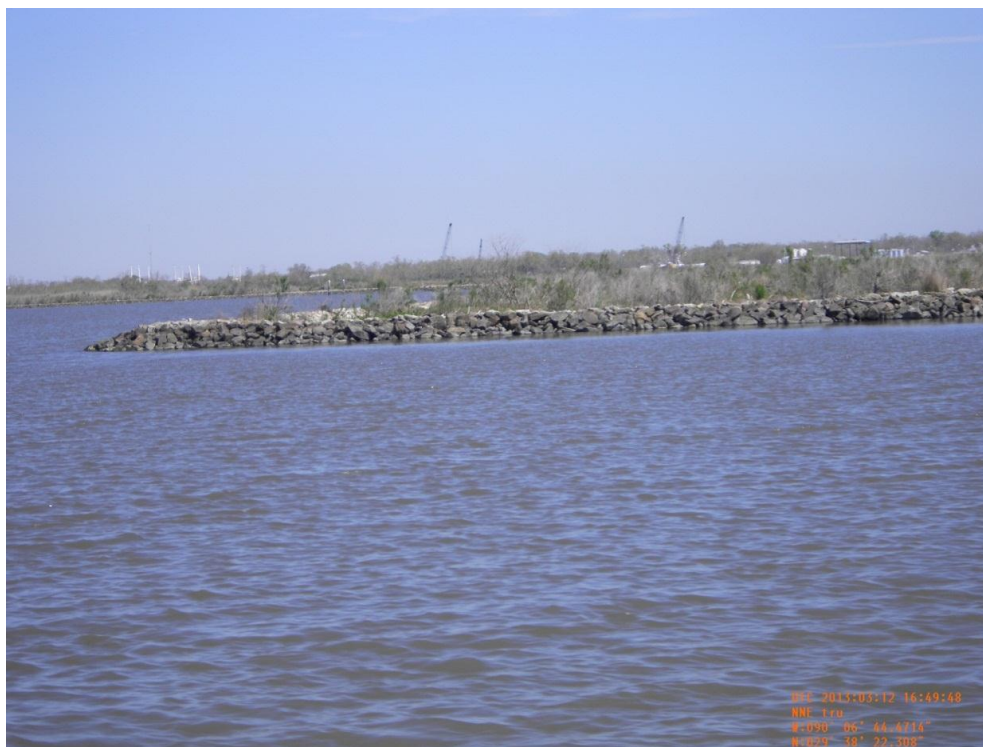
Photo 41: View of CU#6 rock dike from Bayou Rigolettes looking northeast

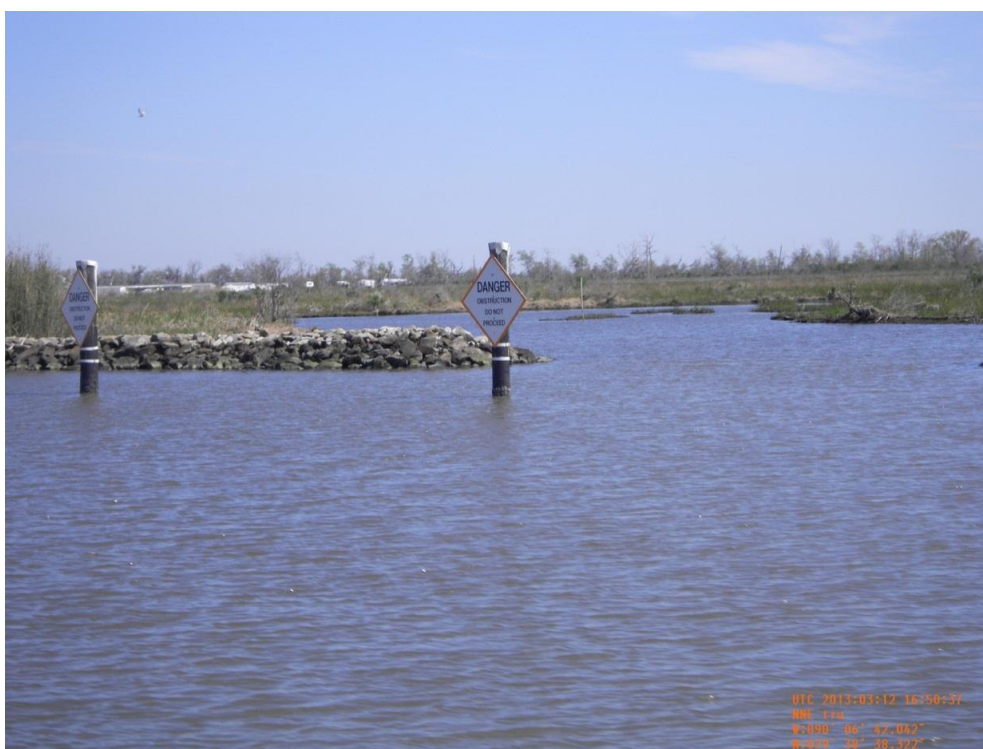
Photo 42: View of warning signs and CU#6 rock dike along eastern side of Bayou Rigolettes

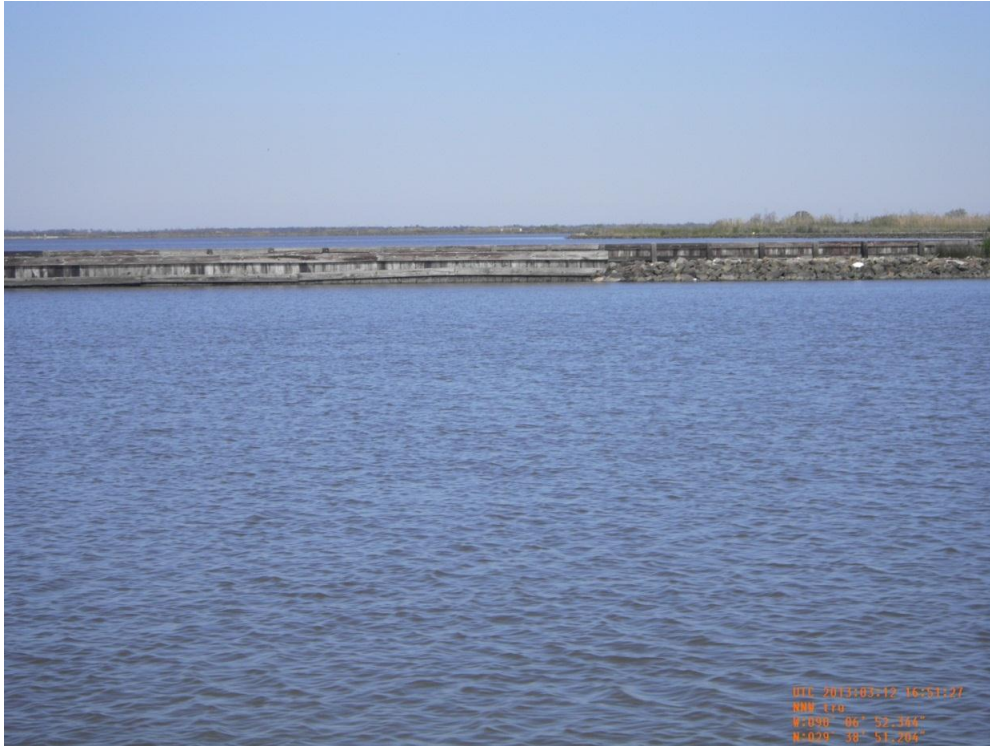
Photo 43: View of intersection of CU#6 rock dike and pipeline timber bulkhead looking north

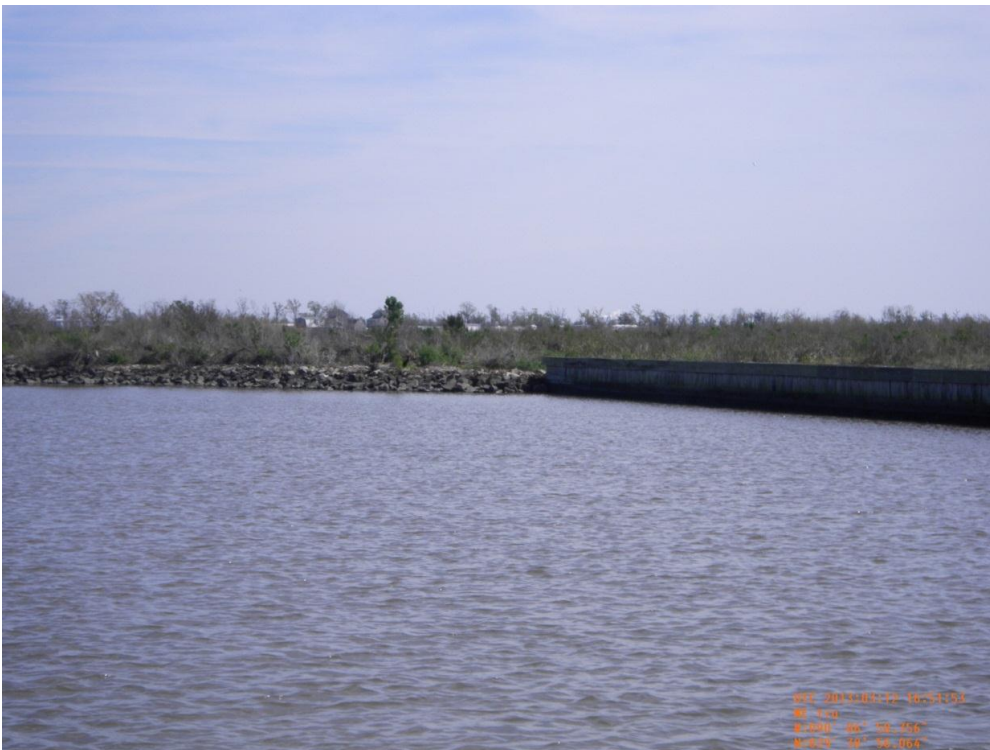
Photo 44: View of intersection of CU#6 rock dike and pipeline timber bulkhead looking east

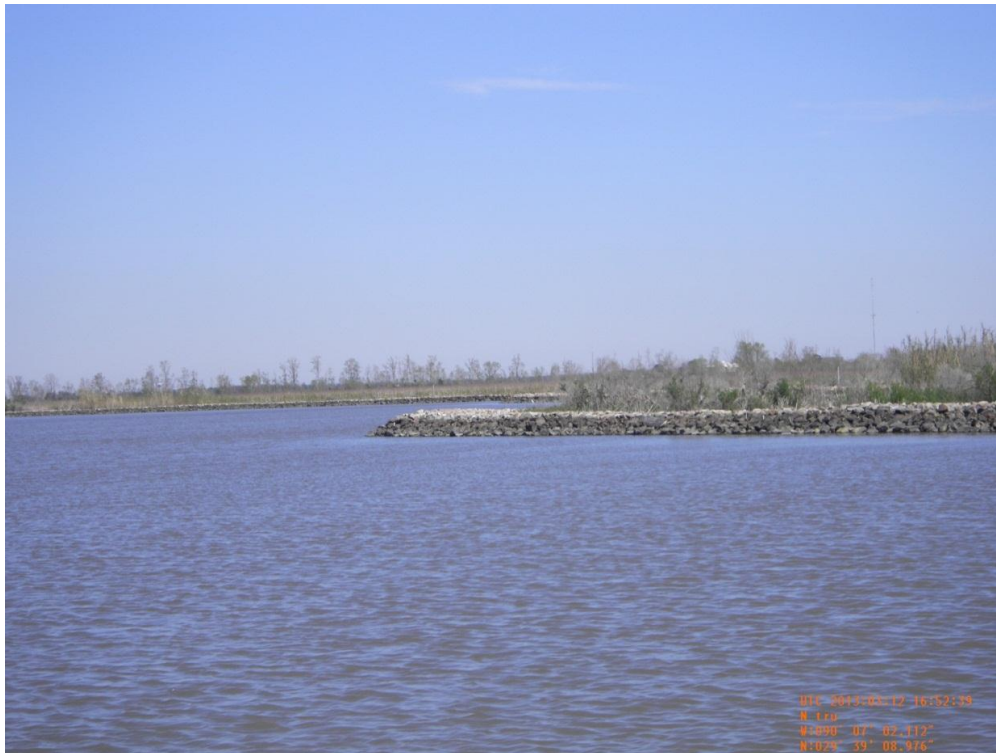
Photo 45: View of CU#6 rock dike from Bayou Rigolettes looking north

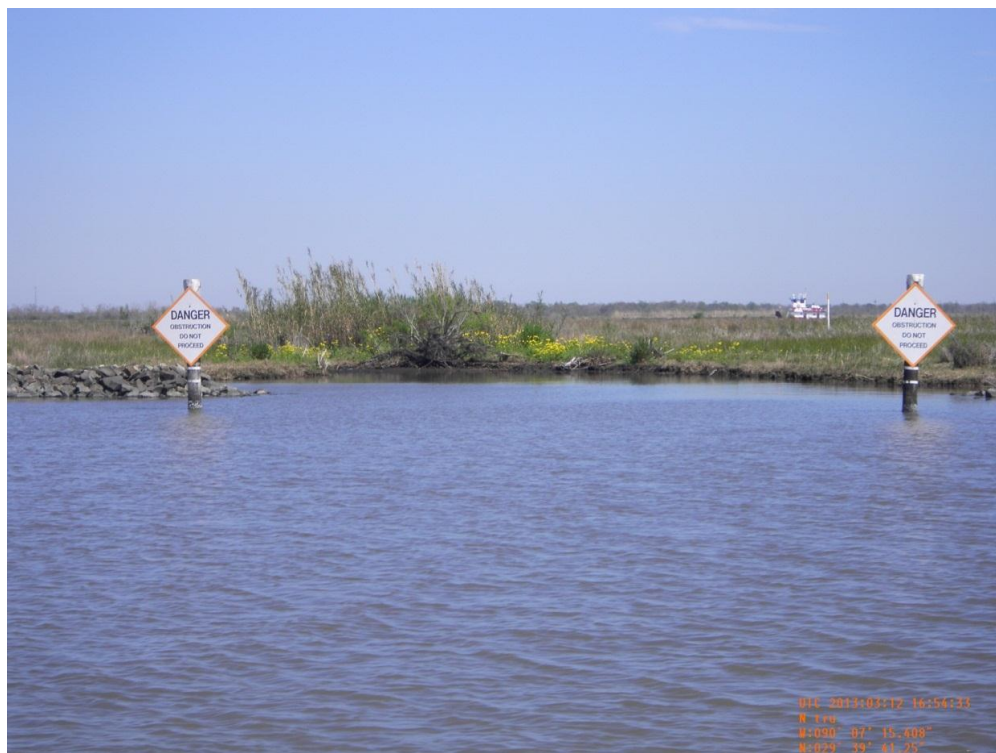
Photo 46: View of warning signs and CU#6 rock dike along eastern side of Bayou Rigolettes

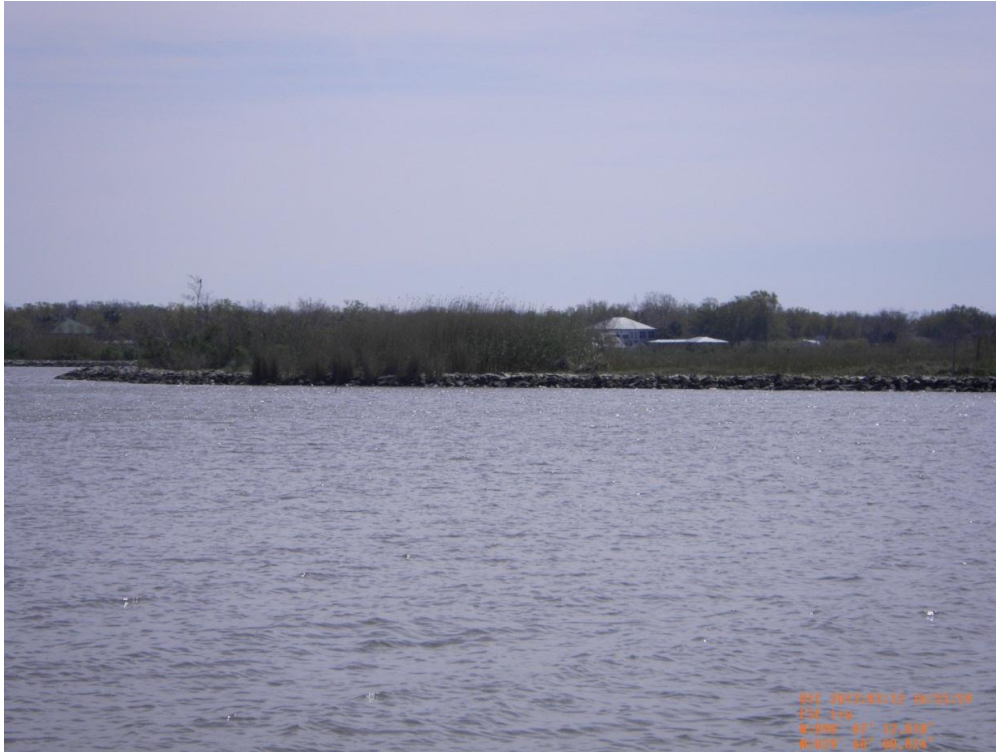
Photo 47: View of CU#6 rock dike from Bayou Rigolettes looking east

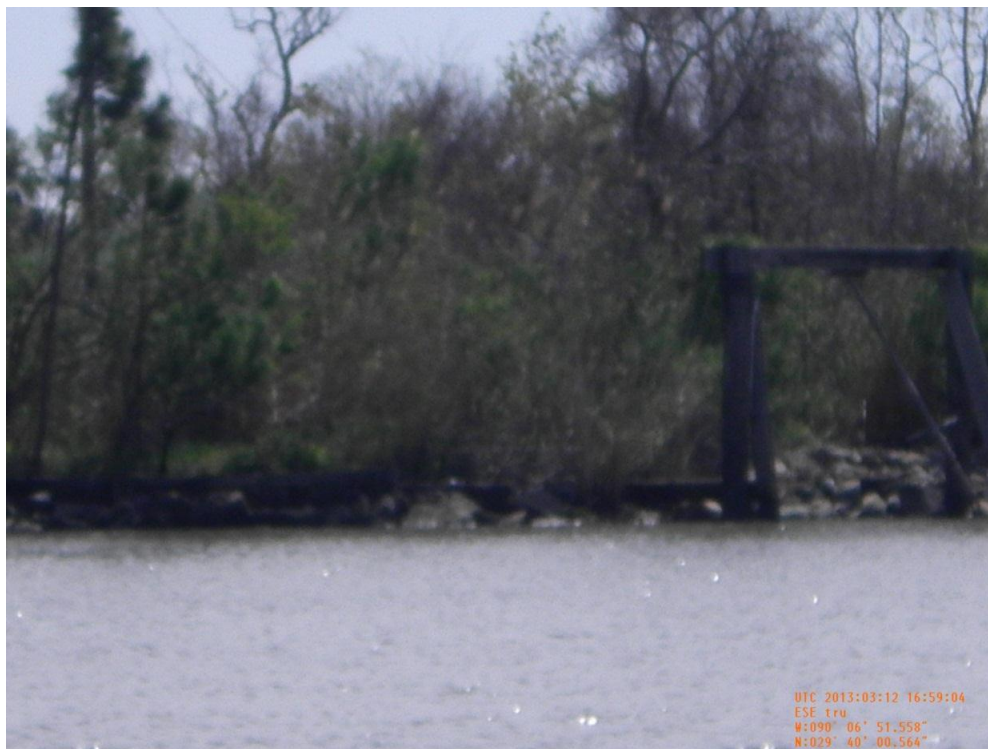
Photo 48: View of northern CU#6 rock dike embankment tie-in near Laffite
