## **2013 Operations, Maintenance, and Monitoring Report**

### **East Marsh Island Marsh Creation**

State Project Number TV-21  
Priority Project List 14

June 2013  
Iberia Parish

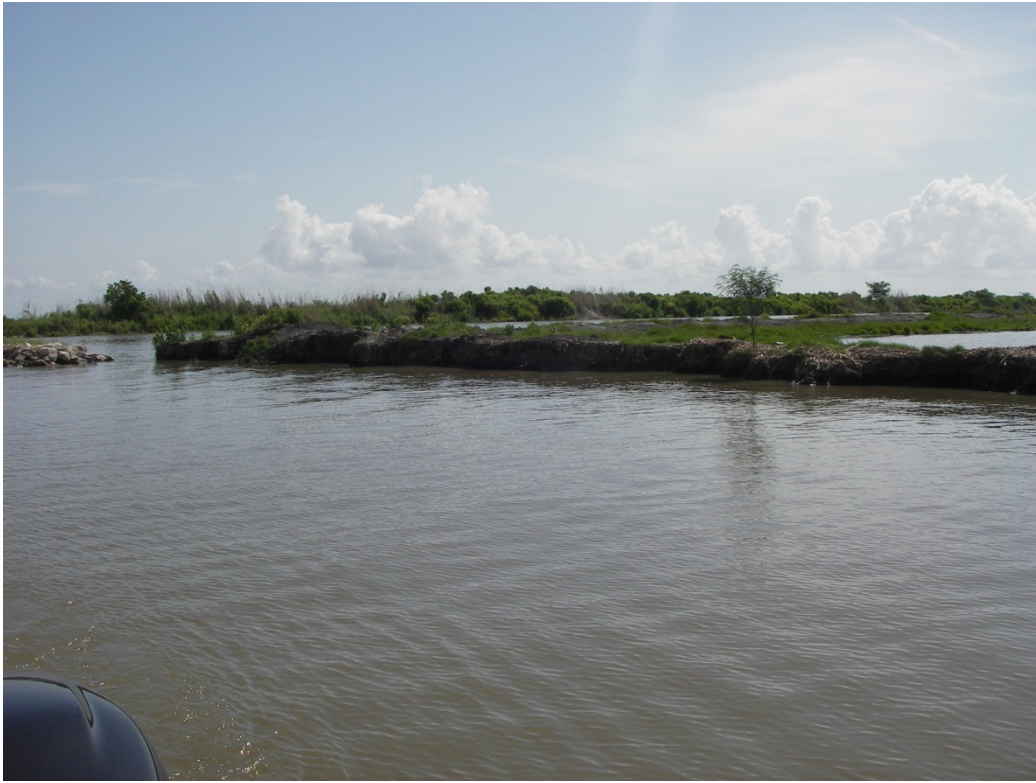
that the marsh platform is settling as expected and is near the target healthy marsh elevation of +1.7 NAVD88 on average. The northern end of the Marsh Creation Cell No. 1 appears to be settling at a greater pace than the remainder of the cell. The majority of the containment dikes are stable and the natural vegetation continues to expand. However, there are two areas of concern which are in need of repair. They are identified by orange ovals in Appendix B, Photo No. 7. One location is along the North-South Canal at its intersection with the East-West Canal adjacent to the rock plug. The second is on the Gulf ward shoreline near the East-West Canal. These areas are experiencing erosion at a fairly rapid rate. (Photos: Appendix B, Photo 2-3 & 7-9)

**Photo No. 3,** Containment Dike along North-South Canal near Rock Plug

Repair and armor the two areas of erosion at each end of the East-West Canal located on the North boundary of Marsh Creation Cell No. 1. These breaches

in the containment dike will allow the exchange of gulf water into an interior oilfield canal making the northeast corner of the project vulnerable to deterioration.

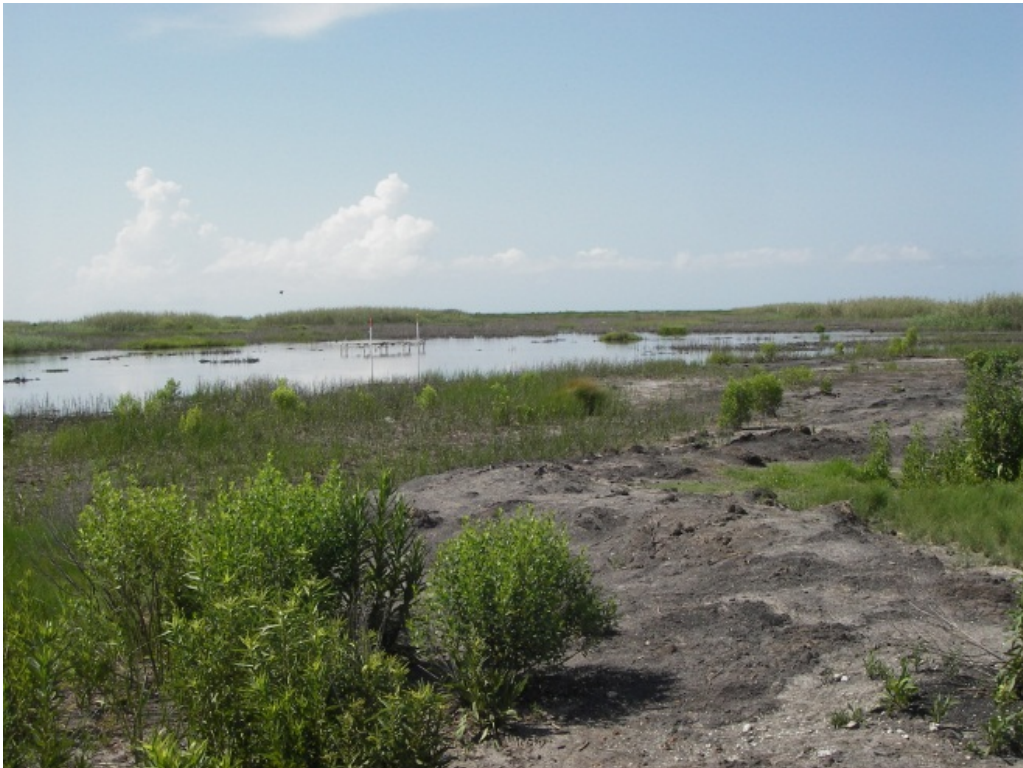
The two marsh creation cells are in good condition since the project was completed in 2010. (Photos: Appendix B, Photo 1, 4, 5 & 7) It is estimated that there is seventy per cent (70%) natural vegetation cover despite the large nutria population. The one year post construction surveys completed by T. Baker Smith in December 2011 indicated

NRCS prepared plans and specifications to install 55,000 vegetative plants (five different species) which was bid in December 2010, awarded in January 2011, and mobilization to the project site on July 2011; however, only 3,257 plants were actually installed before the contractor defaulted on the project. No further planting project was pursued within the two Marsh Creation Cells No. 1 & 2 such that the natural vegetation was flourishing. NRCS is currently looking at planting a woody species on the remnant containment dike. (Photos: Appendix B, Photo 1 &4)

**Photo No. 4,** Marsh Creation Cell No.2 (Looking South)

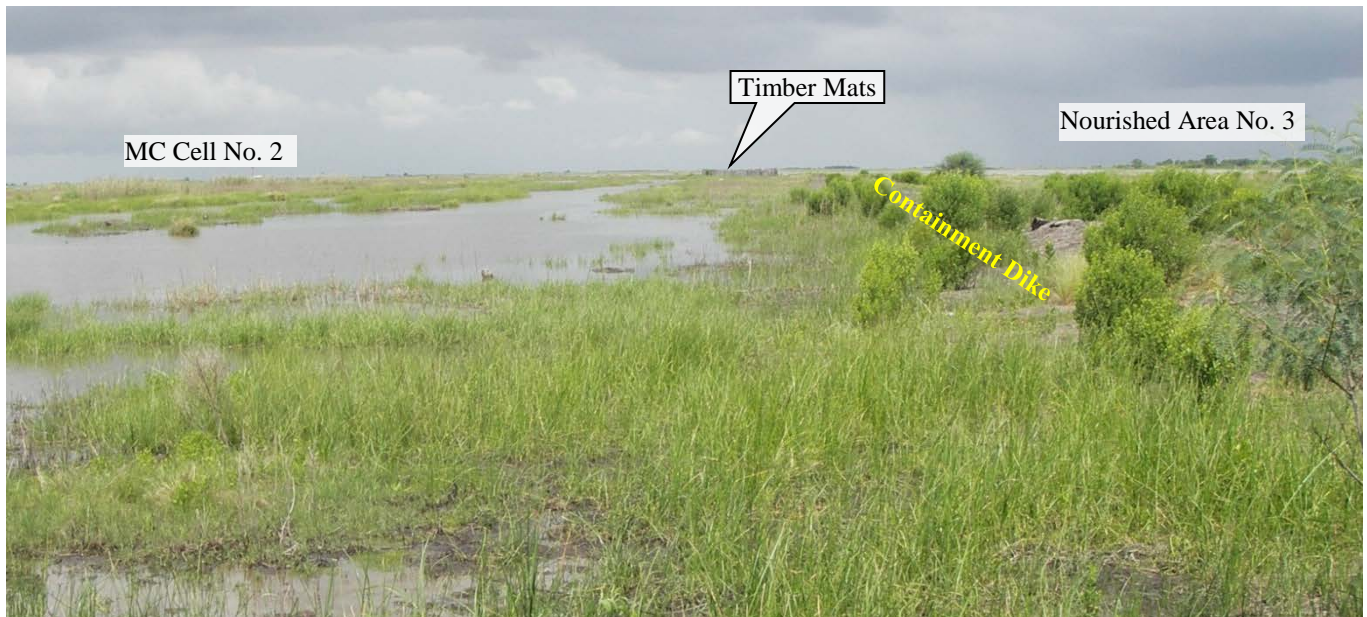
The vegetation in Nourished Areas No. 3 & 4 appears to be in good condition. (Photos: Appendix B, Photo 5) Nourished Areas No. 1 & 2 were not visited during this inspection. However, site visits performed by CPRA monitoring staff indicate that the vegetation in Nourished Area No 2. has been drastically affected by nutria damage.

**Photo No. 5,** Marsh Creation Cell No. 2, Borrow Channel, Containment Dike, Timber Mats, and Nourished Area No. 3 (Looking West)

- Perform the planned gap degrading at the Timber Mat location and Gap “N” in the Marsh Creation cell No. 2 containment dike to allow tidal exchange into that cell.
- Degrade four existing plugs left by the contractor in the interior marsh of Nourishment Area No. 1 and Nourishment Area No. 2 to allow drainage and prevent stagnation.
- NRCS will re-evaluate the vegetation on the containment dikes for a potential Spring 2015 planting (woody species) for those reaches which are bare.

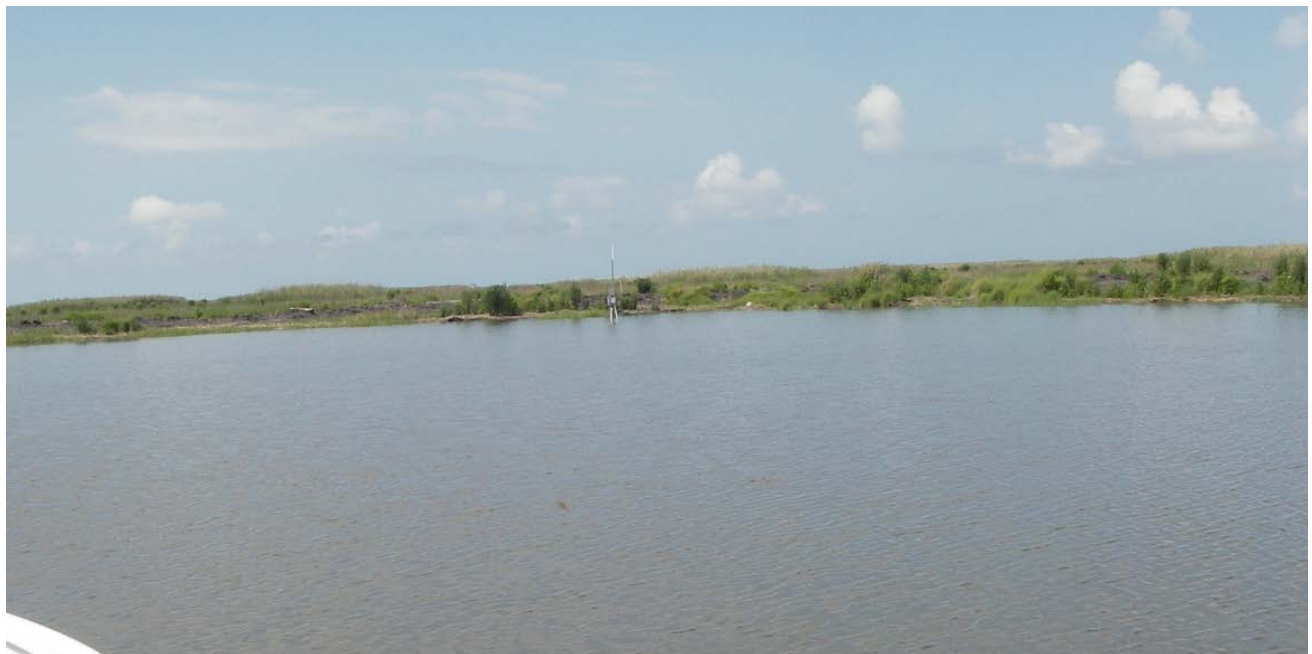
The earthen plug at the end of the North-South Pipeline Canal is holding up well with no differential settlement taking place. There are some bare spots remaining where vegetation has not taken hold. (Photos: Appendix B, Photo 6)

**Photo No. 6,** Earthen Plug at End of North-South Pipeline Canal

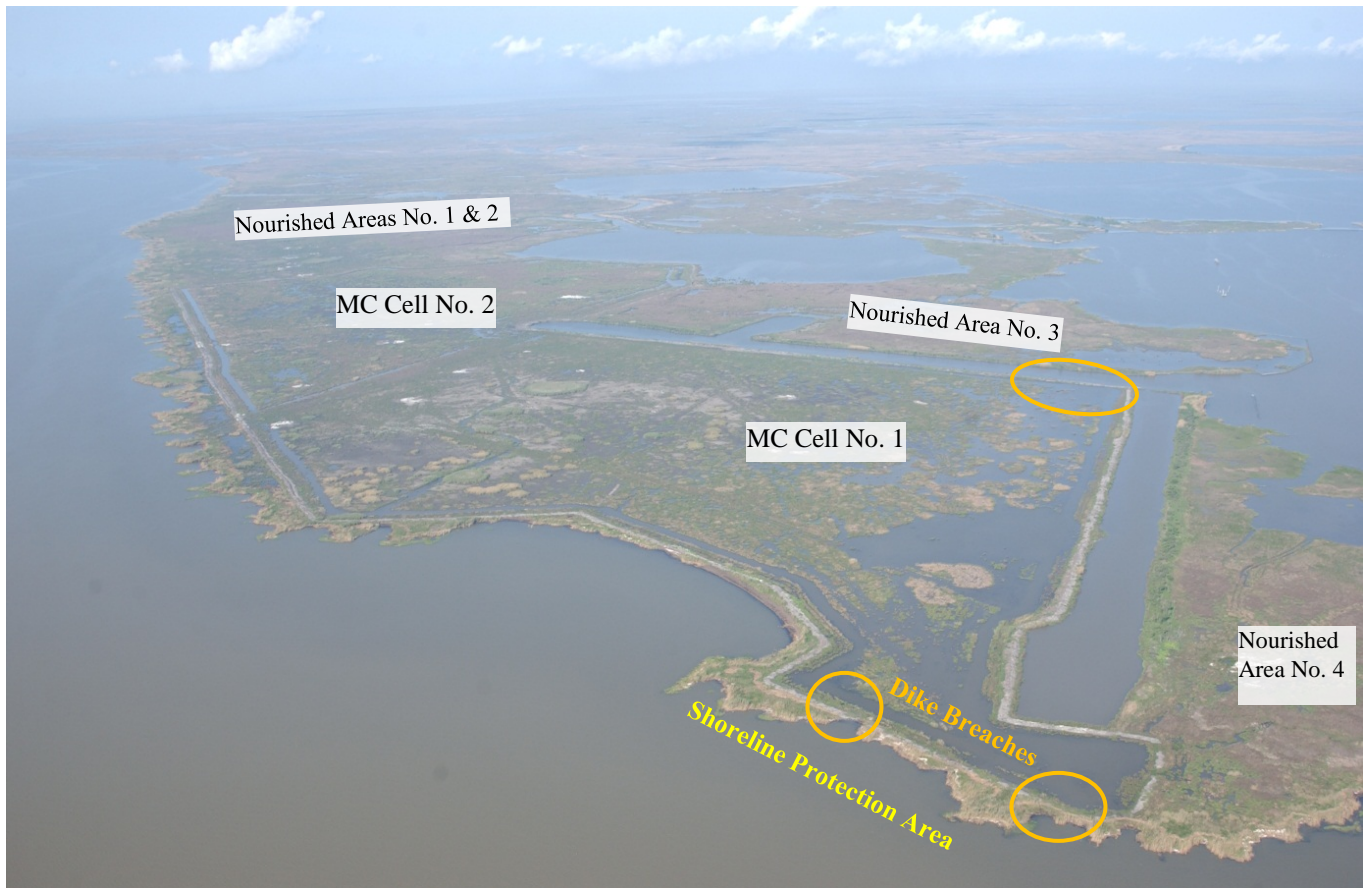
**Photo No. 7**, Aerial view (March 2012), Looking Southwest at Project Area

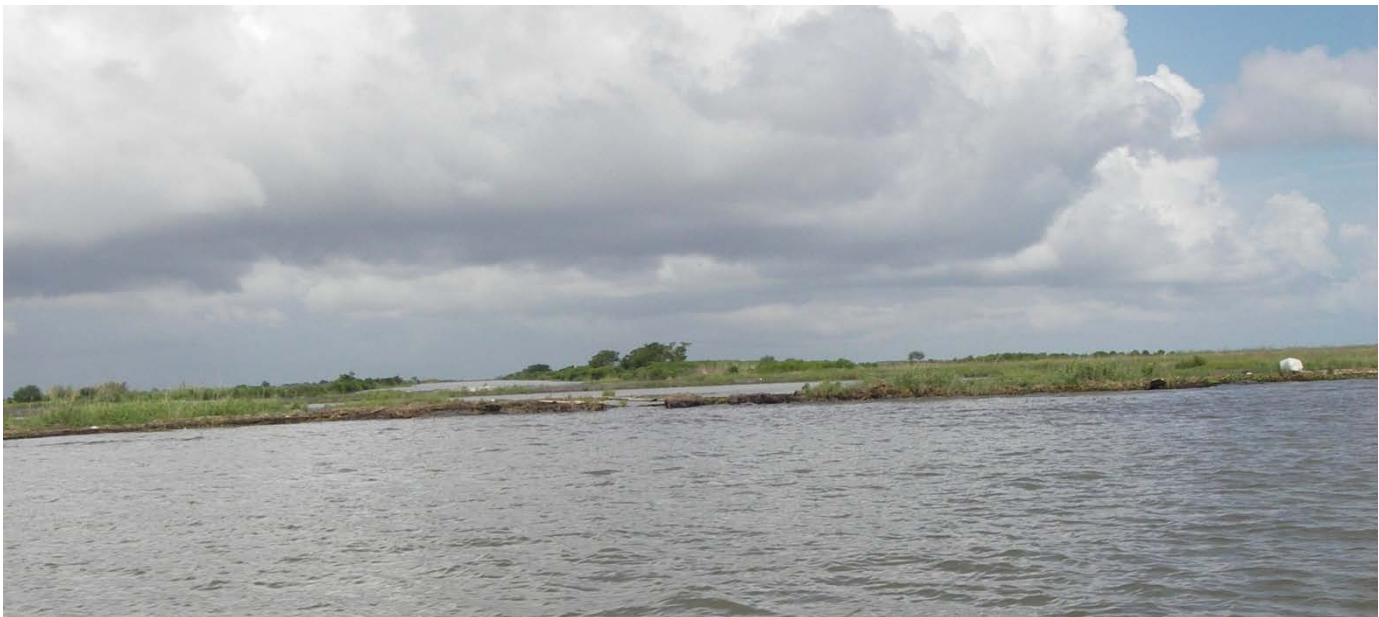
**Photo No. 8**, Containment Dike along Gulfward Shoreline at NE Corner of MC Cell No. 1  
(Northern Most Section of Intended Armor Area)

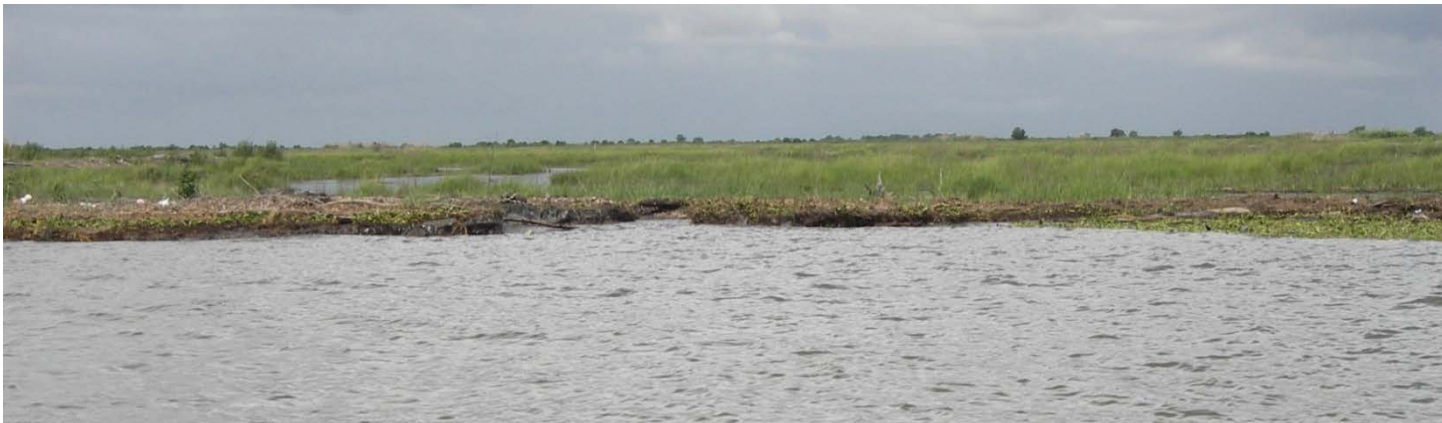
**Photo No. 9,** Containment Dike along Gulfward Shoreline at NE Corner of MC Cell No. 1  
(Original Breach near Southern Section of Intended Armor Area)
