**2013 Operations, Maintenance,  
and Monitoring Report**

**Humble Canal Hydrologic  
Restoration (ME-11)**

State Project Number ME-11  
Priority Project List 8

March, 2013  
Lafayette Parish

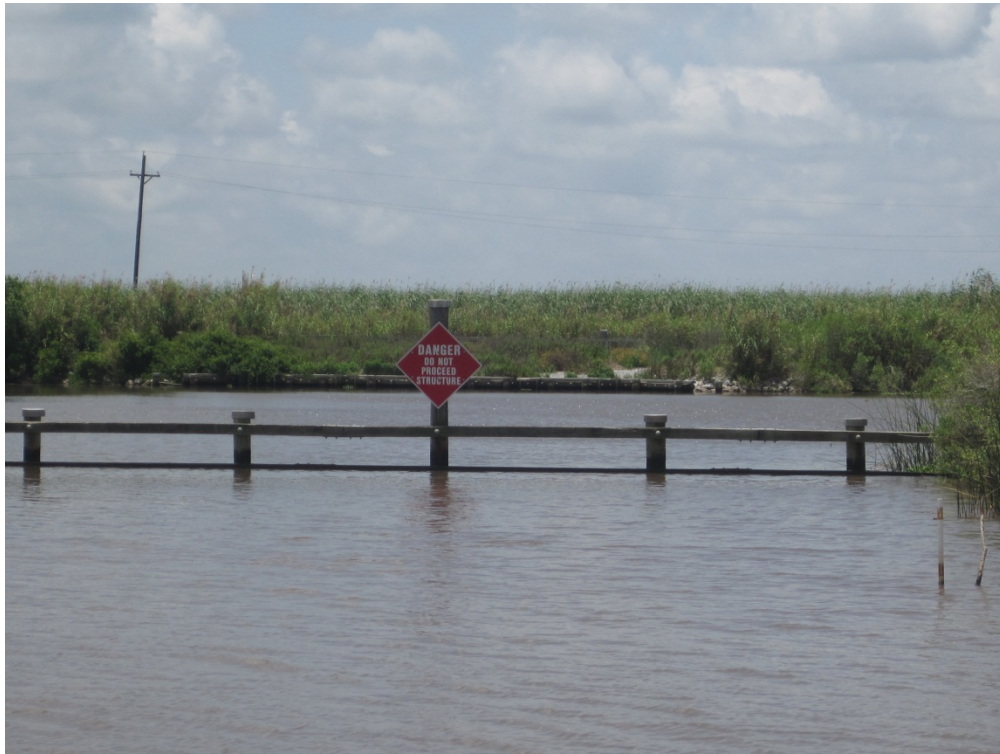
The structure is in excellent condition and the warning signs were intact. (Photos: Appendix A, Photo 1)

**Photo No. 1, Marine barrier with signage.**

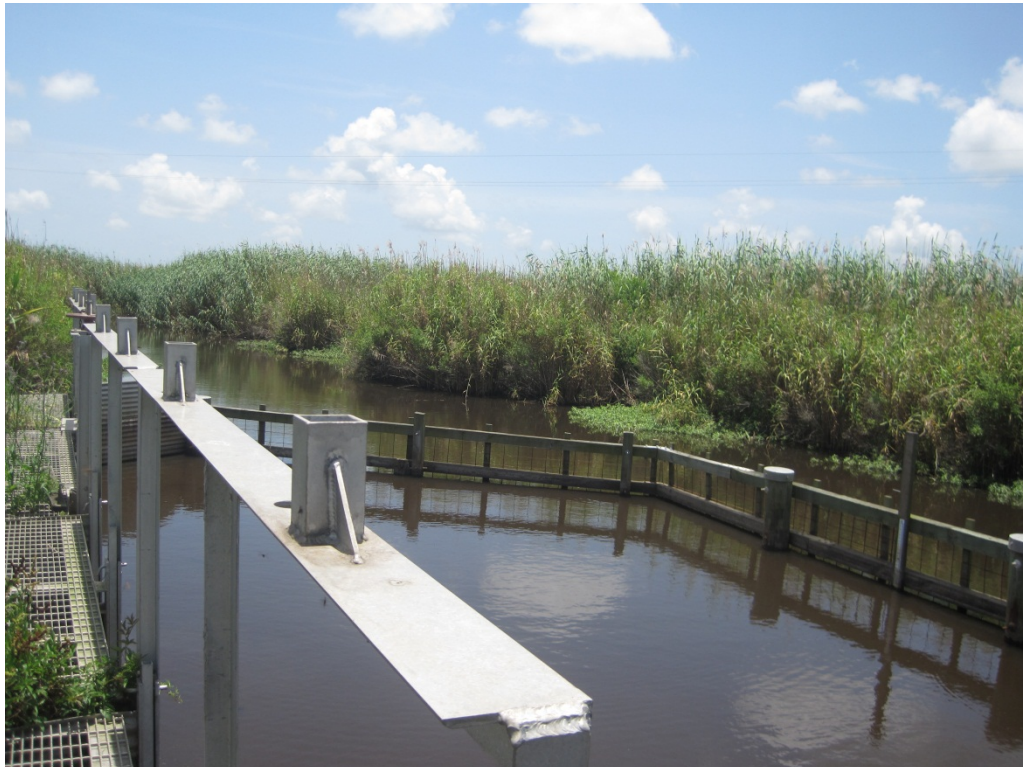
This feature is in good condition. The wire fence material, wooden pilings, and bracing replaced during the last maintenance event are in working order. (Photos: Appendix A, Photo 2 & 3)

The structure is in good condition. The stoplogs, flap gates, and screw gate appear to be functioning as intended. The wingwall rock armor on the inlet and outlet side of the structure and the crushed stone aggregate on the top of the structure are intact. (Photos: Appendix A, Photos 2 & 4)

**Photo No. 2, Inlet side of structure**

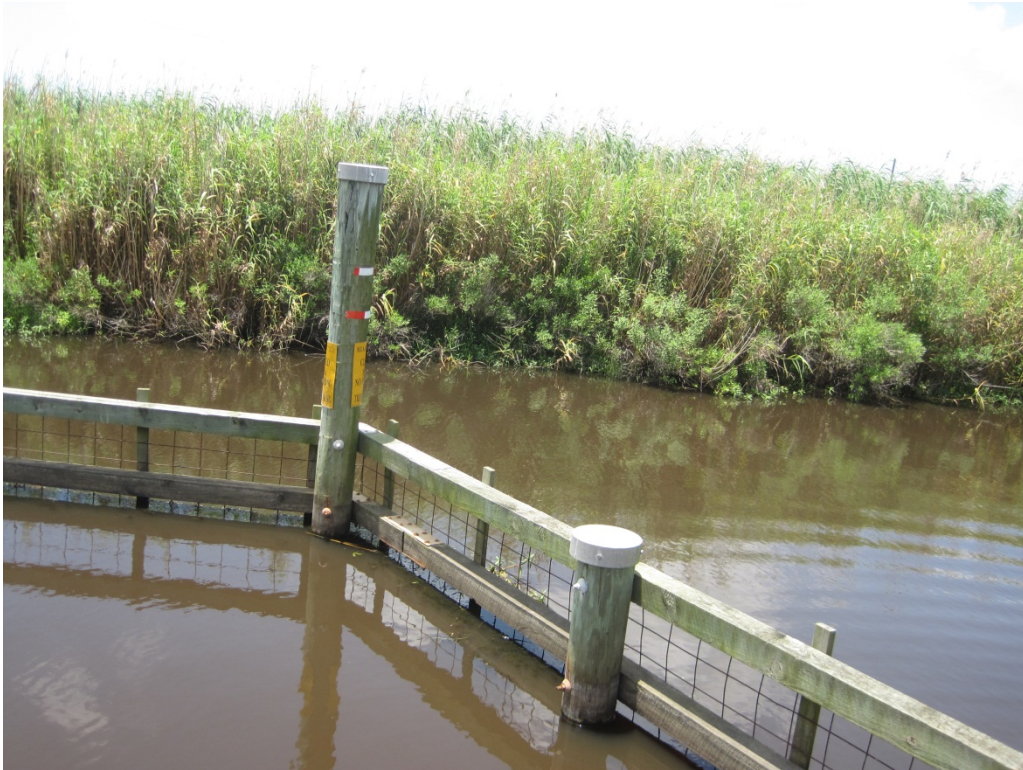
**Photo No. 3, Inlet side of structure**

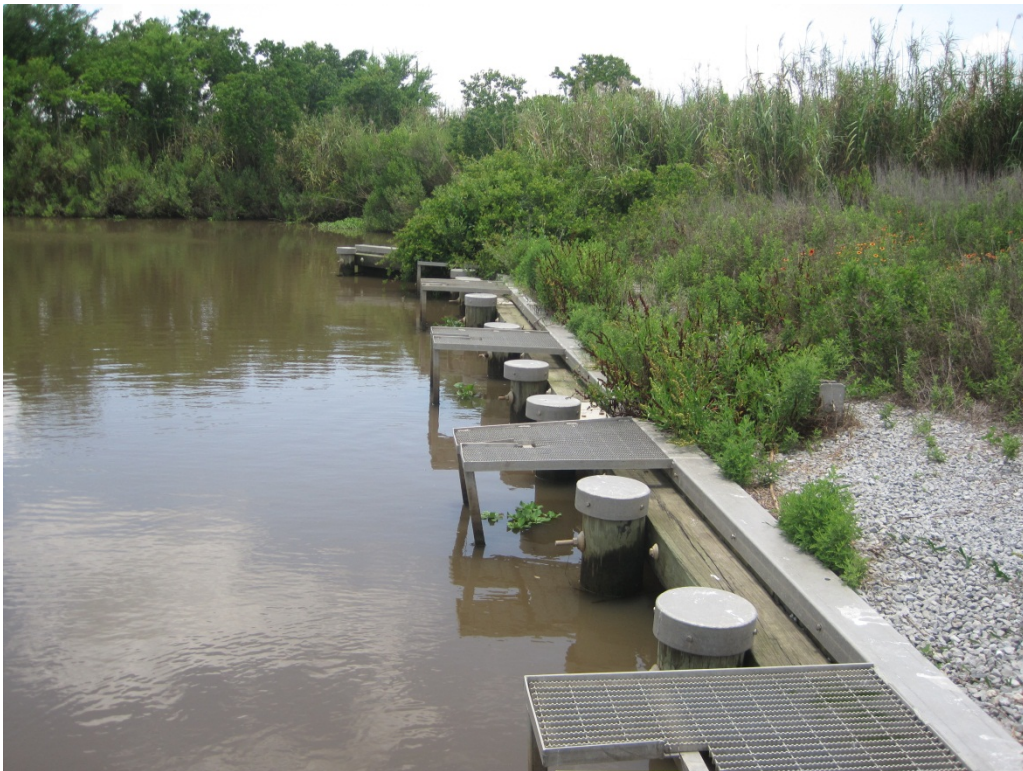
**Photo No. 4, Outlet side of structure**

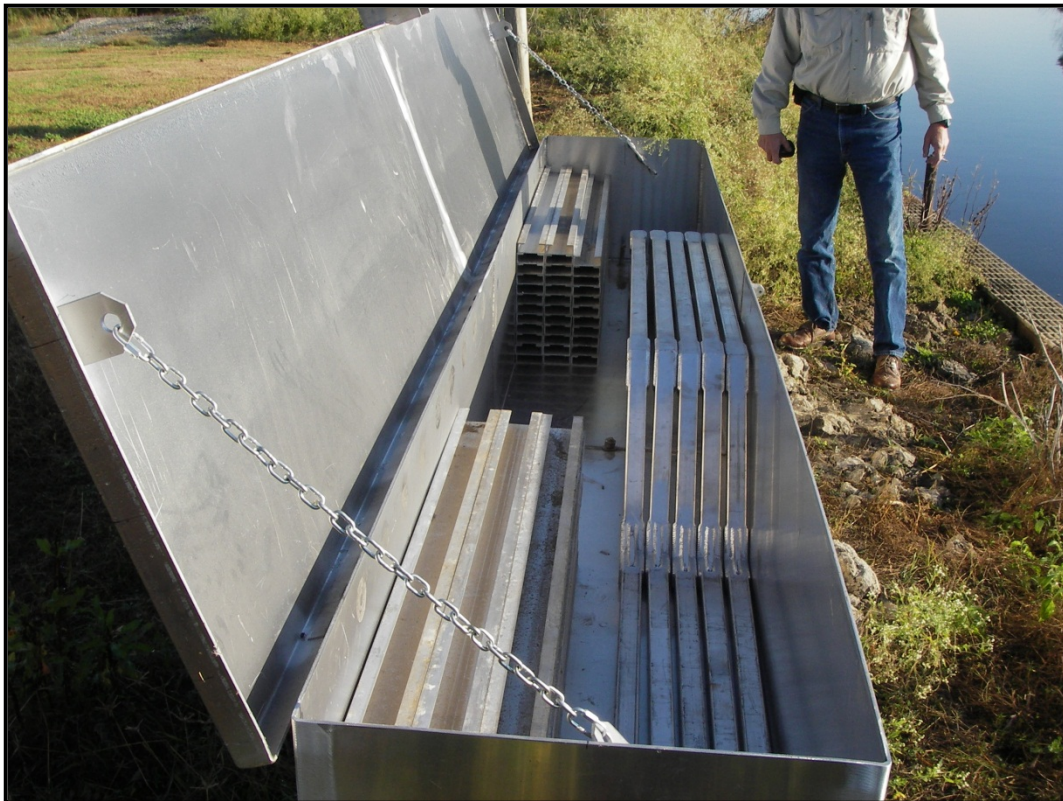
**Photo No. 5,** Storage box for locking arms and stop logs
