2013 Operations, Maintenance, and Monitoring Report

GIWW (Gulf Intracoastal Waterway) to Clovelly Hydrologic Restoration (BA-02)

State Project Number BA-02 Priority Project List 1

December 2013 Lafourche Parish

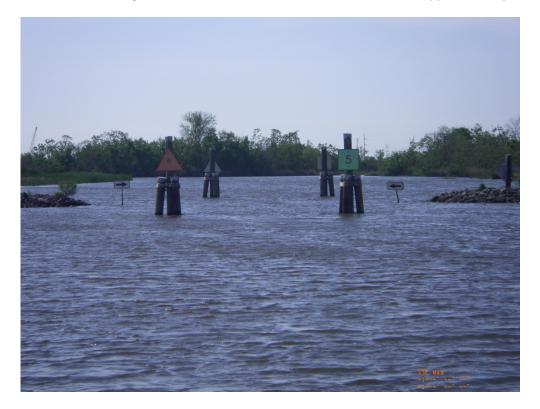
to the four (4) timber pile dolphins at the opening of the barge bay. This damage was believed to be caused by an oilfield barge navigating the opening of the structure and includes the vertical piles splitting, piles displaced from original position, scarring on the surface of the piles, and the complete destruction of one of the four dolphin structures. Due to the poor condition of the timber dolphins, they were replaced and fitted with new signs as part of the 2012 Maintenance Project. Also, as a precaution, the timber dolphins were installed one (1) foot further apart to allow barges to move more freely through the barge bay without future damage to the structure. At the time of the inspection, the timber pile dolphins appeared to be in good condition with no signs of damage. There are no recommendations for maintenance at this time. (See Appendix A, Photos 3 through 8)

Photo 4: Overall view of Structure 1 rock riprap weir, looking southwest

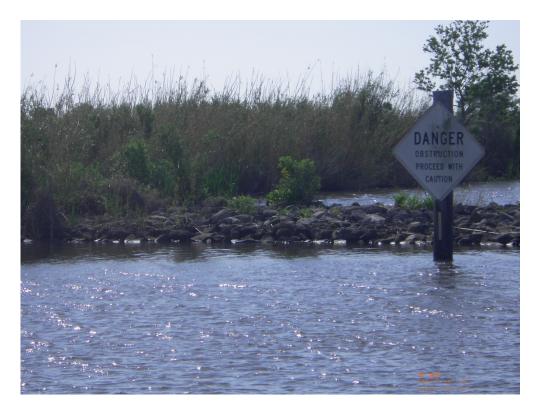
Photo 5: Close up view of the embankment tie-ins on the east side of Structure 1

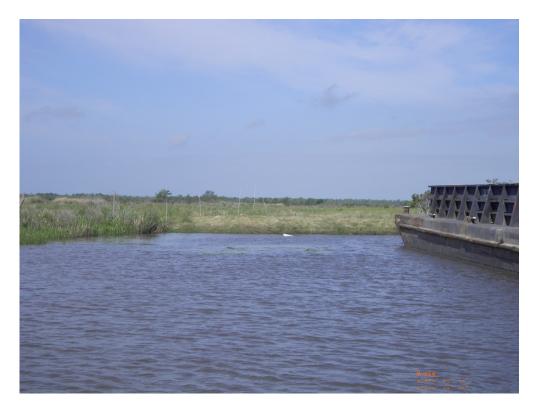
Photo 9: View of Breach Closure No. 5 which was part of the 2012 Maintenance Project

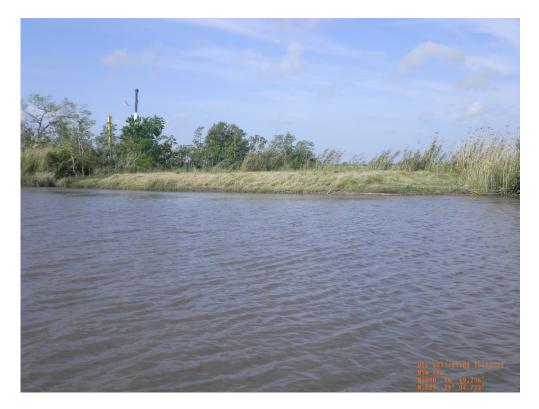
Photo 11: View of Breach Closure No. 4 which was part of the 2012 Maintenance Project

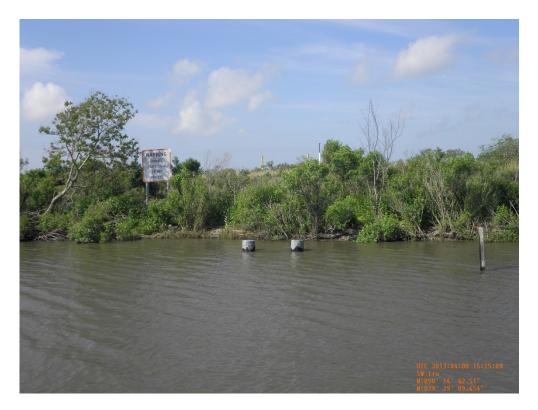
Structure 91 rock plug appeared to be in good overall condition. There were no signs of rock settlement or erosion around the embankment tie-ins. Previous inspections revealed the sheet metal covering the timber piles supporting the corrugated metal pipe were rusted and corroded. As a result, new galvanized timber pile caps were installed as part of the 2012 Maintenance project to prevent the piling from rotting internally. Also, the warning sign for the structure has been damaged by vandals as it appears the sign has endured several shots from a shotgun. Because the sign is still legible, there are no recommendations for maintenance at this time, but it will continue to be monitored on future inspections for further damage. (See Appendix A, Photos 13 through 16)

Photo 13: Overall view of Structure 91 rock plug with culvert and flap gate, looking south

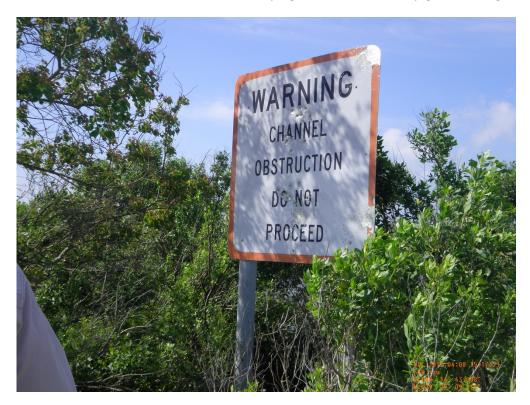
Photo 14: Close up view of Structure 91 warning sign damaged by vandals

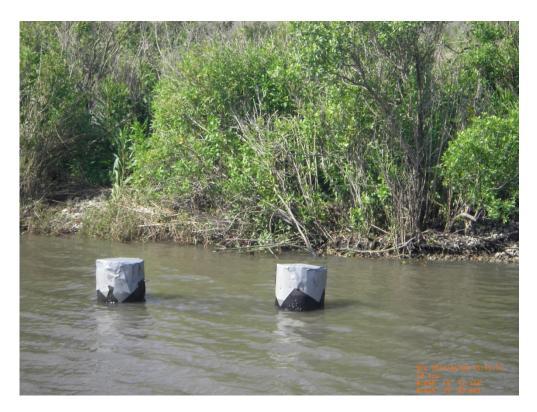
Photo 15: Galvanized pile caps installed on canal side of Structure 91 as part of 2012 Maintenance Project

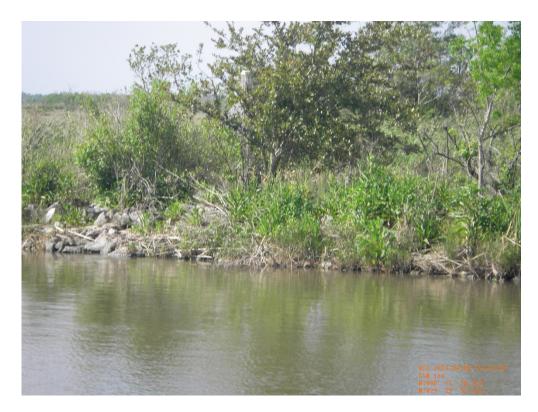
Structure 90 appears to be in overall good condition with no rock settlement/ displacement or erosion around the embankment tie-ins. All warning signs and supports are in good condition also. There are no recommended corrective actions at this time. (See Appendix A, Photos 17 through 20)

Photo 19: Close up view of the embankment tie-in on the northwest side of Structure 90

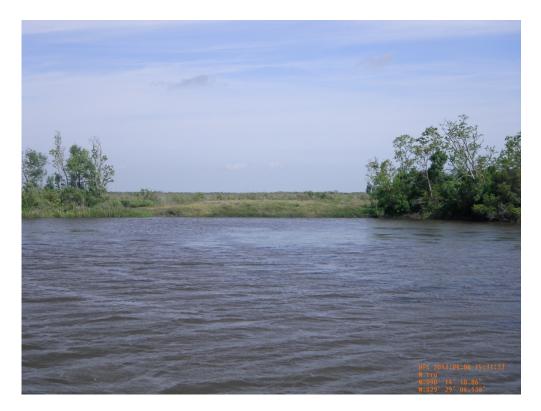
Photo 21: View of Breach Closure No. 2 which was part of the 2012 Maintenance Project

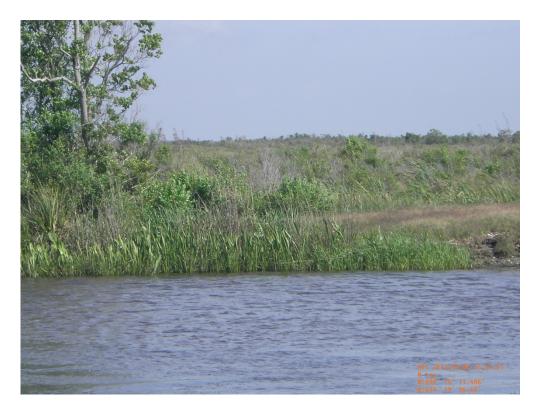
Photo 23: View of Breach Closure No. 2 which was part of the 2012 Maintenance Project

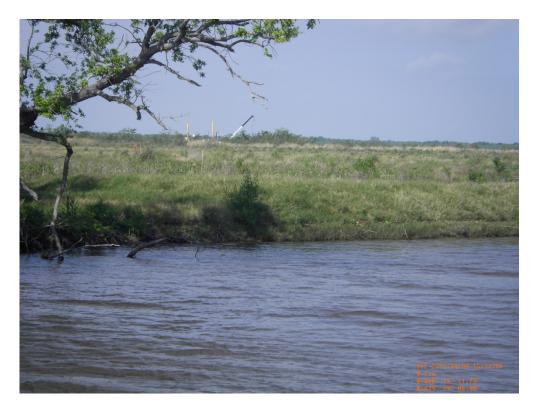
Photo 25: View of Breach Closure No. 3 which was part of the 2012 Maintenance Project

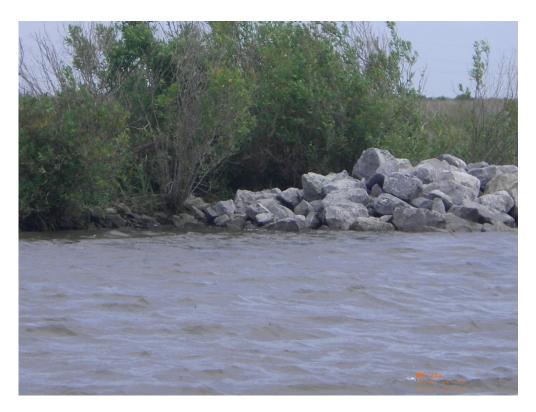
Photo 31: View of the southernmost end of the Lake Rim rock dike refurbishment in Breton Canal

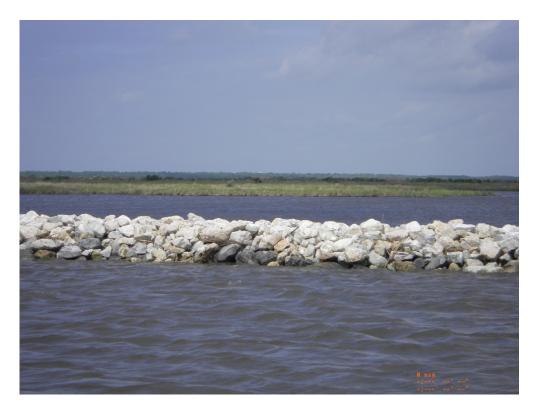
Photo 35: View of the Lake Rim rock dike refurbishment from Breton Canal, looking northwest

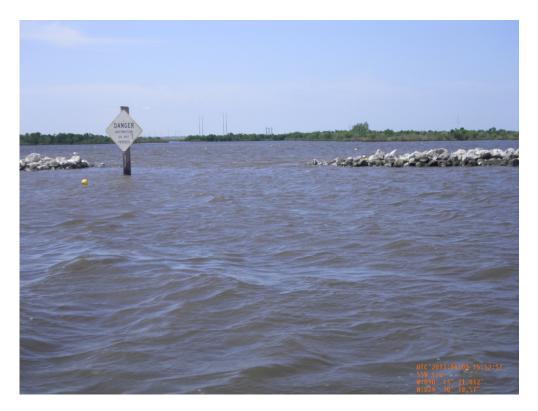
Photo 37: View of Lake Rim fish dip and warning sign from Little Lake, looking west

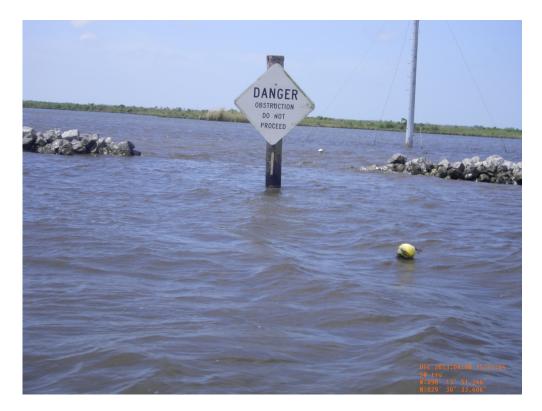
Photo 39: View of Lake Rim fish dip and warning sign from Little Lake, looking southwest

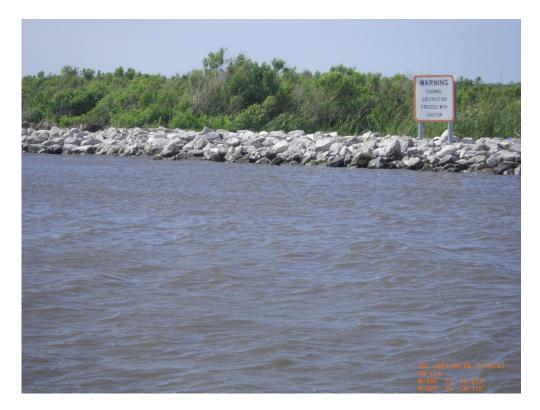
Maintenance Project. By comparing the preconstruction drawings to the as-built drawings, it is shown that the sections between the bank and boat bay have been elevated approximately two (2) feet from +1.0' NAVD88 to +3.0' NAVD88 and the bottom sill of the boat bay elevated approximately seven (7) feet from -12.0' NAVD88 to -5.0' NAVD88. During the inspection, there were no areas where settlement was observed since the end of construction. The warning signs and navigational aids on Structure 2 are in good condition and do not require maintenance at this time. (See Appendix A, Photos 40 through 44)

Photo 41: View of warning sign and rock recap on the southern side of Structure 2

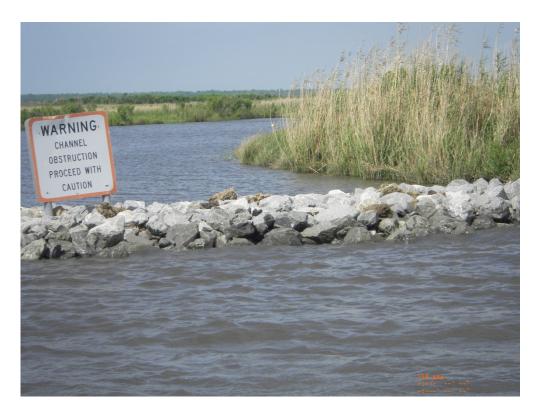
Photo 43: View of warning sign and rock recap on the northern side of Structure 2

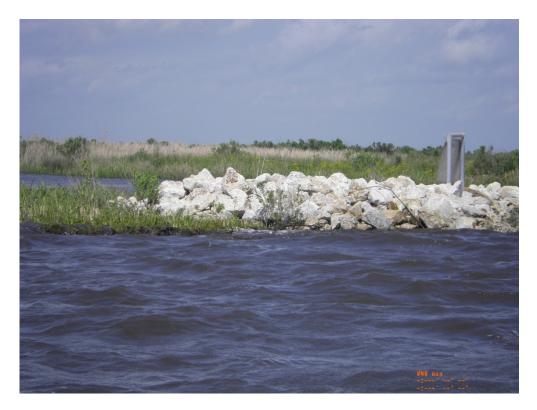
Photo 45: View of the warning sign and embankment tie-in on the south side of Structure 4

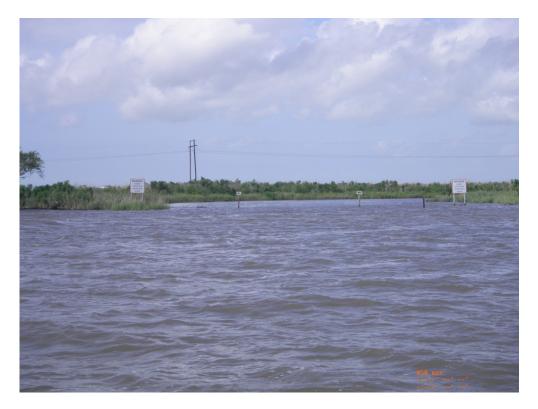
Structure 7 appeared to be in fair condition with some settlement of the rock riprap material but no visual damage to the weir or erosion around the embankment tie-ins. The original as-built drawings show the weir was constructed to a height of -4.4 NAVD in the boat bay and +2.4' NAVD on the north and south sides between the bank and boat bay. Observations and data

from previous surveys show this structure has settled uniformly along the entire length of the structure approximately 1.0' to 1.5'. Because the settlement of the Structure 7 has been minor and uniform causing no breaching of the structure, it was not included in the 2012 Maintenance Project, but the structure will continue to be monitored during future inspections. All warning and navigational signs and their supports appear to be in good condition. (See Appendix A, Photos 53 through 55)

Photo 53: Overall View of Structure 7 fixed crest rock weir with boat bay, looking west

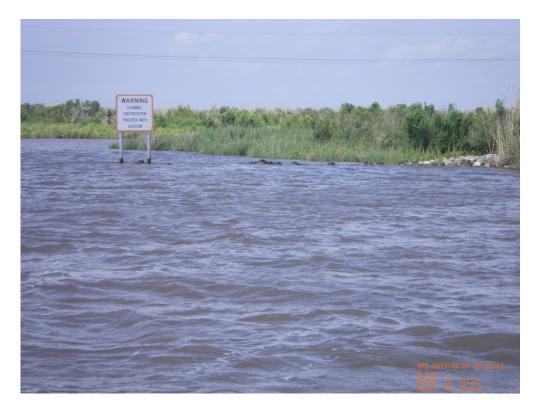
Photo 55: View of the warning sign and embankment tie-in on the northern end of Structure 7

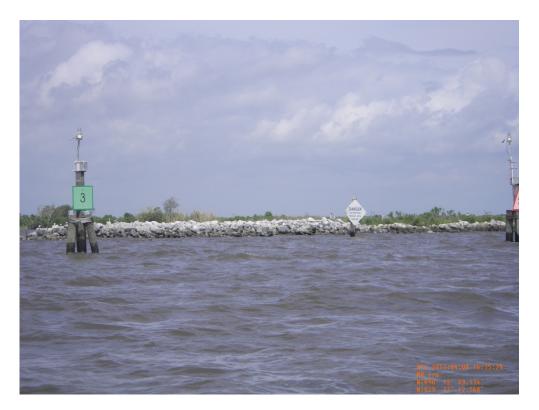
structure was replaced in 2006 and remains in good condition. There are no recommendations for maintenance at this time. (See Appendix A, Photos 58 through 66)

Photo 59: View of the rock recap on the northern side of Structure 14 from Little Lake, looking northwest

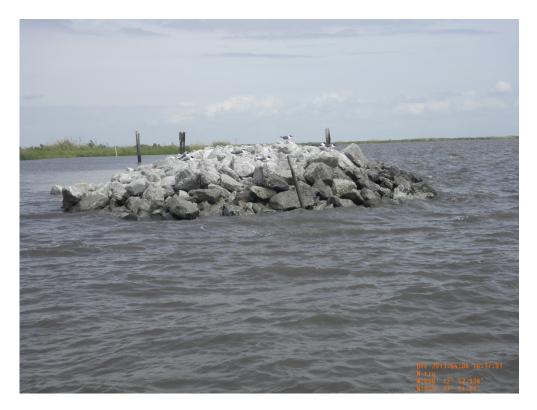
Photo 61: View along the rock recap on the northern side of Structure 14 from the barge bay, looking north

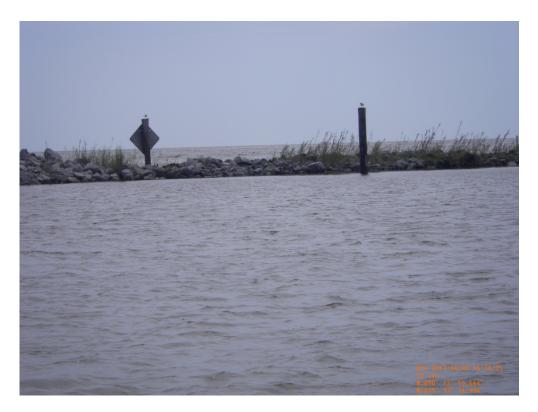
Photo 65: View along the southern side of Structure 14 from Clovelly Canal, looking southeast
