**2012/2013 Annual Inspection
Report**

**SWEET LAKE/ WILLOW LAKE
HYDROLOGIC RESTORATION
PROJECT
(CS-11b)**

State Project Number CS-11b
Priority Project List 5

June 12, 2013
Calcasieu Parish

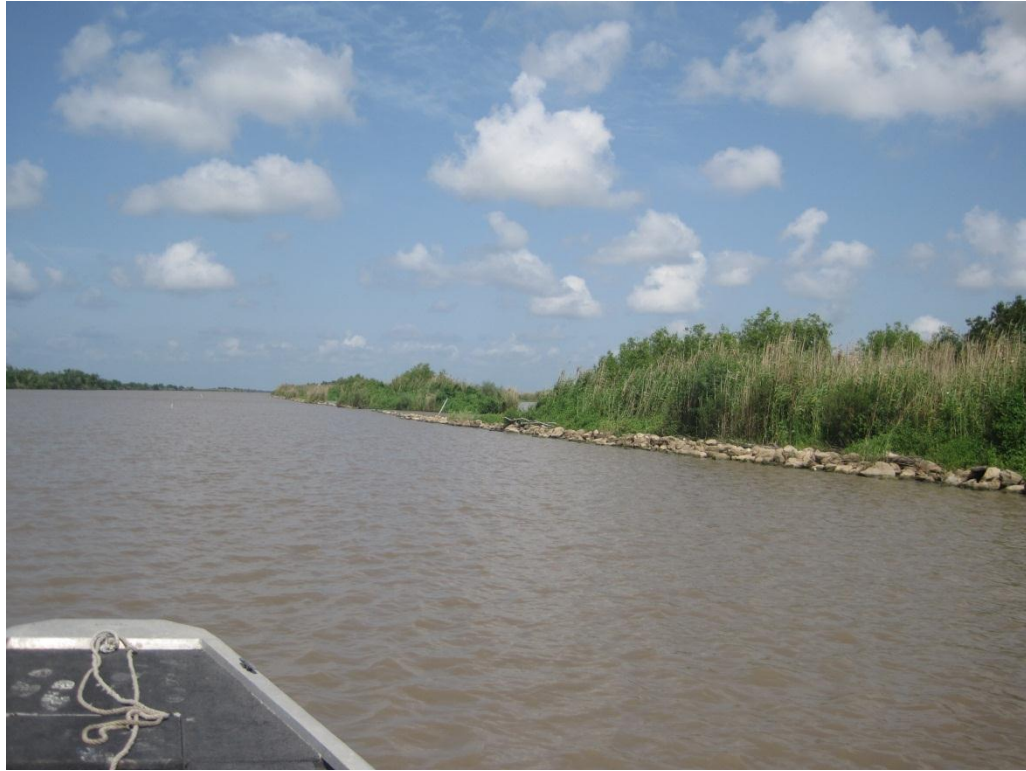
The dikes are in reasonably good condition. (See Appendix B, Photo 1-3). There are a few low places along the length of the rock dike with the most significant stretches along the open water areas adjacent to Sweet Lake along with an area approximately 50 feet wide along the very eastern end of the project area in which the dike appears to have been “pushed back” 10-12 feet apparently by a barge. There is another area approximately 4 feet wide in which the dike appears to have been removed by hunters or fishermen. Several settlement plates are either broken or leaning and are of no use. No gauges were available in the vicinity to determine water levels. The shallow water terraces feature of the project was not inspected at this time. The terraces were not visible during prior inspections.

Photo No. 1, (Sweet Lake) Typical rock dike

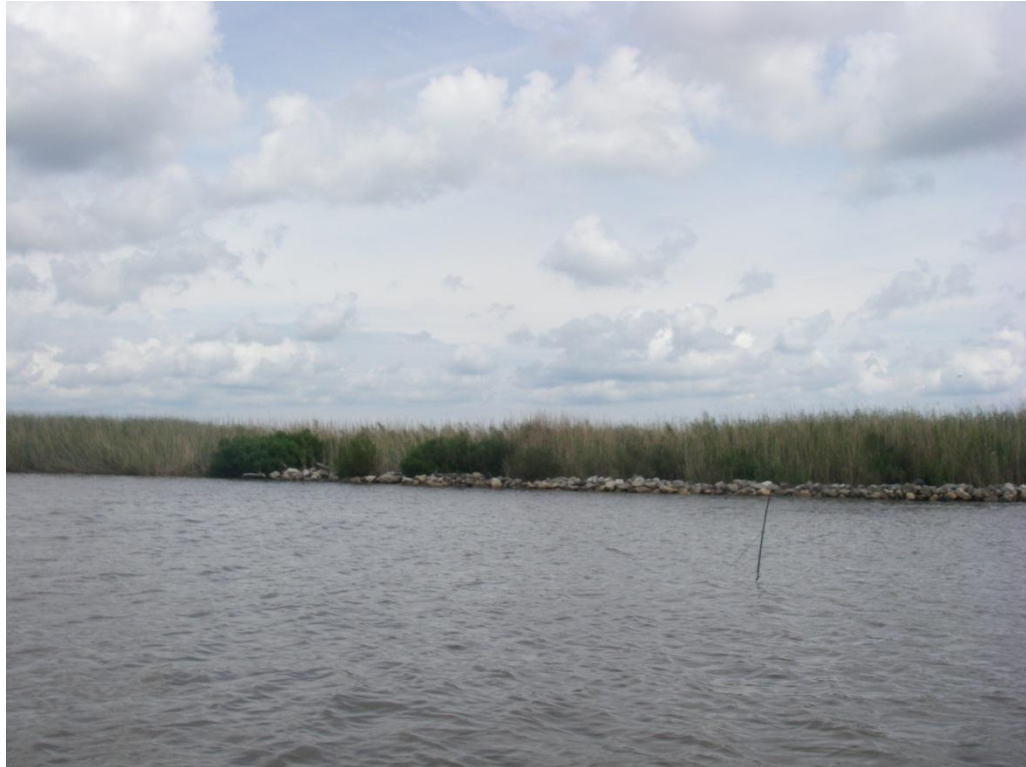
Photo No. 2, Western End of Sweet Lake Rock Dike

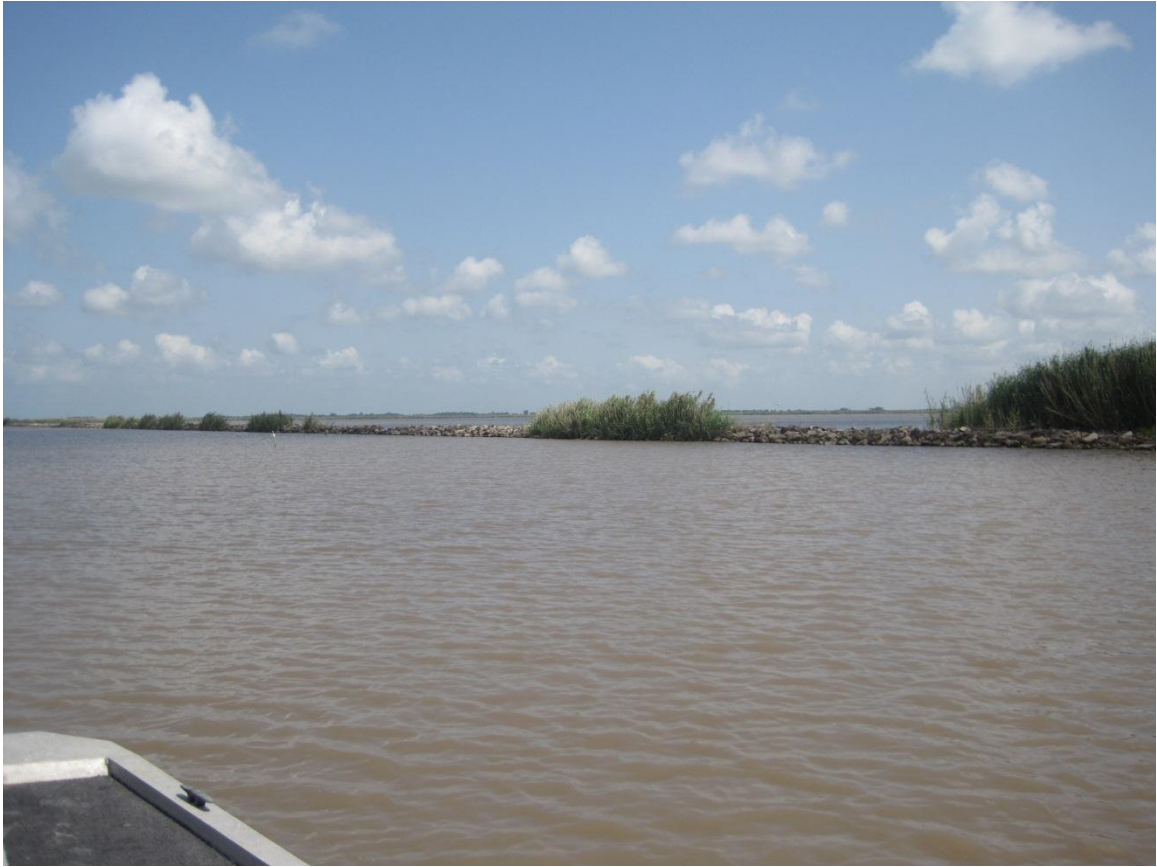
Photo No. 3, Willow Lake Rock Dike (Southeastern End)
