**2012/2013 Annual Inspection
Report**

**CAMERON/CREOLE
WATERSHED HYDROLOGIC
RESTORATION PROJECT
(CS-17)**

State Project Number CS-17
Priority Project List 1

December 12, 2012
Cameron Parish

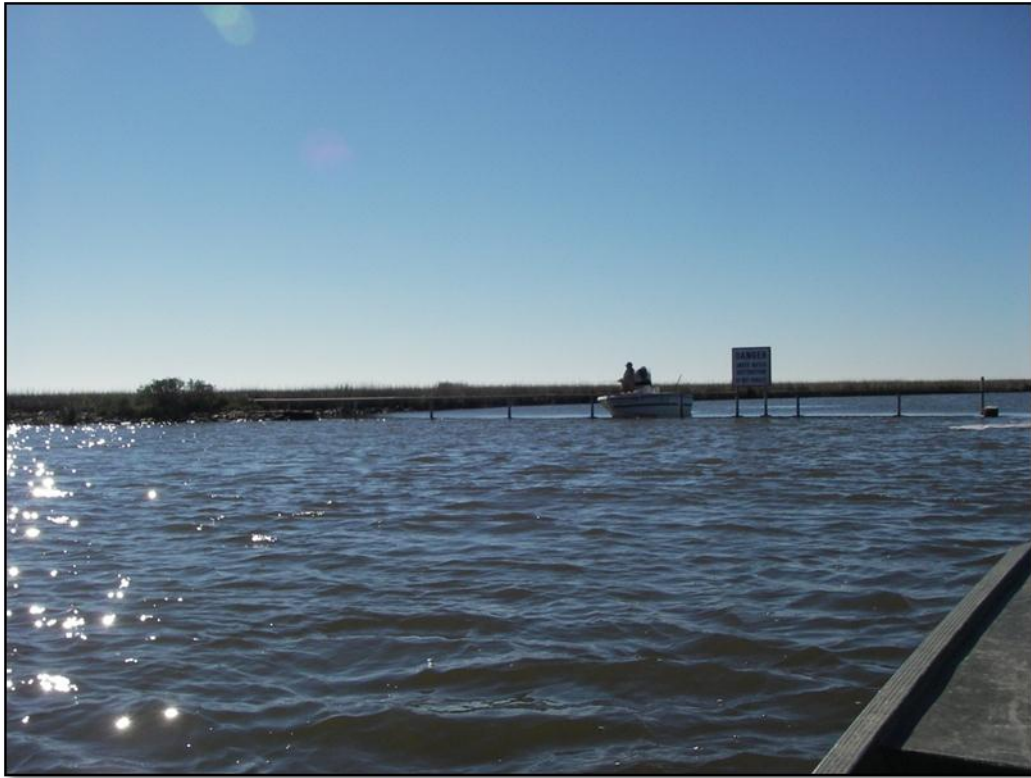
Photo 1, Grand Bayou Weir, view of rock east side.

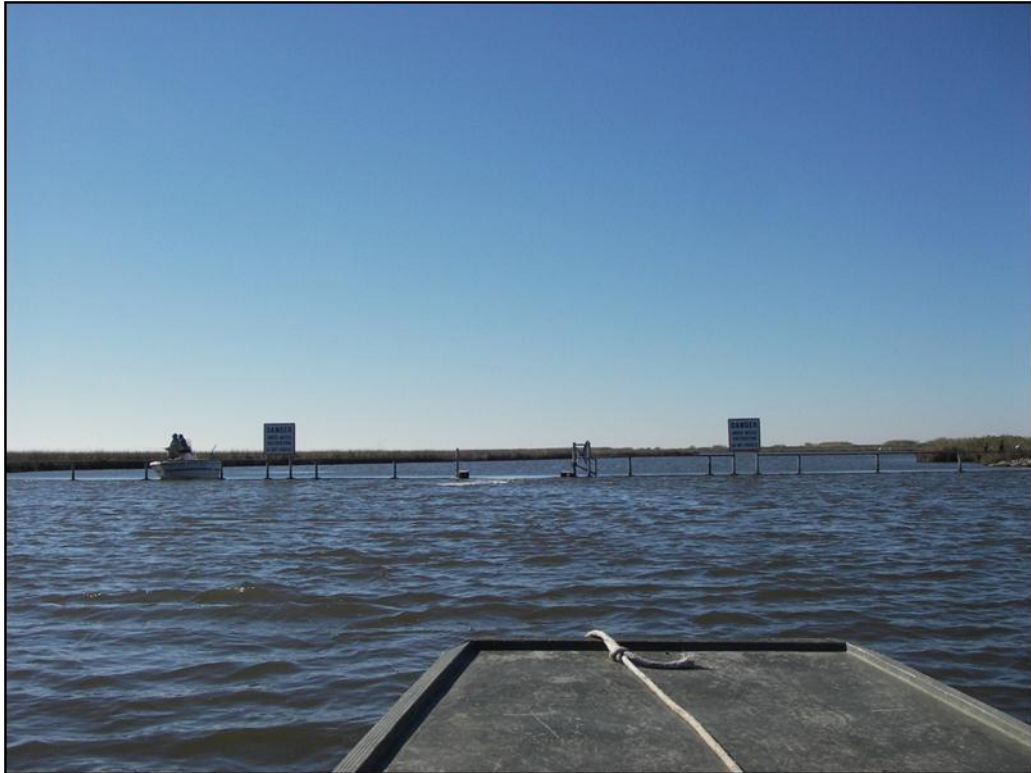
Overall this structure is in good condition. The west boat guide has been removed from the structure assumed to be by vandals. The east boat guide has been removed from the structure by Tal McCain and is currently at Lonnie Harper's Office. Warnings signs, swing gate and top rail are still visible. The recent maintenance event performed in 2009 to armor the ends of the sheet pile wall has been effective and looks in good condition. The sheet pile wall is showing signs of deterioration and will be monitored during future inspections. (Photos: Appendix B, Photos 1-4).

Photo 2, Grand Bayou Weir, view showing missing boat guides.

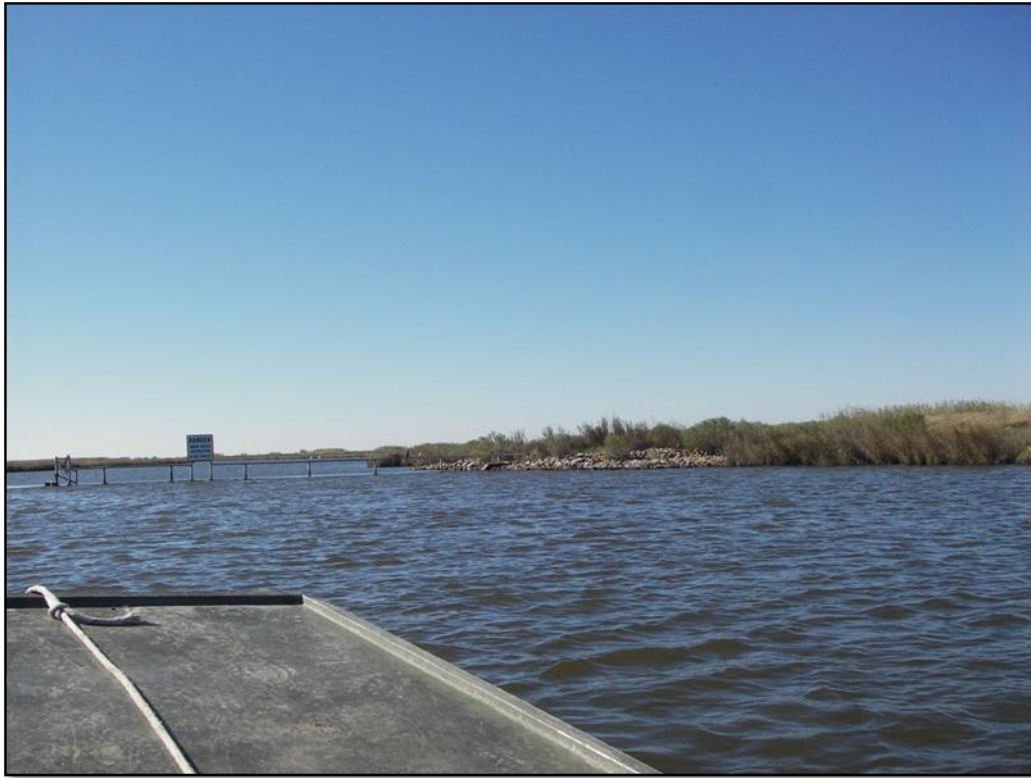
Photo 3, Grand Bayou Weir, view showing rock armor on west side.

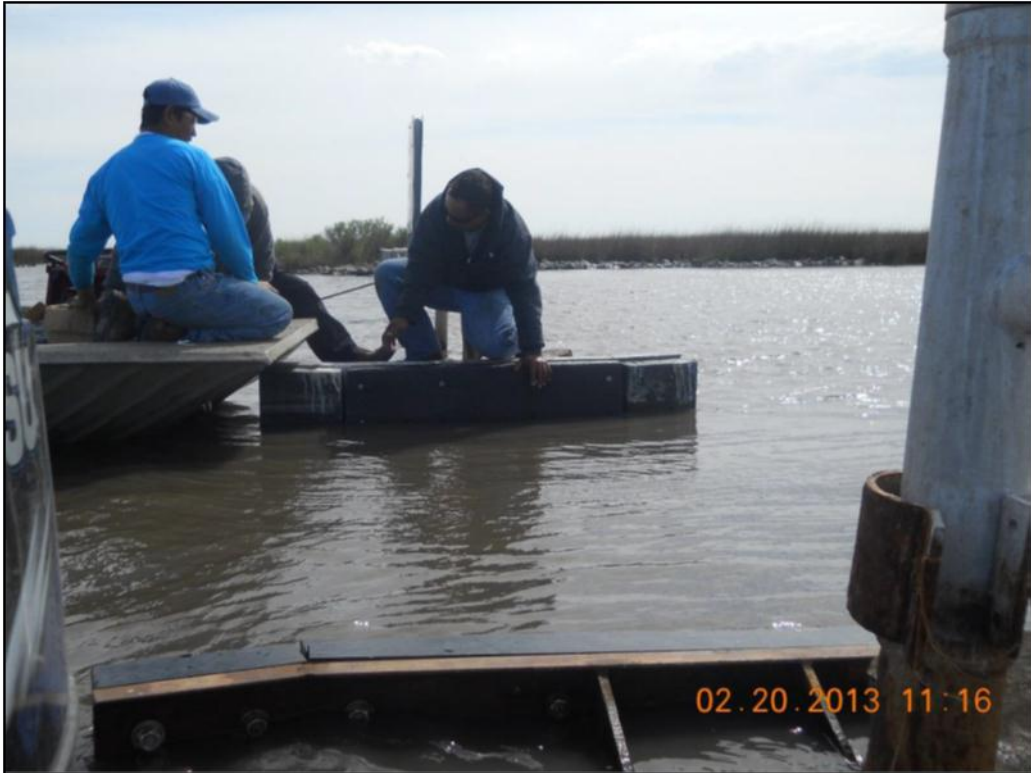
Photo 4, Grand Bayou Weir, boat guide replacement.

Item	Condition	Physical Damage	Corrosion	Photo #	Observations and Remarks
Steel Bulkhead / Caps	Fair				
Steel Grating	N/A				
Stop Logs	N/A				
Hardware	Fair				
Boat Guides	Fair			4	West boat guide missing. East boat guide removed and being held by Lonnie Harper's office. Repaired as part of CS-04a maintenance project (2/20/2013).
Timber Wales	N/A				
Galv. Pile Caps	Fair				
Cables	N/A				
Signage /Supports	Good			1,2,3	
Rip Rap (Rock Armor)	Good			1,3	
Eathern Embankment	Good

Overall, the structures of the Cameron-Creole Watershed Project are still in fair condition and are functioning as designed. The boat guide at Grand Bayou was replaced as part of a maintenance event for the Cameron-Creole CS-04a project (Photos: Appendix B, Photo 4). At the conclusion of the CS-04a project, one of the boat guides at Mangrove Bayou was missing.

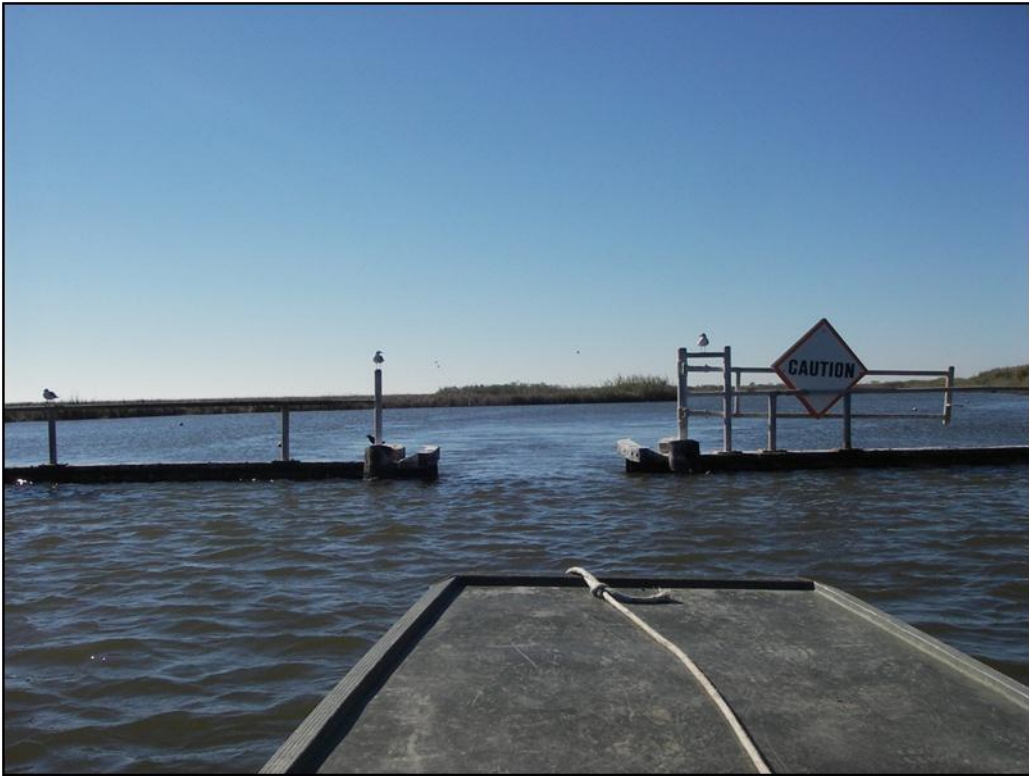
Overall the structure is in good condition. Both boat guides remain on the structure. Warning signs and top railing are still visible. The recent maintenance event performed in 2009 to armor the ends of the sheet pile wall has been effective and looks in good condition. The sheet pile wall is showing signs of deterioration and will be monitored during future inspections. (Photos: Appendix B, Photos 5-7).

Photo 5, Mangrove Weir, view looking south.

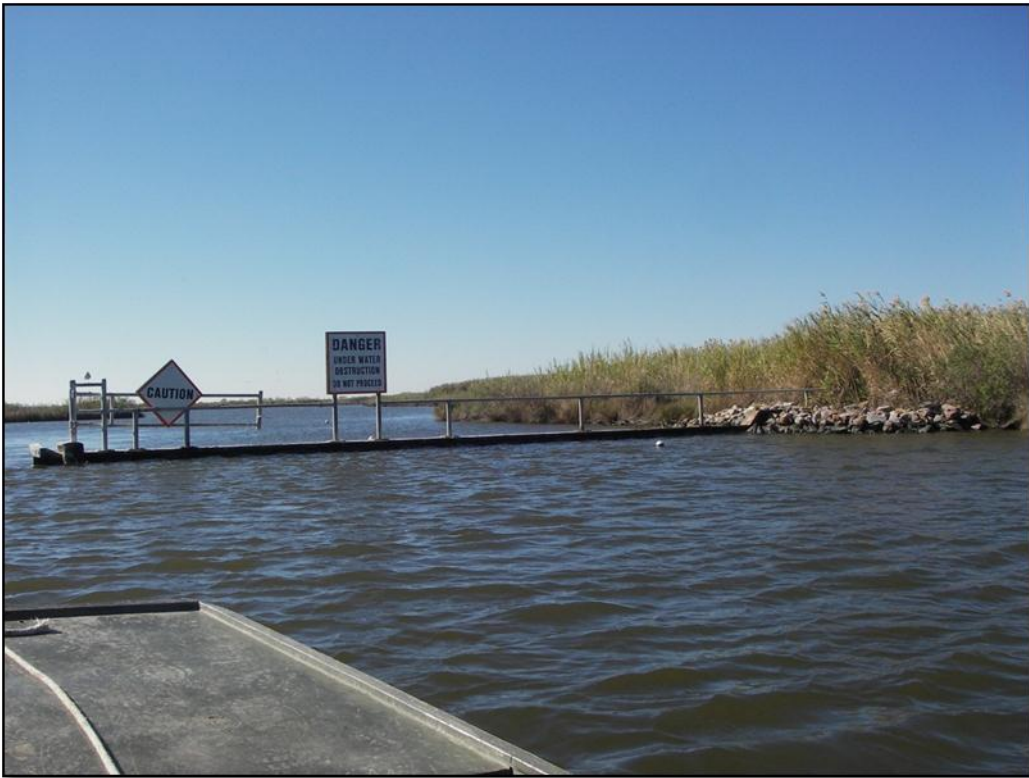
Photo 6, Mangrove Weir, view of rock armor west side.

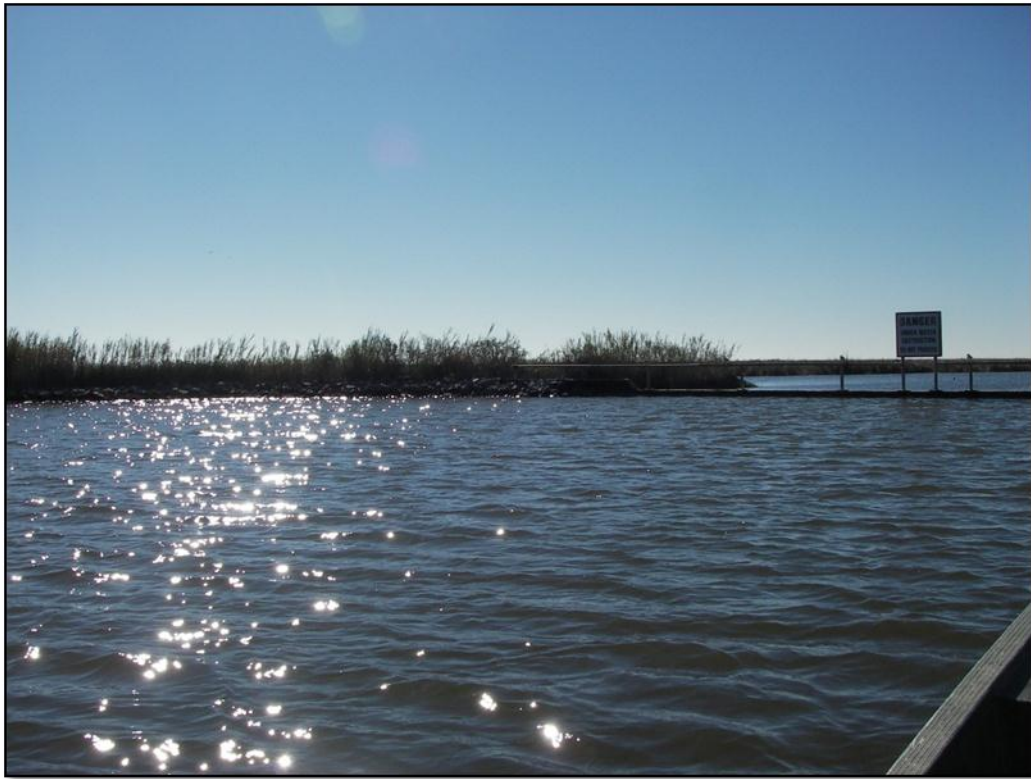
Photo 7, Mangrove Weir, view of rock armor east side.
