**2012/2013 Annual Inspection
Report**

**PECAN ISLAND TERRACING
PROJECT
(ME-14)**

State Project Number ME-14
Priority Project List 7

April 17, 2013
Vermilion Parish

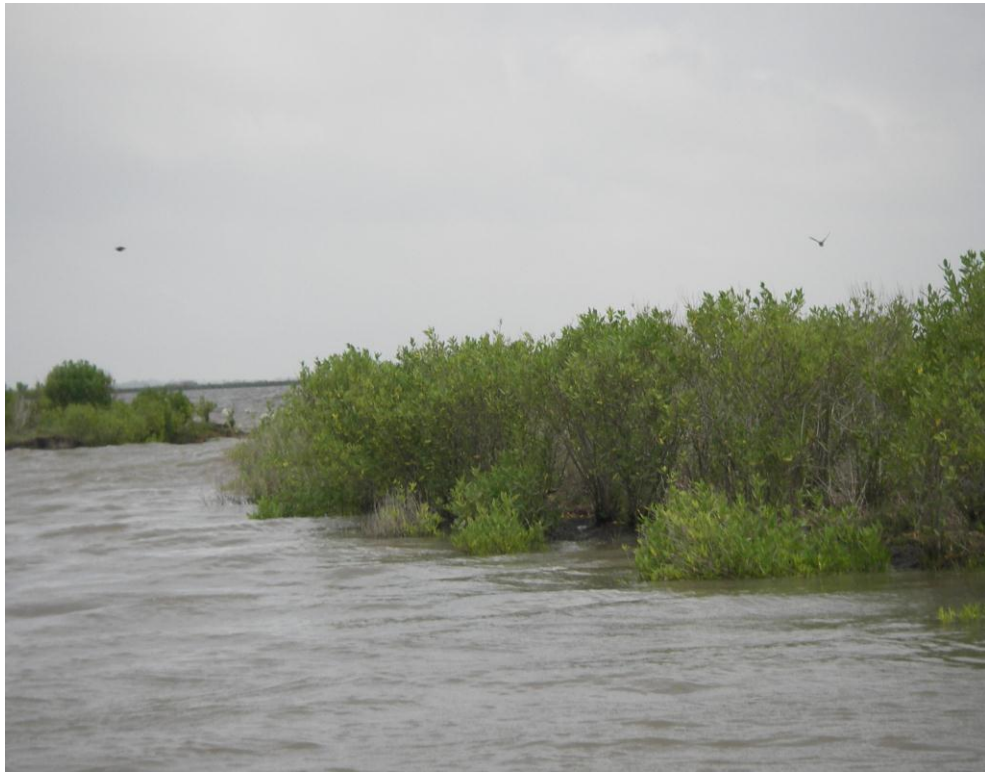
Photo No. 1, Southern Earthen Terraces

The majority of the earthen terraces are in good condition. There is some erosion taking place on the north side of the individual terraces. Previously noted erosion on the southernmost sacrificial terraces has worsened. On the west side of the terrace field, the first two rows of the southernmost sacrificial terraces are no longer visible above the water surface. The third row is also beginning to show signs of degradation. In addition, a portion of the first row of the east southernmost terraces is no longer visible above the water surface. (Photos: Appendix B, Photo 1)

Overall, the Pecan Island Terracing Project (ME-14) is functioning as designed and in good condition. The erosion of the southern sacrificial terraces will continue to be monitored. NOAA and CPRA have agreed to investigate land rights and possible erosion solutions for these sacrificial terraces. If feasible, an additional request for funding will be needed for this maintenance event.

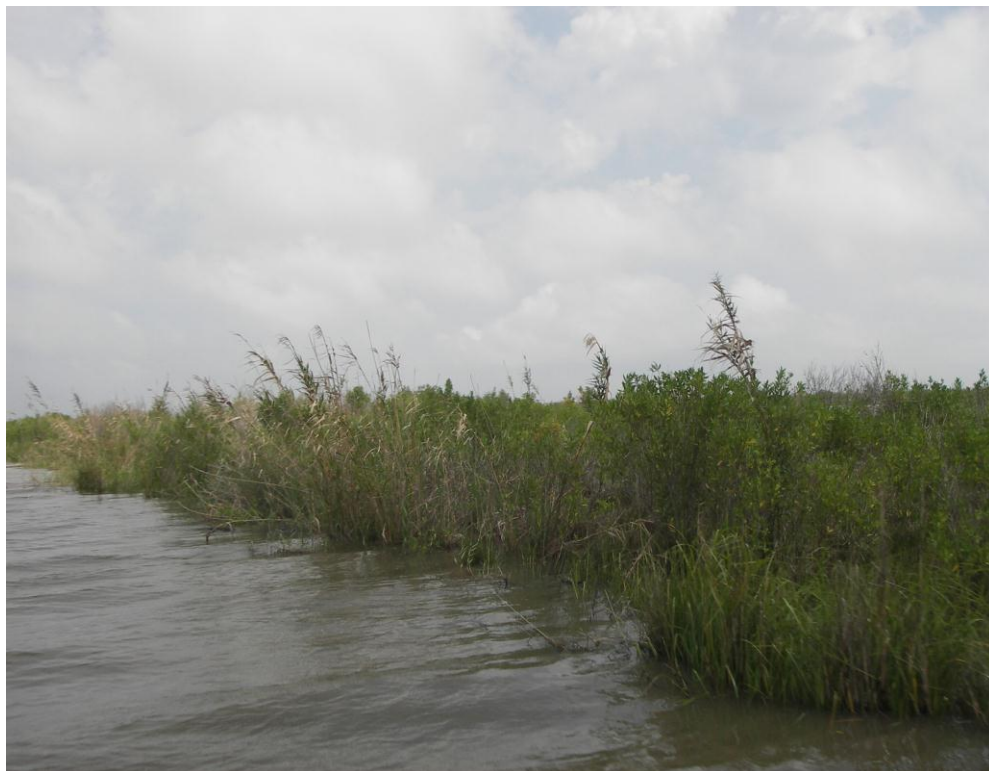
Photo No. 2, Typical Terrace

The tops of the terraces are covered with vegetation. Species noted include *Spartina alterniflora*, *Baccharis*, and *Spartina patens*. (Photos: Appendix B, Photo 2)
