**Coastal Protection and Restoration
Authority of Louisiana (CPRA)**

**2012/2013 Annual Inspection
Report**

**CLEAR MARAIS SHORE
PROTECTION PROJECT
(CS-22)**

State Project Number CS-22
Priority Project List 2

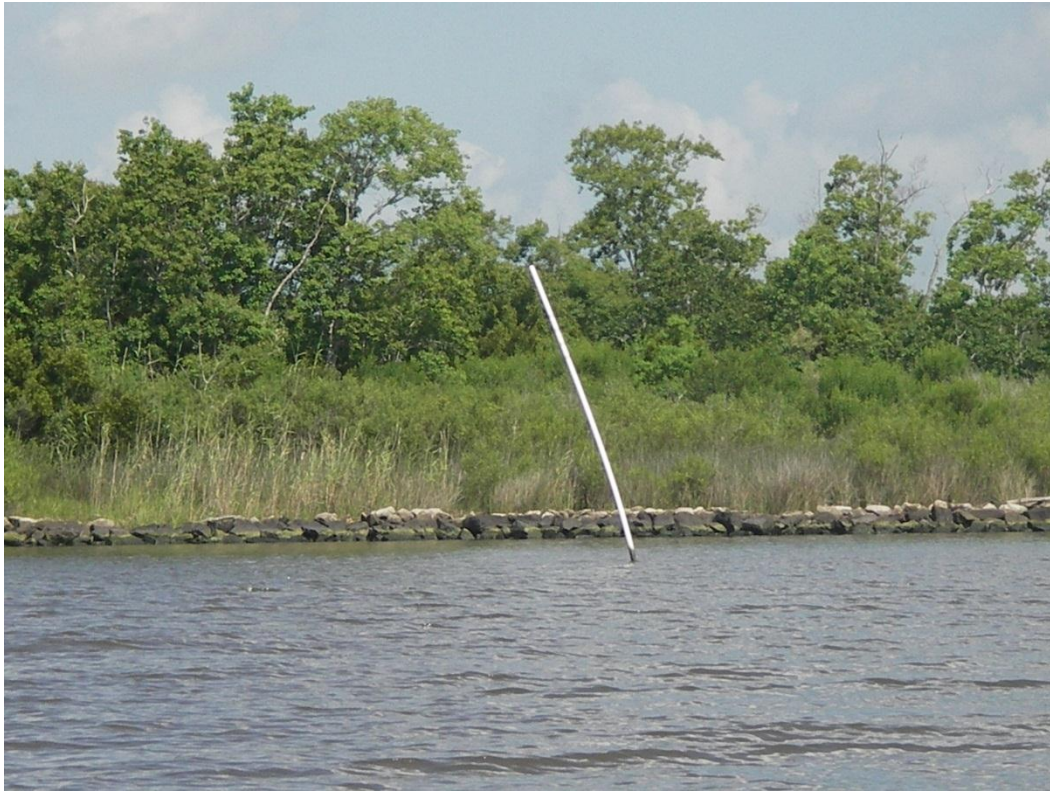
The dike is in good condition. As noted on previous inspections, approximately 4,000 to 5,000 linear feet of dike is below constructed elevation. This appears to be the result of slight settlement rather than displacement. Settlement of the rock dike has not worsened since originally noted and appears to have stabilized. There were two to three gaps approximately 30 feet wide where rock has been displaced by barges nosing up to the dike. These have also been noted on previous inspections and have not worsened or caused a negative impact on the project. Problems such as this are also noted on several other rock dikes along the GIWW. The dike is still functioning as intended and will continue to be monitored. There is no apparent need for any maintenance at this time. (Photos: Appendix B, Photos 1-2)

Photo No. 1, Typical Rock Dike

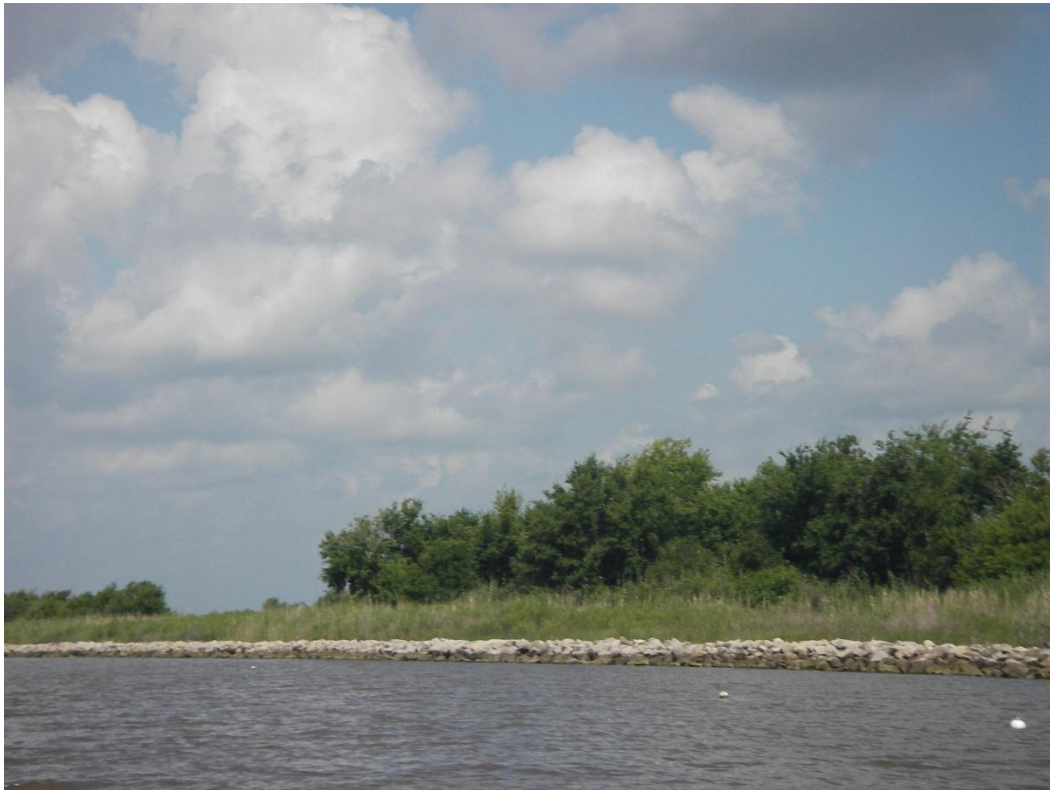
Photo No. 2, Vegetation behind Rock Dike

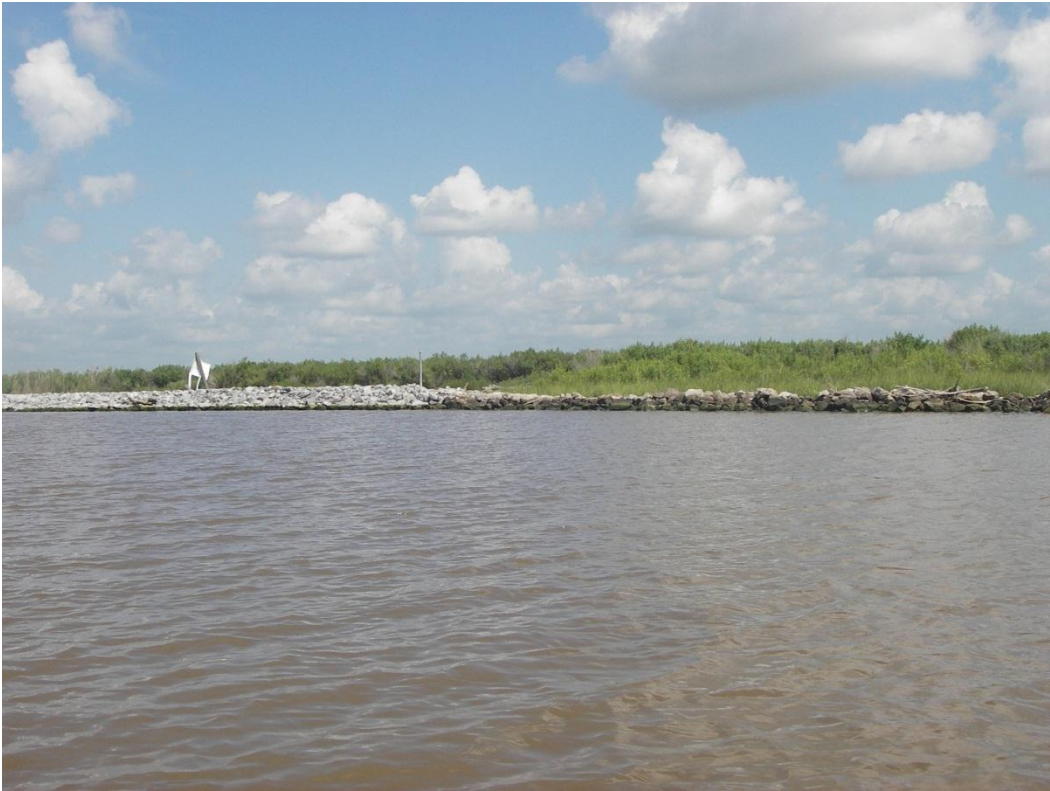
Calcasieu Parish has constructed a rock dike using CIAP funding along the north side of the GIWW that ties into the western end on the CS-22 project. (Photo: Appendix B, Photo 3)

Photo No. 3, Connection at west end of CS-22 and Calcasieu Parish CIAP rock dike
