**2012/2013 Annual Inspection  
Report**

**PERRY RIDGE SHORELINE  
PROTECTION PROJECT (CS-24)**

State Project Number CS-24  
Priority Project List 4

June 13, 2013  
Calcasieu Parish

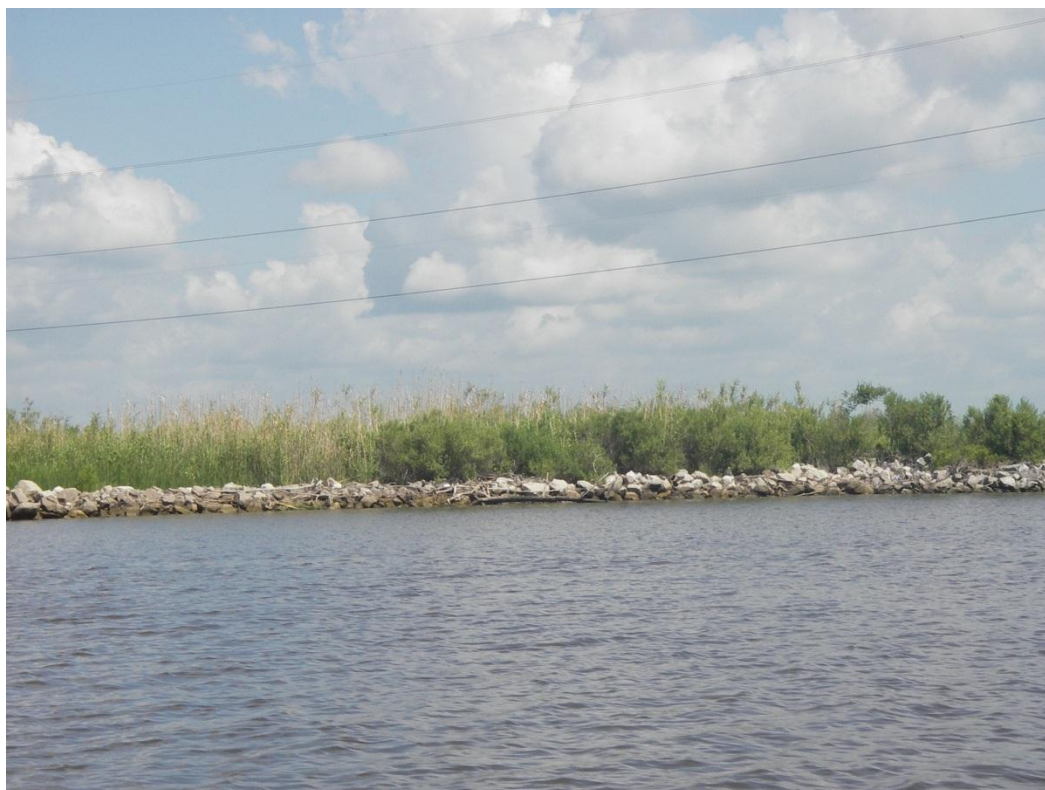
The dike is in good condition with a few low areas below constructed elevation. One 50 foot gap was noted where the dike was disturbed by a barge. Visible signs of accretion are occurring behind the rock dike. No maintenance is recommended at this time. (Photos: Appendix B, Photo 1-2)

**Photo No.1**, Typical Rock Dike

Item	Condition	Physical Damage	Corrosion	Photo #	Observations and Remarks
Steel Bulkhead / Caps	N/A				
Steel Grating	N/A				
Stop Logs	N/A				
Hardware	N/A				
Timber Piles	N/A				
Timber Wales	N/A				
Galv. Pile Caps	N/A				
Cables	N/A				
Signage / Supports	N/A				
Rip Rap (fill) (foreshore dike)	Good			1-2	Rock Dike in good condition. A few low areas below original construction elevation. One 50 foot gap in dike possibly due to a barge nosing into rock. Accretion occurring behind rock dike.
Earthen Embankment	N/A

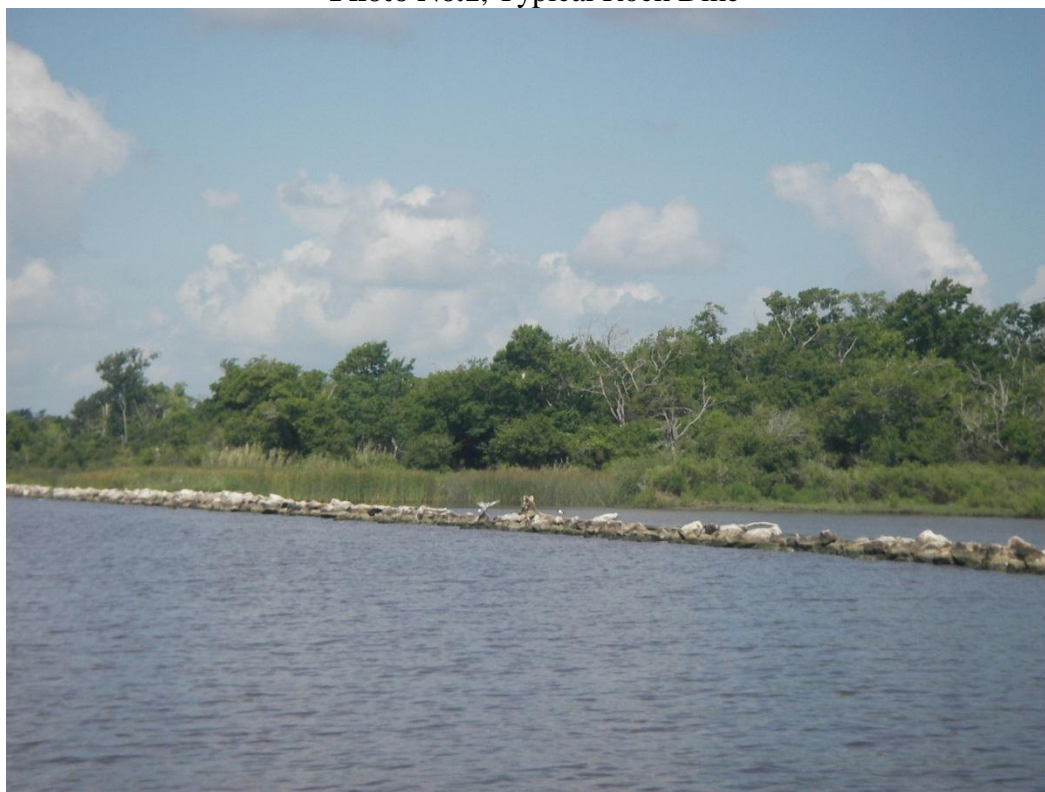
**Photo No.2**, Accretion behind Rock Dike
