**2012/2013 Annual Inspection
Report**

**BLACK BAYOU HYDROLOGIC
RESTORATION PROJECT
(CS-27)**

State Project Number CS-27
Priority Project List 6

March 20, 2013
Calcasieu and Cameron Parishes

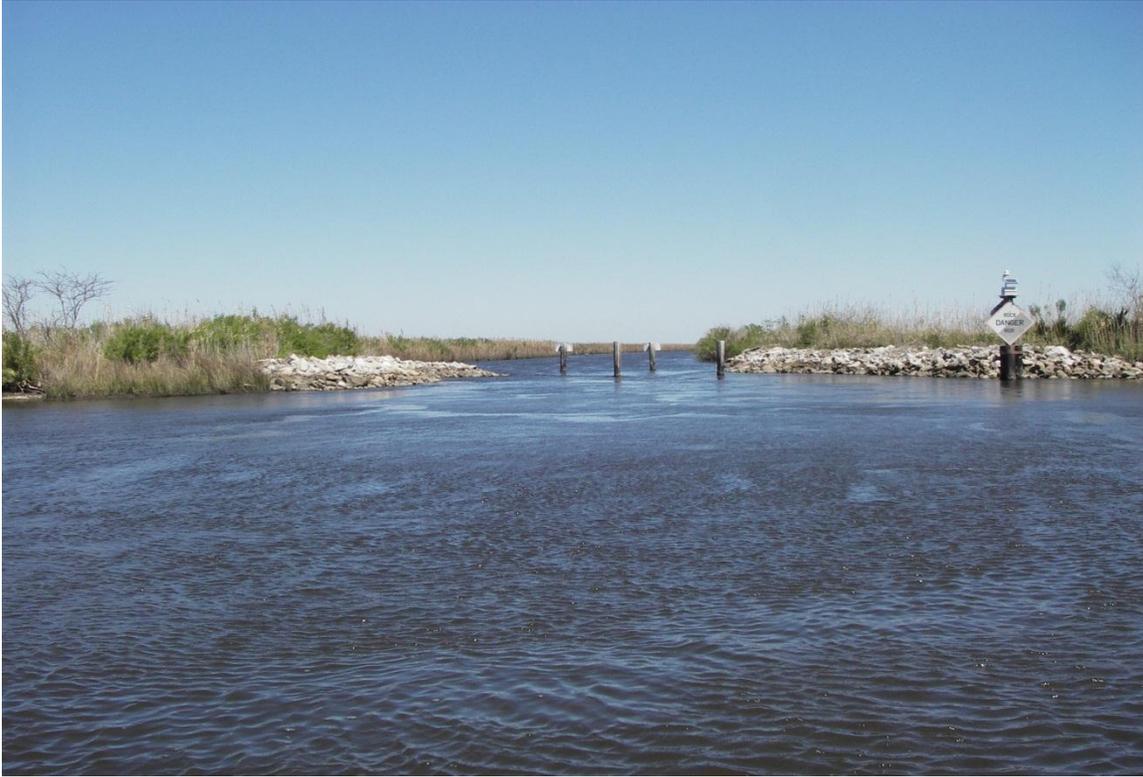
The rock weir is in excellent condition. The two arrow signs on the Black Bayou side of the structure are missing and will need to be replaced. The erosion on the SE will continue to be monitored, but has stabilized. No need for maintenance at this structure. Conditions of the Navigational Aid Lights were last inspected on 01/08/13. (Photos: Appendix B, Photo 1)

Photo 1—Navigational Aids and signage at Block's Creek

The Black Bayou Hydrologic Restoration Project constructed components are still in very good, functioning condition. The only maintenance required at this time is the replacement of the arrow signs on the Block's Creek structure. It has been learned that the alligator crossing that was repaired during the last maintenance event may have been designed incorrectly. It has since been learned that alligators will cross areas such as this at the narrowest point, regardless of the elevation. The crossing repaired was wide and low and should have been higher and narrower. This will be considered during future events as such as this. Concrete sacks work extremely well in areas where small sections of rock dike need repair and should be considered in these situations. Warning signs in areas of severe current caused by installation of rock or sheet pile weirs should always be included. These signs should be installed in concrete blocks out of the way of traffic since this has proven to be very effective. Also, railings or fences around water control structures should be considered.

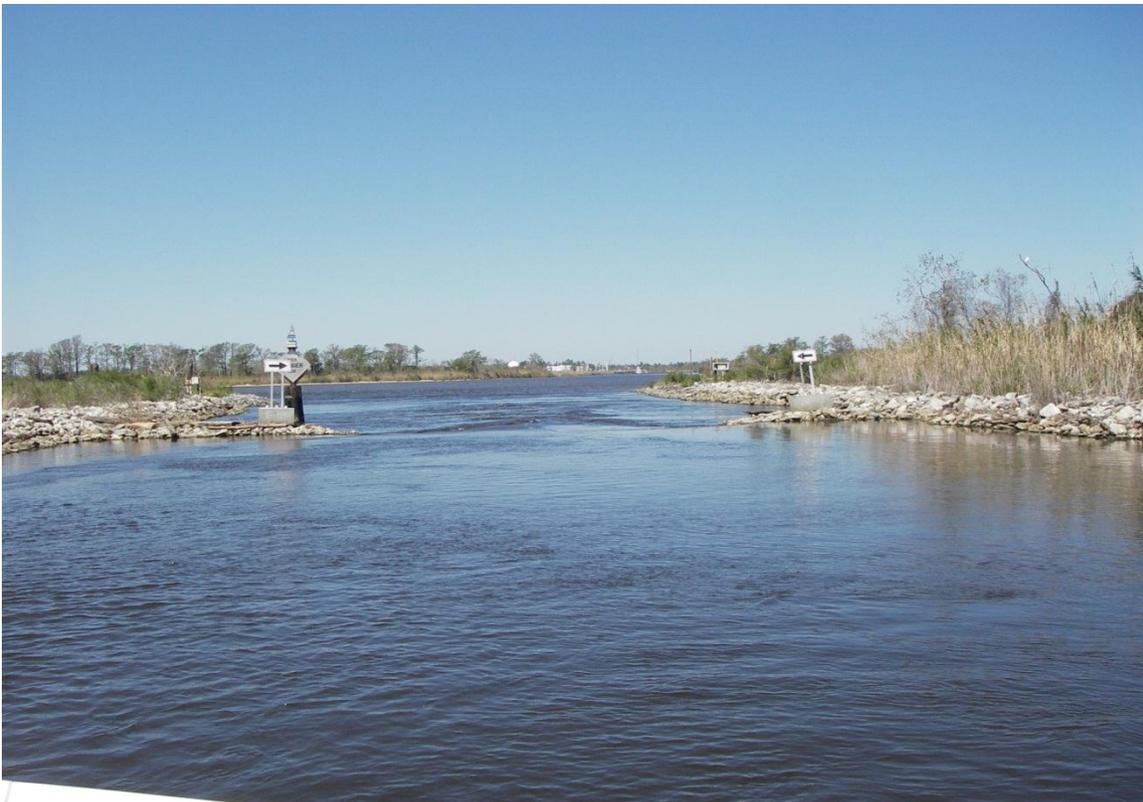
The weir is in good condition. The scouring along the canal banks inside of the weir at the end of the dike has stabilized. Arrow signs installed as part of the last maintenance event are working well. No need for any maintenance at this time. The Navigational Aid Lights were last inspected on 01/08/13. (Photos: Appendix B, Photo 2)

Photo 2—Burton Canal Structure

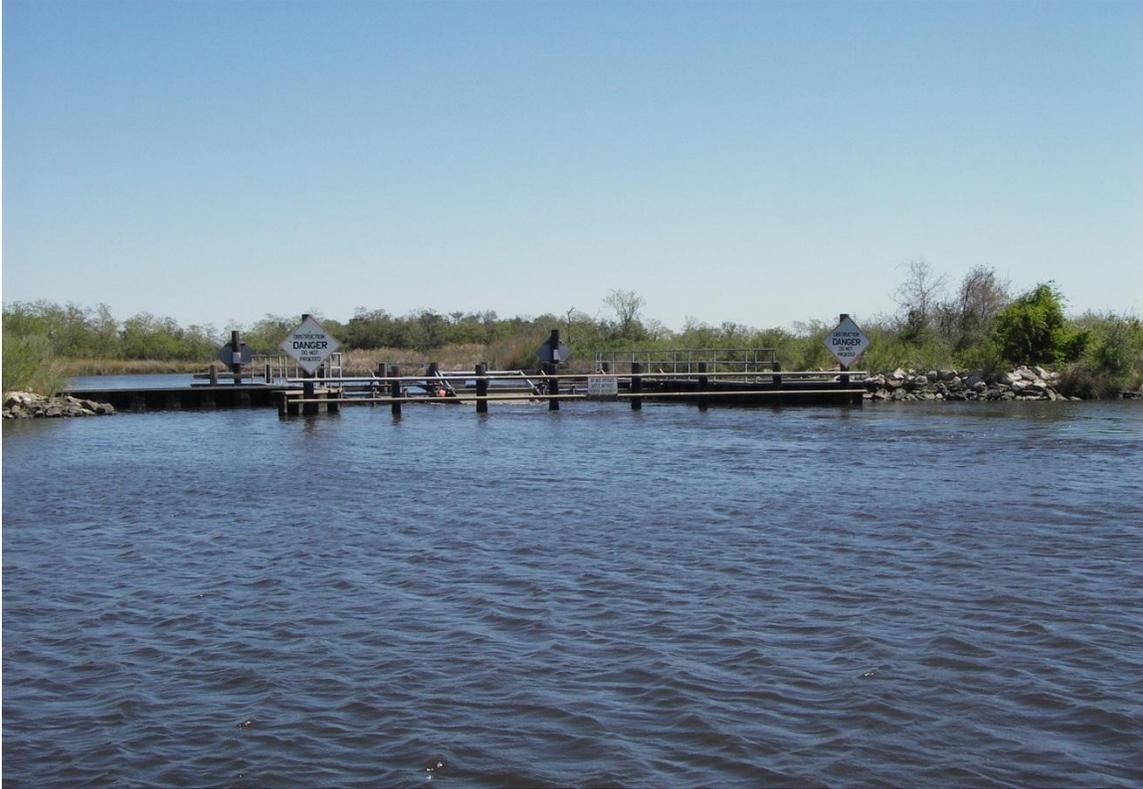
The structure itself is in very good condition. The pillow blocks replaced during the last maintenance event, signage, railings, wingwalls, etc. are in excellent condition. The railing along the top of the gate is showing fairly significant rust. The seams at the sheet piles are rusting also, however there is no need for maintenance at this time. (Photos: Appendix B, Photos 3-5)

Photo 3—SRT Gate

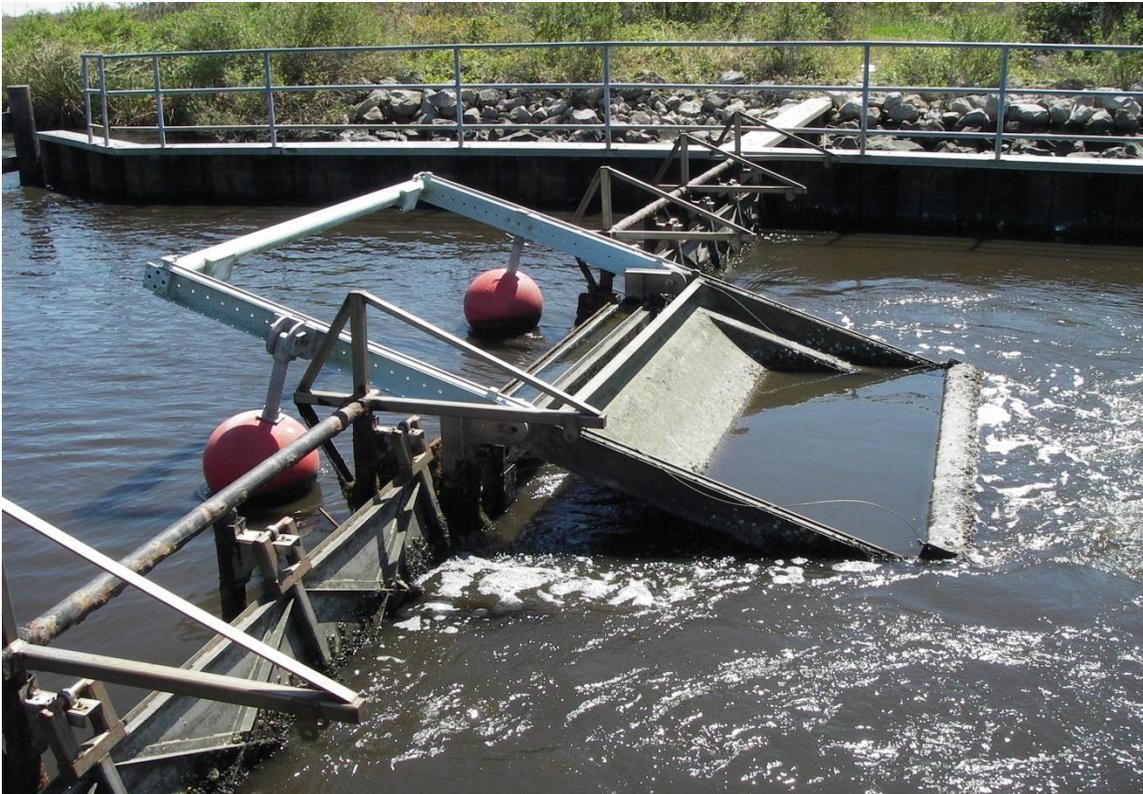
Photo 4—SRT Gate railings, etc.

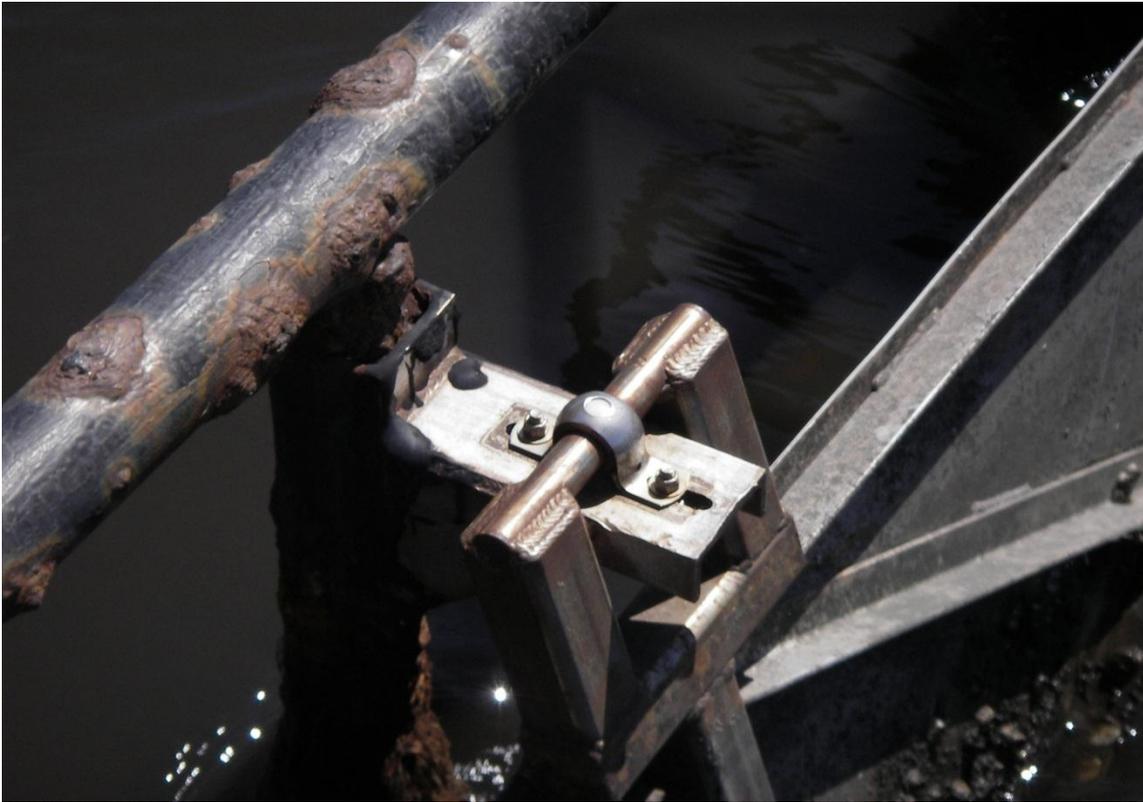
Photo 5—pillow block on SRT Gate flap & railing rust

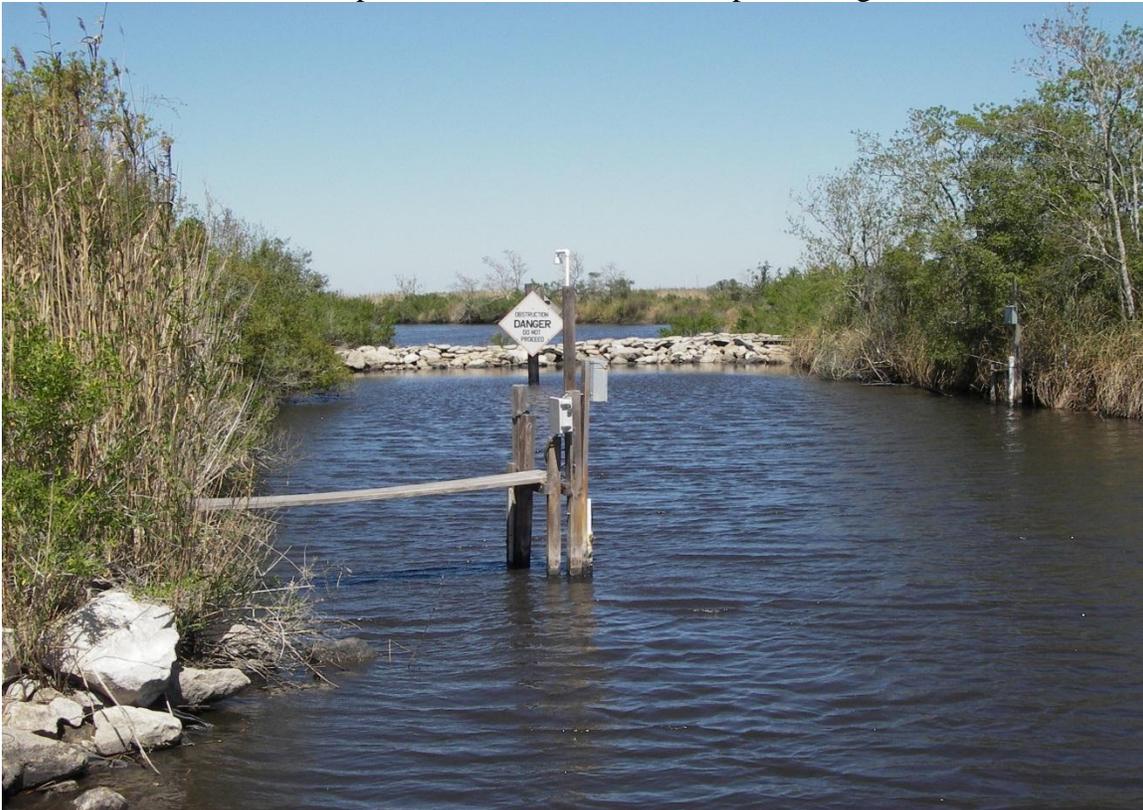
The rock dike, as repaired with the concrete sacks is functioning as designed. Tie-ins are stable. No maintenance required. (Photos: Appendix B, Photo 6)

Photo 6—plug near SRT Gate

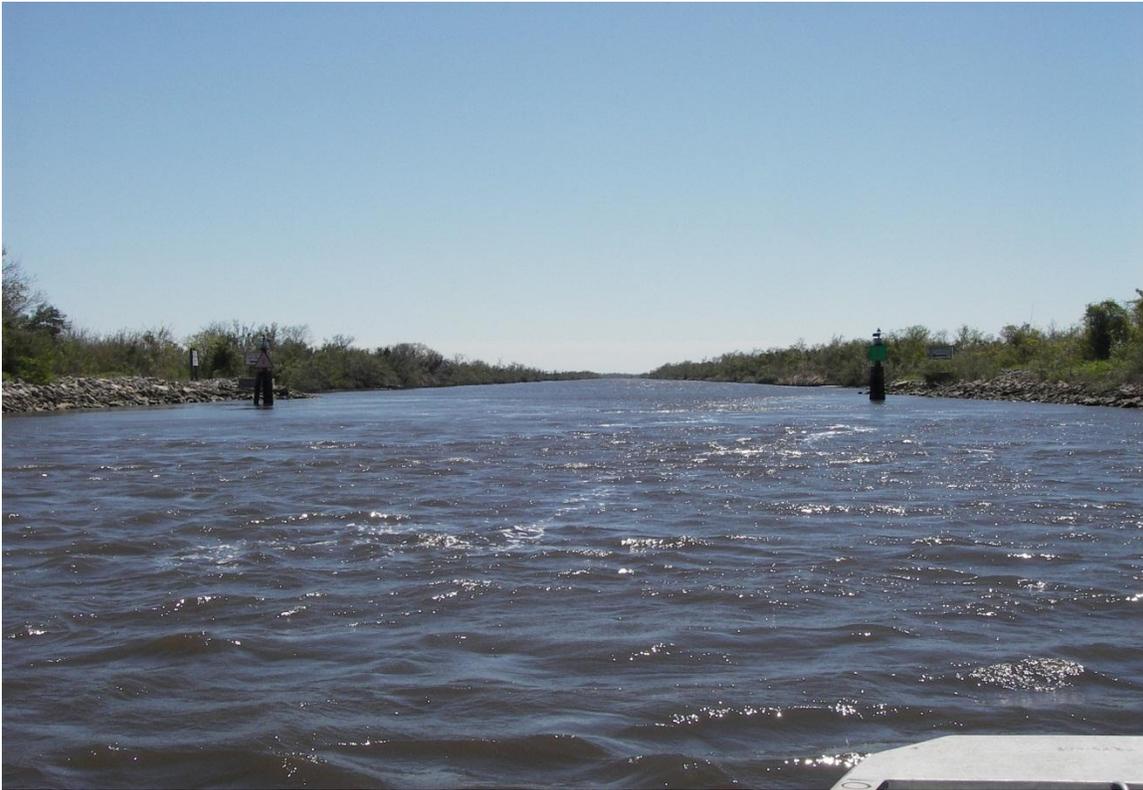
This component is in immediate post construction condition. No need for maintenance at this time. Conditions of the Navigational Aid Lights are inspected quarterly and were last inspected on 01/08/13. (Photos: Appendix B, Photo 7)

Photo 7—Black Bayou Cut-off Canal structure

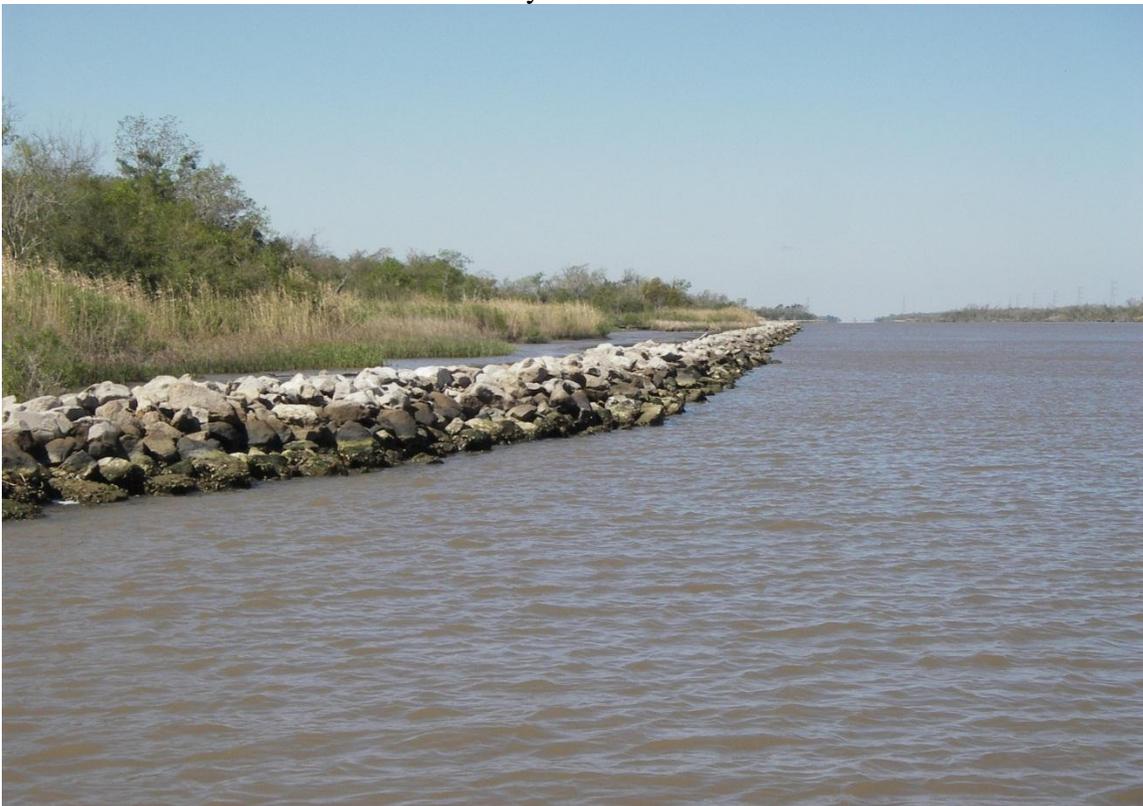
Tie-ins on both the east and west end of the dike are stable. As mentioned in previous inspections, the warning signs at both the Vinton and Black Bayou closures have been stolen. The spoil placed behind the rock dike at the Black Bayou Canal has washed away on the western end. There is also a gap in the dike in front of this area. Rock is still at the base, but exchange is taking place. Landowner repairs to the four C-stone closures have been completed. Small gaps were left at two of these repairs to allow high tidal events to pass around the plugs without continuing to wash away the banks. There are a few low spots (approximately 400 linear feet) on the rest of the main dike, apparently caused by barges but these areas are still functioning and not in need of repair. The repair to the dike across from

Photo 8—Typical section of rock dike

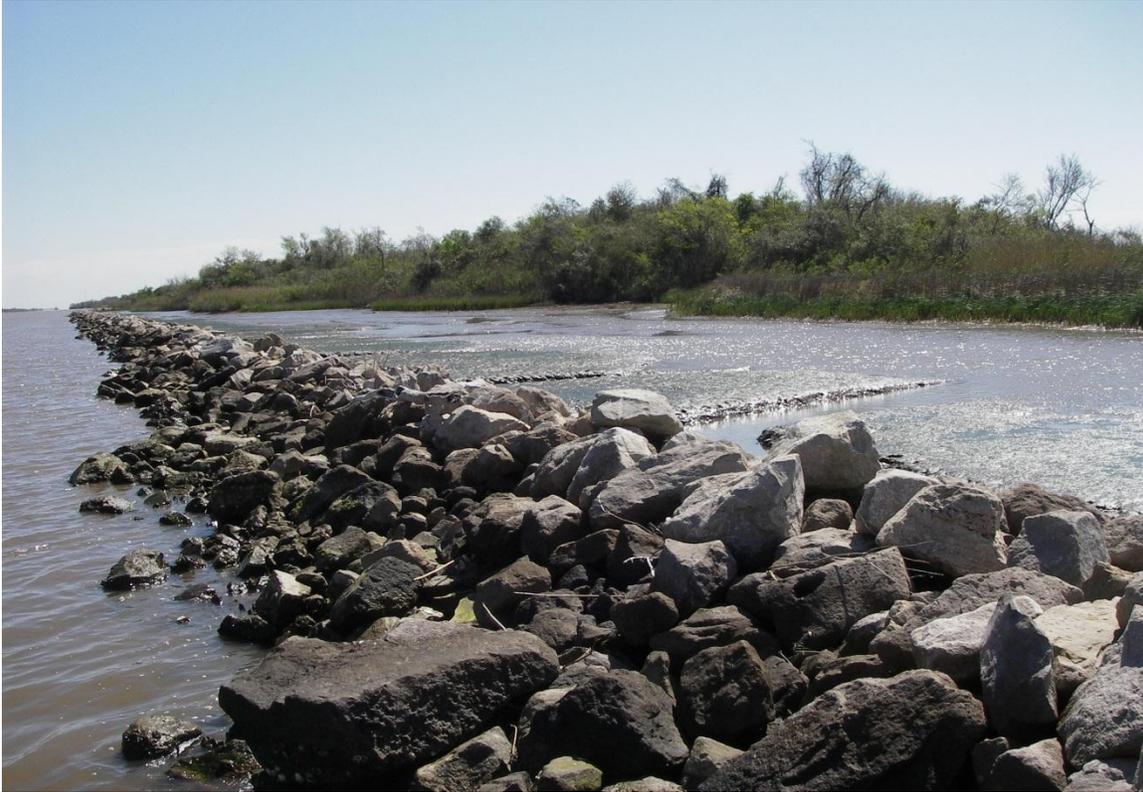
the Vinton Canal with concrete sacks is working extremely well. Significant build-up of sediment is becoming apparent between the dike and the shoreline. (Photos: Appendix B, Photos 8-12)

Photo 9—sediment building up behind dike

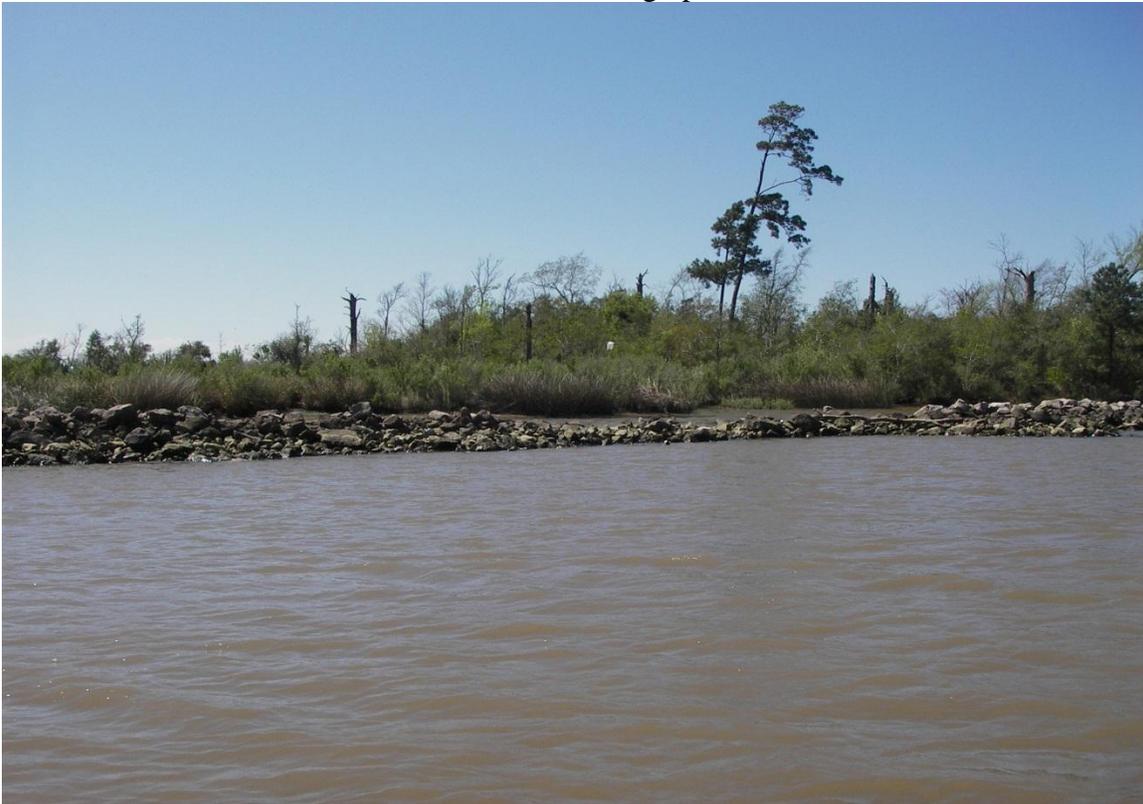
Photo 10—low area of dike displaced by barge

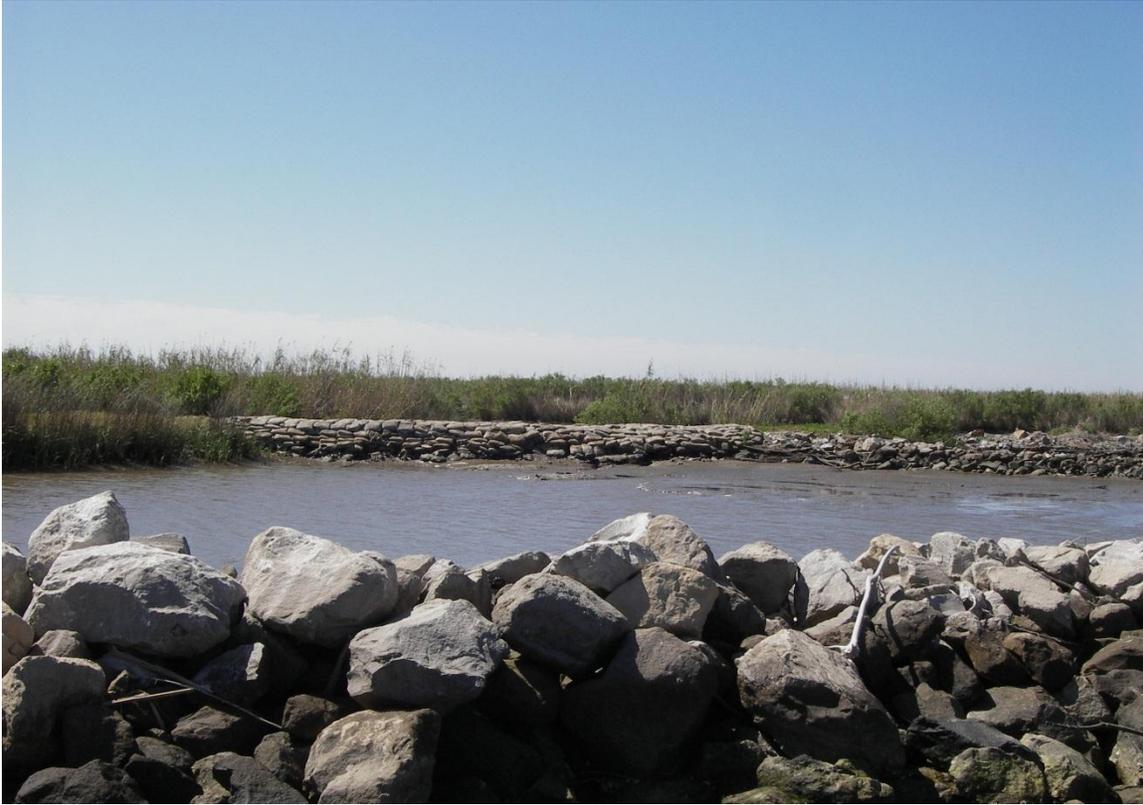
Photo 11—one of the four interior breaches as repaired

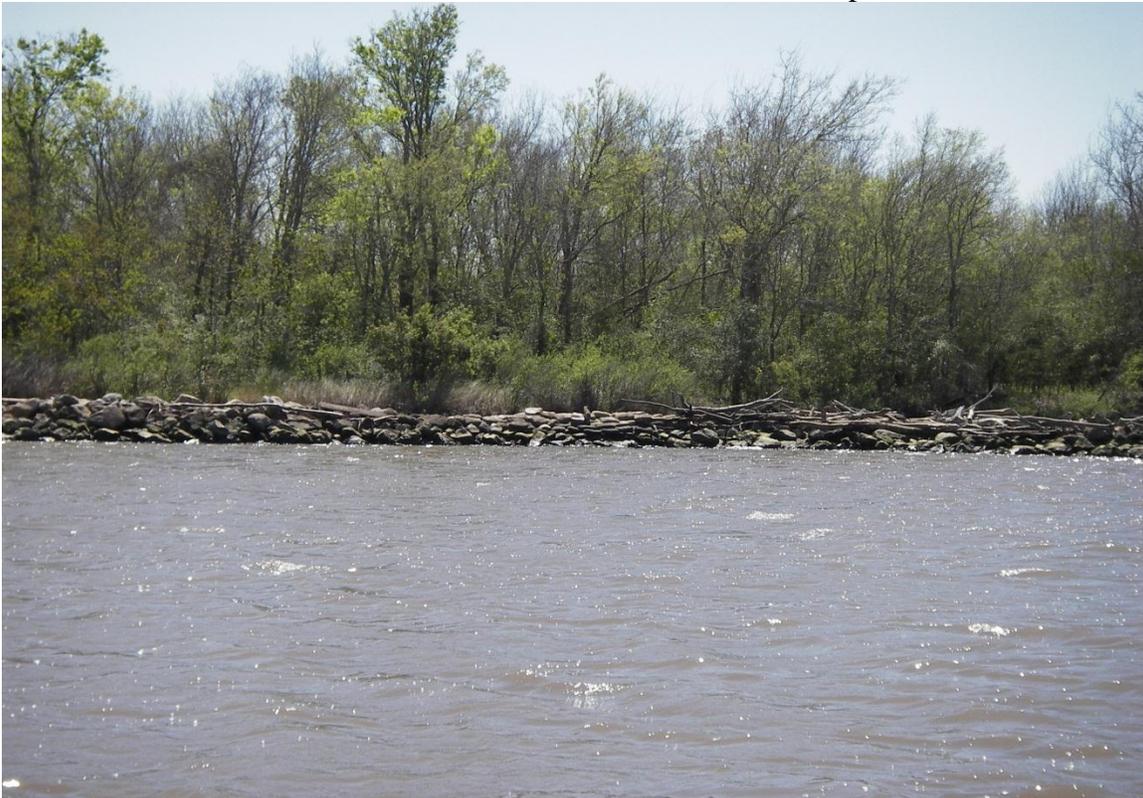
Photo 12—low area on dike as repaired
