**Coastal Protection and Restoration
Authority of Louisiana (CPRA)**

2012/2013 Annual Inspection Report

FRESHWATER INTRODUCTION SOUTH OF HWY 82 PROJECT (ME-16)

State Project Number ME-16
Priority Project List 9

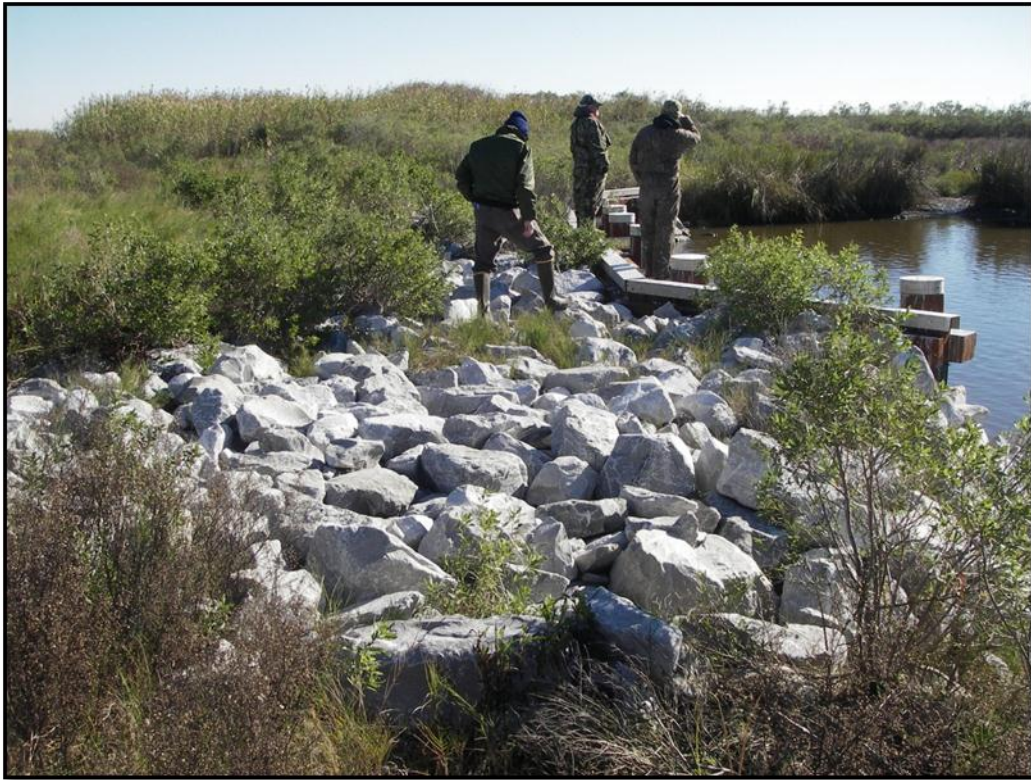
The structure is in good condition. Leaks at interface of pipe and headwall discovered during the recent maintenance project have been repaired by the contractor. Rock revetment looks good. (Photos: Appendix B, Photos 1 & 2)

Photo No. 1, New Cop-Cop Structure, rock placement on outlet side of structure.

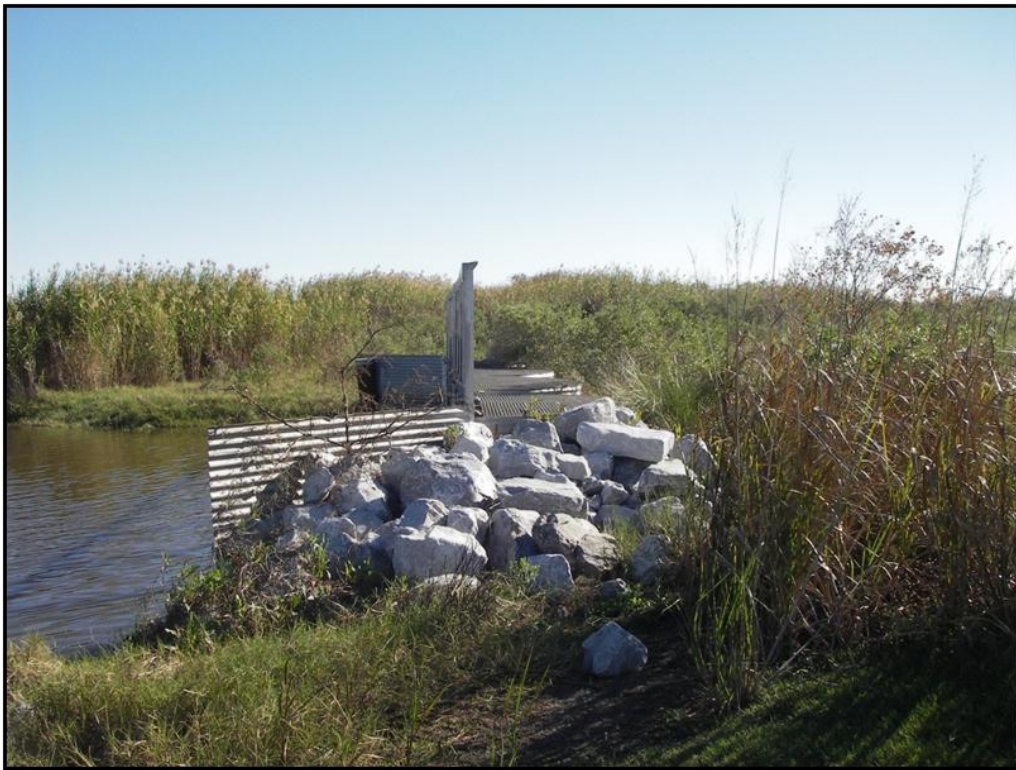
Photo No. 2, New Cop-Cop Structure, inlet side of structure.

Item	Condition	Physical Damage	Corrosion	Photo #	Observations and Remarks
Flapgates	Good				Contractor needs to provide lifting chains for opening flapgates.
Steel Grating	Good				
Stop Logs	Good				
Hardware	Good				
Timber Piles Timber Walkway	Good				
Timber Wales	Good				
Galv. Pile Caps	Good				
Culverts	Good				
Signage /Supports Staff Gages	N/A				
Rip Rap (fill)	Good			1 & 2	
Earthen Embankment	Good

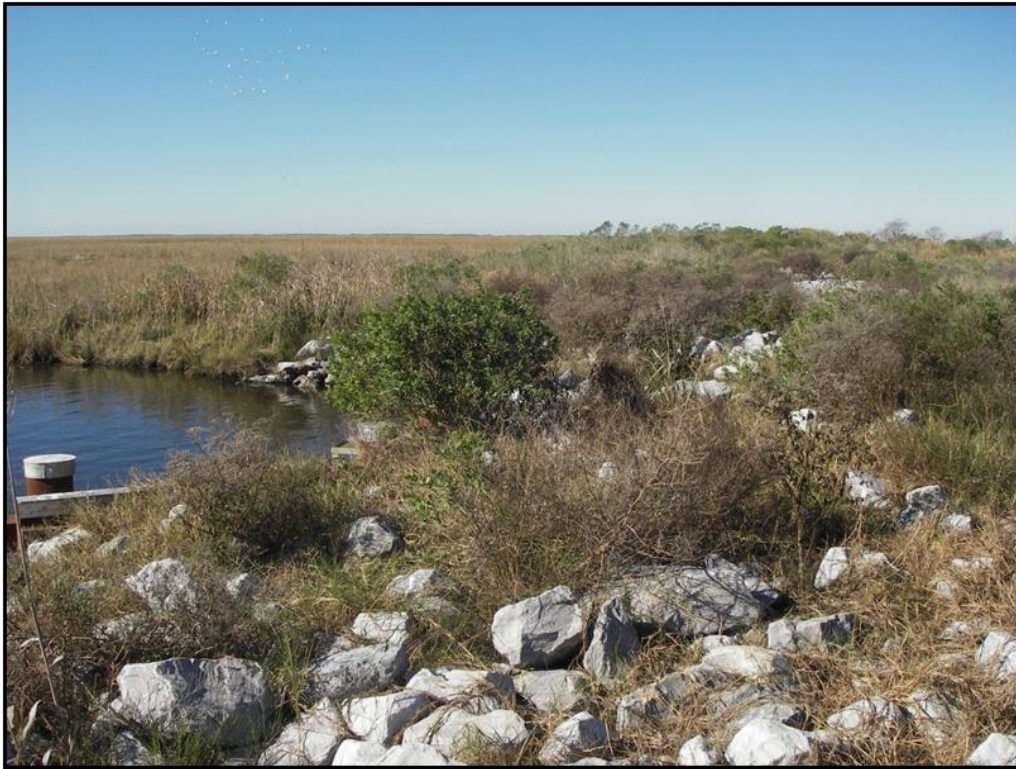
Overall this structure is also in good condition. Rock revetment looks good. (Photos: Appendix B, Photo 3 & 4)

Photo No. 3, Structure No. 12, rock placement on outlet side of structure.

Item	Condition	Physical Damage	Corrosion	Photo #	Observations and Remarks
Steel Bulkhead / Caps	N/A				
Steel Grating	Good				
Stop Logs	Good				
Hardware	Good				
Timber Piles	Good				
Timber Wales	Good				
Galv. Pile Caps	Good				
Cables	N/A				
Signage /Supports Staff Gages	N/A				
Rip Rap (fill)	Good			3 & 4	
Earthen Embankment	Fair			3 & 4

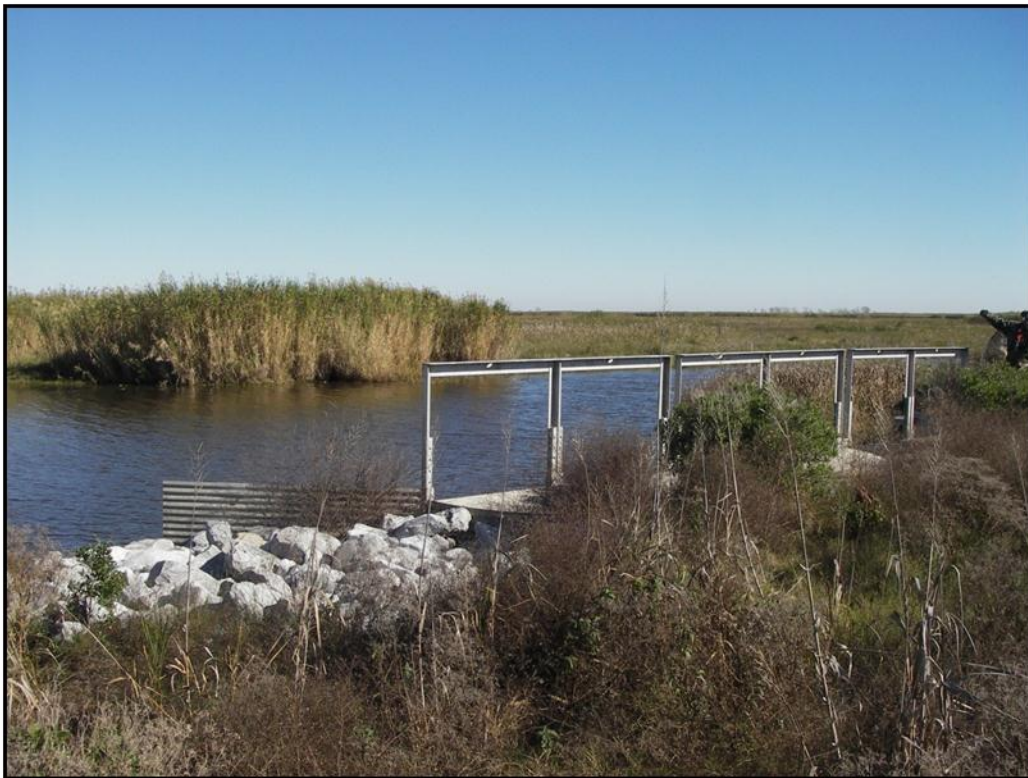
Photo No. 4, Structure No. 12, rock placement on inlet side of structure.

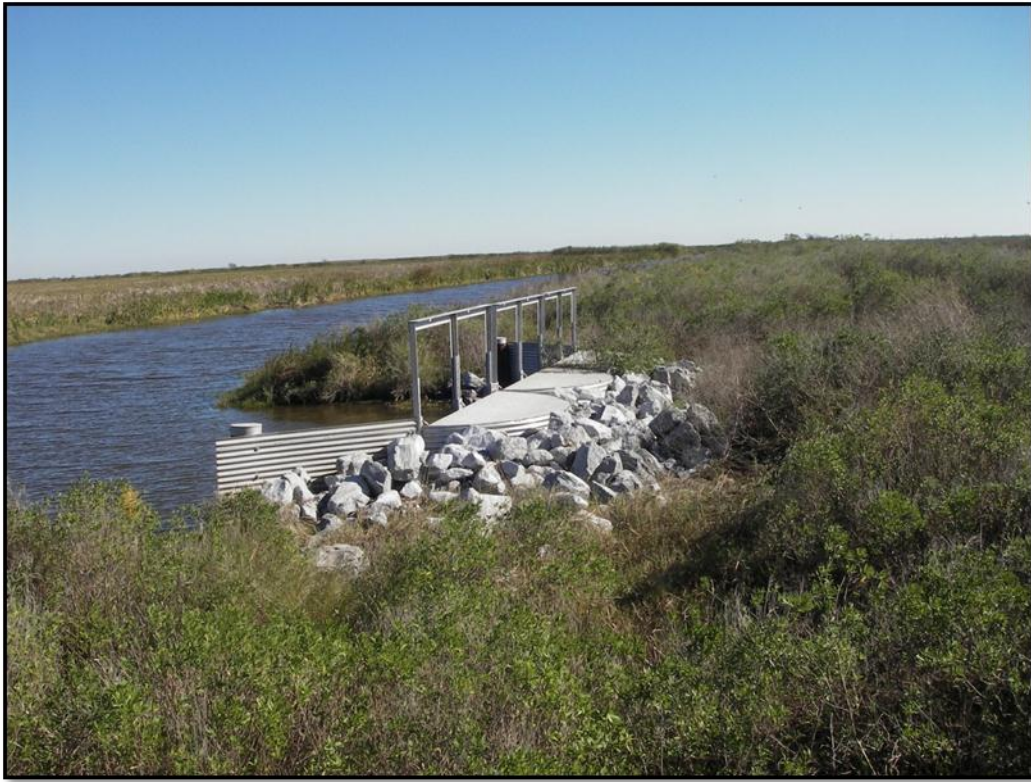
Overall this structure is in good condition. Rock revetment looks good. (Photos: Appendix B, Photo 5 & 6)

Photo No. 5, Structure No. 10, rock placement on inlet side of structure.

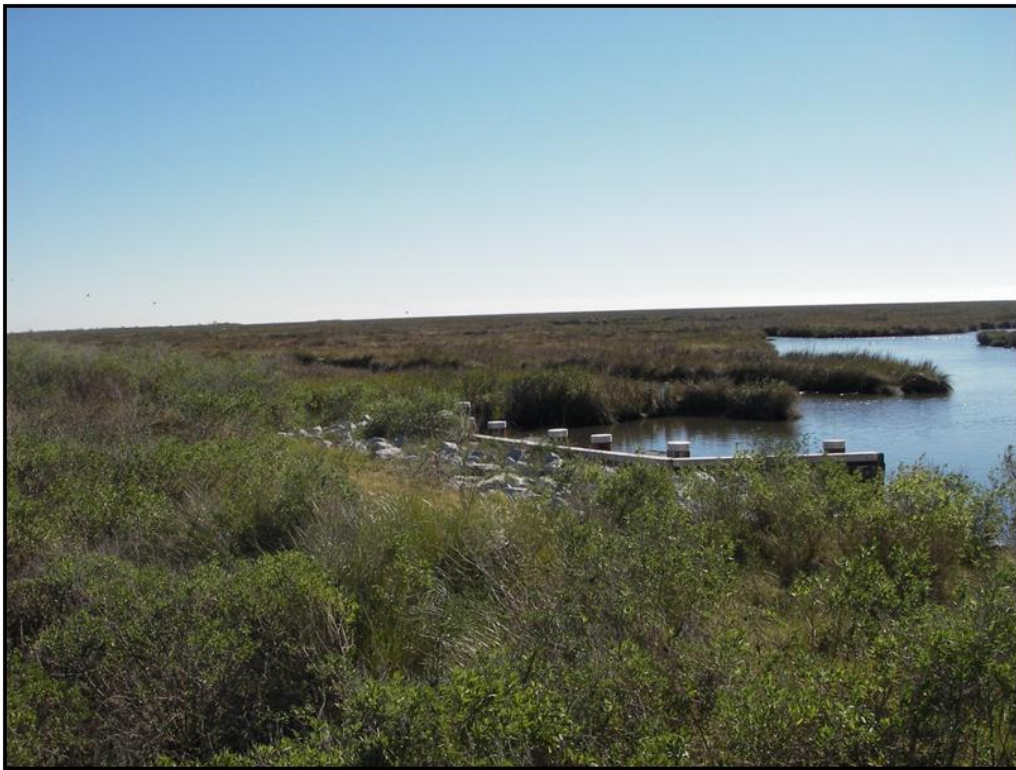
Photo No. 6, Structure No. 10, rock placement on outlet side of structure.

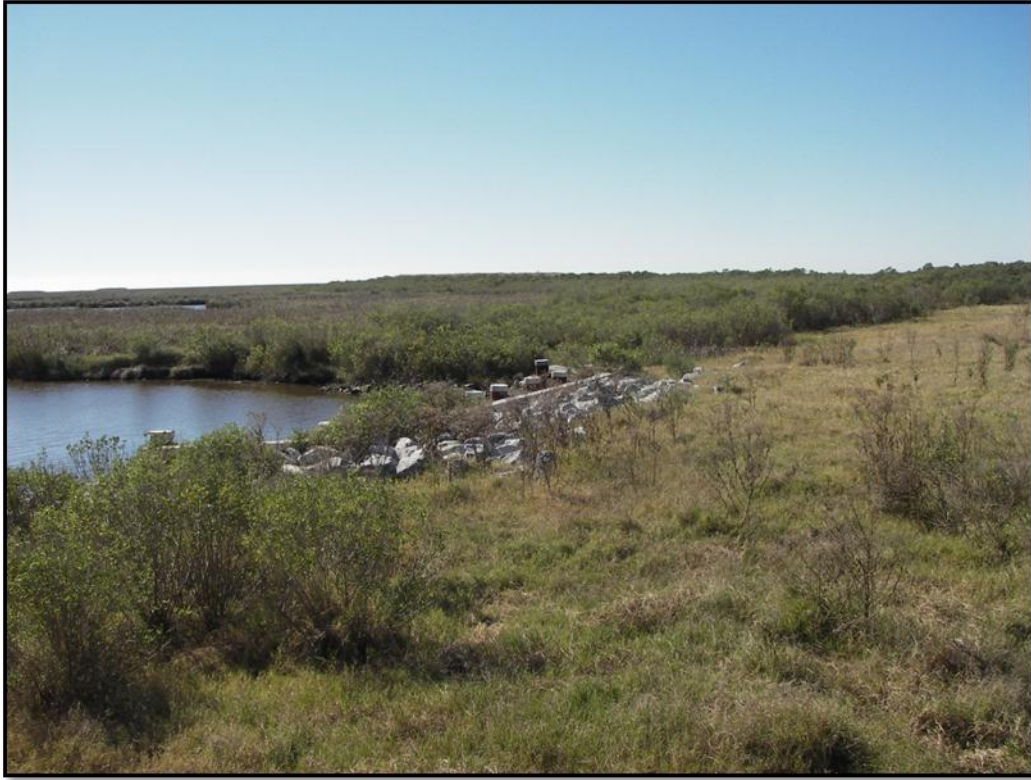
Overall this structure is in good condition. Rock revetment looks good. (Photos: Appendix B, Photo 7 & 8)

Photo No. 7, New Dyson Structure, rock placement on outlet side.

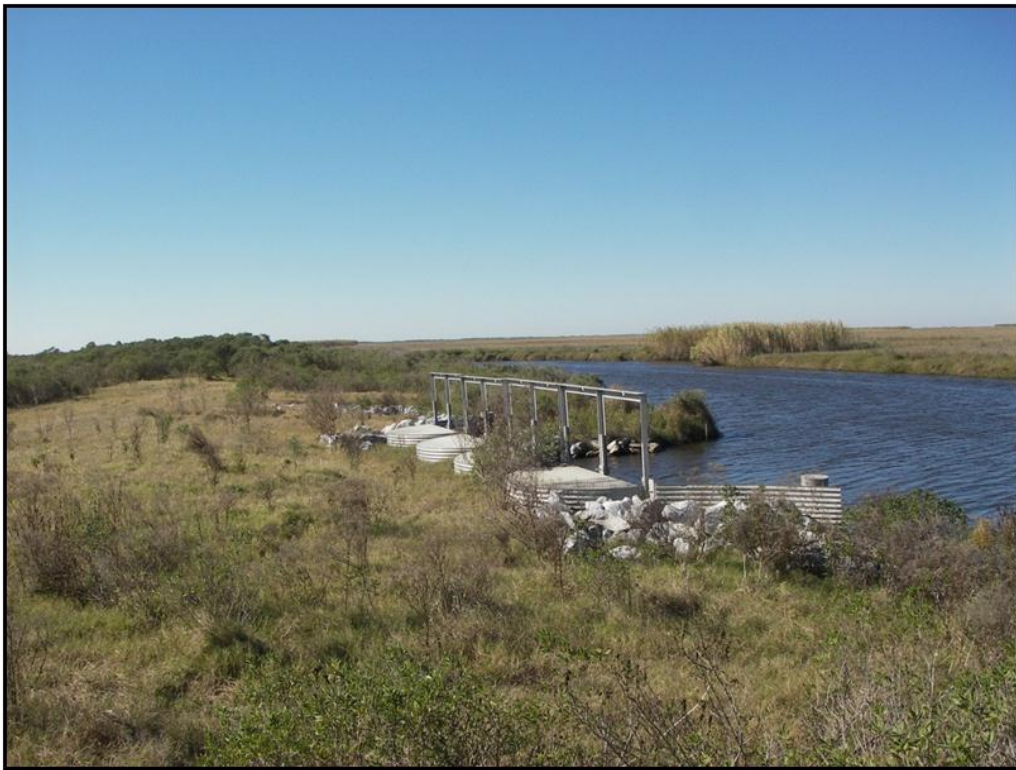
Photo No. 8, New Dyson Structure, rock placement on inlet side.

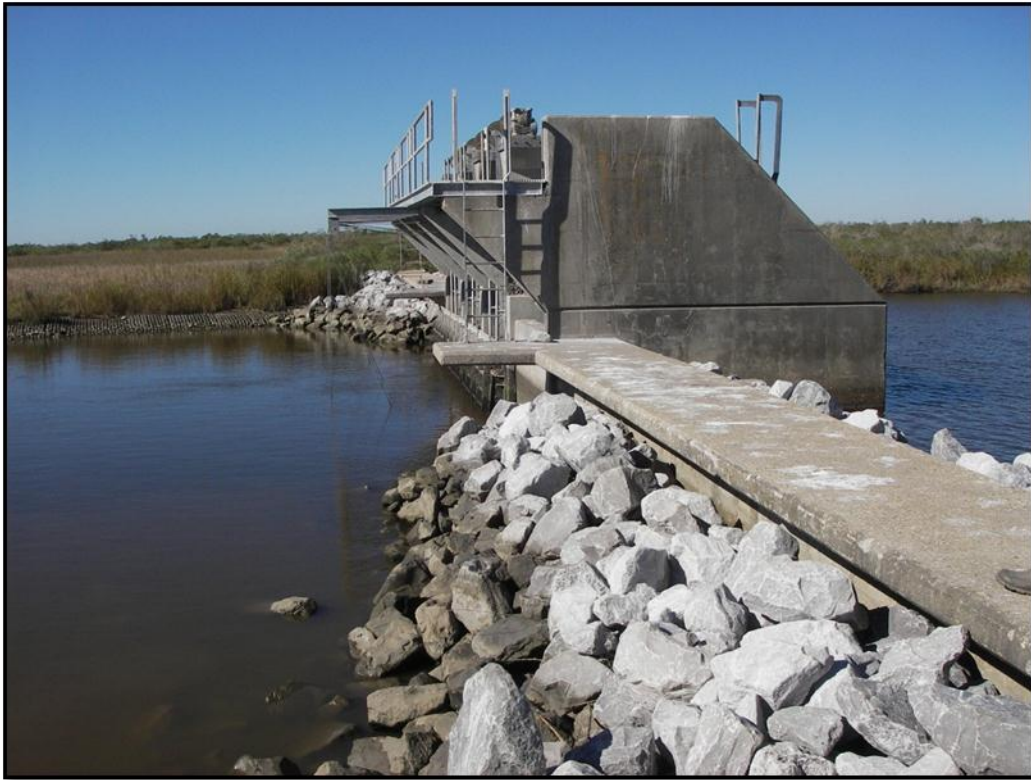
Overall this structure is in good condition. Rock revetment looks good. (Photos: Appendix B, Photo 9 & 10)

Photo No. 9, Little Constance Structure, rock placement on east side of structure.

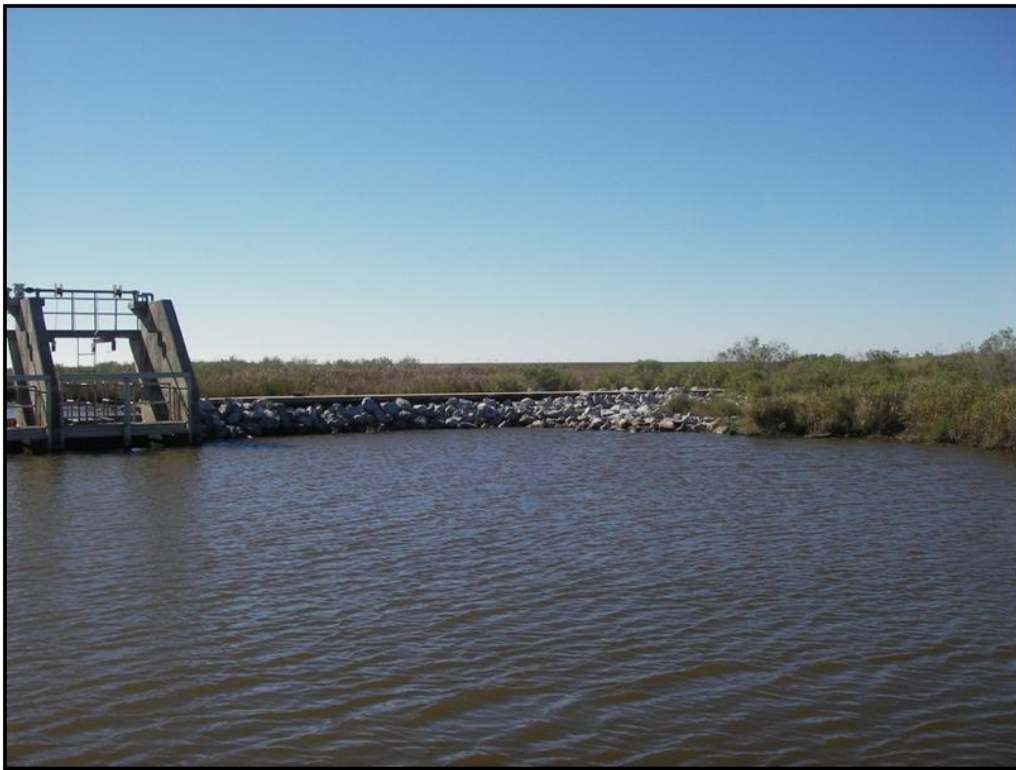
Photo No. 10, Little Constance Structure, rock placement on west side of structure.

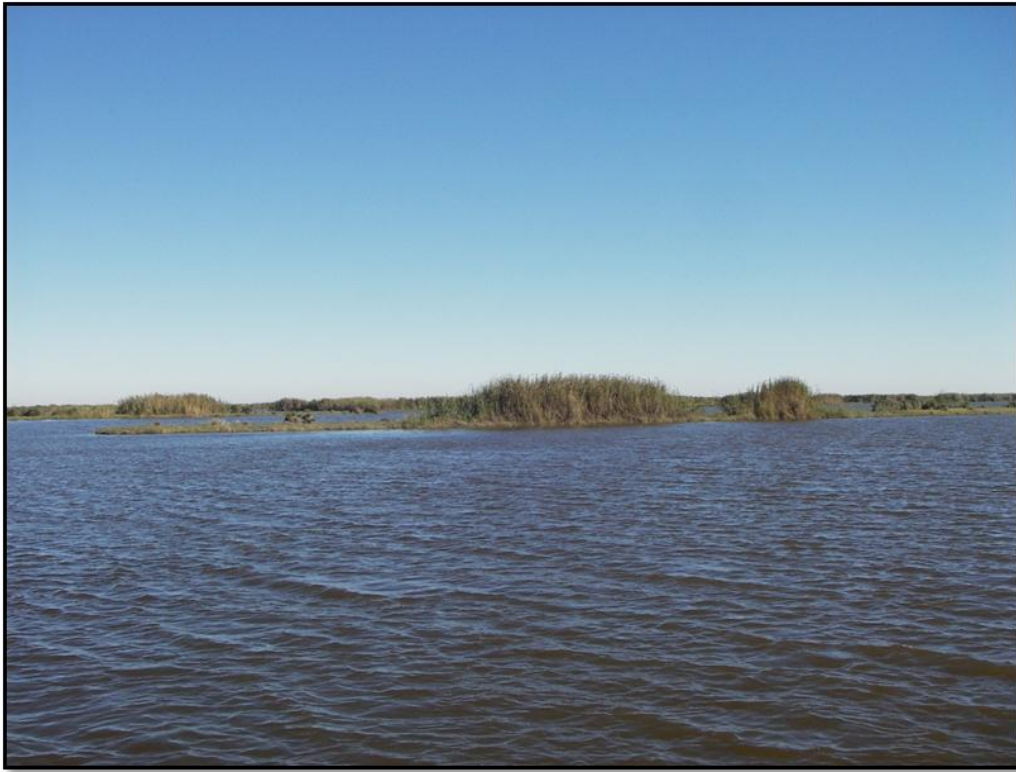
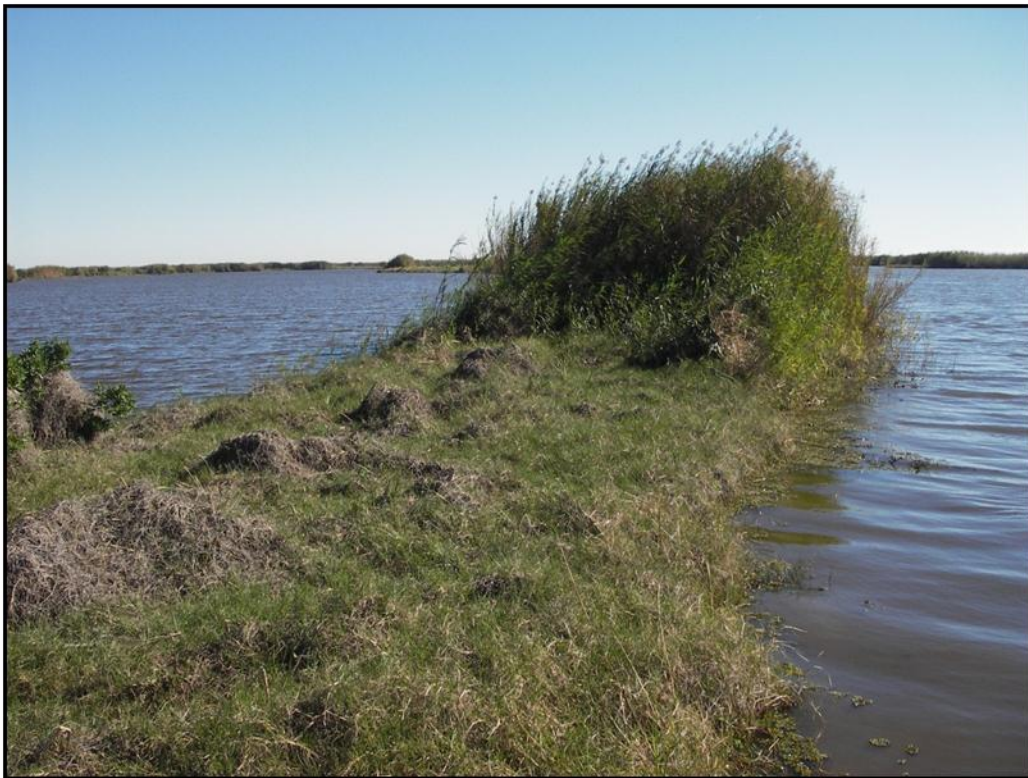
The terrace field is in very good condition. The vegetation is healthy and there appears to be little erosion. (Photos: Appendix B, Photo 11 & 12)

Item	Condition	Physical Damage	Corrosion	Photo #	Observations and Remarks
Steel Bulkhead / Caps	N/A				
Steel Grating	N/A				
Stop Logs	N/A				
Hardware	N/A				
Timber Piles	N/A				
Timber Walkway	N/A				
Timber Wales	N/A				
Galv. Pile Caps	N/A				
Cables	N/A				
Signage /Supports	N/A				
Staff Gages	N/A				
Rip Rap (fill)	N/A				
Earthen Terraces	Good			11 & 12	Fully vegetated.
