**2012/2013 Annual Inspection  
Report**

**LITTLE VERMILION BAY  
SEDIMENT TRAPPING  
PROJECT (TV-12)**

State Project Number TV-12  
Priority Project List 5

April 17, 2013  
Vermilion Parish

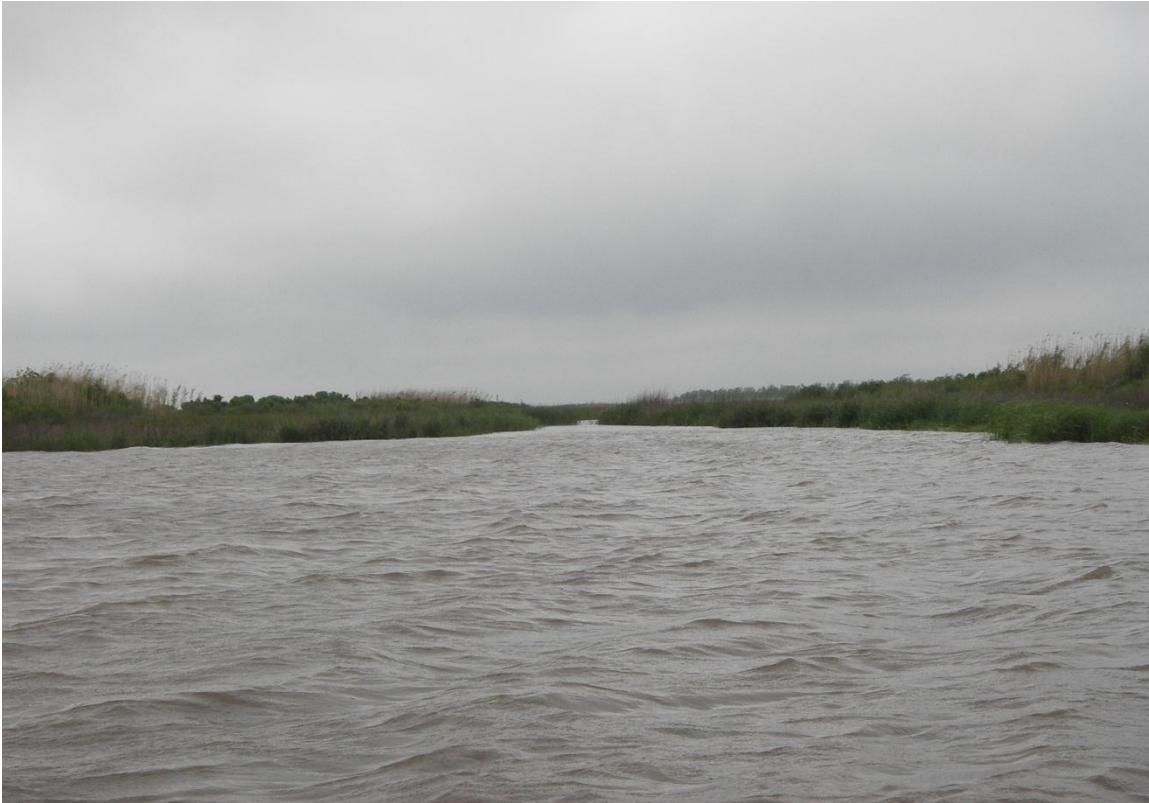
Vegetation has expanded significantly from the original plantings and appears strong. Emergent vegetation between the terraces is also becoming established. No maintenance with regard to vegetation needed at this time.

**Photo No. 1**—vegetation growing between terraces

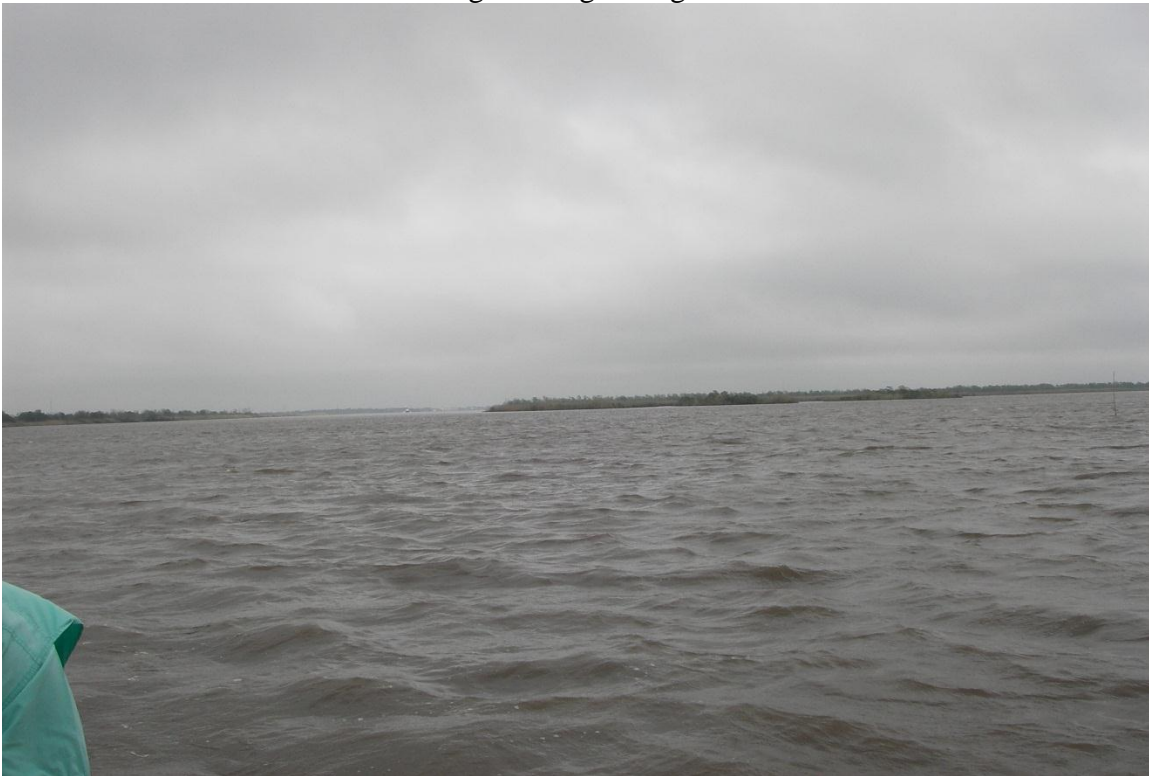
The terraces remain in very good condition with the exception of the terraces nearest Freshwater Bayou Canal (FWB) and the southernmost sacrificial terrace. Still, only three terraces remain on this southern row. The terraces nearest FWB continue to erode as the bankline along Freshwater Bayou continues to worsen. Measurements from 2010 aerial photography show this opening to have widened to over 1700 feet with about 500 linear feet of narrow marsh left along the northeast corner that remains vulnerable. Consideration is still being given to what will be the best method to reduce the opening to FWB. Additional

funding will be required. Surveys have been performed assisting in the estimation of the costs associated with possible actions. (Photos: Appendix B, Photos 1-2)

**Photo No. 2**—Freshwater Bayou Canal with opening to terrace field to right

The Little Vermilion Bay Sediment Trapping Project is in very good condition and still functioning as intended. Emergent vegetation is becoming established. Narrowing the opening into FWB and re-establishing the sacrificial terraces to the south will allow this project to continue to be successful.
