**Coastal Protection and Restoration
Authority of Louisiana (CPRA)**

2012/2013 Annual Inspection Report

MARSH ISLAND HYDROLOGIC RESTORATION PROJECT (TV-14)

March 26, 2013
Iberia Parish

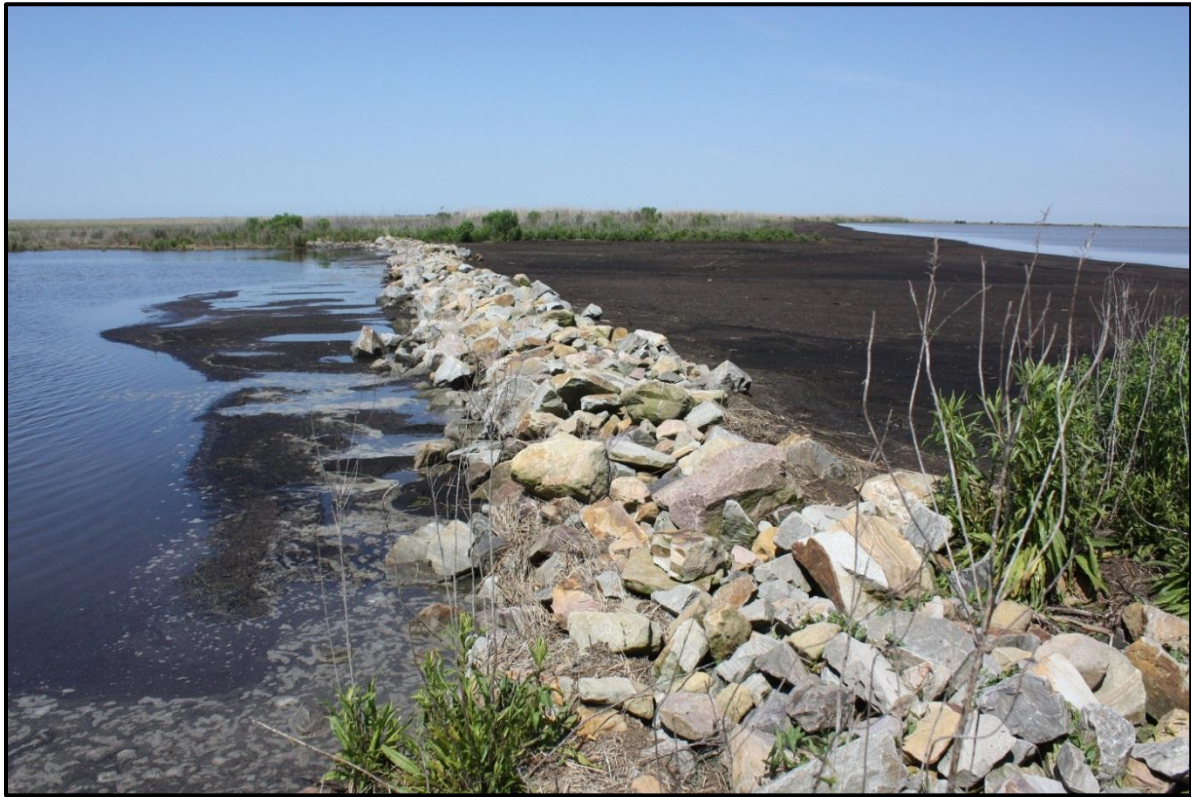
Photo No. 1, Closure No. 1

The erosion problems and Hurricane Rita damages have been repaired through the recent maintenance project that was completed in February 2009. The dike was capped and bank paving installed on both ends of the closure. This site is in good condition since this work was performed. We were unable to get near the closure due to low water. Using binoculars, everything appeared to be in good shape. An additional site visit was made by WLF staff in an airboat and a photo of Structure No. 1 is included in Appendix B, Photo 1.

Item	Condition	Physical Damage	Corrosion	Photo #	Observations and Remarks
Steel Bulkhead / Caps	N/A				
Steel Grating	N/A				
Stop Logs	N/A				
Hardware	N/A				
Timber Piles	N/A				
Timber Wales	N/A				
Galv. Pile Caps	N/A				
Cables	N/A				
Signage / Supports	N/A				
Rip Rap (fill)	Good			1	We were not able to get near the closure due to low water. A follow up visit was made by WLF in air boat.
Earthen Embankment	N/A

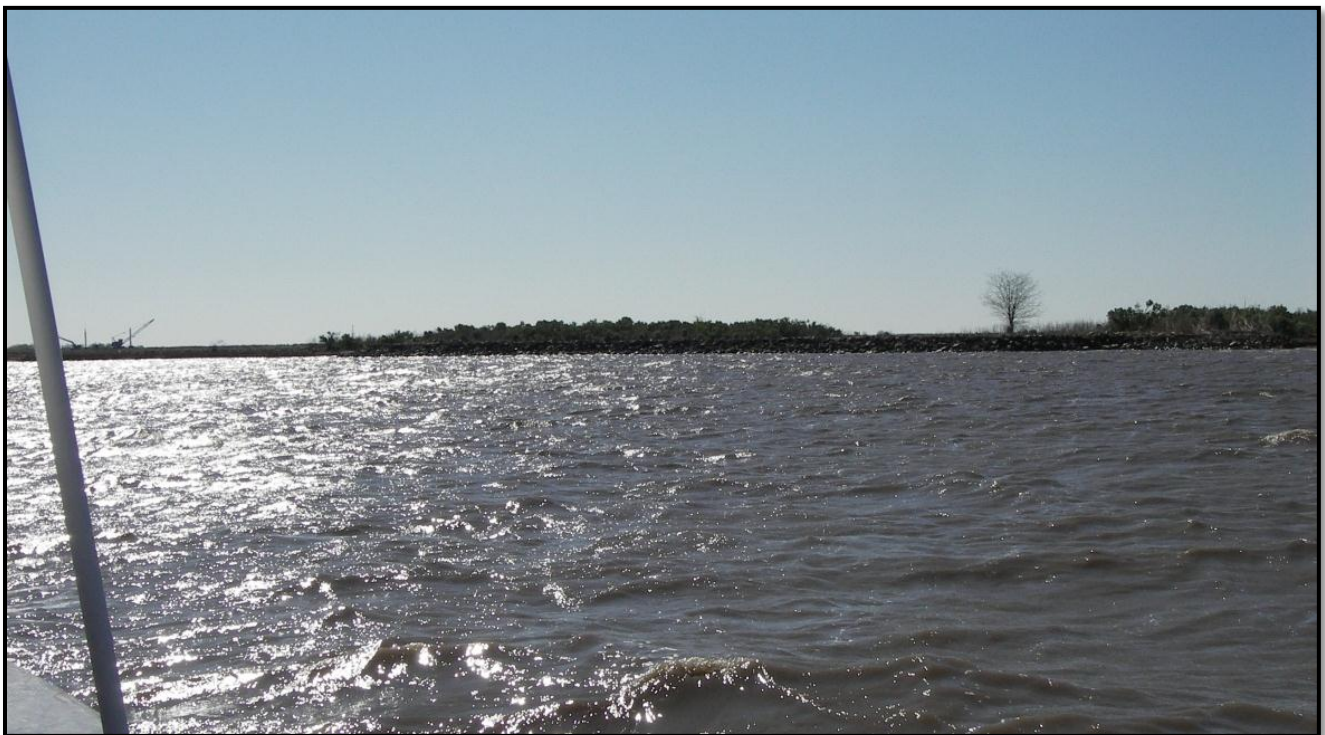
Photo No. 2, Closure No. 2

The dike was capped and bank paving installed as noted above and is in good condition since the work was performed. (Photos: Appendix B, Photo 2).

Item	Condition	Physical Damage	Corrosion	Photo #	Observations and Remarks
Steel Bulkhead / Caps	N/A				
Steel Grating	N/A				
Stop Logs	N/A				
Hardware	N/A				
Timber Piles	N/A				
Timber Wales	N/A				
Galv. Pile Caps	N/A				
Cables	N/A				
Signage / Supports	N/A				
Rip Rap (fill)	Good			2	Looks good
Earthen Embankment	N/A

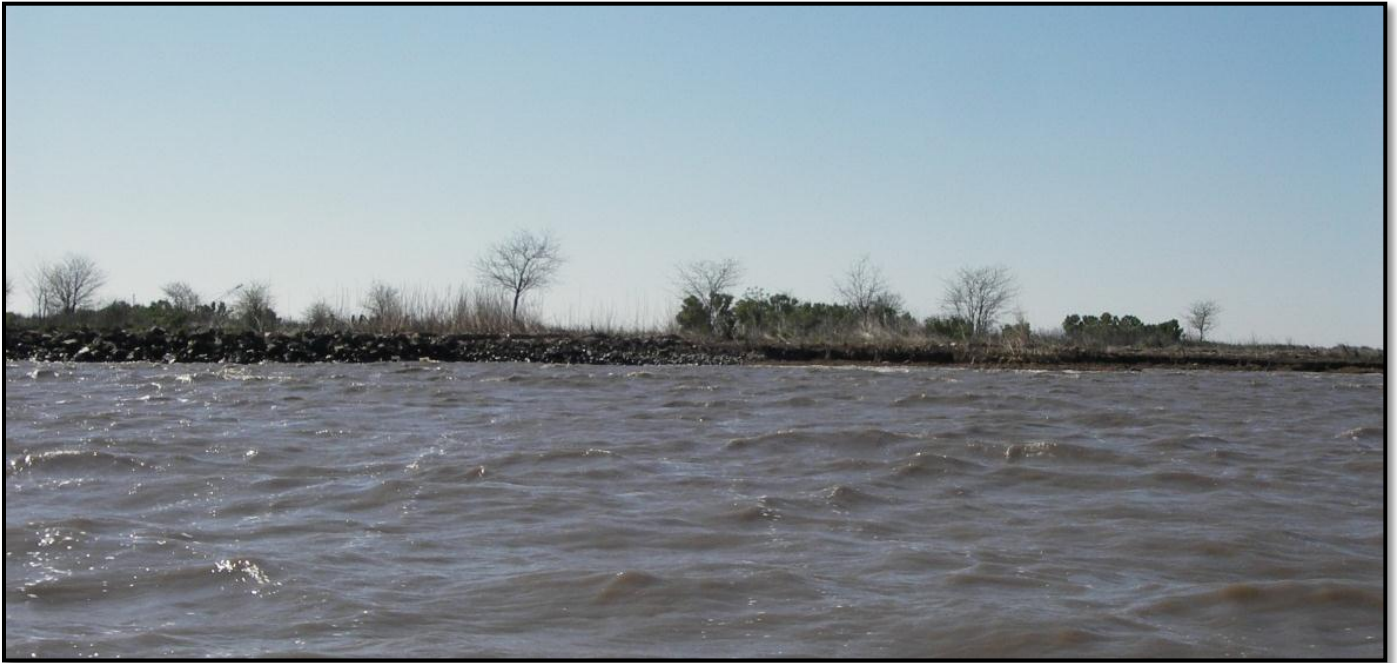
Photo No.3, Closure No. 3

The rock closure dike appears in good condition and was extended on the western end along with installing bank paving during the recent maintenance event. Also, it was observed (and confirmed with aerial photography post Hurricane RITA) that a large open water area has developed within the marsh near the western terminus of Closure No. 3 and that the bankline between that point and the eastern end of Closure No. 2 has eroded very severely and such that the “landbridge” between Vermilion Bay on the north of Marsh Island and the northwestern portion of Lake Sand proper is now narrow and may become subject to breaching thus allowing an undesirable water connection between the two bodies of water. CPRA and COE agree that this area is in poor condition and should be considered for maintenance at some point in time. It is recommended that an additional reach of shoreline protection dike be constructed, an estimated 1,500 to 1,800 linear feet, to connect the western end of Closure No. 3 to the eastern end of Closure No. 2. This reach of bank has been recently surveyed and the estimated cost for rock dike and flotation is approximately \$800,000. CPRA and COE agreed that due to this area being of concern but not yet critical status; and budget constraints, this maintenance work would be undertaken at a later time. (Photos: Appendix B, Photo 3).

Item	Condition	Physical Damage	Corrosion	Photo #	Observations and Remarks
Steel Bulkhead / Caps	N/A				
Steel Grating	N/A				
Stop Logs	N/A				
Hardware	N/A				
Timber Piles	N/A				
Timber Wales	N/A				
Galv. Pile Caps	N/A				
Cables	N/A				
Signage / Supports	N/A				
Rip Rap (fill)	Good			3	Looks good
Earthen Embankment	N/A

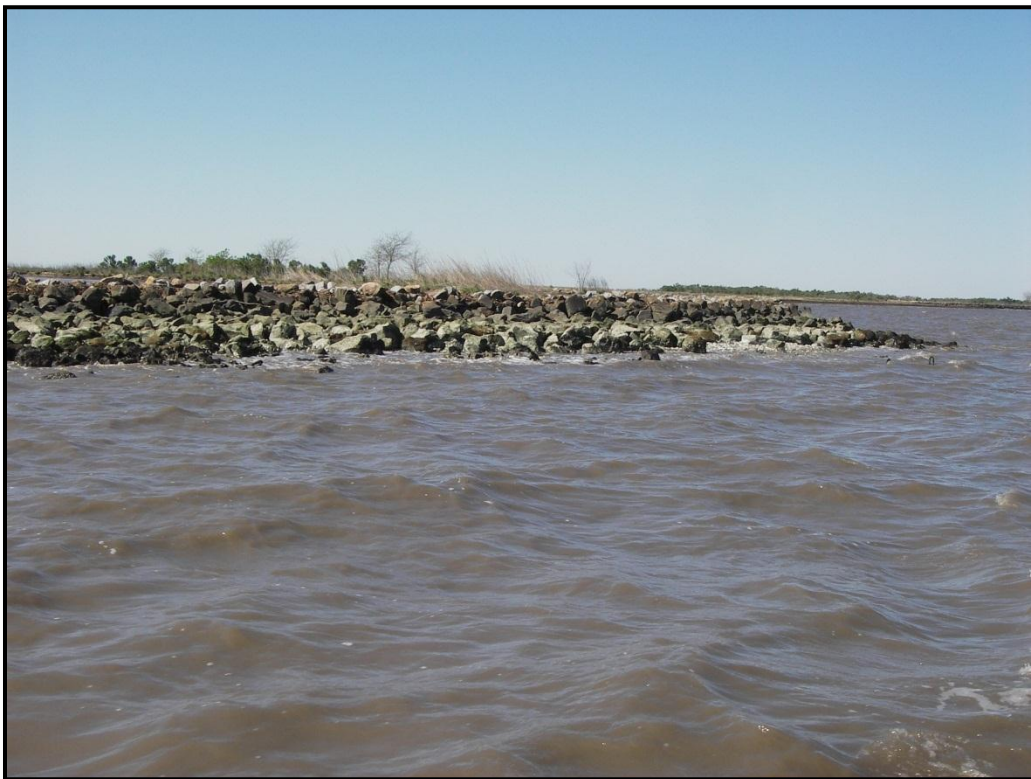
Photo No. 4, Closure No. 4

The Lake Sand Dike closure as originally constructed and recently repaired for Hurricane Rita damages, appears in good condition. The dike was capped in those areas where it was below elevation +3.0 as well as extended on the eastern end with bank paving. Dike has maintained

elevation in capped areas. There is some settlement on the eastern end of the dike. (Photos: Appendix B, Photos 4).

Item	Condition	Physical Damage	Corrosion	Photo #	Observations and Remarks
Steel Bulkhead / Caps	N/A				
Steel Grating	N/A				
Stop Logs	N/A				
Hardware	N/A				
Timber Piles	N/A				
Timber Wales	N/A				
Galv. Pile Caps	N/A				
Cables	N/A				
Signage / Supports	N/A				
Rip Rap (fill)	Good			4	Looks good
Earthen Embankment	N/A

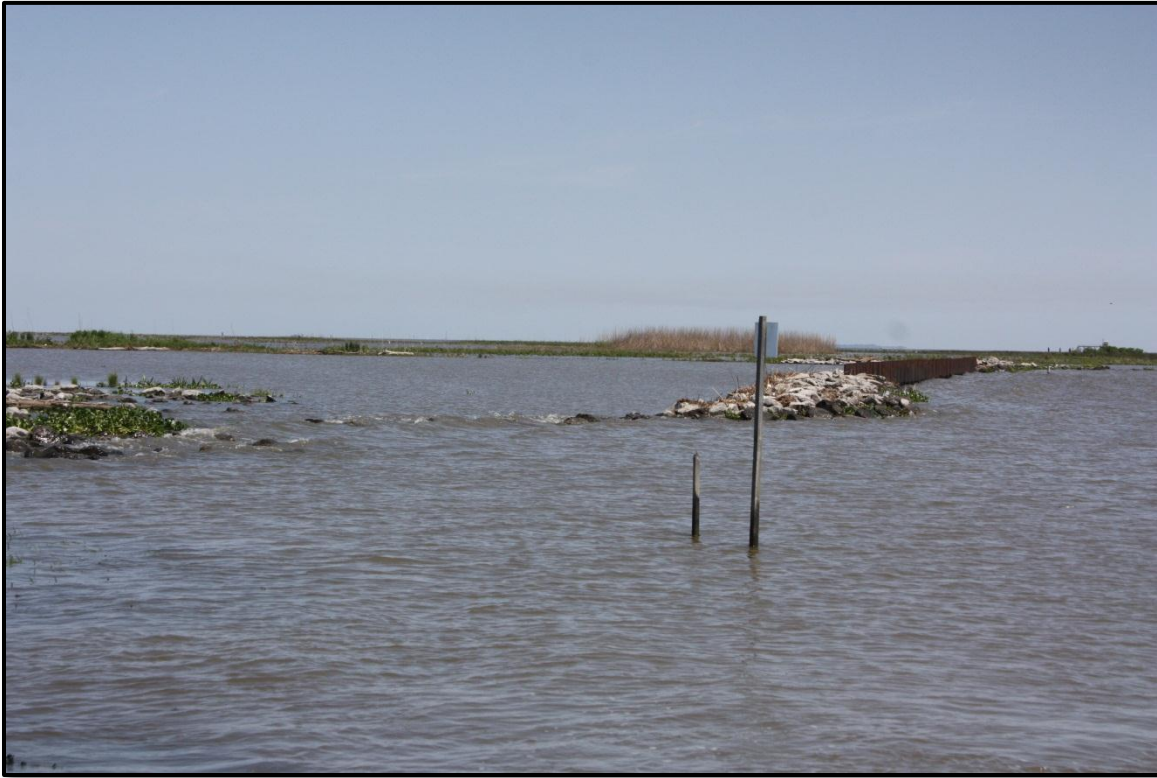
Photo No. 5, Closure No. 5

The steel sheet pile, rock riprap wingwalls, and stone bank/marsh paving placed as part of the Hurricane LILI repair project is in good condition and were apparently very effective in preventing additional damage by the erosive action of Hurricane RITA. The staff gage was re-set as part of the recent maintenance event. The overbank marsh areas paved to make same “hard” and paid for with O & M funding needs to be continually evaluated for its effectiveness. There is a breach on the southern side of the bank paving where water is passing through. (Photos: Appendix B, Photo 5).

Item	Condition	Physical Damage	Corrosion	Photo #	Observations and Remarks
Steel Bulkhead / Caps	Good			5	
Steel Grating	N/A				
Stop Logs	N/A				
Hardware	N/A				
Timber Piles	N/A				
Timber Wales	N/A				
Galv. Pile Caps	N/A				
Cables	N/A				
Signage / Supports	N/A				
Rip Rap (fill)	Good			5	Looks good. No change since previous inspection. Bank paving is holding up well. There is a small breach on the Northern side.
Earthen Embankment	N/A

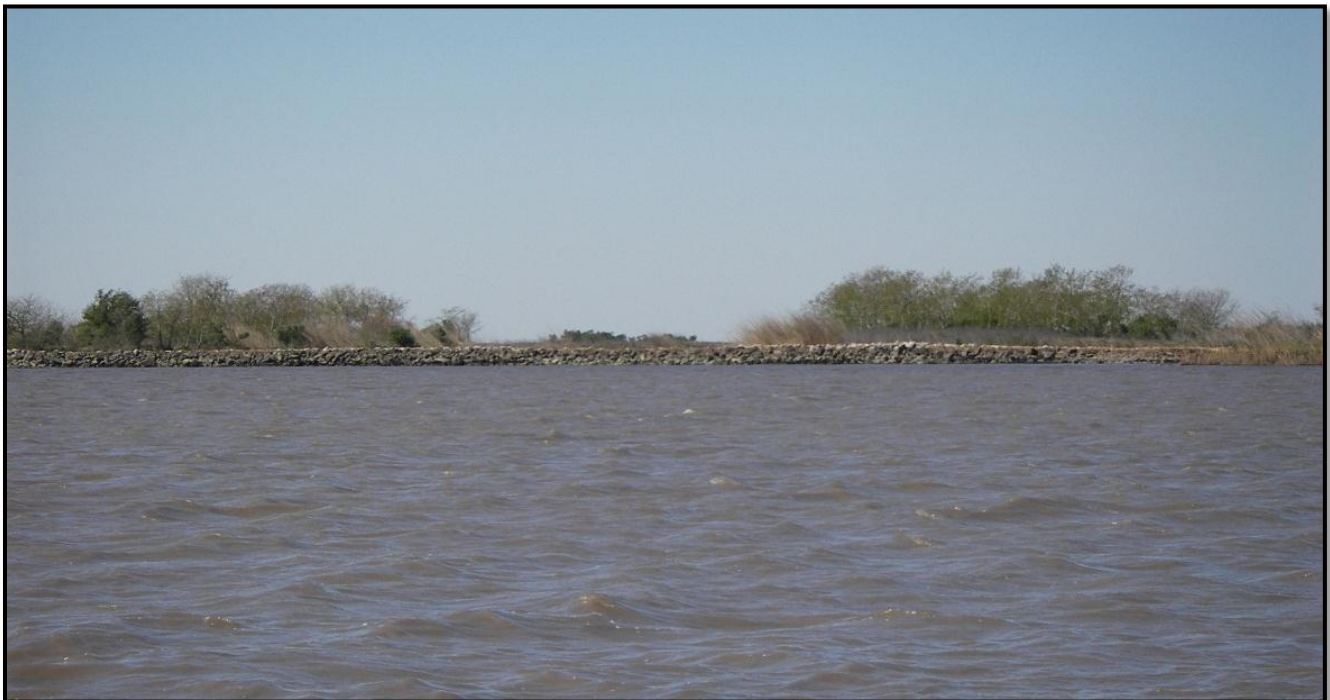
Photo No. 6, Closure No. 6

The breach on the southern end of the dike that had occurred prior to Hurricane Rita and subsequently worsened as a result of the tidal surge has been repaired as part of the recent maintenance event. The dike was extended on the northern end and bank paving was installed on both ends of the closure. This site is in good condition since the repairs have been made. There is good sediment deposition on the southern end of the dike. (Photos: Appendix B, Photo 6).

Item	Condition	Physical Damage	Corrosion	Photo #	Observations and Remarks
Steel Bulkhead / Caps	N/A				
Steel Grating	N/A				
Stop Logs	N/A				
Hardware	N/A				
Timber Piles	N/A				
Timber Wales	N/A				
Galv. Pile Caps	N/A				
Cables	N/A				
Signage / Supports	N/A				
Rock Dike	Good			6	Looks good
Earthen Embankment	N/A

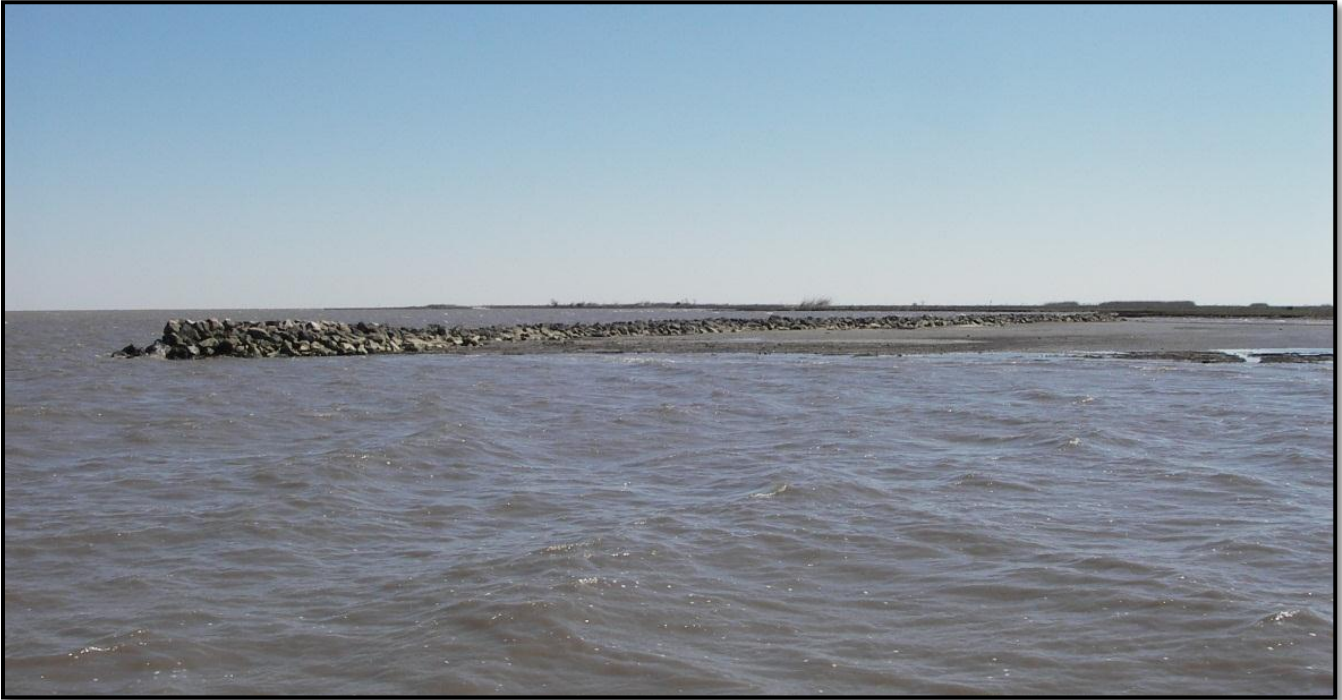
Photo No. 7, Structure No. 7

This closure site is in good condition and spoil material from the dredging of the north-south canal in 2008 was placed along the eastern end of the rock dike in an effort to stabilize this section of shore. In addition dredge spoil material was pumped behind the rock dike as part of this same access dredging and a small area of marsh creation was formed which is now starting to vegetate. There is some settlement along two (2) 150 foot lengths of the rock dike. (Photos: Appendix B, Photos 7).

Item	Condition	Physical Damage	Corrosion	Photo #	Observations and Remarks
Steel Bulkhead / Caps	N/A				
Steel Grating	N/A				
Stop Logs	N/A				
Hardware	N/A				
Timber Piles	N/A				
Timber Wales	N/A				
Galv. Pile Caps	N/A				
Cables	N/A				
Signage / Supports	N/A				
Rock Dike	Good			7	Looks good
Earthen Embankment	N/A

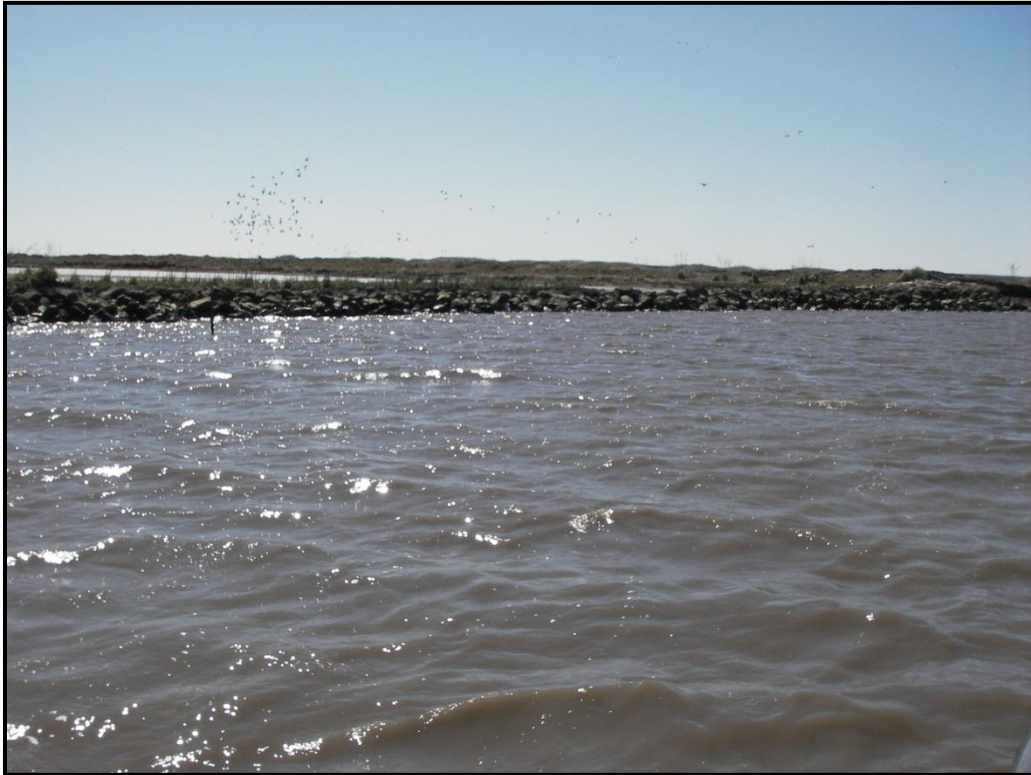
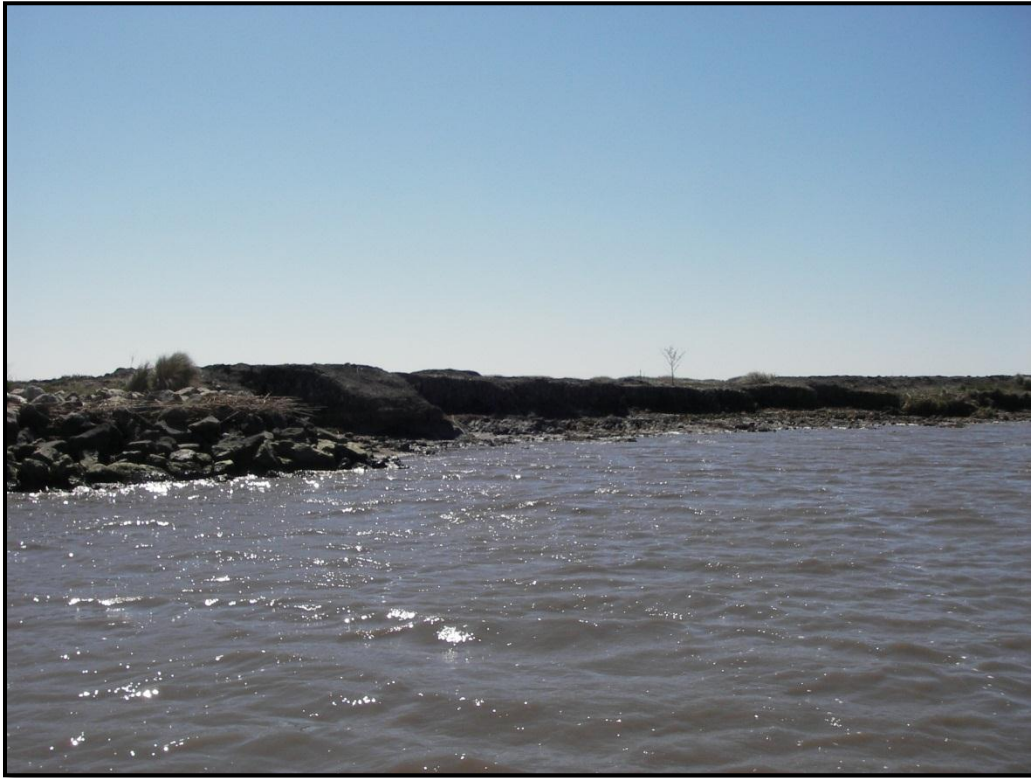
This closure site is in good condition since the existing breach on the south side of the closure was repaired in the 2008 maintenance event noted above in Section IV. Spoil material was placed to close off the breach and also placed on top of the existing rock dike. Spoil material was also placed from the north end of the rock dike towards the bay to make a connection to the existing mitigation rock dike along the bayshore. The rock is starting to settle. (Photos: Appendix B, Photos 8-9).

Item	Condition	Physical Damage	Corrosion	Photo #	Observations and Remarks
Steel Bulkhead / Caps	N/A				
Steel Grating	N/A				
Stop Logs	N/A				
Hardware	N/A				
Timber Piles	N/A				
Timber Wales	N/A				
Galv. Pile Caps	N/A				
Cables	N/A				
Signage / Supports	N/A				
Rock Plug	Good			8,9	Looks good. Grass establishing nicely in the two (2) marsh creation cells just east of the plug. Rock is settling at mouth of canal.
Earthen Embankment	N/A

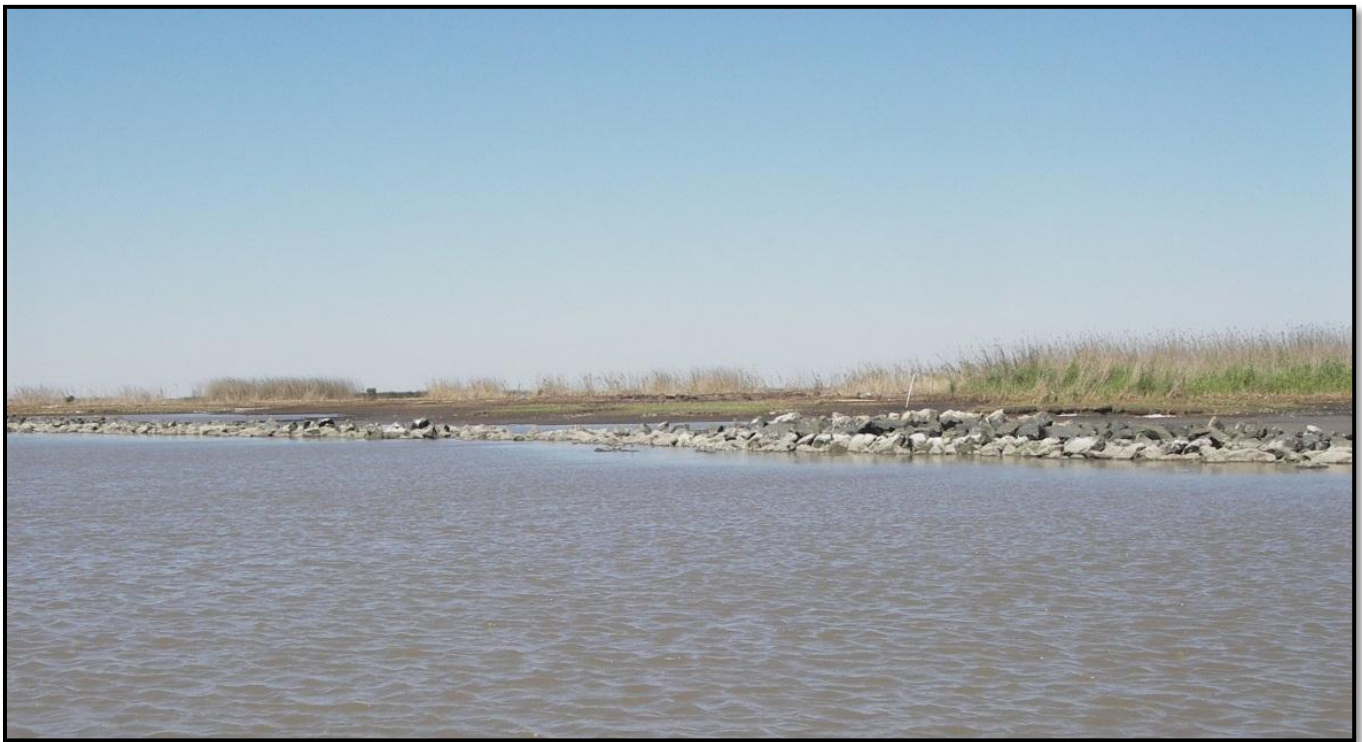
Photo No. 10, Structure No. 9 rock dike

The rock riprap shoreline protection dike constructed on the south shoreline of Marsh Island was noted to now sit out further into the waters of the Gulf as discussed in the last inspection. Conditions were such that the feature was functioning well and that sediment had accreted and a growth of marsh vegetation had extended over the new fill. This rock shoreline feature will still function as a breakwater and extend the life of the earthen pipeline closure to the north.

The recent construction of the TV-21 East Marsh Island Marsh Creation project has helped to reinforce the breach that had occurred on the southeast corner of the pipeline canal since the last inspection. The pipeline canal north of the rock breakwater was filled in with sediment from the marsh creation project and construction of containment dikes have now closed off the breach at the shoreline. No maintenance will be necessary at closure No. 9 as a result of the work performed through the TV-21 project. (Photos: Appendix B, Photos 10).

Item	Condition	Physical Damage	Corrosion	Photo #	Observations and Remarks
Steel Bulkhead / Caps	N/A				
Steel Grating	N/A				
Stop Logs	N/A				
Hardware	N/A				
Timber Piles	N/A				
Timber Wales	N/A				
Galv. Pile Caps	N/A				
Cables	N/A				
Signage / Supports	N/A				
Rock Dike	Fair			10	Dike is settling in some areas. Breach is closed and shoreline looks good since the TV-21 project.
Earthen Embankment	N/A
