**Coastal Protection and Restoration
Authority of Louisiana (CPRA)**

2012/2013 Annual Inspection Report

SEDIMENT TRAPPING AT THE JAWS PROJECT (TV-15)

June 14, 2013
St. Mary Parish

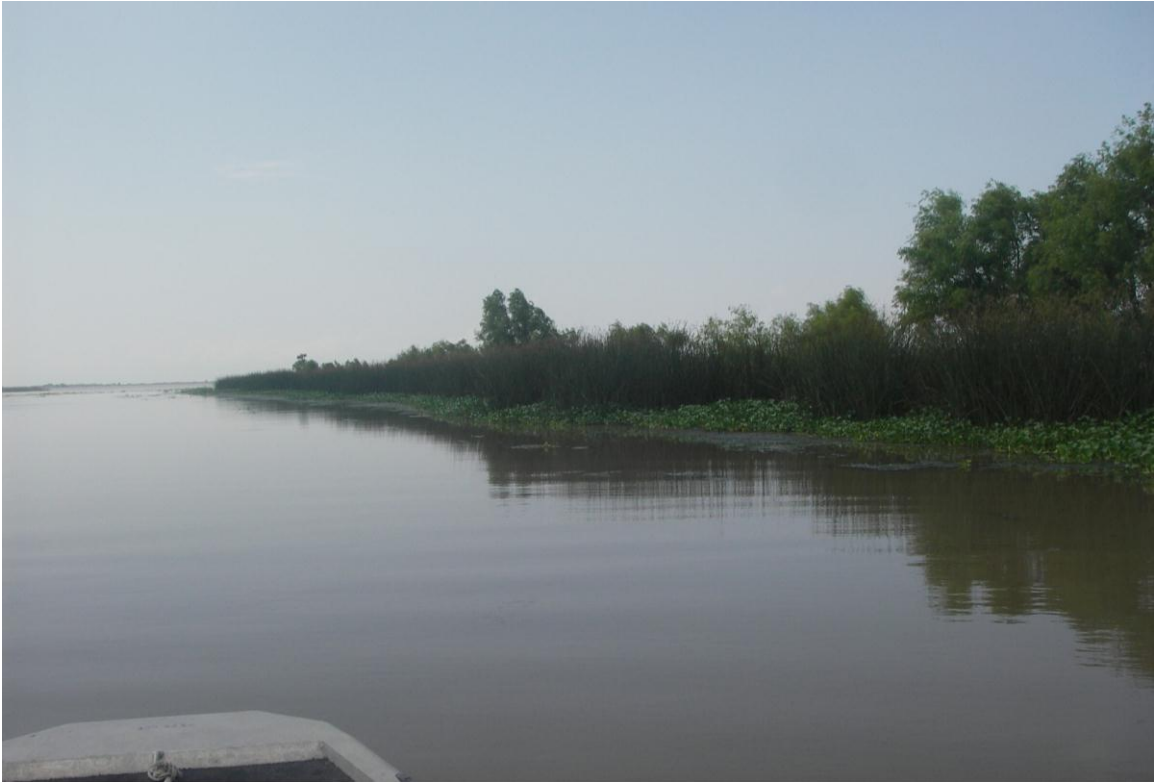
Photo No. 1--typical terrace

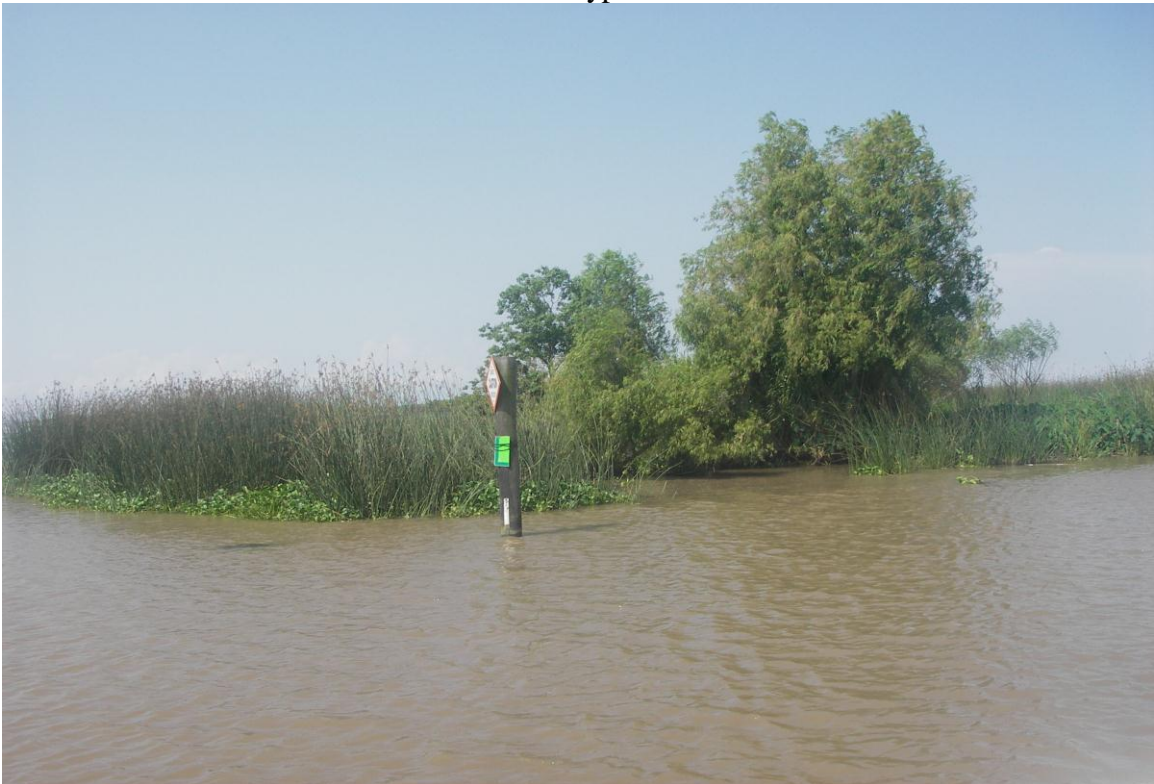
Photo No. 2--typical terrace and warning sign

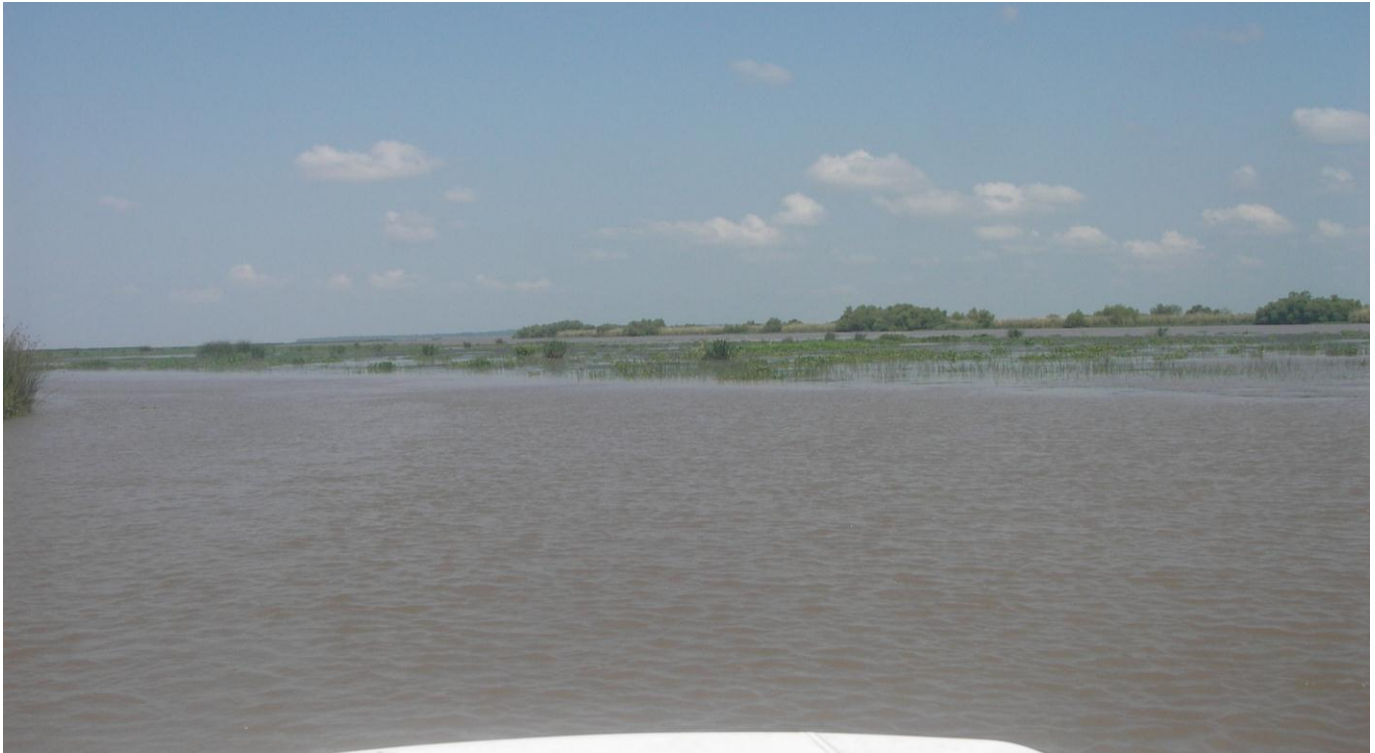
Photo No. 3--emergent vegetation between terraces

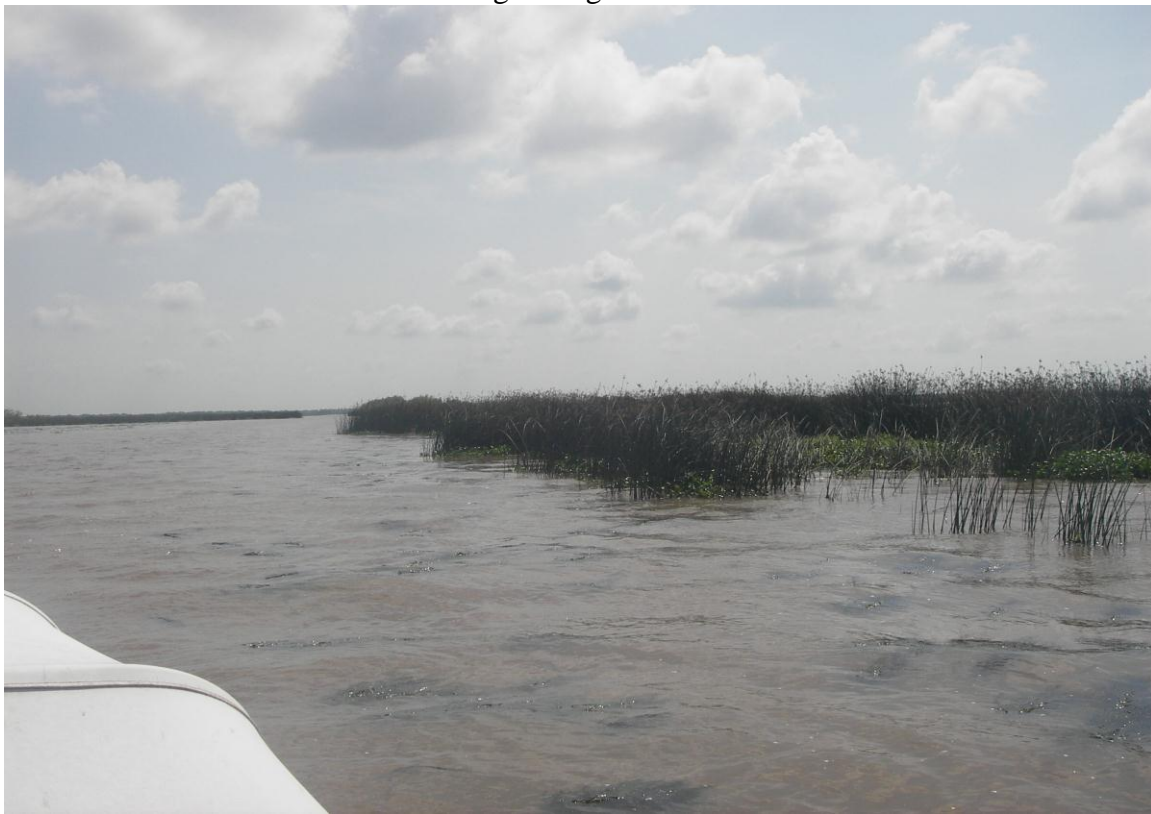
Photo No. 4—stands of bullwhip on the end of a terrace
