**Coastal Protection and Restoration
Authority of Louisiana (CPRA)**

**2012/2013 Annual Inspection
Report**

**FOUR MILE CANAL TERRACING
AND SEDIMENT TRAPPING
PROJECT (TV-18)**

April 17, 2013
Vermilion Parish

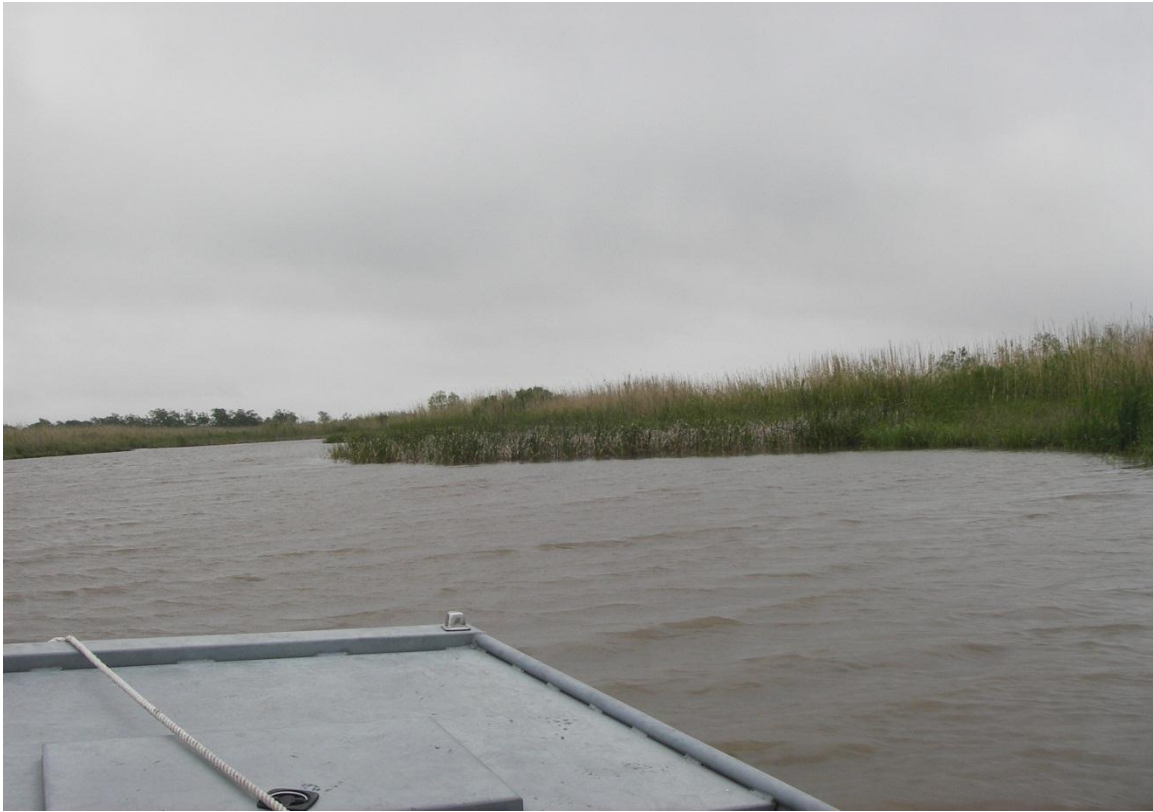
In Little White Lake, the 4th row of terraces continues to erode, however some terraces are still visible and functioning. The 3rd row remains in fairly decent shape, but some erosion of this row is becoming more evident. The 1st and 2nd rows are in excellent condition. Silting within the channels is increasing. The eastern terraces adjacent to the Four Mile Canal continue to erode as well as the western most terraces. Discussions continue on what type of protection will or will not be provided. The boat wakes continue to damage these terraces. Channels between the terraces are silting in. (Photos: Appendix B, Photo 1-4)

Photo No. 1—Little White Lake terraces (interior row)

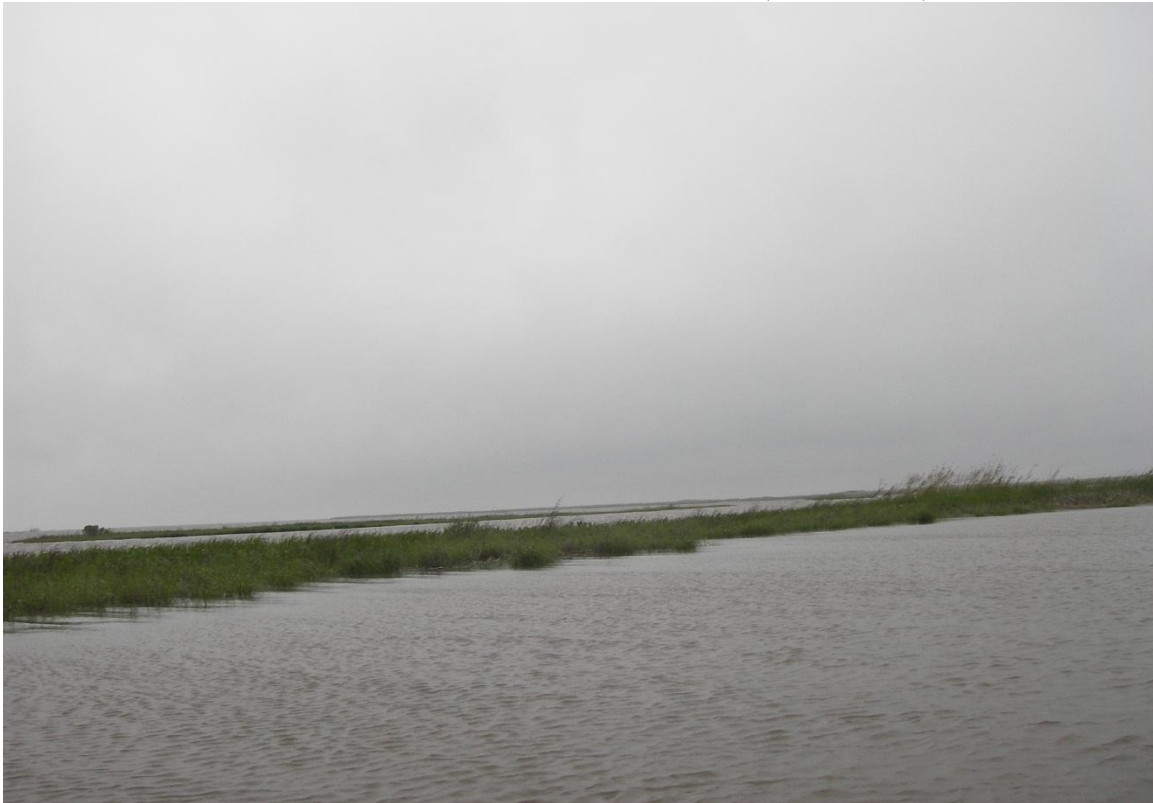
Photo No. 2—Little White Lake terraces (2nd and 3rd rows)

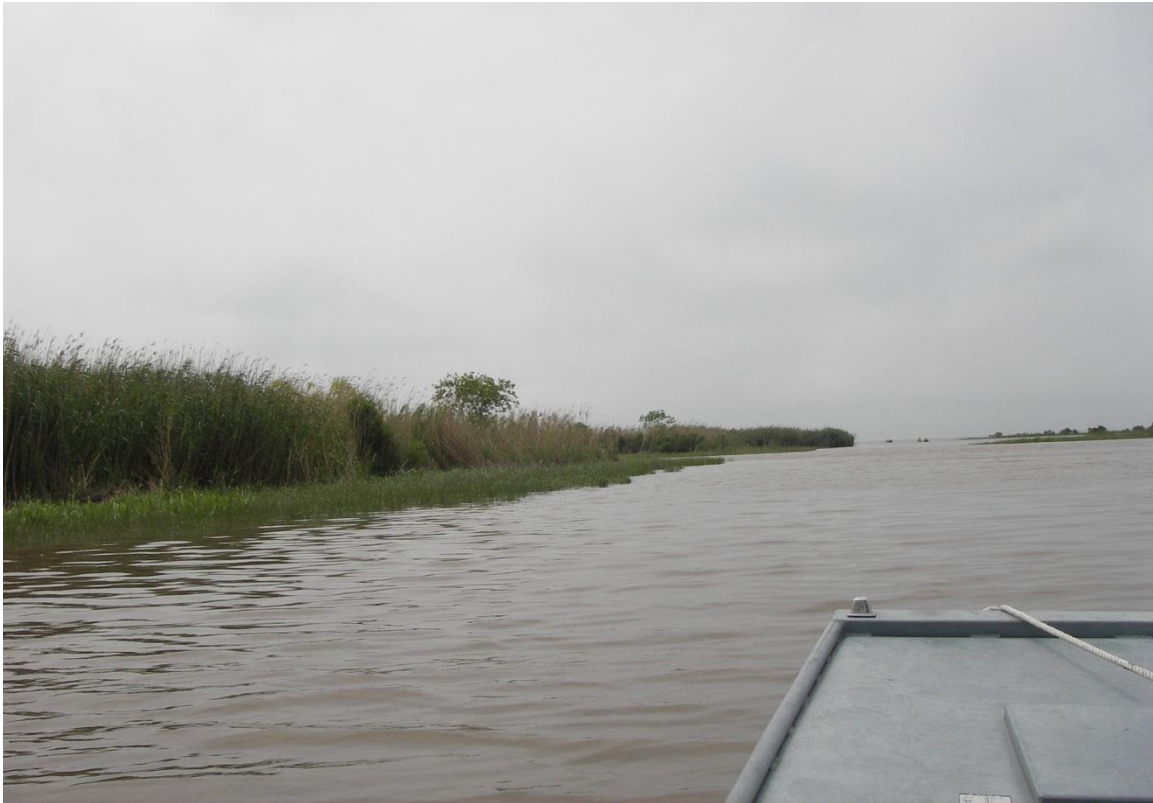
Photo 3—Four Mile Canal terraces

The Four Mile Canal Terracing and Sediment Trapping Project is in very good condition and functioning as intended. The terraces along Four Mile Canal, however, will need to be protected.

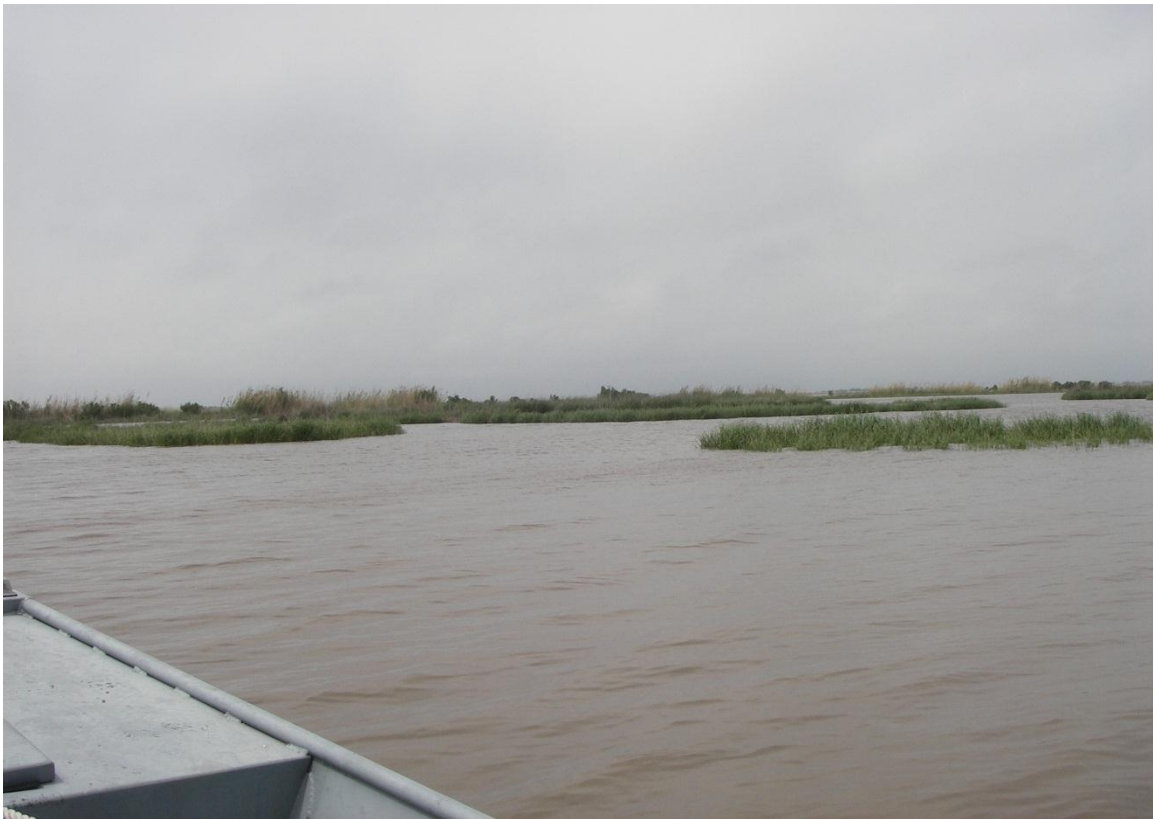
Vegetation on stable terraces in both areas is doing extremely well. Emergent vegetation is becoming established. No maintenance with regard to the plantings is needed at this time.

Photo 4—emergent vegetation within Four Mile Canal terraces
