## **2012/2013 Annual Inspection Report**

### **LAKE PORTAGE LAND BRIDGE PROJECT (TV-17)**

State Project Number TV-17  
Priority Project List 8

May 21, 2013  
Vermilion Parish

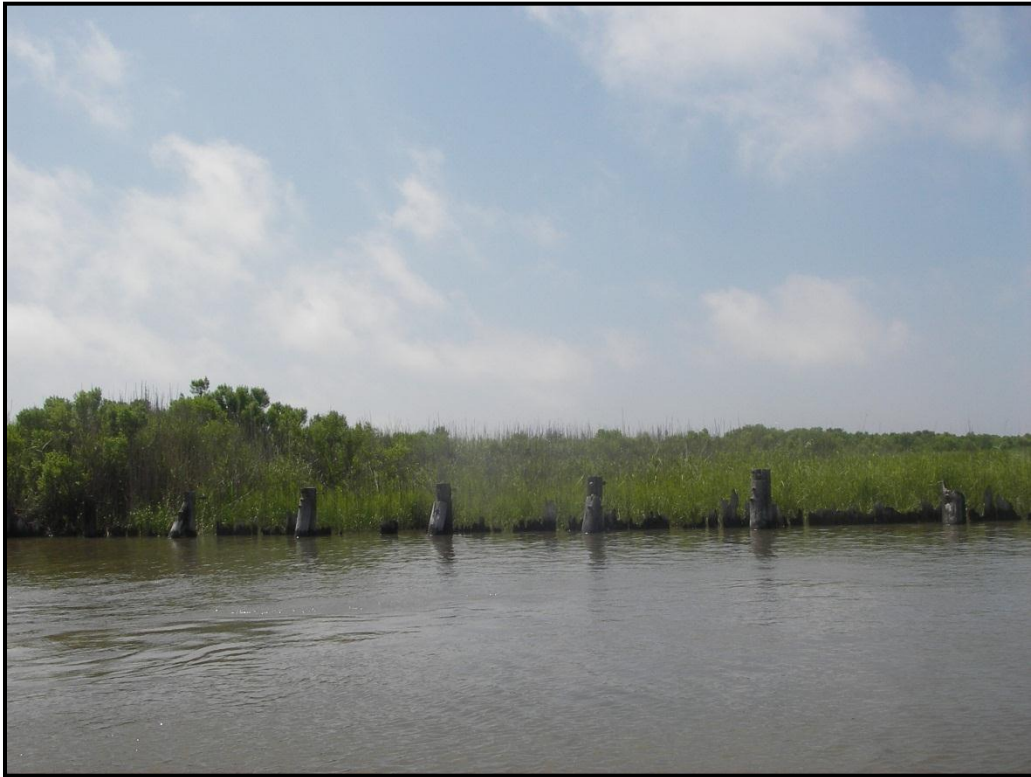
Area 1 is in good condition and vegetation has continued to expand from the containment banks moving towards the center of the channel and is 100 per cent vegetated. As a result of the inspection of Area 1, CPRA and NRCS agree that no corrective actions will be required this year. An aerial photo taken by Edmond Mouton of LDWF shows the pipeline canal has established a healthy vegetative stand. (Photos: Appendix B, Photo 1 & 6).

Photo 1, Area 1, Timber bulkhead.

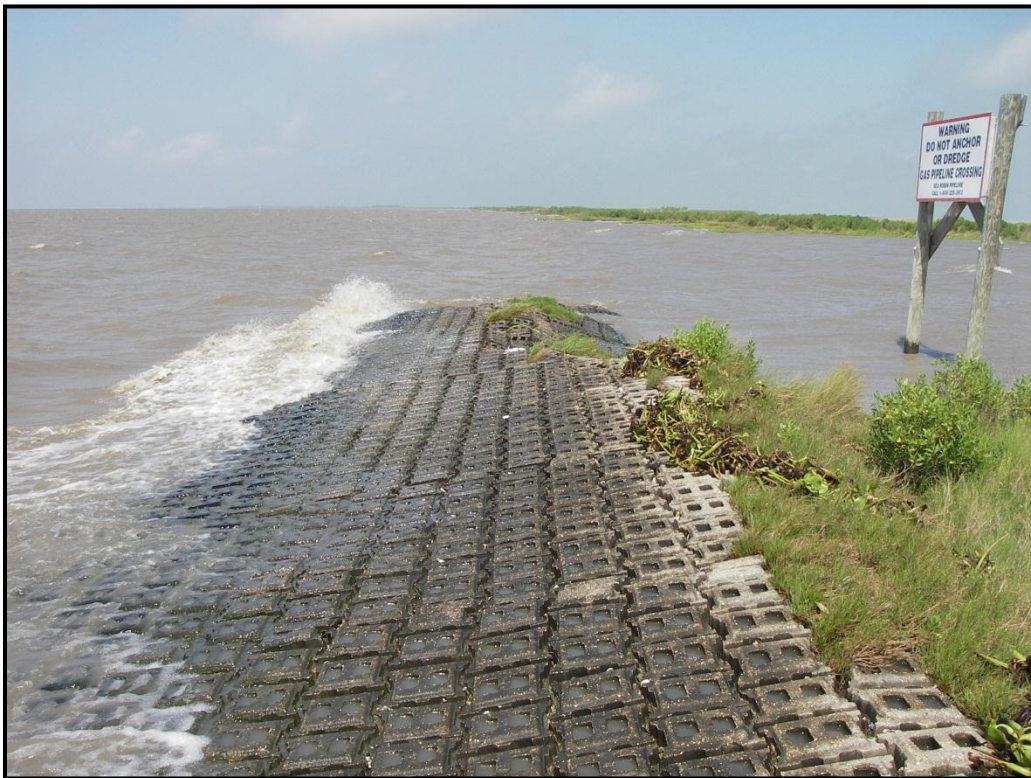
Area 2 is also in good condition and is fully vegetated, such that this reach was preexisting with additional dredge material added through this project to fill in any trenasses. Some erosion at the ends of the concrete mats along the Gulf shoreline has occurred over time and part of the mat system is showing signs of failure. Although the concrete mat system is not a feature to be maintained as part of this project, this area is experiencing erosion that may threaten the integrity of the overall project. Therefore, CPRA and NRCS agree that maintenance may be required at some time in the future. (Photos: Appendix B, Photos 2, 3, 4 & 6).

Photo 2, Area 2, West side of concrete mats.

| MAINTENANCE INSPECTION REPORT CHECK SHEET | | | | | |
|---|---|---|---|---|---|
| Concrete Mats | Good | | | 2, 3, 4, 6 | Some erosion each side of concrete mats along Gulf shoreline. |

Overall, the Lake Portage Land Bridge Project is in good condition and functioning as designed. However, the erosion problem occurring at the Gulf shoreline will need to be addressed. Preliminary survey work to develop an accurate estimate of costs was performed in 2008 and a subsequent request made to CWPPRA for additional funds. The Task Force decided that monitoring of the shoreline should continue and opted not to take any action at this time.

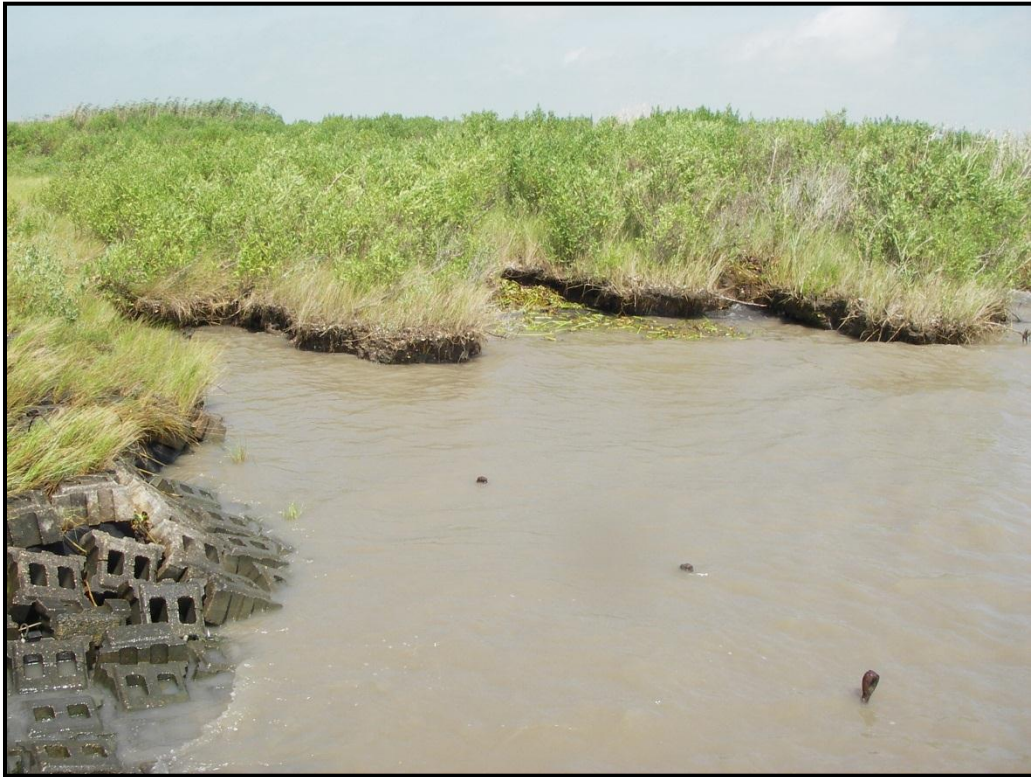
Photo 3, Area 2, Close up view of erosion on east side of concrete mats.

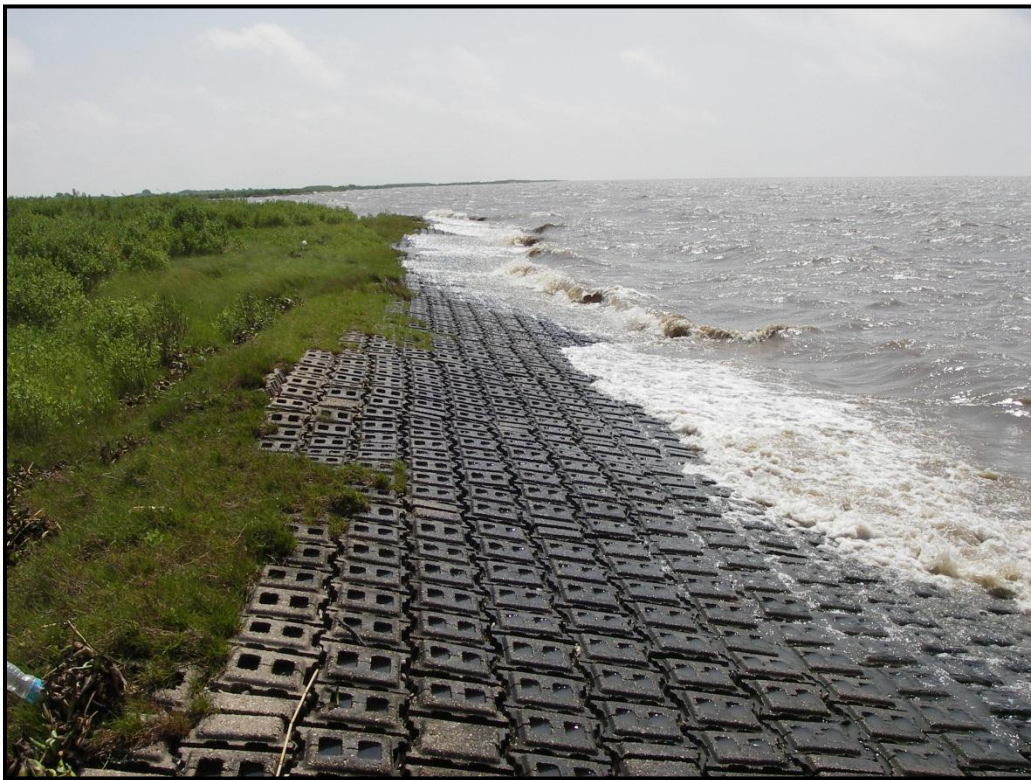
Photo 4, Area 2, East side of concrete mats.

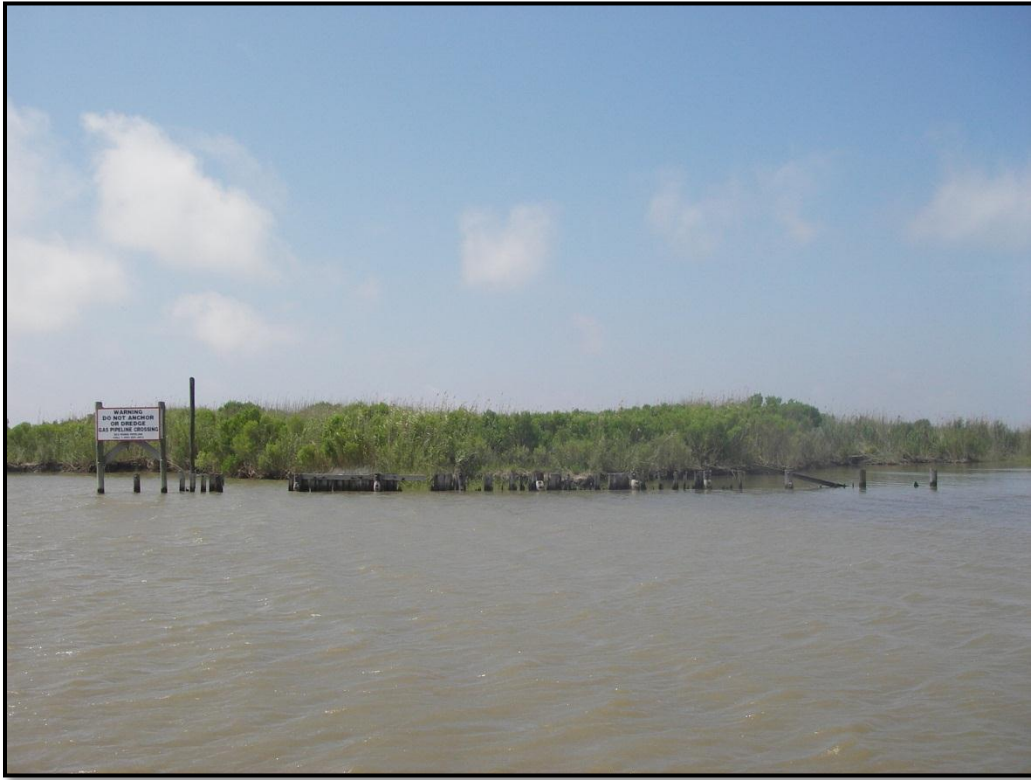
Area 3 also is in good condition. The northern part of this reach is fully vegetated, mainly due to the fact that this reach was constructed first, and has been in place since May, 2003. There is some minor erosion occurring on each side of the northern timber bulkhead which will need to be monitored on future annual inspections. CPRA and NRCS agree that this area is in good condition and no maintenance will be required at this time. (Photos: Appendix B, Photos 5 & 7).

Photo 5, Area 3, near bulkhead on north end.

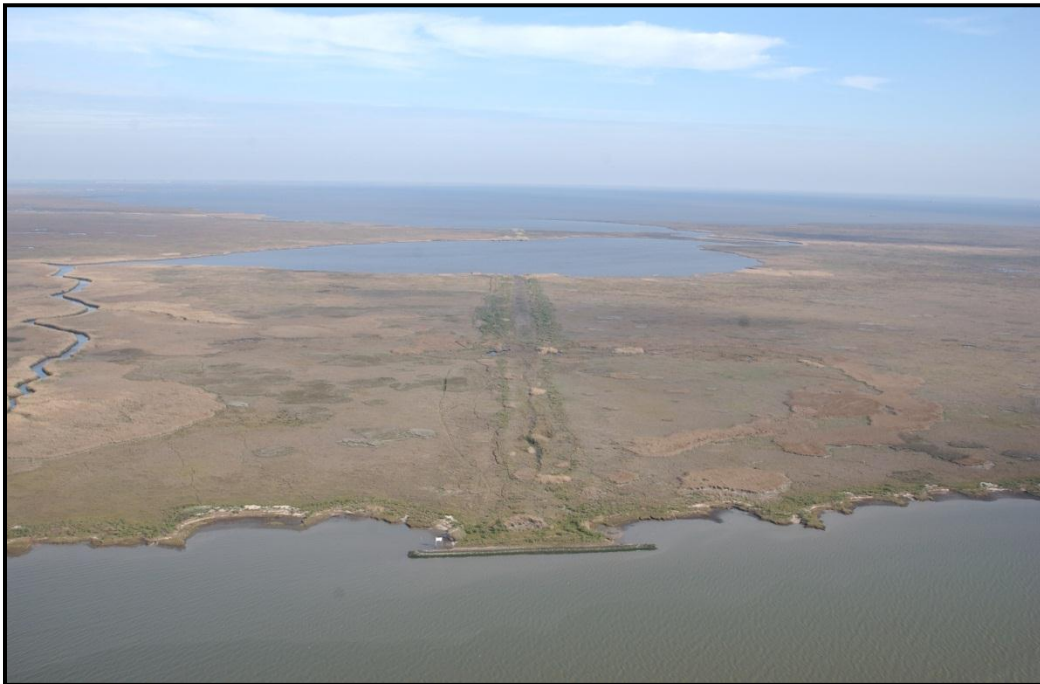
Photo 6, Areas 1 & 2, Aerial view from Gulf of Mexico looking north to Lake Portage

| MAINTENANCE INSPECTION REPORT CHECK SHEET | | | | | |
|---|---|---|---|---|---|
| Vegetation | Good | | | 6, 7 | Area 3 fully vegetated, Area 2 existing vegetation, Area 1 fully vegetated. |

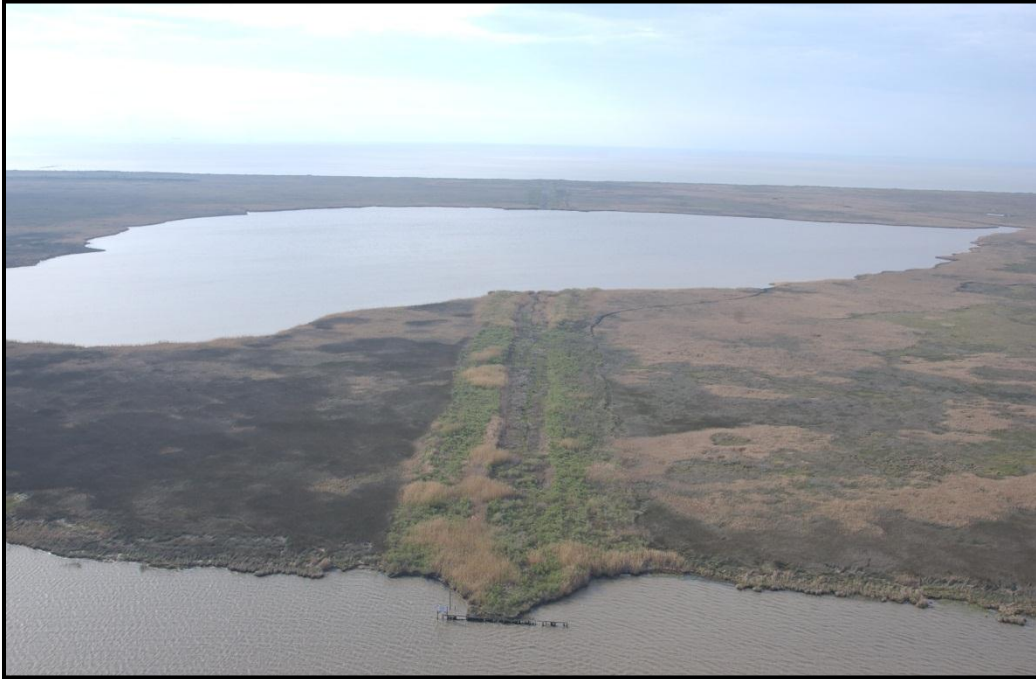
Photo 7, Areas 3, Aerial view from Lake Portage looking south to the Gulf of Mexico
