2012/2013 Annual Inspection Report

OAKS/AVERY CANALS HYDROLOGIC RESTORATION PROJECT

State Project Number TV-13a
Priority Project List 6

December 11, 2012
Vermilion/Iberia Parishes

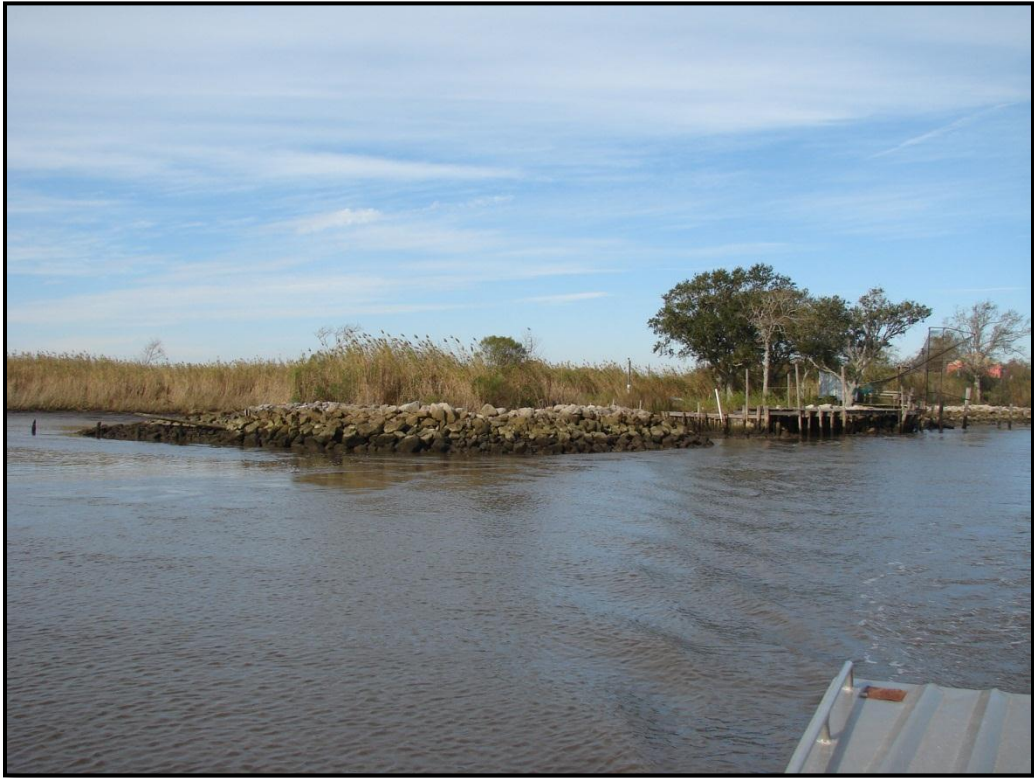
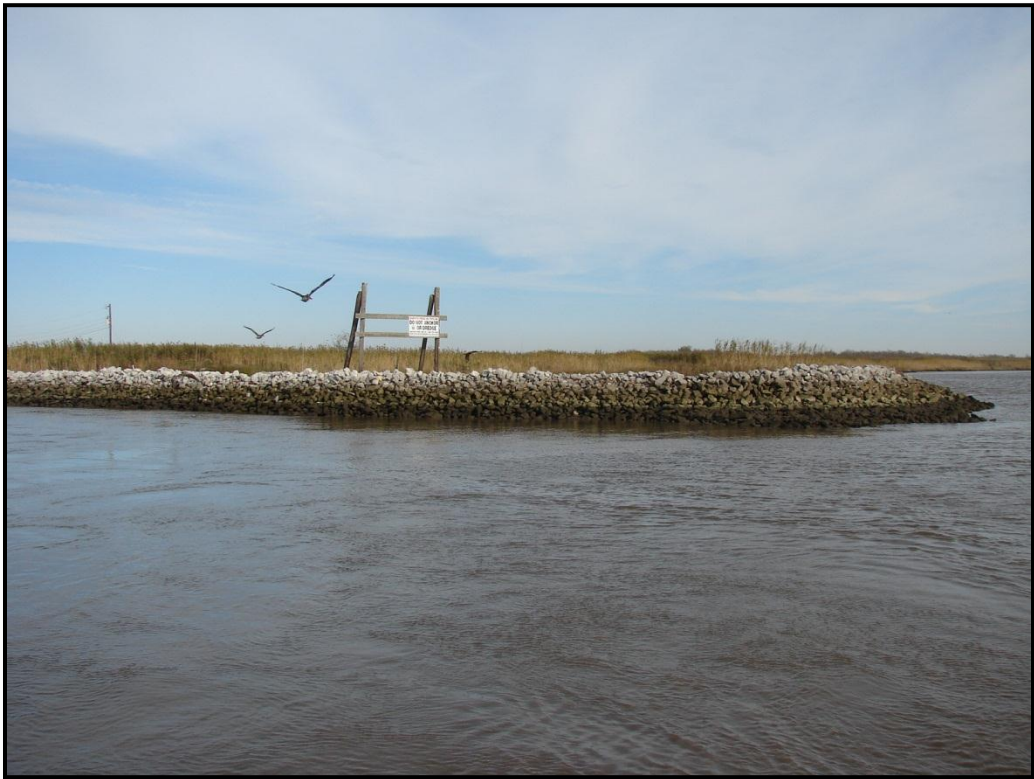
No worsening in this area was evident. The bank between the bay and Bayou Hebert is still only about 6 feet wide and has not gotten any worse. Additional rock has been added to connect the end of the existing rock paving to the rock island protecting two pipelines located on the eastern side of the Oaks Canal. This work was performed by ChevronTexaco Pipeline, LLC-Erath in 2009 through CUP No. 20070581. No immediate maintenance required at this time. (Appendix B; Photos 1-2)

Photo No.1, Rock dike at Oaks Canal, west side

Photo No. 2, Rock dike at Oaks Canal, east side

Item	Condition	Physical Damage	Corrosion	Photo #	Observations and Remarks
Steel Bulkhead / Caps	N/A				
Steel Grating	N/A				
Stop Logs	N/A				
Hardware	N/A				
Timber Piles	N/A				
Timber Wales	N/A				
Galv. Pile Caps	N/A				
Vegetation	N/A				
Signage / Supports	N/A				
Rip Rap (fill)	Excellent			1,2	Rock in excellent condition
Eathem Embankment	N/A				
What are the conditions of the existing levees?					
Are there any noticable breaches?					
Settlement of rock plugs and rock weirs?					
Position of stoplogs at the time of the inspection?					
Are there any signs of vandalism?

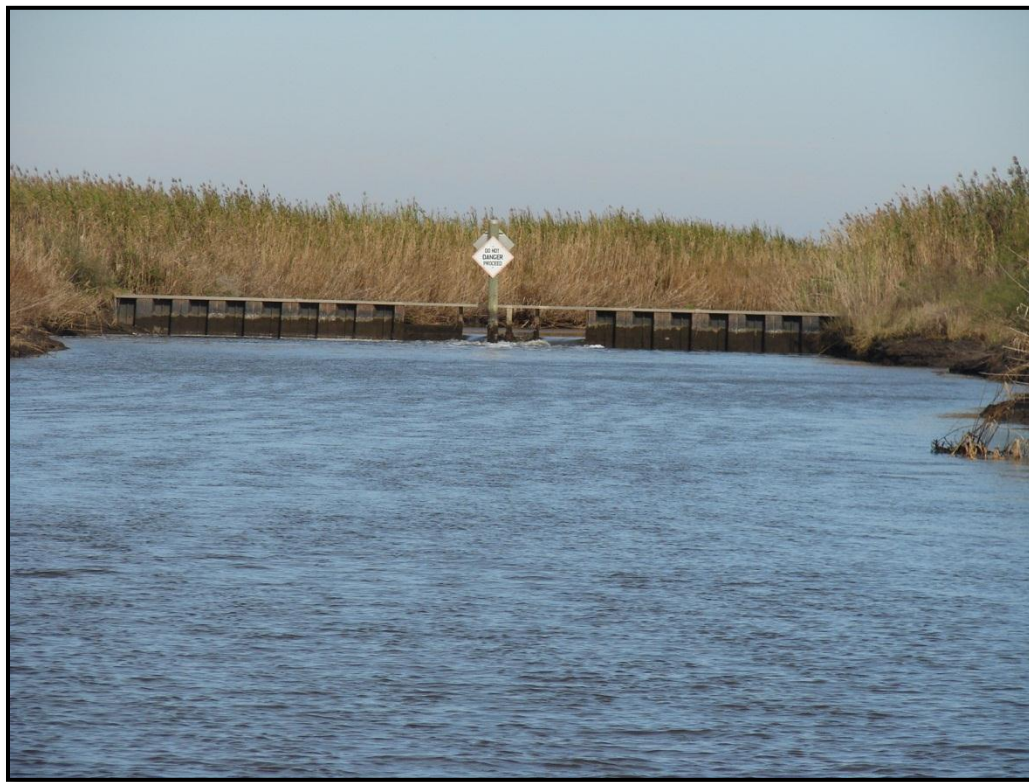
Due to low water conditions, the structure could not be inspected. Water could be seen pouring out of structure. (Appendix B; Photo 3)

Photo No. 3, Cow Path Structure

Item	Condition	Physical Damage	Corrosion	Photo #	Observations and Remarks
Steel Bulkhead / Caps	Excellent			3	Could not inspect due to low water.
Steel Grating	N/A				
Stop Logs	N/A				
Hardware	Good			3	Could not inspect due to low water.
Timber Piles	N/A				
Timber Wales	N/A				
Galv. Pile Caps	Excellent				
Vegetation	N/A				
Signage / Supports	Excellent			3	
Rip Rap (fill)	N/A				
Eathern Embankment	Excellent				
What are the conditions of the existing levees?					
Are there any noticable breaches?					
Settlement of rock plugs and rock weirs?					
Position of stoplogs at the time of the inspection?					
Are there any signs of vandalism?

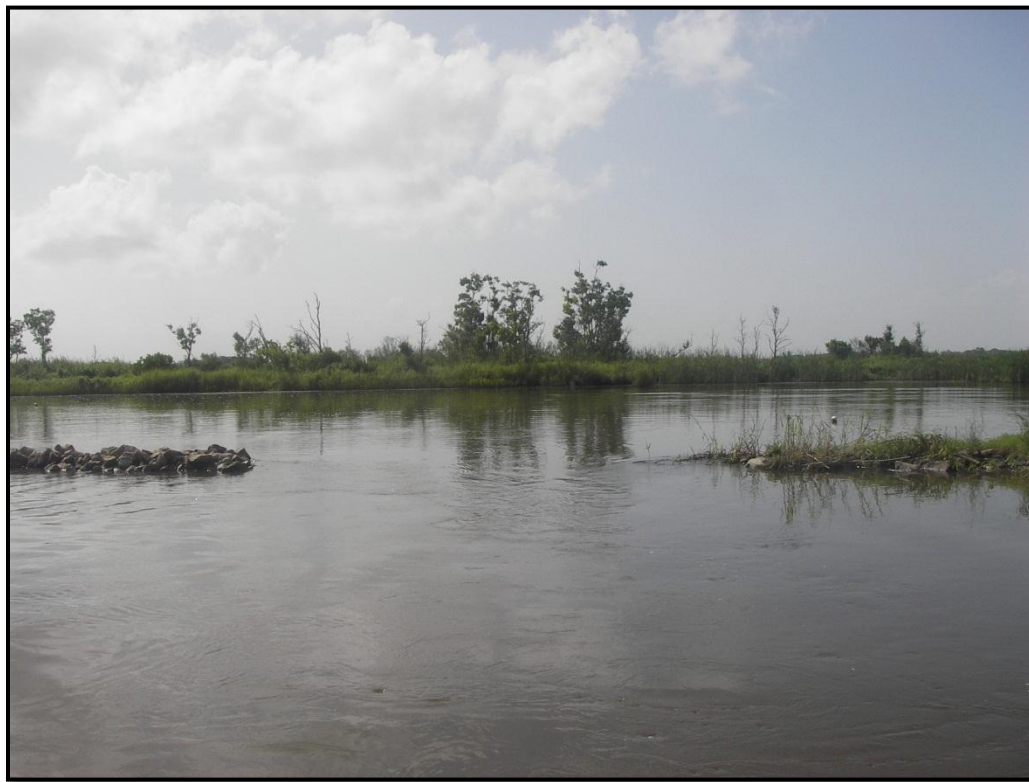
The rock plug located on the north section of the project area near Union Canal has been gapped with the latest maintenance event. (Appendix B; Photo 4)

Photo No. 4, Rock plug gapped as part of maintenance event. (photo taken 07/02/2012)

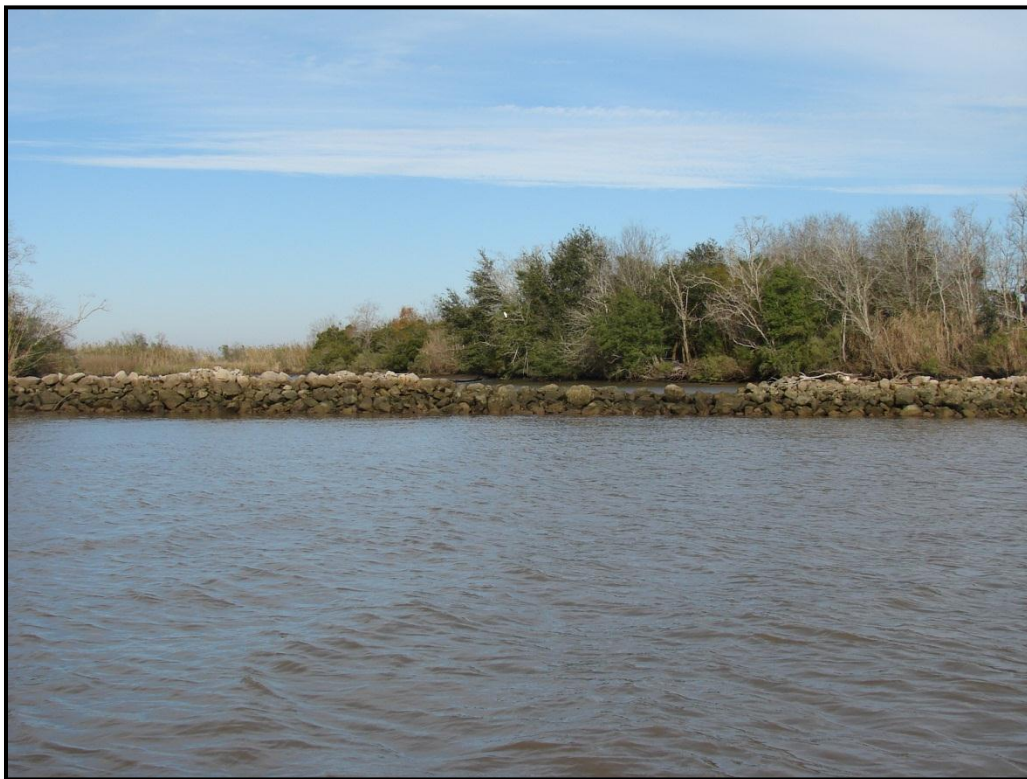
The dike is in excellent condition. Approximately 50 linear feet on the eastern end at an oilfield location canal continues to settle but is in no need of any repairs. This low area is located at N 29° 49' 58.3" and W 91° 59' 25.9". East and west tie-ins are stable; however, there is some minor erosion occurring at the east tie-in which will be monitored on future inspections. The water level was low at the time of the inspection so the entire rock dike was visible. (Appendix B; Photo 5)

Photo No. 5, Rock along north bank of GIWW showing low area

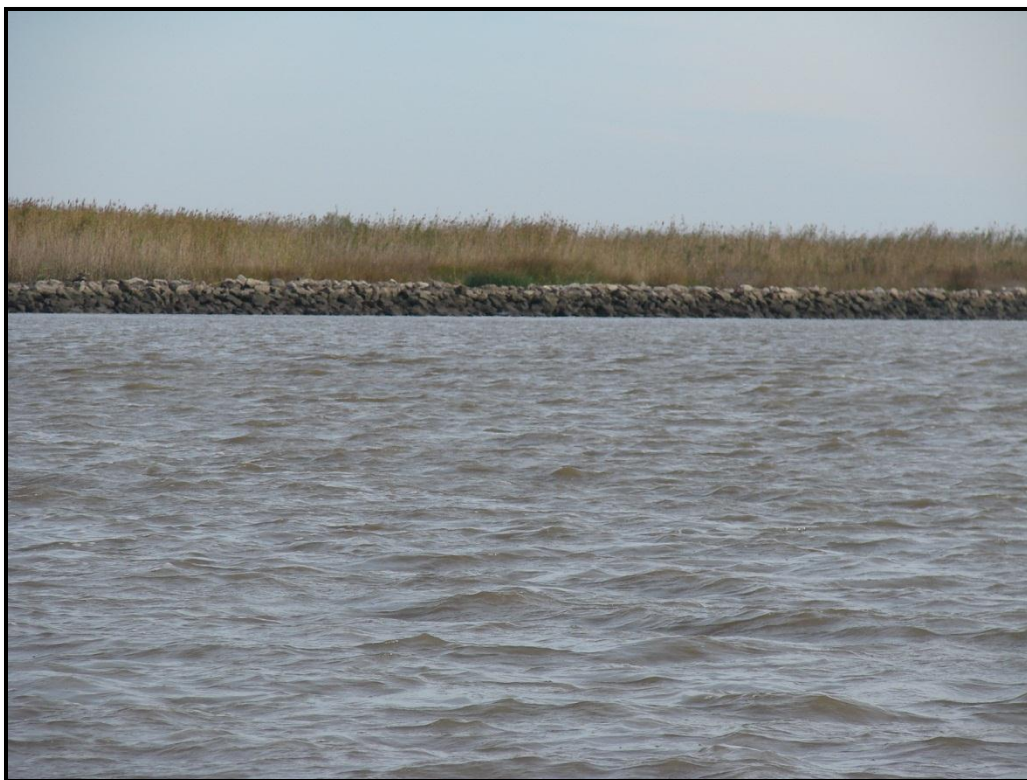
The rock dike is similar to immediate post construction condition and in no need of any repairs. (Appendix B; Photo 6)

Photo No. 6, Rock dike along south bank of GIWW

Item	Condition	Physical Damage	Corrosion	Photo #	Observations and Remarks
Steel Bulkhead / Caps	N/A				
Steel Grating	N/A				
Stop Logs	N/A				
Hardware	N/A				
Timber Piles	N/A				
Timber Wales	N/A				
Galv. Pile Caps	N/A				
Vegetation	N/A				
Signage / Supports	N/A				
Rip Rap (fill)	Excellent			6	Rock dike is in good condition.
Eathem Embankment	N/A				
What are the conditions of the existing levees?					
Are there any noticable breaches?					
Settlement of rock plugs and rock weirs?					
Position of stoplogs at the time of the inspection?					
Are there any signs of vandalism?

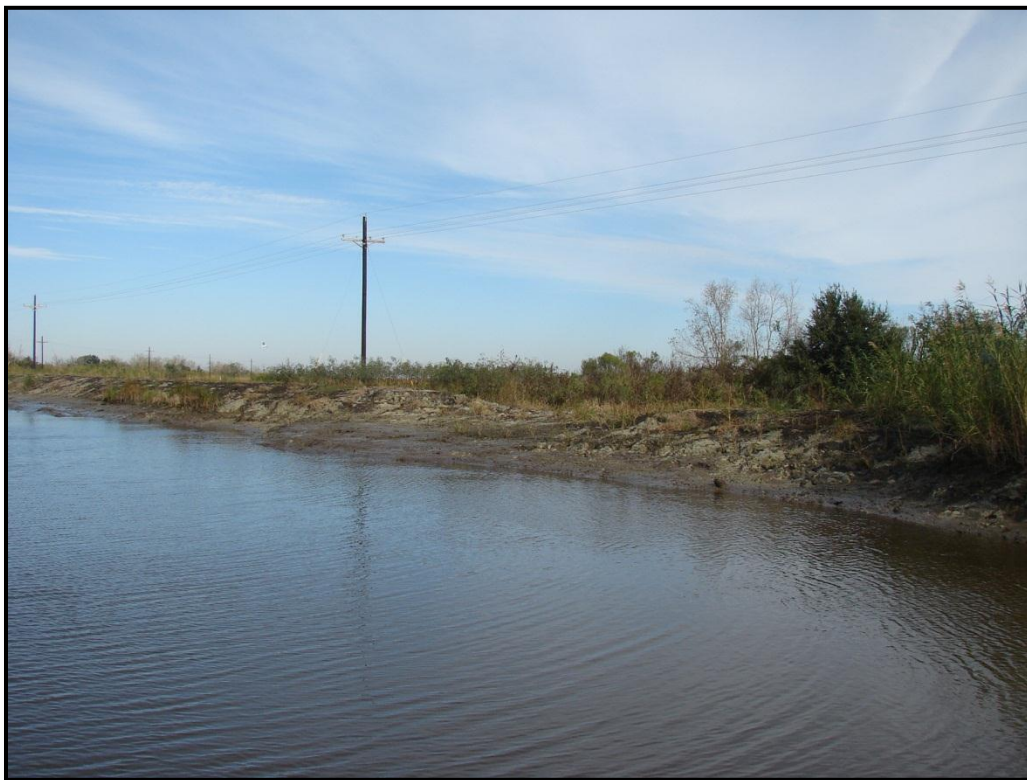
The recently completed spoilbank maintenance on the Oaks canal looks great and was built to a +5.0' elevation. As part of the spoilbank maintenance an old slip that provided access to a landowner camp was plugged. The plug has some settlement in the middle (15-20 feet in length) and is at approximately +2.5' elevation, where the settlement has occurred. (Appendix B; Photo 7)

Photo No. 7, Spoilbank Maintenance along Oaks Canal

Item	Condition	Physical Damage	Corrosion	Photo #	Observations and Remarks
Steel Bulkhead / Caps	N/A				
Steel Grating	N/A				
Stop Logs	N/A				
Hardware	N/A				
Timber Piles	N/A				
Timber Wales	N/A				
Galv. Pile Caps	N/A				
Vegetation	Good			7	Plantings from recent maintenance event still in place. No growth due to short duration in soil and time of year.
Signage /Supports	N/A				
Rip Rap (fill)	N/A				
Earthen Embankment	Good			7	Spoilbank is built up to +5' elevation or greater. Earthen canal plug has experienced settlement and may need additional work.
What are the conditions of the existing levees?					
Are there any noticeable breaches?					
Settlement of rock plugs and rock weirs?					
Position of stoplogs at the time of the inspection?					
Are there any signs of vandalism?

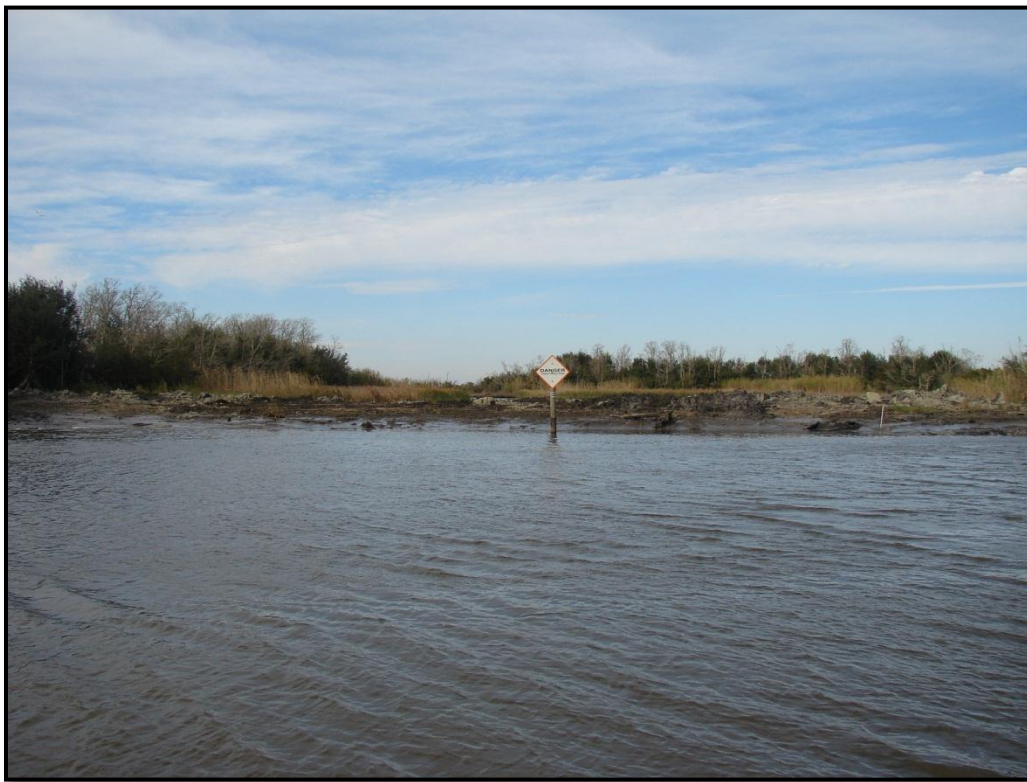
The Earthen Canal plug has experienced some settlement in a 50' section and is approximately at a +2.5' elevation where the settlement occurred.

Photo No. 8, Earthen Canal plug on Union Canal

Item	Condition	Physical Damage	Corrosion	Photo #	Observations and Remarks
Steel Bulkhead / Caps	N/A				
Steel Grating	N/A				
Stop Logs	N/A				
Hardware	N/A				
Timber Piles	N/A				
Timber Wales	N/A				
Galv. Pile Caps	N/A				
Vegetation	Good			8	Plantings from recent maintenance event still in place. No growth due to short duration in soil and time of year.
Signage /Supports	N/A				
Rip Rap/dike	N/A				
Earthen Embankment	Good			8	The earthen canal plug has experienced settlement and may need additional work.
What are the conditions of the existing levees?					
Are there any noticable breaches?					
Settlement of rock plugs and rock weirs?					
Position of stoplogs at the time of the inspection?					
Are there any signs of vandalism?

Overall, the Oaks/Avery Canals Hydrologic Restoration Project is in good condition and functioning as designed. Additional work may need to be done at a later time to shore up the earthen canal plugs constructed during the recent maintenance event. High tides and southerly winds may cause water to migrate across the plugs in the settled sections, and cutting may occur.
